AGENDA
REGULAR DRAINAGE MEETING
Wednesday, December 30, 2020 9:30 AM
Large Conference Room

Drainage Work Order Request For Repair Hardin County

Investigation and Repair Summary:

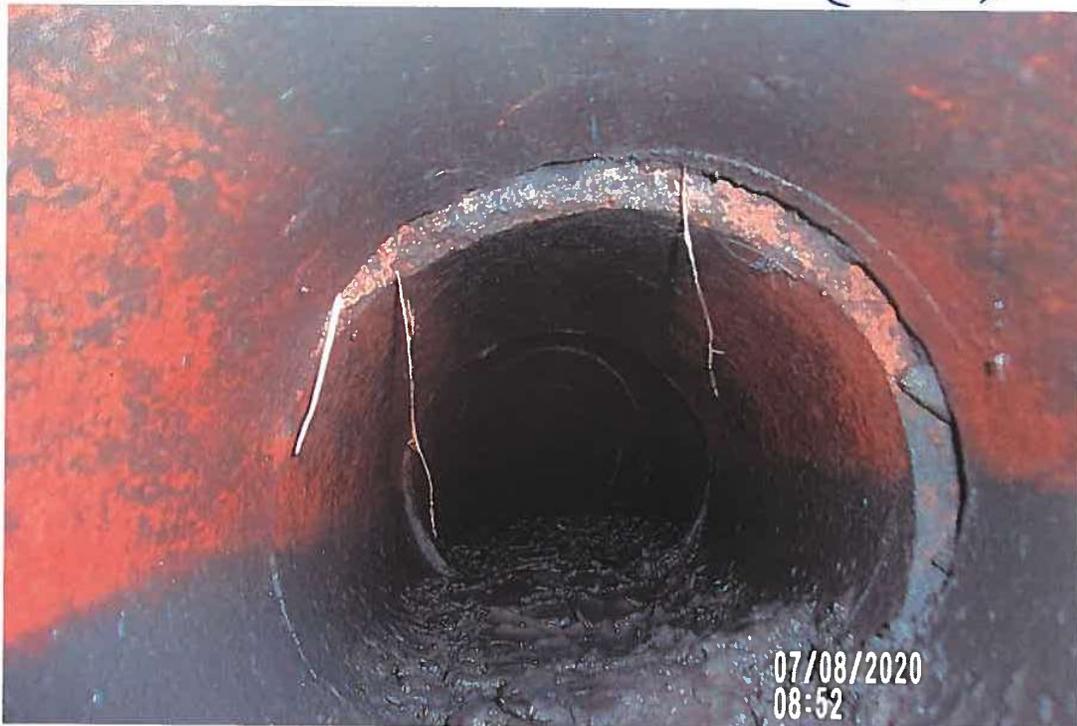
GPS# 252 TOP 14" CLAY TILE
(4.9' ± DEEP)

PICTURE# 4052 IS LOOKING NW UPSTREAM INSIDE 8" CLAY TILE WITH 2" ± OF MUD IN FLOWLINE FROM GPS# 250. TILE IS IN GOOD SHAPE WITH FEW FINE ROOTS AND A FEW OFFSET JOINTS

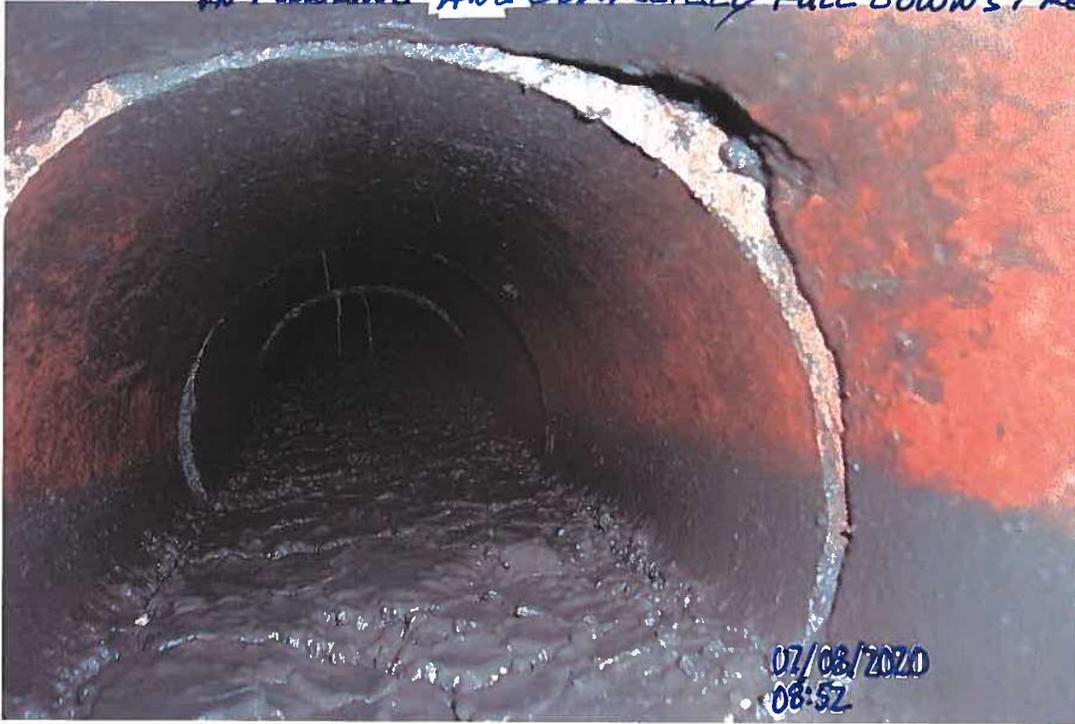
PICTURE # 4053 IS LOOKING SE DOWNSTREAM INSIDE 8" CLAY TILE WITH 2"± OF MUD IN FLOWLINE FROM GPS # 251. TILE HAS A LITTLE POPOUT AT NEXT JOINT AND IS IN GOOD SHAPE WITH 2" MUD IN FLOWLINE AND COMPLETELY FULL DOWNSTREAM. RON THINKS THIS TILE IS ABANDONED.

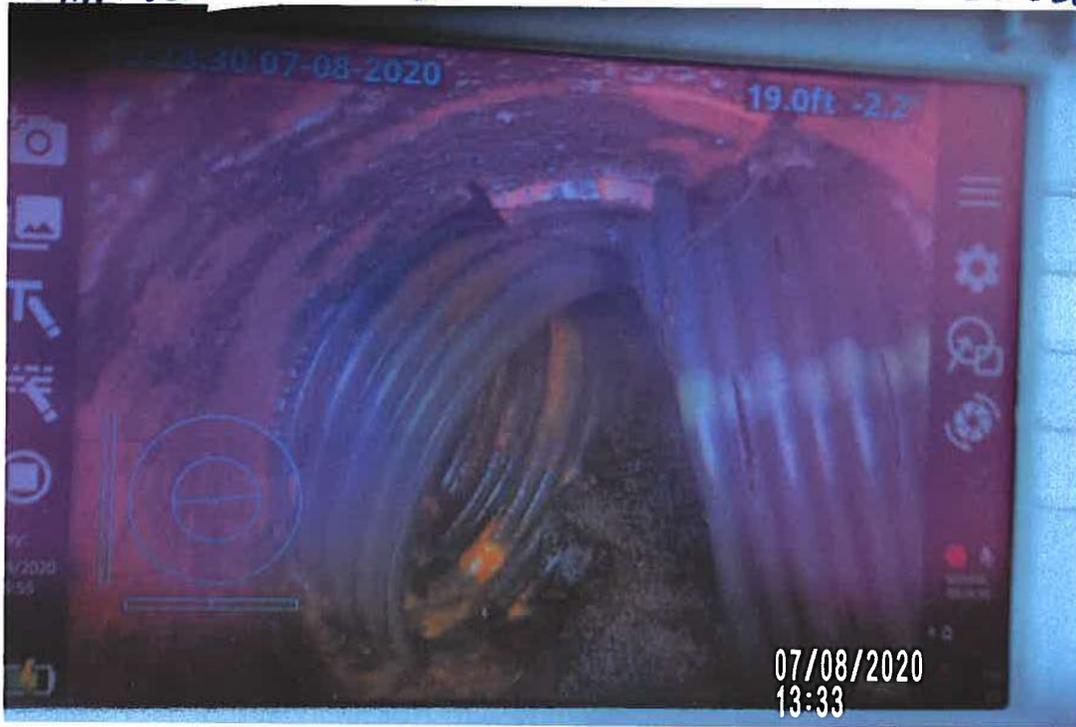
PICTURE # 4060 IS LOOKING UPSTREAM INSIDE 8" CLAY TILE @ 2 1/3' UPSTREAM FROM BEEHIVE INTAKE SHOWING 5" PERF SW HOPE TILE FROM EAST & FROM WEST CONNECTING AT SAME LOCATION WITH SIDES CRACKED AND TOP CAVING DOWN WITH TILE PLUGGED UPSTREAM WITH SOIL & ROOTS

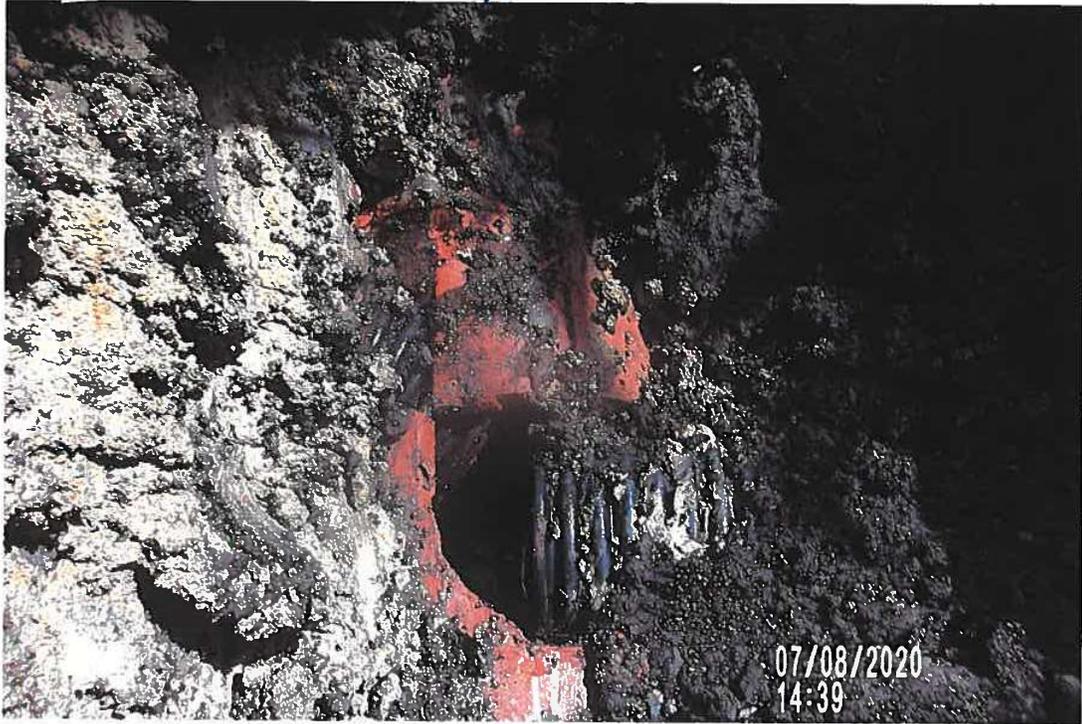
PICTURE # 4062 IS LOOKING SE AT TOP VIEW OF 5" HDPE SW PERF TILE FROM WEST & EAST TIEING INTO SAME LOCATION INTO BROKEN 8" CLAY TILE AND PLUGGED LINE

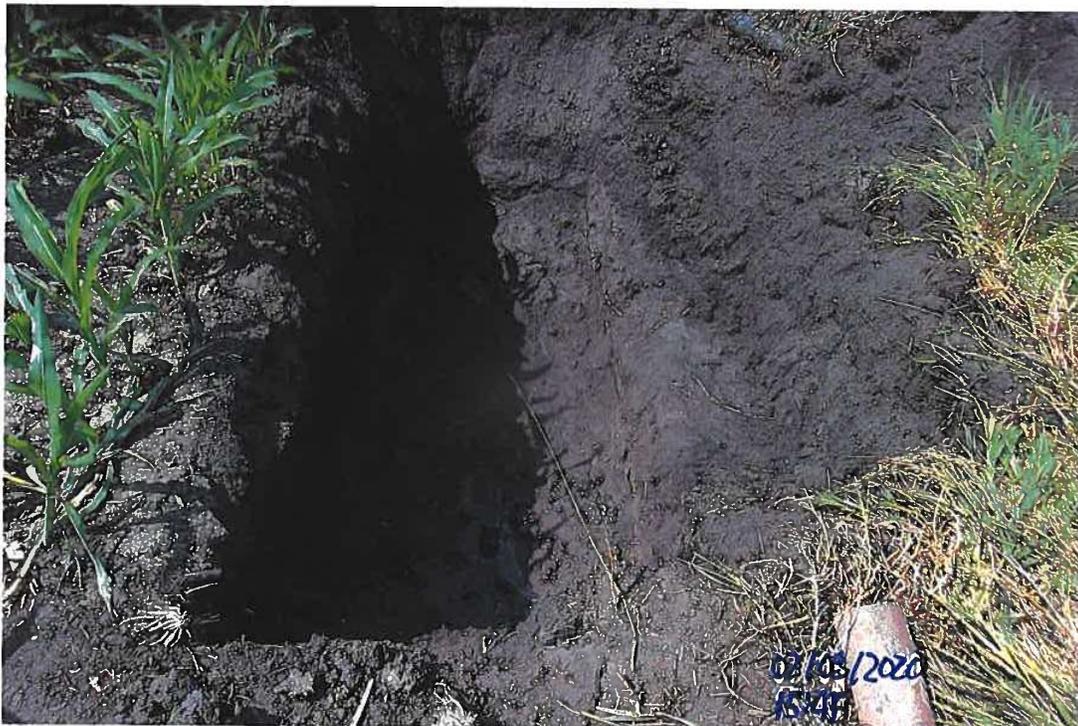
PICTURE# 4065 IS LOOKING SOUTH SHOWING 5" HOPE TILE CONNECTION WITH 5" HOPE TILE FROM WEST HAVING A SAC OR HUMPE UP IN A SPOT.

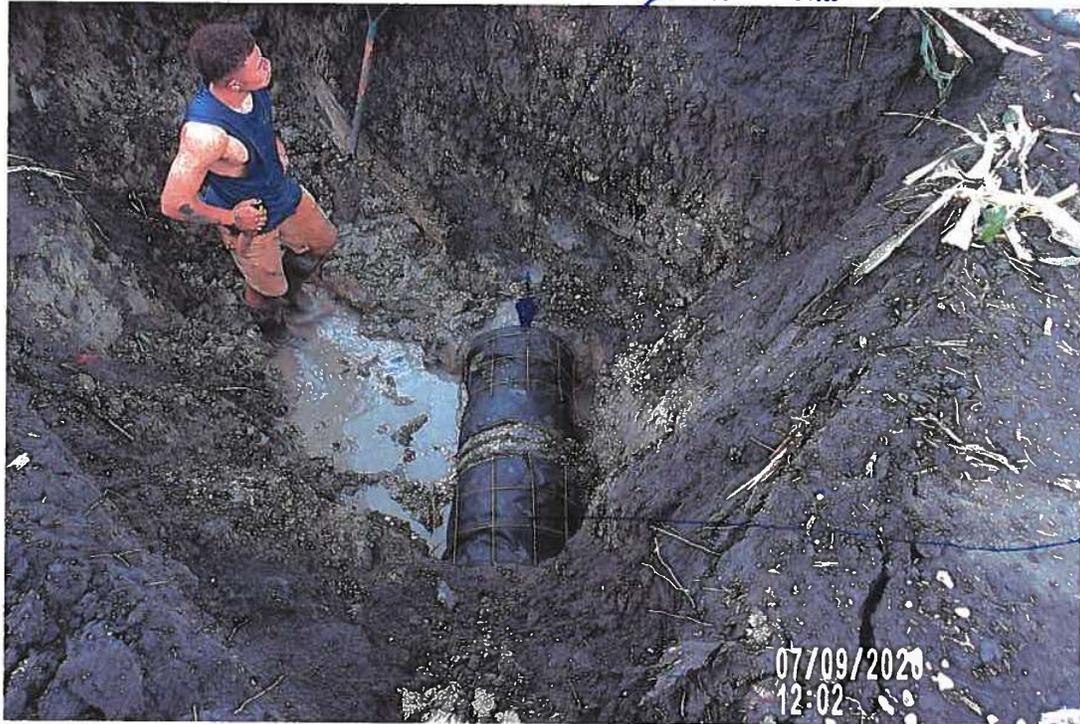
PICTURE # 4095 IS LOOKING SE SHOWING 2.6 LF. PIECE
OF 15" Ø DW HDPE NONPERF TILE IN PLACE FOR REPAIR
WITH BEDDING ROCK UNDER TILE

① 14" CLAY TILE REPAIR (NORTH OF D41) 2.6 LF 15" Ø DW HOPE WOOD PERF TILE

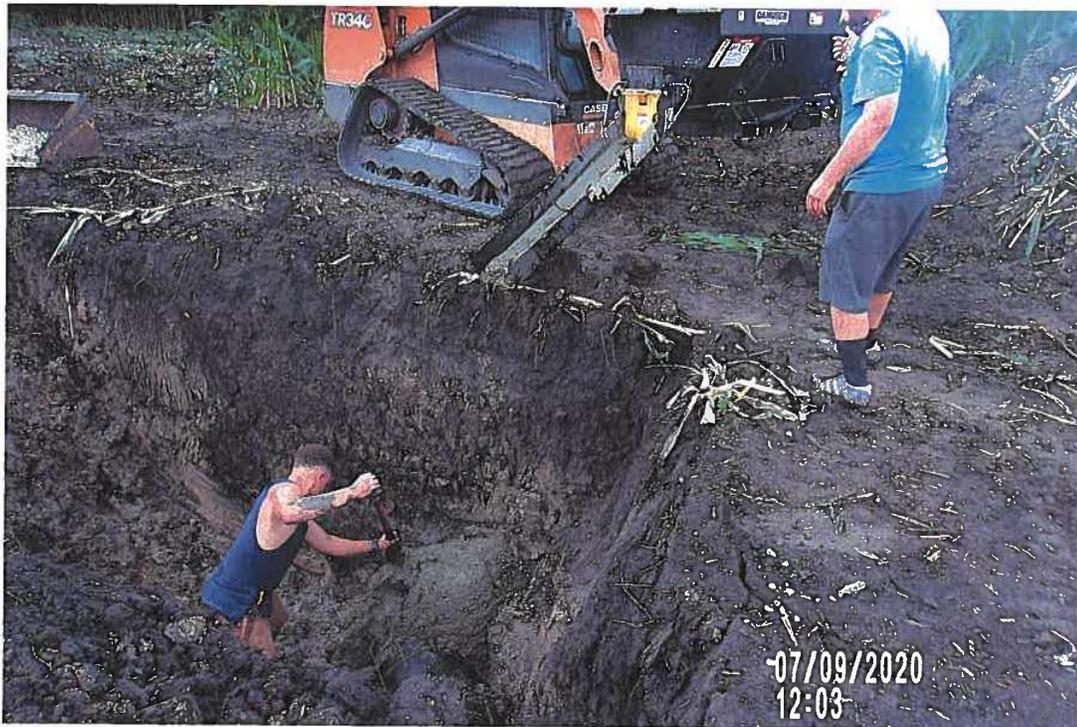
PICTURE# 4096 IS LOOKING NW SHOWING FABRIC & MESH OVER NORTH & SOUTH TIE IN JOINTS FOR 14" CLAY TILE REPAIR NORTH OF COMWY D41

6.5# 2.0'x3.5' FABRIC & 1.5' X 4.0' WIRE MESH OVER JOINT BEFORE COLLARS POURED

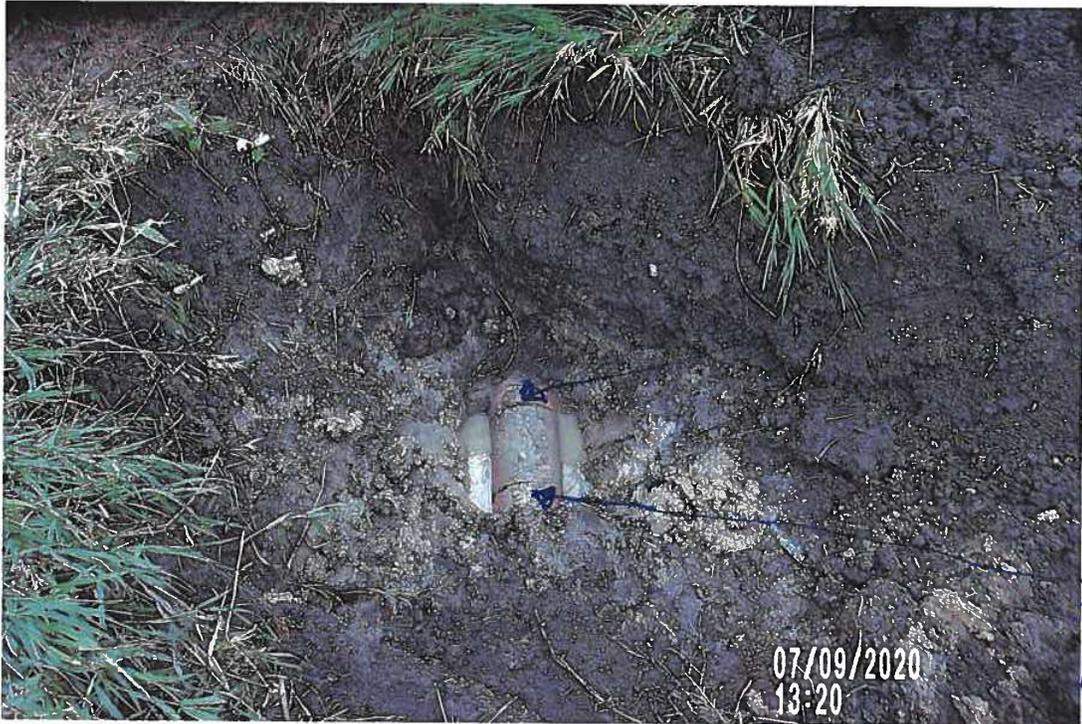
PICTURE #4102 IS LOOKING NW IN SOUTH DITCH OF CO HWY 041 9.5' ± WEST OF WEST RIM OF BEEHIVE INTAKE SHOWING 8" CLAY TILE SECTION ROLLED BACK IN PLACE.

③ 8" CLAY ROLL BACK IN (SOUTH DITCH OF D41) REPAIR

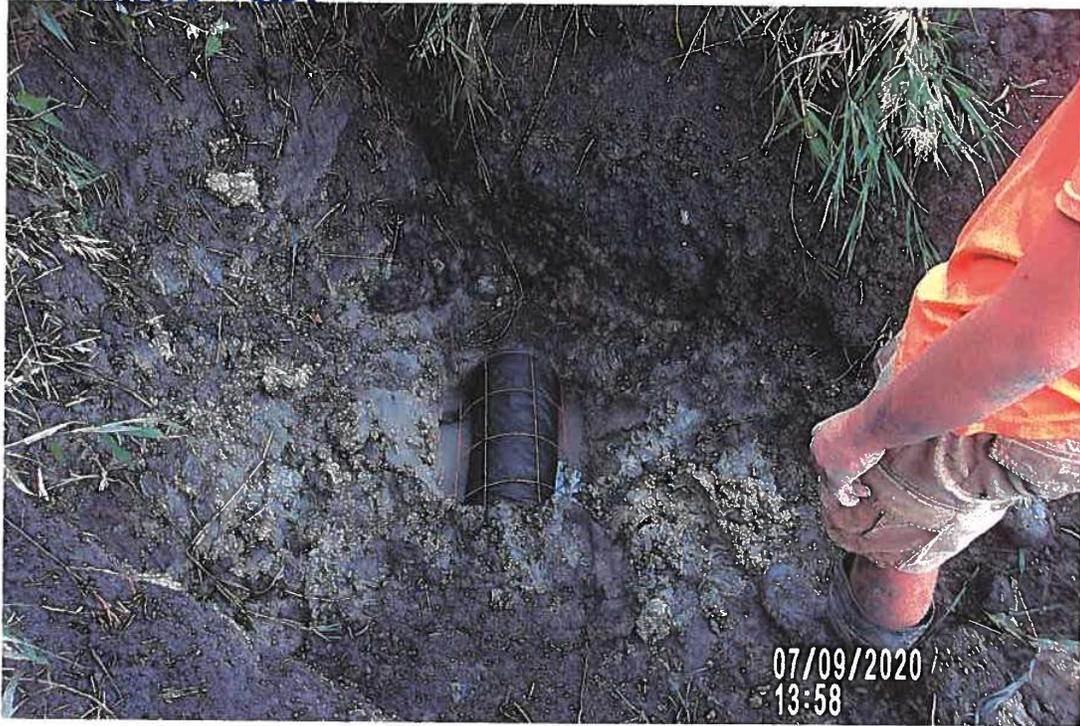
PICTURE #4104 IS LOOKING NW SHOWING 2.0'X2.0' ENGINEERING FABRIC & 1.5'X2.0' 6"X6" SQUARE WIRE MESH OVER JOINT FOR 8" CLAY TILE SECTION ROLLED BACK INTO PLACE BEFORE 3/4 CONCRETE COLLAR POURED.

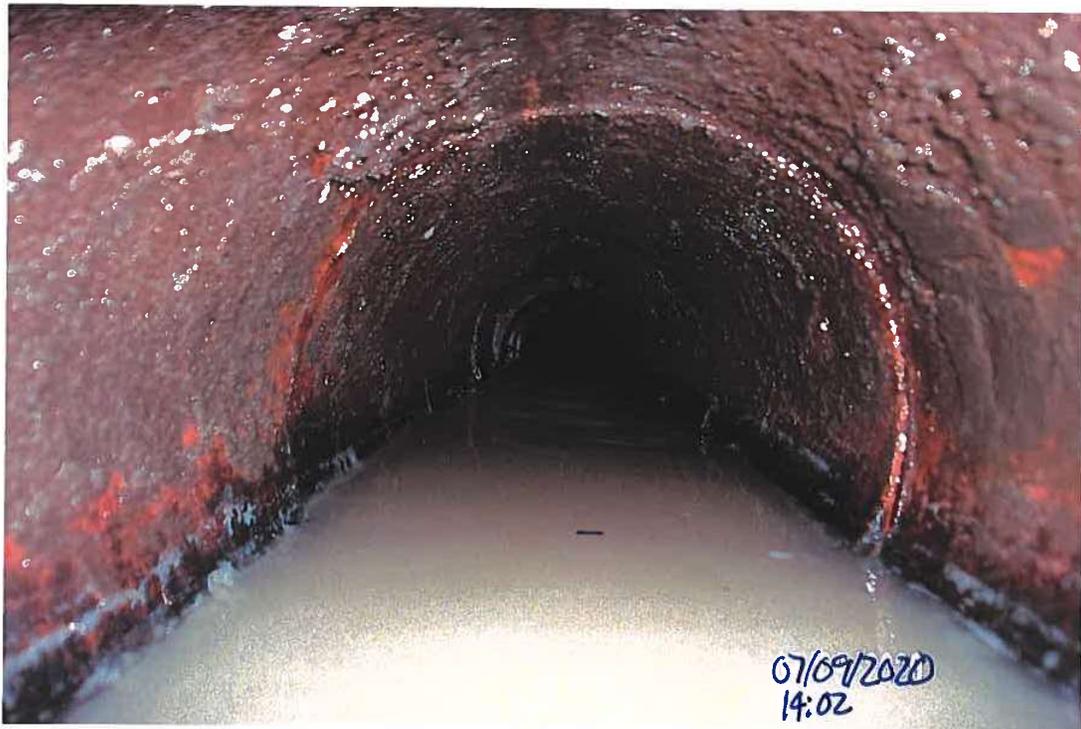
PICTURE #4105 IS LOOKING DOWNSTREAM INSIDE 8" CLAY TILE WITH ABOUT 2"± OF SLOW WATER FLOW.

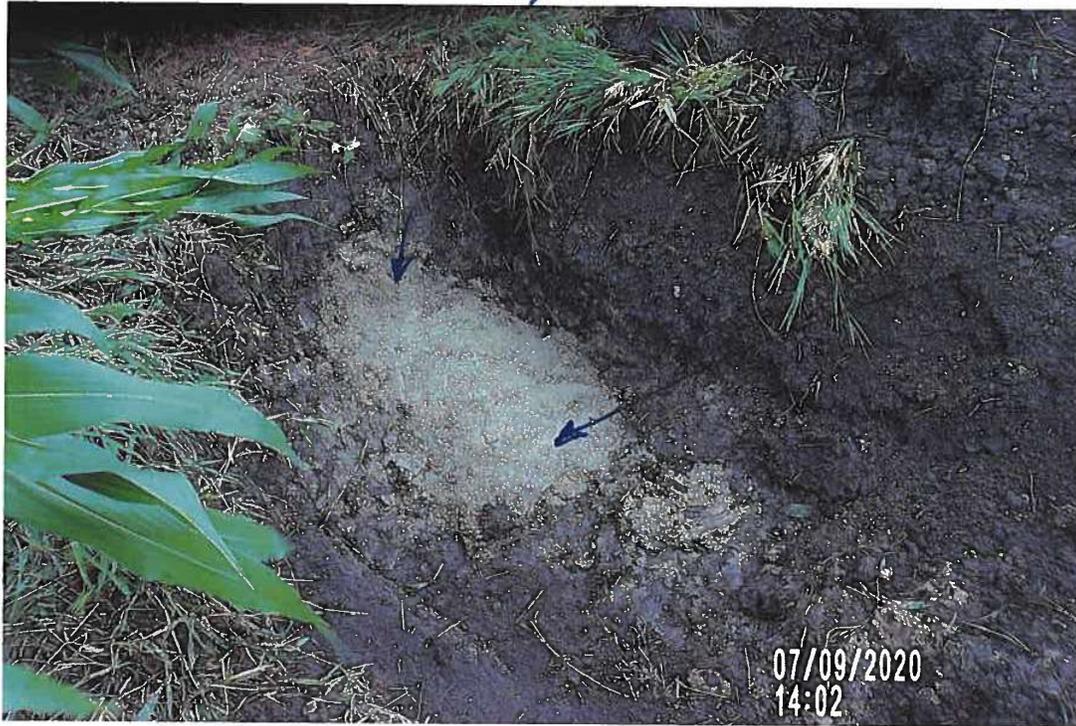
PICTURE # 4106 IS LOOKING NORTH SHOWING 3/4" CONCRETE COLLAR POURED FOR 8" CLAY TILE SECTION ROLLED BACK INTO PLACE WEST OF BEHIVE ENTIRE. CREW USED 5-60LB BAGS OF QUIKRETE HIGH STRENGTH / GP#255

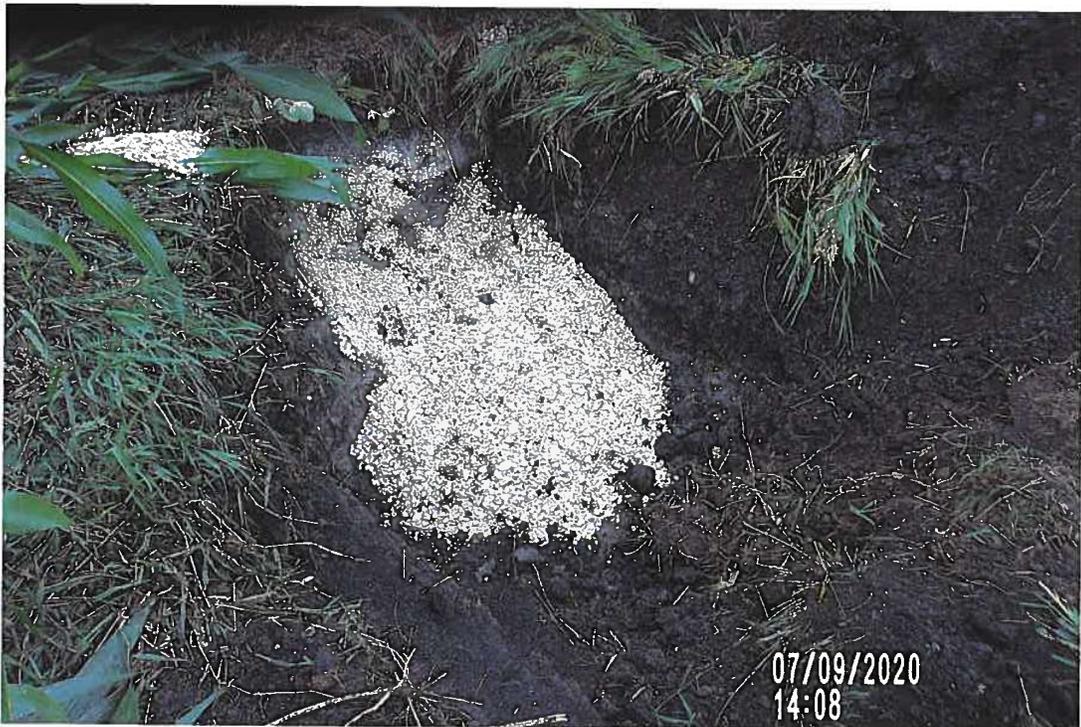
PICTURE # 4107 IS LOOKING NORTH SHOWING BEDDING ROCK BACKFILLED AROUND 3/4" CONCRETE COLLAR IN SOUTH DITCH OF HWY D41 FOR 8" CLAY TILE SECTION ROLLED BACK INTO PLACE.

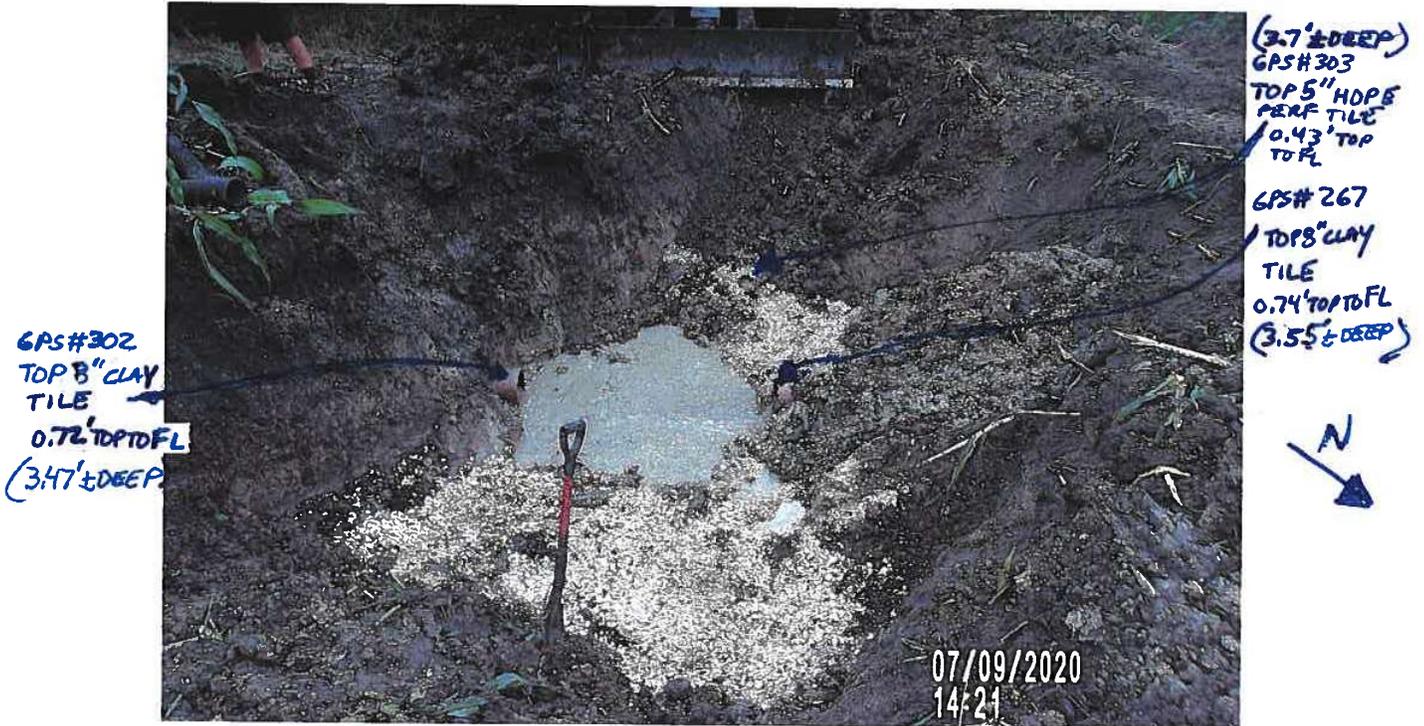
PICTURE # 4108 IS LOOKING SW SHOWING 8" CLAY TILE REMOVED WITH BEDDING ROCK IN PLACE TO TIE IN 5" SW HOPE PERF TILE LINES INTO 8" CLAY TILE LATERAL

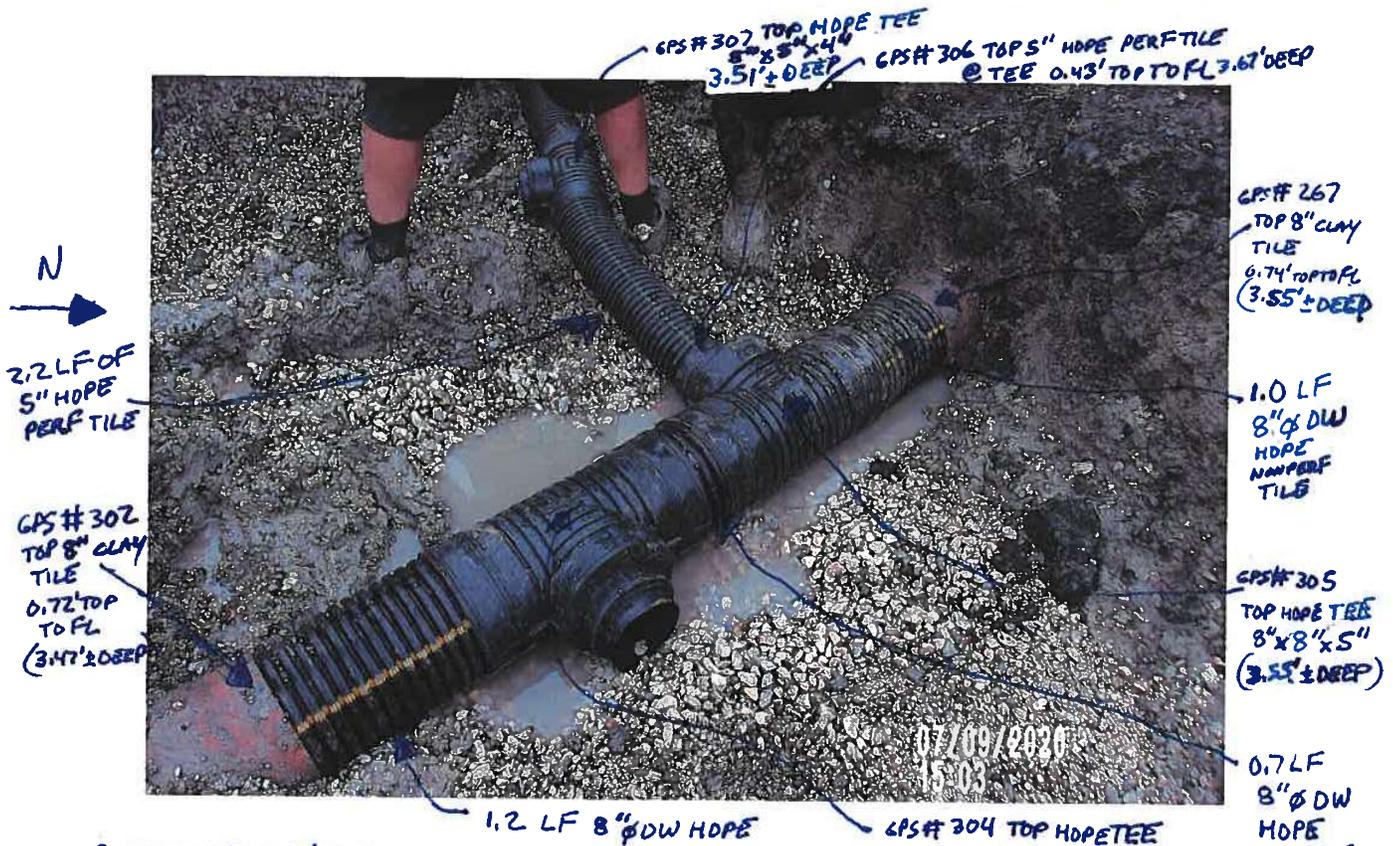
PICTURE # 4109 IS LOOKING WEST AT 8" DW HOPE NONPERF TILE INSTALLED WITH A 8" x 8" x 5" HOPE TEE EAST & WEST & 5" HOPE PERF TILE INSTALLED INTO TEE WITH 5" x 5" x 4" HOPE TEE INSTALLED ON IT WITH BEDDING ROCK UNDER CONNECTION.

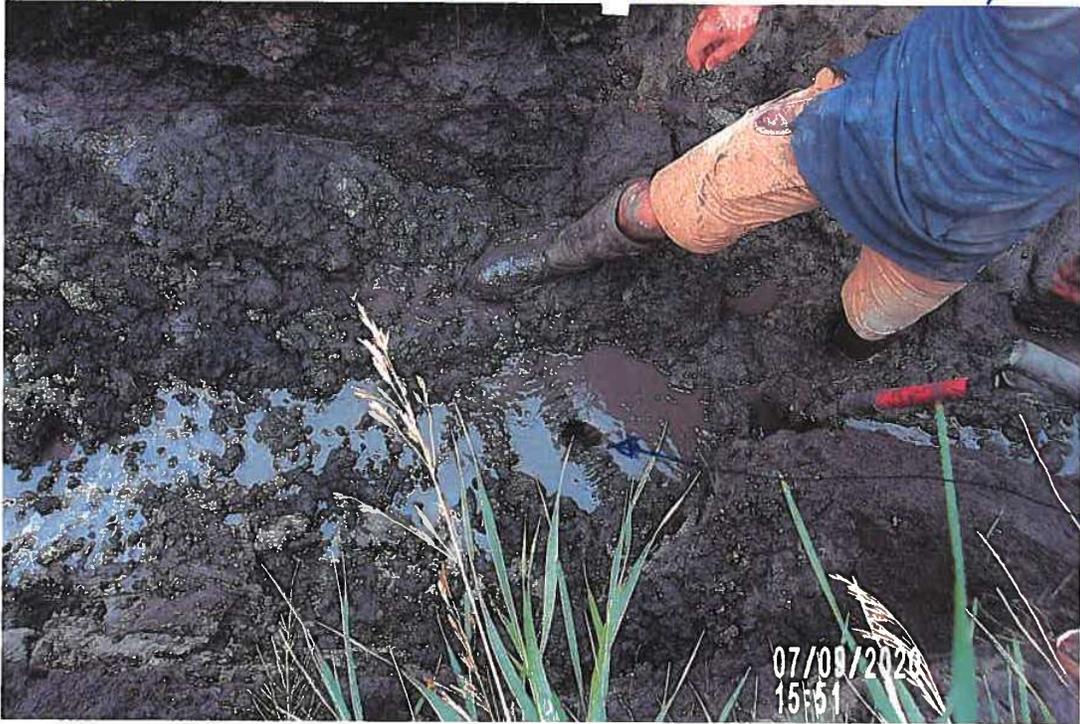
PICTURE # 4116 IS LOOKING EAST SHOWING HOLE IN TOP OF 8" HOPE NONPERF TILE EXCAVATED BY ANOTHER CONTRACTOR AND LEFT OPEN 322'E SOUTH OF COM HWY 041 & 9.6'±

EAST OF
EAST ROW
FENCE
COM HWY
S-27
IN WETLAND
AREA

PICTURE #4121 IS LOOKING AT FINISHED 3/4 CONCRETE COLLAR OVER HOLE IN 8" DW HOPE NON PERF TILE. CREW USED 4 - 60 LB BAGS OF QUIKRETE HIGH STRENGTH CONCRETE ON COLLAR

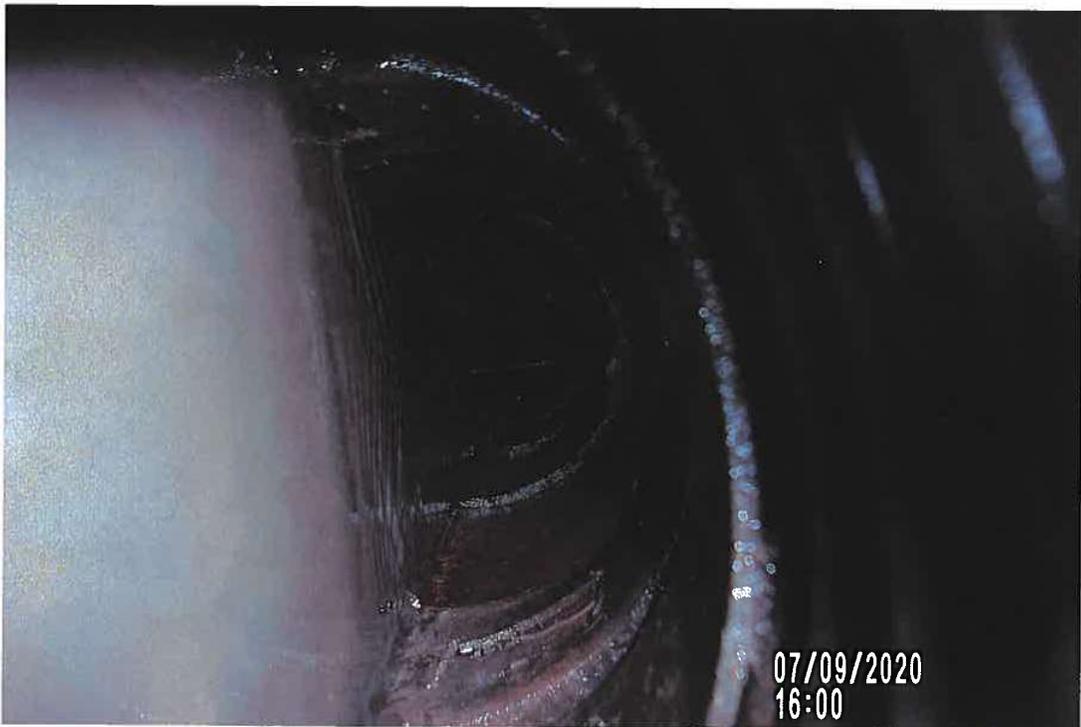
PICTURE # 4117 IS LOOKING DOWNSTREAM (FROM GPS # 311) INSIDE 8" TILE SHOWING CHANGE OF MATERIAL. TILE LOOKS GOOD SHAPE WITH WATER LEVEL AT 4" (SLOW FLOW). ALSO FLOWLINE HAS SOFT MUCK BUT SHOULD FLUSH OUT NOW TILE OPEN.

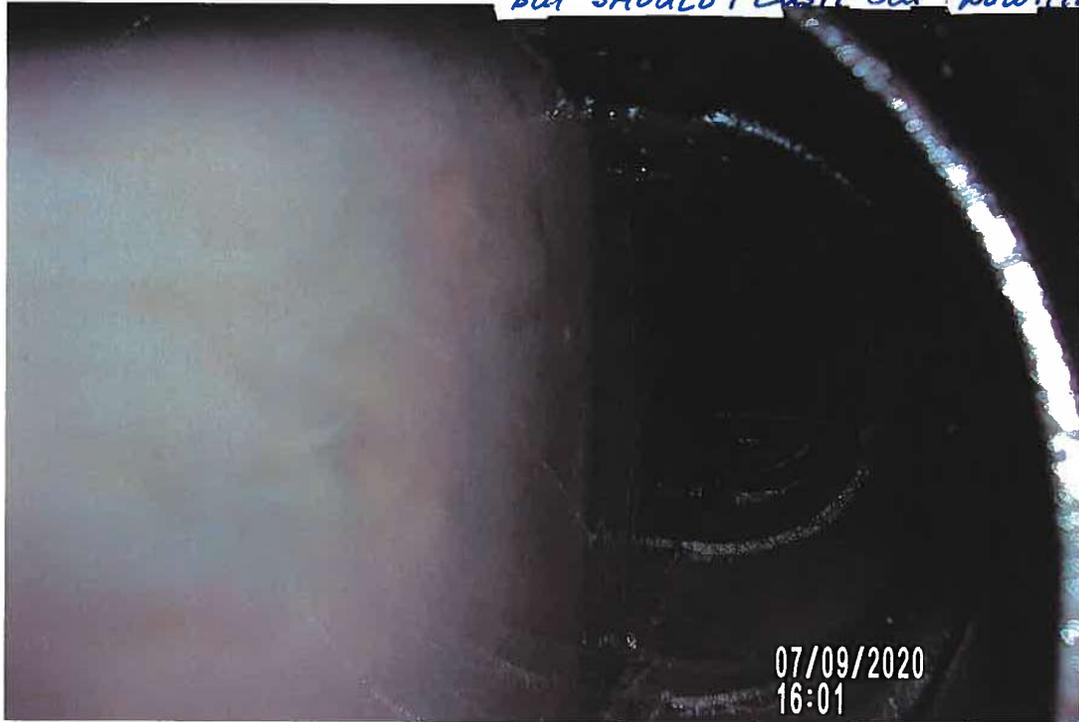
PICTURE # 4119 IS LOOKING UPSTREAM (FROM GPS #311) INSIDE 8" TILE
SHOWING TILE IN GOOD SHAPE BUT CHANGED TO CLAY WITH
WATER LEVEL AT 4" (SLOW FLOW). ALSO FLOWLINE HAS SOFT MUCK
BUT SHOULD FLUSH OUT NOW THAT IT IS
OPEN,

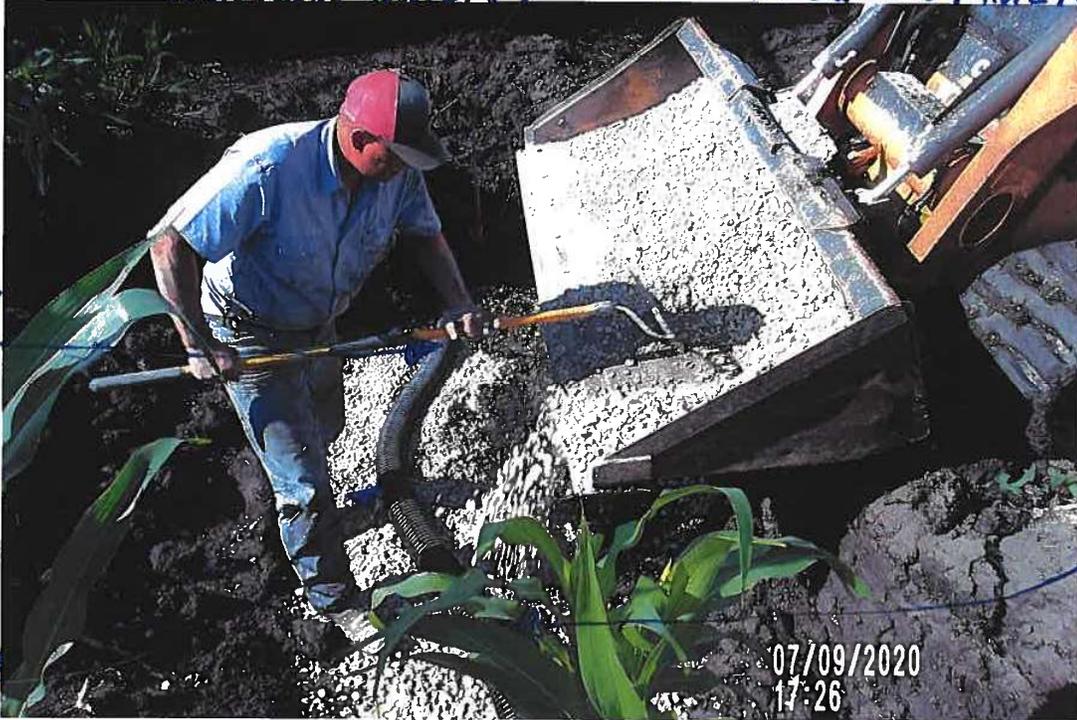
PICTURE #4122 IS LOOKING NW SHOWING 4" SW HOPE PERF TILE THAT NEEDS REPLACED AFTER CUTTING TILE WHILE EXCAVATING TO CHECK LAT #2 TILE FLOW STATUS ON EAST SIDE OF CO HWY S-27.

PICTURE # 4123 IS LOOKING NORTH SHOWING 9.8 LF OF 4" HDPE SW PERF TILE INSTALLED WITH 4" HDPE INTERNAL COUPLERS AND OFF TO SIDE SOME FOR FIRMER GROUND & BEDDED WITH ROCK UNDER. GPS # 312 TOP EXISTING 4" HDPE PERF TILE

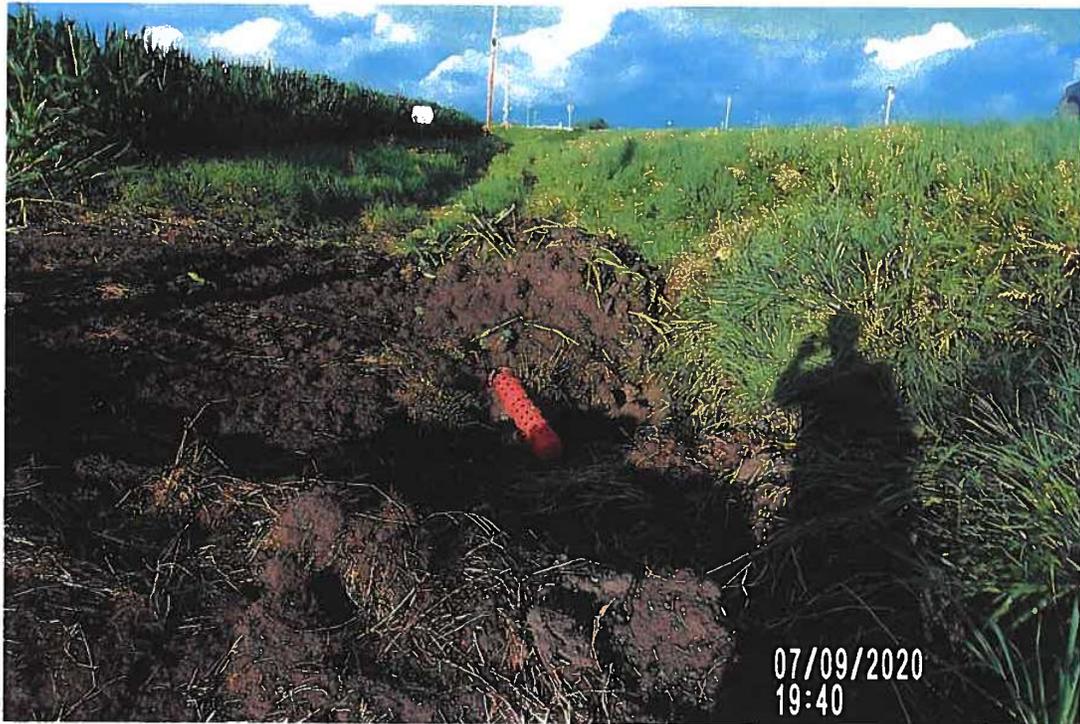
PICTURE# 4128 IS LOOKING NW SHOWING NORTH 14" CLAY TILE EXPOSED TRENCH WITH TILE BEDDED WITH ROCK TO TOP OF TILE

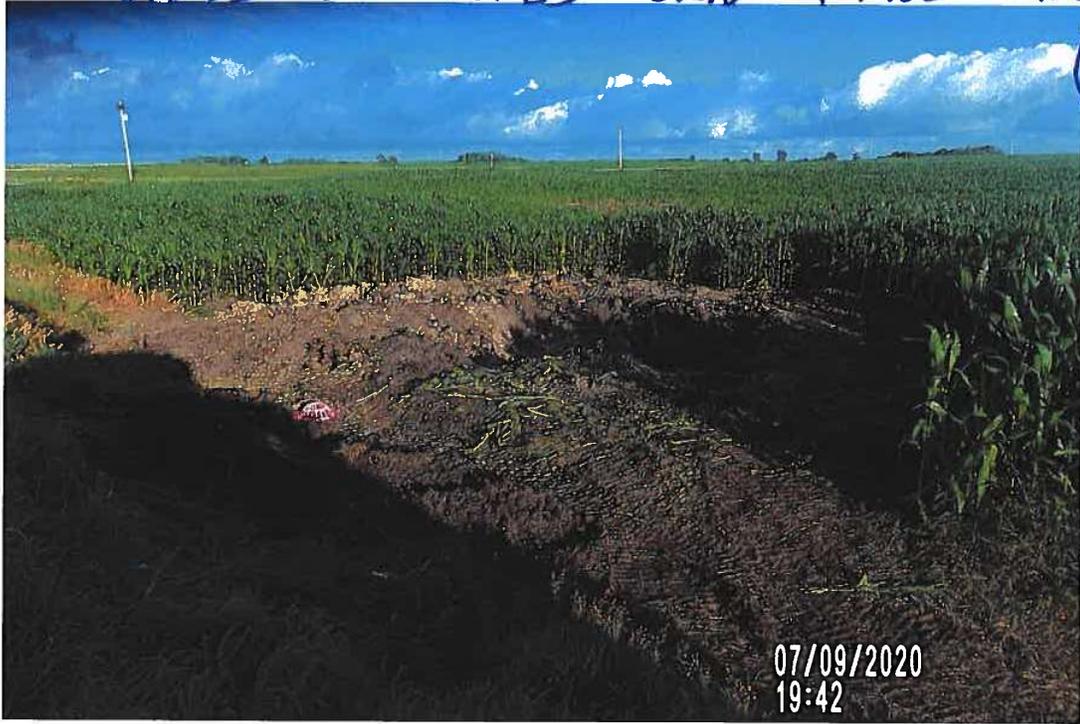
PICTURE#4131 IS LOOKING SE SHOWING 5" HOPE TIE IN
TRENCH THAT NEEDS BACK FILLED YET. PICTURE
SHOWS 0.051 ACRES CORN DAMAGE DURING REPAIR

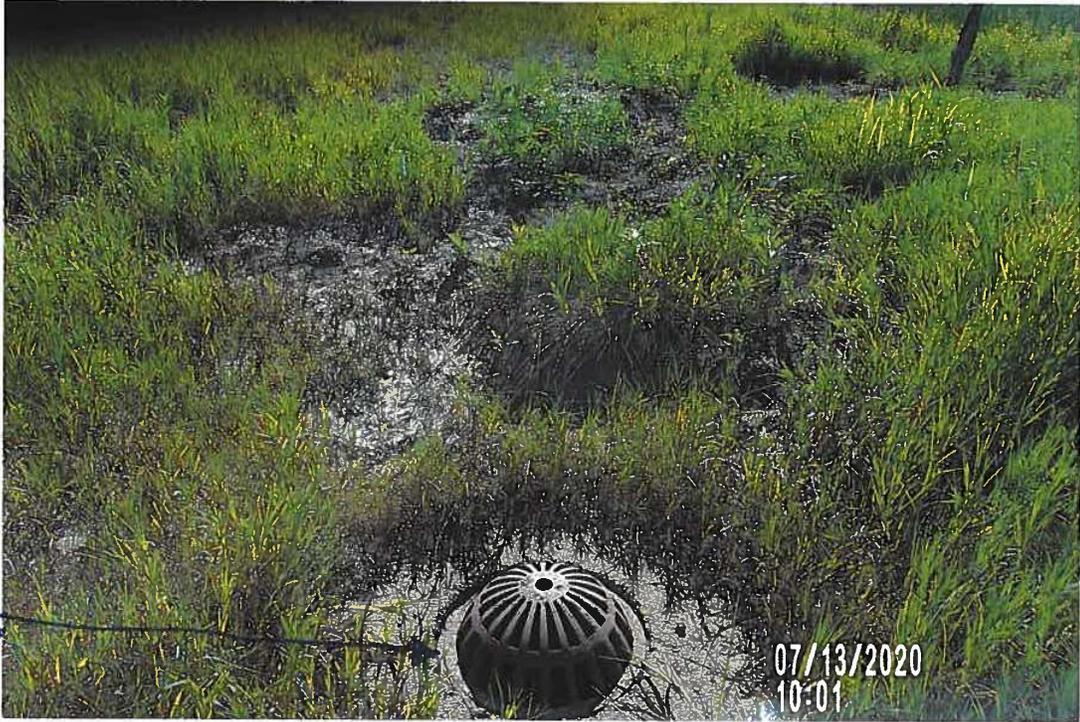
PICTURE# 4138 IS LOOKING EAST SHOWING SMALL SINKHOLE ON EAST SIDE OF BEEHIVE INTAKE PER RANDY'S REPORT AREA LOOKED LIKE IT HAD BEEN EXCAVATED AT ONETIME

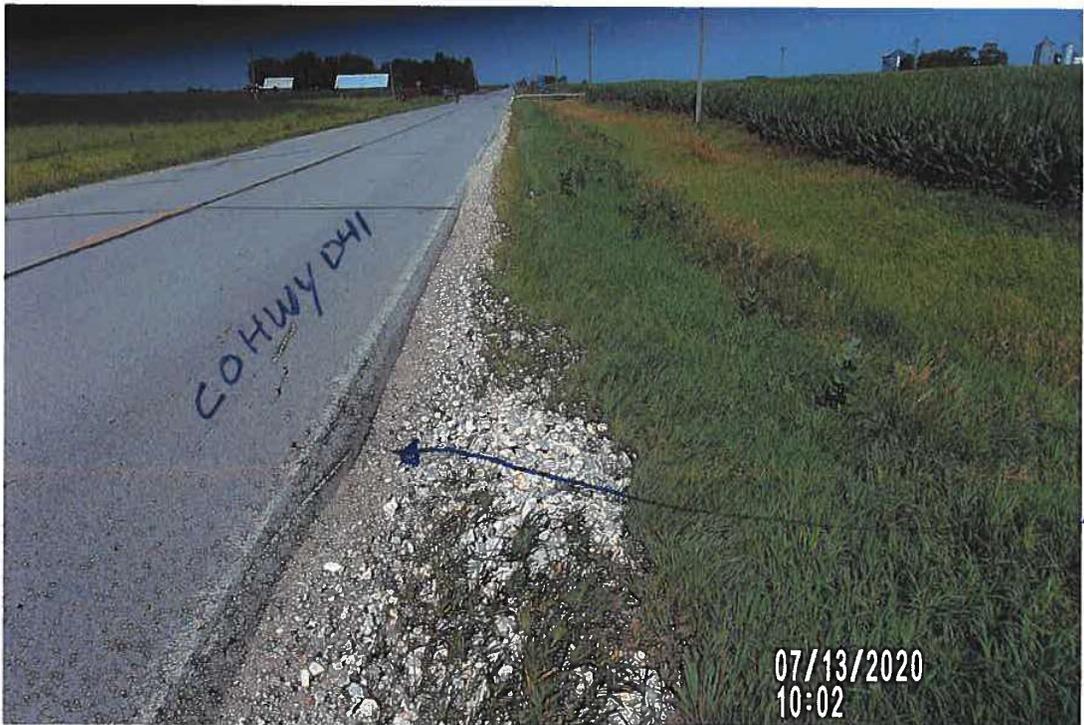
DIP IN
GRAVEL
SHOULDER
WITH
FRESH
ROCK

PICTURE#4139 IS LOOKING WEST ON NORTH SHOULDER OF CO HWY 241 SHOWING SINK HOLE PER RANDY'S REPORT WITH A LITTLE DIP IN ALL 2 GRAVEL AND APPEARS SOMEONE HAS PUT FRESH ROCK IN SINK HOLE.

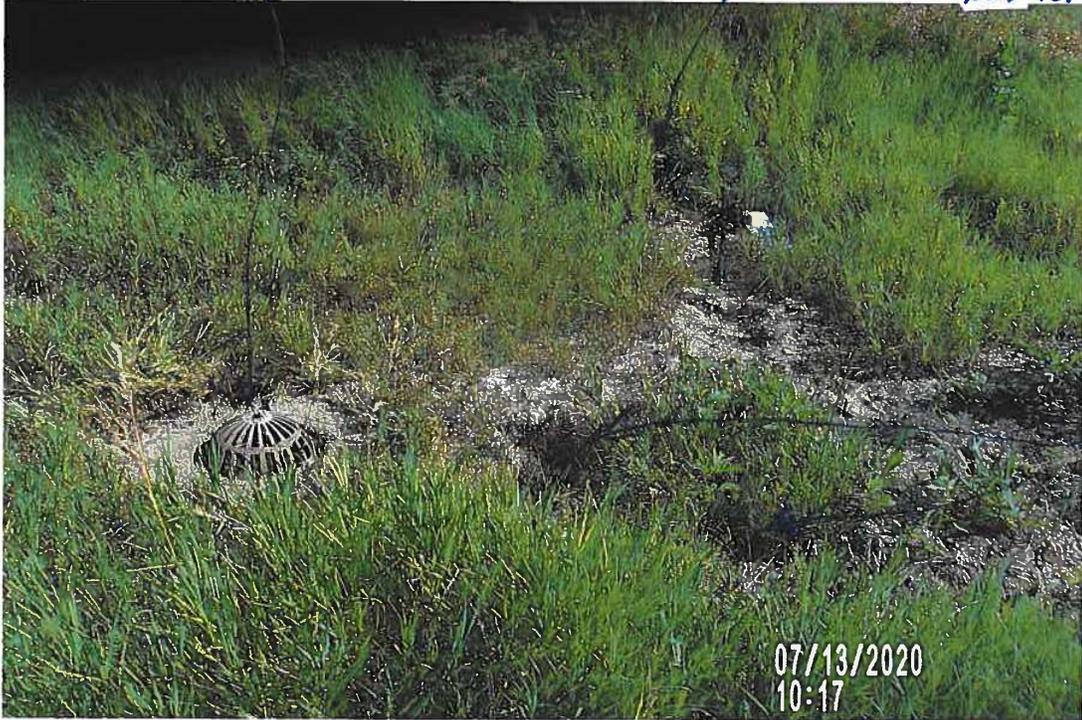
PICTURE# 4140 IS LOOKING NORTH TOWARDS CO HWY D41
 SHOWING 18" CMP OUTLET FOR CULVERT UNDER CO HWY D41
 & 18" BEEHIVE INTAKE IN SOUTH DITCH OF CO HWY D41 WITH SINKHOLE
 GPS# 337 NRM BEEHIVE INTAKE GPS# 338 TOP 18" CMP TO EAST,
 1.54' TO TOP FL

SINKHOLE
 EAST OF
 BEEHIVE
 INTAKE

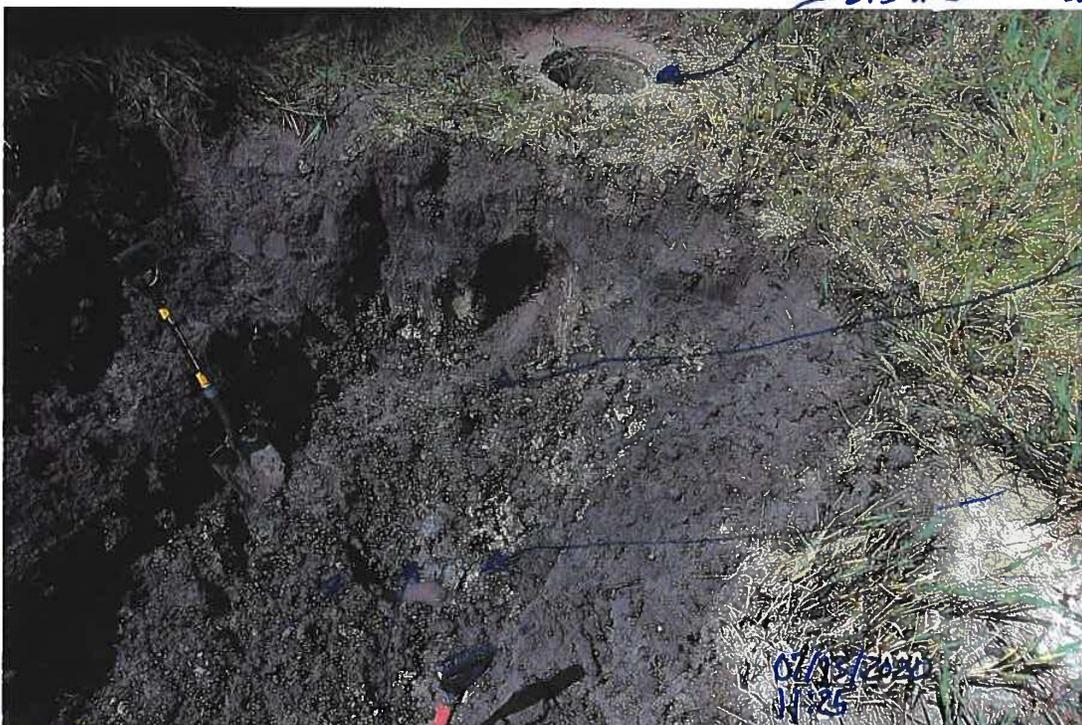
PICTURE# 4142 IS LOOKING SE SHOWING 6" HDPE PERF TILE CONNECTION TO 6" CLAY TILE EAST OF BEEHIVE INTAKE. PICTURE SHOWS CREW EXCAVATING TO CHECK ON TILE CONNECTION. 6" HDPE / 6" CLAY TILE CONNECTION CLAY TILE BROKE & WILL NEED REPLACED.

TILE BROKE & WILL NEED REPLACED.

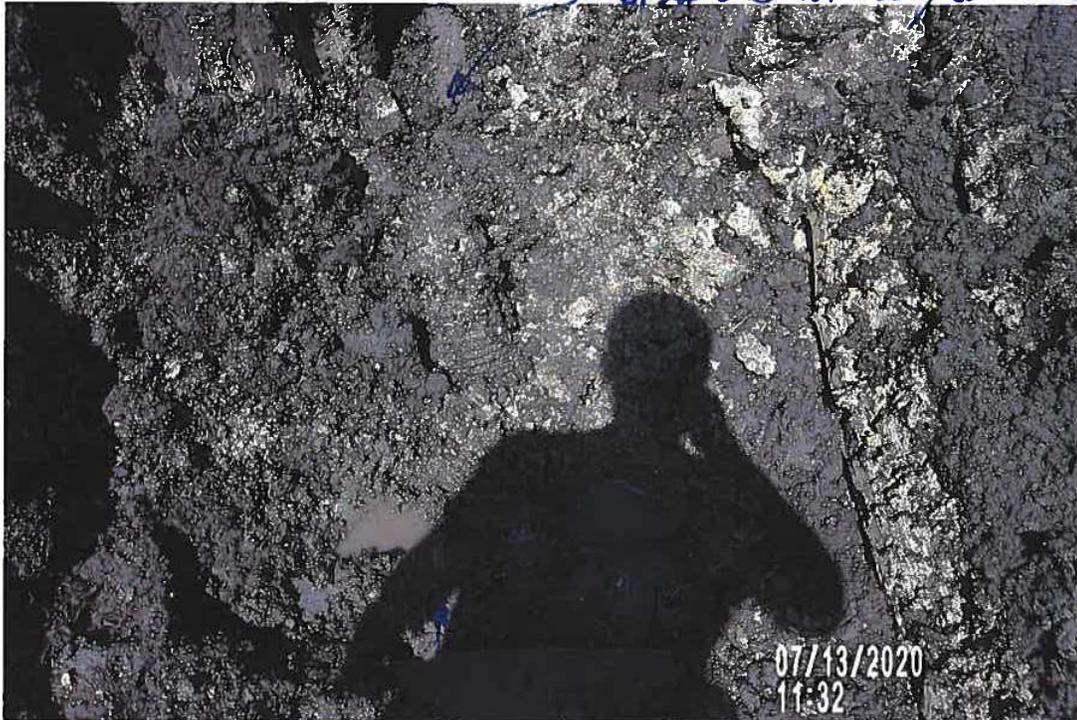
PICTURE# 4143 IS LOOKING AT 6" x 6" x 6" HDPE TEE CONNECTION WITH 6" HDPE / 6" CLAY CONNECTION DAMAGE AND NEEDS REPLACED

PICTURE # 4144 IS LOOKING WEST SHOWING 6"x6"x6" HOPE TEE CONNECTION & 6" HOPE PERFTILE / 6" CLAY TILE WITH ISSUE BETWEEN PLASTIC & CLAY TILE

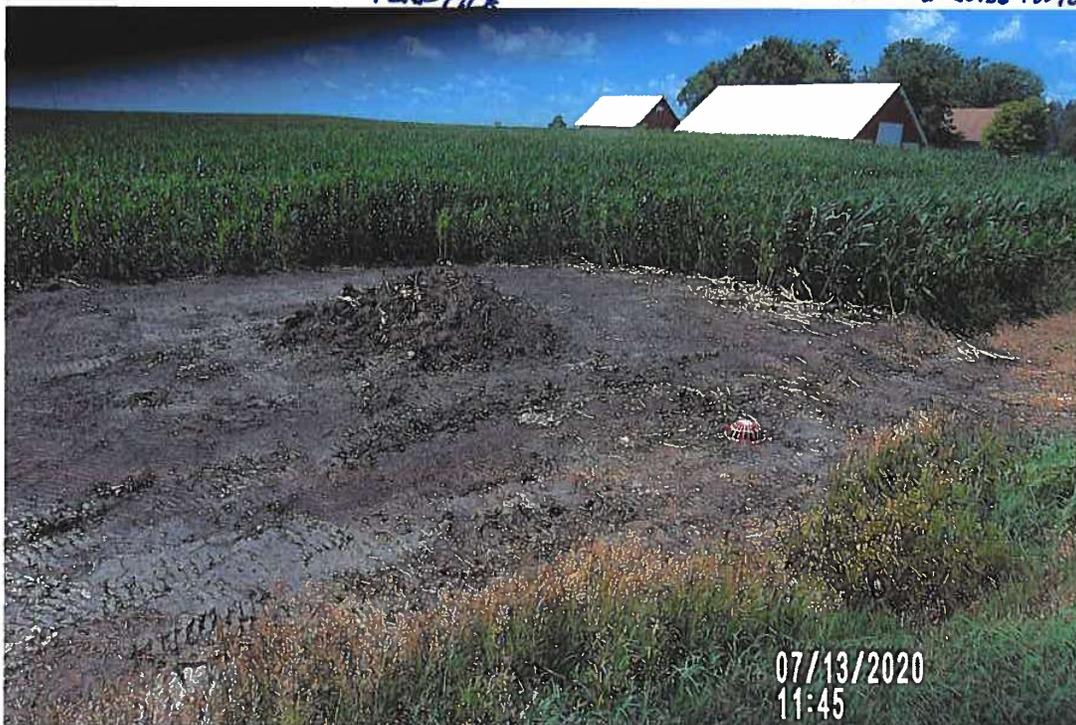
PICTURE # 4145 IS LOOKING SW ON SOUTH SIDE OF HWY 041 SHOWING DITCH GRADED TO INTAKE & TRENCH BACKFILL & GRADED. EXTRA SOIL PILED UP. BLEND EXTRA SOIL AROUND

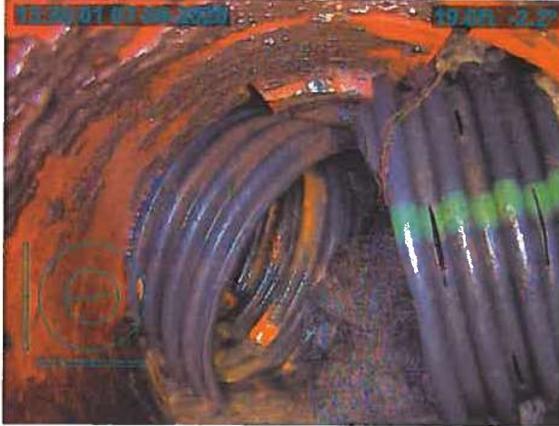
BR 2020_07_08-13_30_01_583.jpg

Video Ref	Dist (ft)	Cont Defect	Code	Photo Ref	Diameter/ Dimension	Clock		Intrusion		Remarks
						At	To	%	mm	
0:00:00	19.0		BR	2020_07_08- 13_30_01_583.jpg
