AGENDA
REGULAR DRAINAGE MEETING
Wednesday, December 30, 2020 9:30 AM
Large Conference Room

Drainage Work Order Request For Repair Hardin County

Investigation and Repair Summary:

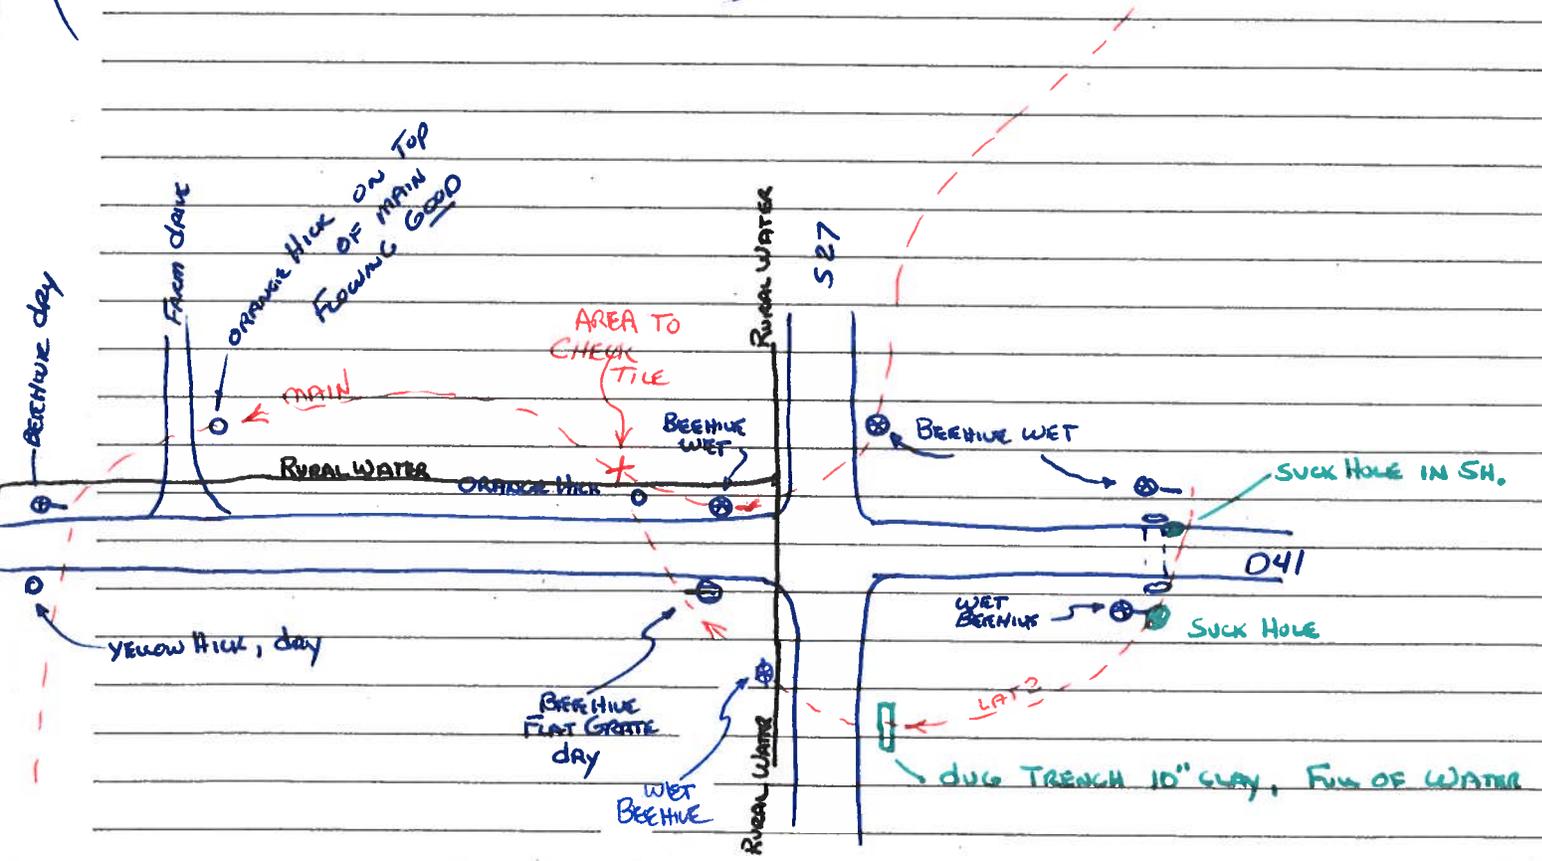
LAT 2 HAS RESTRICTION @ D41 (N. OR S. SIDE?). NEED TO DIG ON NORTH SIDE 1ST, TRY AND FIND LAT 2 CONNECTION TO MAIN. INTAKES ON MAIN @ FARM DRIVE LOOK GOOD WITH FLOWING WATER IN MAIN

TALKED TO RON VIKRAMA (80 YRS OLD) HE AGREED WITH ME THAT THE LAT 2 CONNECTION SHOULD BE CHECKED, BUT HE HAD NO IDEA WHERE IT WAS AT.

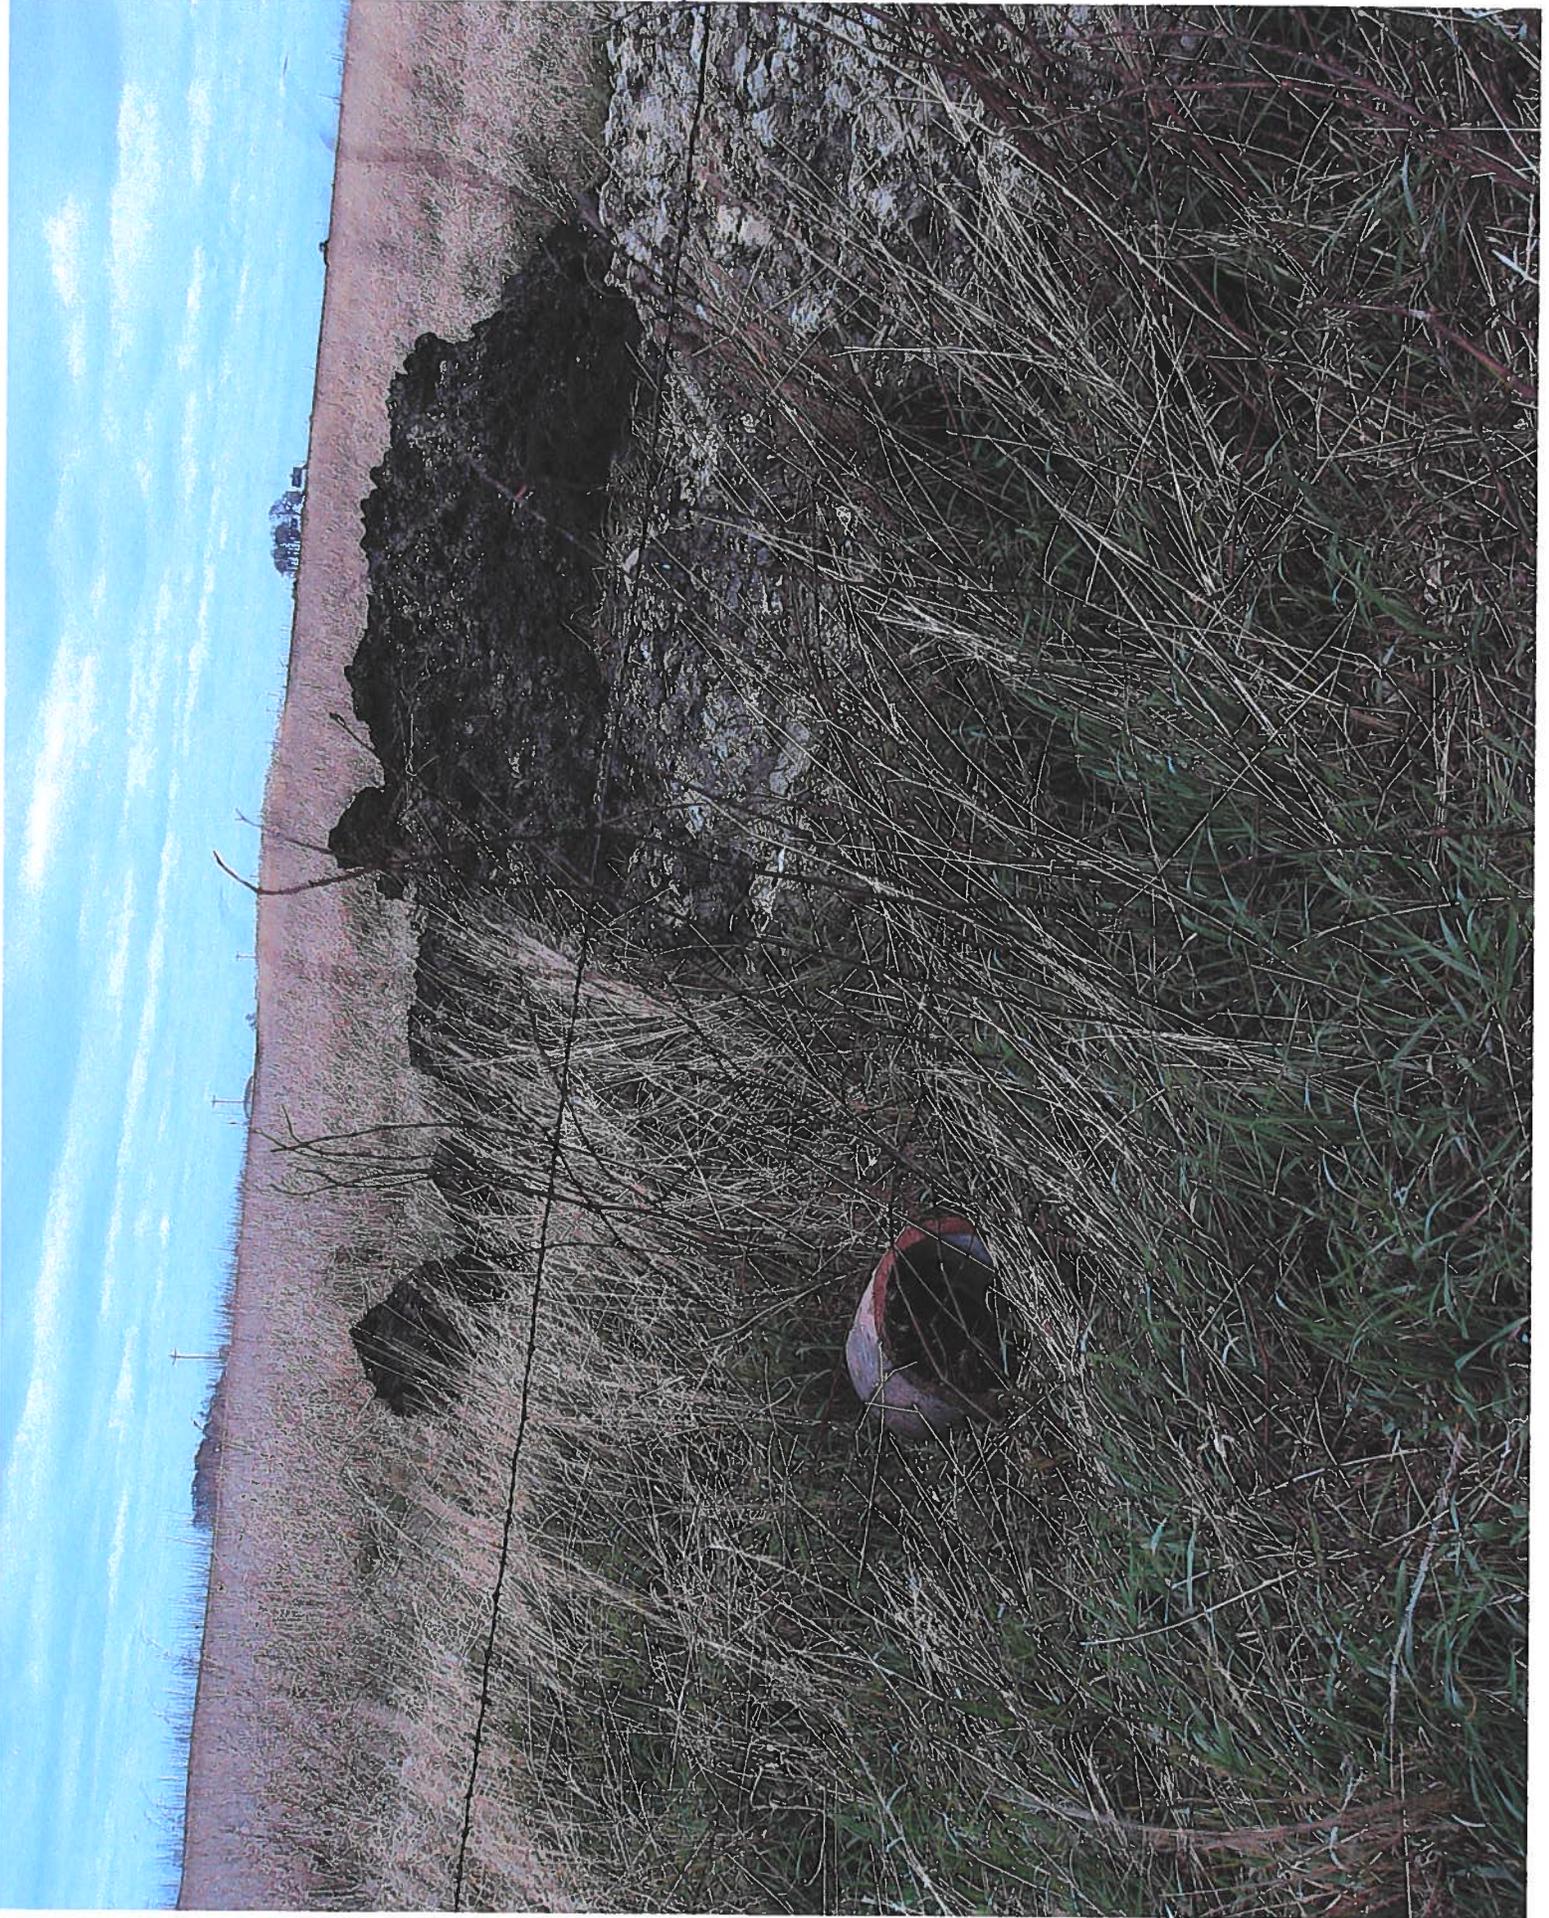
LOOKING E. @ 10" CLAY ON LAT 2, E. OF S27

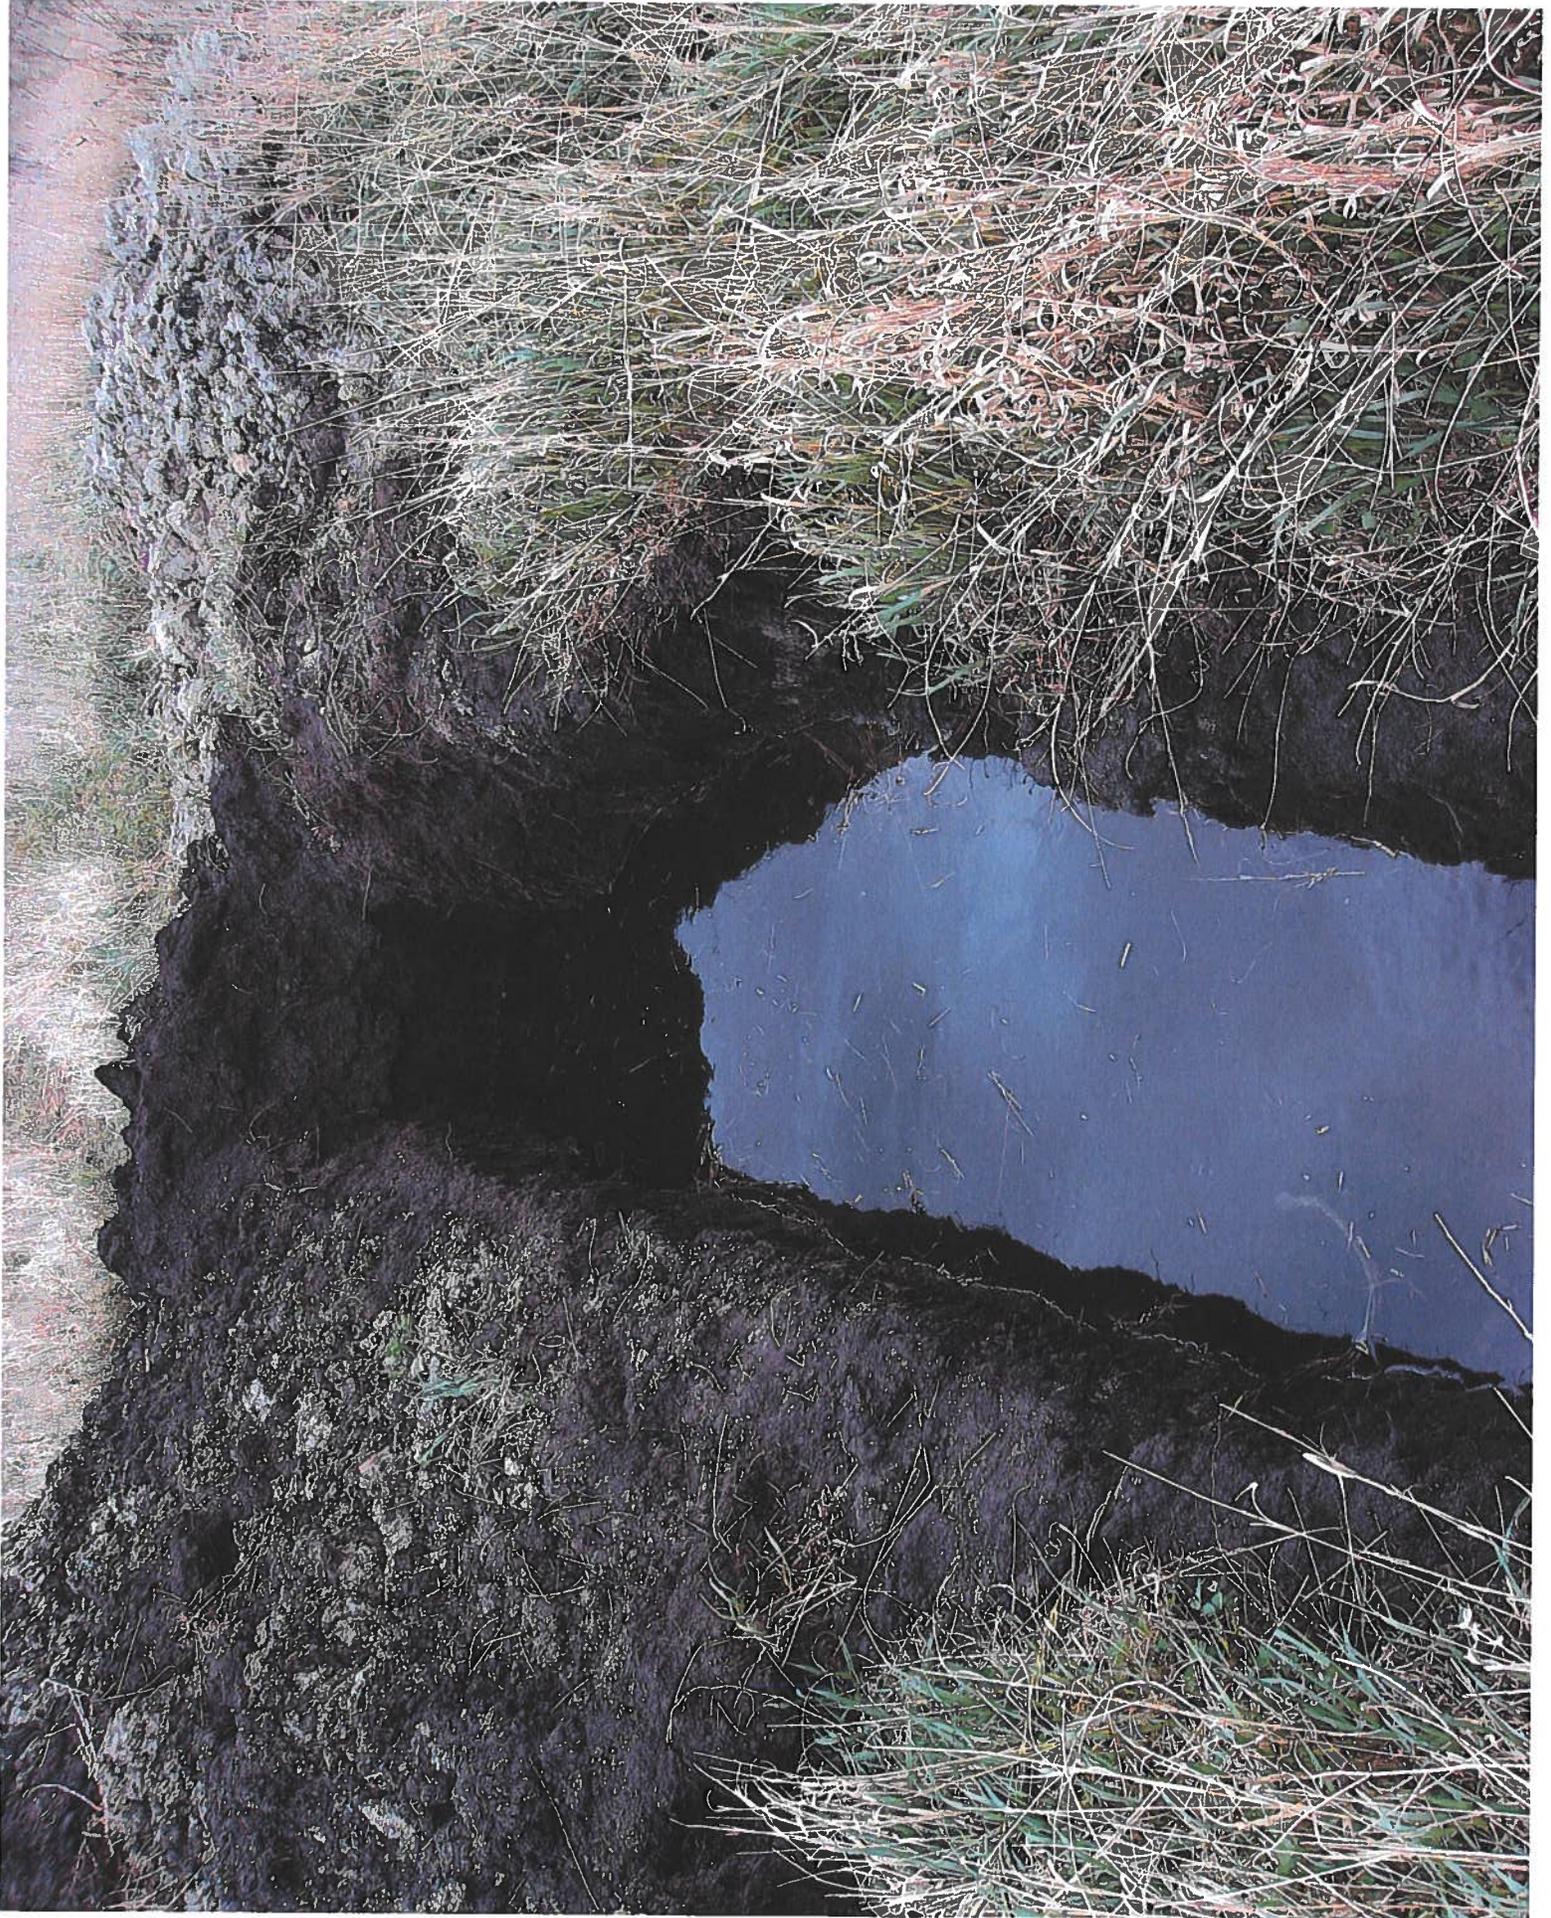
TRENCH ON LAT 2, E SIDE S27

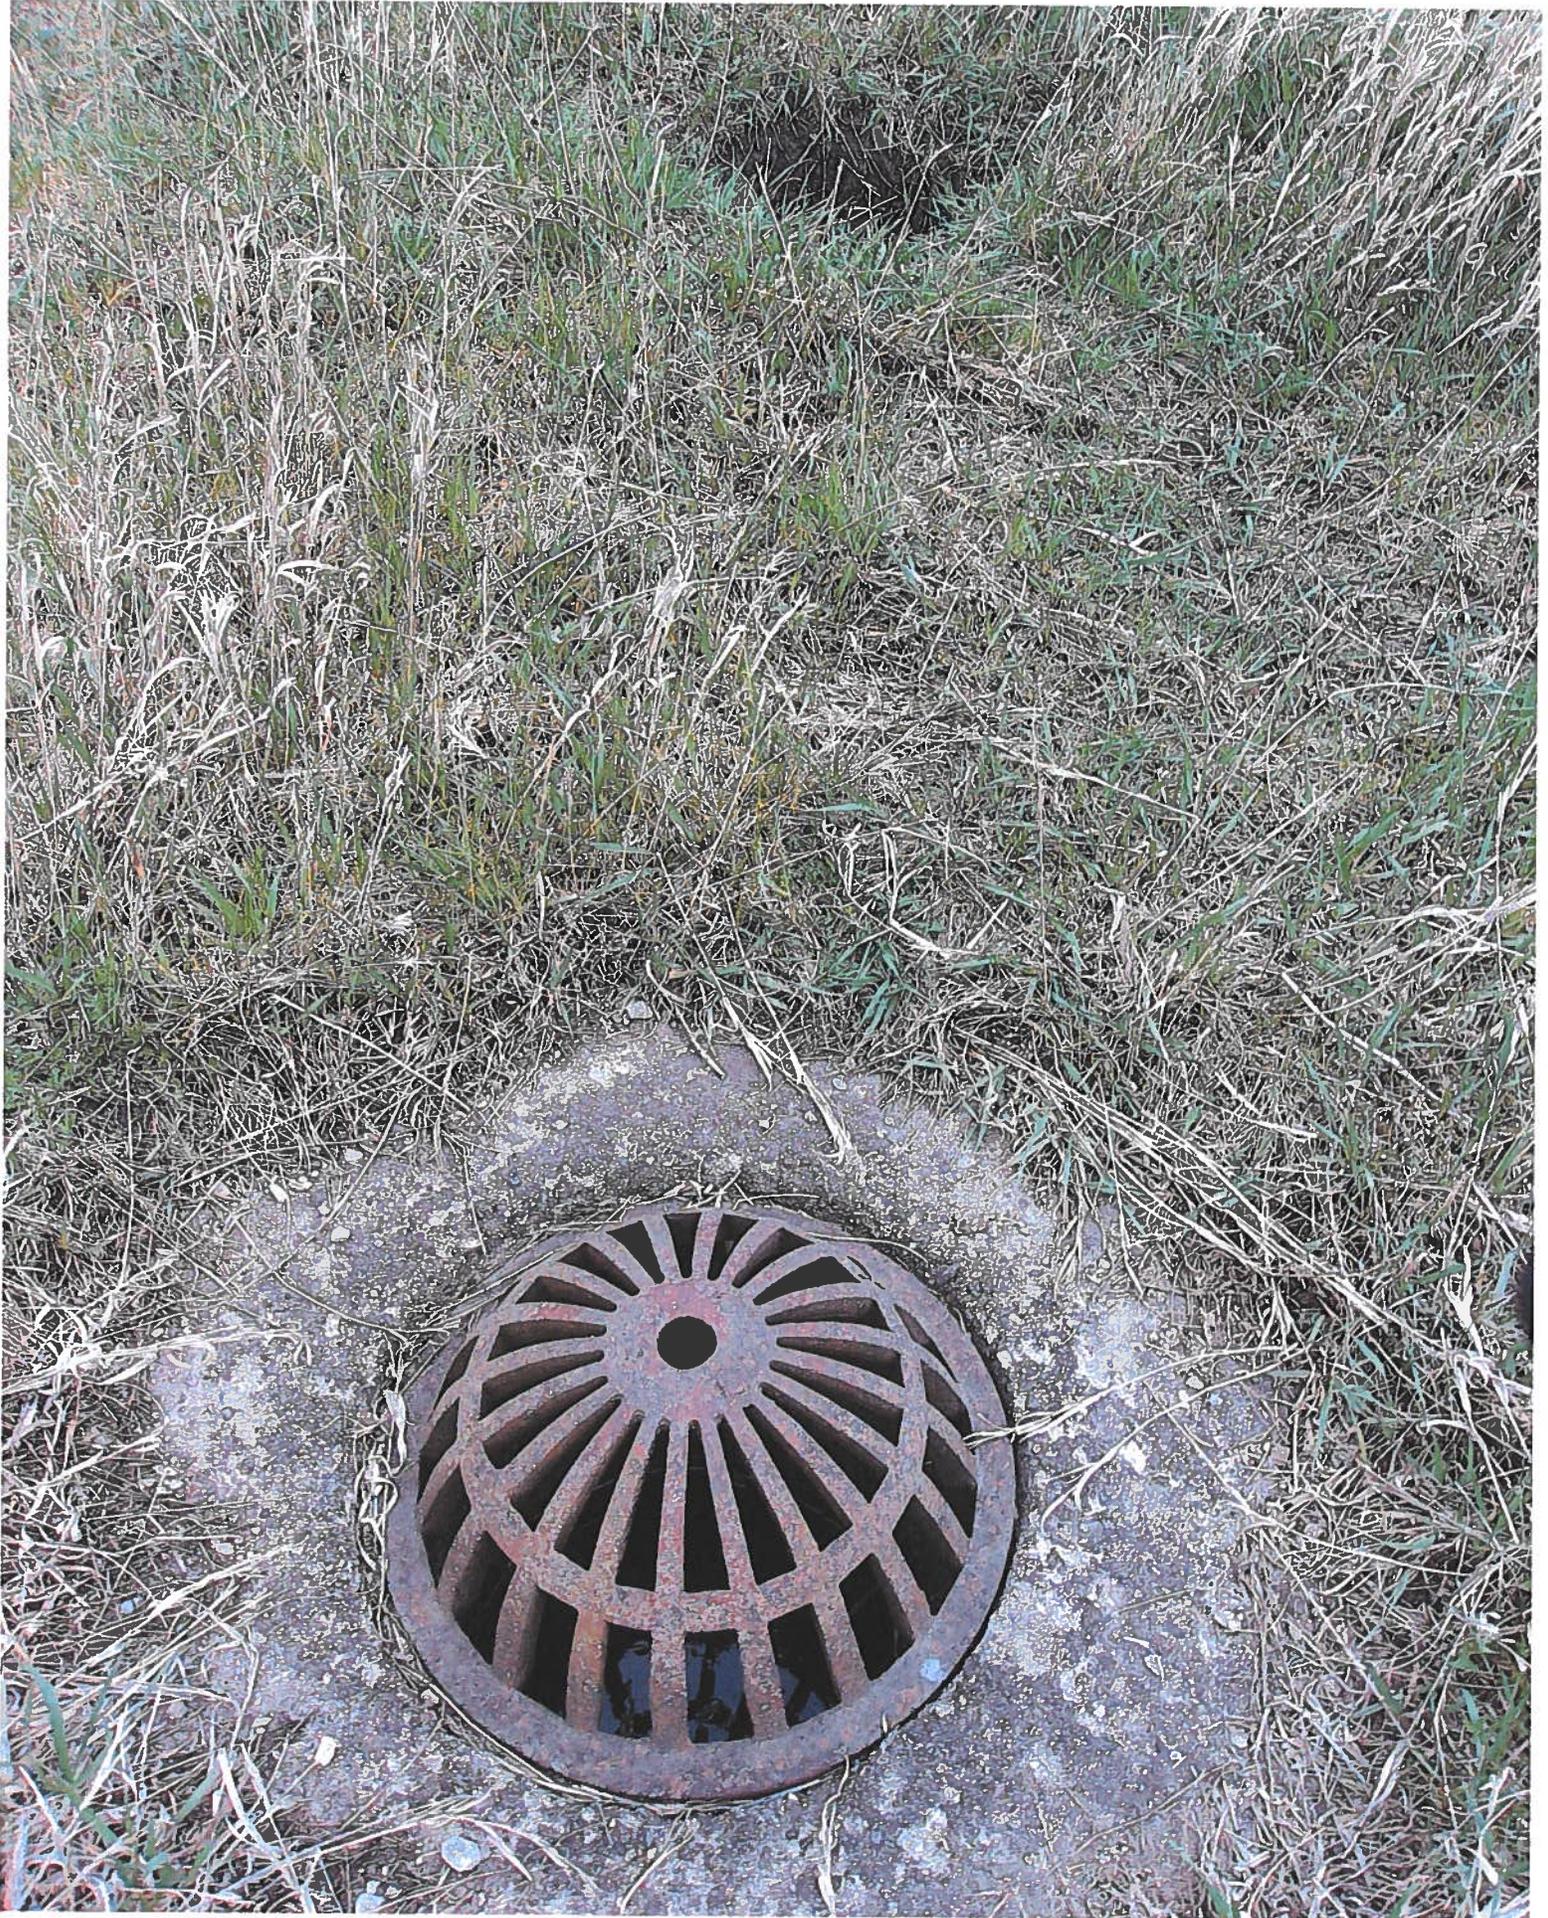
LOOKING EAST @ BEEHIVE WITH HOLE ON LAT2, S. SIDE D41 BY CRP

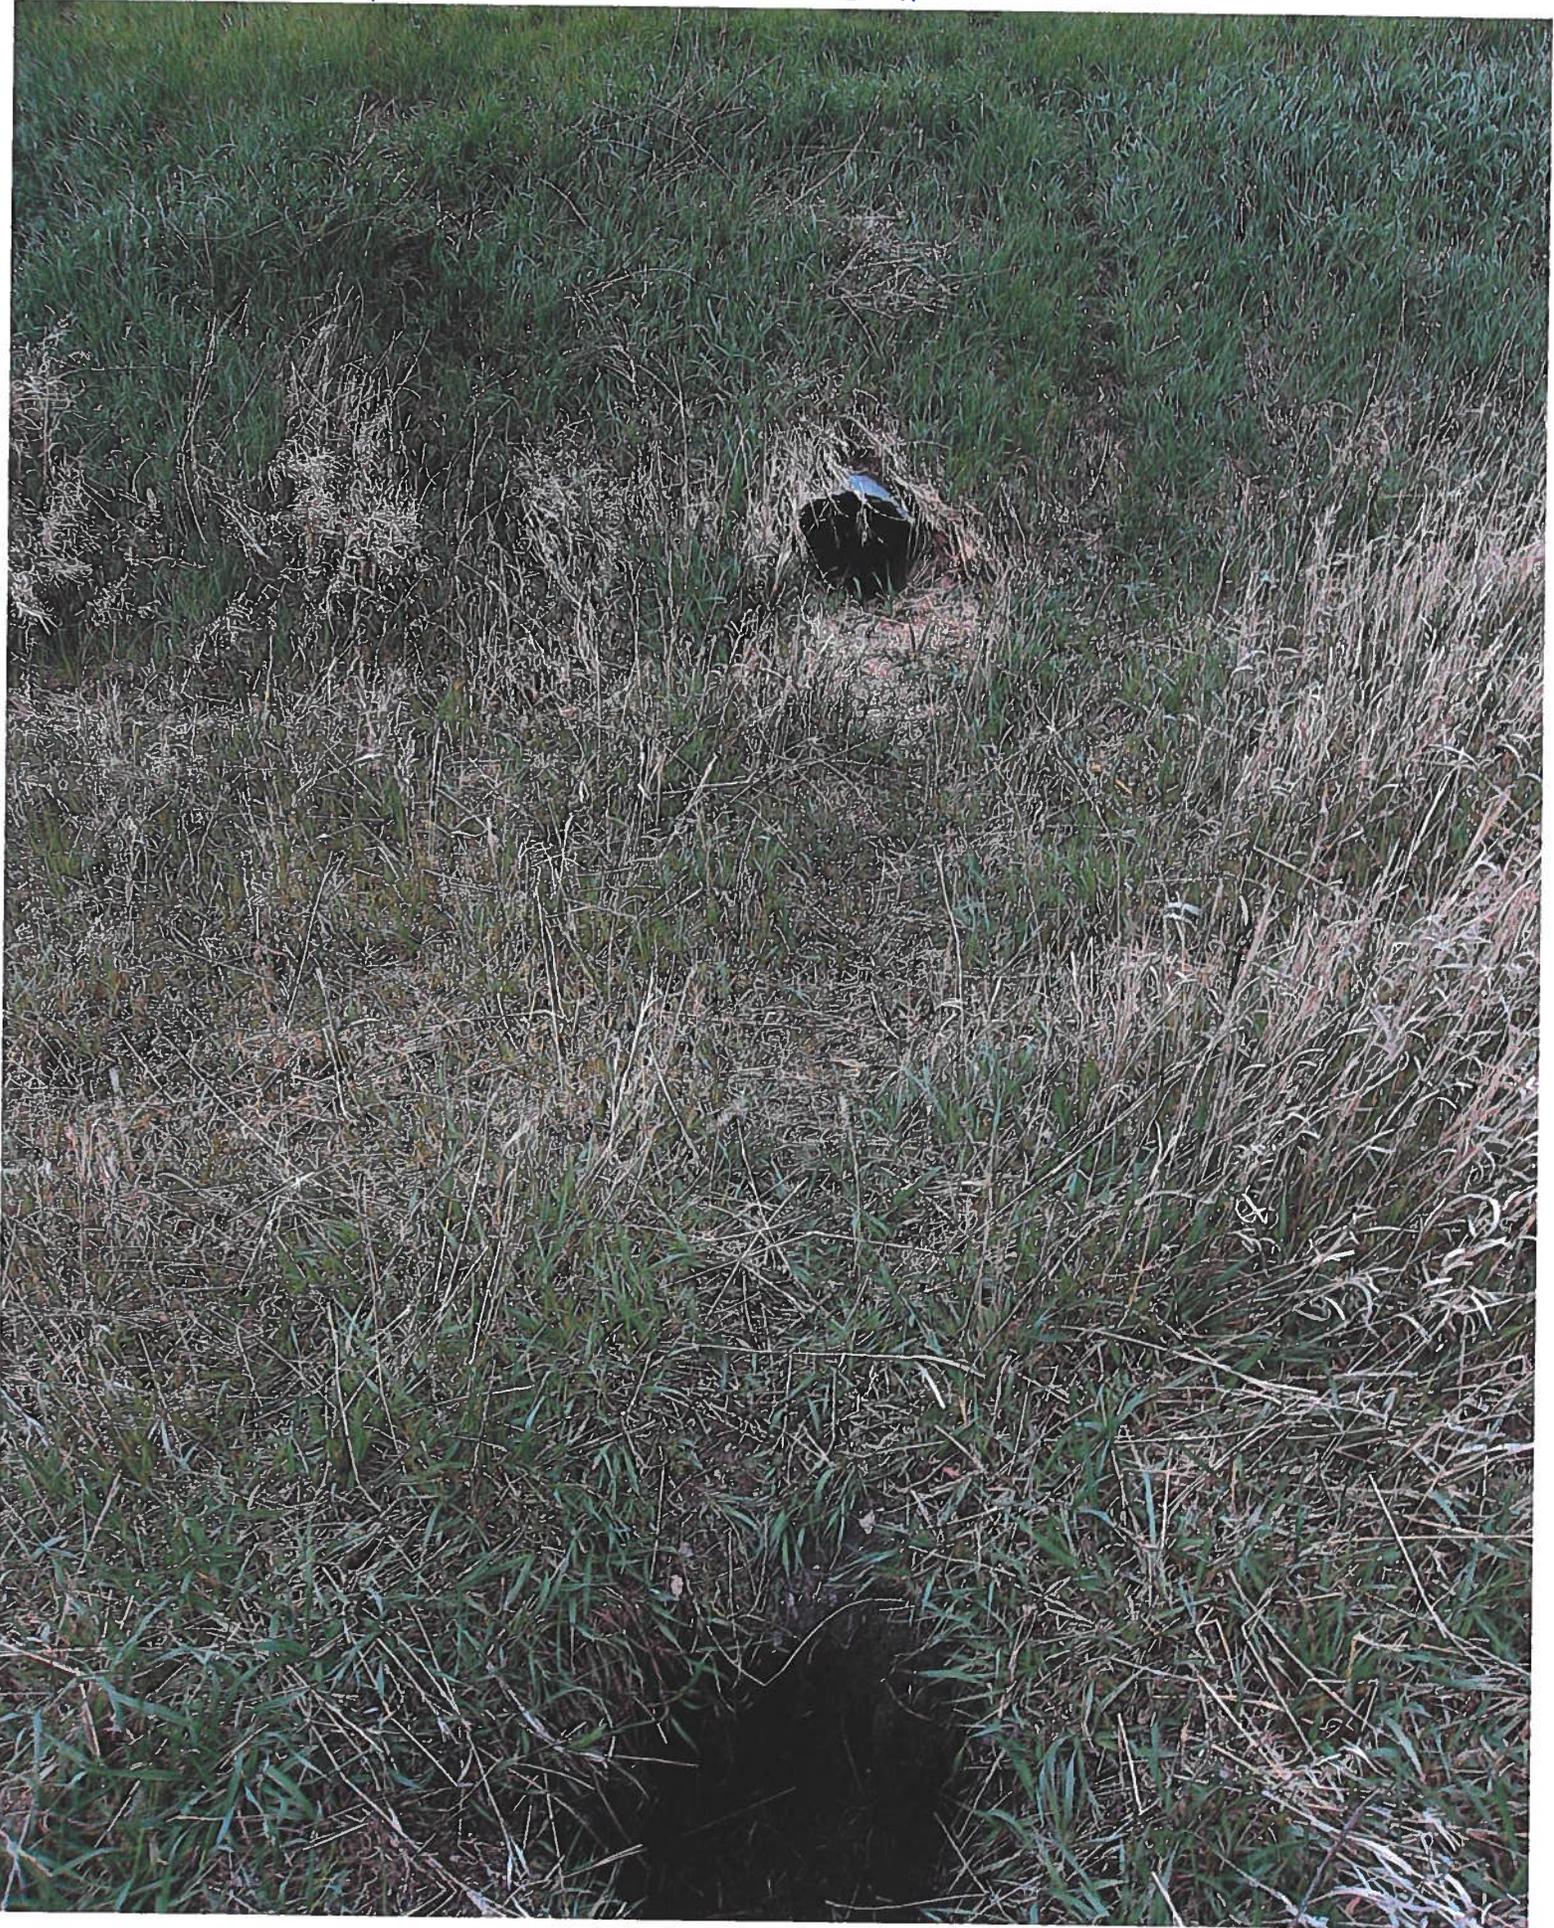
S. SIDE D41 , HOLE ON LAT 2 , LOOKING N.

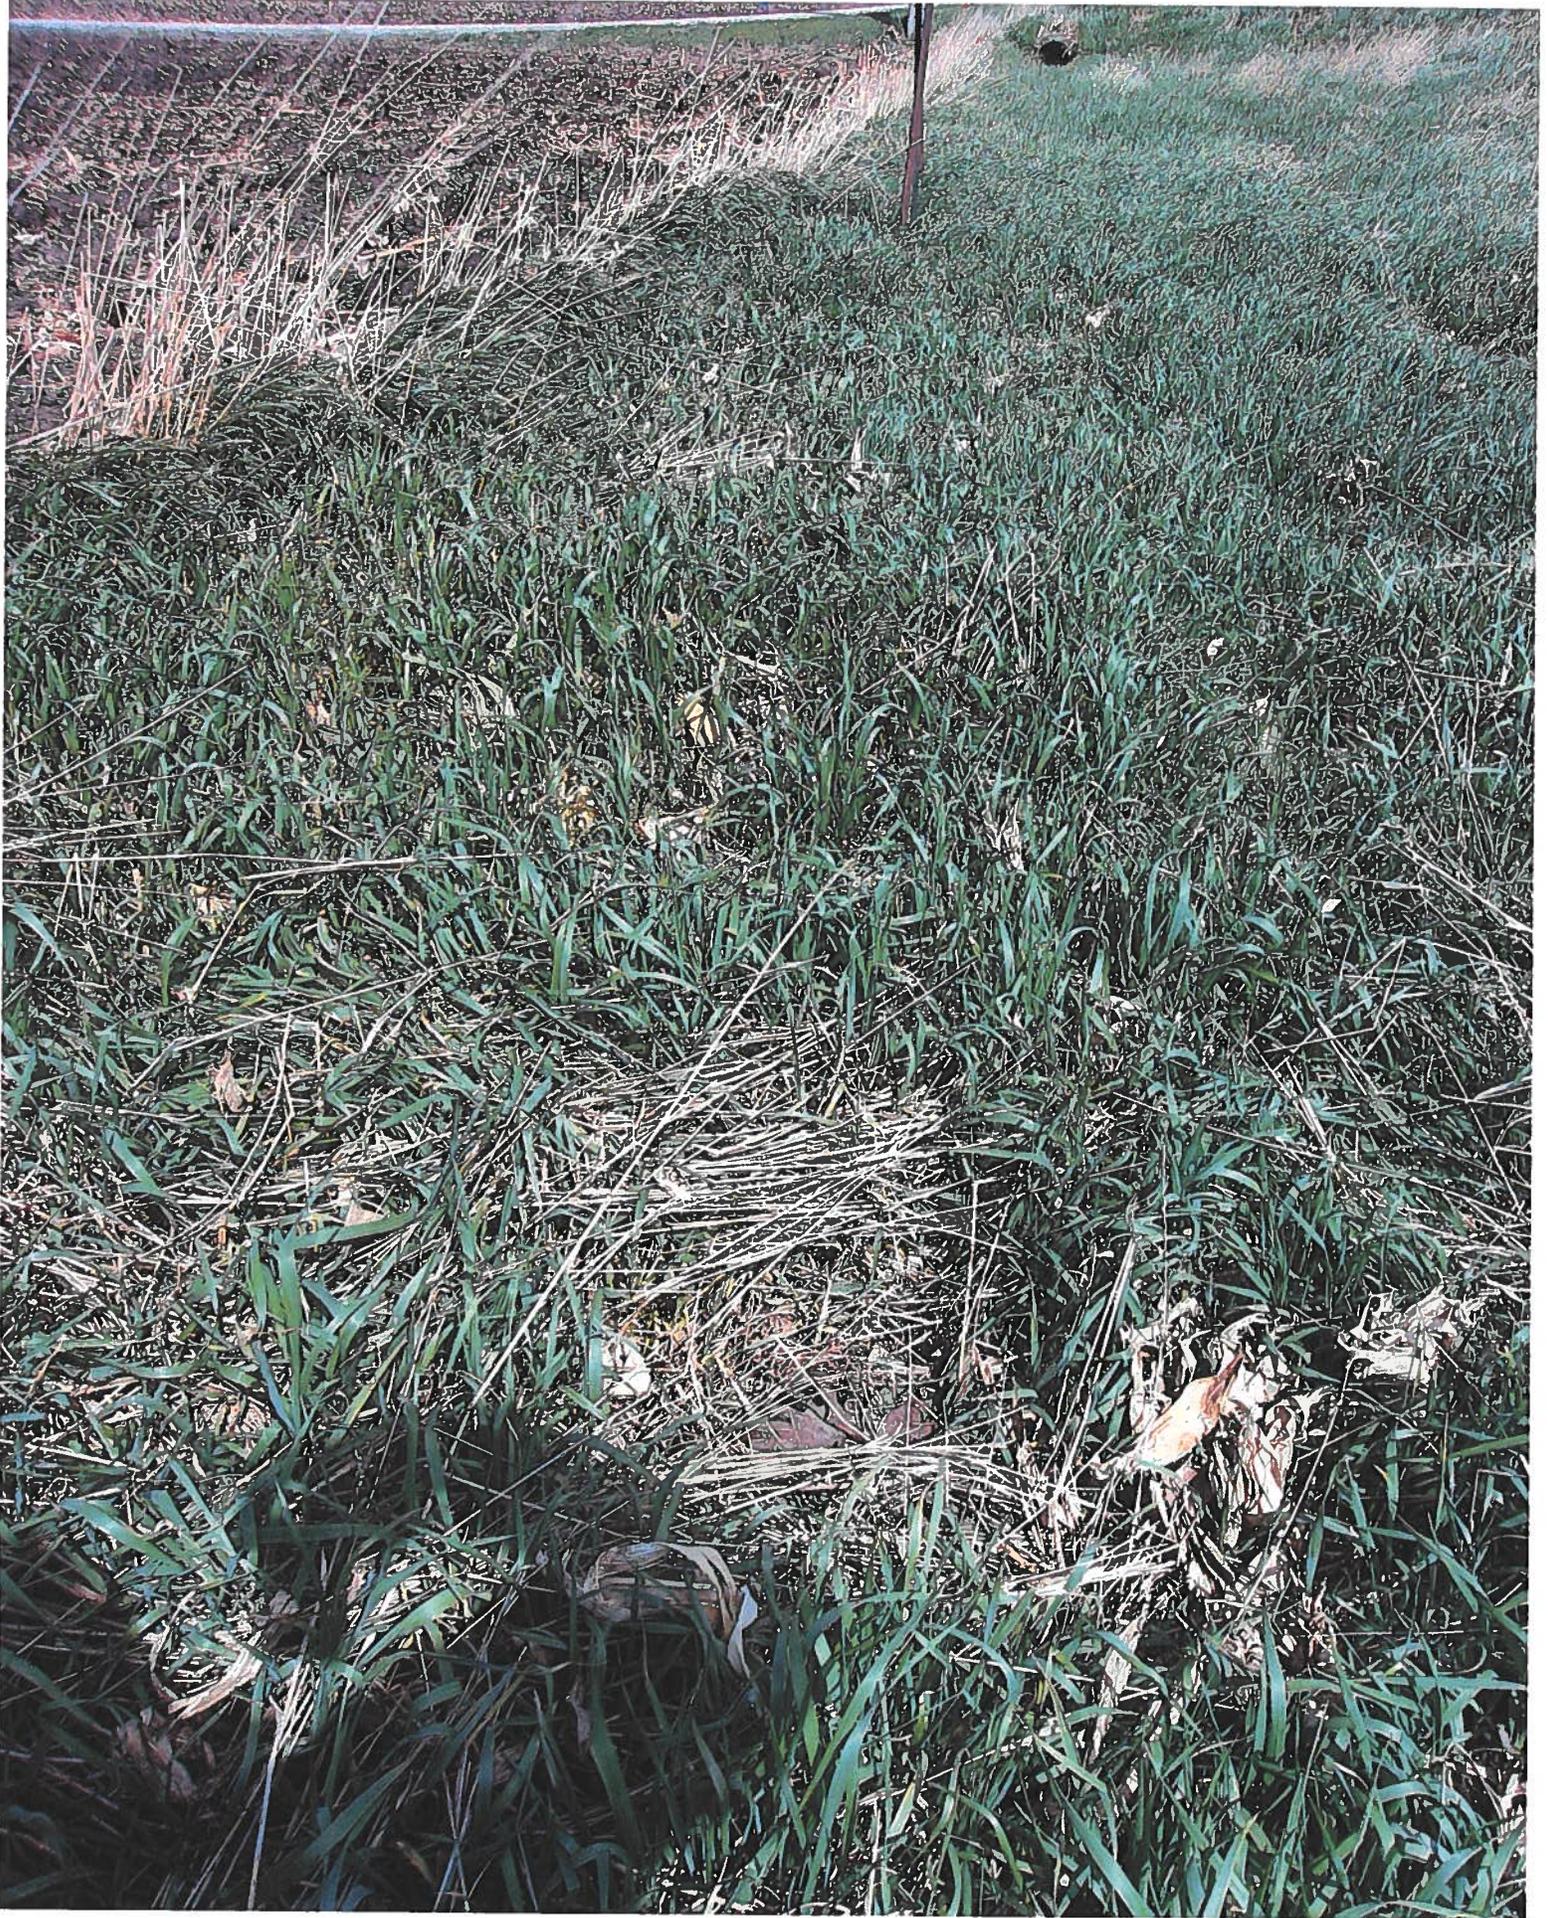
LOOKING E @ S27, BEEHIVE IN N DITCH D41

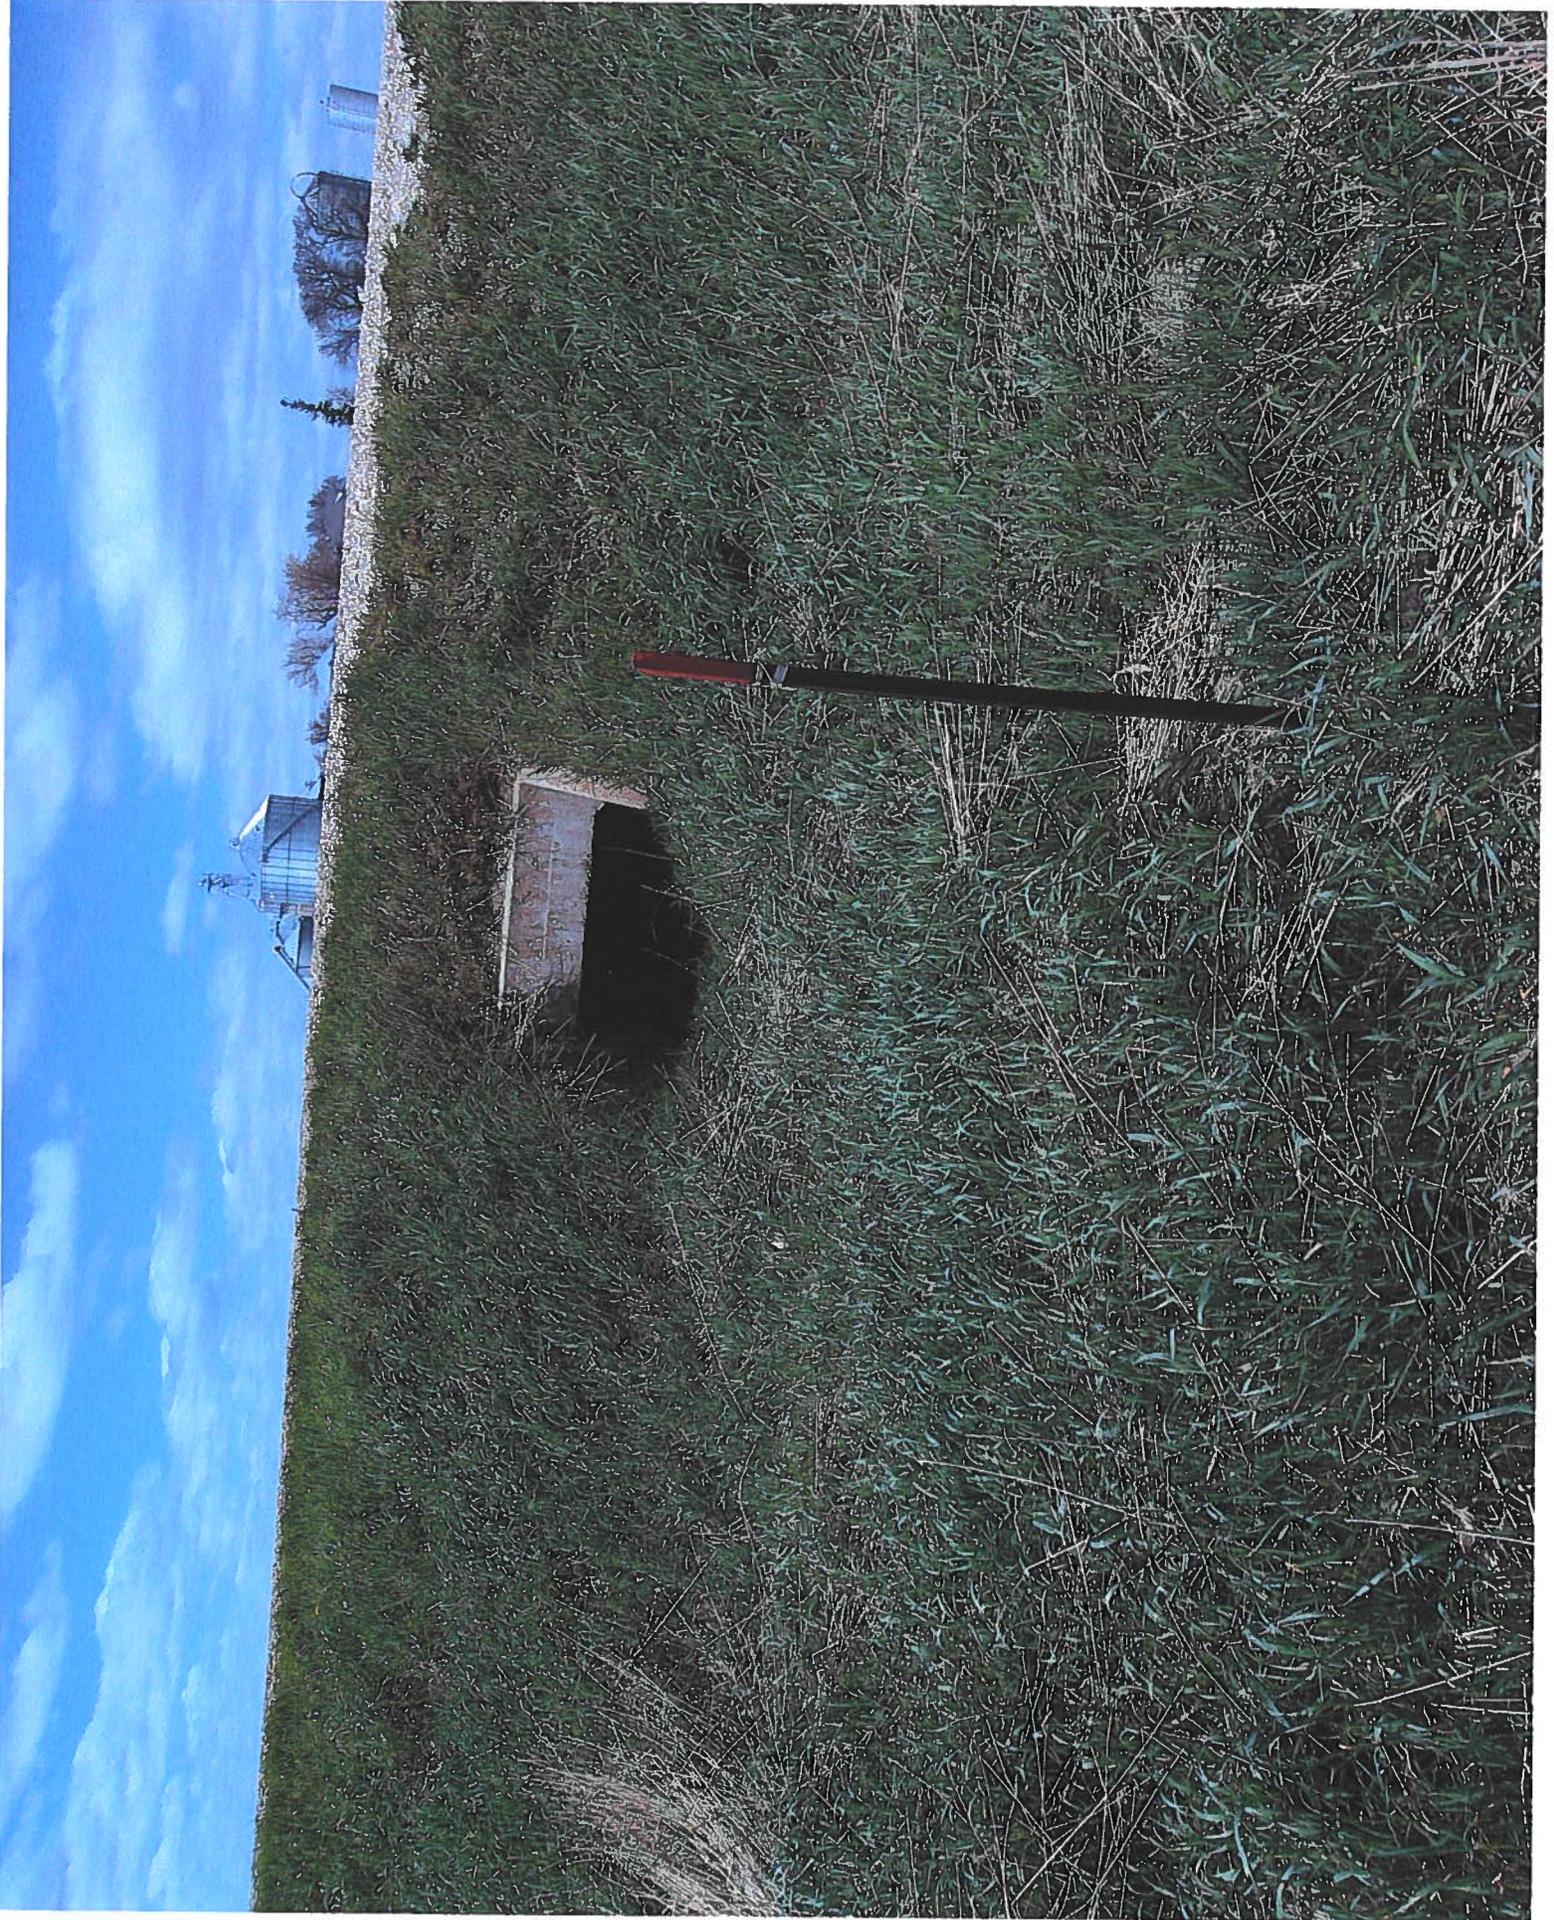
LOOKING UPSIDEAM ON MAIN, S. OF D41, TRST SET ON MAIN BY REPAIR

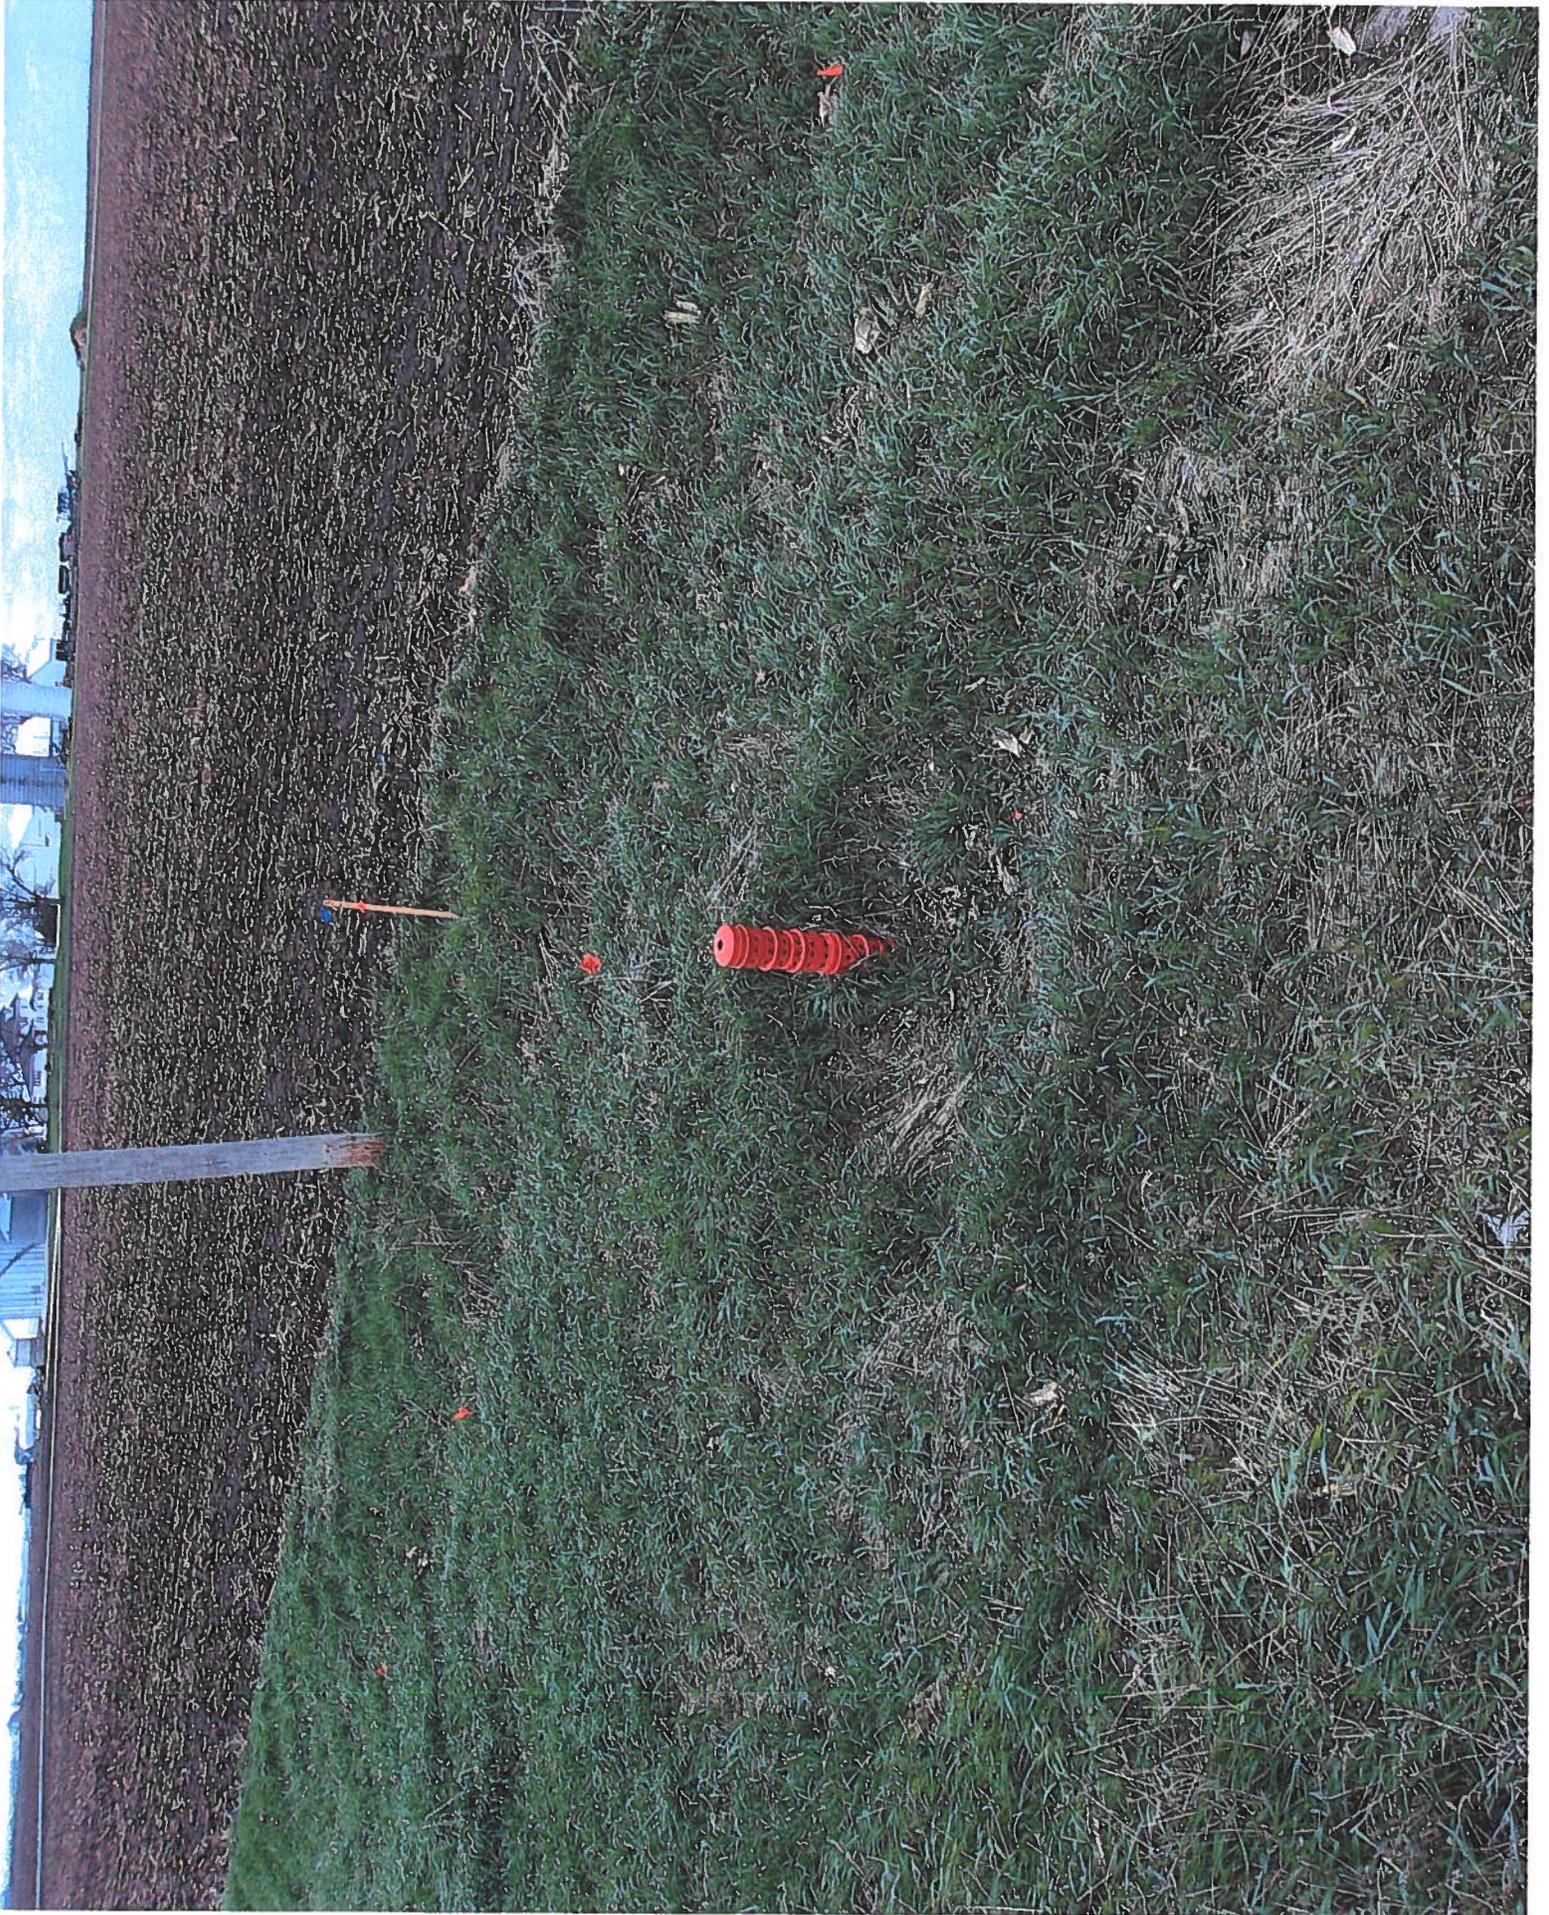
ORANGE HICK ON LAT 2? ON N DITCH D41
