AGENDA
REGULAR DRAINAGE MEETING
Wednesday, December 30, 2020 9:30 AM
Large Conference Room

Drainage Work Order Request For Repair Hardin County

Investigation and Repair Summary:

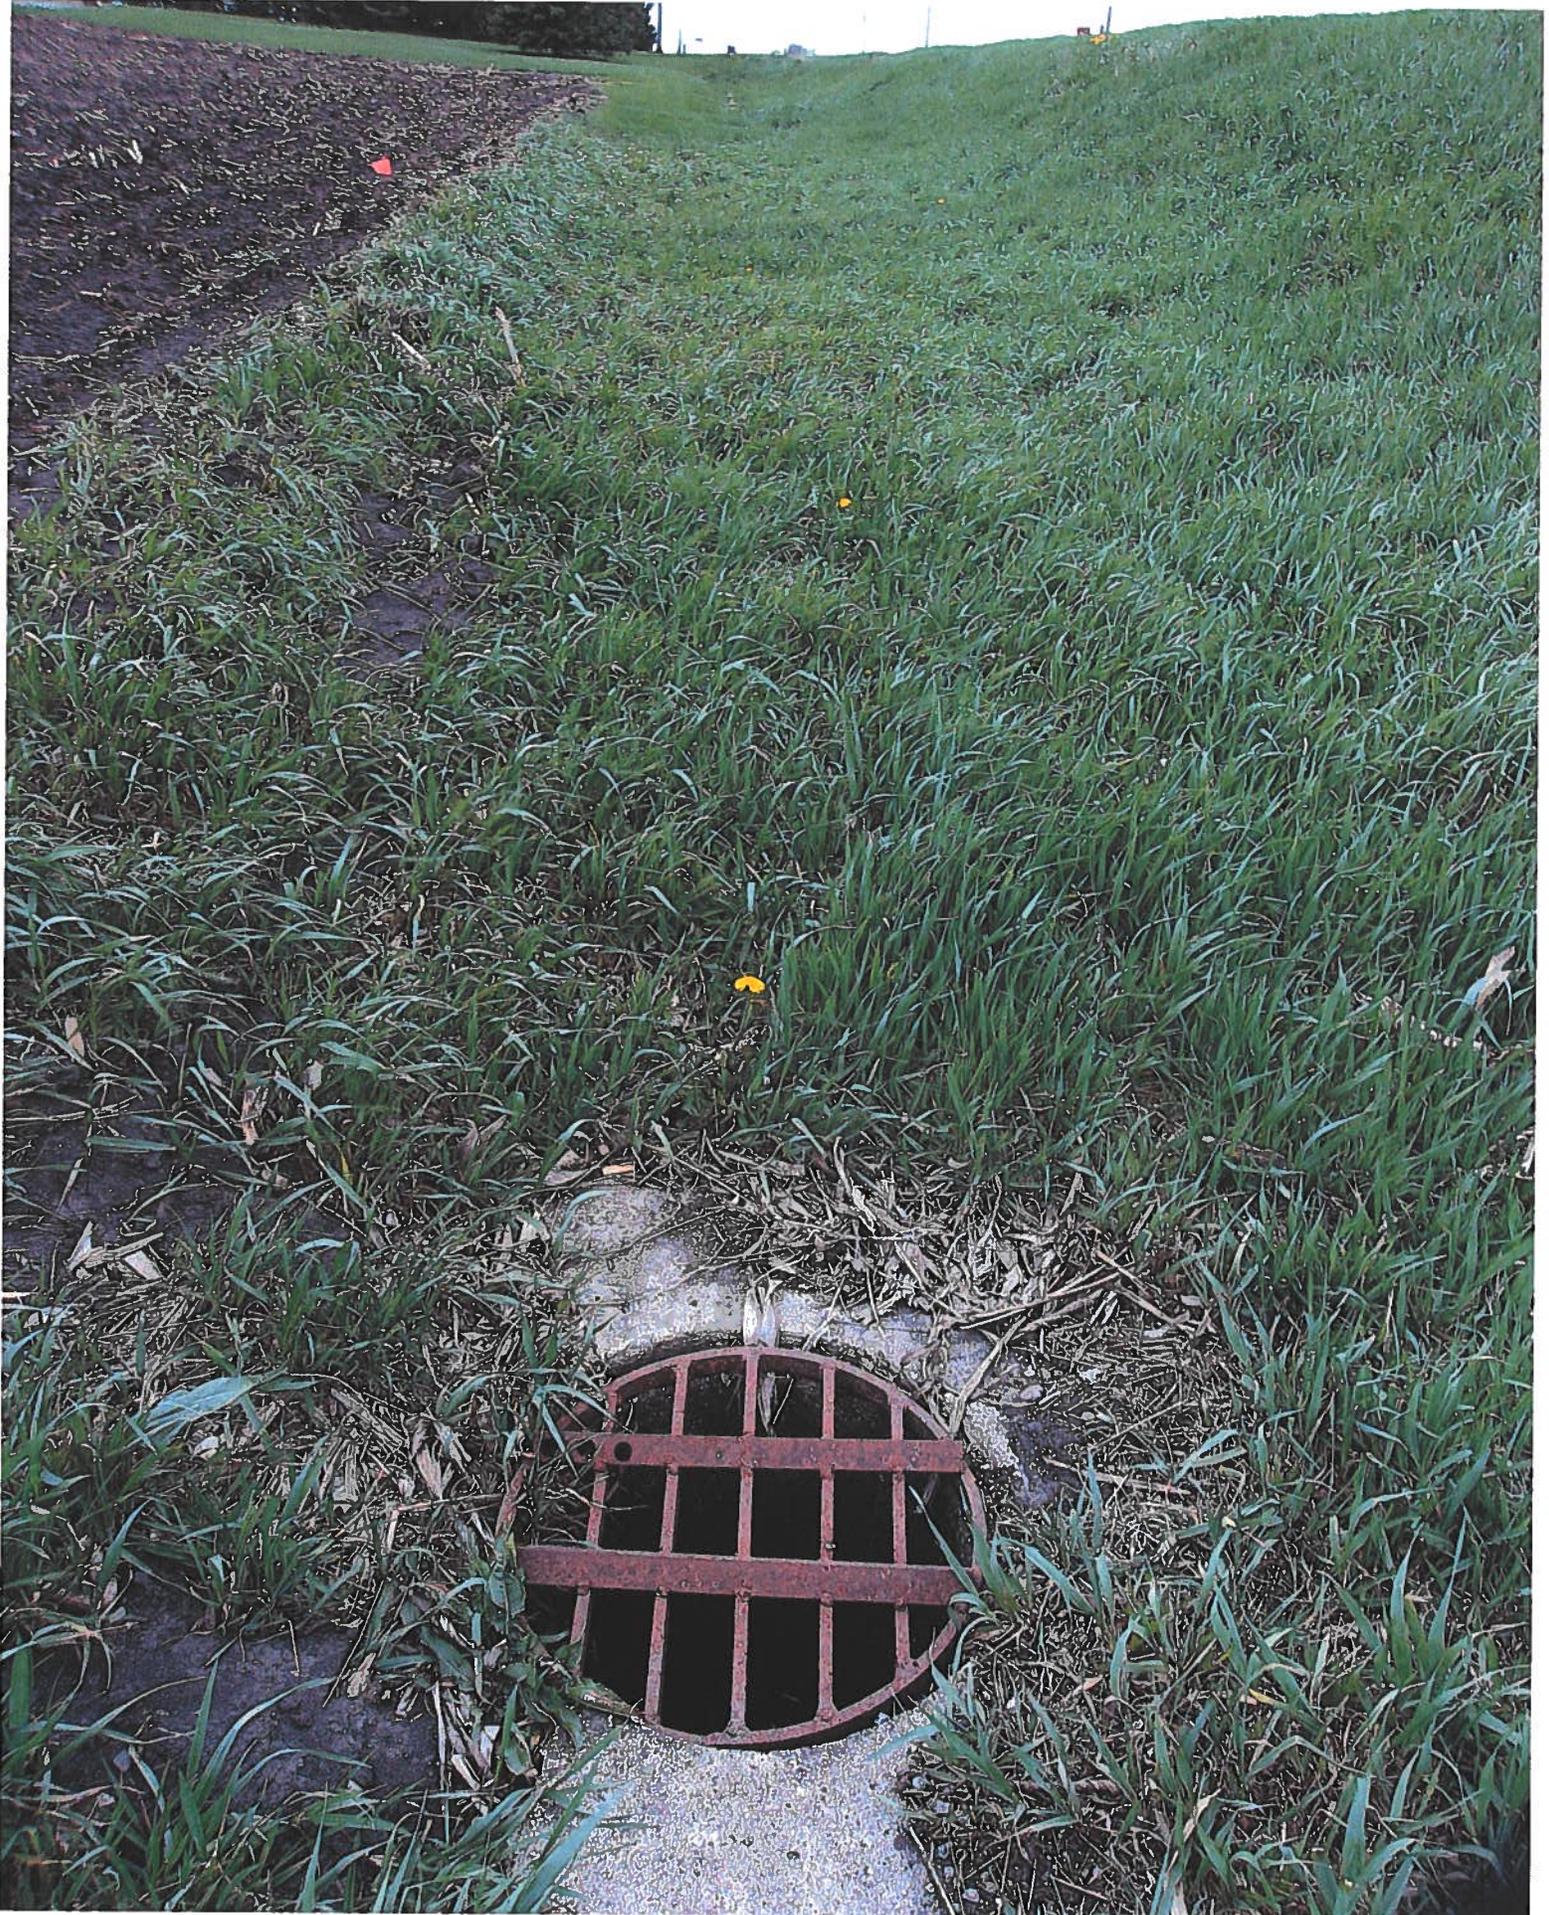
Dry INTAKE ON LAT 2 , S. ditch 041 (inv. of S27)

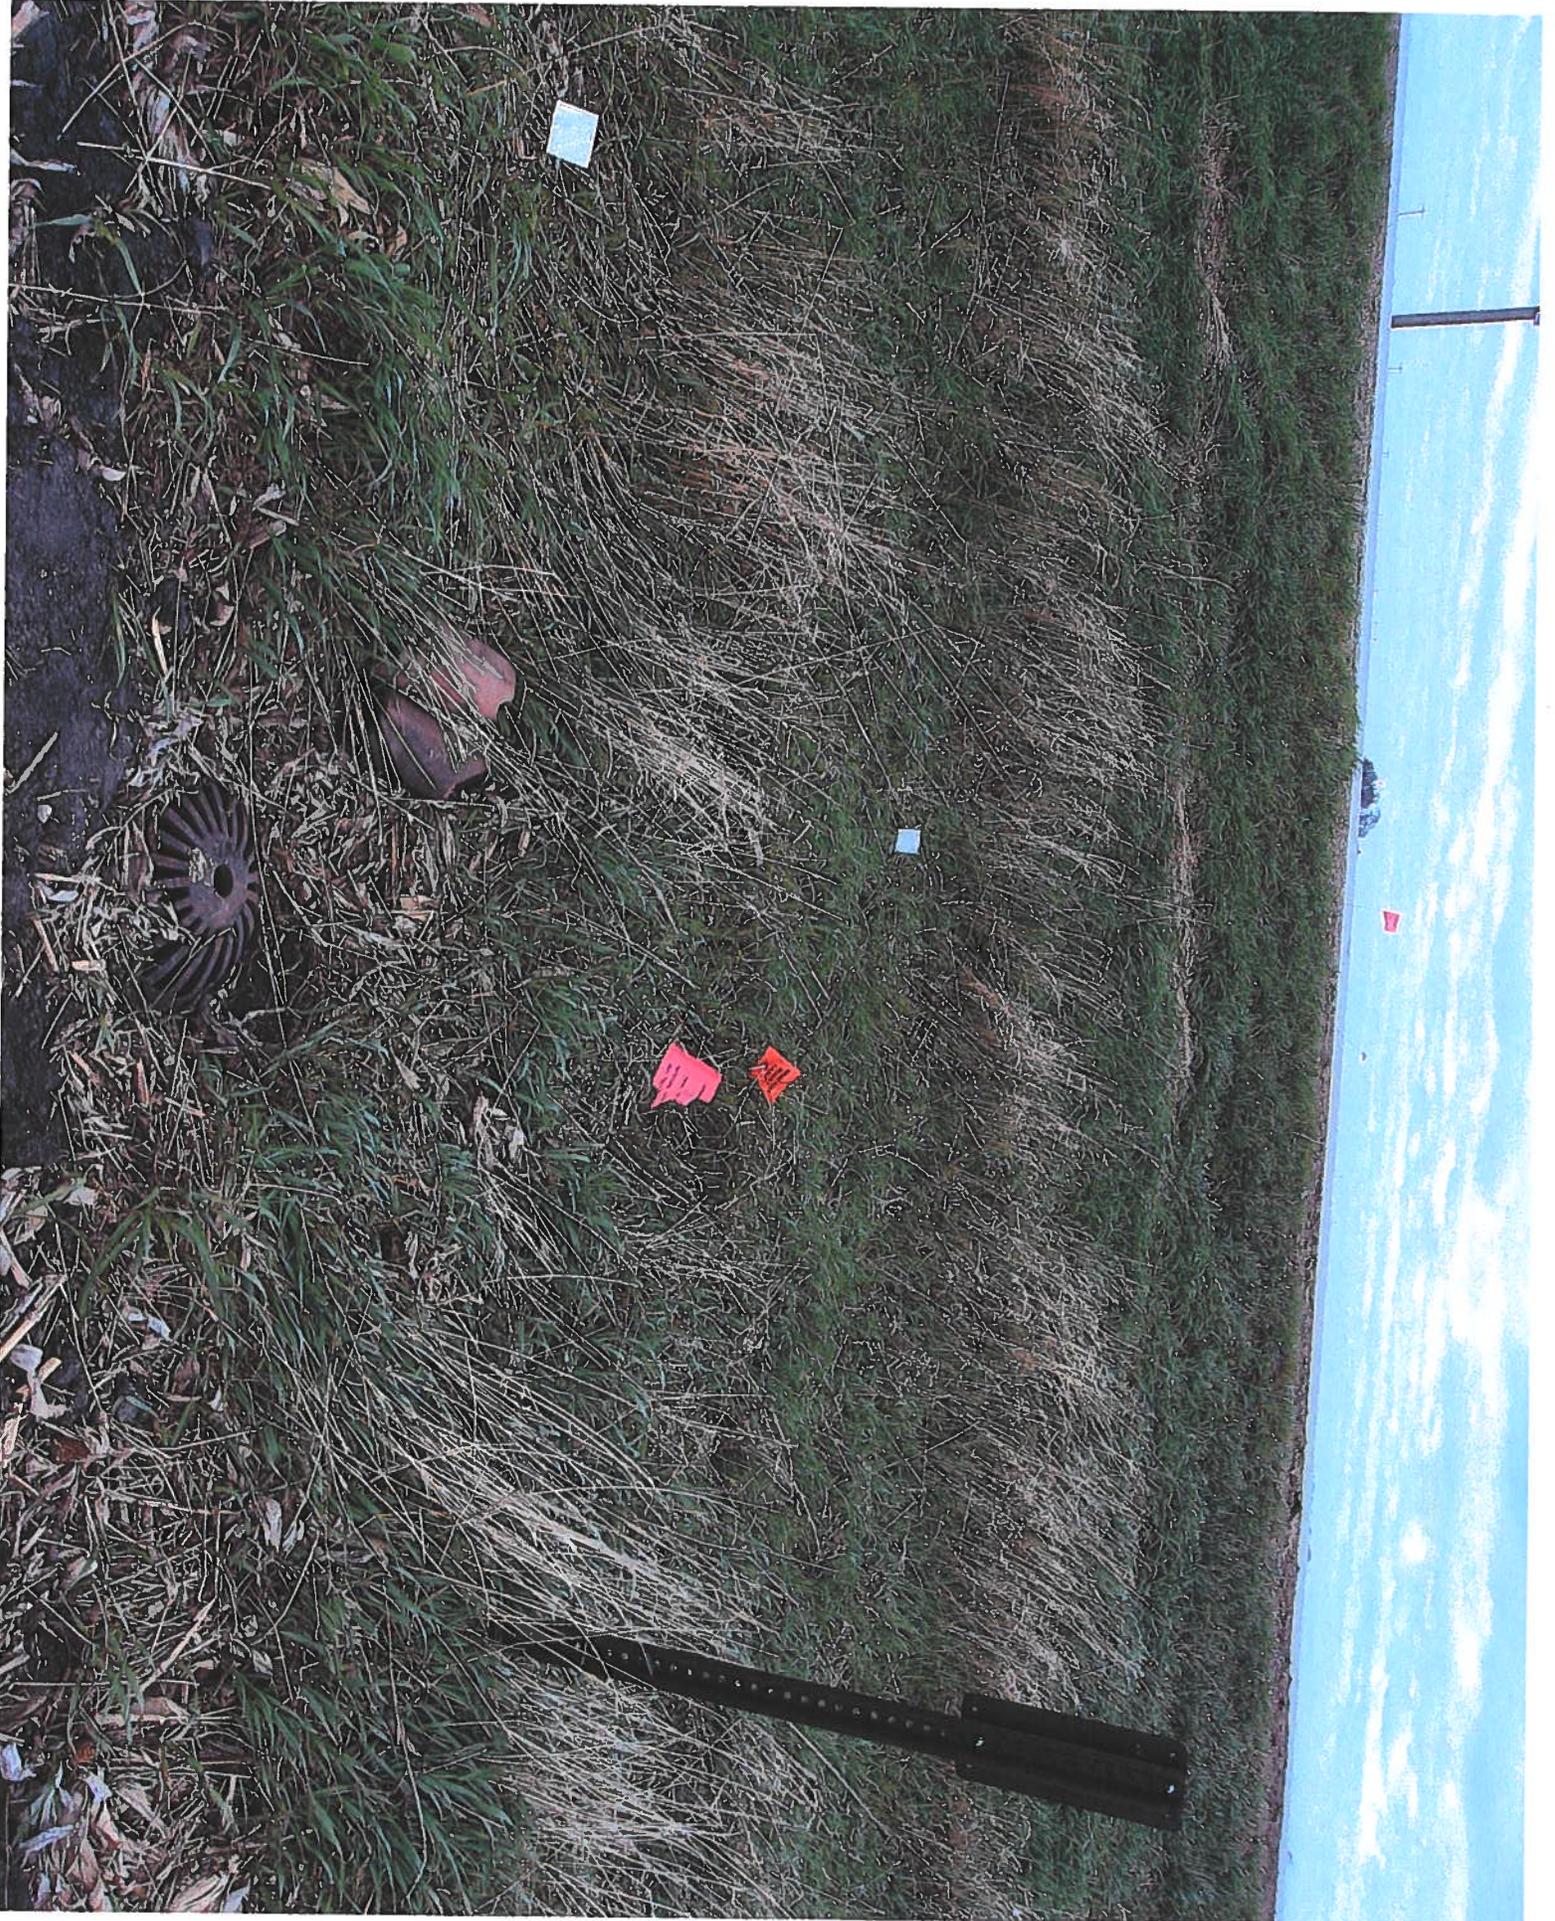
LAT 2, WET BEEHIVE, W. SIDE S27
