**AGENDA**  
**REGULAR DRAINAGE MEETING**  
**Wednesday, March 11, 2020 9:30 AM**

7. DD 100 WO 248 - Discuss W Possible Action - Repair Summary

## Repair Summary:

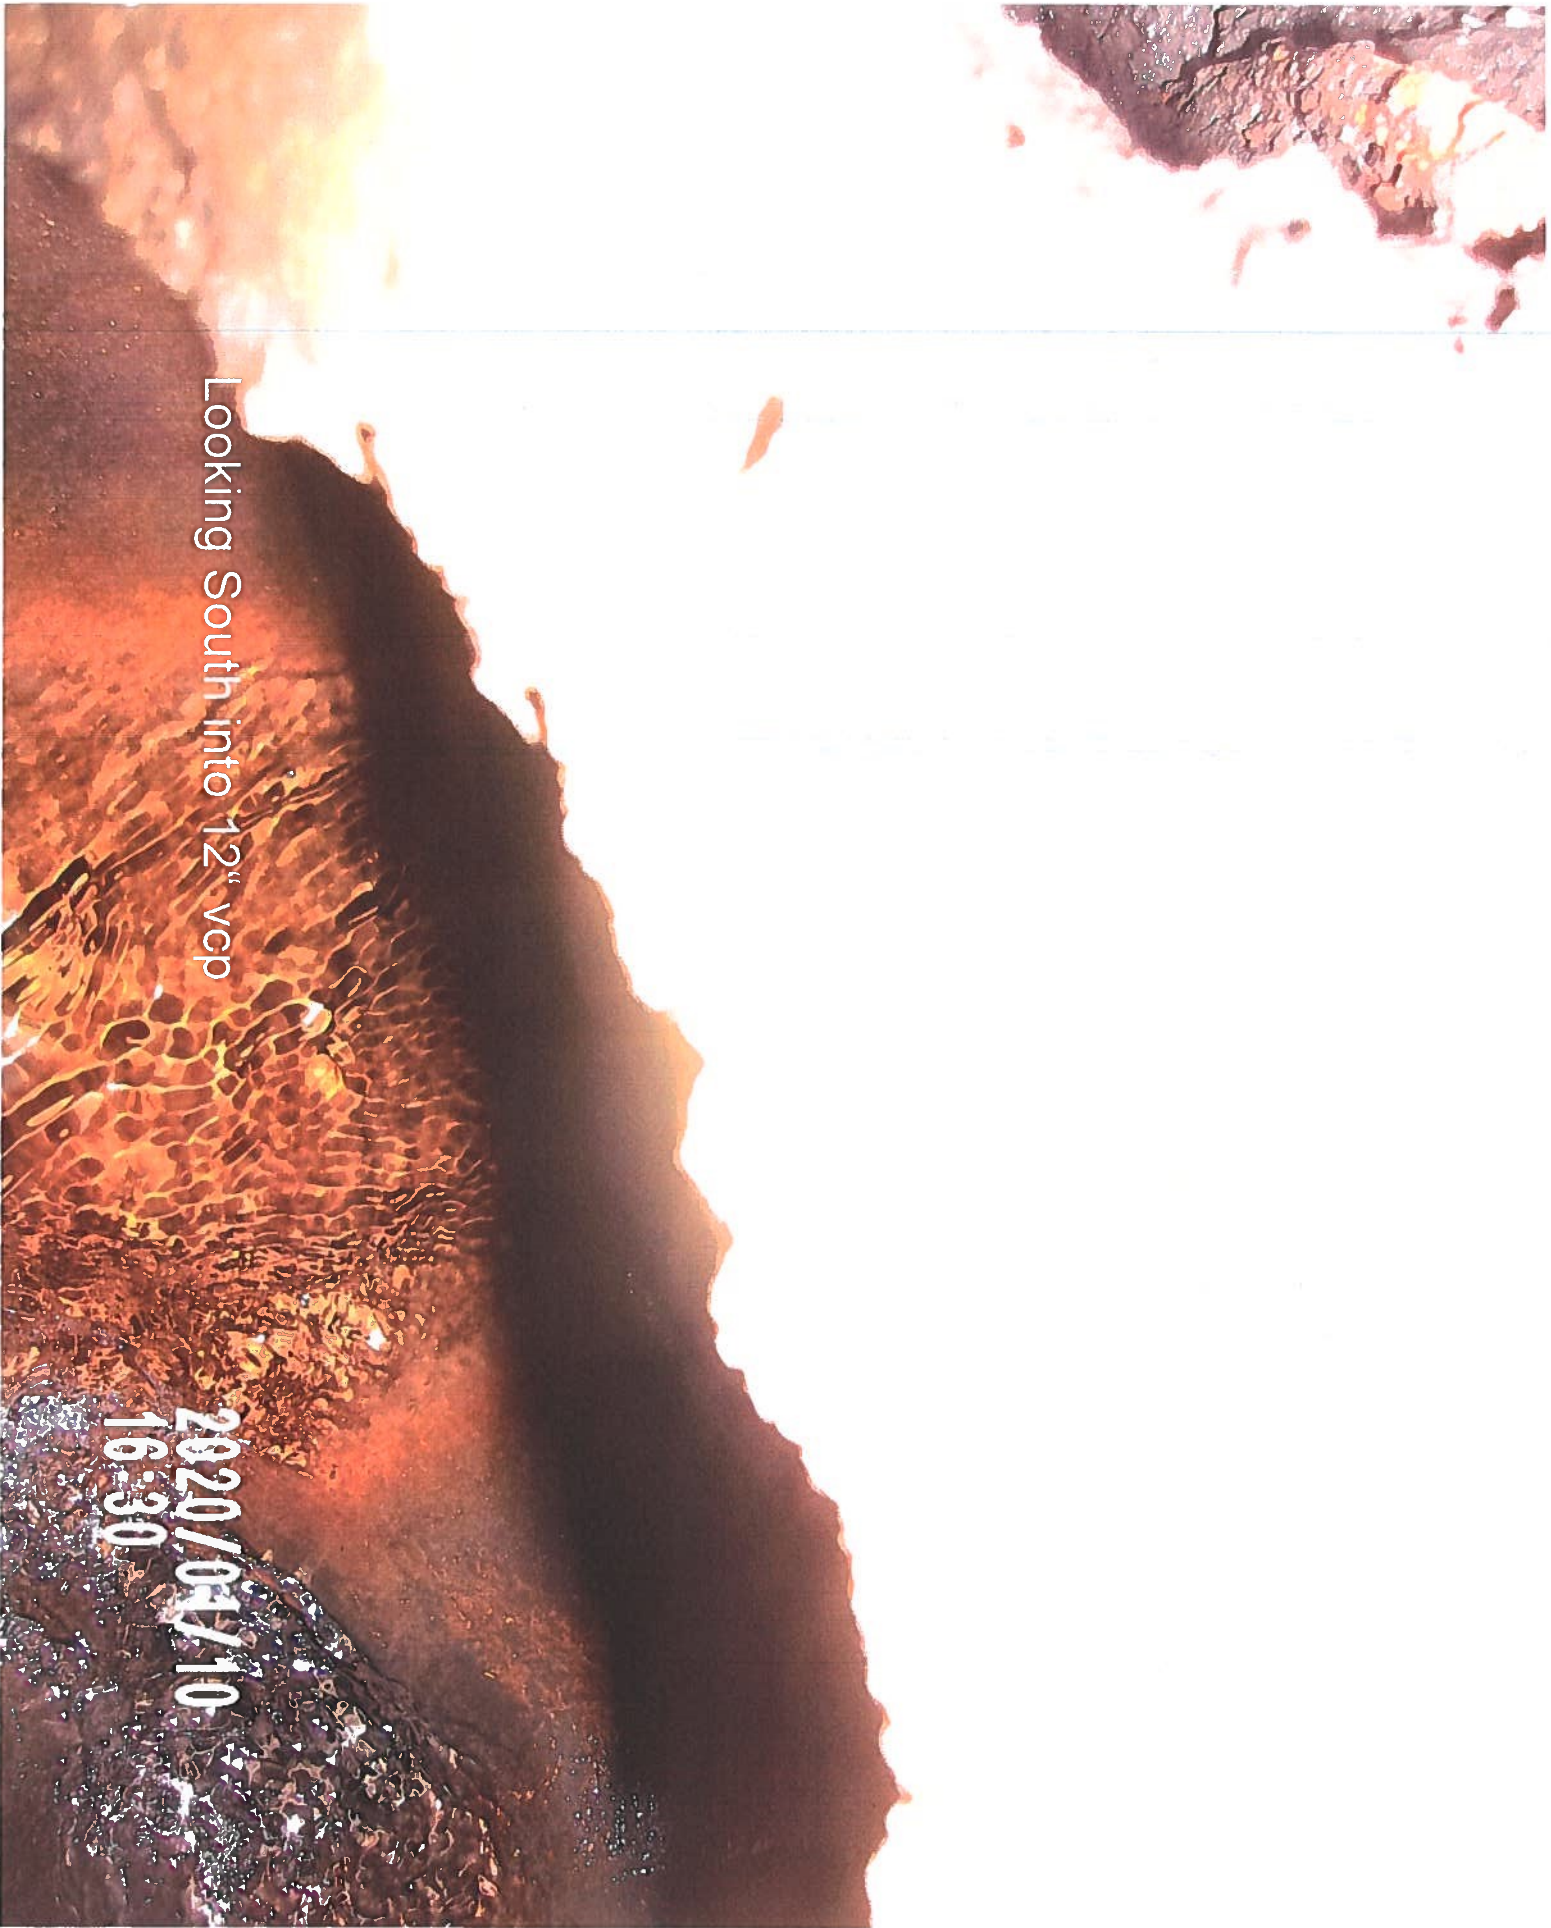
Looking South into 12" vcp

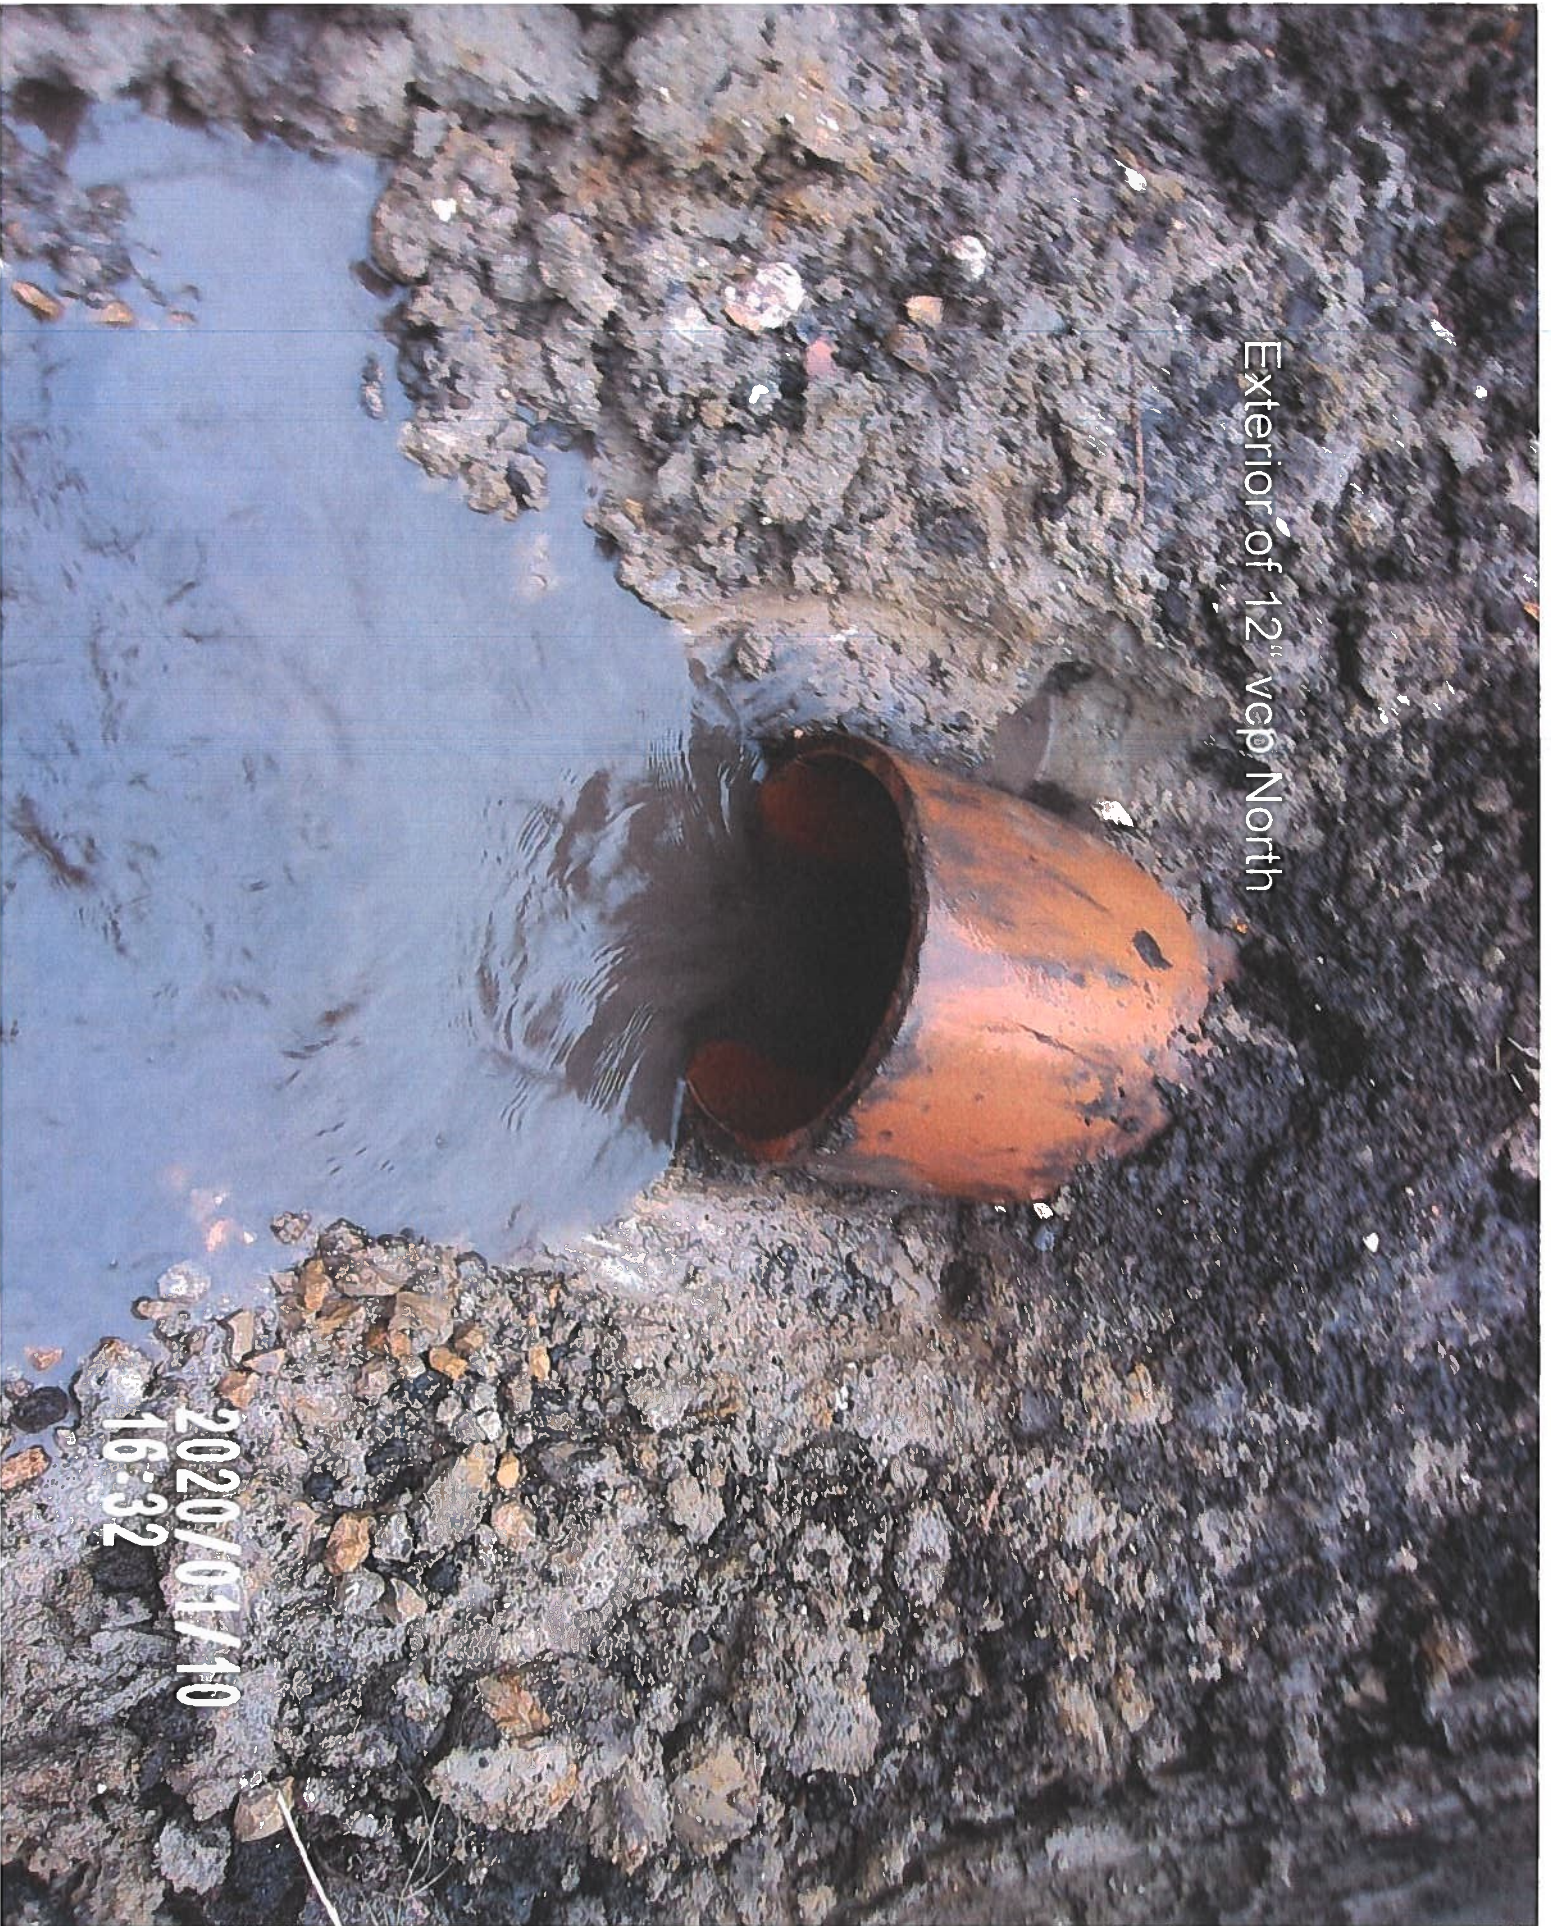
Existing tile removed from spot repair

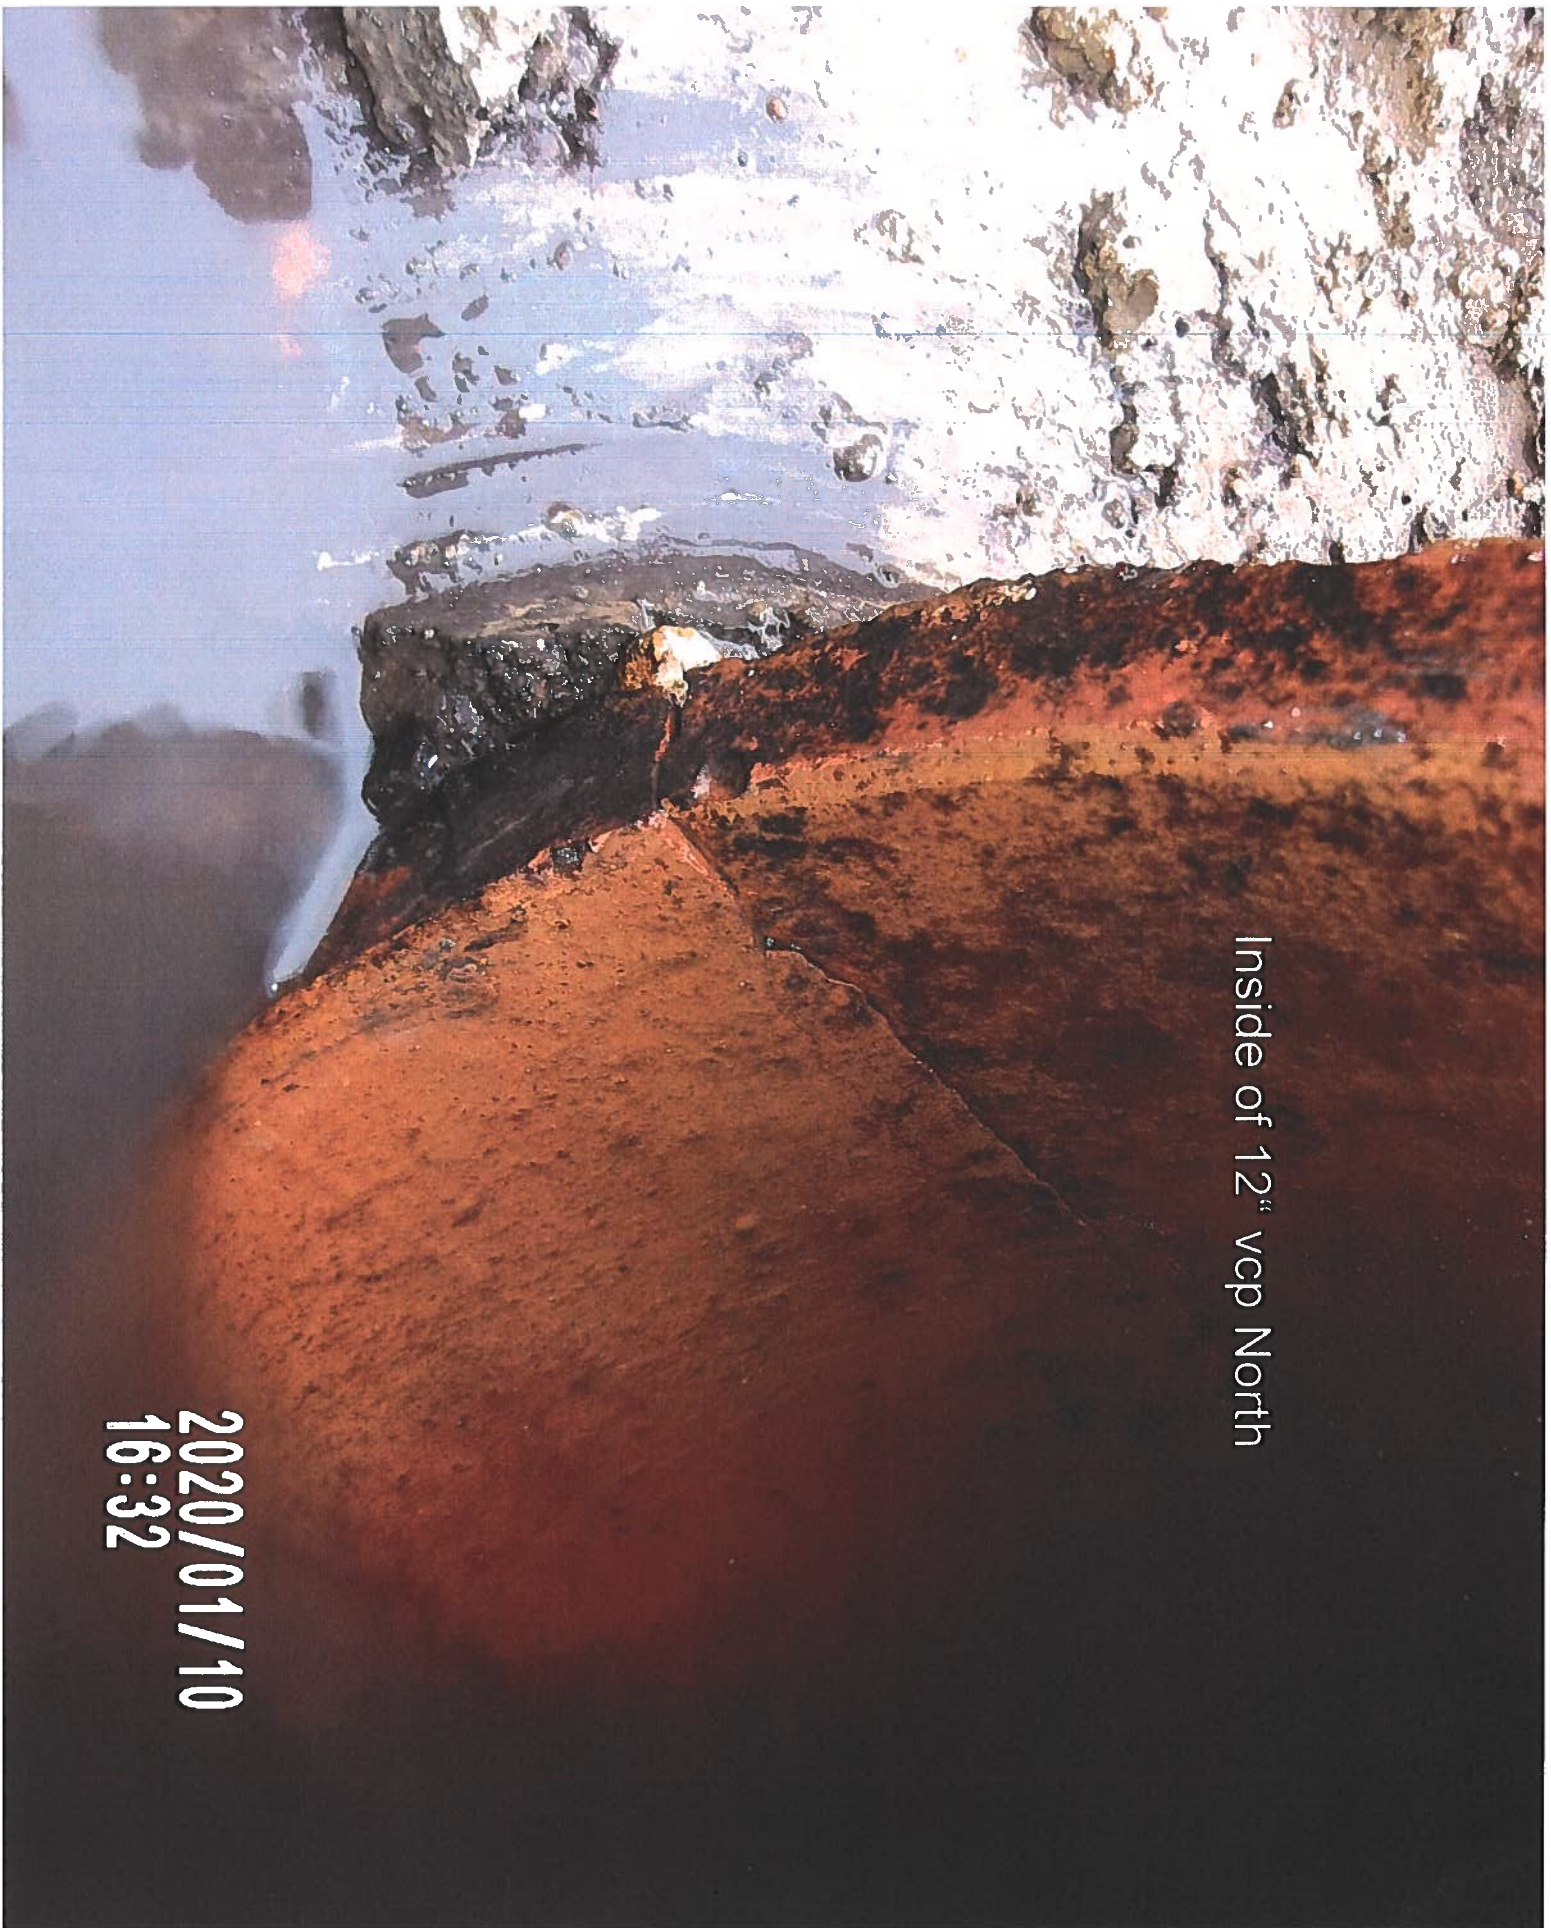
Installing 12" dual wall HDPE

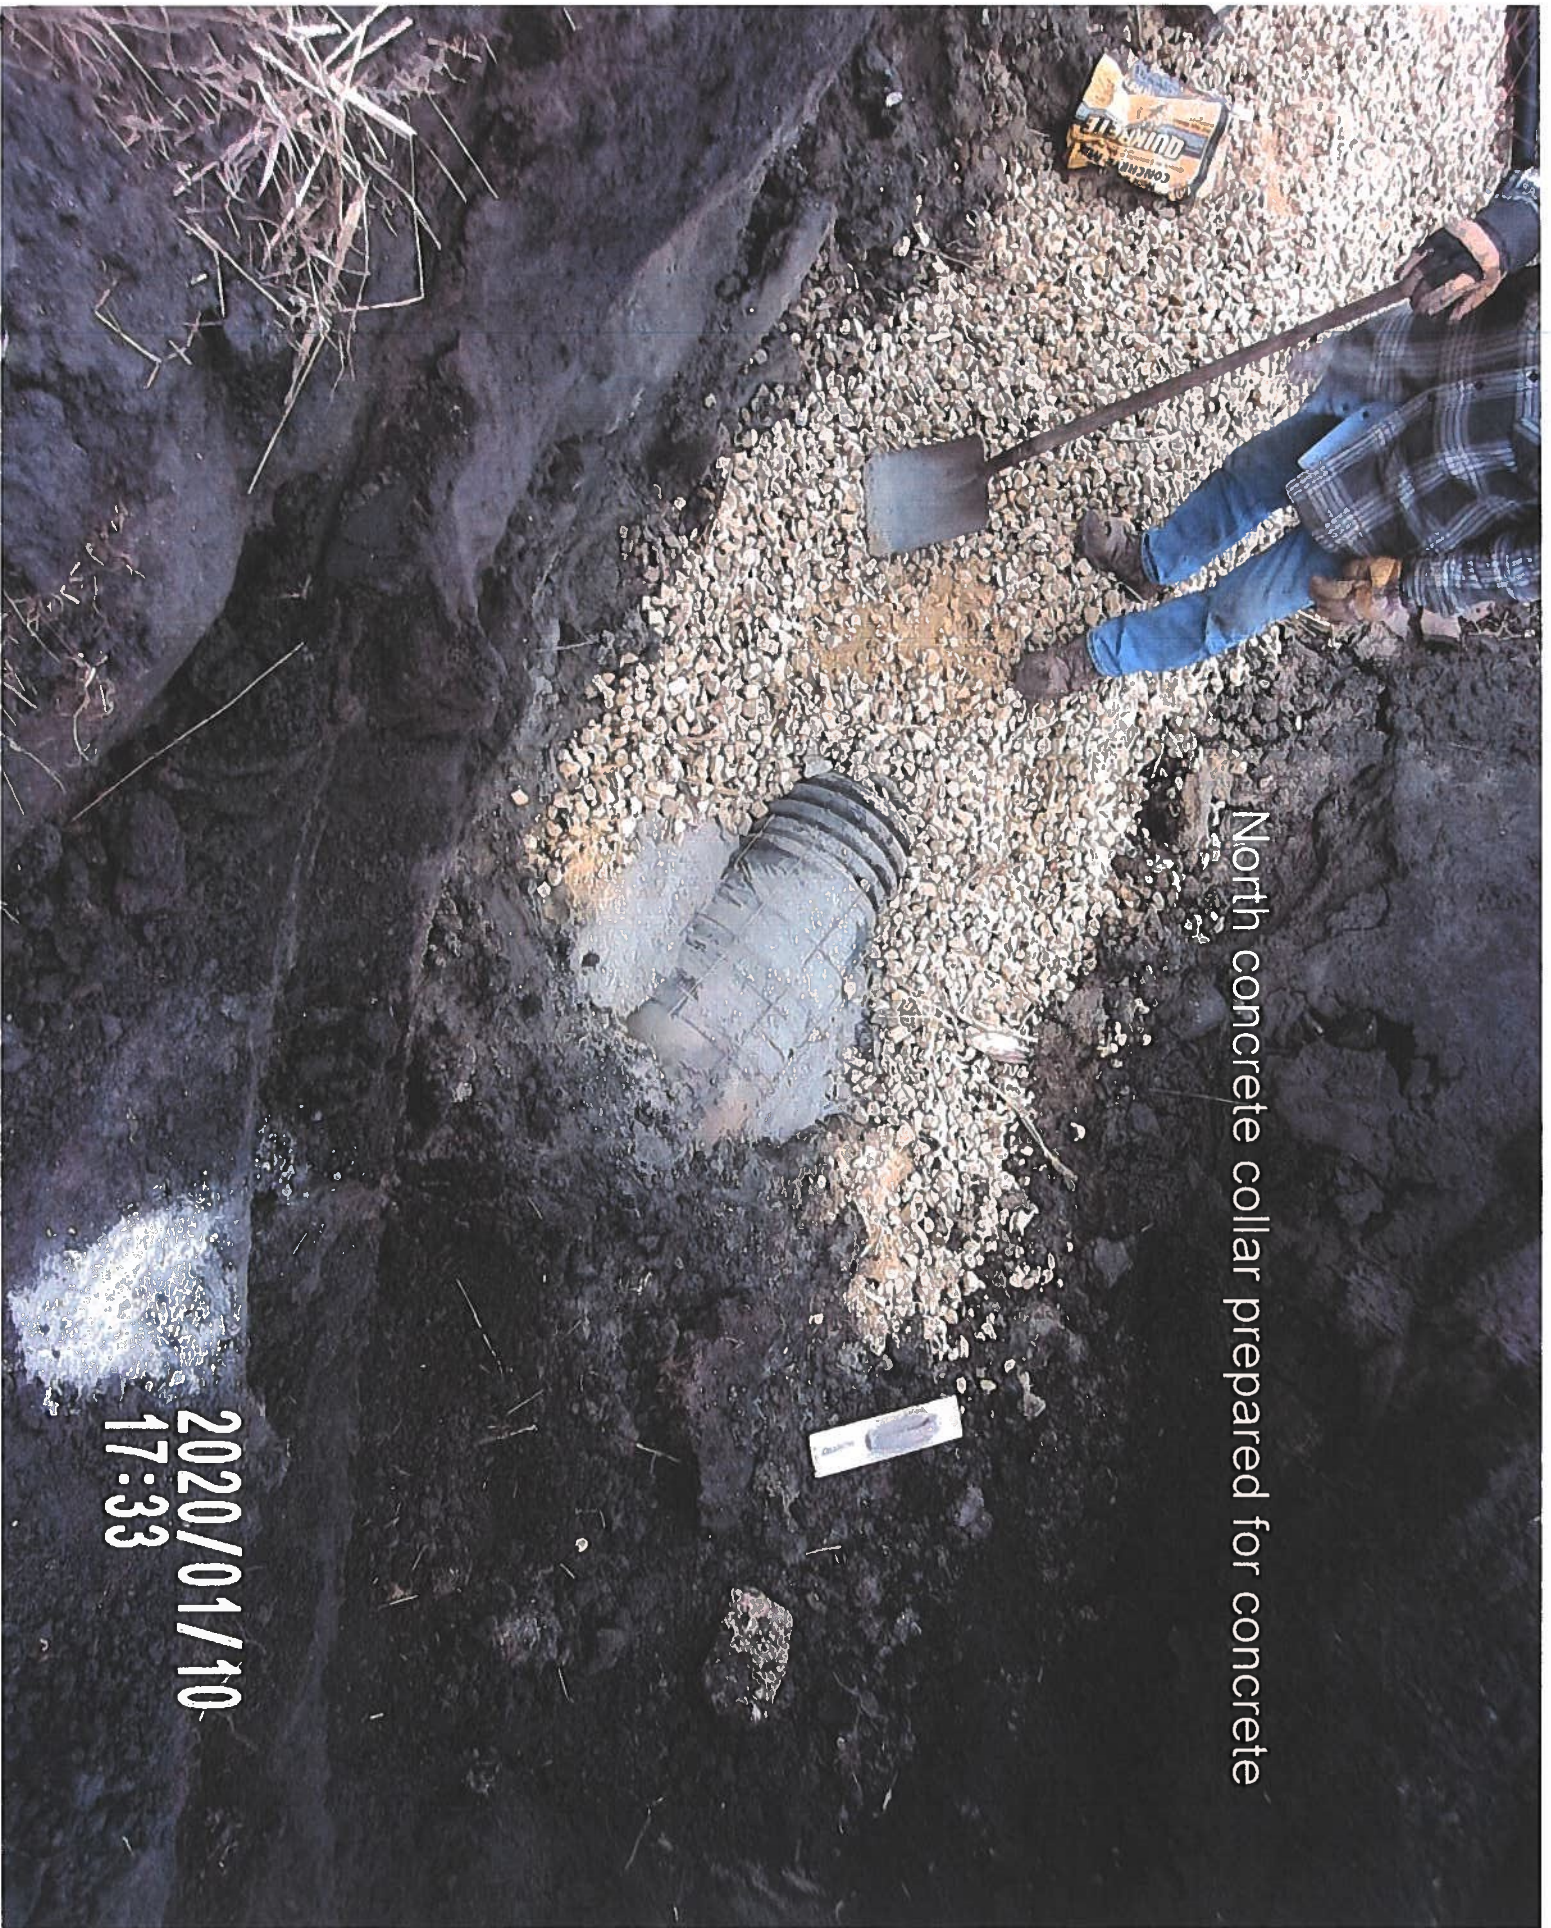
North concrete collar complete

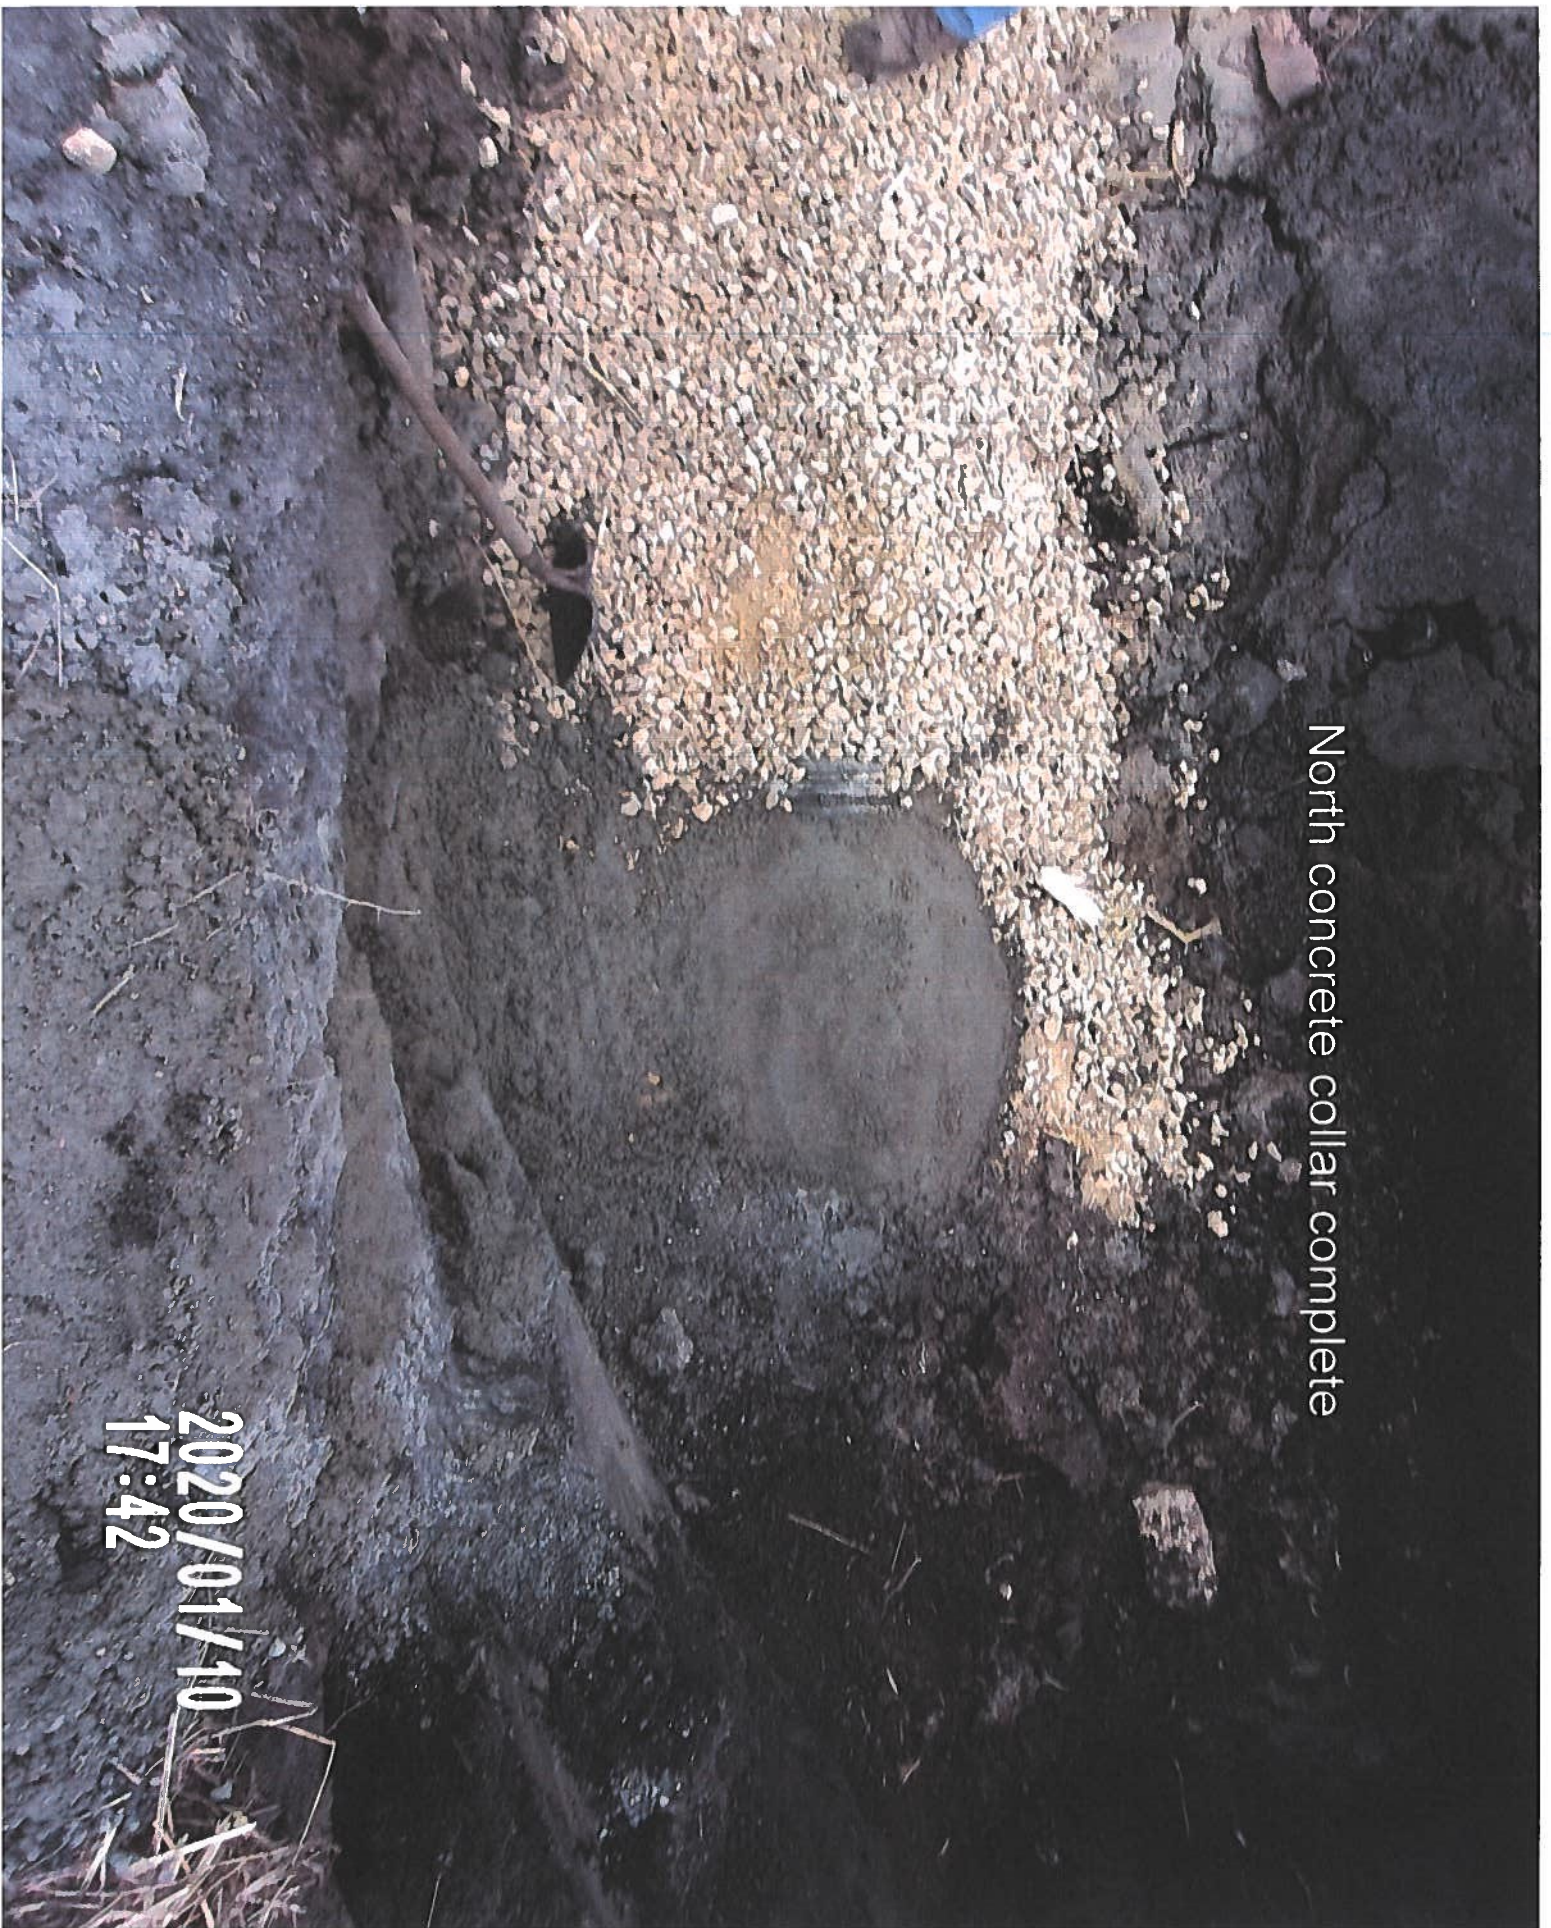
Pouring South concrete collar

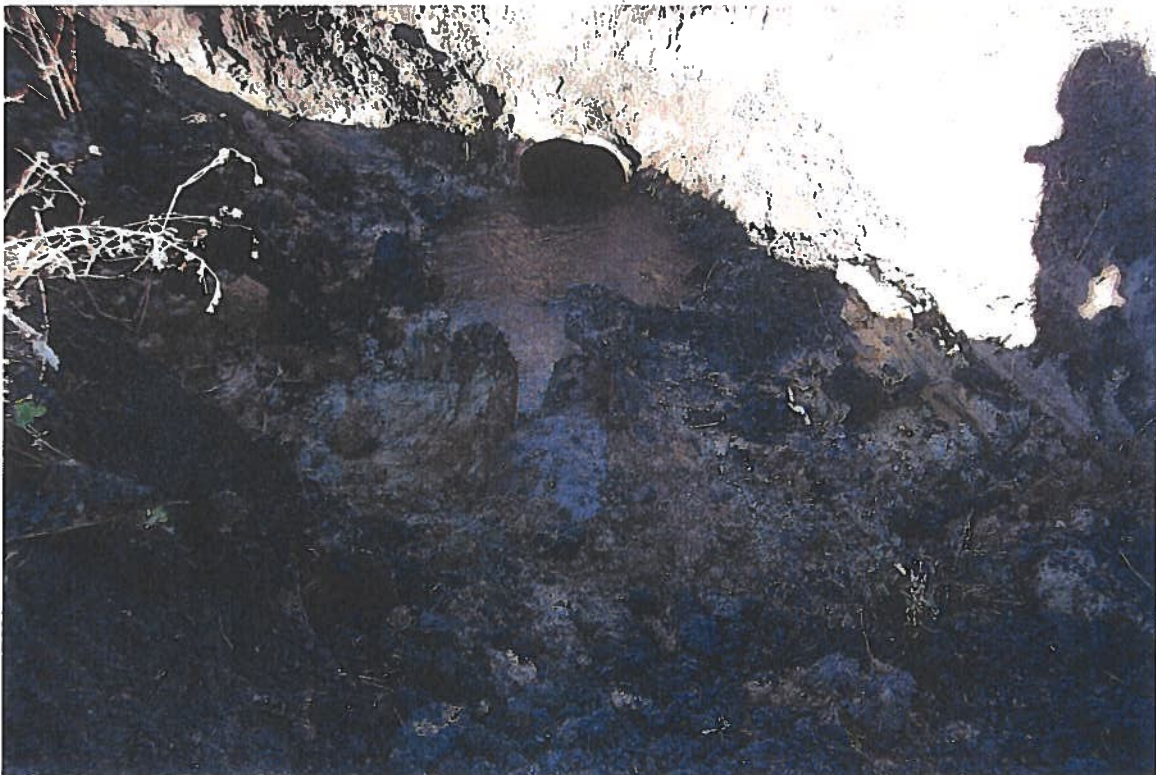
PICTURE # 2420 IS LOOKING NORTH AFTER SECTION  
OF 18" CLAY TILE WAS REMOVED THAT WAS CRACKED  
WITH JT O/S ON SOUTH END

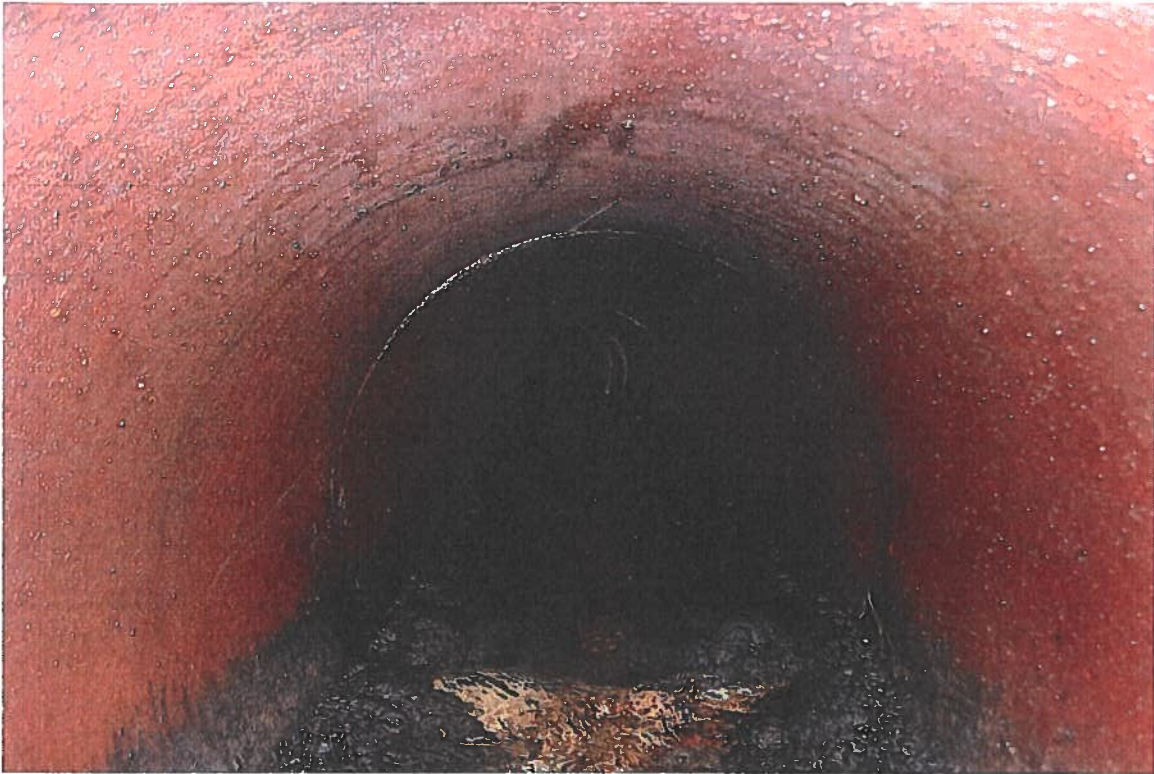
PICTURE # 2421 IS LOOKING SOUTH UPSTREAM FROM  
GPS # 22 TOP 18" CLAY TILE (1.62' TOP TO FL) WITH  
3" OF FLOW IN TILE (2.9' ± DEEP)

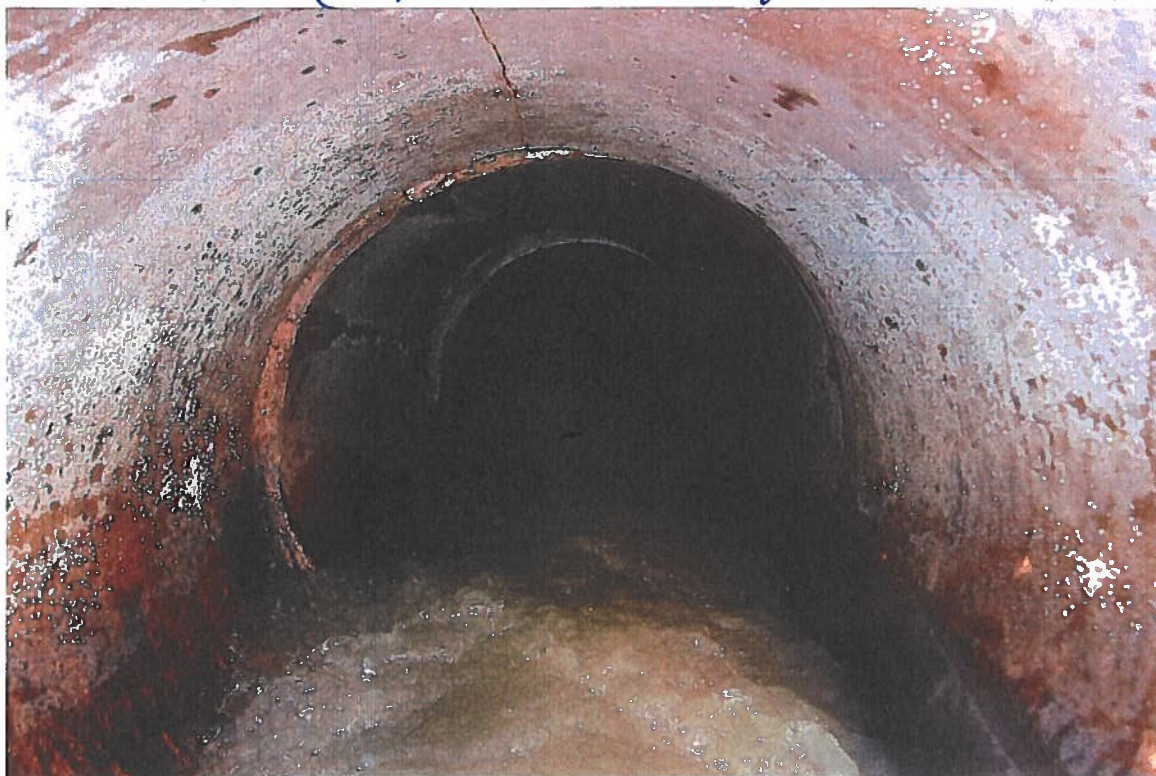
PICTURE # 2427 IS LOOKING NW SHOWING 2 SECTIONS OF  
TILE THAT WILL BE REMOVED DUE TO CRACK ON  
TOP, WIDE JOINT & VOID ON EAST SIDE,

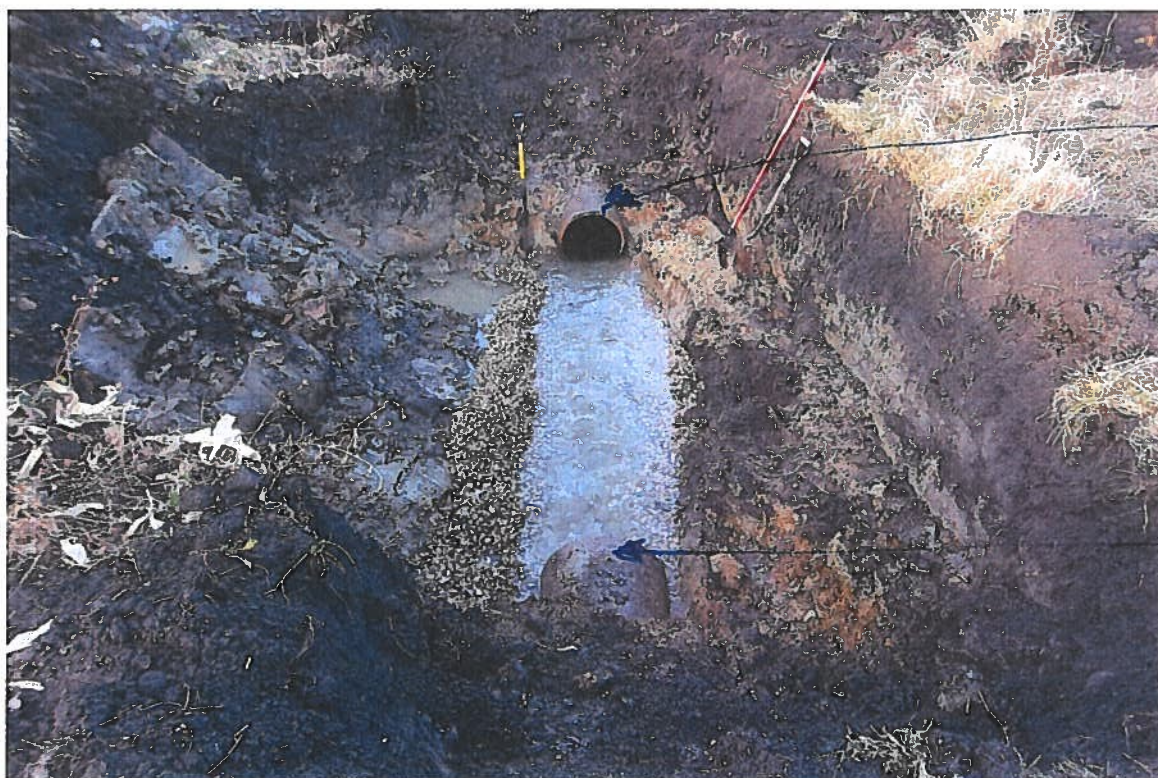
PICTURE# 2428 IS LOOKING NORTH DOWNSTREAM INSIDE  
NORTH END EXISTING 18" CLAY TILE I/N (1.58' TOP TO FL)  
TILE IS CRACKED ON TOP BUT NOT CAVING DOWN.

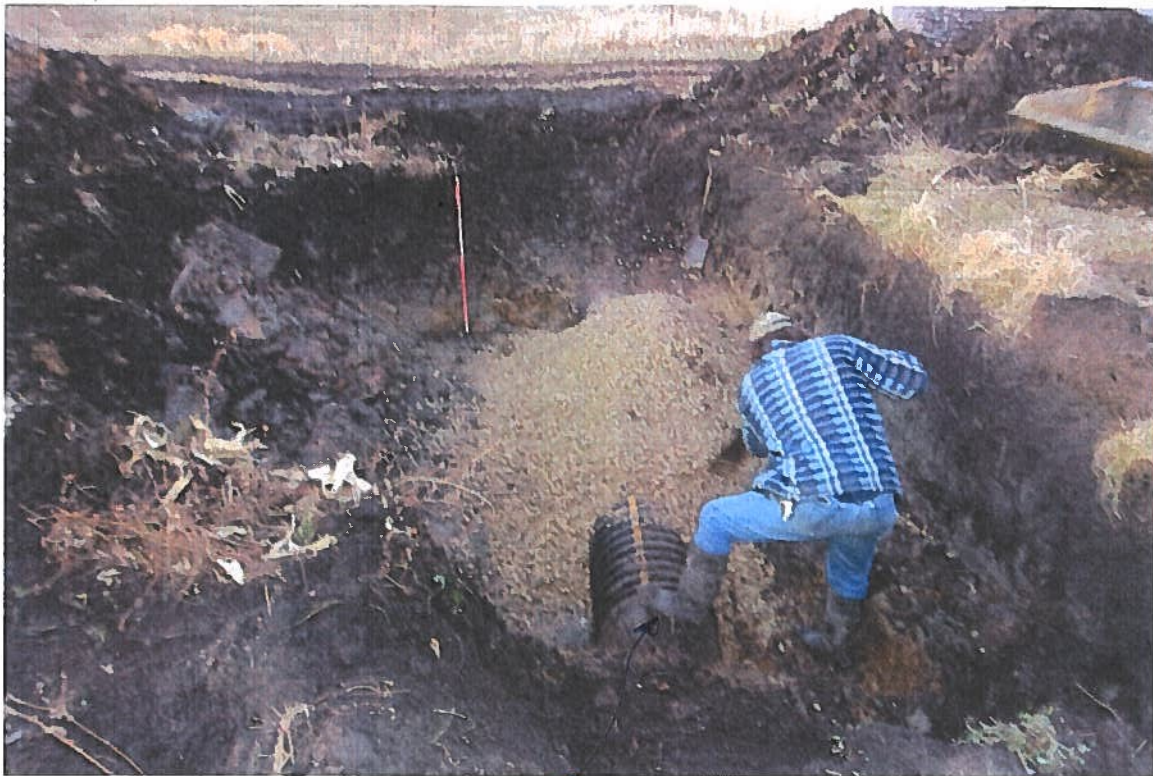
PICTURE# 2429 IS LOOKING NORTH SHOWING BOTTOM  
OF TRENCH GRADED WITH 4" OF ROCK IN BOTTOM.

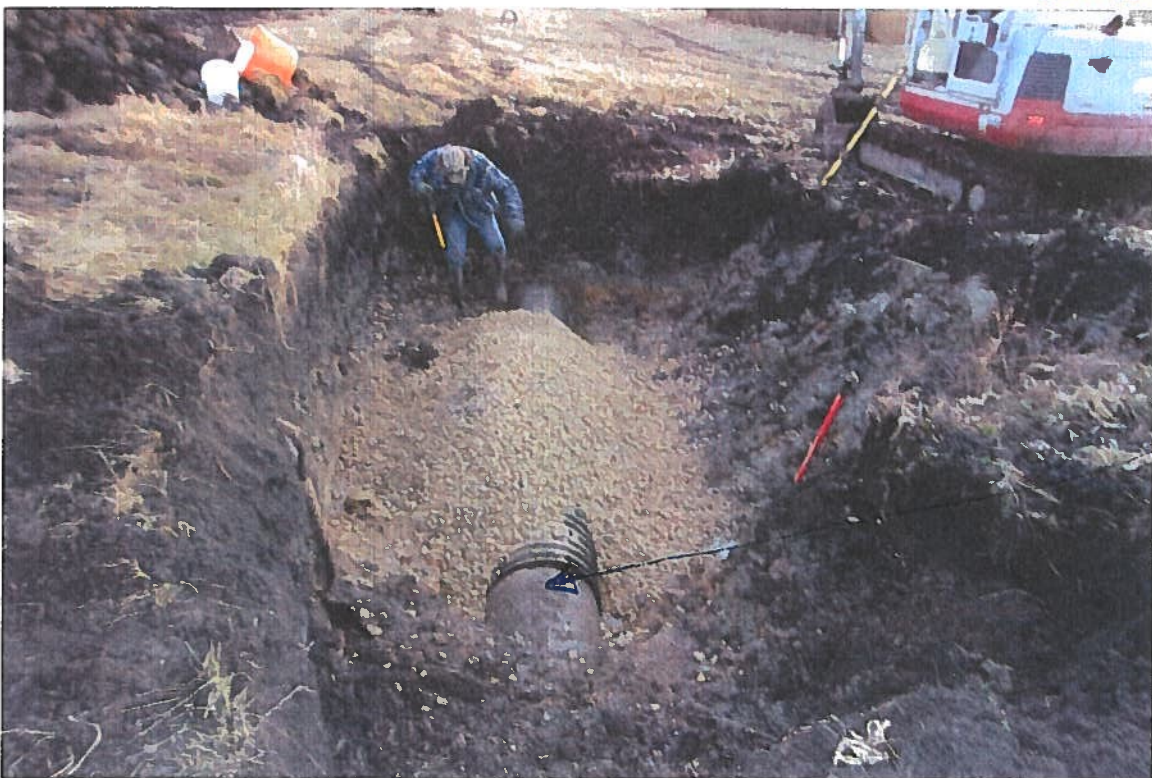
PICTURE #2430 IS LOOKING NORTH SHOWING 12.90 LF OF  
18" NONPERF TILE WITH CREW TAMPING IN ROCK UNDER  
AND ABOVE TOP OF TILE,

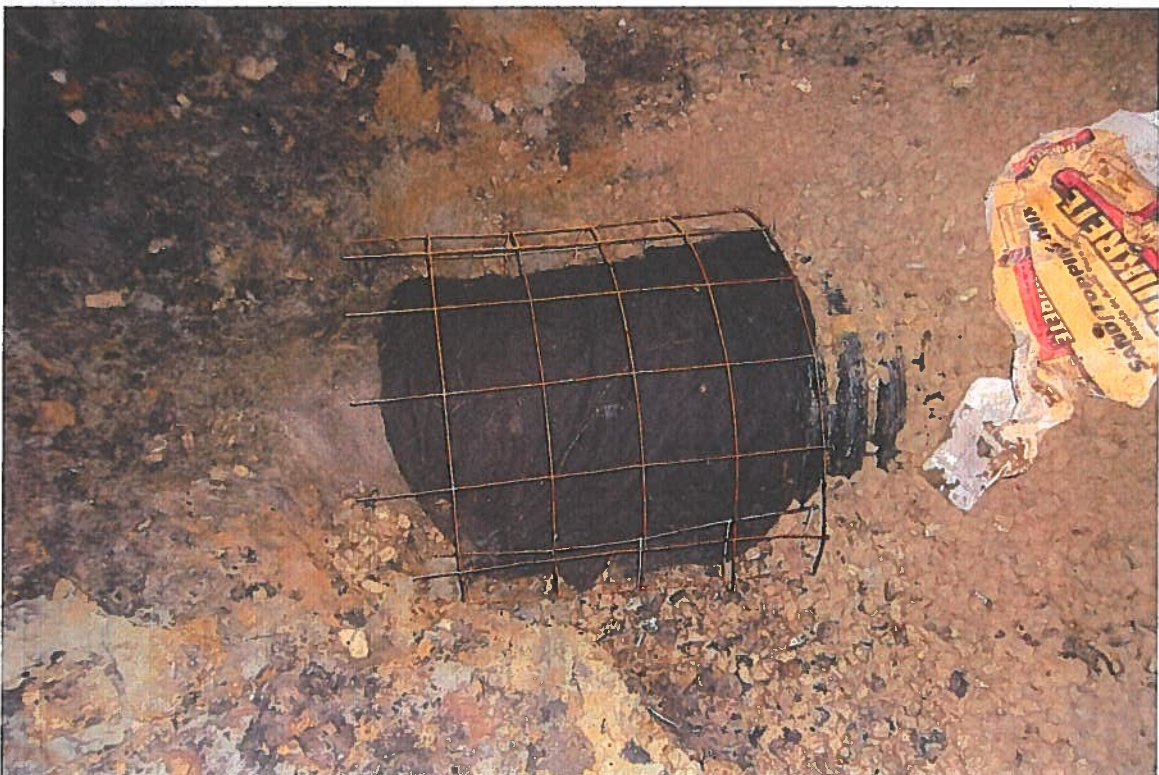
PICTURE# 2432 IS LOOKING SOUTH SHOWING CREW USING  
 (2.0'X5.0') OF 6"x6" WIRE MESH ON CONCRETE COLLAR  
 ON SOUTH END TIE IN. NO FABRIC OVER JOINT SINCE  
 OBSERVER DID NOT CATCH IT IN TIME BEFORE 1ST BAG DUMPED ON

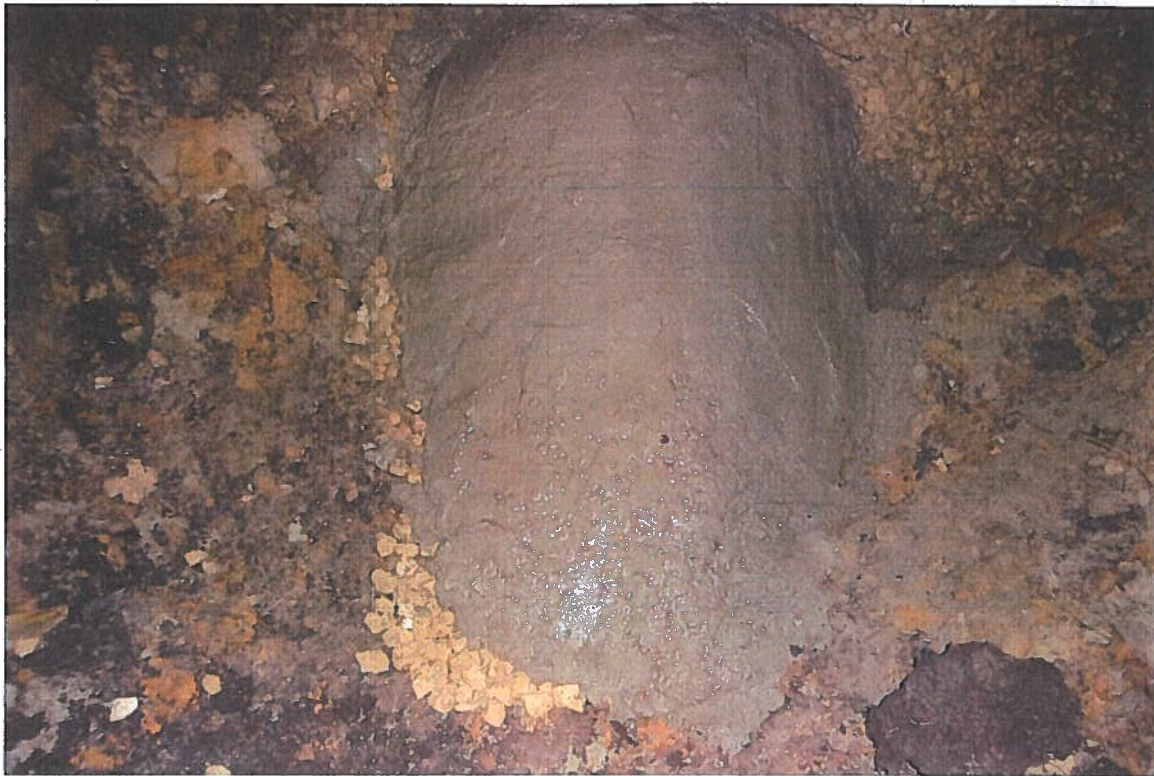
PICTURE# 2433 IS LOOKING EAST SHOWING CREW USING 2.0' X  
 5.0') OF 6"x6" WIRE MESH ON CONCRETE COLLAR ON NORTH END  
 TIE IN. REUSED ENGINEERING FABRIC OVER JOINT FROM EXISTING TIE.  
 1ST BAG NOT DUMPED YET
