**AGENDA**  
**REGULAR DRAINAGE MEETING**  
**Wednesday, March 11, 2020 9:30 AM**

7. DD 100 WO 248 - Discuss W Possible Action - Repair Summary

## Repair Summary:

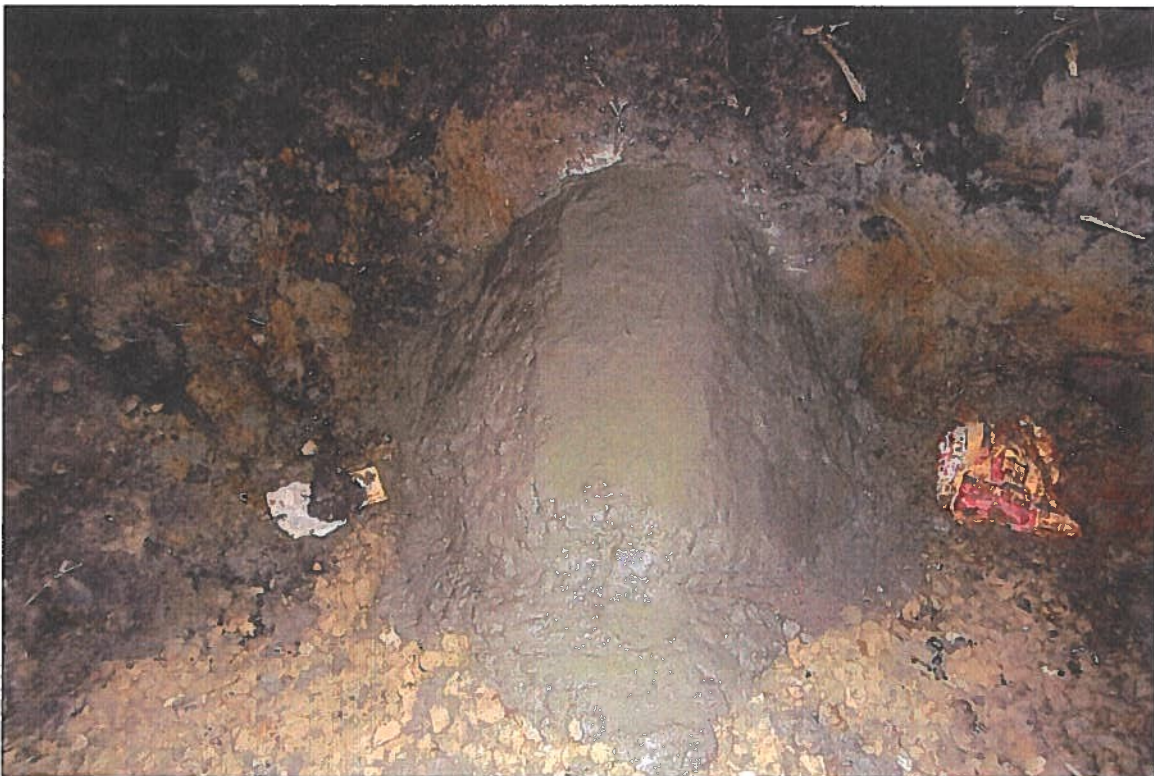
PICTURE # 2434 IS LOOKING NORTH AT CONCRETE COLLAR  
POURED ON NORTH ED TIE IN. CREW USED 7.5 - 60LB BAGS  
OF SAND/TOPPING CONCRETE MIX SINCE CREW SAID IOWA FALLS  
WAS OUT OF REGULAR CONCRETE (CREW ADDED SOME GRAVEL TO

MIX  
WHILE  
MIXING

(A  
CONCRETE  
WAS  
MIXED  
BY  
HAND)

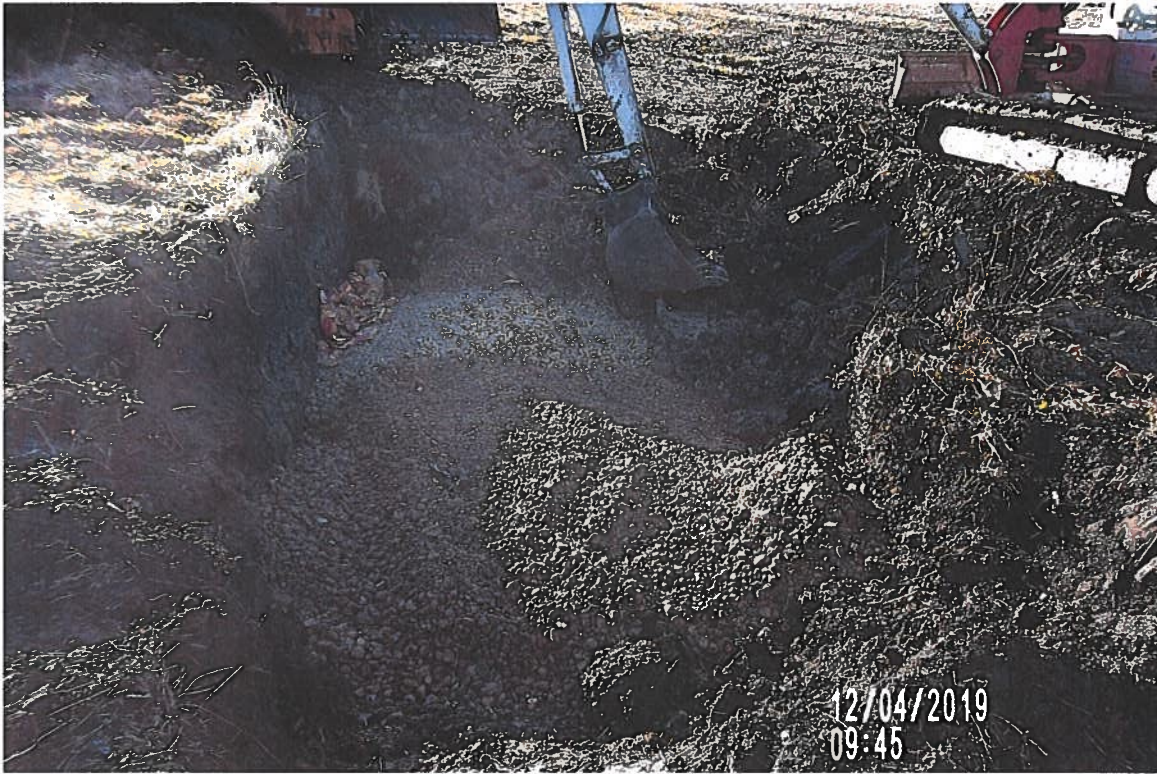
PICTURE # 2436 IS LOOKING SOUTH SHOWING BOTH CONCRETE COLLAR TIE INS AND TRENCH BACK FILLED WITH ADDITIONAL STONS OF ROLK

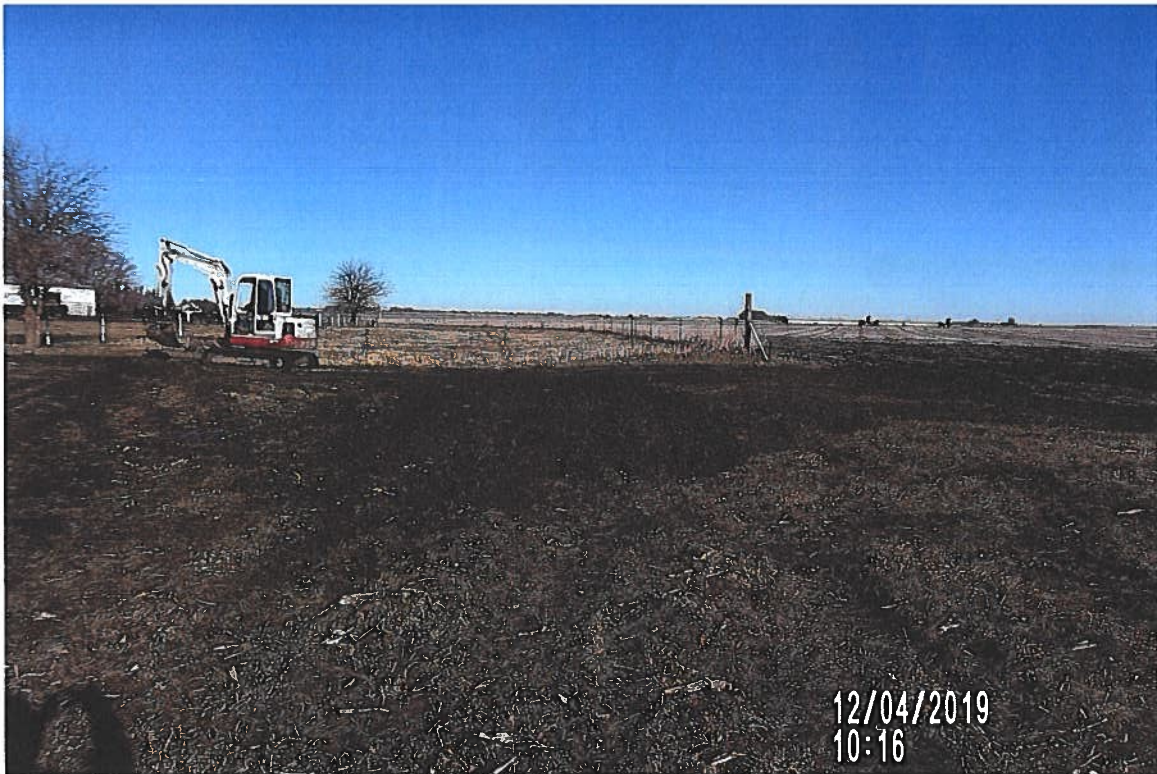
PICTURE # 2437 IS LOOKING NORTH FROM GRASS SWALE SOUTH OF REPAIR AT BACK FILL SOIL ALL DRESSED UP

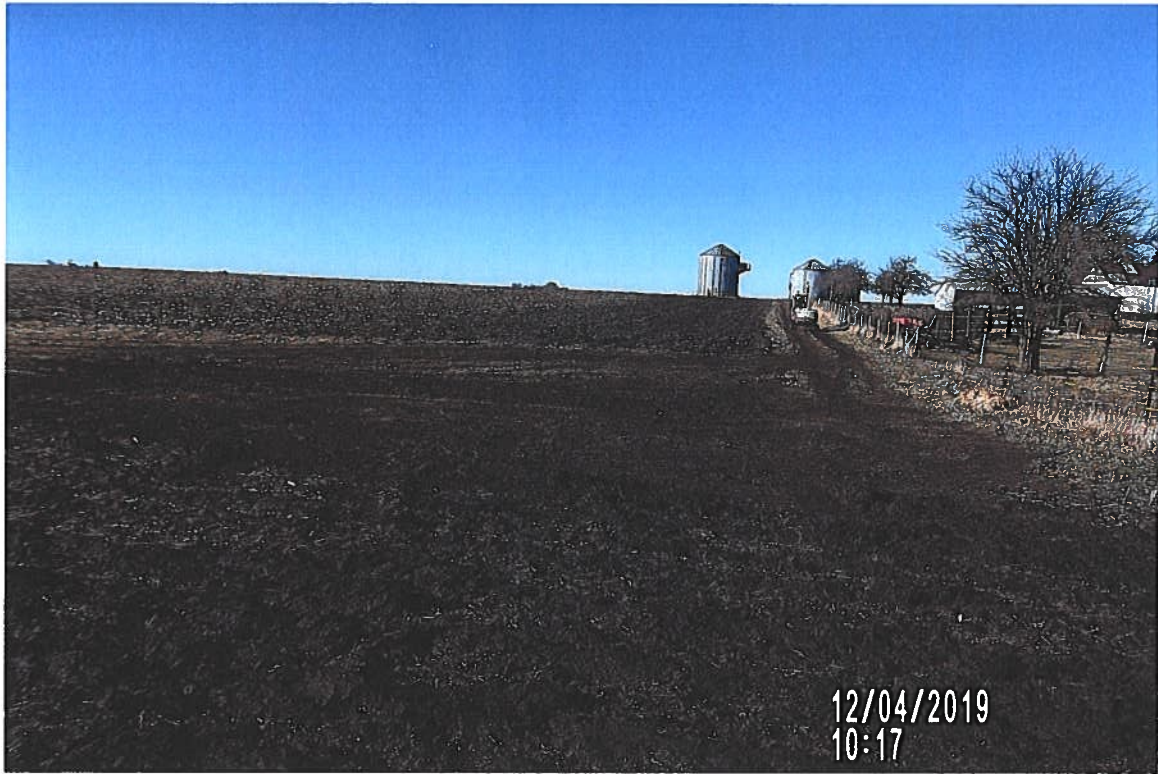
PICTURE# 2438 IS LOOKING WEST SHOWING  
TOPSOIL BACK FILLED AND DRESSED UP.

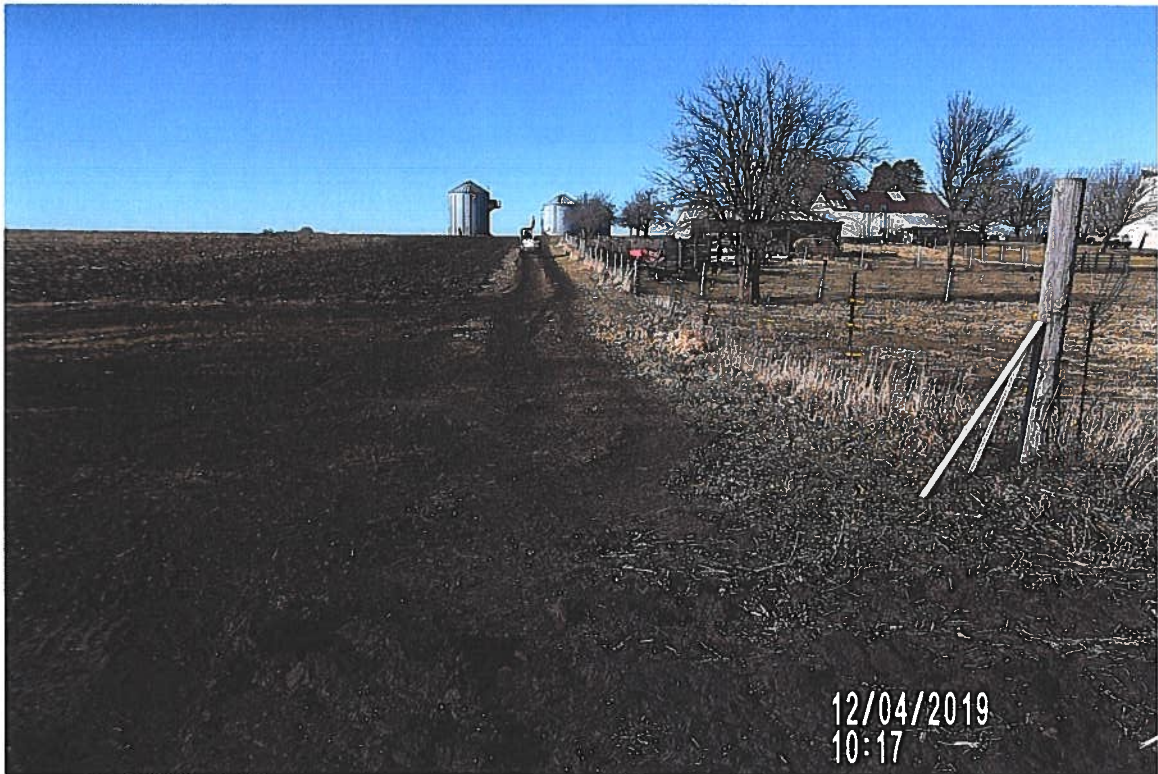
PICTURE# 2439 IS LOOKING WEST SHOWING GRASSLAND SOUTH  
OF 13312 CO HWY. S-56 CATTLE PASTURE USED TO GET TO  
TILE REPAIR
