AGENDA
REGULAR DRAINAGE MEETING
February 5, 2020 9:30 AM

**ENGINEER'S REPORT
ON REPAIRS
TO MAIN TILE
DRAINAGE DISTRICT
NO. 86
HARDIN COUNTY,
IOWA**

SUPPLEMENT TO
ENGINEER'S REPORT
ON REPAIRS
TO MAIN TILE
DRAINAGE DISTRICT
NO. 86
HARDIN COUNTY,
IOWA

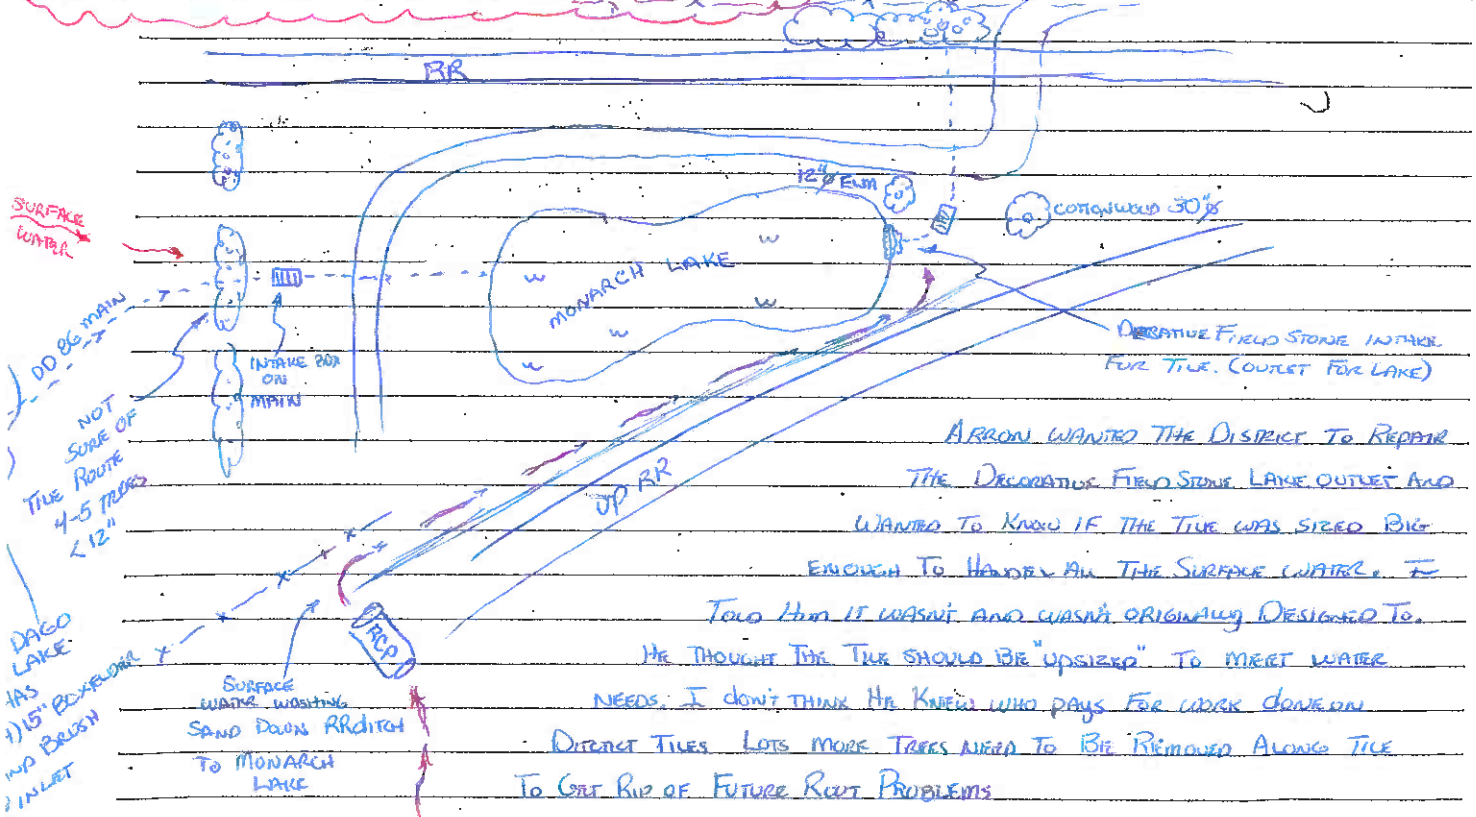
* 200+ TREES NEED REMOVED FROM DAGO LAKE TO OUTLET

TOLD HIM IT WASN'T AND WASN'T ORIGINALLY DESIGNED TO.
HE THOUGHT THE TILE SHOULD BE "UPSIZED" TO MEET WATER
NEEDS. I DON'T THINK HE KNEW WHO PAYS FOR WORK DONE BY
DISTRICT TILES. LOTS MORE TREES NEED TO BE REMOVED ALONG TILE
TO GET RID OF FUTURE ROOT PROBLEMS

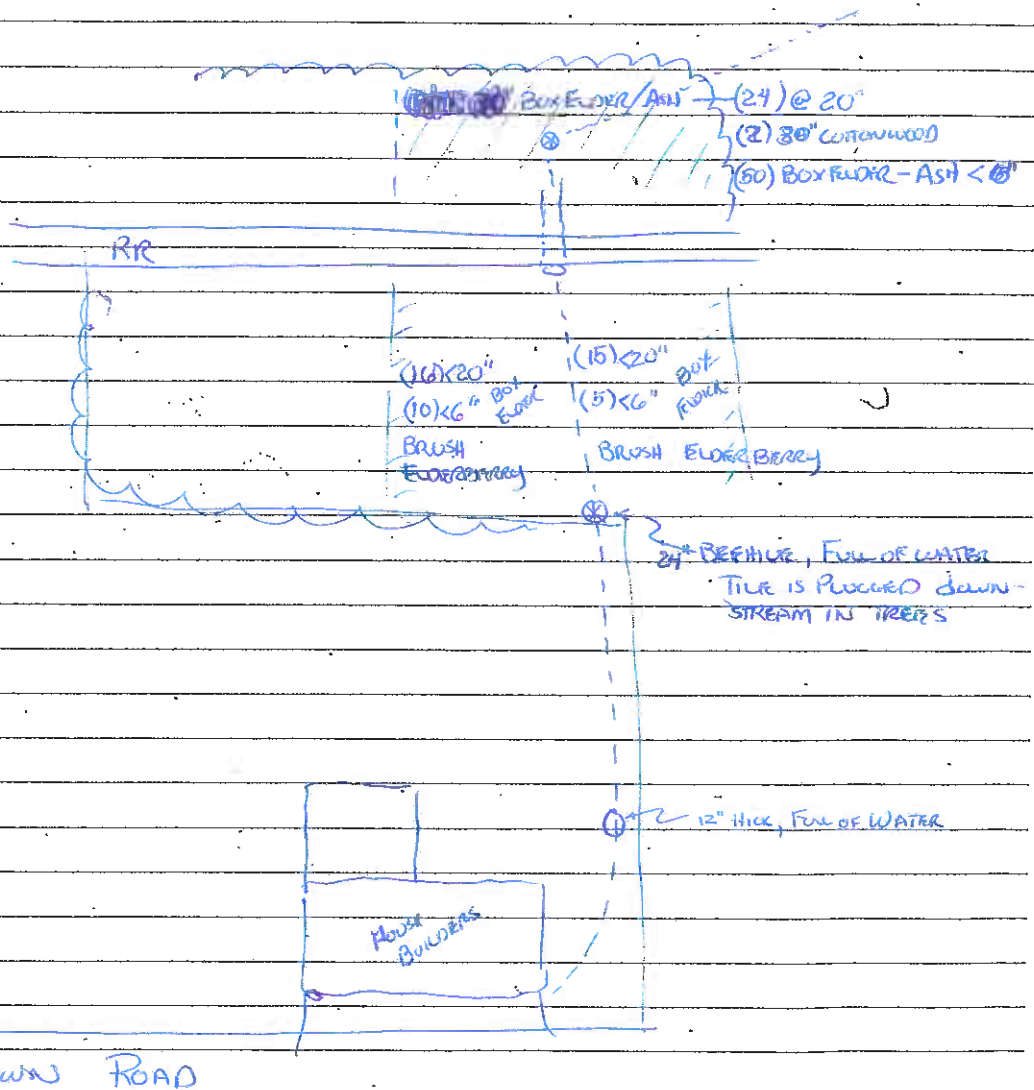
DAGO LAKE INLET (DD86 OLD MAIN) (14) 15" BOX ELDER AND HONEYSUCKLE BRUSH NEEDS REMOVED

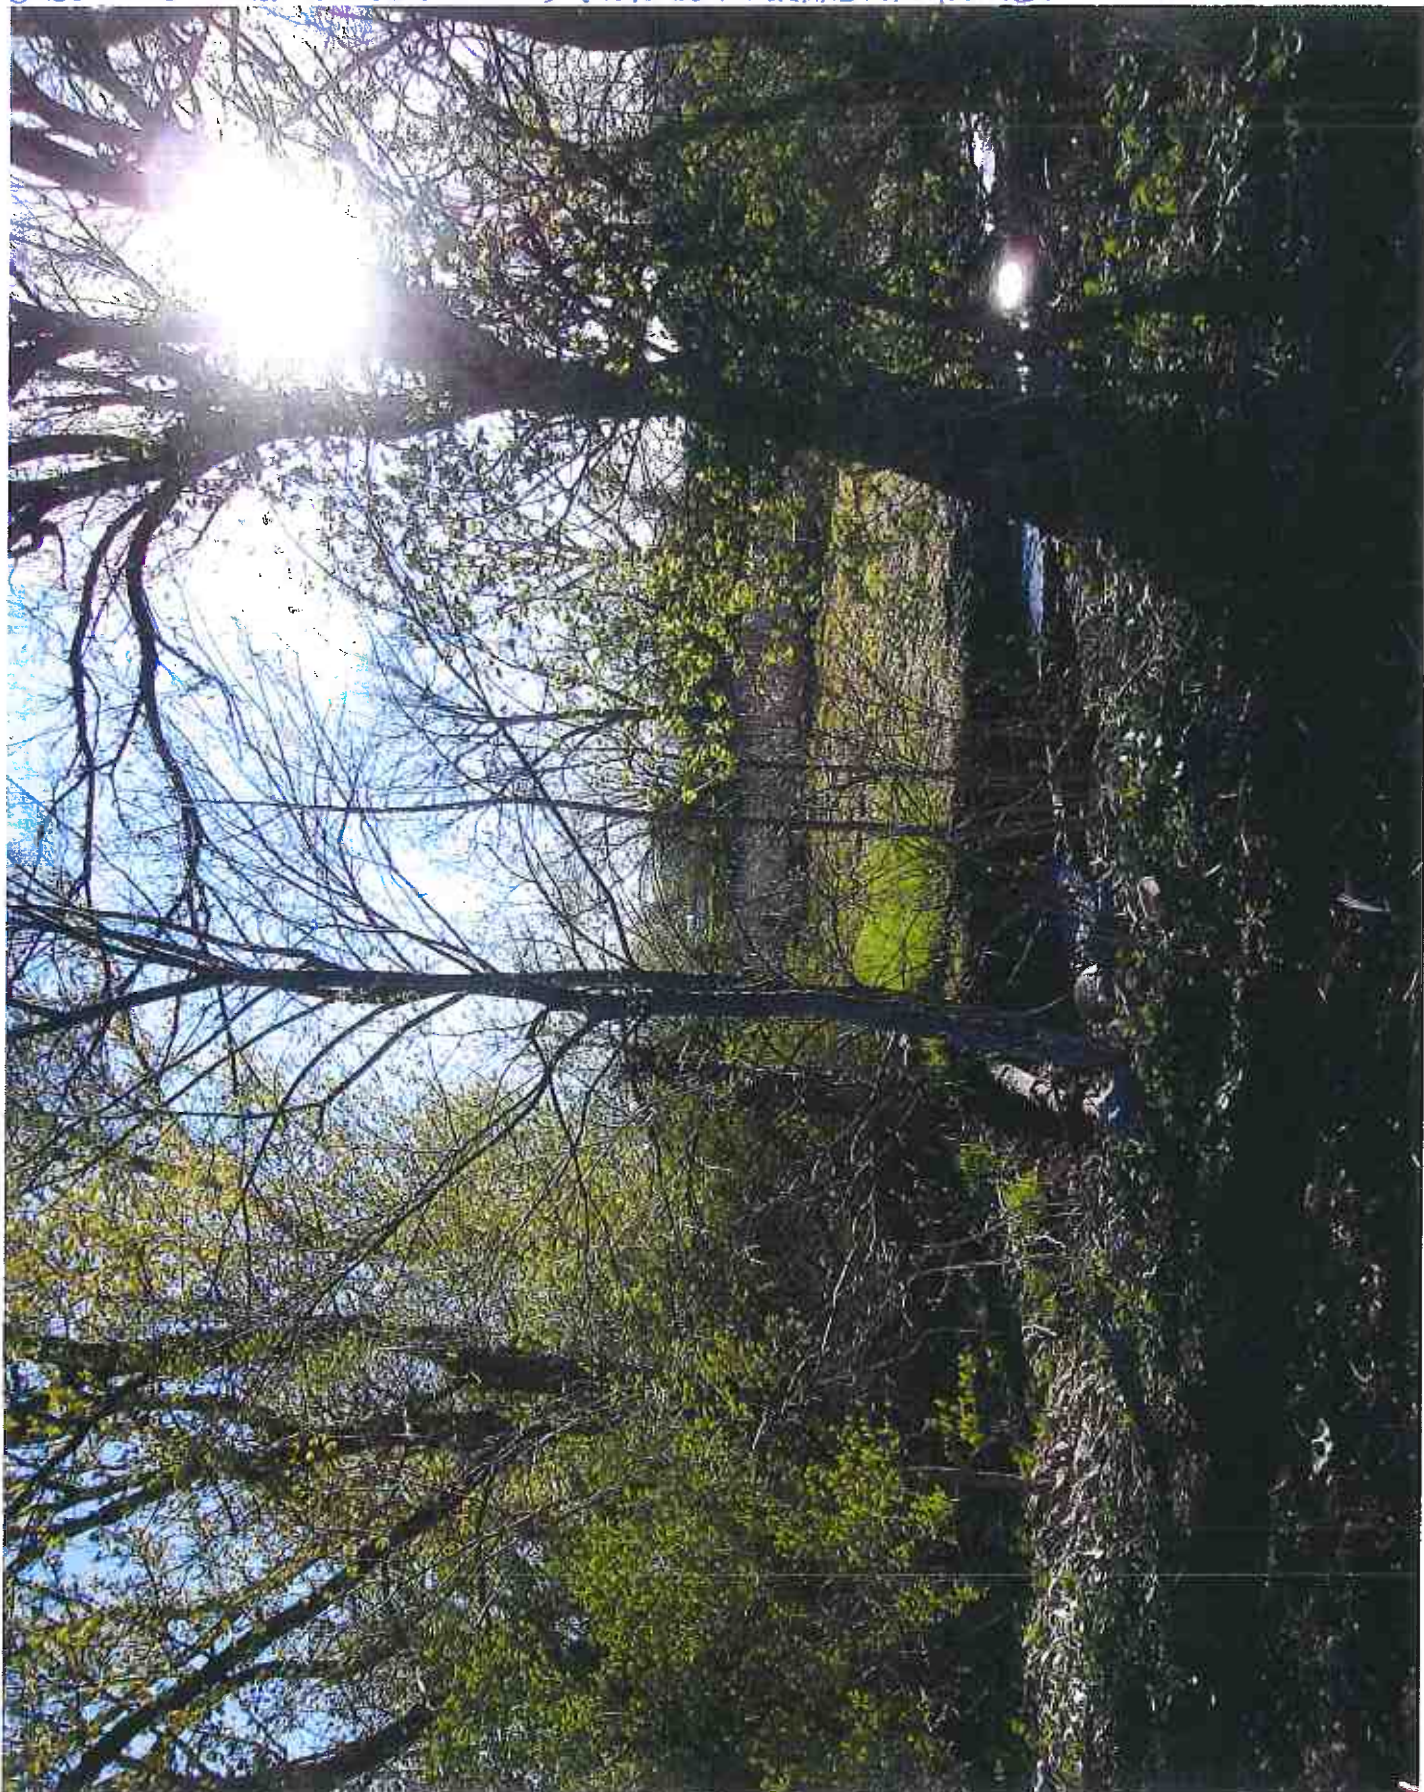
LOOKING WEST FROM MONARCH TO DAGO LAKE

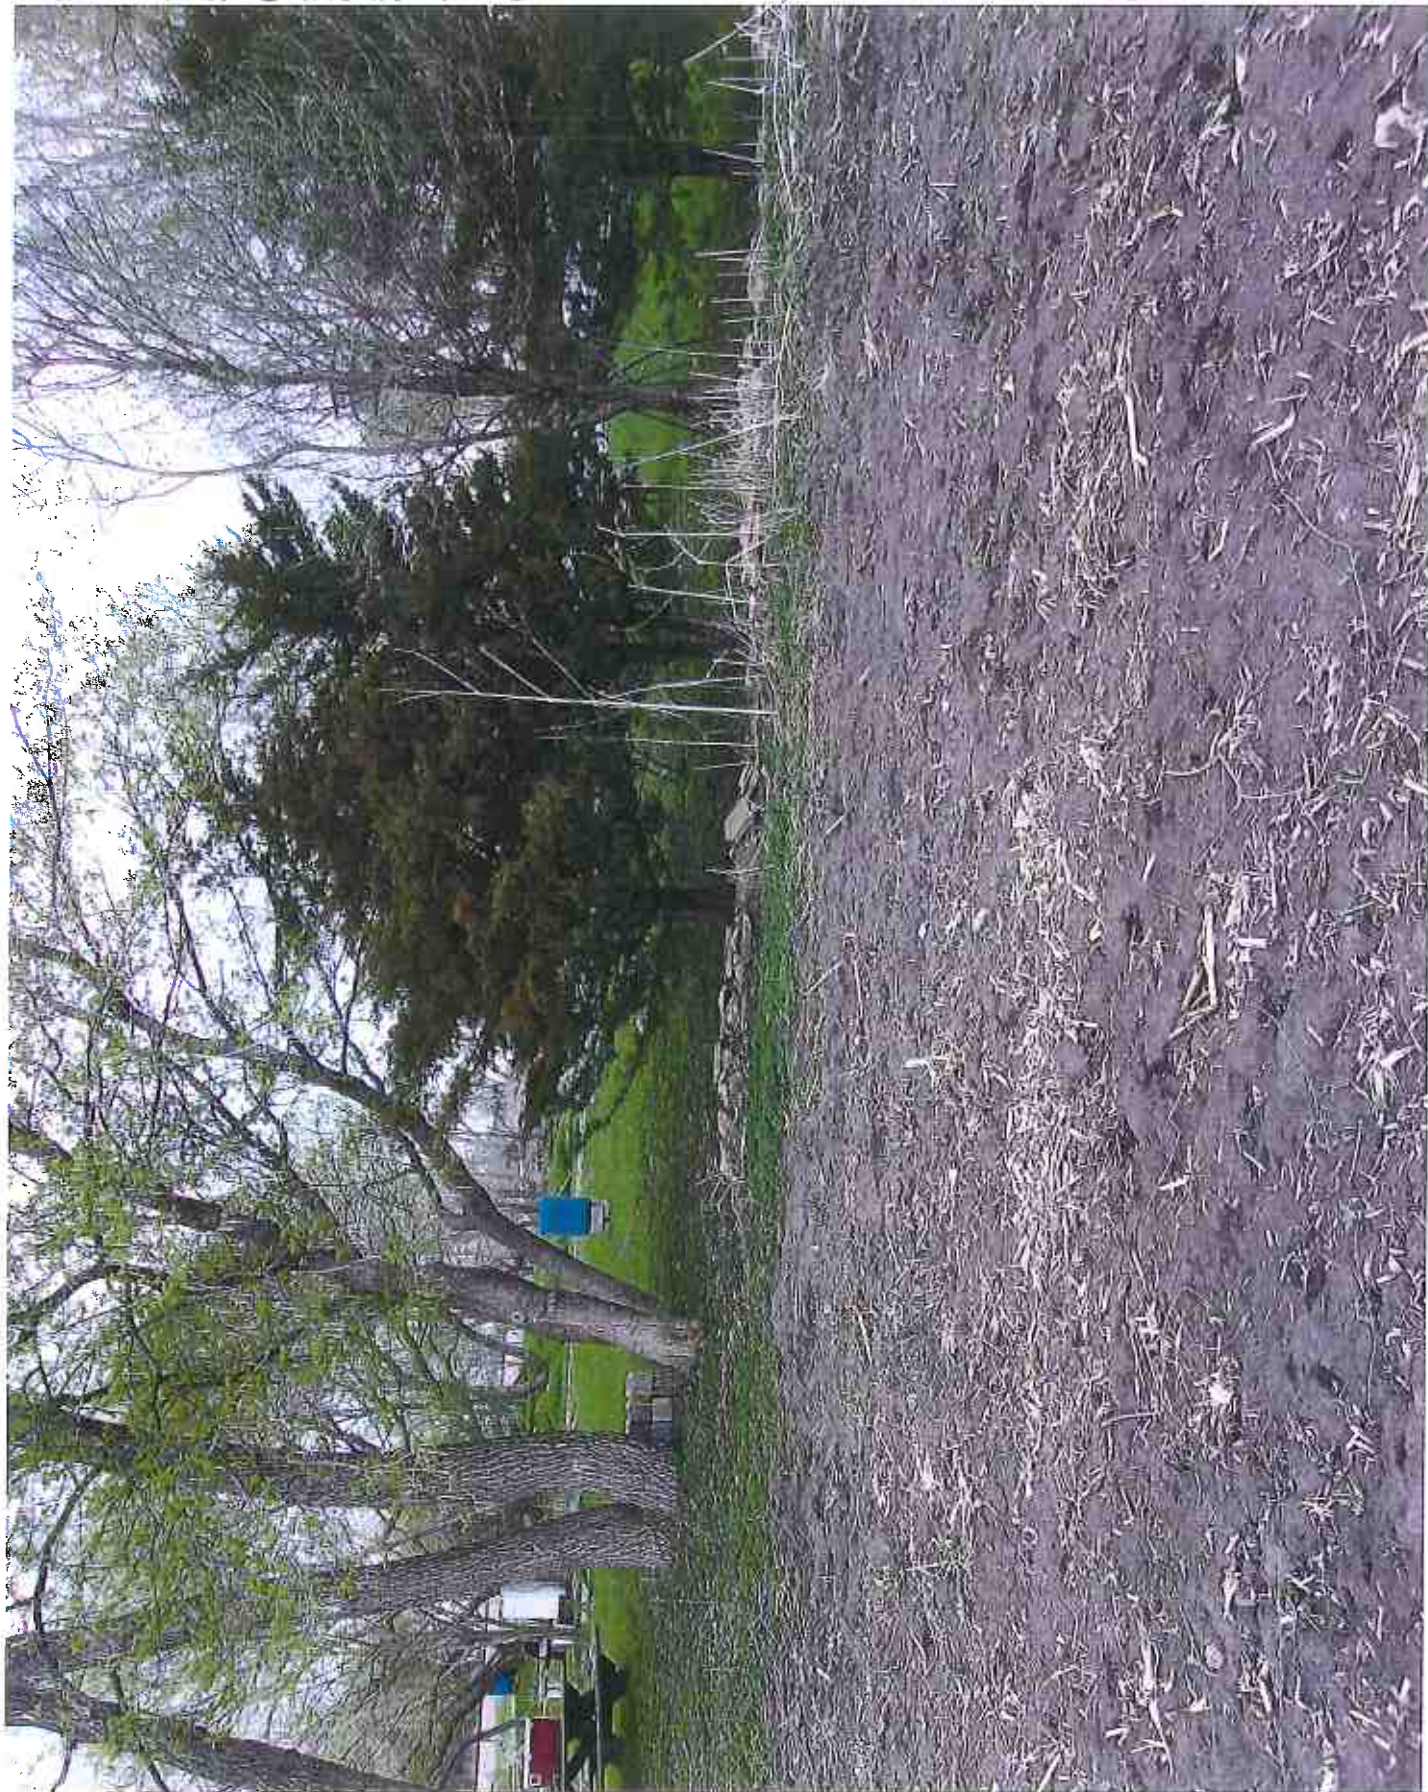
INTAKE ON TILE @ E. END OF MONARCH LAKE

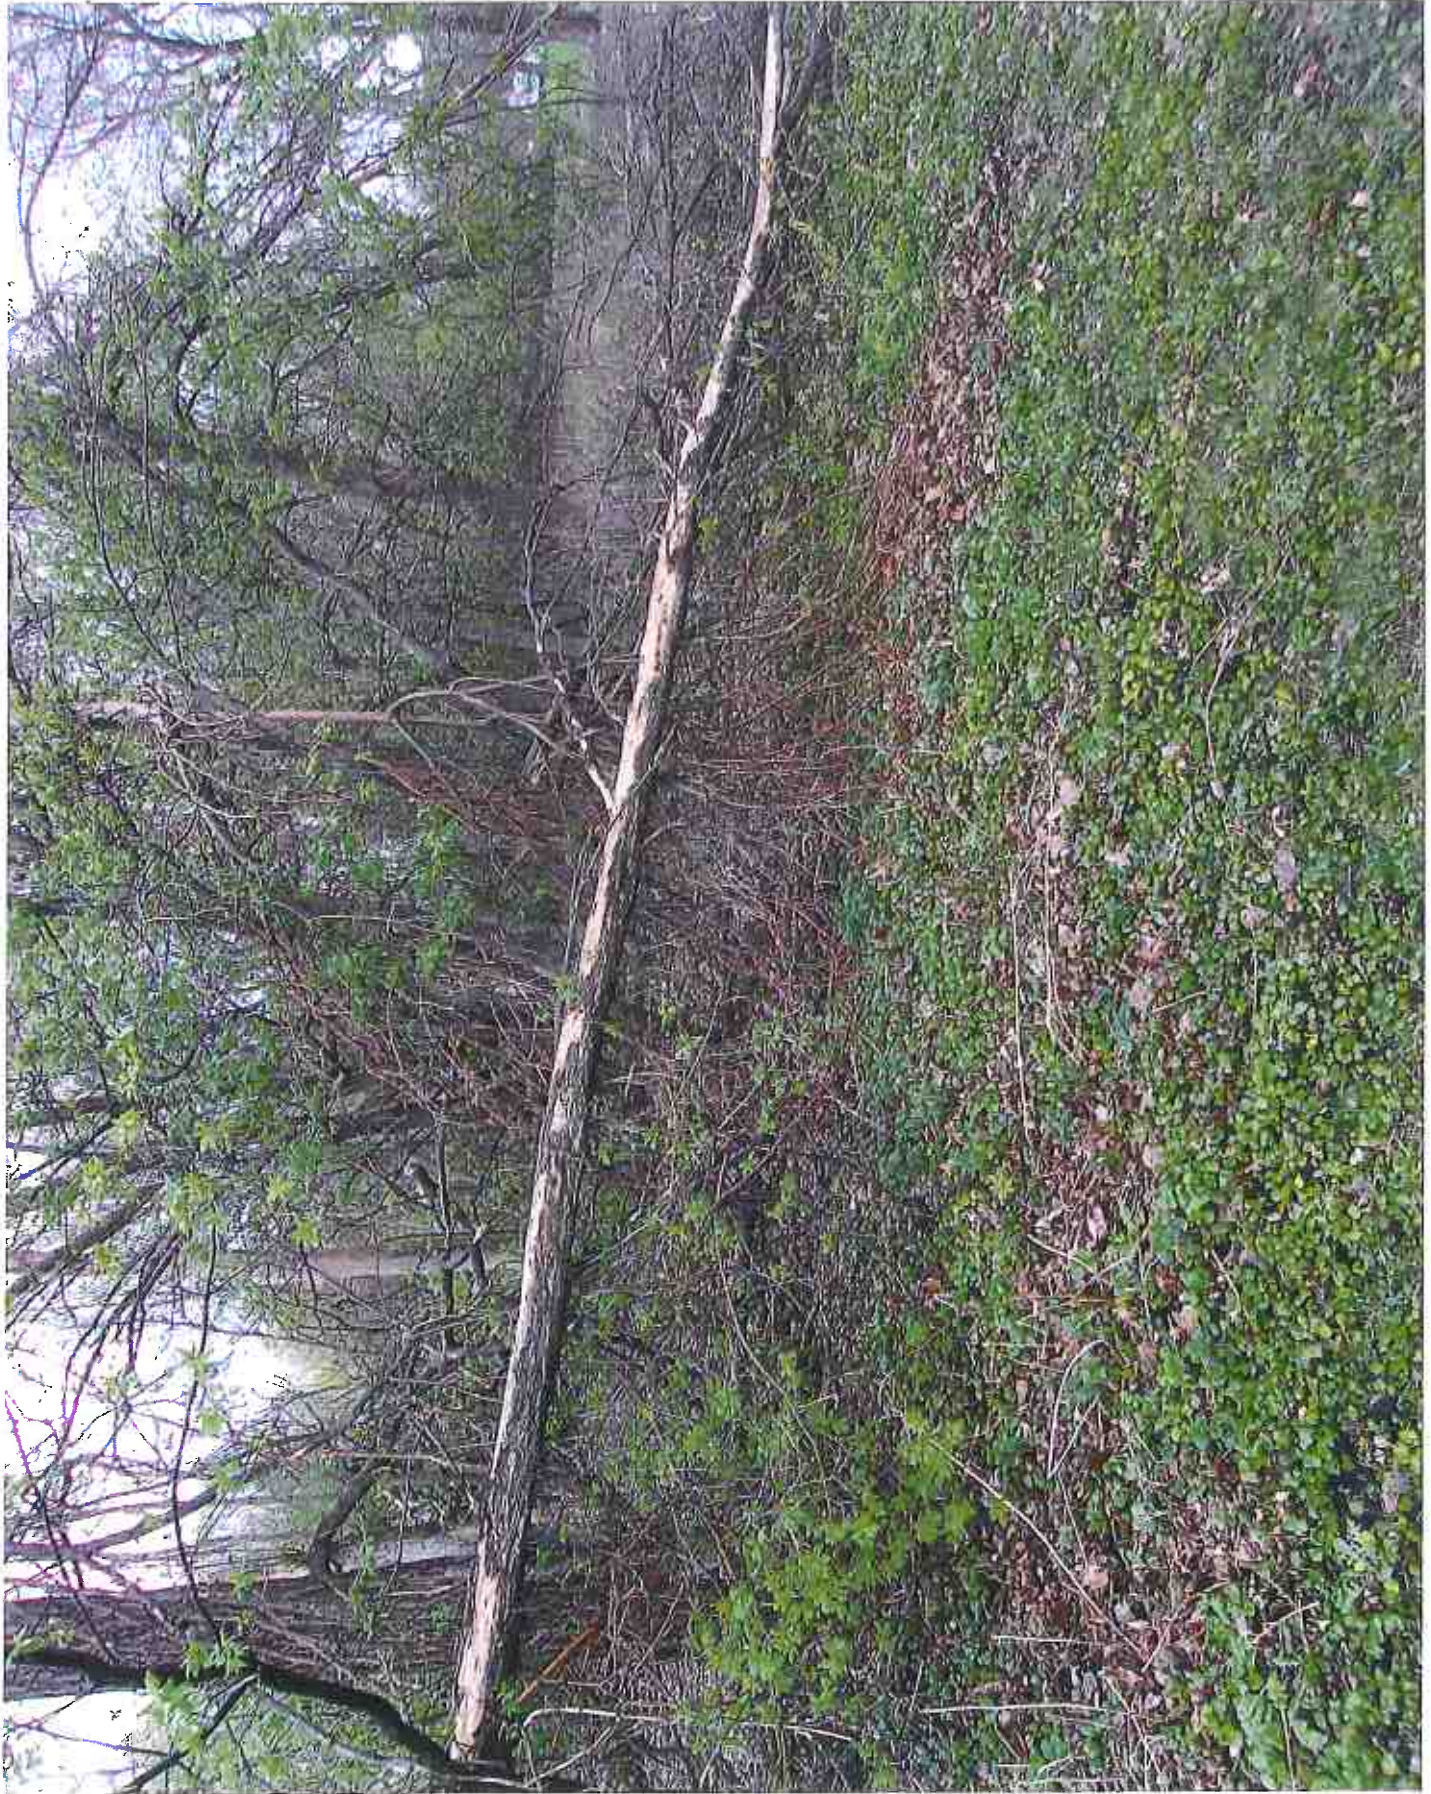
BEEHIVE INTAKE IS IN TREES SOMEWHERE 90+ TREES IN THE R/W N. OF RR

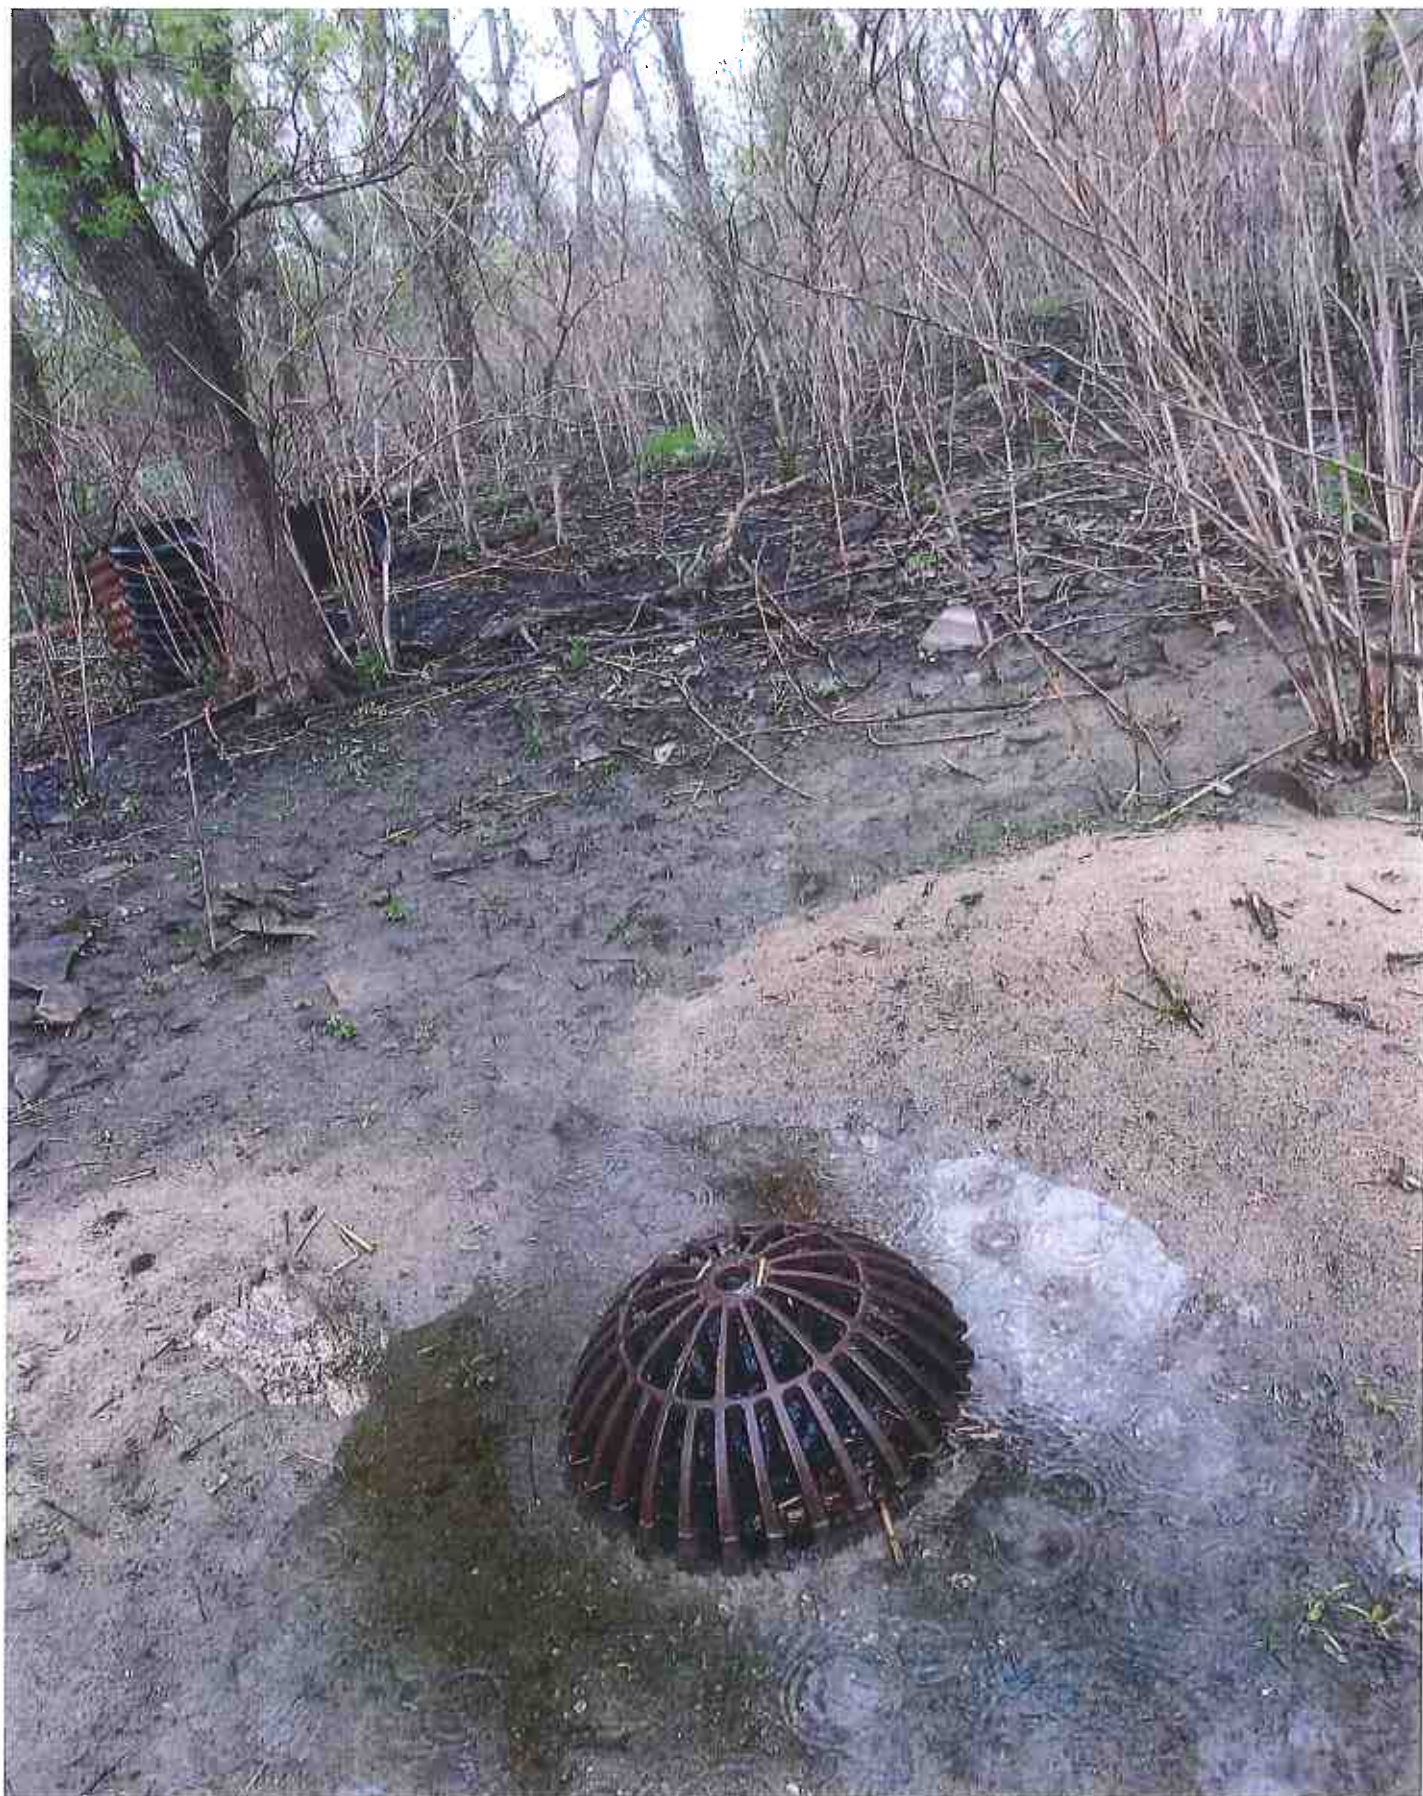
TILE HAS BEEN PARTIALLY PLUGGED FOR SOME TIME
LOOKING DOWN STREAM, NOTE ALL SEDIMENT SAND BLOWN OUT OF INTAKE

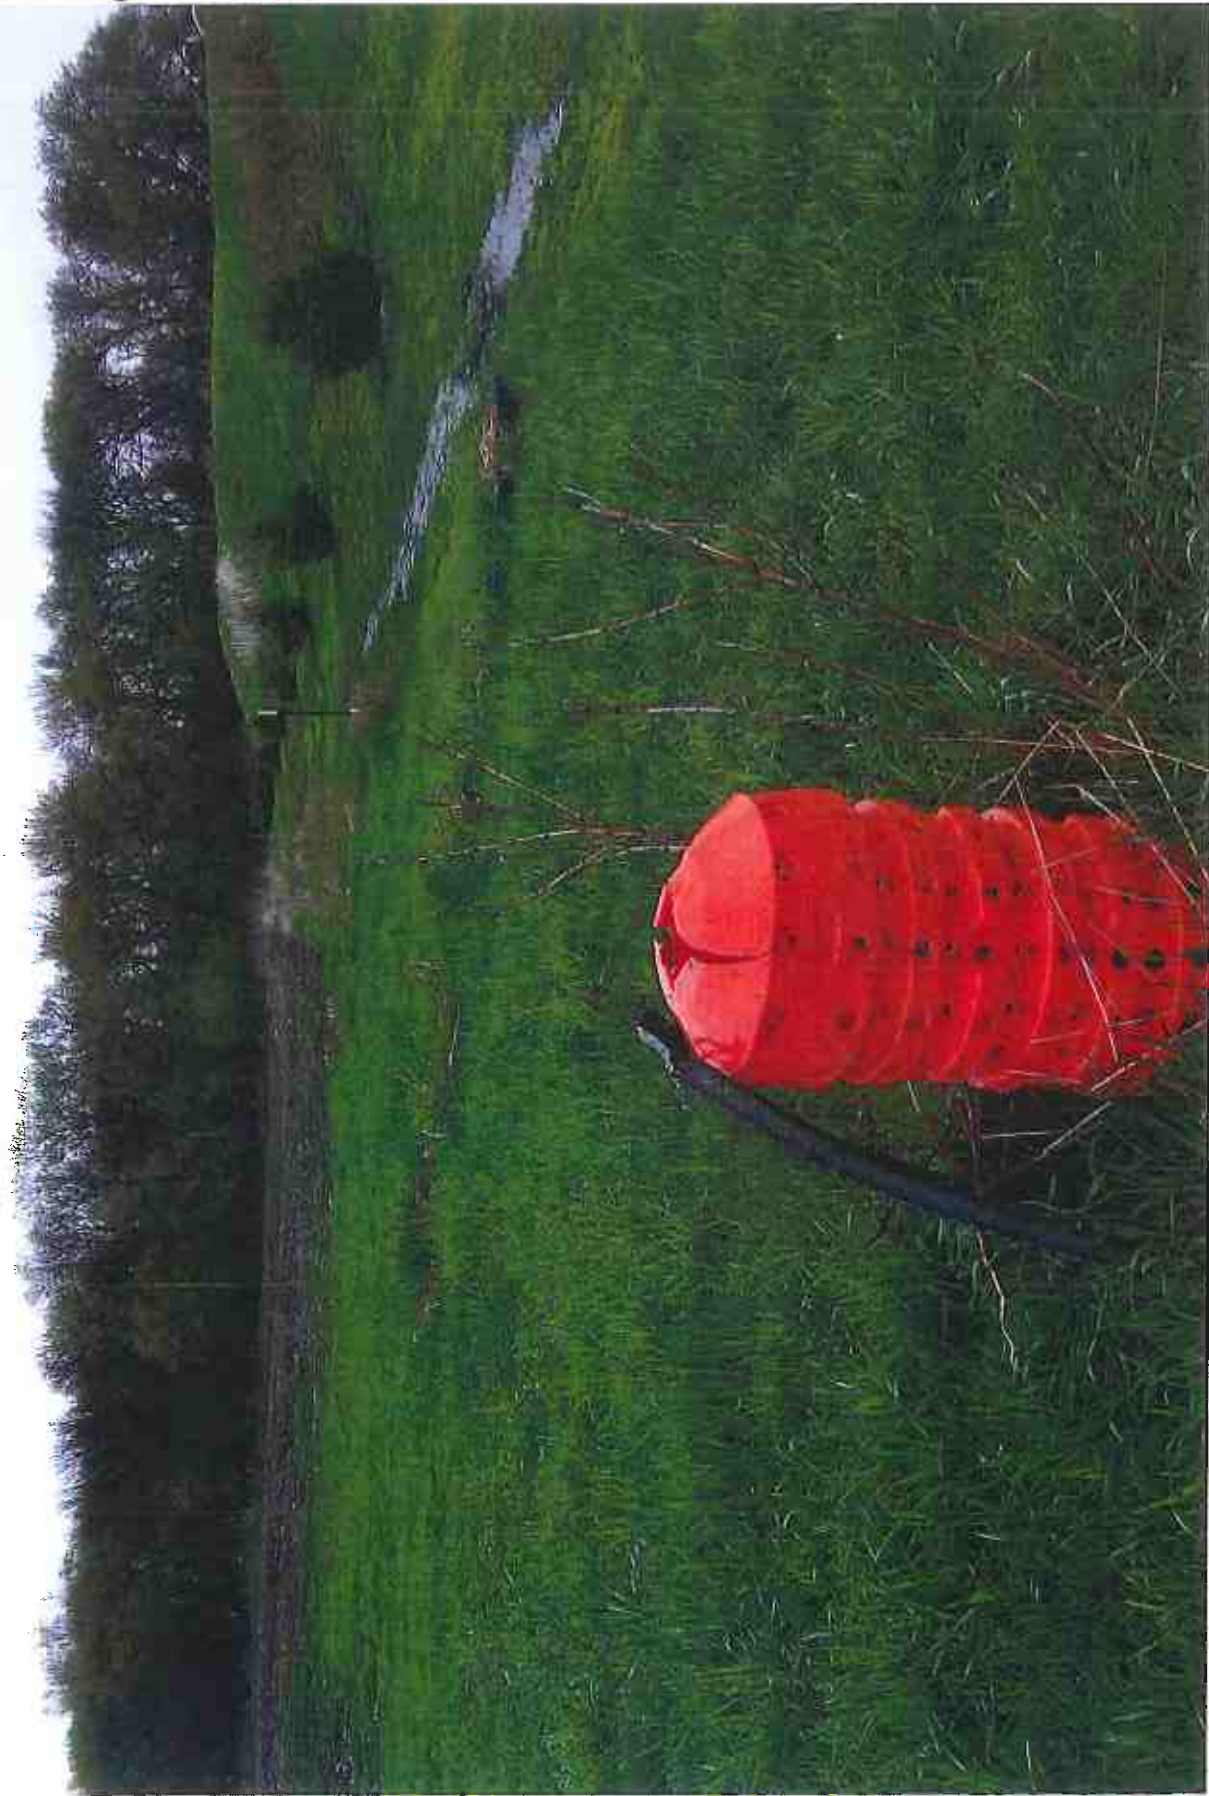
12" HICK INTAKE FULL OF WATER, SWIRLING

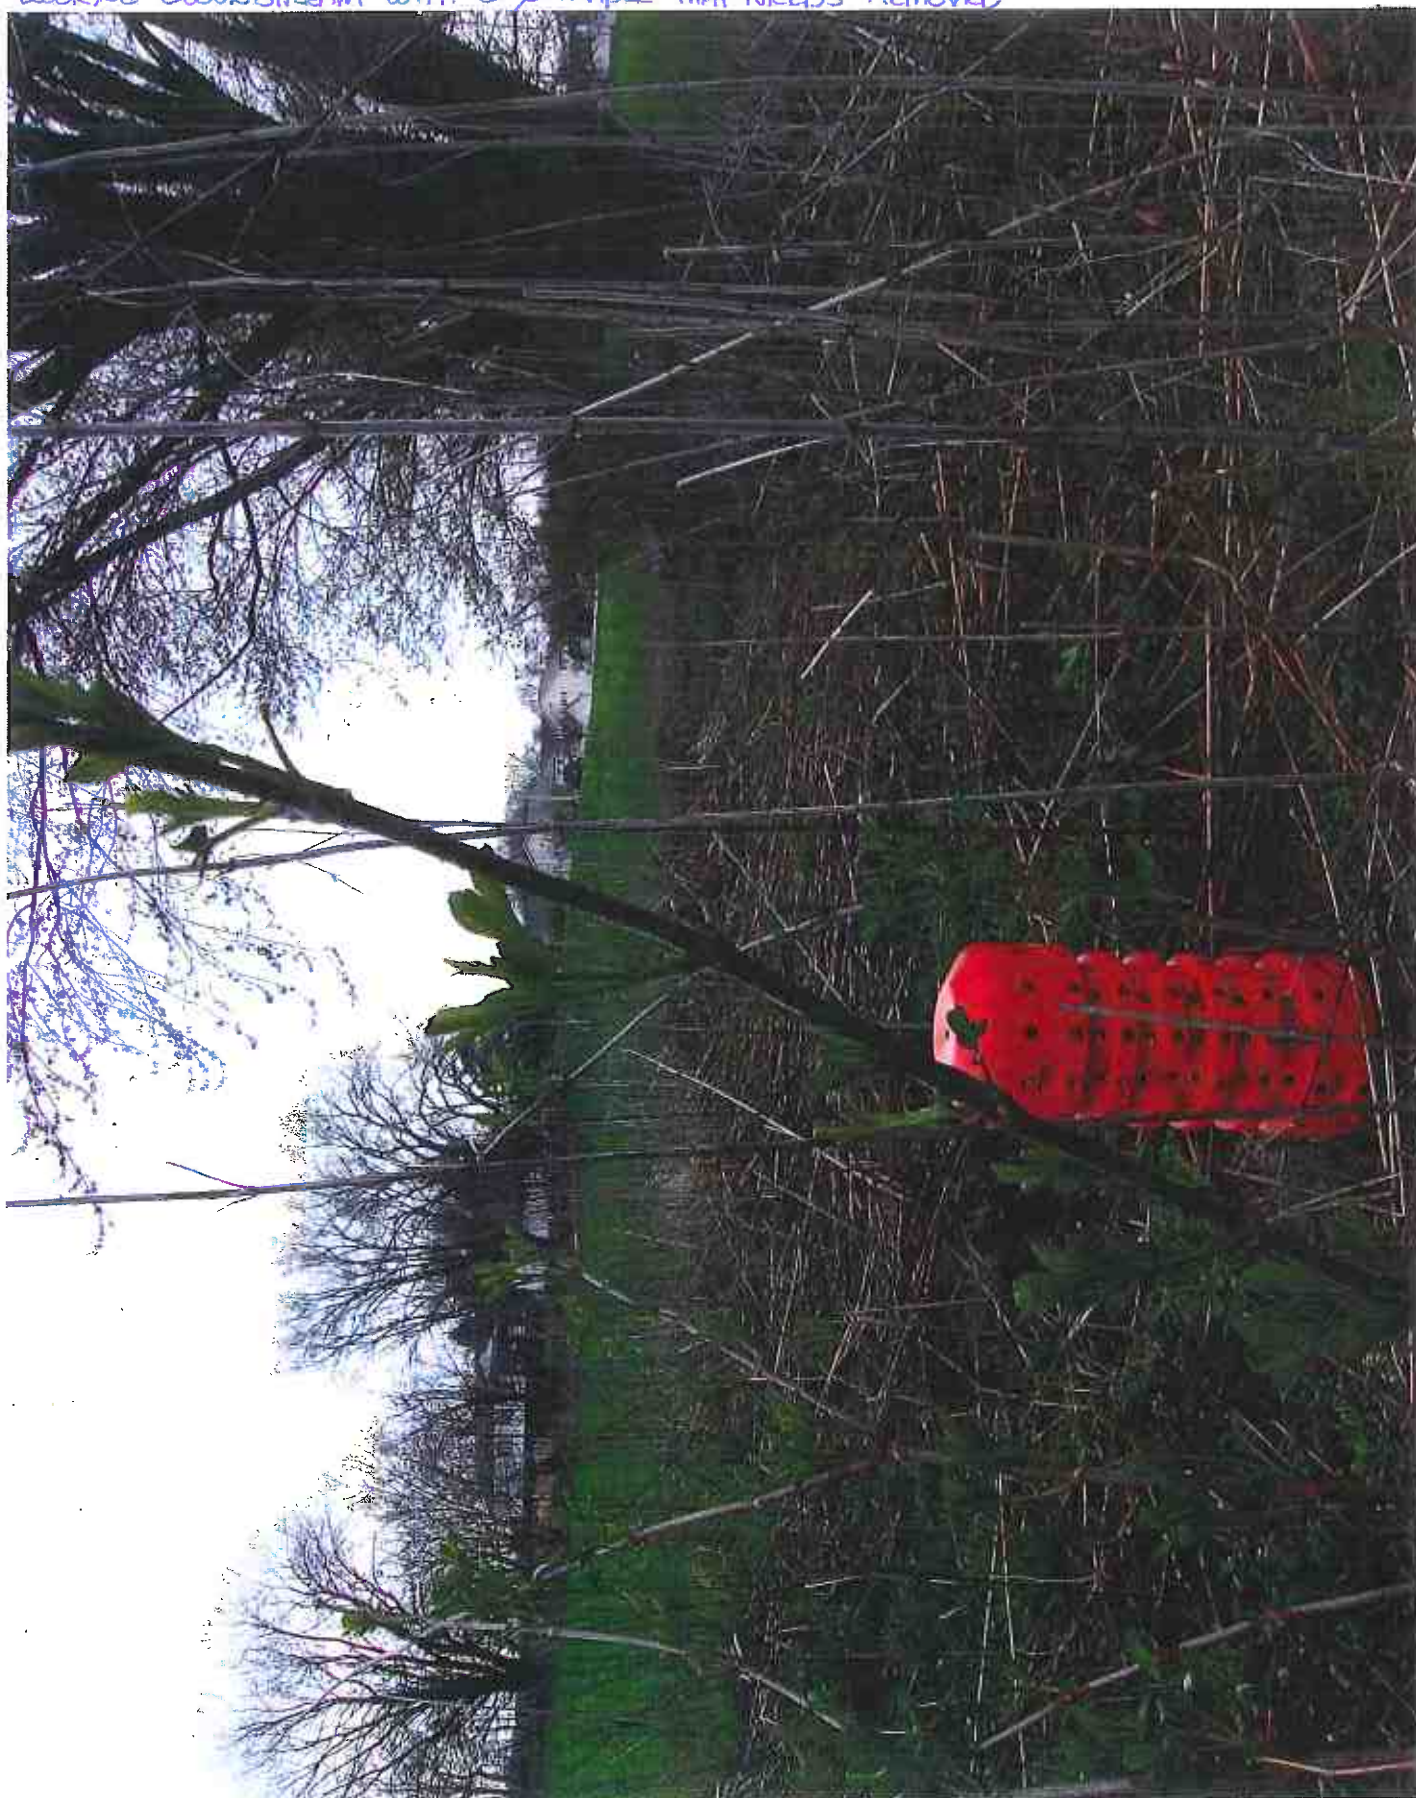
Looking downstream with 5' Ø maple that needs removed

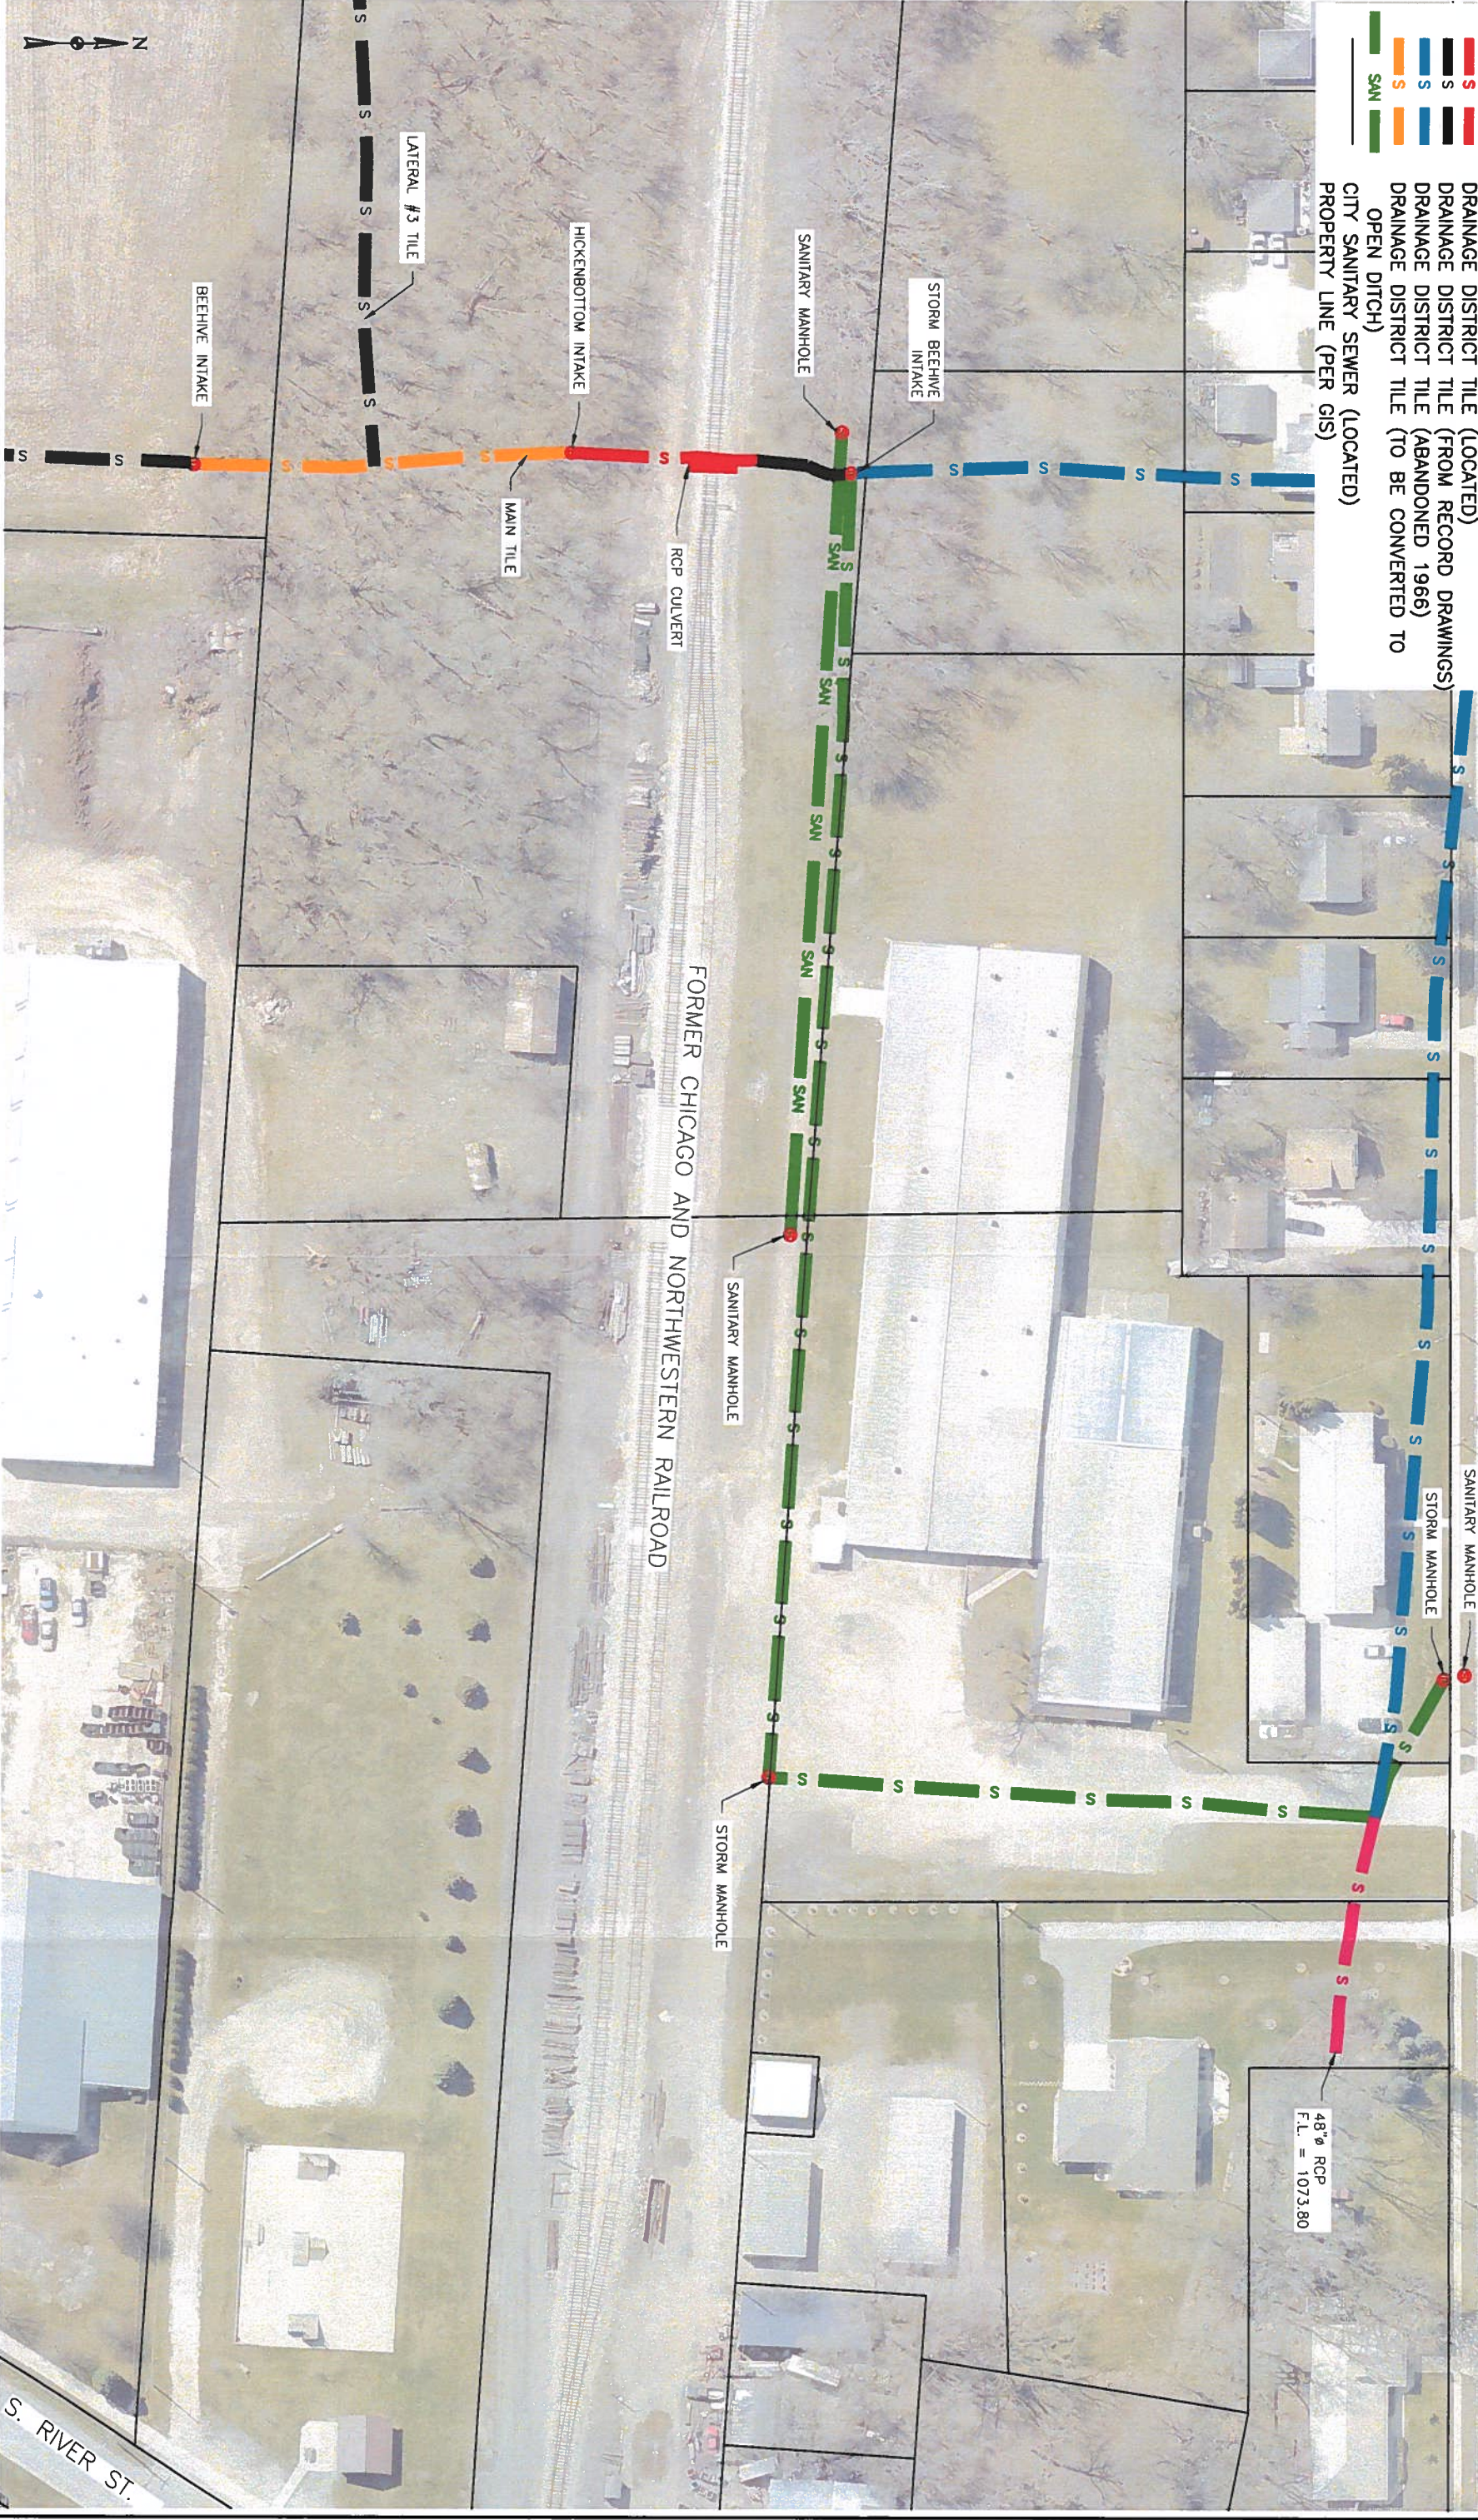
DETAILED REPAIR MAP

- For the portion of the Main tile south of the former C&NW railroad tracks that is severely plugged with tree roots, remove trees within 50' of the Main tile.
- For the portion of the Main tile south of the former C&NW railroad tracks that is severely plugged with tree roots, remove and replace the existing Main tile with an open ditch. Typically, an open ditch would be in the same location as the existing Main tile in order to locate and outlet private and district tile.
- For reference, the detailed location of the proposed work near the C&NW railroad tracks is shown on the map included in Appendix I.
- For the remainder of the Main tile between Dago Lake and the former C&NW railroad tracks, verify the Main tile route and remove any trees within 50' of the Main tile.

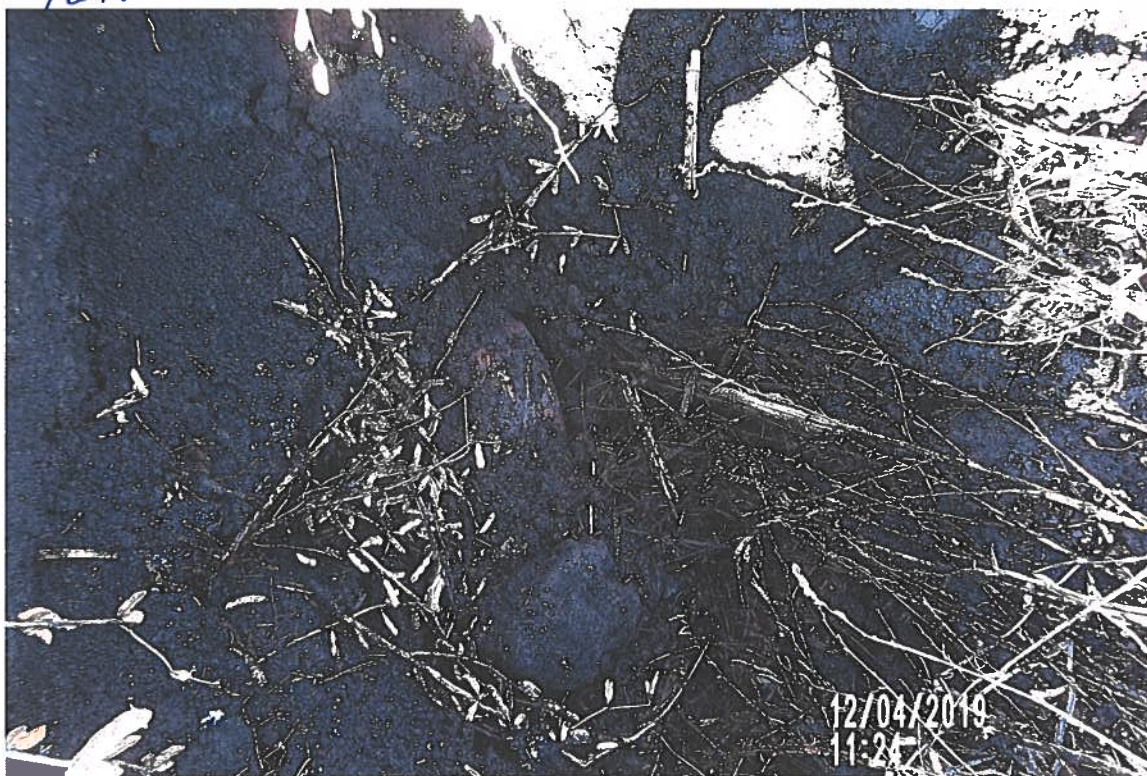
PICTURE # 2442. IS LOOKING AT TOP OF 12" CLAY TILE EXPOSED
IN TILE BLOWOUT HOLE THAT APPEARED TO BE SUCKING
SOIL DOWNSTREAM TO SW WITH TILE TO NE NOT EXPOSED
YET.

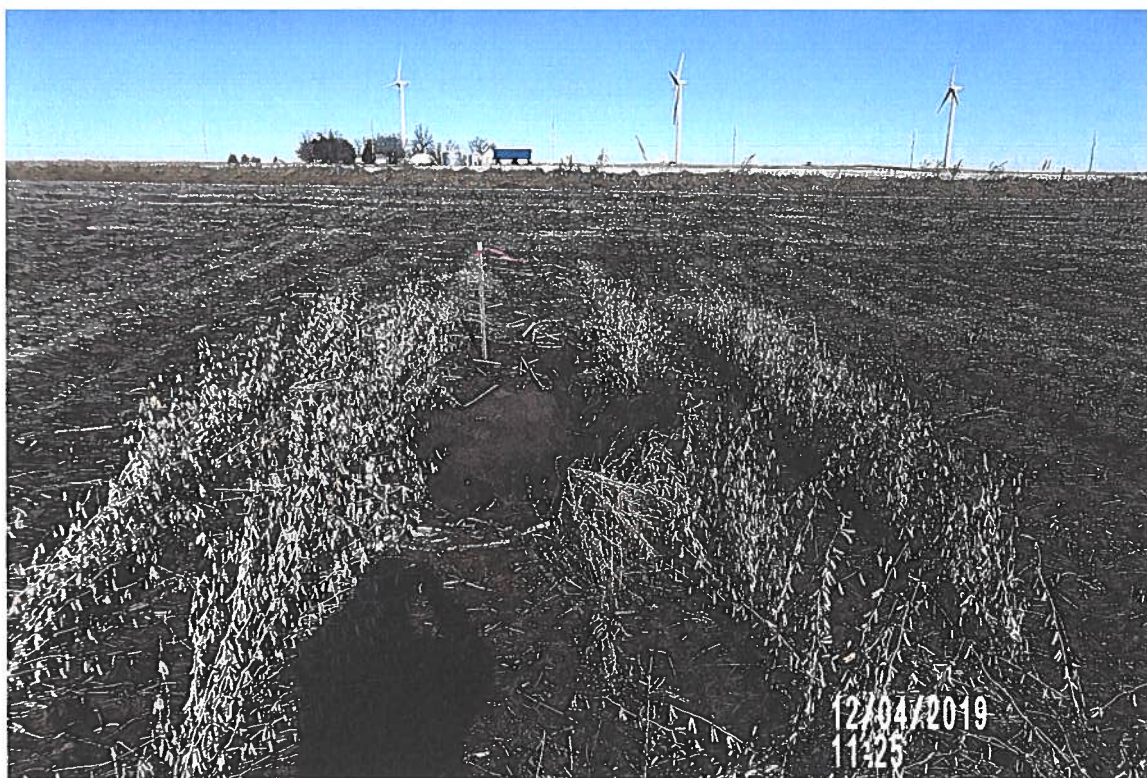
PICTURE # 2443 IS LOOKING NORTH AT 8.0' N-S X 6.0' E-W X
3.7' DEEP TILE BLOWOUT IN FIELD 593' ± NORTH OF NORTH GRAVEL
LAWE EDGE FOR WIND TOWERS E-W, 133' SOUTH OF 1/4-1/4 FENCE E-W & 741' ±
WEST OF 1/2 MILE FENCE N-S
