AGENDA
REGULAR DRAINAGE MEETING
February 5, 2020 9:30 AM

**ENGINEER'S REPORT
ON REPAIRS
TO MAIN TILE
DRAINAGE DISTRICT
NO. 86
HARDIN COUNTY,
IOWA**

SUPPLEMENT TO
ENGINEER'S REPORT
ON REPAIRS
TO MAIN TILE
DRAINAGE DISTRICT
NO. 86
HARDIN COUNTY,
IOWA

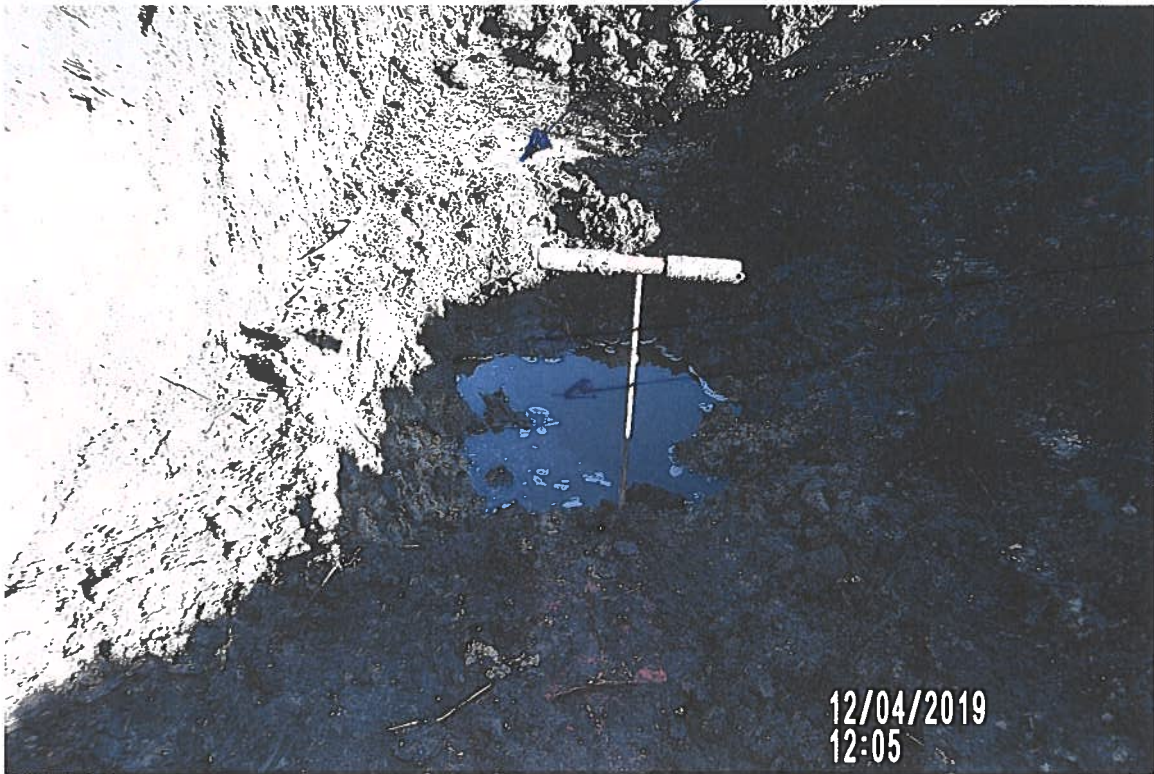
PICTURE# 2450 IS LOOKING NE SHOWING BROKE OUT TILE
 & DROP DOWN AREA IN TILE BLOW OUT AREA
 WHERE SINGLE TILE BUTTED INTO EXISTING 12" CLAY DROPPED DOWN 6",
 12" SW PERFORATED TILE BEFORE
 DROP DOWN

12" SW PERF
 TILE DROP
 DOWN 6"

EXISTING 12"
 CLAY TILE

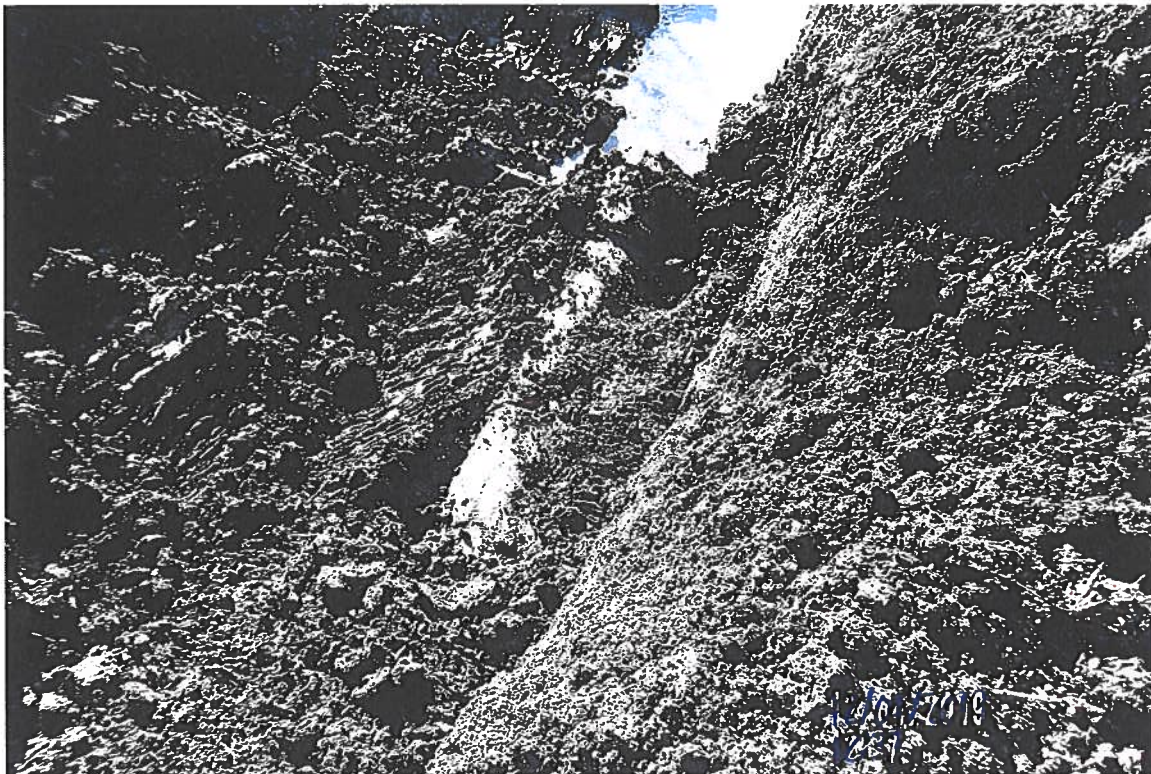
PICTURE # 2453 IS LOOKING SW SHOWING 4 SECTIONS OF
 CLAY TILE THAT WILL BE REPLACED DUE TO A SLIGHT SAG &
 ONE WITH AN OFFSET/WIDE JOINT ON EAST END OF REPAIR.

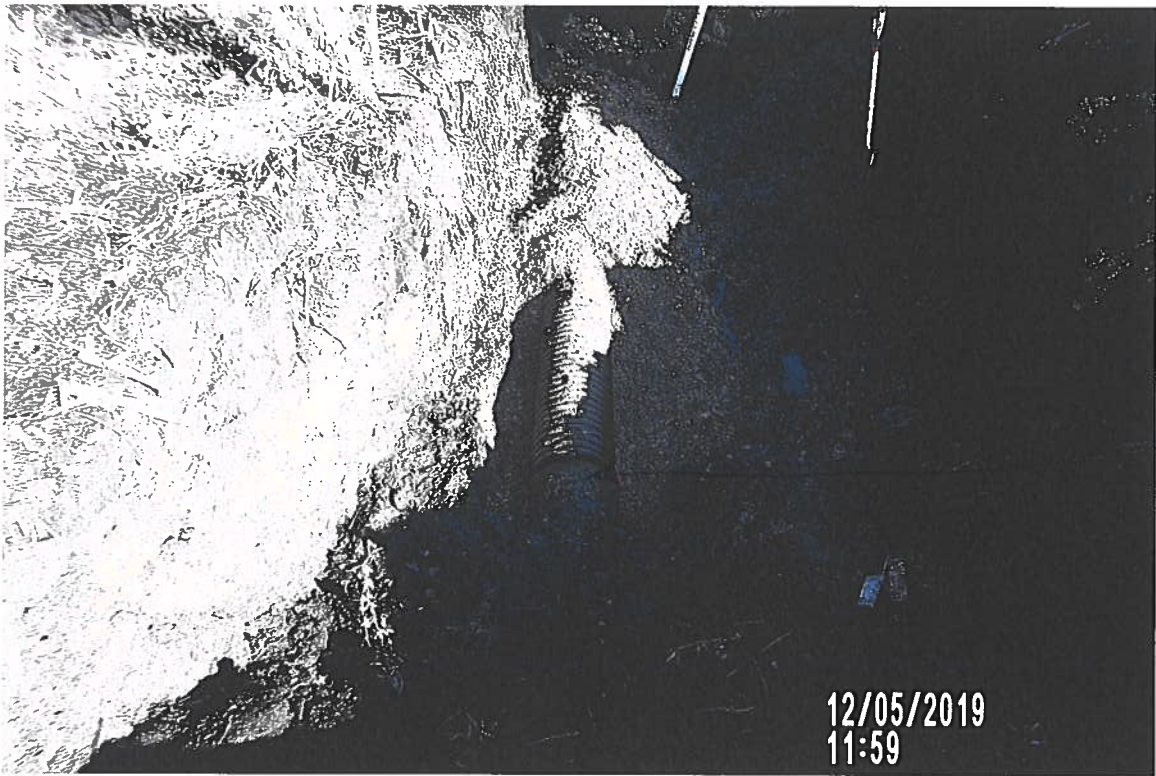
PICTURE #2467 IS LOOKING NE SHOWING 16.2 LF OF 12" HDPE DUAL WALL NONPERFORATED TILE IN PLACE WITH ROCK TAMPED IN UNDER AND AROUND TILE TO TOP OF TILE.

GPS#60
TOP 12" CLAY
TILE
1.06' TOP TO FL

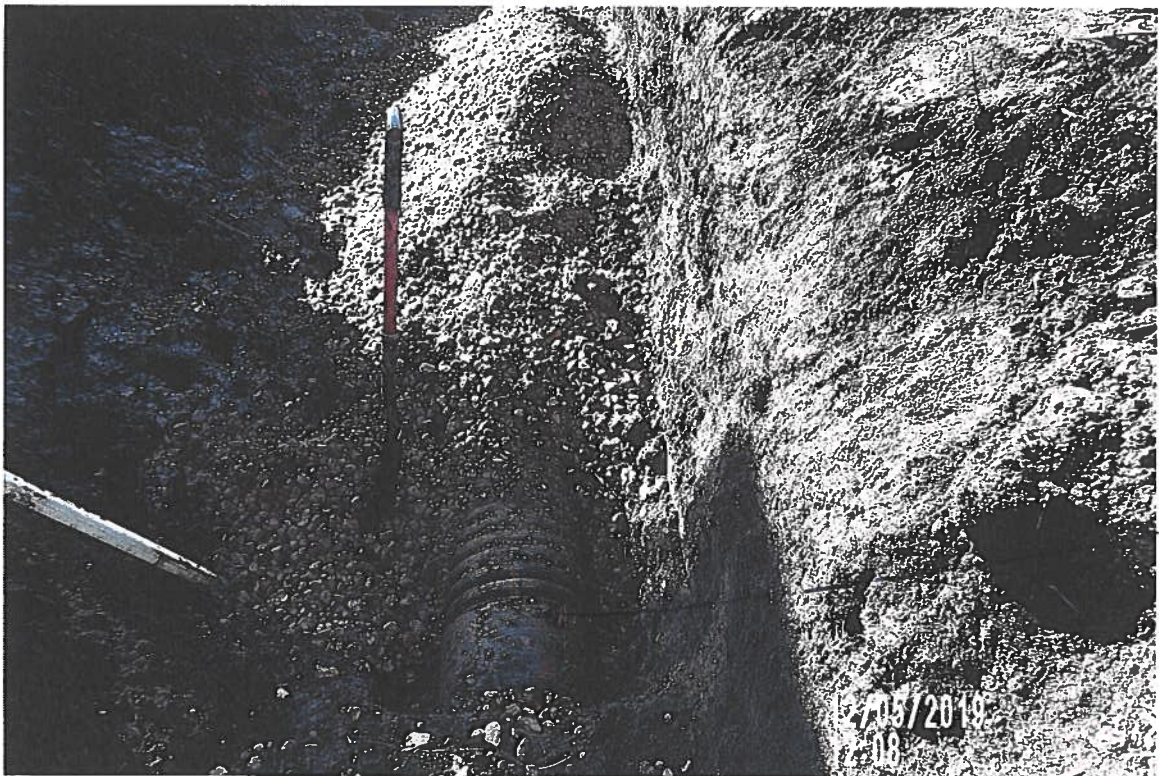
GPS#61
TOP 12" CLAY
TILE
1.07' TOP TO FL

PICTURE #2470 IS LOOKING SW SHOWING 16.2 LF OF 12" HDPE DUAL WALL NONPERFORATED TILE IN PLACE WITH ROCK TAMPED IN UNDER AND AROUND TILE TO TOP OF TILE.

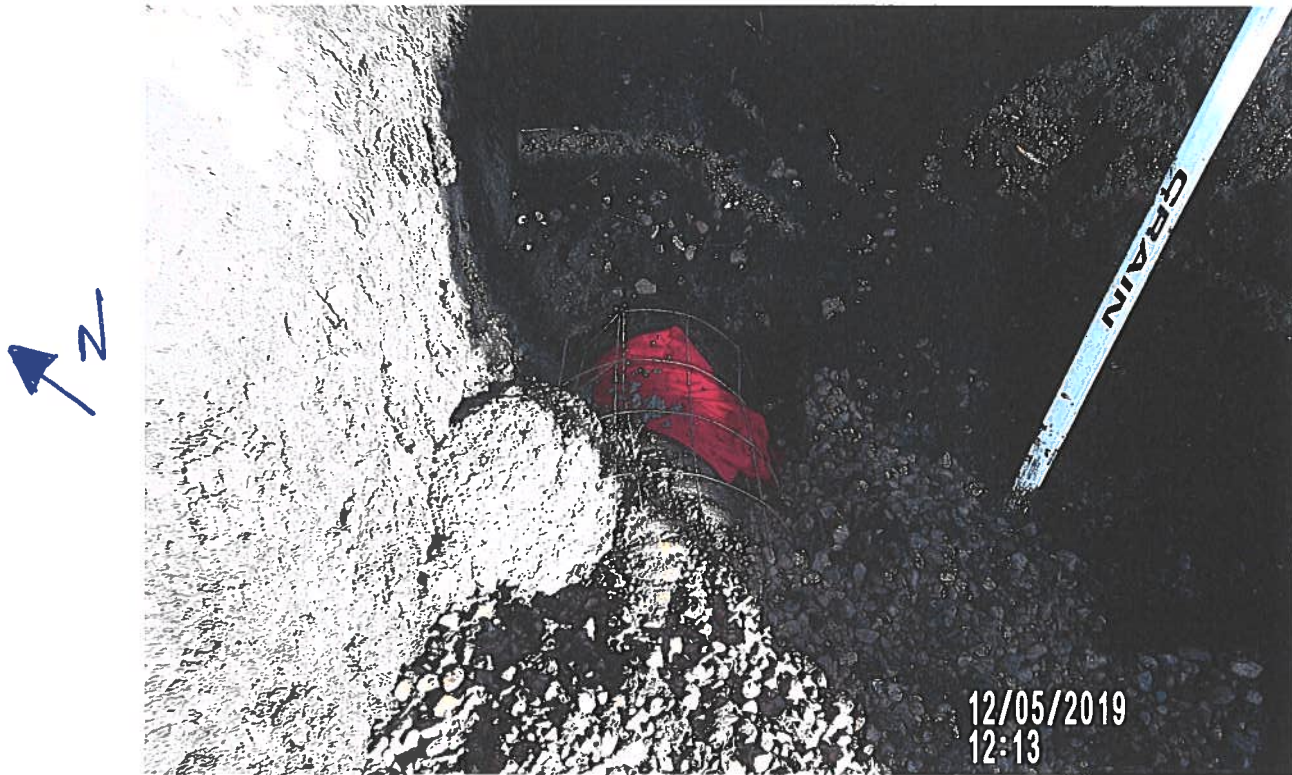
PICTURE # 2471 IS LOOKING WE SHOWING AIR JORDAN SHIRT OVER
 NE TIE IN CONNECTION JOINT (CONTRACTOR DID NOT HAVE FABRIC ON SITE) & 1.5' X 3.5' 6" X 6"
 WIRE MESH OVER TIE IN CONNECTION BEFORE 3/4 COLLAR
 POURED

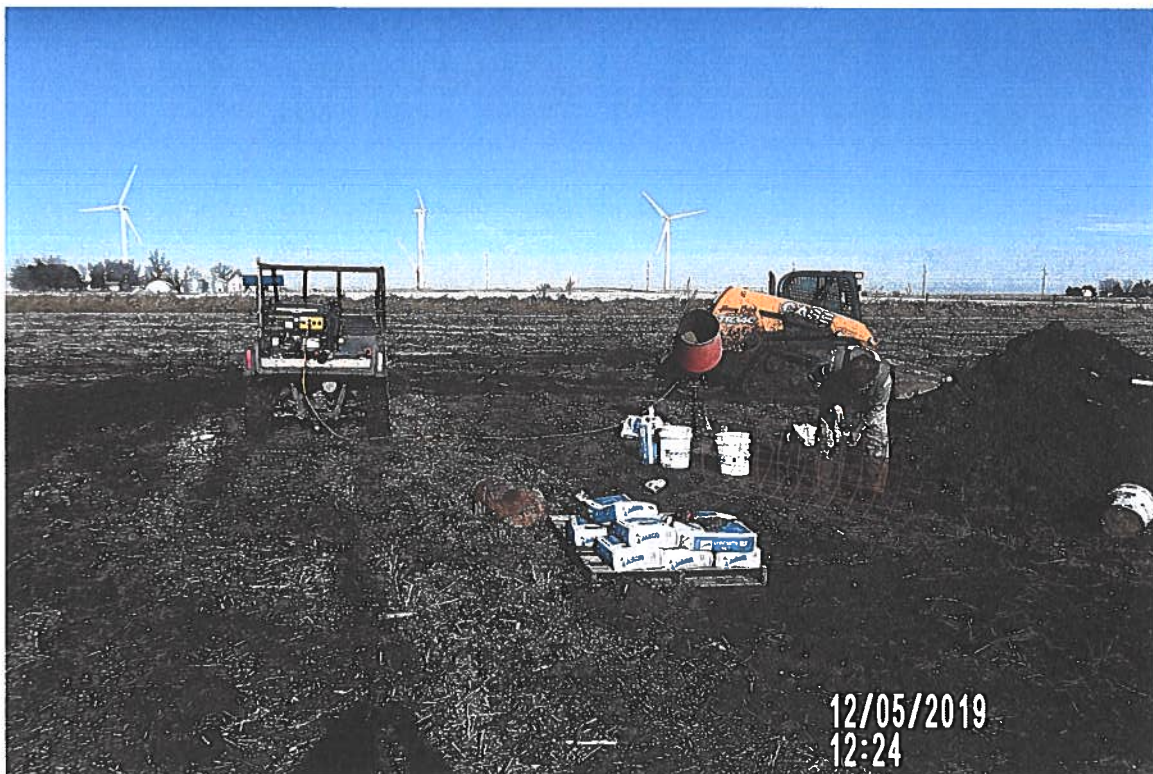
PICTURE # 2472 IS LOOKING NORTH SHOWING GENERATOR
 & CONCRETE MIXER USED TO MIX UP CONCRETE FOR
 COLLARS FOR TIE IN CONNECTIONS

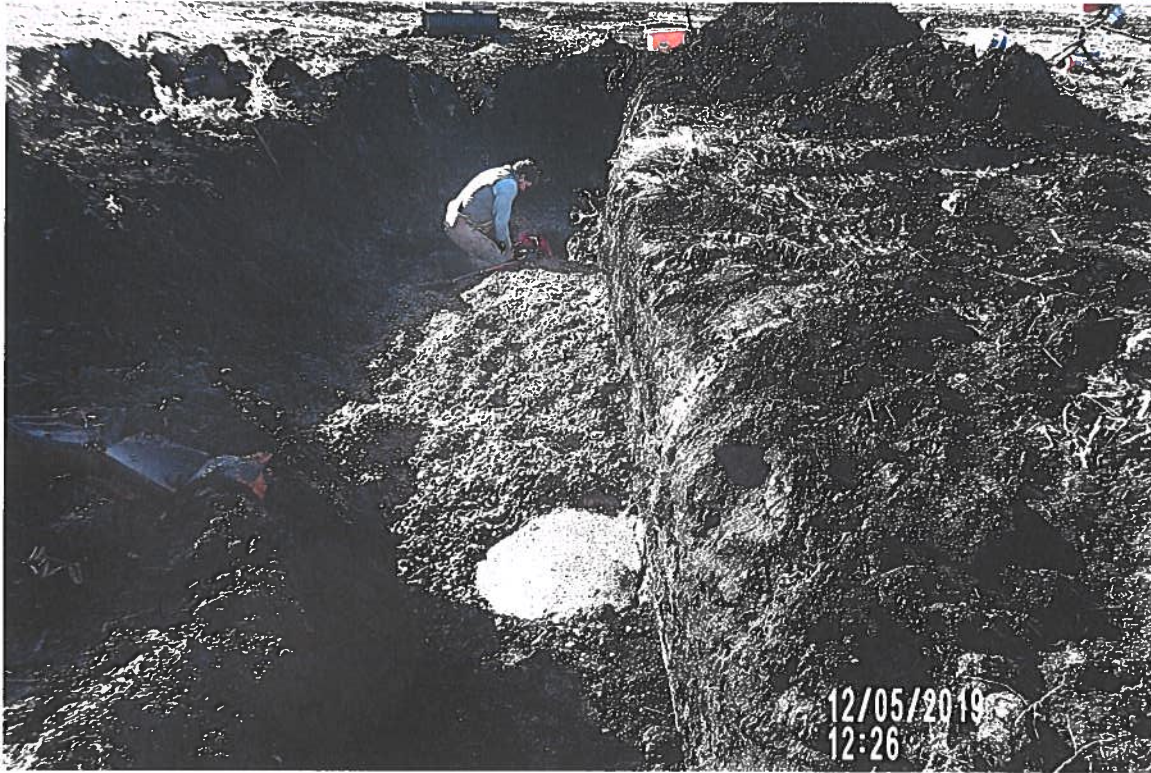
PICTURE # 247.3 IS LOOKING SW SHOWING $\frac{3}{4}$ CONCRETE COLLAR
POURED FOR NE TIE CONNECTION WITH ROCK TAMPED ON
TO TOP OF TILE OVER ENTIRE REPAIR EXCEPT FOR
COLLAR AREAS

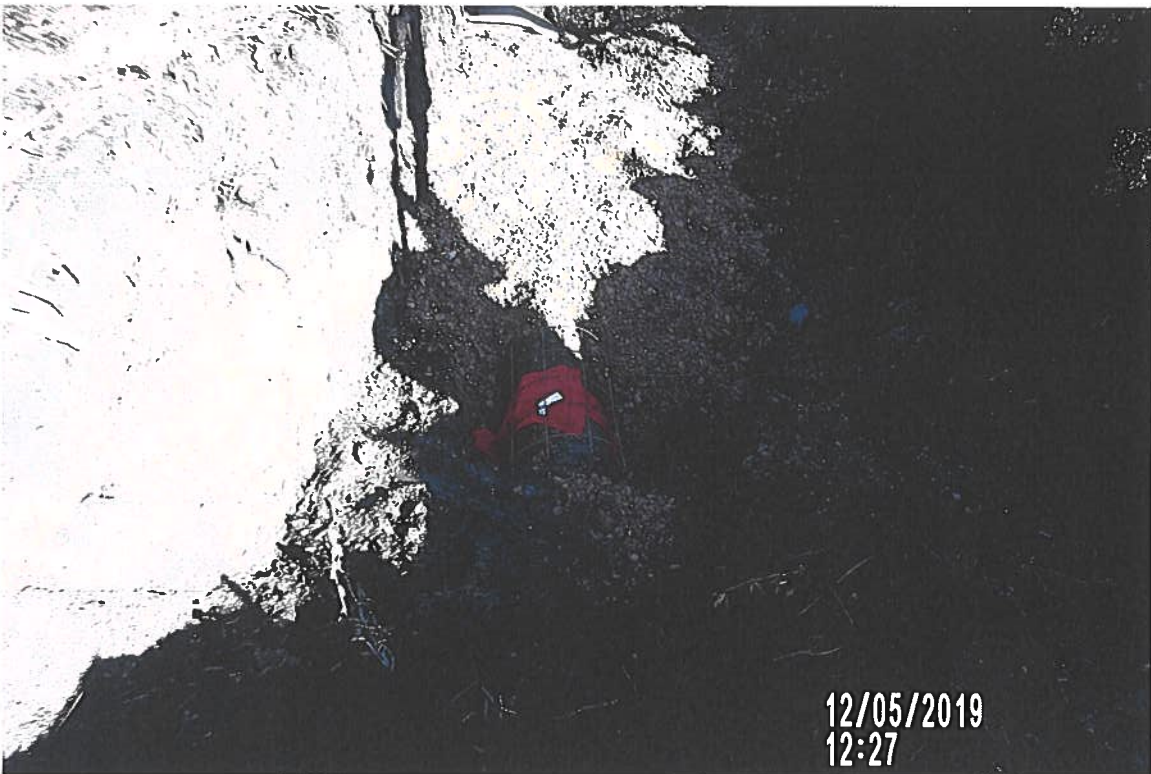
PICTURE # 2474 IS LOOKING NE SHOWING AIR JORDAN'S SHIRT
OVER SW TIE IN CONNECTION JOINT (CONTRACTOR DID NOT HAVE FABRIC
ON SITE & 2.0' X 3.5' 6" X 6" WIRE MESH OVER TIE IN CONNECTION
BEFORE $\frac{3}{4}$ COLLAR PAURED).

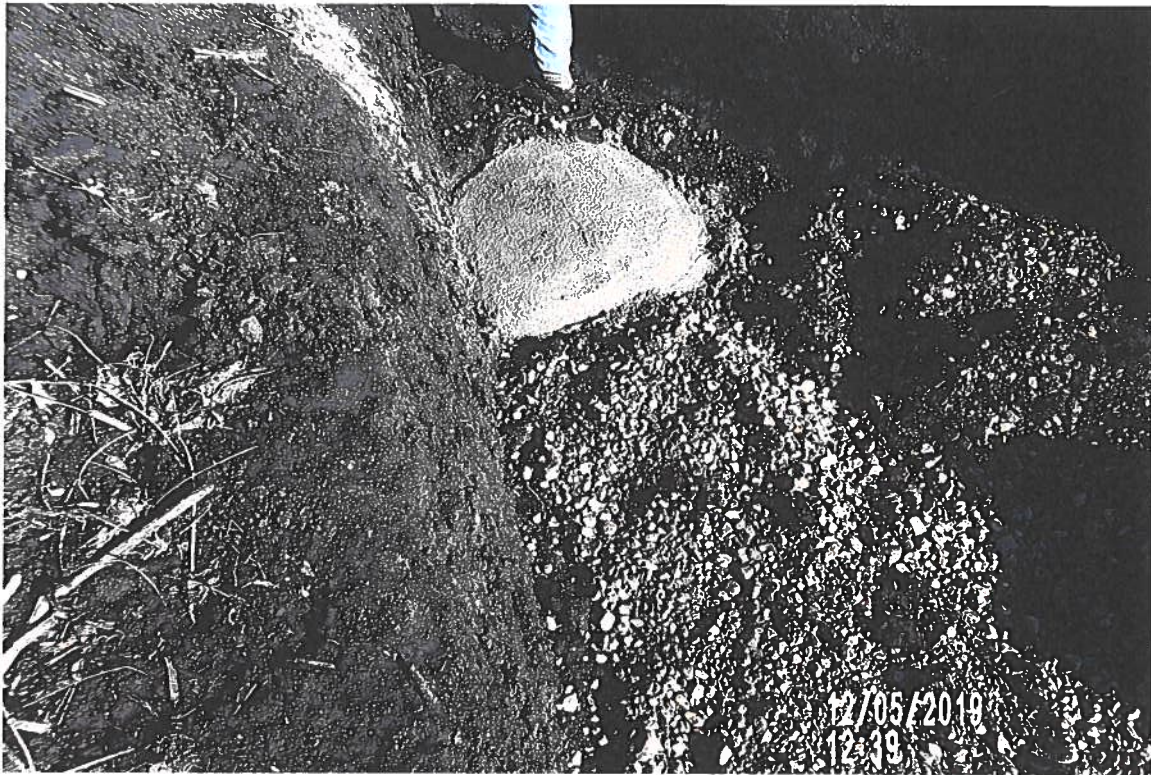
PICTURE# 2475 IS LOOKING NE SHOWING $\frac{3}{4}$ CONCRETE COLLAR
POURED FOR NE TIE IN CONNECTION (6- 60LB BAGS OF ALLSTAR
CONCRETE USED FOR COLLAR).

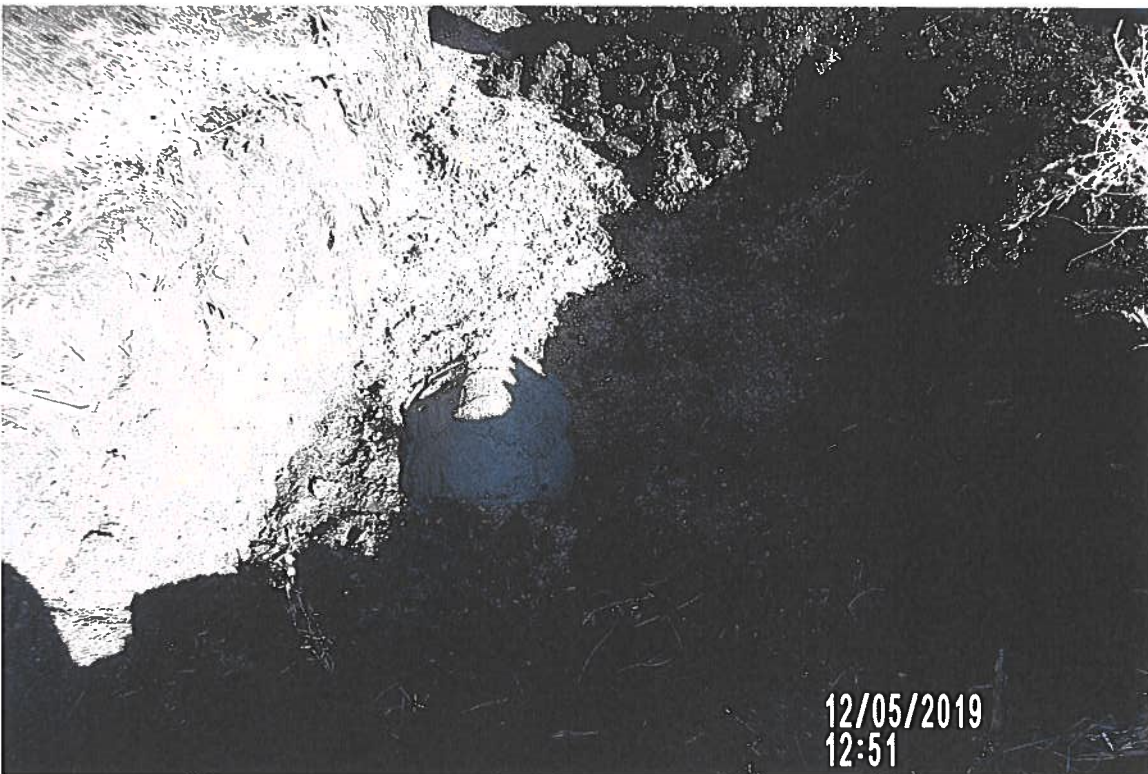
PICTURE# 2476 IS LOOKING NE SHOWING $\frac{3}{4}$ CONCRETE COLLAR
POURED FOR SW TIE IN CONNECTION (6- 60LB ALLSTAR
CONCRETE BAGS USED FOR COLLAR)

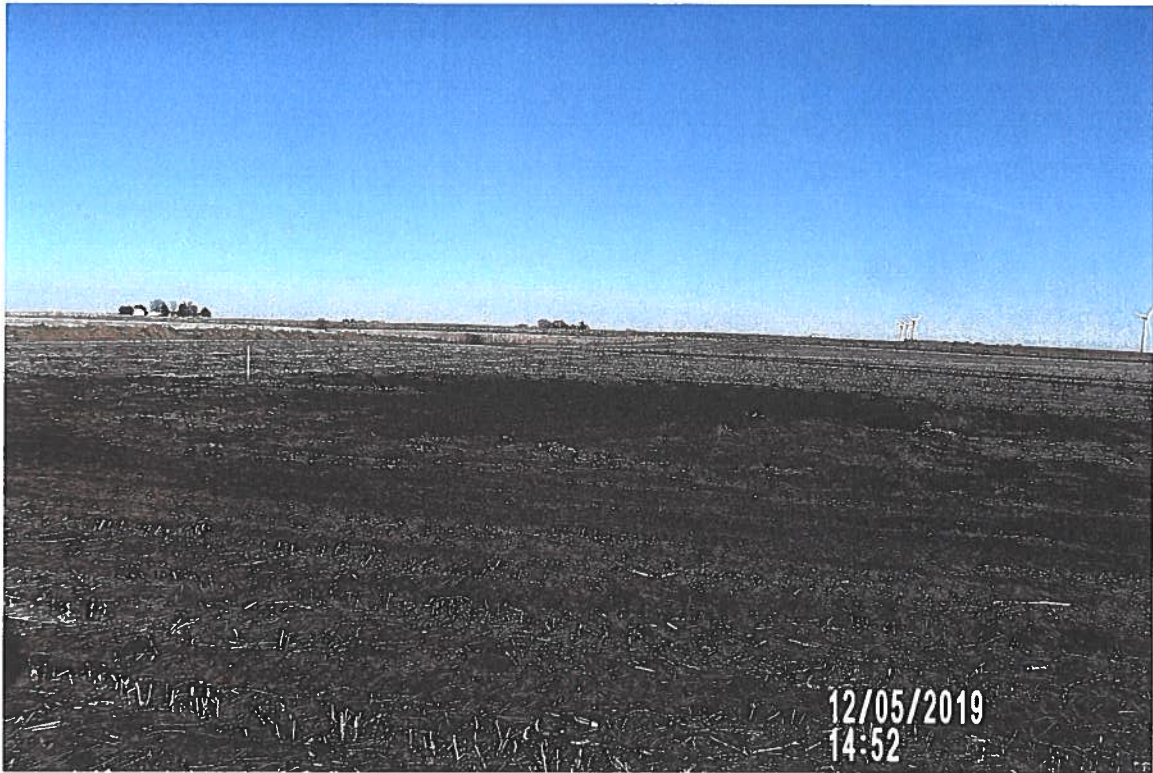
PICTURE#2477 IS LOOKING NE SHOWING FIELD AROUND
TRENCH BACKFIELD & DRESSED UP

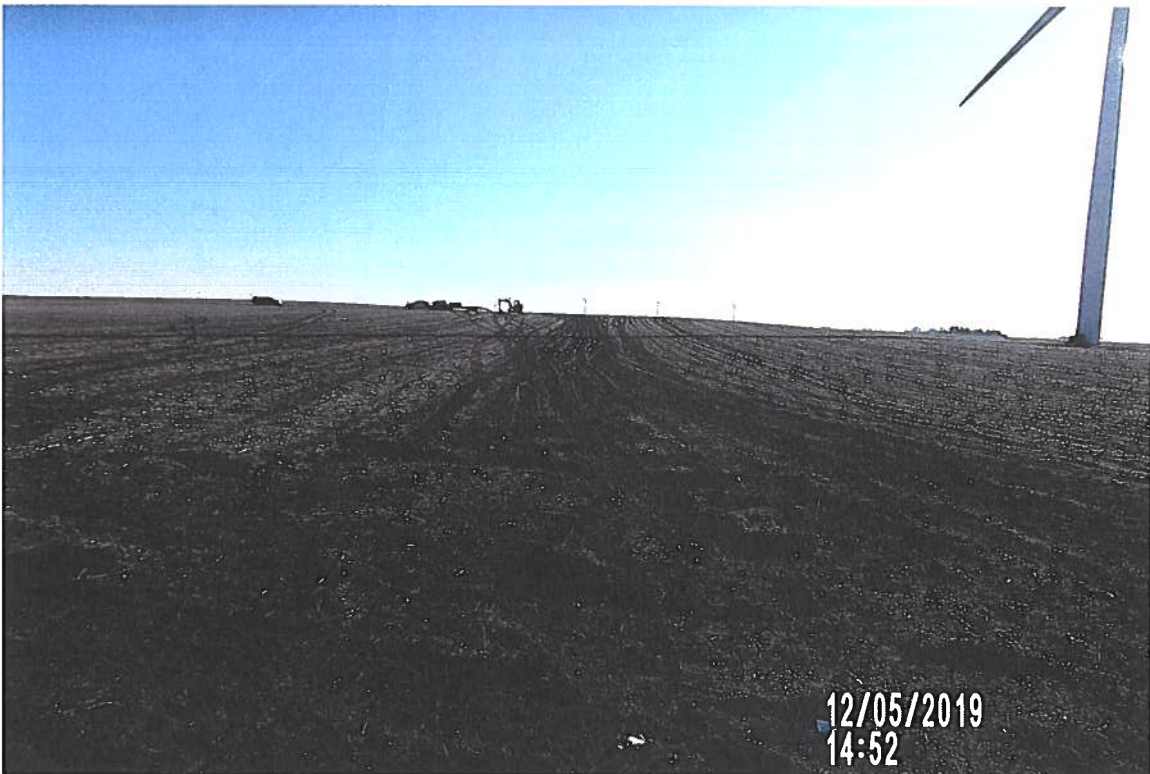
PICTURE# 2478 IS LOOKING SOUTH SHOWING TRACKS
FROM REPAIR AREA TO WIND TOWER GRAVEL LANE

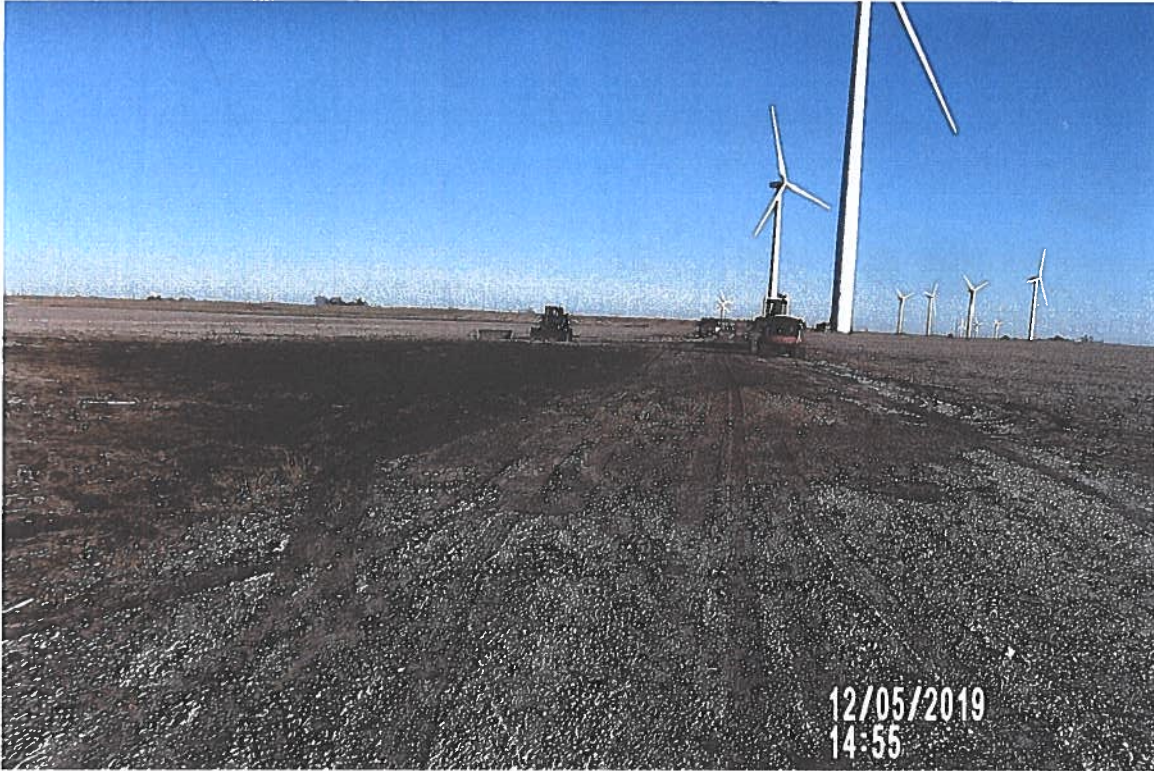
PICTURE # 2479 IS LOOKING EAST SHOWING
WINDTOWER GRAVEL LAWE & FIELD DRESSED
UP AS BEST AS POSSIBLE WITH CONDITIONS

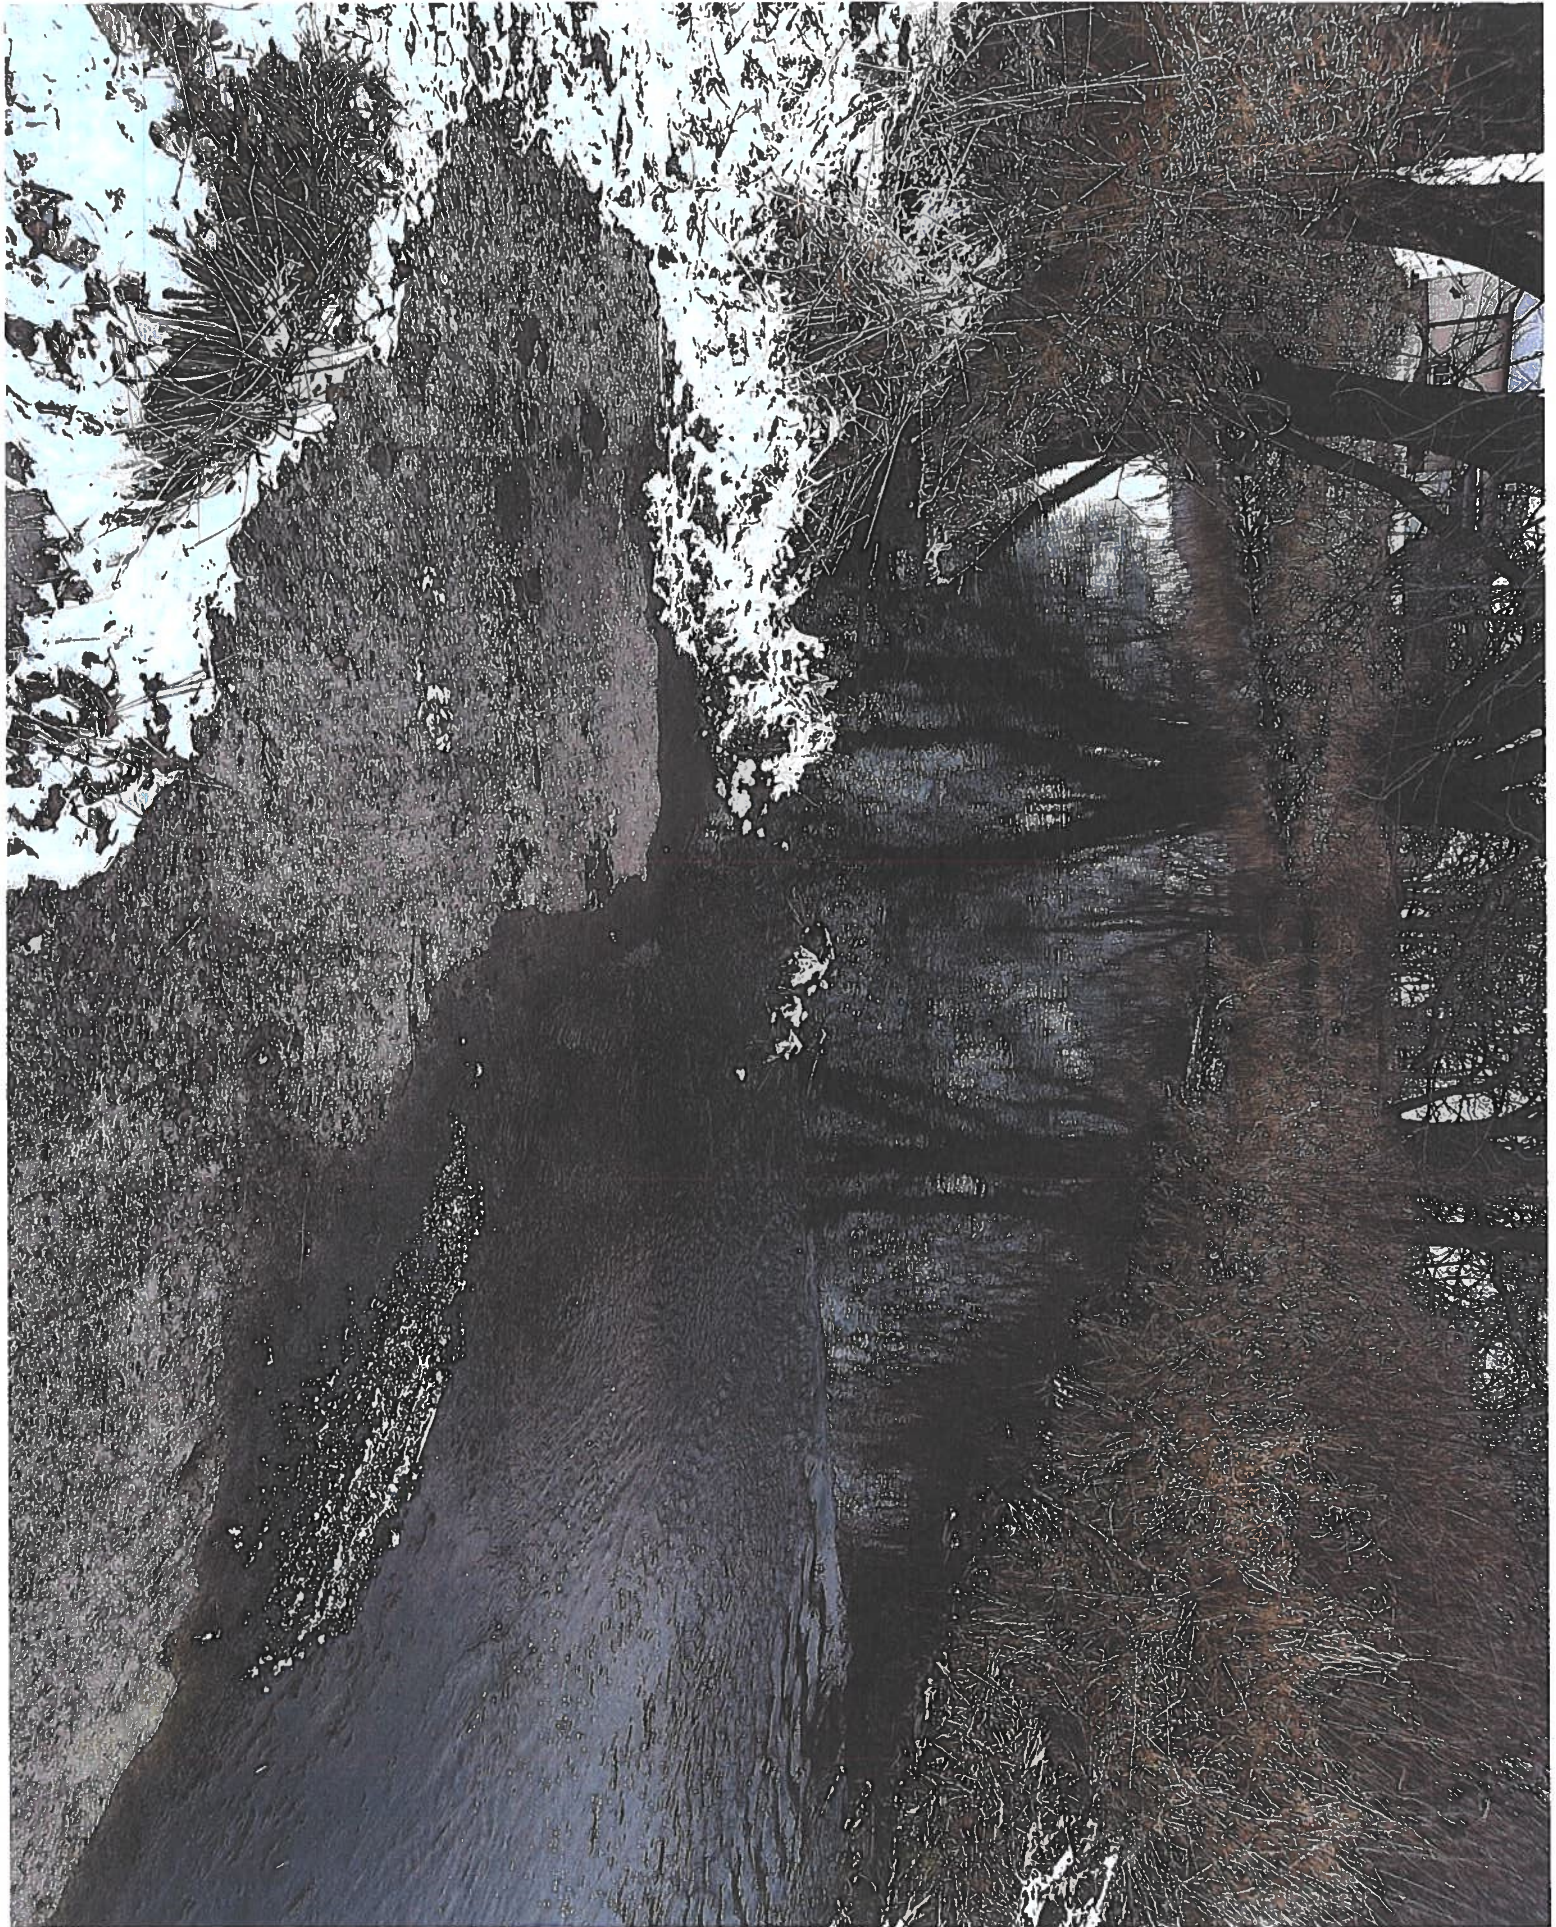
Looking West From Conc. Field Xing

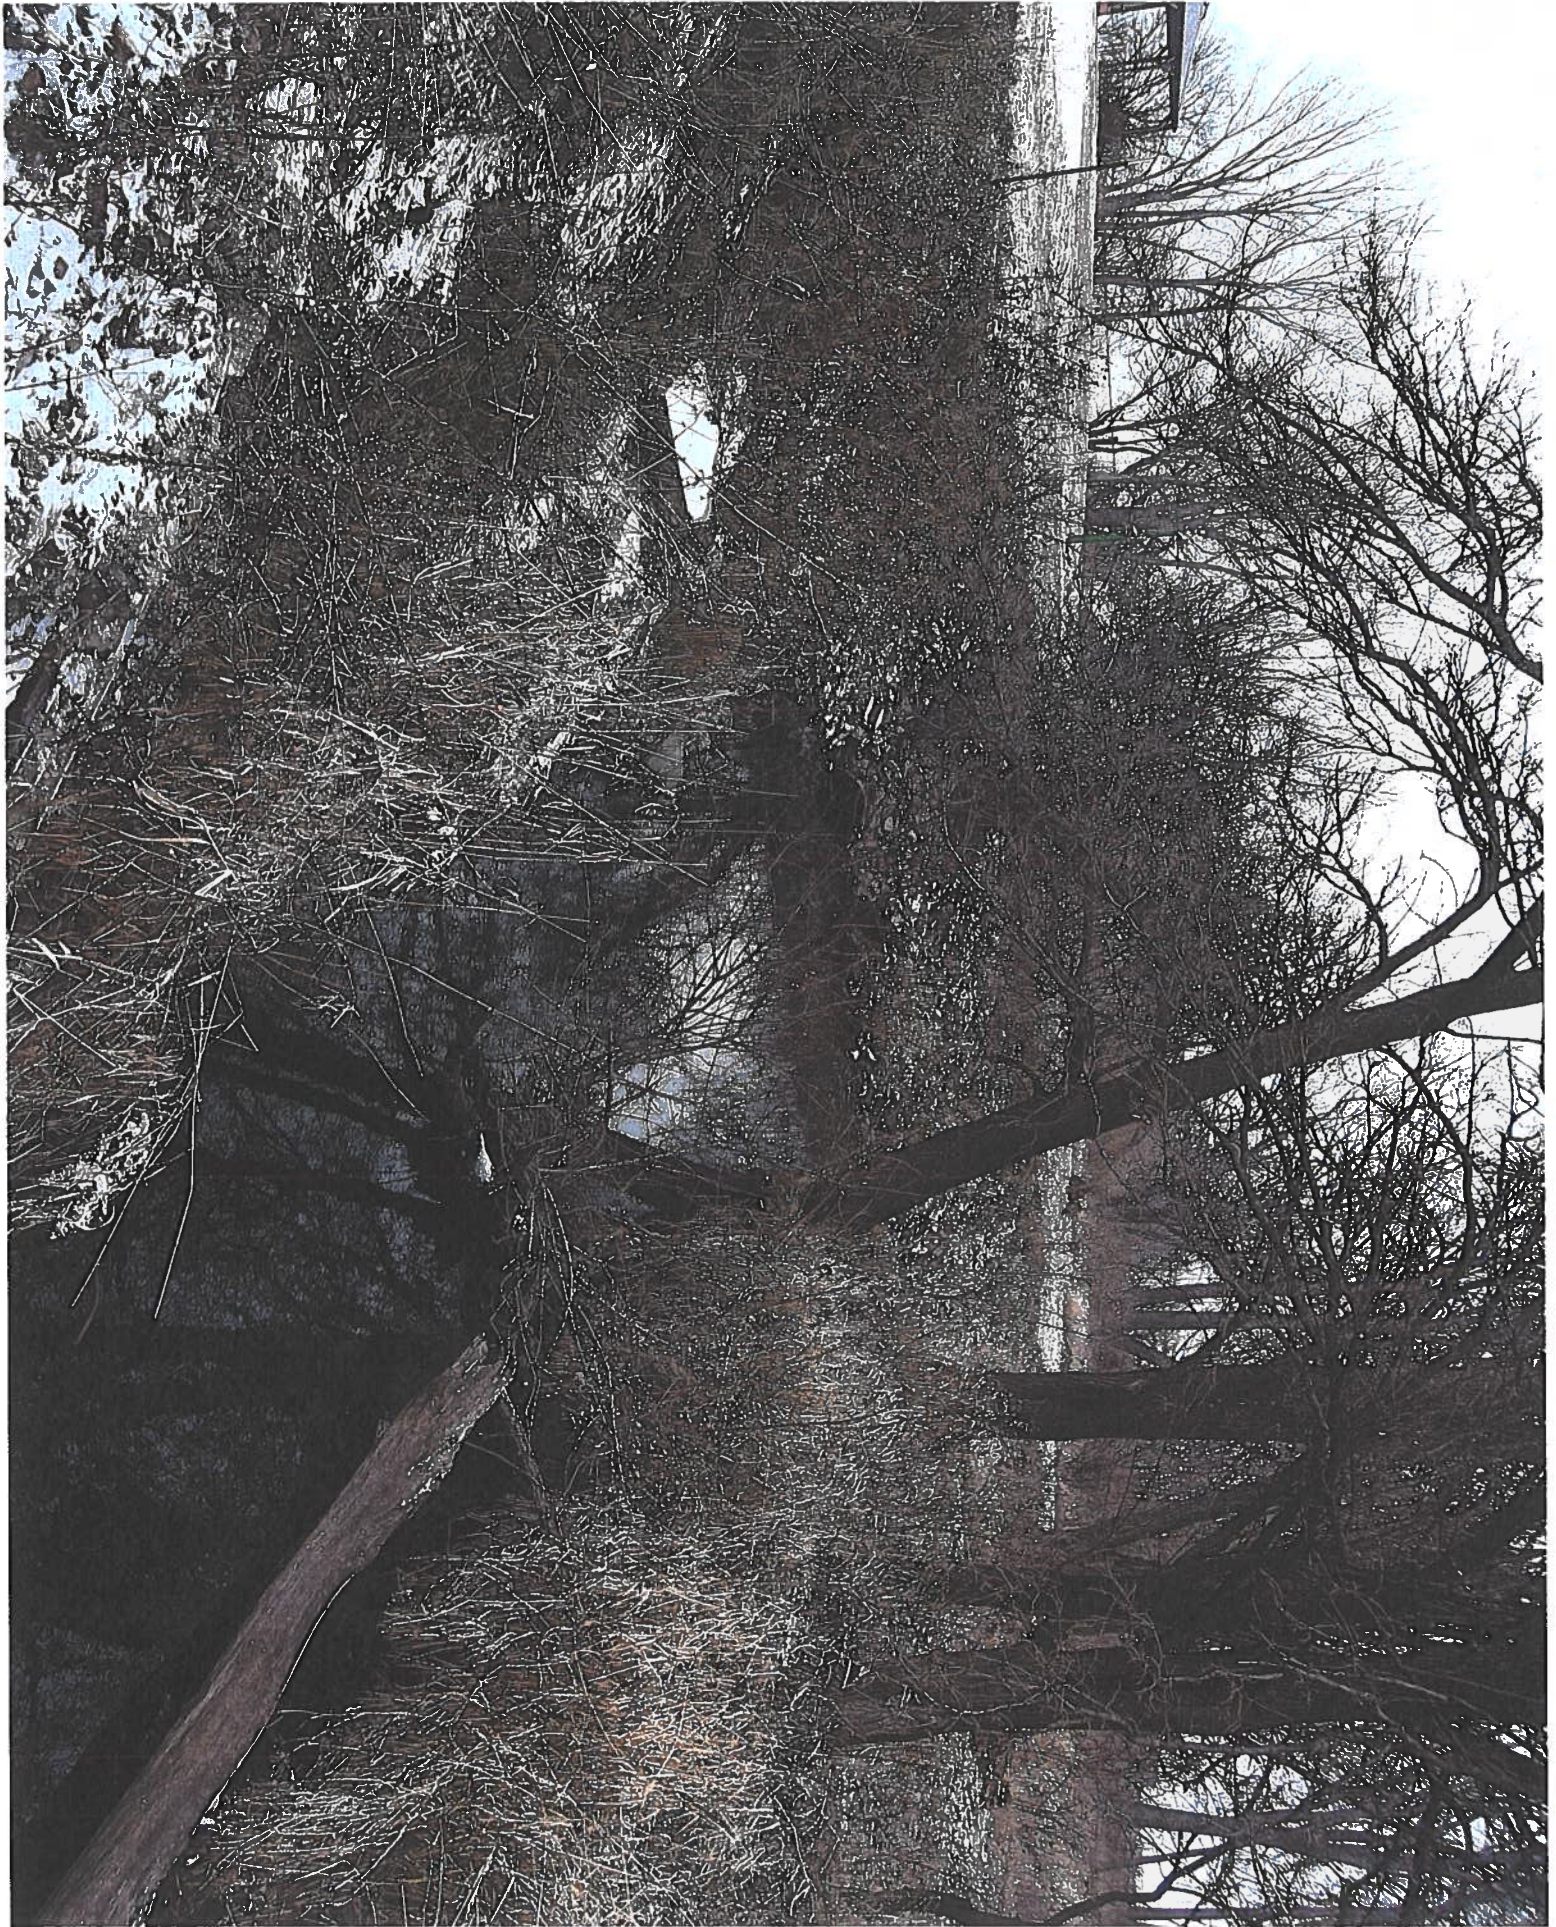
Looking W. @ DD154 CMP Outlet

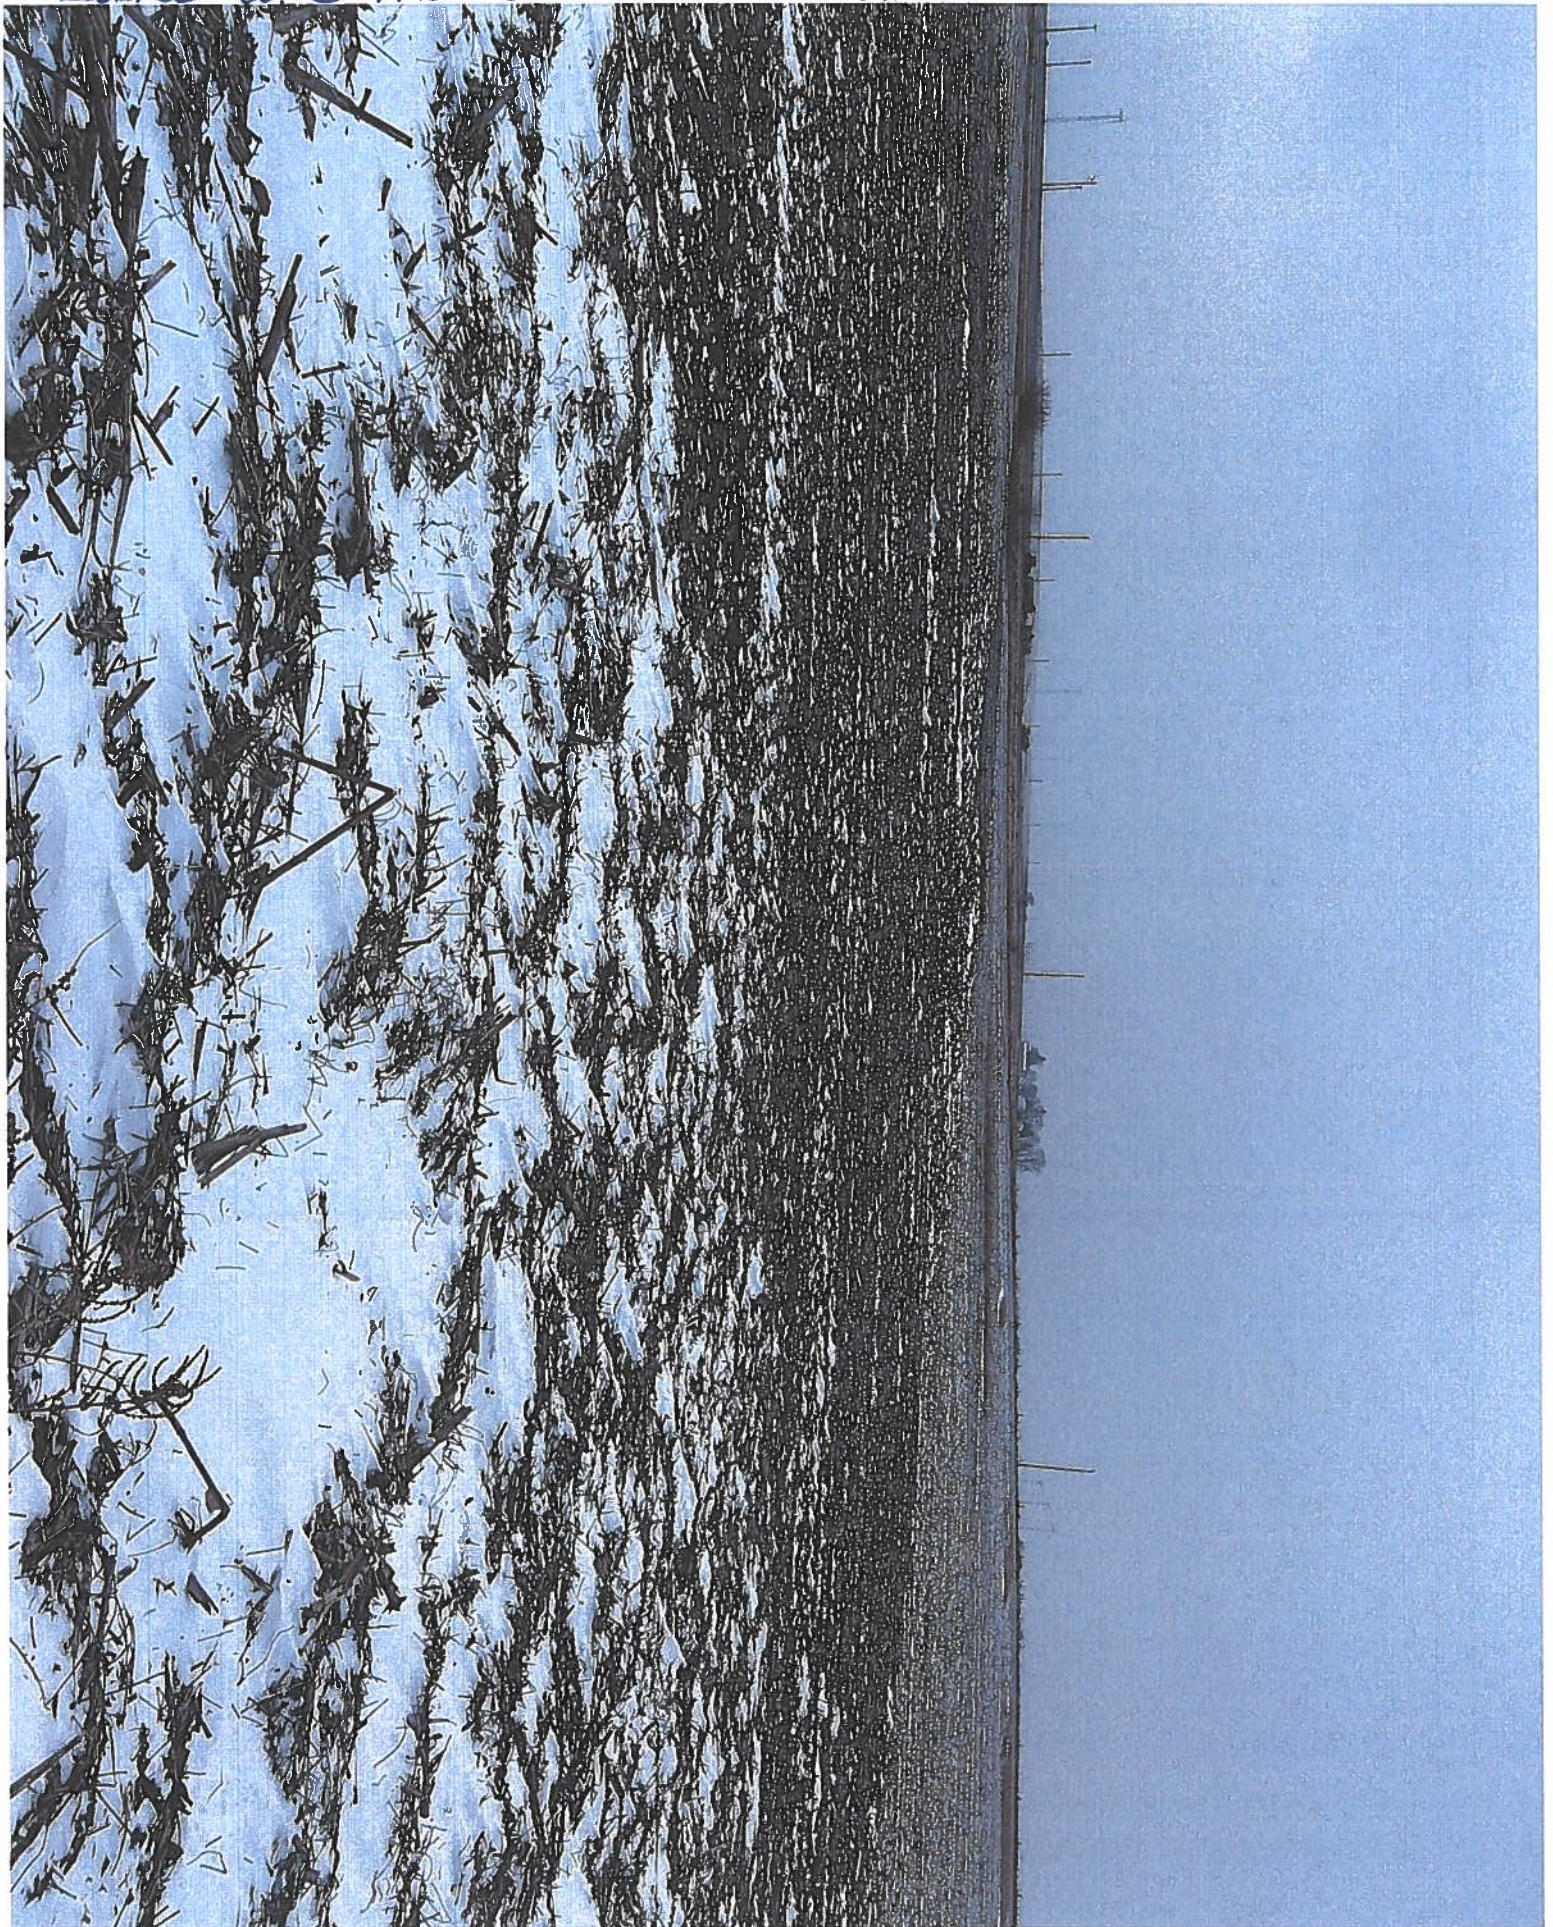
LOOKING W @ FARM SWALE OR THE ROUTE
