AGENDA
REGULAR DRAINAGE MEETING
Wednesday, October 14, 2020 9:30 AM
Large Conference Room

PAY ESTIMATE NO. 6
REPAIRS TO MAIN TILE AND LATERAL 3 DD#25 & REPAIRS TO MAIN TILE DD#1, HARDIN CO.
PROJECT NUMBER: 6501
DATE: 10-5-20

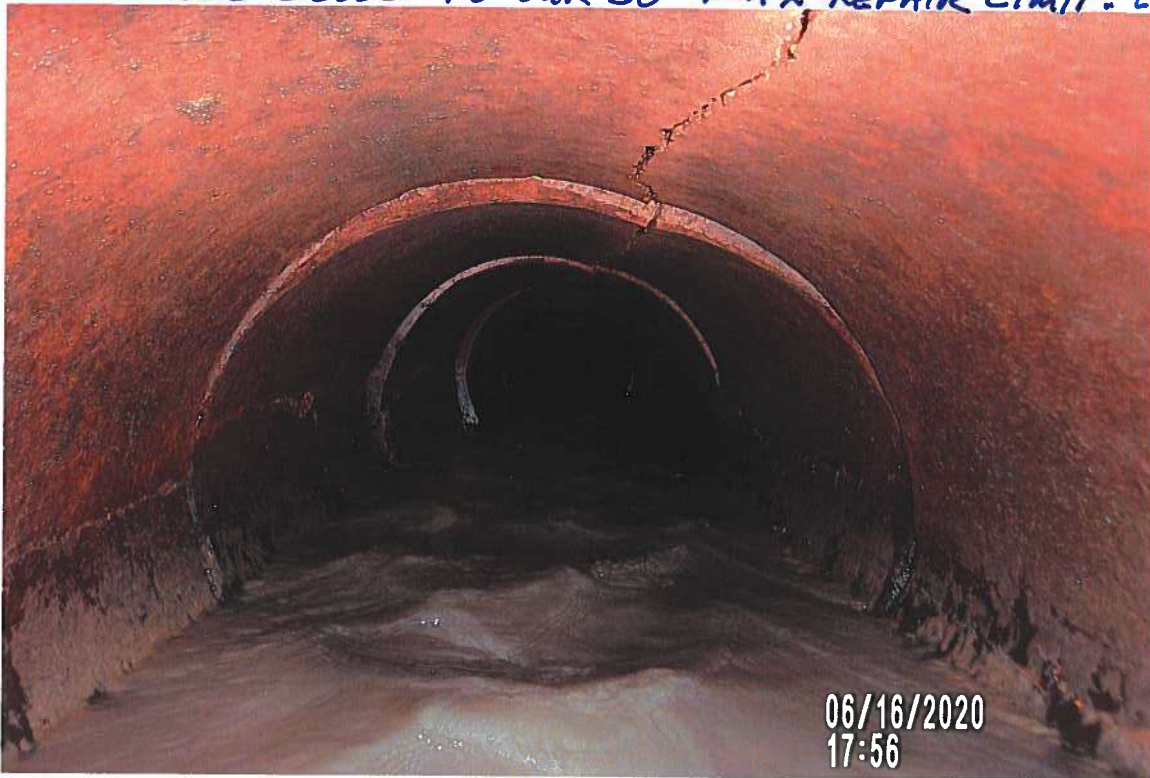
CPS # 394 TOP 21" CLAY TILE (5.4' DEEP)

PICTURE # 3802 IS LOOKING NE FROM GPS # 394 SHOWING INSIDE OF 21" CLAY TILE WITH TOP CRACKED AND CAVING DOWN. APPEARS NEXT 3 JOINTS ARE IN SAME CONDITION BUT ARE CLOSE TO OUR 50' MAX REPAIR LIMIT. LEE WILL TALK

(41.8' DOWNSTREAM FROM GPS # 392)

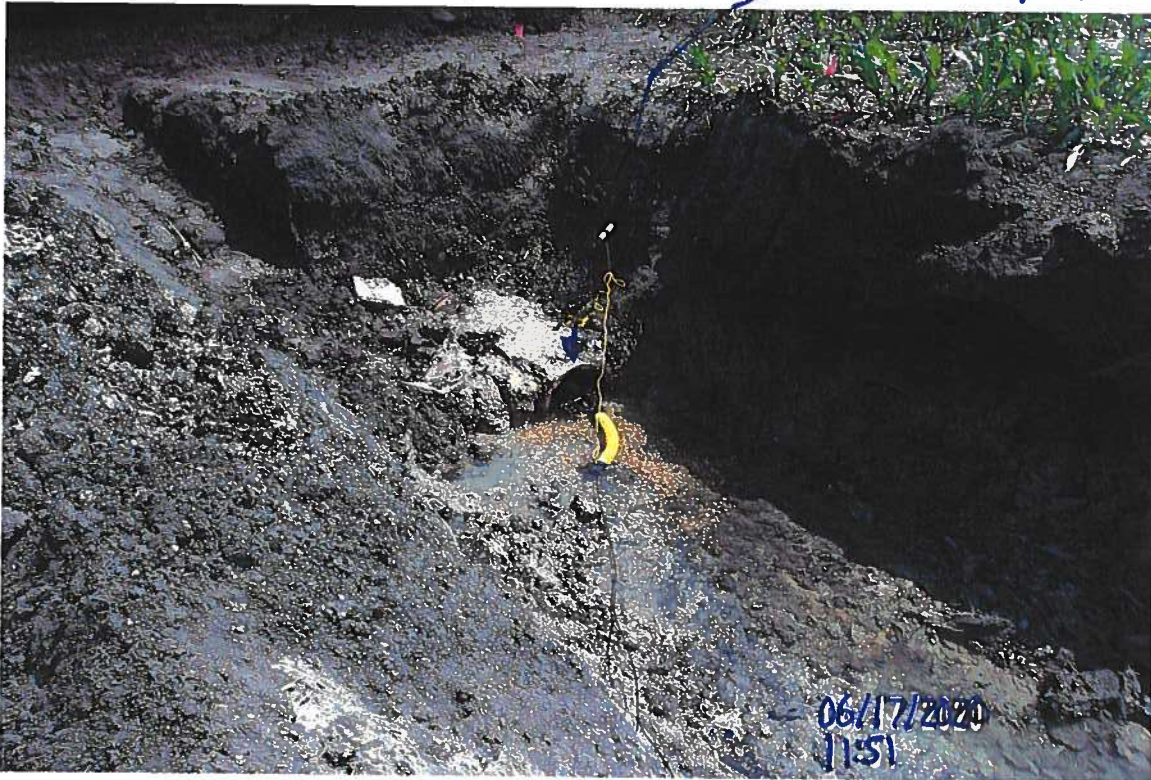
PICTURE# 3809 IS LOOKING NE SHOWING DOWN STREAM
 END OF EXPOSED TILE WHERE PAUL STARTED TELEVISIONING
 DOWN STREAM FROM WITH CAMERA IN TILE READY TO TELEVIEW.

GPS # 394 TOP 21" CLAY TILE
 1.72' TOP TO
 FL

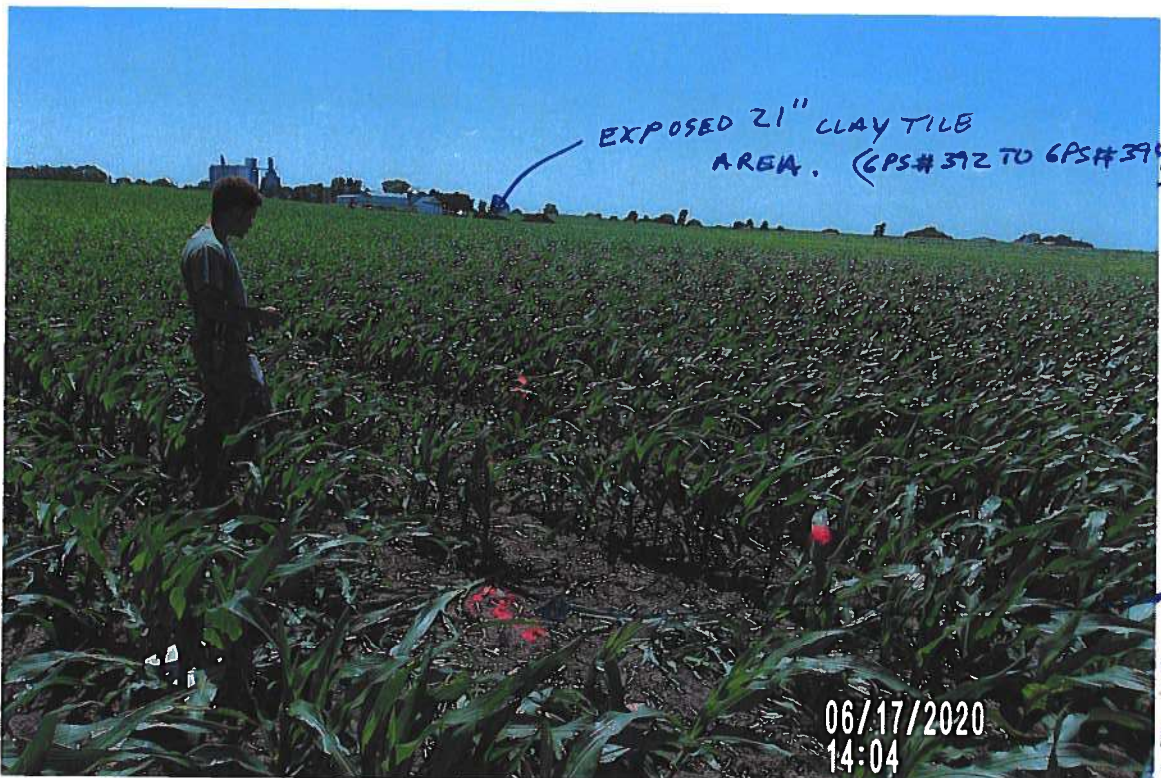
EXPOSED 21" CLAY TILE
 AREA. (GPS# 392 TO GPS# 394)

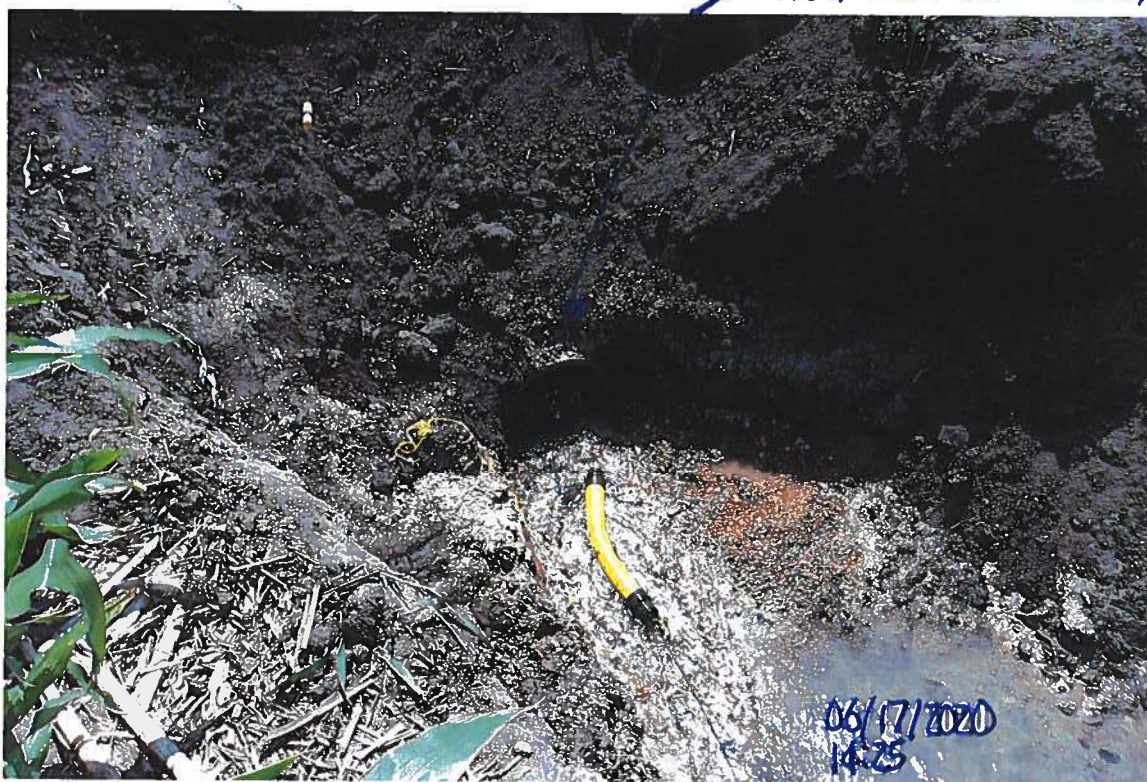
PICTURE #3811 IS LOOKING SW SHOWING CAMERA TRACTOR
IN UPSTREAM SIDE TILE OF BLOWOUT AND READY
TO START TELEVISING UPSTREAM.
GPS# 392 TOP 21" CLAY TILE (4.8' DEEP)

(1.79' TOP
TO RL)

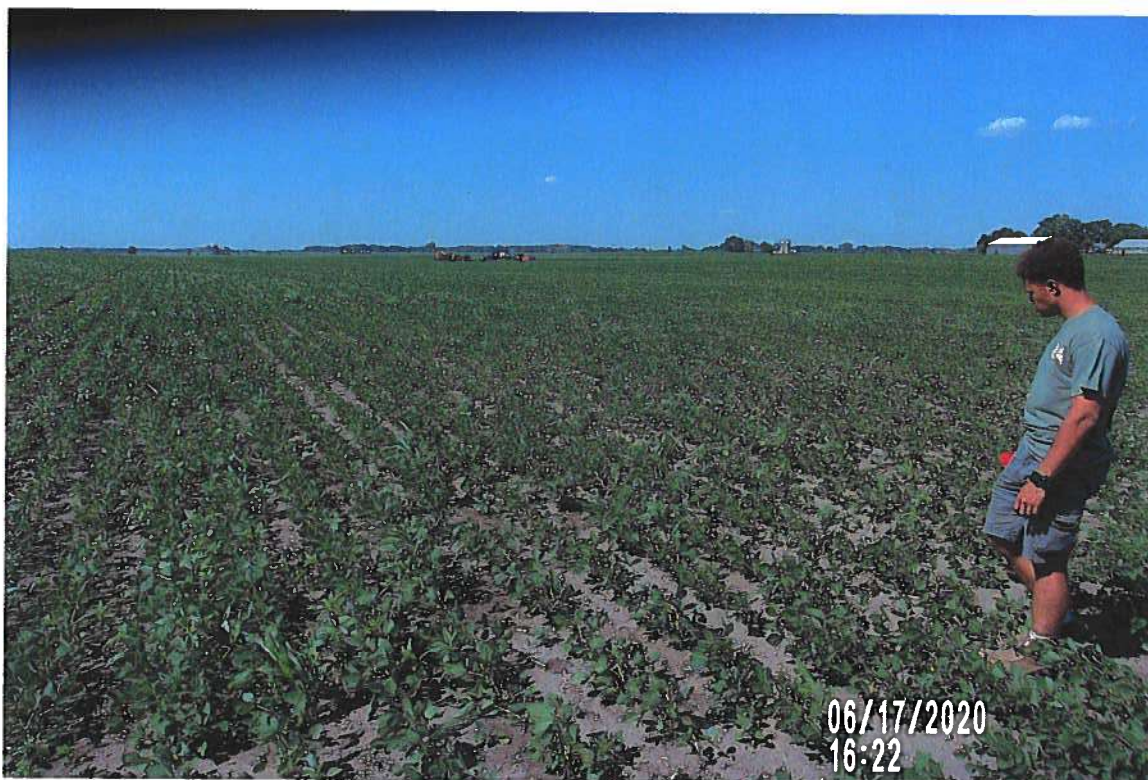
PICTURE #3812 IS LOOKING NE FROM END OF CABLE
TILE LOCATE GPS# 429 TOWARD TILE BLOWOUT START
OF LOCATES (976.0')

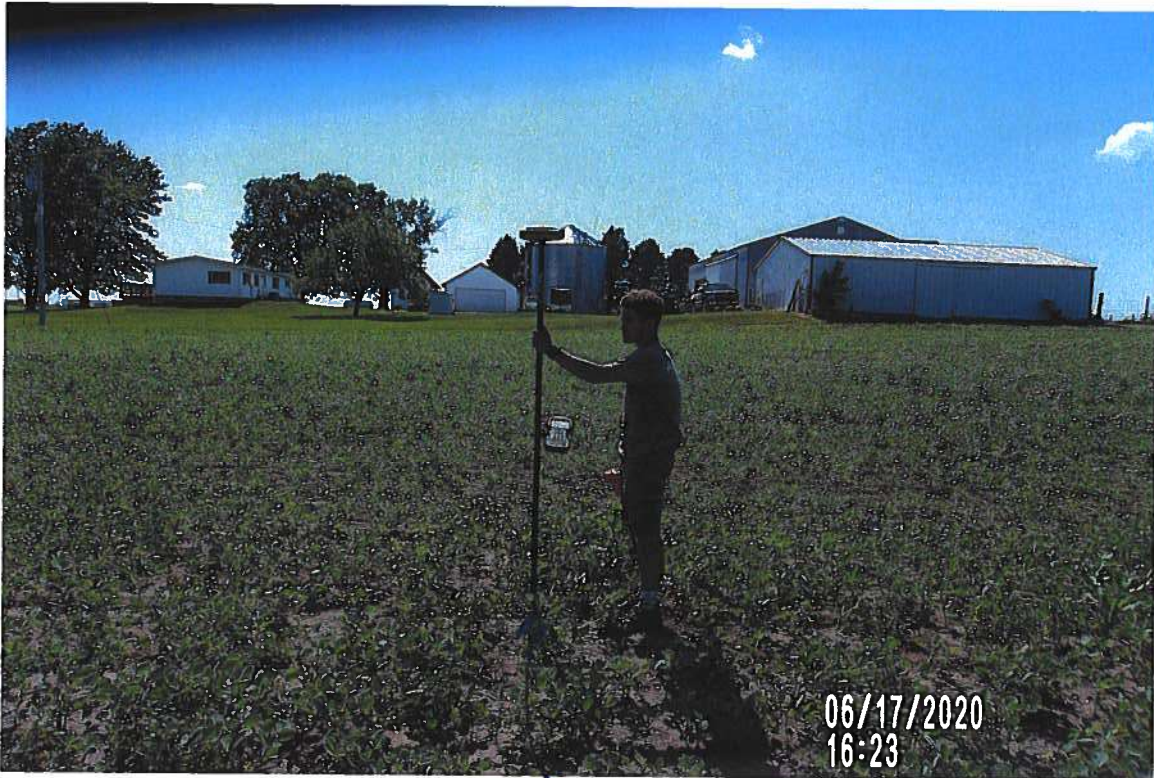
✓ CPS# 429 END OF TILE LOCATE
(END OF CABLE)

PICTURE#3814 IS LOOKING WEST TOWARDS 402 PRAIRIE AVENUE
FROM LOCATION OF END TILE LOCATE (END OF CABLE)

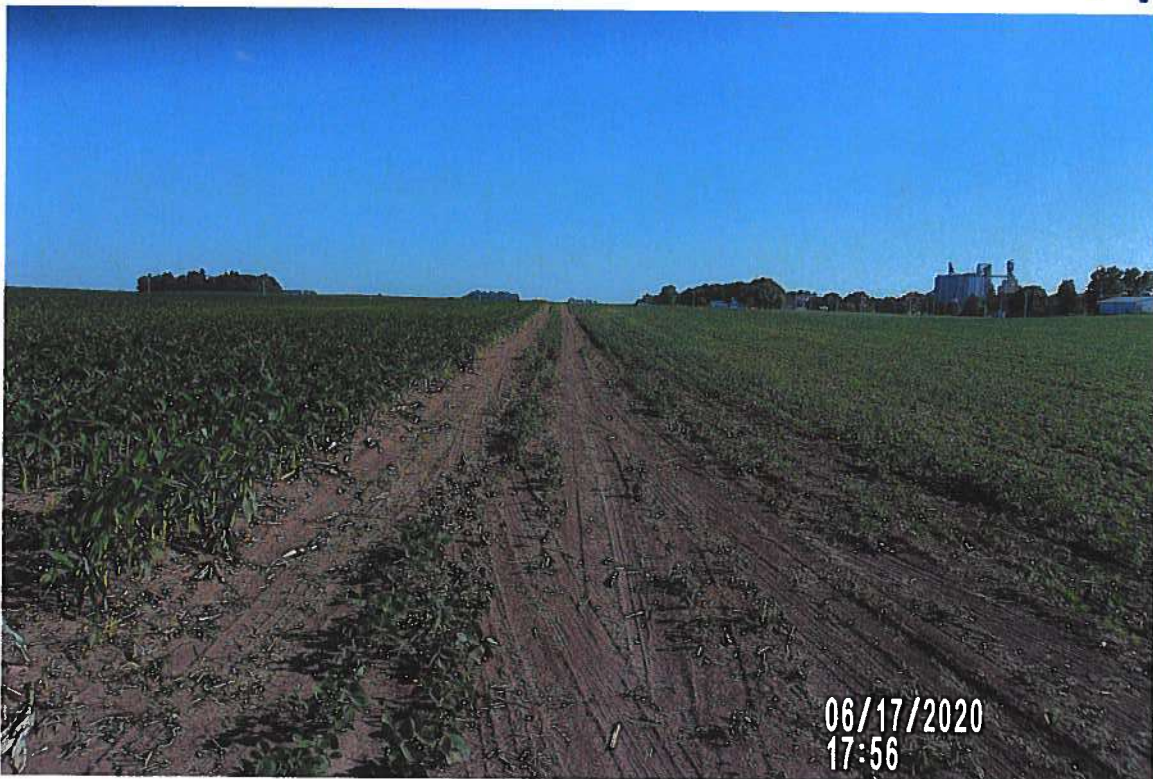
PICTURE#3815 IS LOOKING SOUTH AT BEAN & CORN DAMAGE
ON ACCESS LANE OUT TO TILE REPAIR

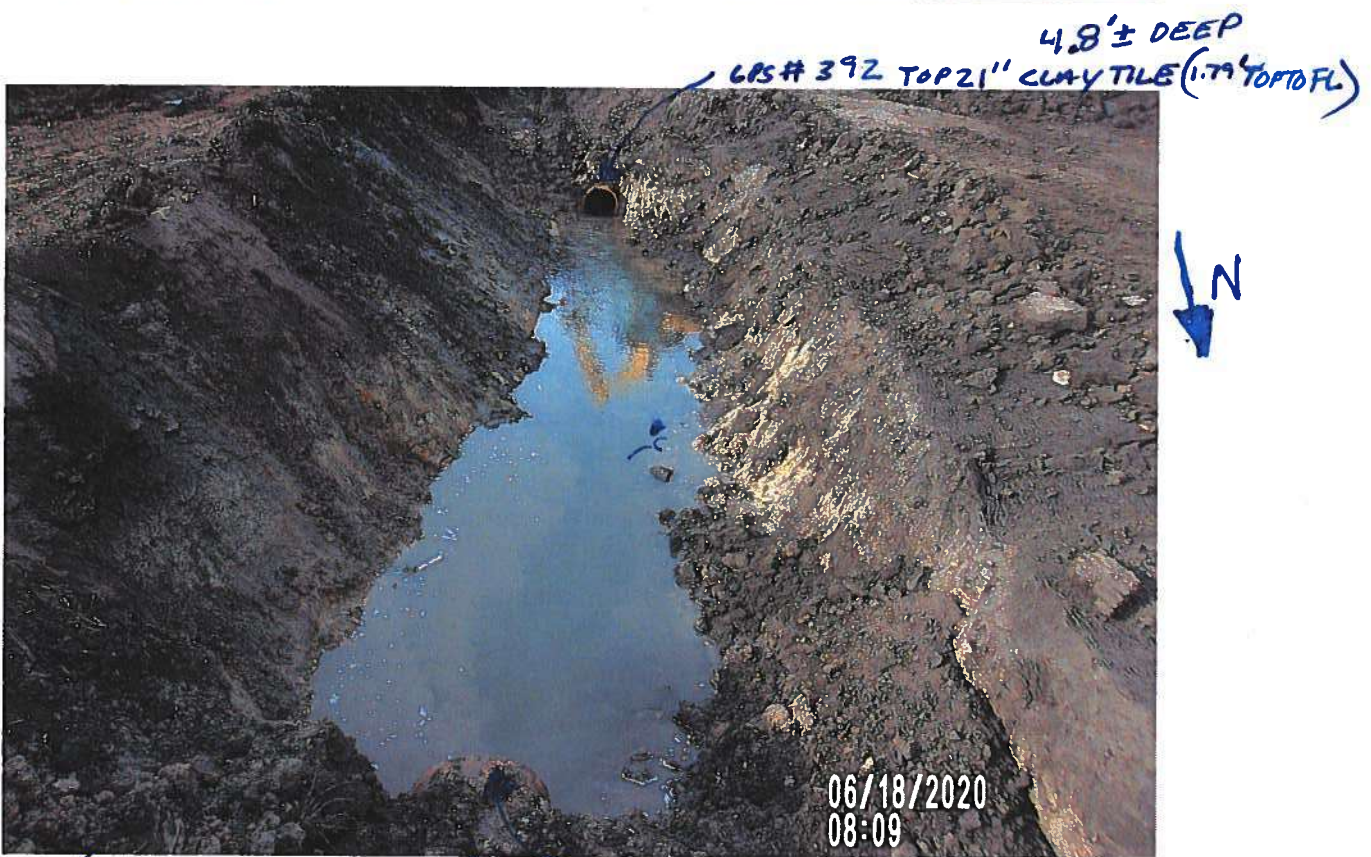
PICTURE# 3818 SHOWING CREW DRILL HOLES IN
 BOTTOM OF 24" DW HOPE NONPERF TILE BEFORE
 INSTALLED TO PREVENT TILE FROM FLOATING UP,

(TEMPORARY REPAIR)
 PICTURE# 3819
 IS LOOKING SOUTH UPSTREAM
 OUT OF BOTTOM OF TRENCH & READY TO INSTALL
 24" HOPE DW NONPERF TILE. BOTTOM IS SOFT IN AREAS AND WILL USE SOME ROCK
 TO FIRM UP ON INSTALLATION
 GPS# 392 TOP 21" CLAY TILE (1.71' TOP TO FL)
 4.8' ± DEEP
 GPS# 394 TILE TOP 21" CLAY (1.72' TOP TO FL)
 5.4' ± DEEP
 WITH MUCK CLEANED

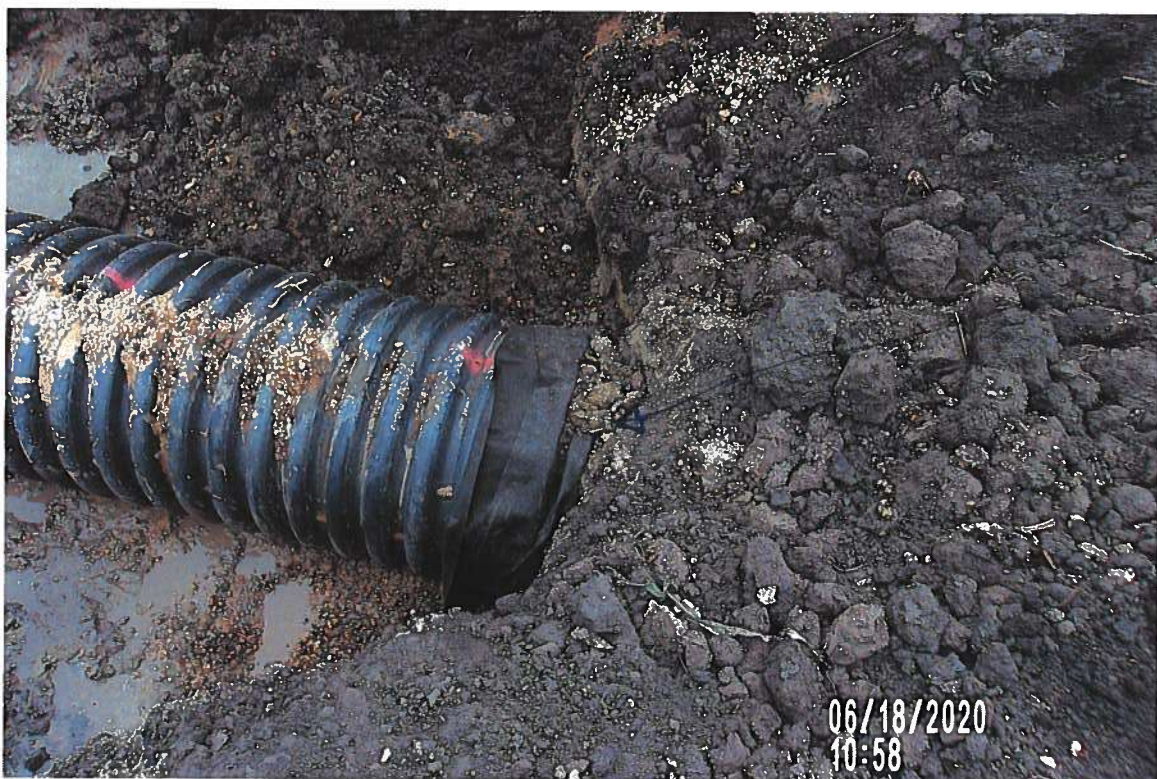
GPS # 392

PICTURE # 3823 IS LOOKING EAST AT ENGINEER FABRIC STUFFED
 IN JOINT & OVER JOINT. CREW STOMPED IN CLAY AROUND
 HDPE EDGE BEFORE BACK FILLING SOIL IN TRENCH. BEDDING ROCK
 TAMPED IN UNDER TILE TO KEEP IT IN PLACE.

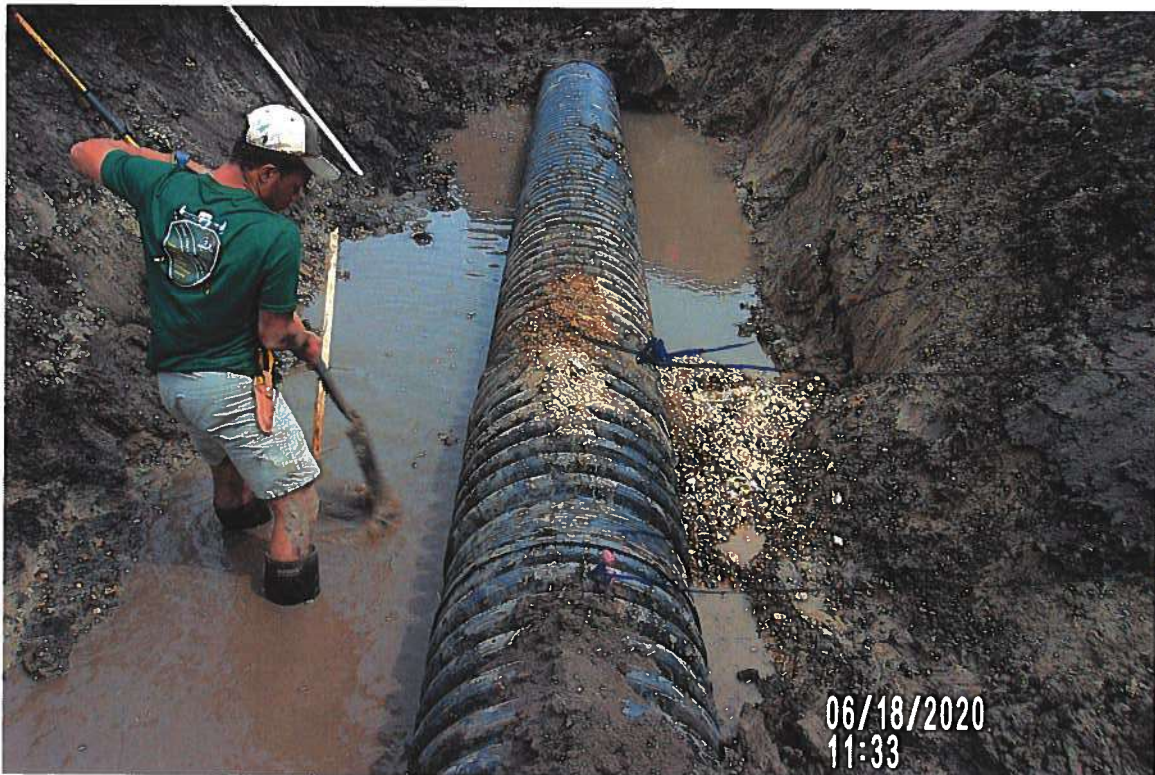
GPS#453

PICTURE# 3824 IS LOOKING SW SHOWING CREW BACKFILLING
SOIL AROUND NEW TILE WITH CREW TAMPING IN SOIL
AROUND HAUNCH OF TILE. SOIL IS GETTING LITTLE MURKY DUE
TO WATER AROUND TILE BUT WITH FIRM BOTTOM UNDER TILE;

BUTT JOINT
CONNECTION
WRAPPED
WITH FABRIC

PICTURE#3825 IS LOOKING NE SHOWING SMALL SECTION 24" Ø
HDPE NONPERF TILE WITH BELL-SPIGOT CONNECTION & SPIGOT
BUTT CONNECTION ON DOWN STREAM END WITH JOINT WRAPPED WITH
FABRIC & BEDDING ROCK TAMPED UNDER CONNECTION

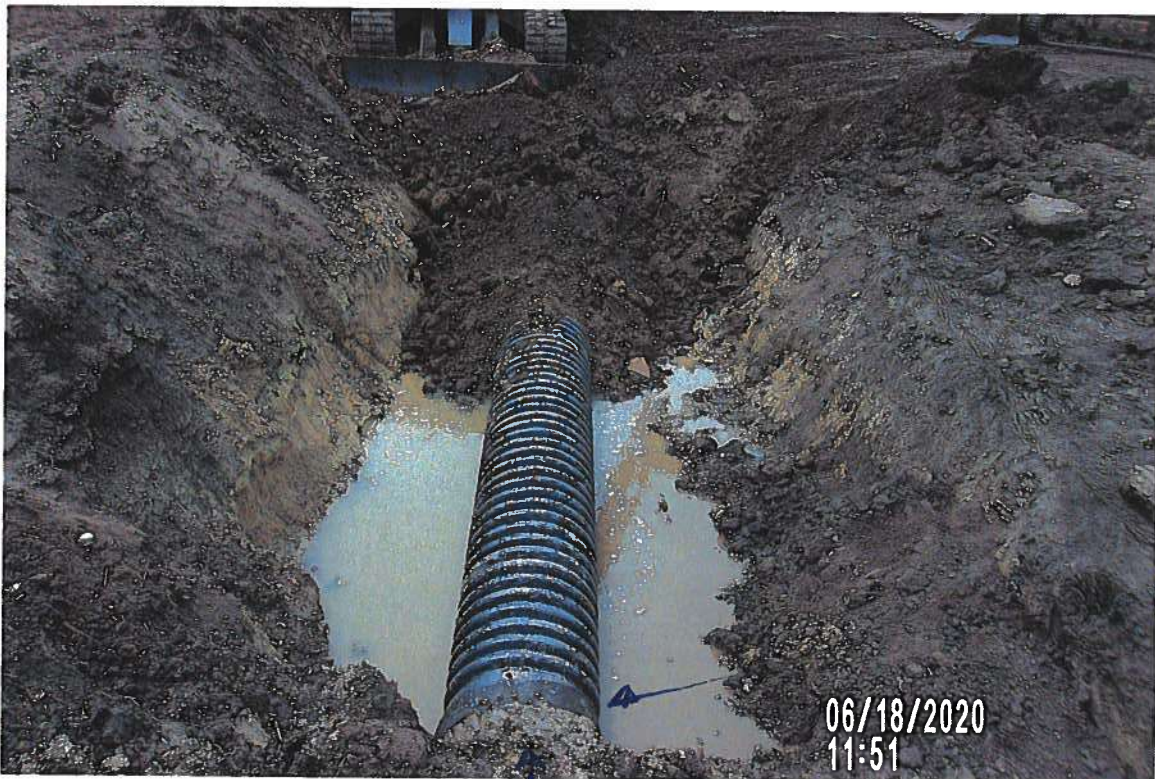
GPS # 394 DOWNSTREAM END TIE IN

PICTURE # 3826 SHOWING A PIECE OF FABRIC WITH CLAY TILE PIECES OVER A EXPOSED TILE JOINT THAT IS WIDER THAN NORMAL JOINT FOR NEXT JOINT NORTH OF TIE IN

CONNECTION,
CREW STAMPED
CLAY OVER
TOO.

BEDDING ROCK
TAMPED UNDER
HDP TILE
TO KEEP BOTTOM
OF INSIDE OF
BELL TIGHT
UP TO BOTTOM
OF CLAY TILE

PICTURE # 3827 AS LOOKING SW SHOWING LOOSE SOIL BEING BACKFILLED AROUND TILE. CREW STUFFED FABRIC IN GAP BETWEEN INSIDE BELL AND TOP OF CLAY. CREW PLACED 2.0' x 5.0' PIECE OF ENGINEERING FABRIC OVER JOINT AND STAMPED CLAY AROUND EDGE OF TILE BEFORE BACKFILLING

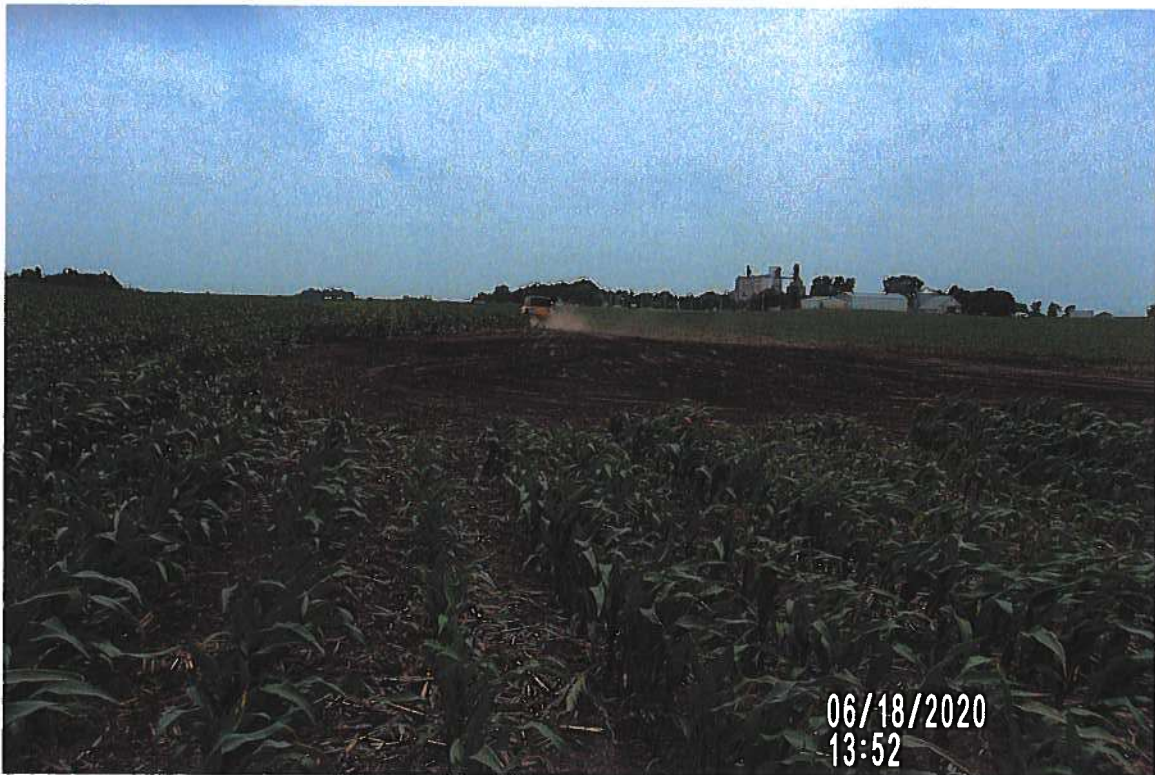
PICTURE # 3842 IS LOOKING SOUTH SHOWING BEAN DAMAGE
IN REPAIR WITH AREA CLEANED UP.

PICTURE # 3843 IS LOOKING SOUTH SHOWING CORN DAMAGE
IN REPAIR AREA WITH AREA CLEANED UP

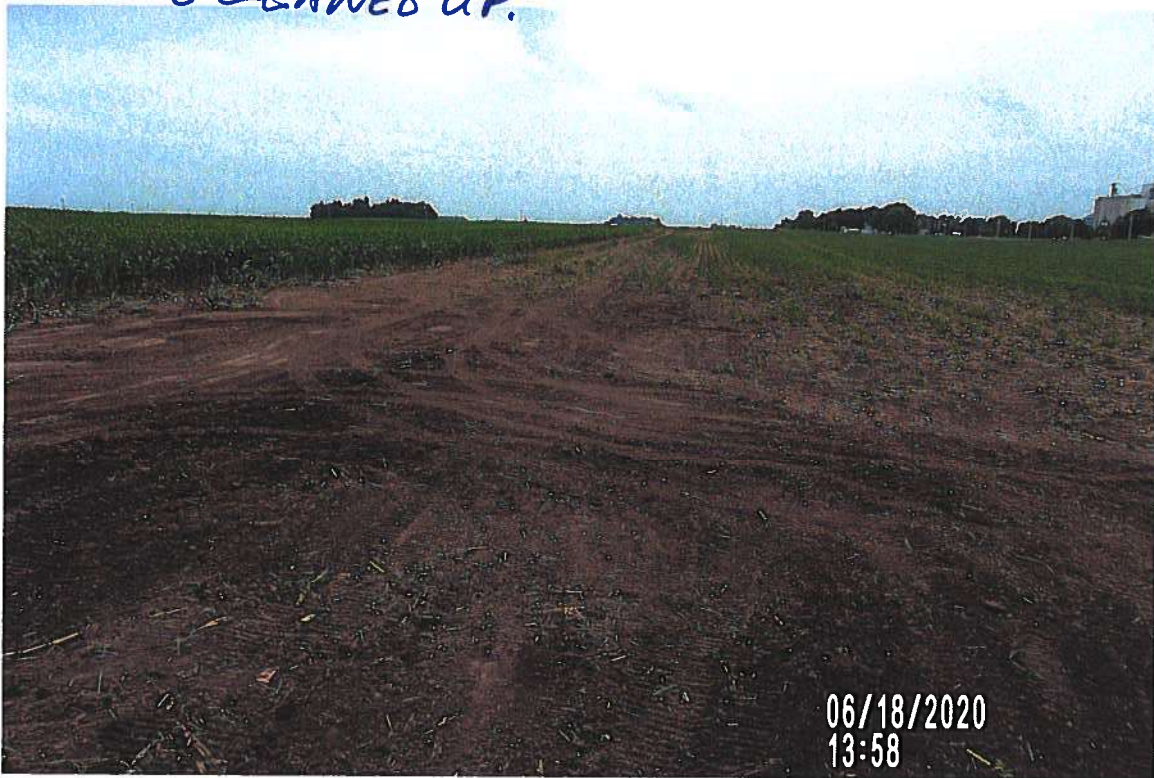
PICTURE # 3846 IS LOOKING SOUTH AT BEAN
DAMAGE TO ACCESS LANE WITH AREA
CLEANED UP.

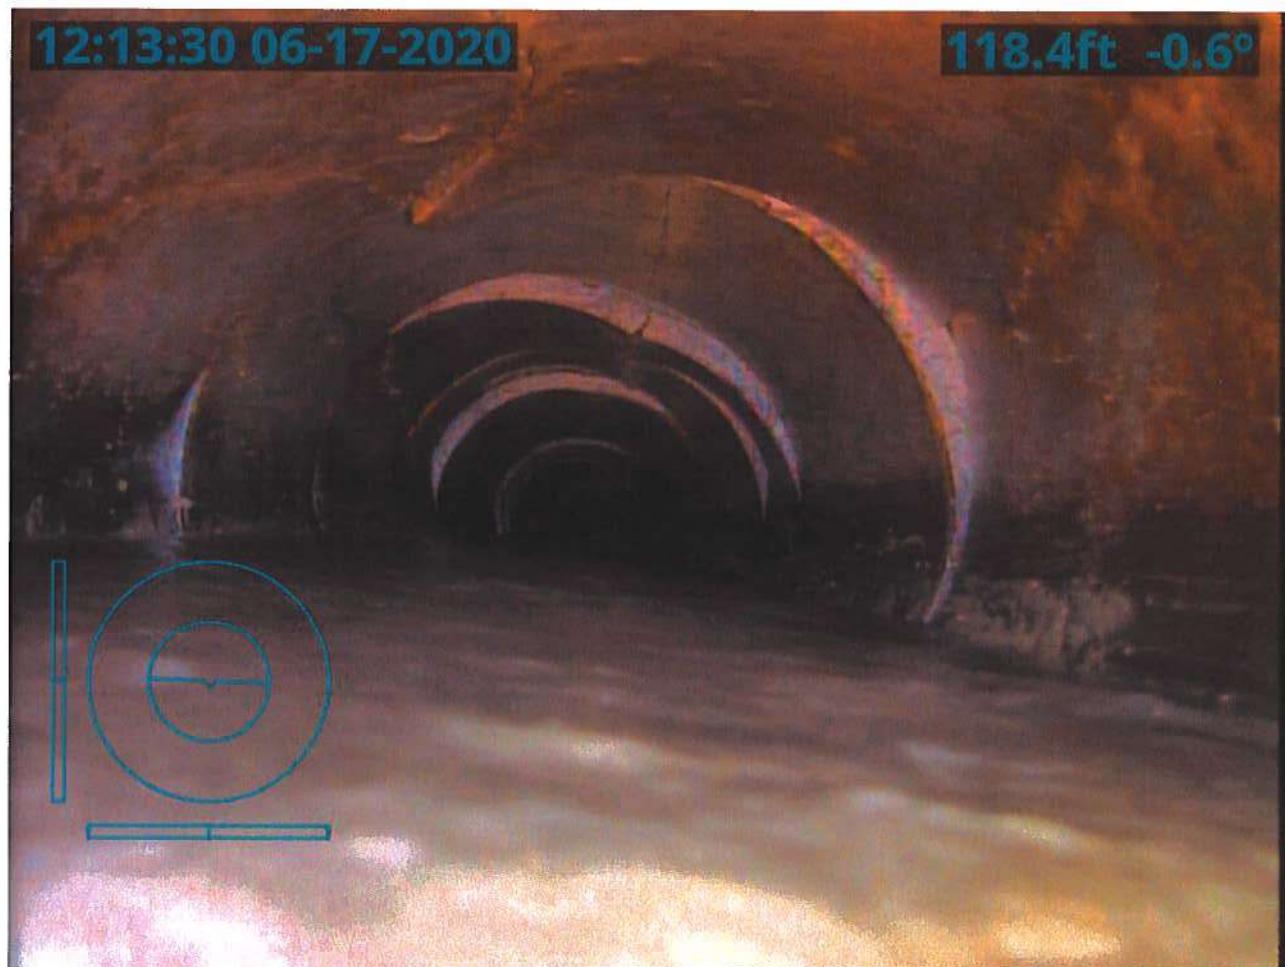
118.4ft -0.6°

12	11			LOTS OF BROKEN PIPE AS FAR AS VISIBLE
0:15:06	118.4		B	2020_06_17-12_13_30_307.jpg

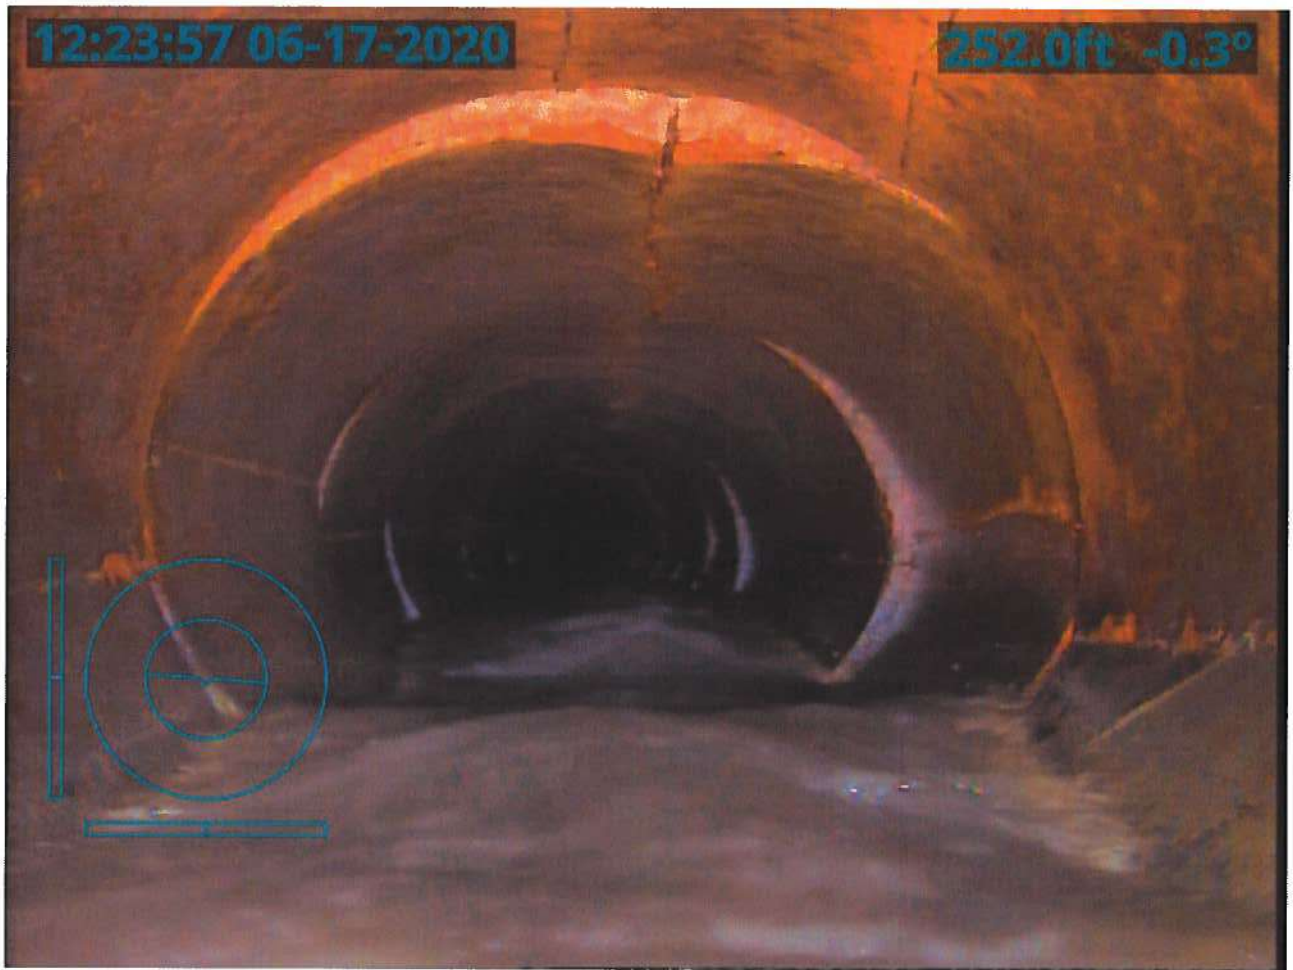
252.0ft -0.3°

06	09			TILE HAS BROKEN OFF AND INTRUDING INTO PIPE.
0:24:18	252.0		B	2020_06_17-12_23_57_456.jpg

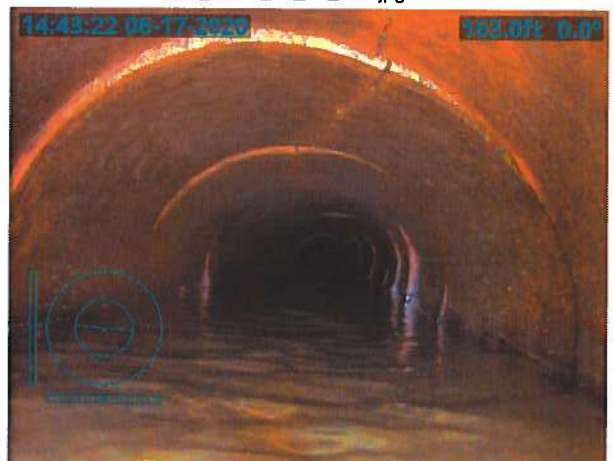
CL 2020_06_17-14_43_22_128.jpg

00				LOOKS TO BE CRACKED AT 12 AND 6
0:13:54	163.0		CL	2020_06_17- 14_43_22_128.jpg

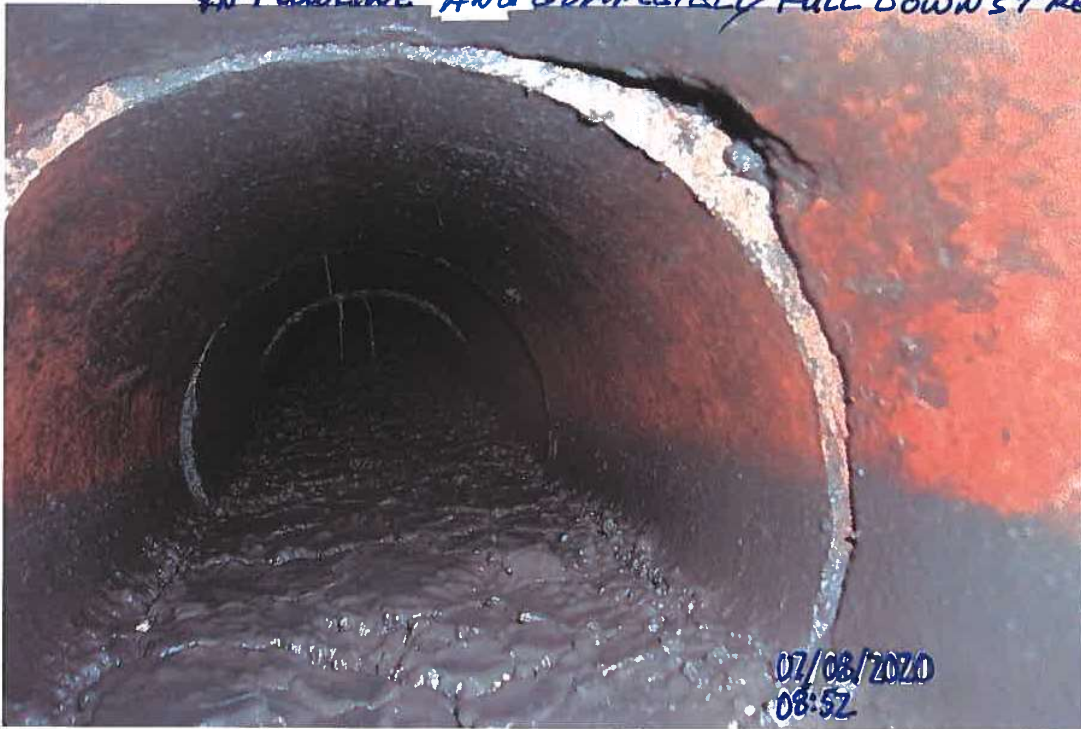
PICTURE# 4053 IS LOOKING SE DOWNSTREAM INSIDE 8" CLAY TILE
WITH 2"± OF MUD IN FLOWLINE FROM GPS# 251. TILE HAS A
LITTLE POPOUT AT NEXT JOINT AND IS IN GOOD SHAPE WITH 2" MUD
IN FLOWLINE AND COMPLETELY FULL DOWNSTREAM. RON

THINKS
THIS TILE
IS
ABANDONED

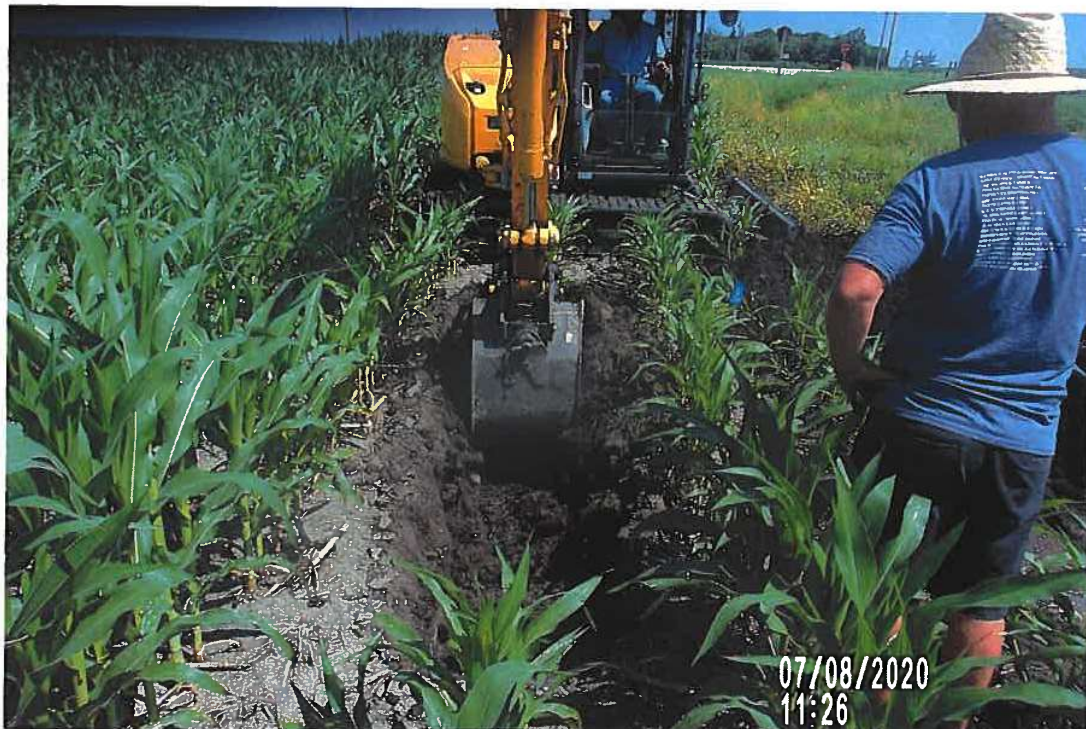
PICTURE #4059 IS LOOKING NORTH SHOWING CREW NOW
EXCAVATING ON WEST SIDE OF WATER MAIN TO CHECK IF
WATER MAIN IS THE CAUSE.

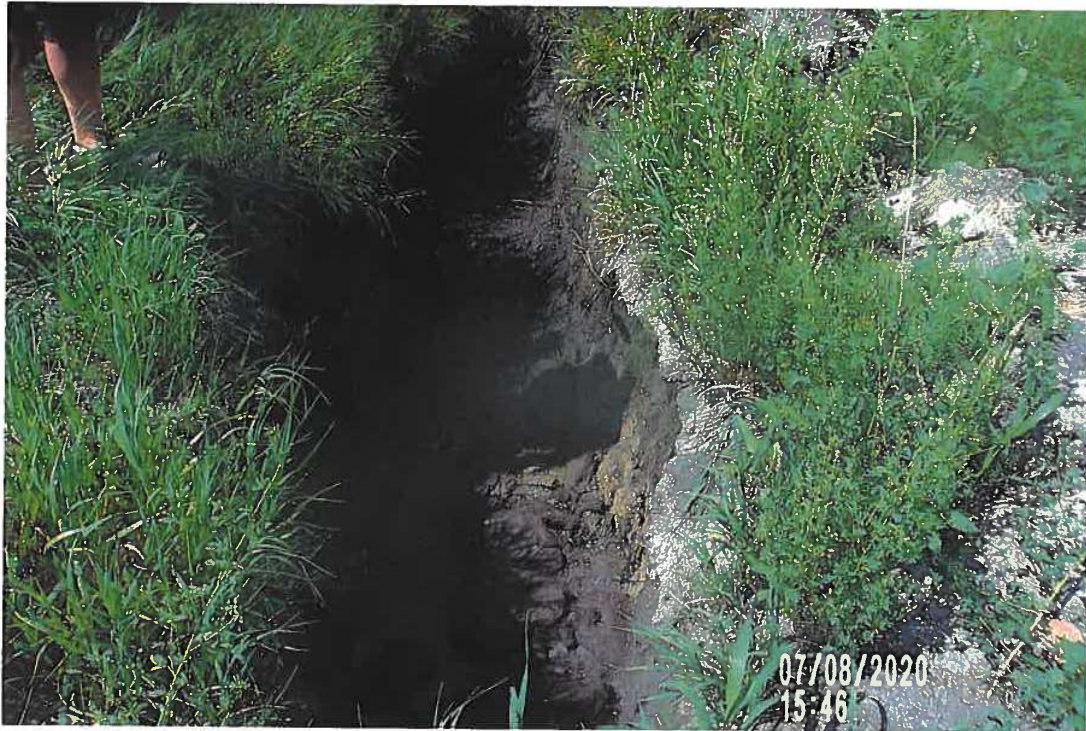
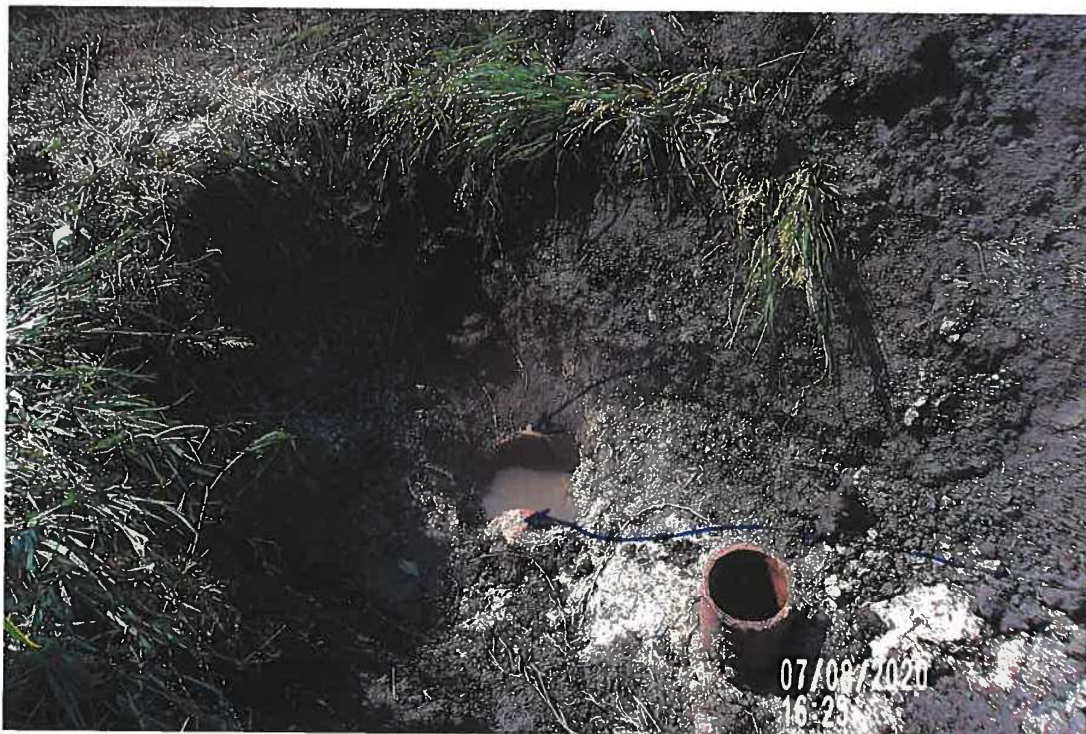
PICTURE# 4068 IS LOOKING NW SHOWING TILE FLOWING
IN SOUTH DITCH OF CO. HWY D41

PICTURE #4069 IS LOOKING EAST SHOWING 5" HOPE SW PERF
TILE CONNECTION AREA. 8" CLAY TILE STILL FLOWING
GOOD.

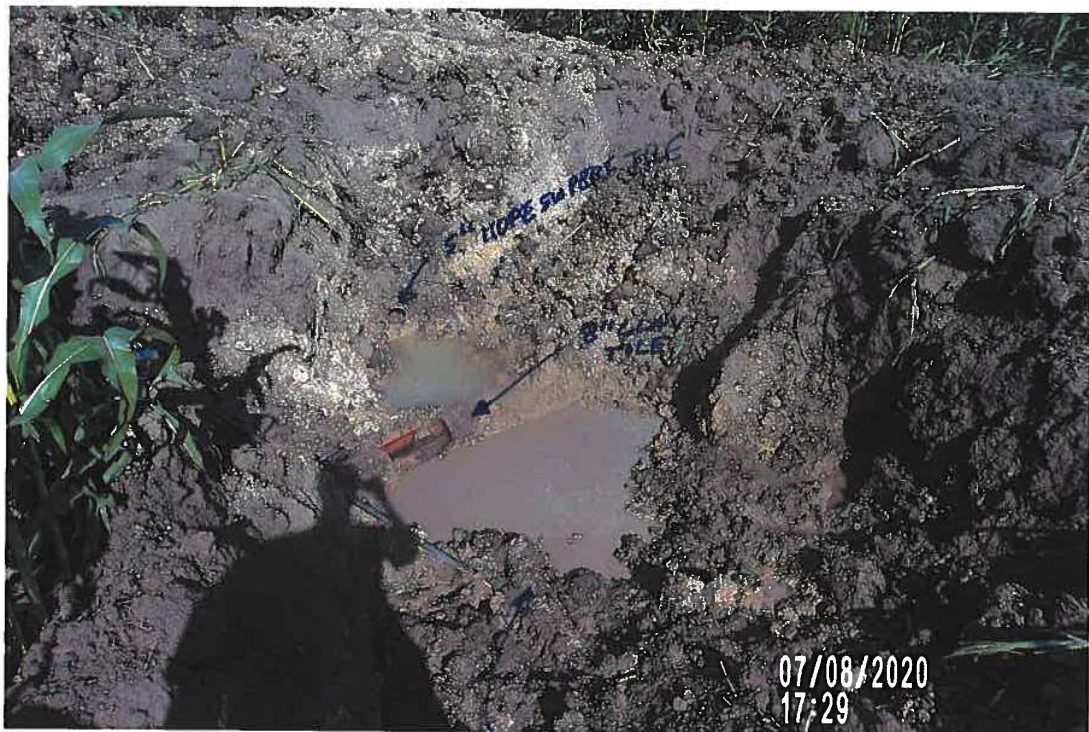
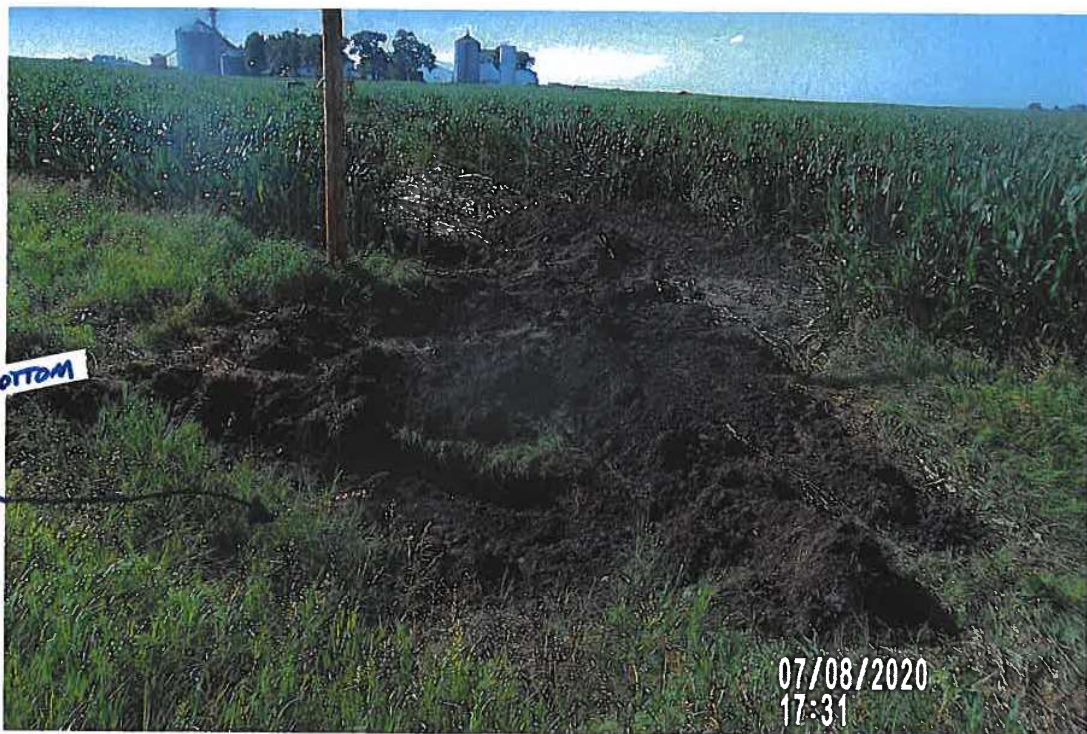
PICTURE #4070 IS LOOKING NW FROM CO HWY 041
SHOWING AREA IN NORTH DITCH EXCAVATED AND HOLE EXCAVATED
IN FIELD AT TILE/WATERMAIN CROSSING.

PICTURE # 4071 IS LOOKING SE TOWARDS CO HWY 04/
SHOWING 14" CLAY TILE FLOWING GOOD

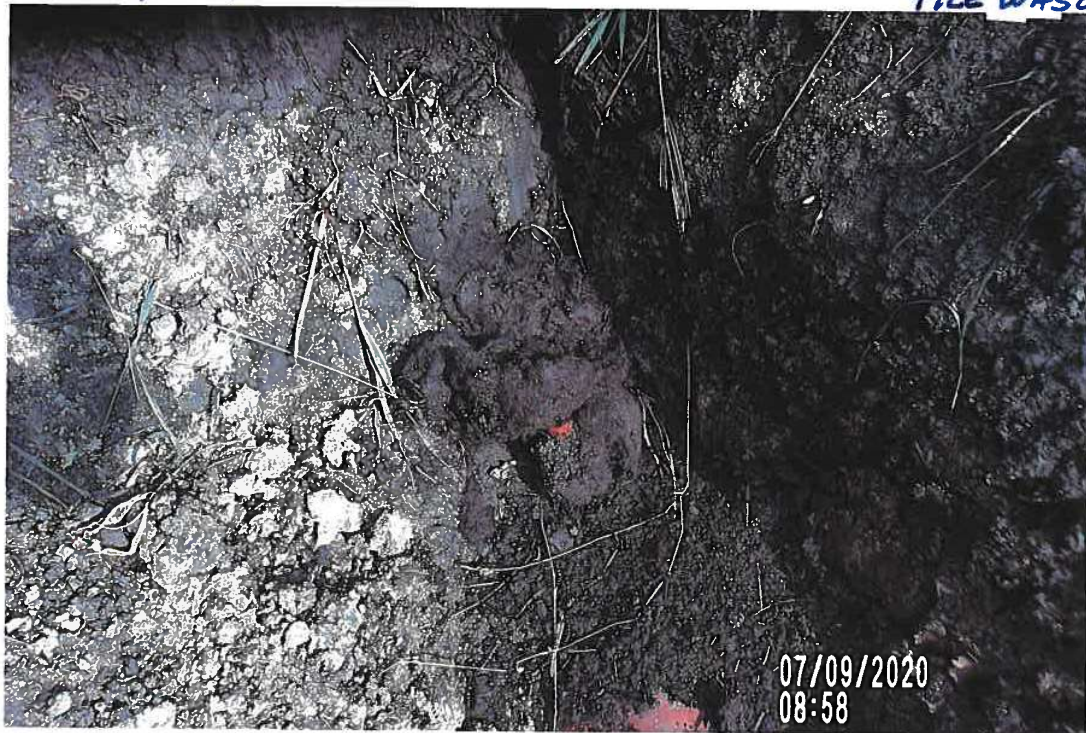
PICTURE # 4088 SHOWING PILE OF DEBRIS PULLED OUT OF TILE
 (WHERE 8" CLAY TILE SECTION WAS ROLLED OUT IN SOUTH DITCH OF
 CO HWY D41) BEFORE IT WENT DOWNSTREAM AFTER PLUGGED
 TILE WAS OPENED

PICTURE # 4089 IS LOOKING NE INSIDE TILE WYE ACCESS LID
 ON SOUTH SIDE OF CO HWY D41 1195.6' ± WEST OF E CO HWY S27
 SHOWING TILE IS STILL FLOWING GOOD AT THIS LOCATION

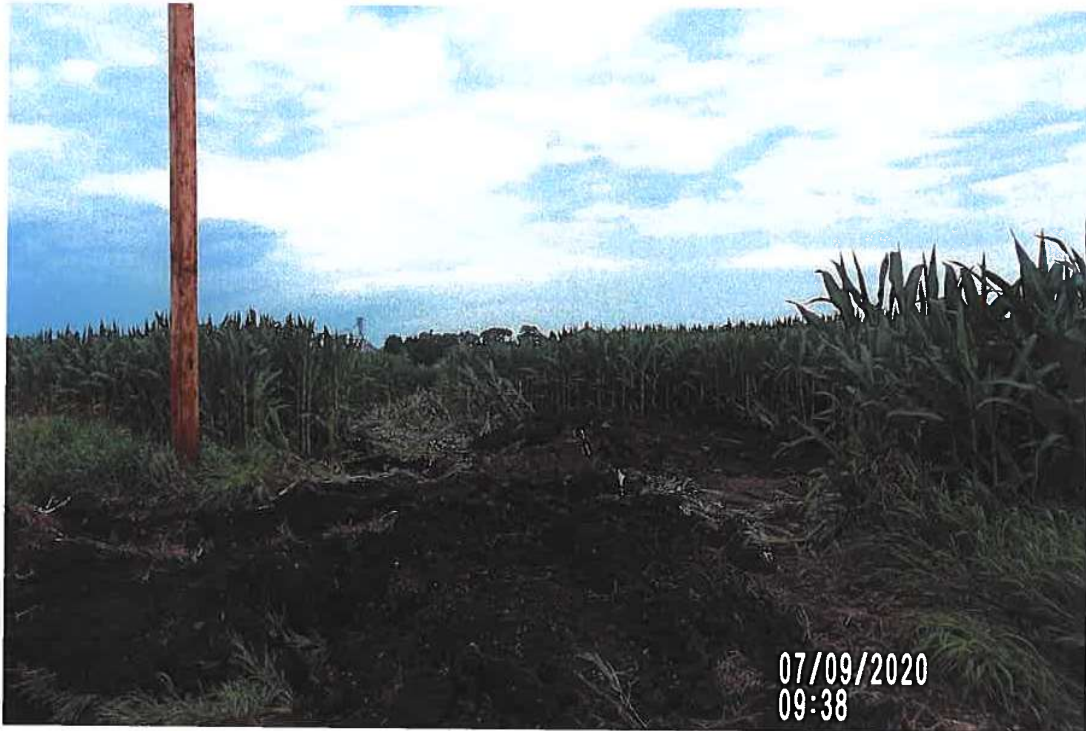
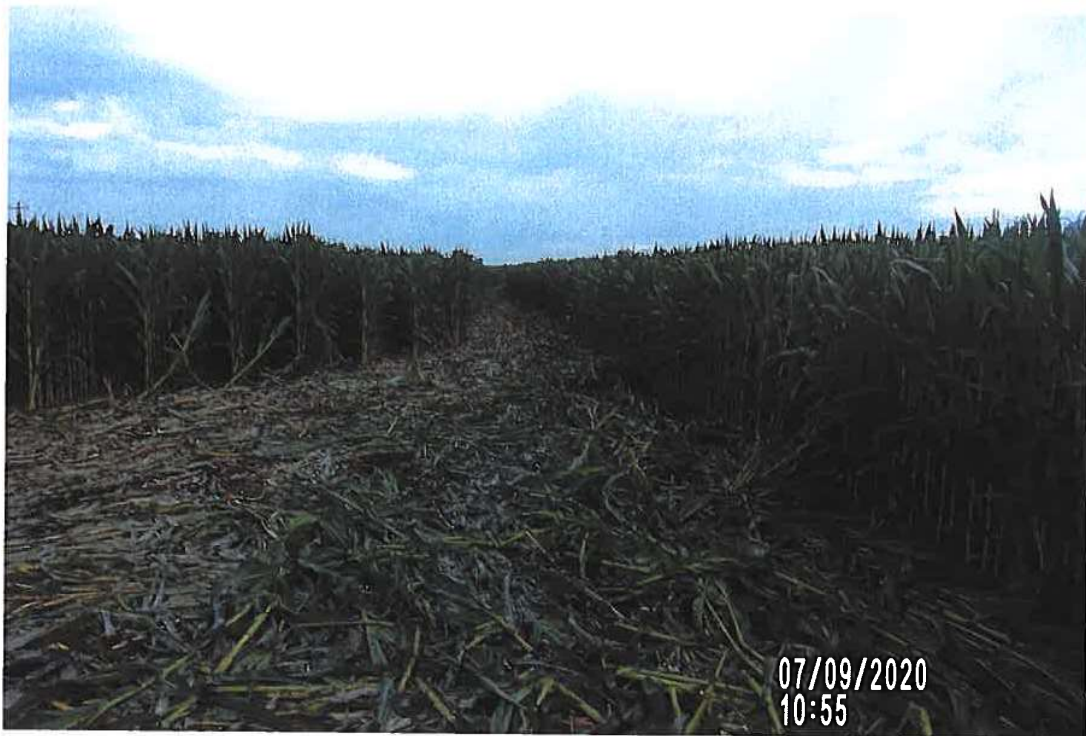
PICTURE# 4093 IS LOOKING WEST SHOWING CORN DAMAGE /
TO TILE REPAIR - LOOKING TOWARDS 20825th CO HWY 527
GRAVEL DRIVE OFF CO HWY D41.

PICTURE # 4094 IS LOOKING SE TOWARDS CONWY041
 @ CORN DAMAGE / TO TILE REPAIR
