AGENDA
REGULAR DRAINAGE MEETING
Wednesday, October 14, 2020 9:30 AM
Large Conference Room

PAY ESTIMATE NO. 6
REPAIRS TO MAIN TILE AND LATERAL 3 DD#25 & REPAIRS TO MAIN TILE DD#1, HARDIN CO.
PROJECT NUMBER: 6501
DATE: 10-5-20

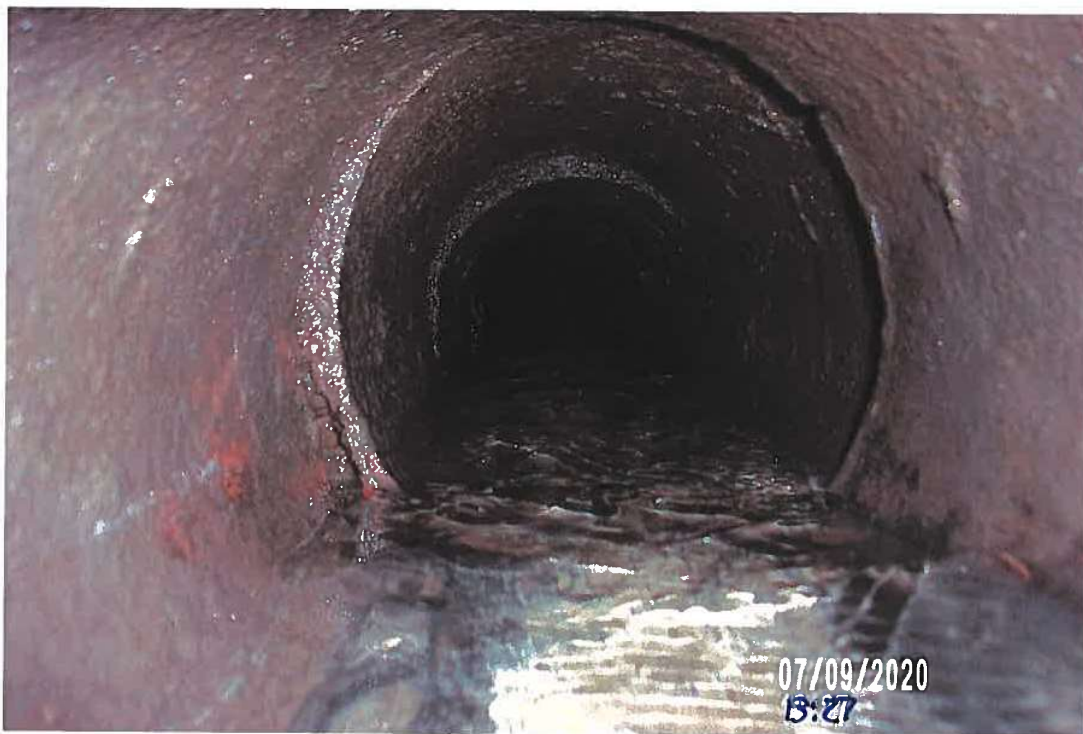
PICTURE #4103 IS LOOKING UPSTREAM INSIDE 8" CLAY TILE
 WITH ABOUT 1" FLOW AT GPS #302 (TOP 8" CLAY TILE) (0.72' TOP
 TO FL)

PICTURE #4104 IS LOOKING NW SHOWING 2.0'X2.0' ENGINEERING FABRIC & 1.5'X20' 6"X6" SQUARE WIRE MESH OVER JOINT FOR 8" CLAY TILE SECTION ROLLED BACK INTO PLACE BEFORE $\frac{3}{4}$ CONCRETE COLLAR POURED.

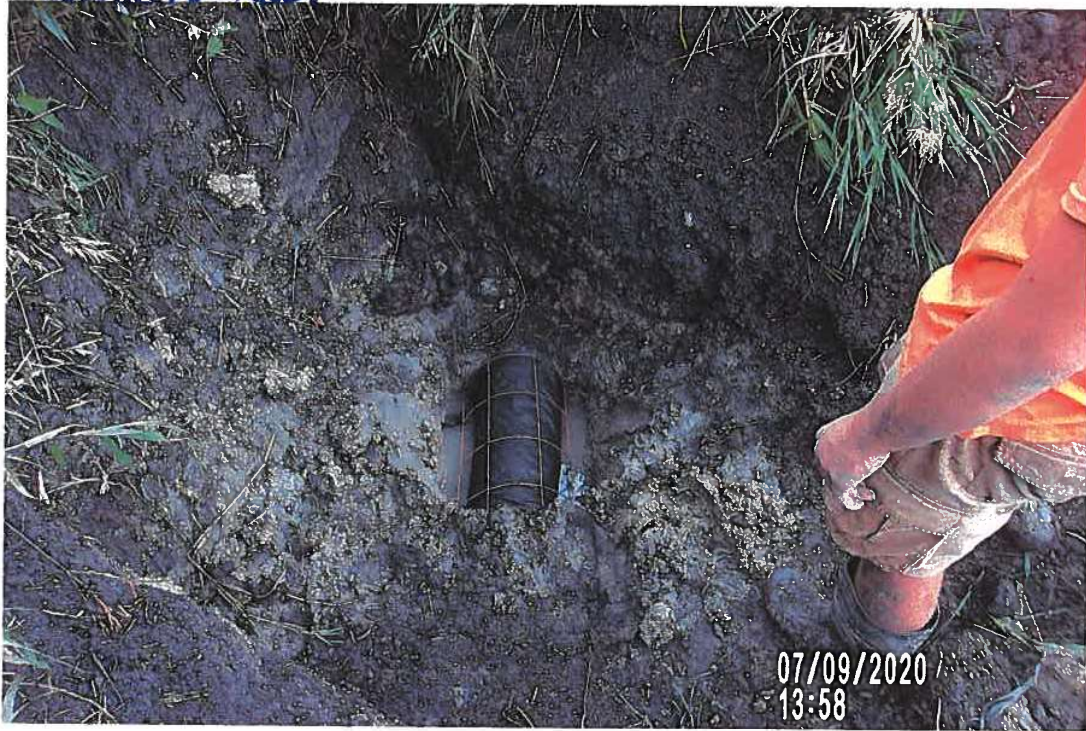
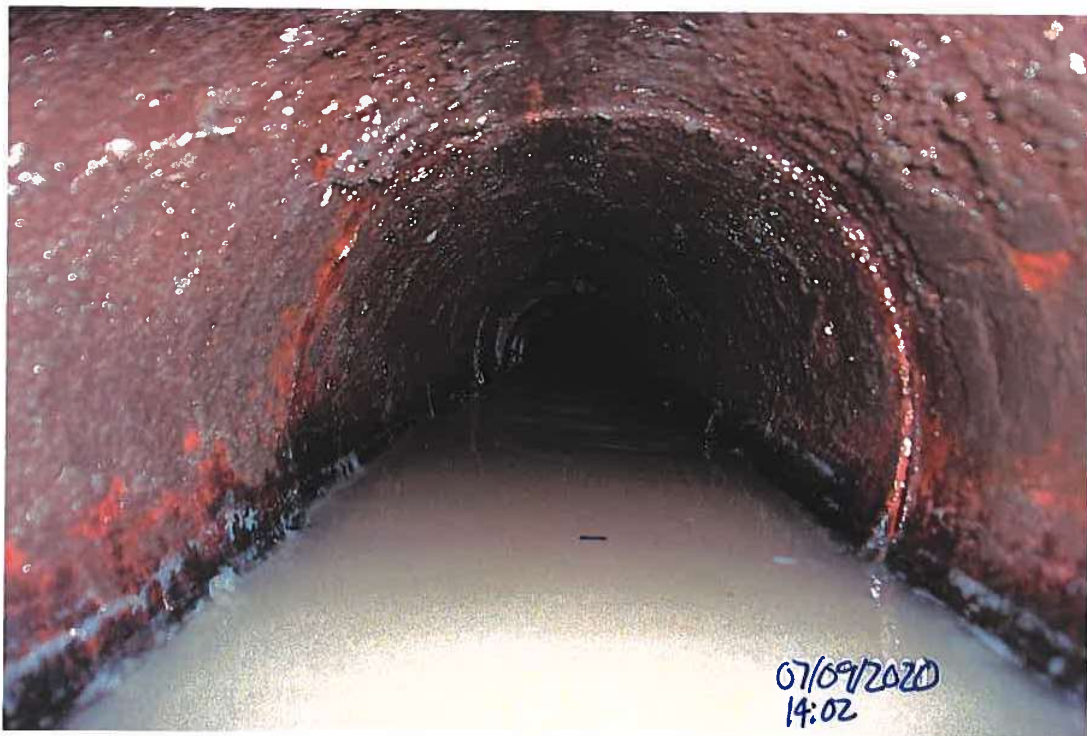
PICTURE #4105 IS LOOKING DOWN STREAM INSIDE 8" CLAY TILE WITH ABOUT 2"± OF SLOW WATER FLOW.

PICTURE # 4106 IS LOOKING NORTH SHOWING $\frac{3}{4}$ " CONCRETE COLLAR POURED FOR 8" CLAY TILE SECTION ROLLED BACK INTO PLACE 9'5" WEST OF BEHIND ENTRANCE. CREW USED 5-60LB BAGS OF QUIKRETE HIGH STRENGTH / GSH255

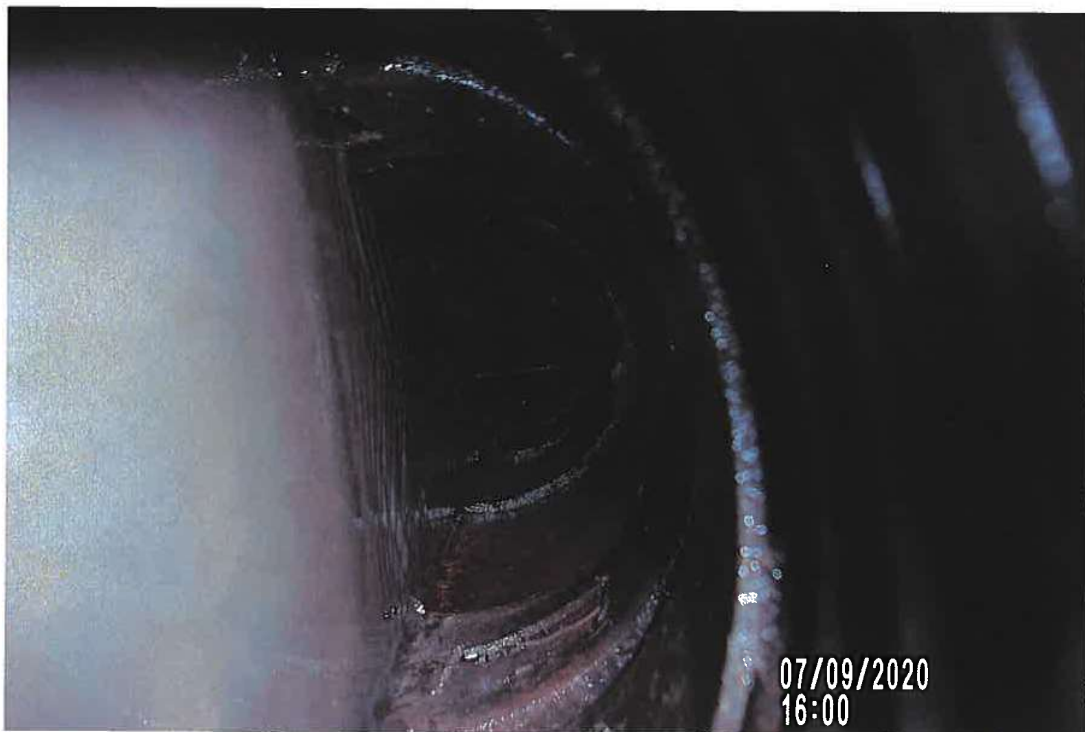
PICTURE # 4117 IS LOOKING DOWNSTREAM (FROM GPS #311) INSIDE 8" TILE SHOWING CHANGE OF MATERIAL. TILE LOOKS GOOD SHAPE WITH WATER LEVEL AT 4" (SLOW FLOW). ALSO FLOWLINE HAS SOFT MUCK BUT SHOULD FLUSH OUT NOW TILE OPEN.

PICTURE # 4119 IS LOOKING UPSTREAM (FROM GPS #311) INSIDE 8" TILE
 SHOWING TILE IN GOOD SHAPE BUT CHANGED TO CLAY WITH
 WATER LEVEL AT 4" (SLOW FLOW). ALSO FLOWLINE HAS SOFT MUCK
 BUT SHOULD FLUSH OUT NOW THAT IT IS
 OPEN,

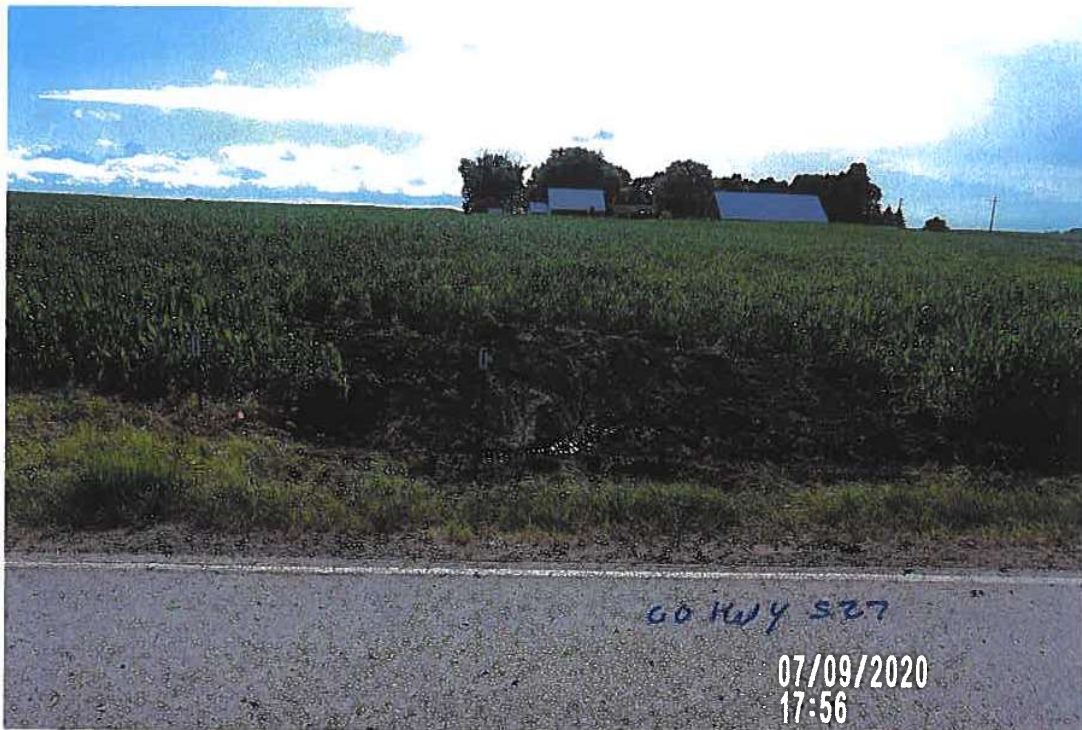
PICTURE#4126 IS LOOKING WEST FROM COMWY S27 ABOUT 330'± SOUTH E COMWY D41 SHOWING 4" HDPE SUPER TILE REPAIR BACK FILLED & GRADED. ALSO SHOWS 0.043 AC CORN DAMAGE (GPS# 320 - #324) DURING REPAIR.

PICTURE# 4127 IS LOOKING EAST SOUTH OF SOUTH
ROW OF COMWY D41 SHOWING 5" HDPE PERF TILE
THE INS BEDDED WITH ROCK TO TOP OF TILE

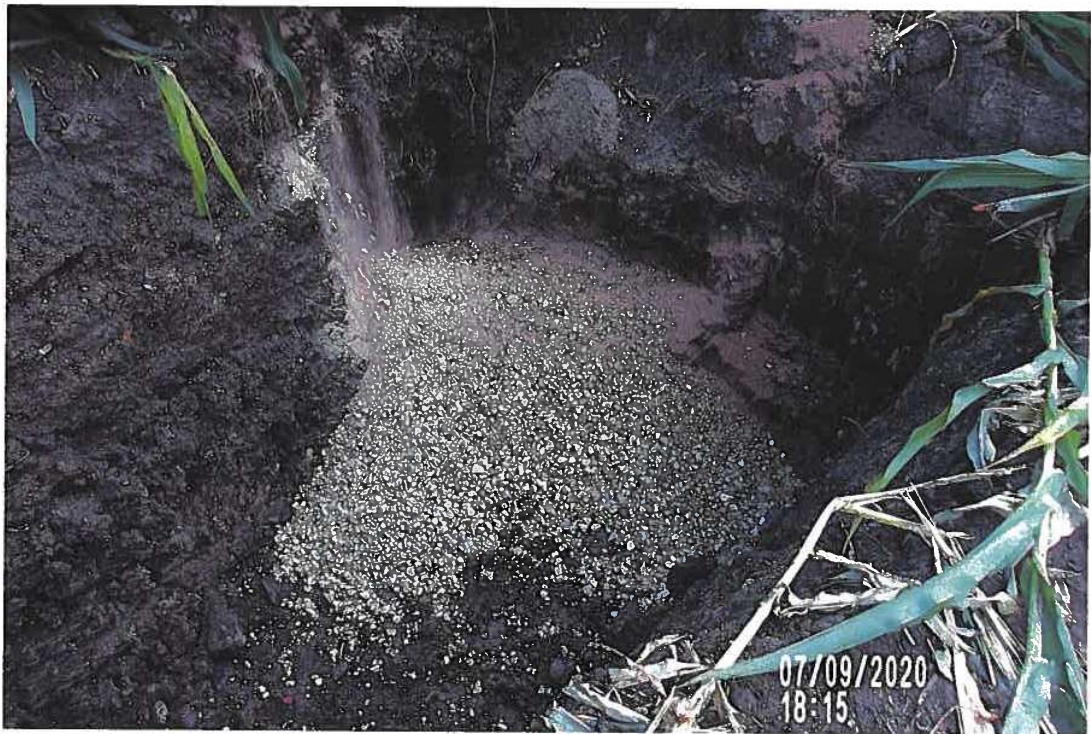
PICTURE# 4128 IS LOOKING NW SHOWING NORTH 14" CLAY TILE EXPOSED TRENCH WITH TILE BEDDED WITH ROCK TO TOP OF TILE

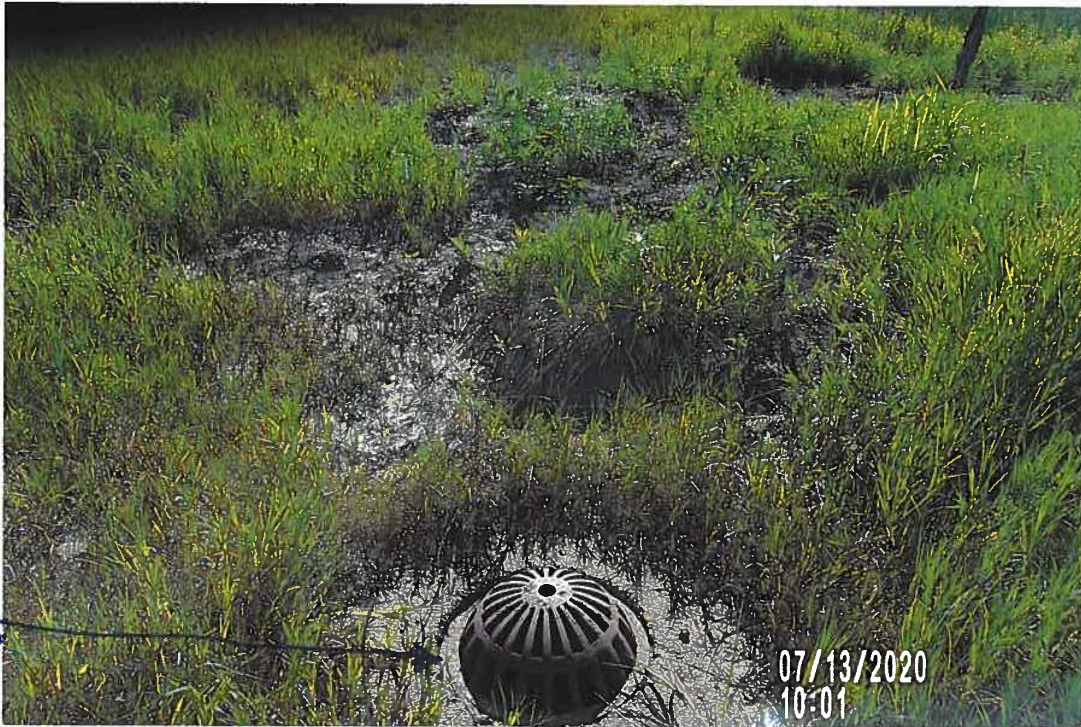
PICTURE# 4138 IS LOOKING EAST SHOWING SMALL
SINKHOLE ON EAST SIDE OF BEEHIVE INTAKE PER RANDY'S REPORT
AREA LOOKED LIKE IT HAD BEEN EXCAVATED AT ONE TIME

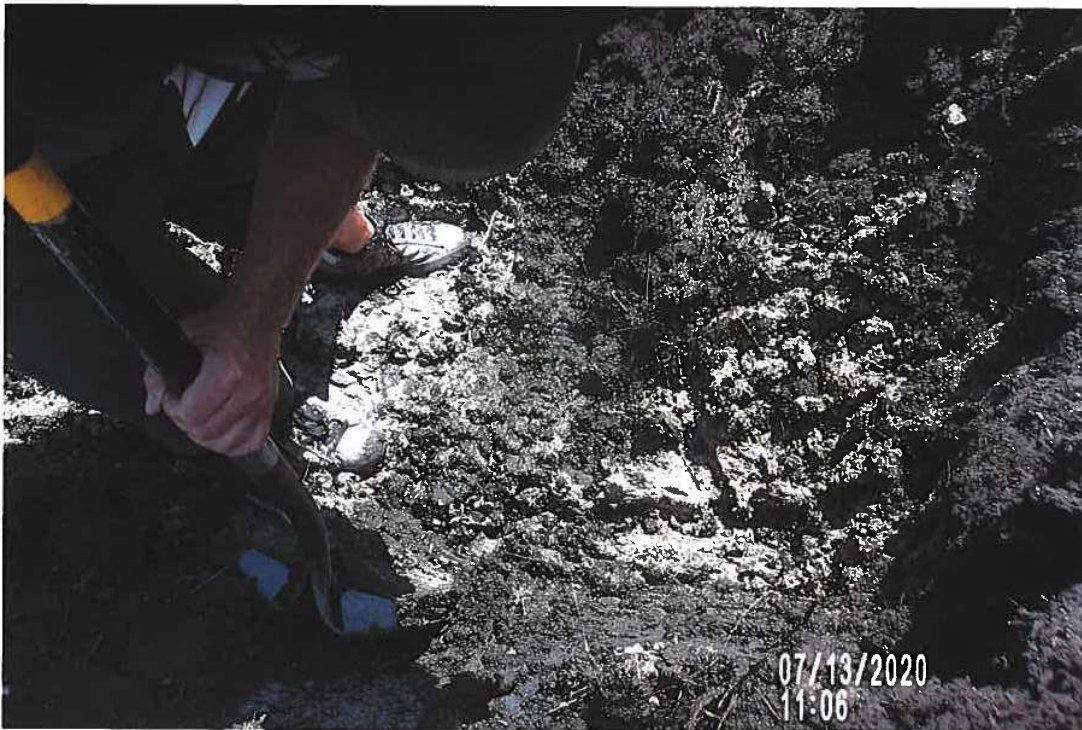
PICTURE# 4141 IS LOOKING EAST ON EAST SIDE OF
 BEEHIVE INTAKE SHOWING 6" HDPE PERF TILE CONNECTION
 TO 6" CLAY TILE OUTLET EAST FROM BEEHIVE INTAKE,

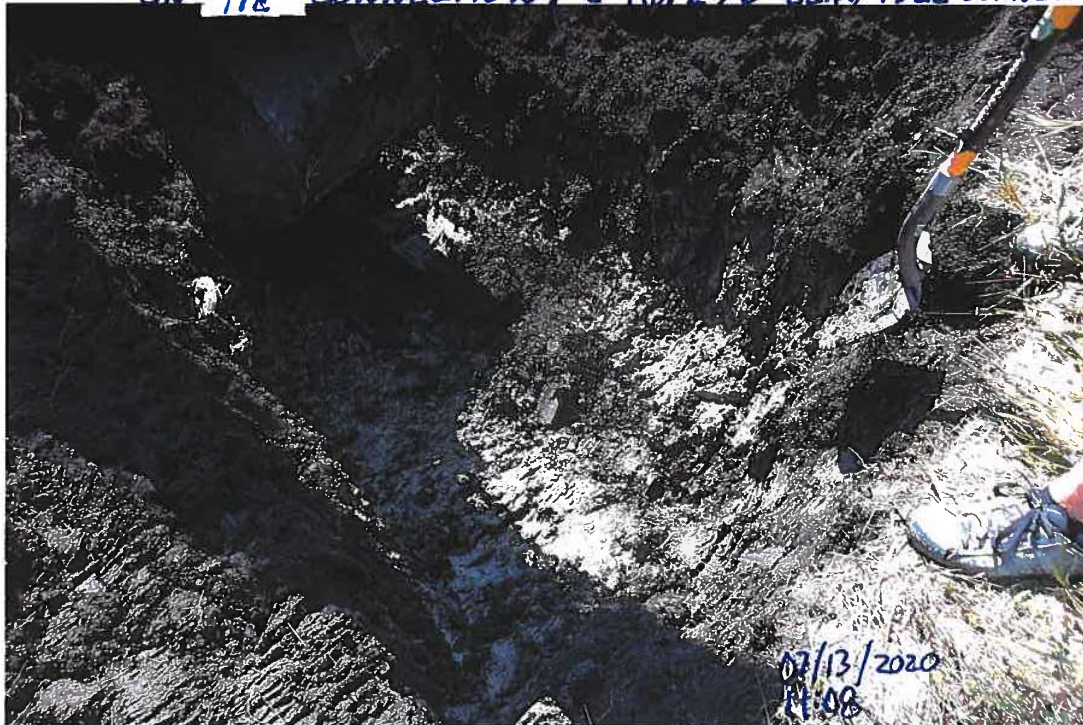
PICTURE# 4142 IS LOOKING SE SHOWING 6" HDPE PERF
TILE CONNECTION TO 6" CLAY TILE EAST OF BEEHIVE
INTAKE. PICTURE SHOWS CREW EXCAVATING TO CHECK
ON TILE CONNECTION. 6" HDPE / 6" CLAY TILE CONNECTION CLAY
TILE
BROKE
& WILL
NEED
REPLACED.

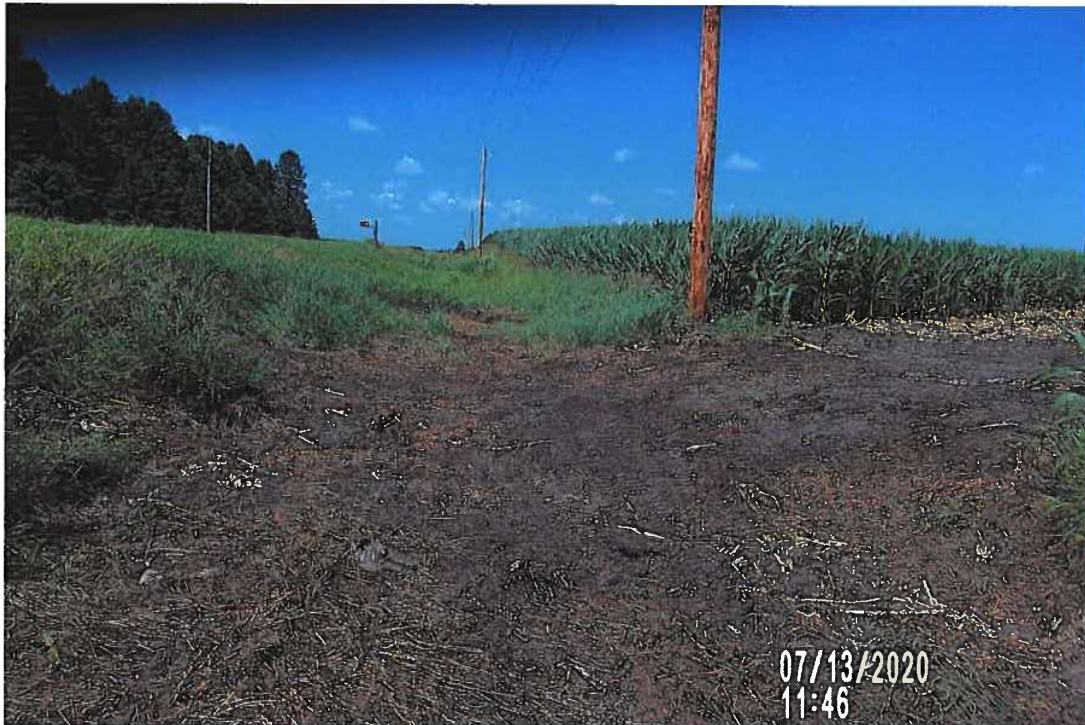
PICTURE #4147 IS LOOKING WEST SHOWING NORTH DITCH
GRADED ABOVE TRENCH

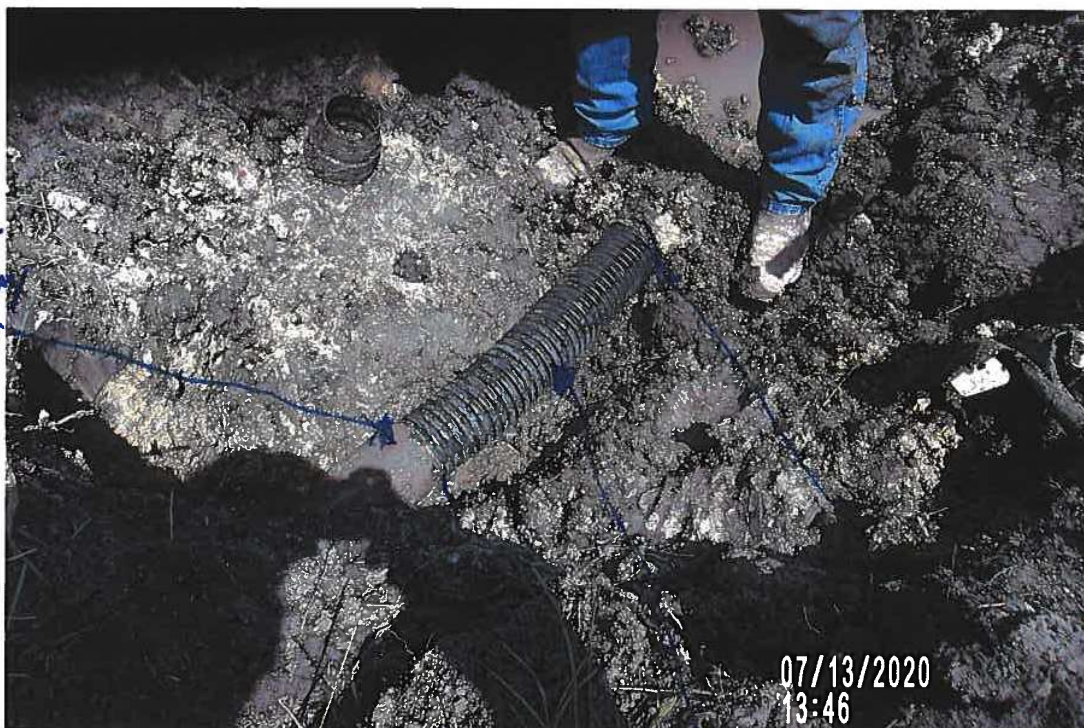
IS LOOKING NE SHOWING 6" HDPESM PERF TILE
SLIDE INTO TEE & TIED UPSTREAM INTO 6" CLAY TILE WITH
6" HDPE INTERNAL COUPLER.

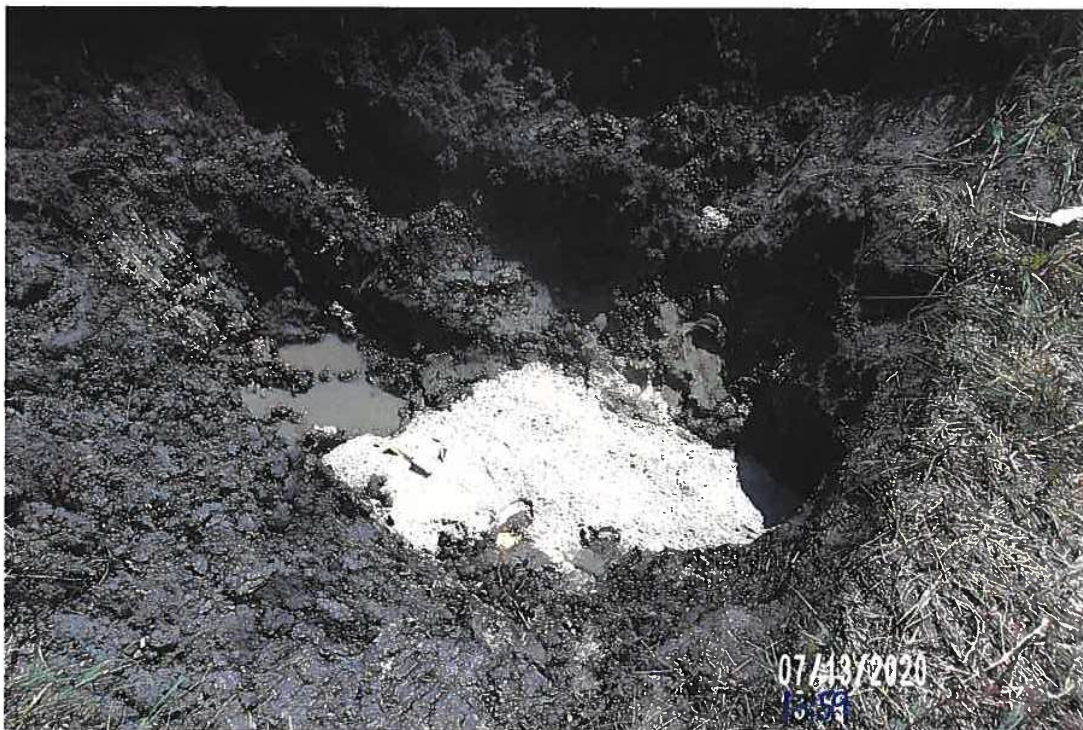
PICTURE# 4150 IS LOOKING SE SHOWING: $\frac{3}{4}$ CONCRETE COLLAR
POURED OVER BEEHIVE OUTLET TILE TIE IN CONNECTION.

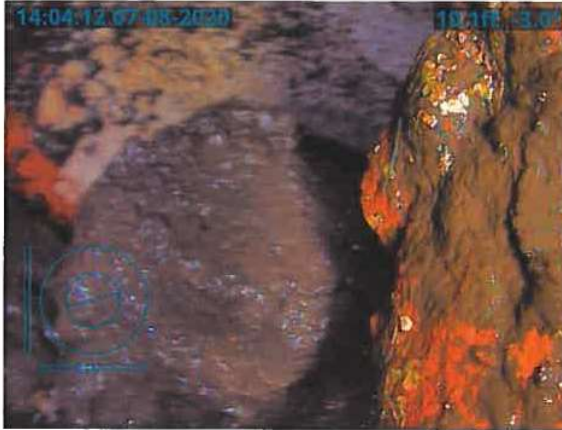
Video Ref	Dist (ft)	Cont Defect	Code	Photo Ref	Diameter/ Dimension	Clock		Intrusion		Remarks
						At	To	%	mm	
0:00:00	10.1		CN	2020_07_08-14_04_12_399.jpg
