Drainage Work Order Request For Repair

Hardin County

Work Order #: WO00000294

Investigation Summary:

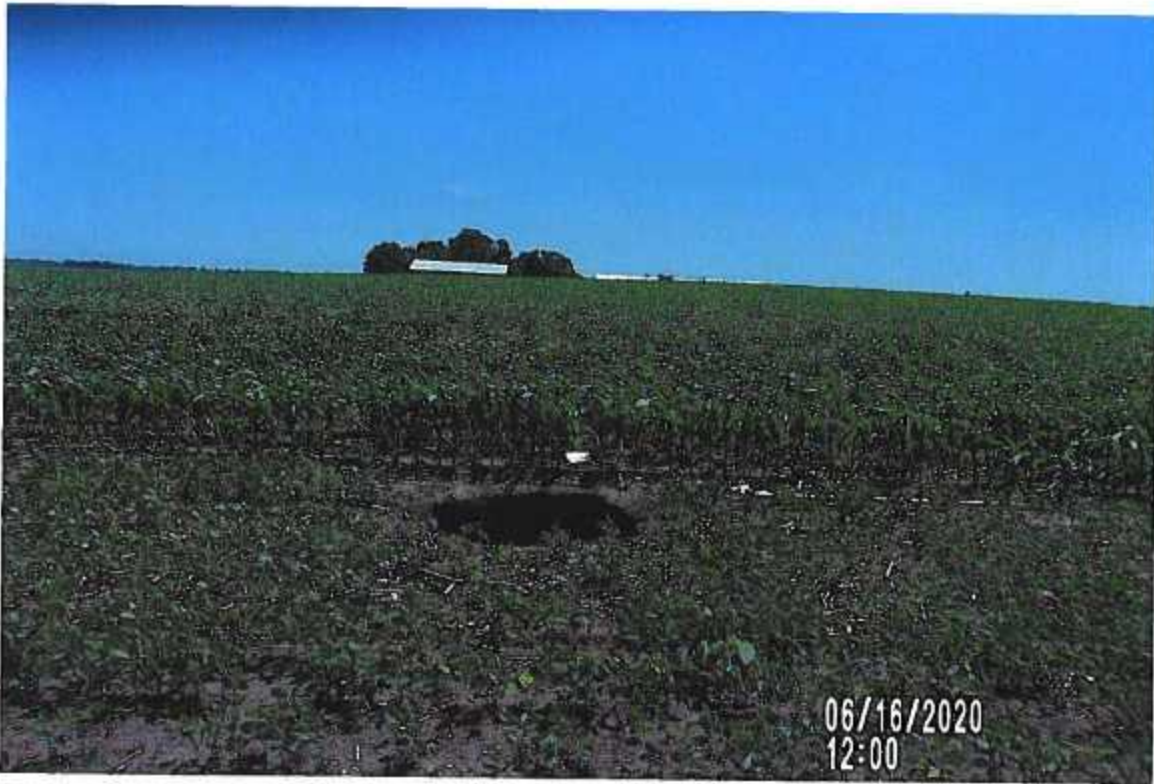
PICTURE#3774 IS LOOKING EAST TOWARDS ACREAGE @19131
G AVE - SHOWING 5.0' ϕ X 2.0' DEEP BLOWOUT IN BEAN
GROUND JUST WEST OF CROP CHANGE.

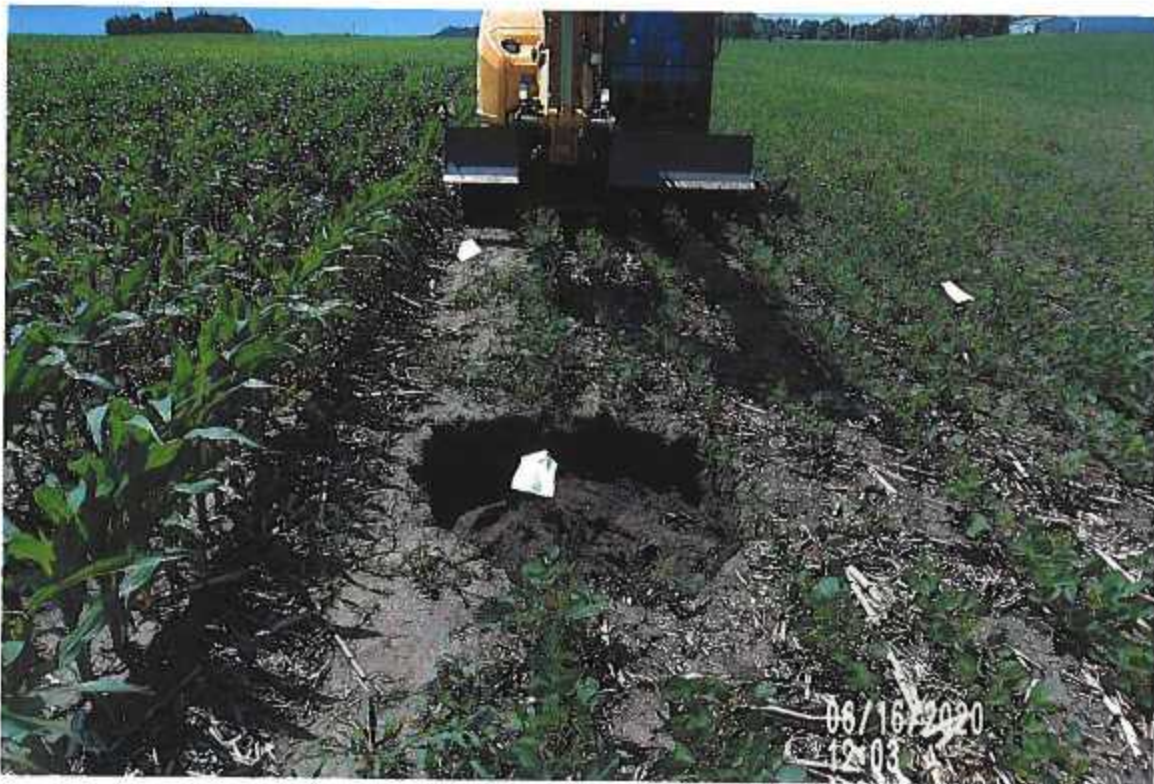
PICTURE#3775 IS LOOKING SOUTH TOWARDS 195TH STREET
AT 5.0' ϕ X 2.0' DEEP BLOWOUT IN BEAN GROUND
(WEST SIDE) OF CROP CHANGE

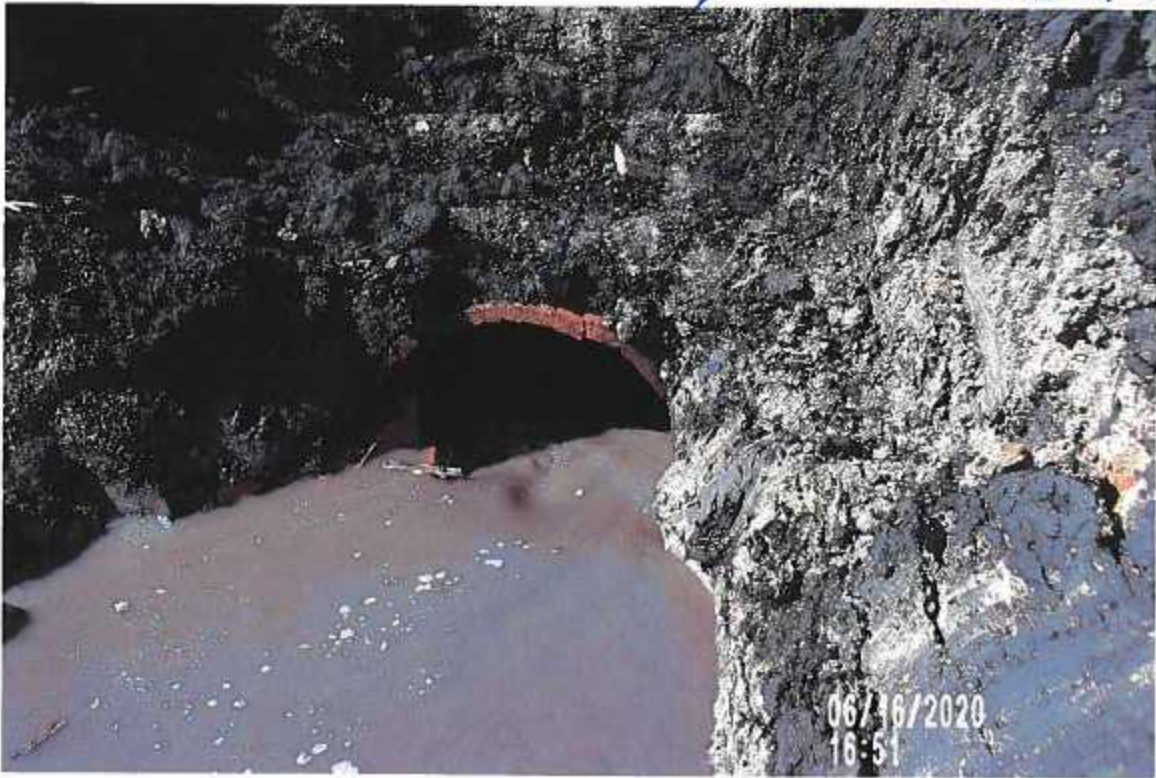
31.00' DOWN STREAM FROM GPS#
392

PICTURE# 3794 IS LOOKING NORTH @ 21" CLAY TILE SHOWING
TILE STILL CRACKED AND CAVING DOWN

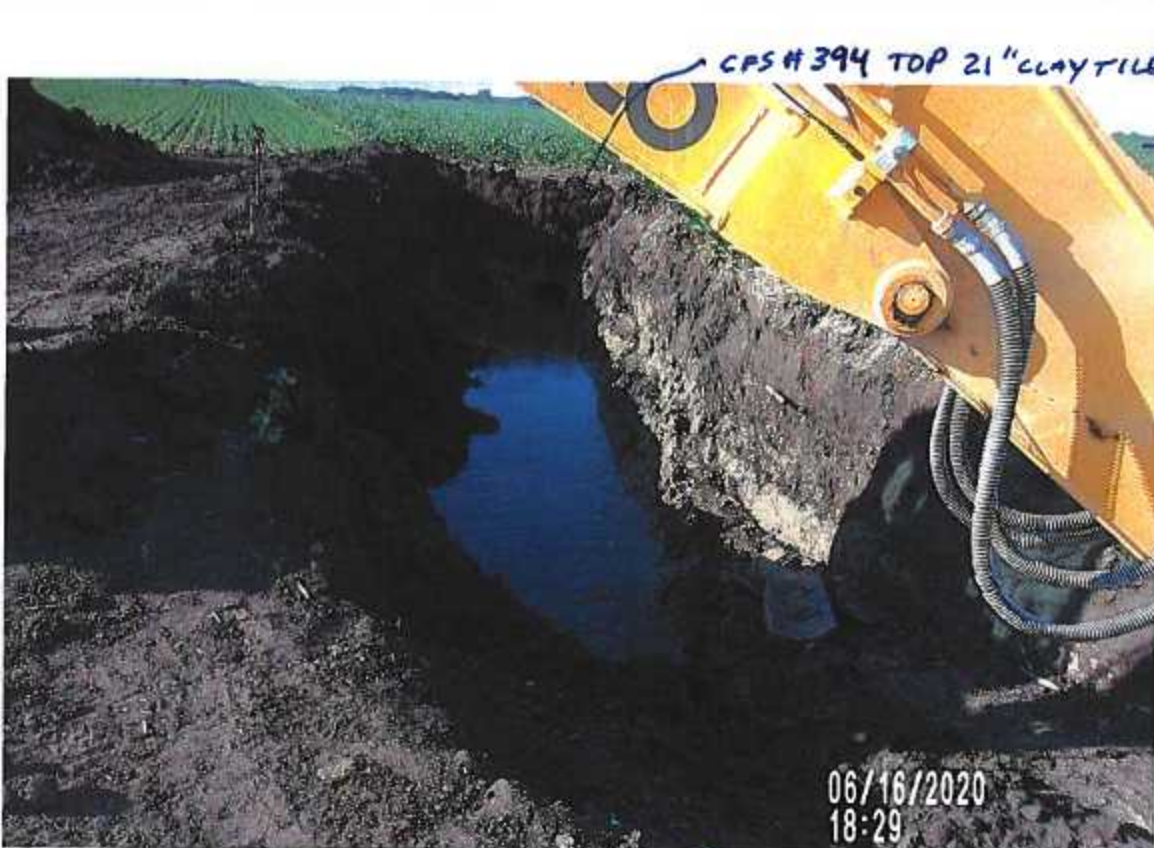
(41.8' DOWNSTREAM
FROM GPS # 392)

PICTURE # 3802 IS LOOKING NE FROM GPS # 394 SHOWING INSIDE OF 21" CLAY TILE WITH TOP CRACKED AND CAVING DOWN. APPEARS NEXT 3 JOINTS ARE IN SAME CONDITION BUT ARE CLOSE TO OUR 50' MAX REPAIR LIMIT. LEE WILL TALK TO SUPERVISORS IN MORNING ABOUT TELEVISIONING LINE.

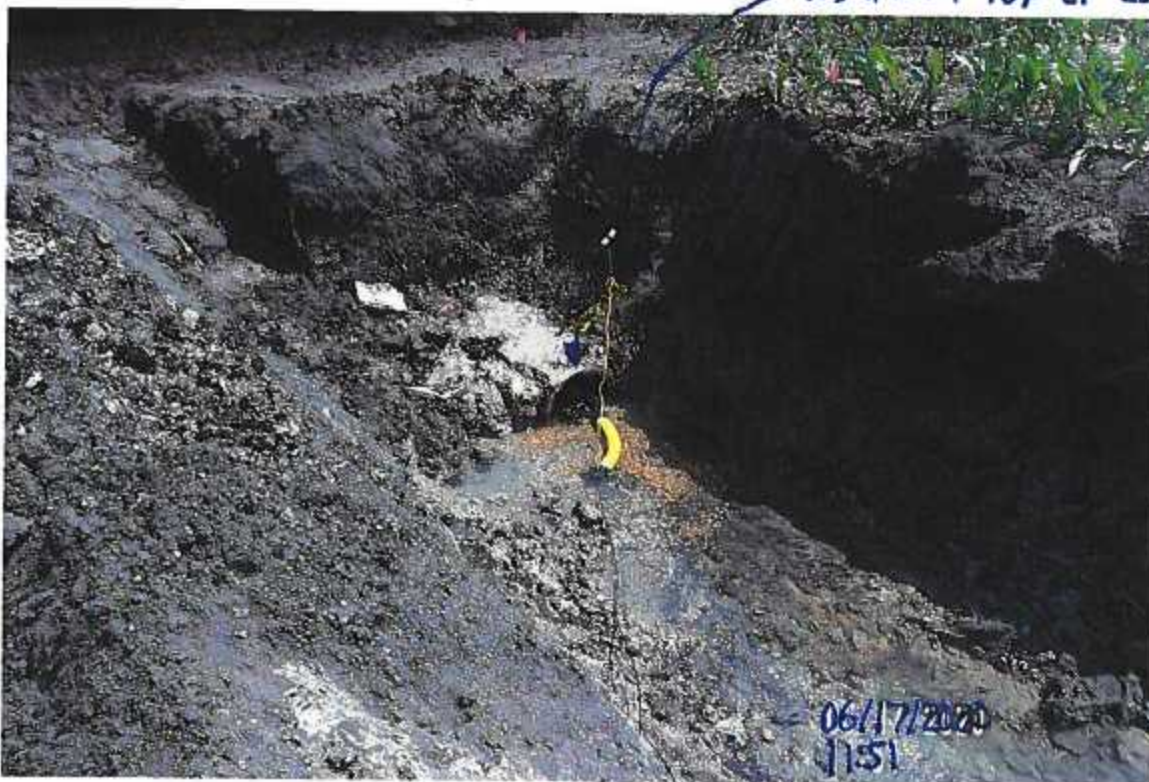
PICTURE# 3809 IS LOOKING NE SHOWING DOWN STREAM
 END OF EXPOSED TILE WHERE PAUL STARTED TELEVISIONING
 DOWN STREAM FROM WITH CAMERA IN TILE READY TO TELEVISION
 GPS # 394 TOP 21" CLAY TILE

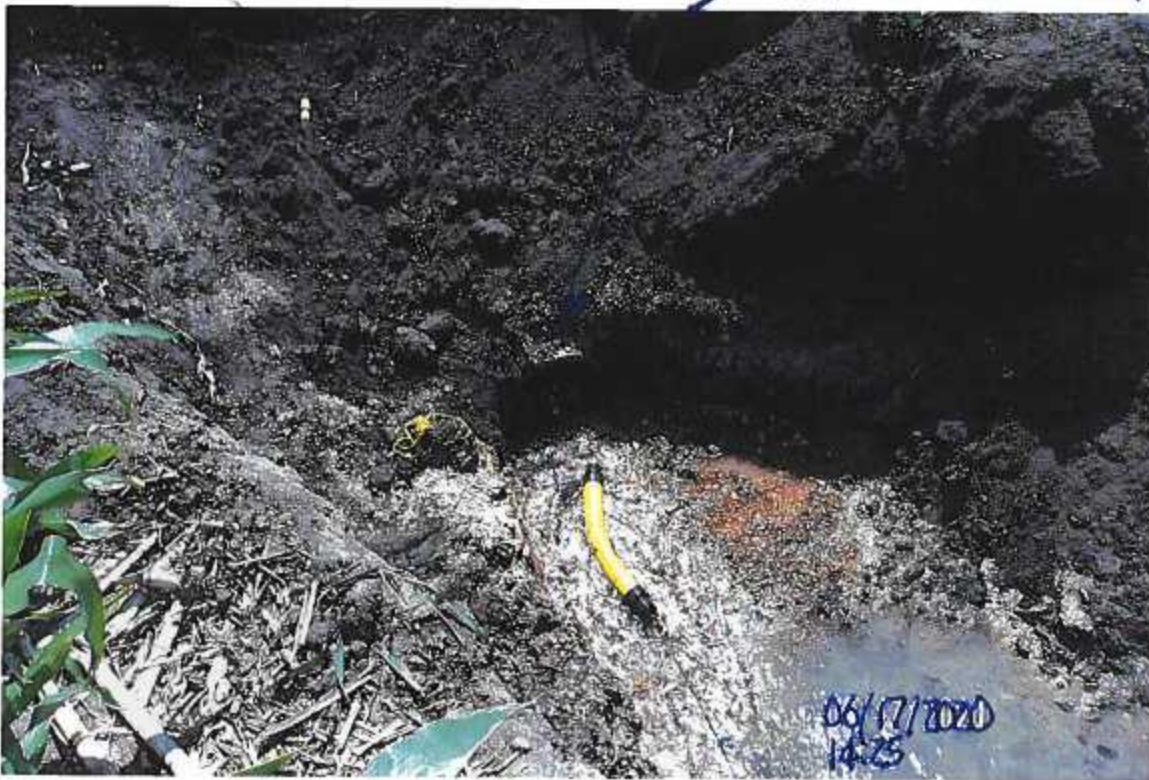
PICTURE #3811 IS LOOKING SW SHOWING CAMERA TRACTOR
IN UPSTREAM SIDE TILE OF BLOWOUT AND READY
TO START TELE VISING UPSTREAM,
GPS# 392 TOP 21" CLAY TILE (4.8' DEEP)

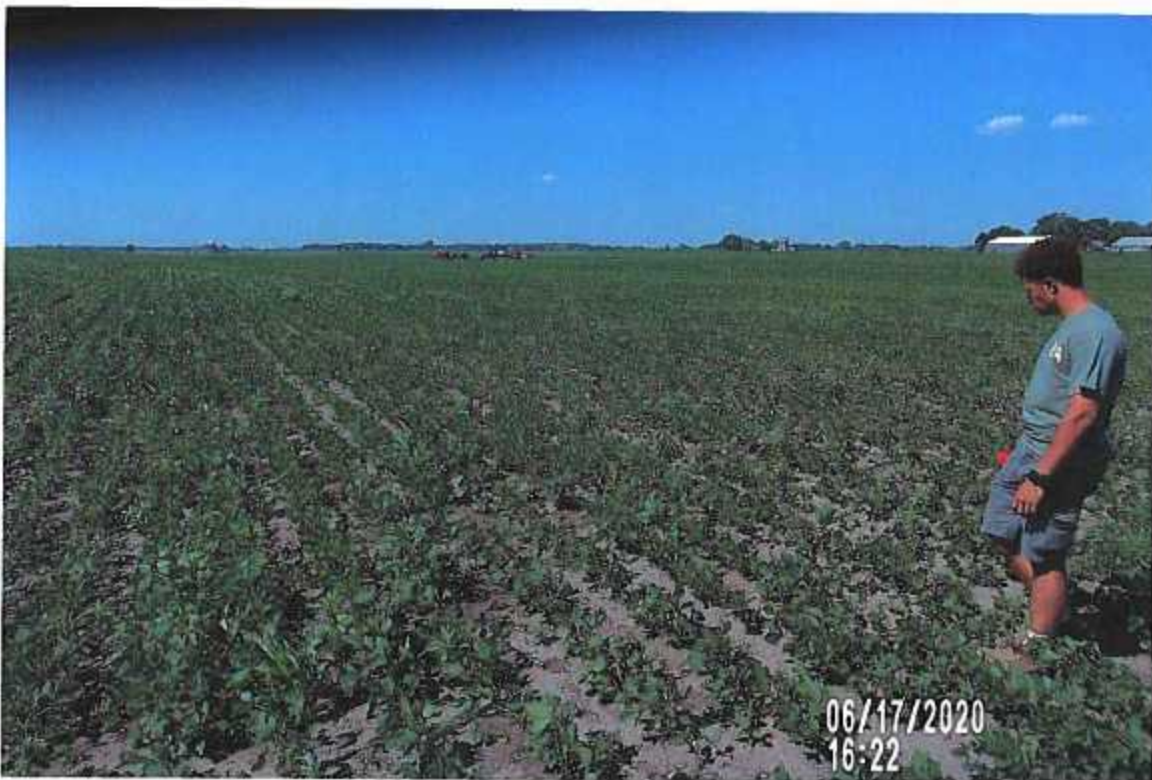
PICTURE #3812 IS LOOKING NE FROM END OF CABLE
TILE LOCATE GPS# 429 TOWARD TILE BLOWOUT START
OF LOCATES (976.0')

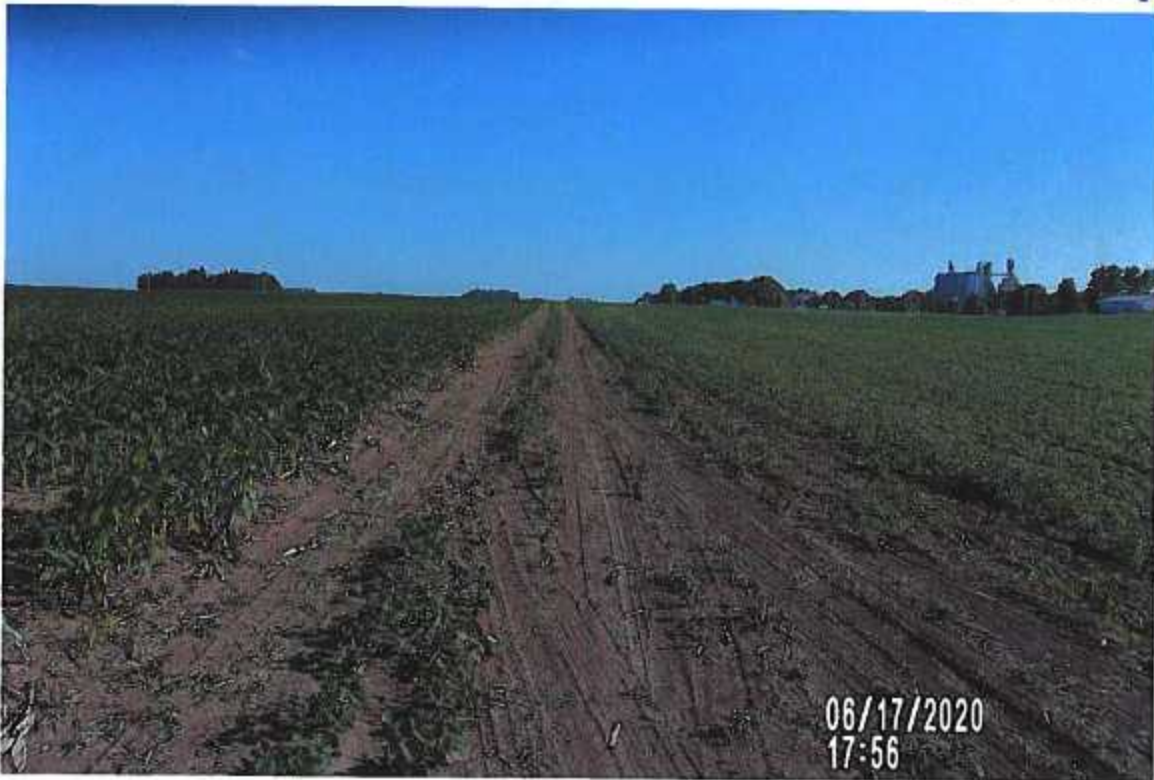
PICTURE#3815 IS LOOKING SOUTH AT BEAN & CORN DAMAGE
ON ACCESS LANE OUT TO TILE REPAIR

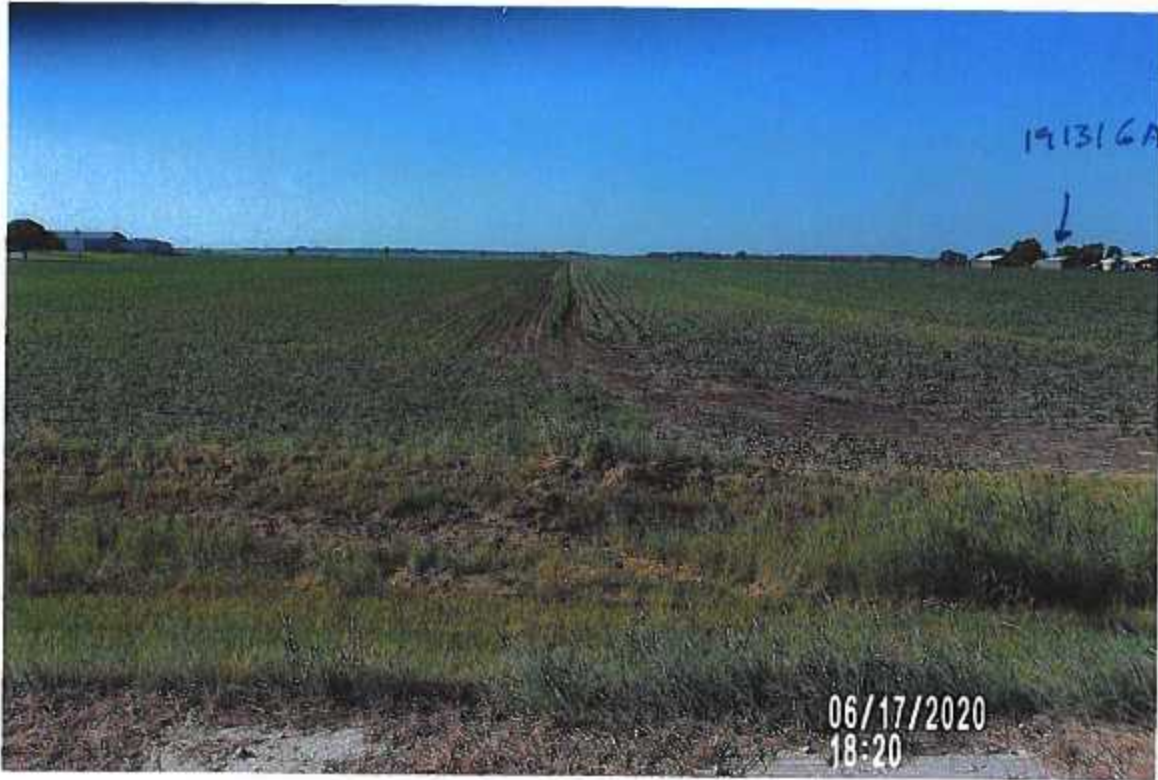
PICTURE # 3816 IS LOOKING NORTH FROM 195TH ST / PRAIRIE ST
(GRAVEL ROAD) @ CORN/BEAN DAMAGE ON ACCESS LANE OUT TO TILE
REPAIR.

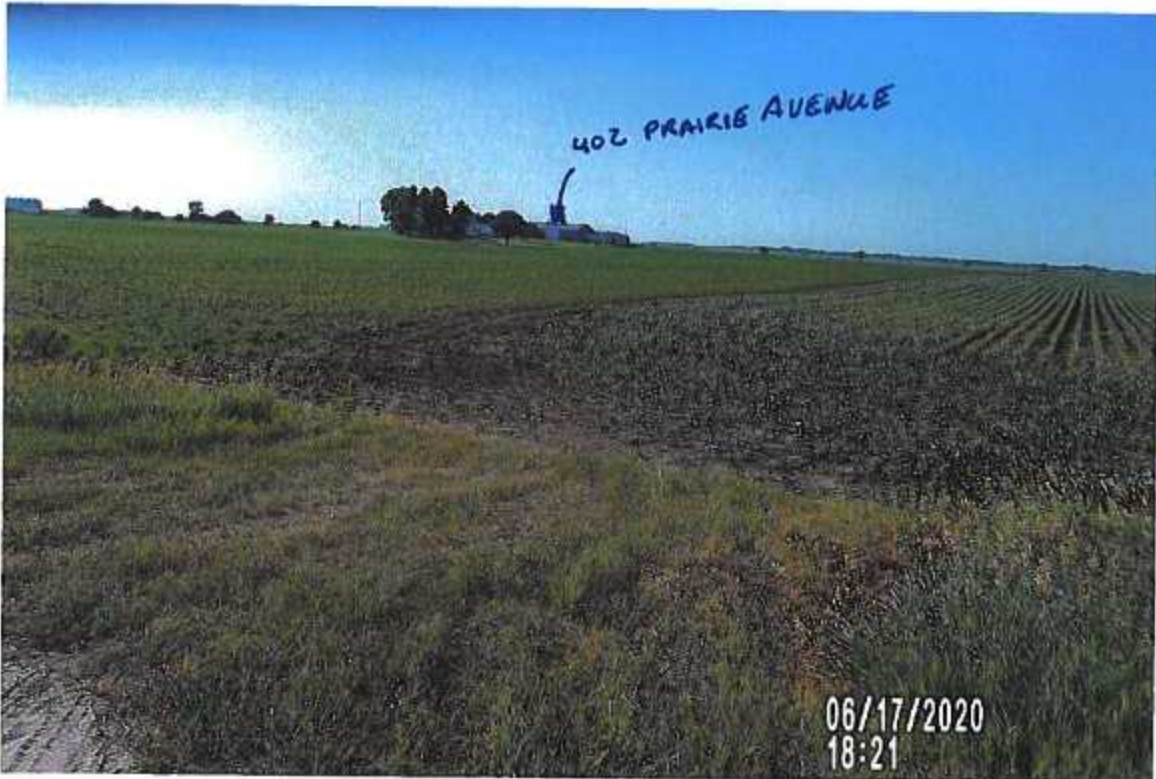
PICTURE 3817 IS LOOKING NW AT BEAN / CORN DAMAGE
FROM FIELD ENTRANCE ON NORTH SIDE 195TH ST / PRAIRIE ST
(GRAVEL ROAD) TO ACCESS LANE OUT TO TILE REPAIR.

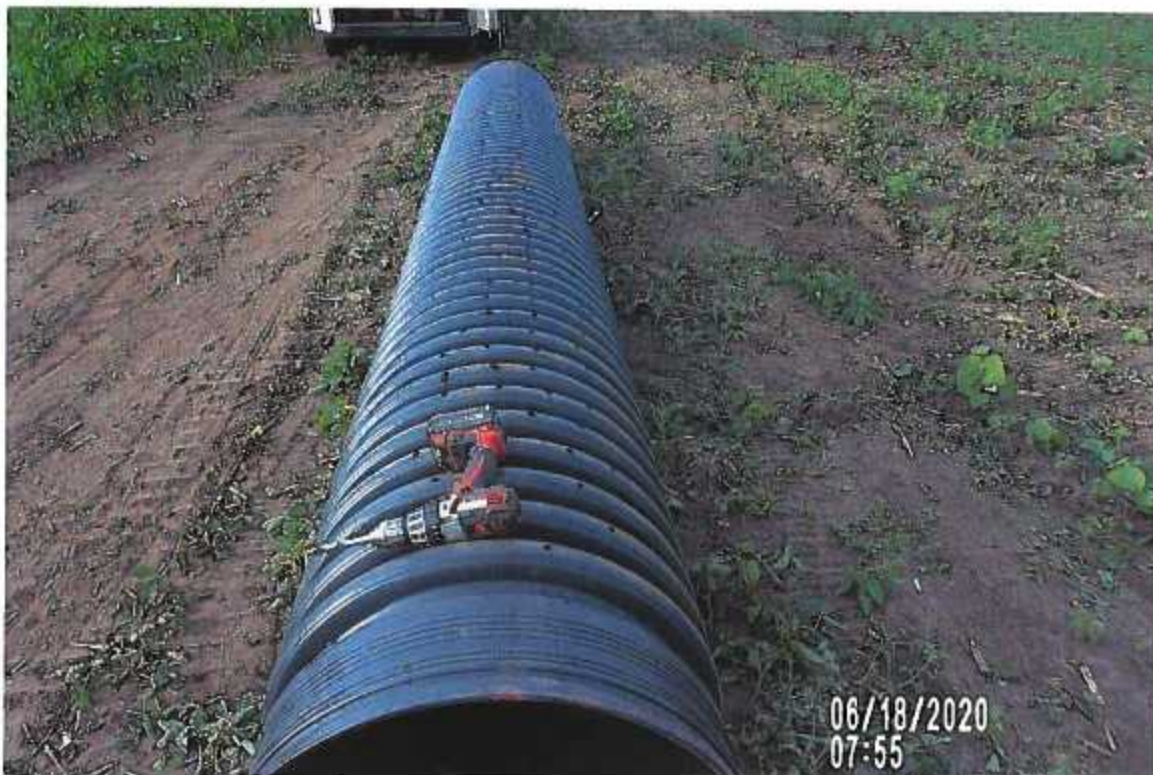
PICTURE# 3818 SHOWING CREW DRILL HOLES IN BOTTOM OF 24" DW HOPE NONPERF TILE BEFORE INSTALLED TO PREVENT TILE FROM FLOATING UP.

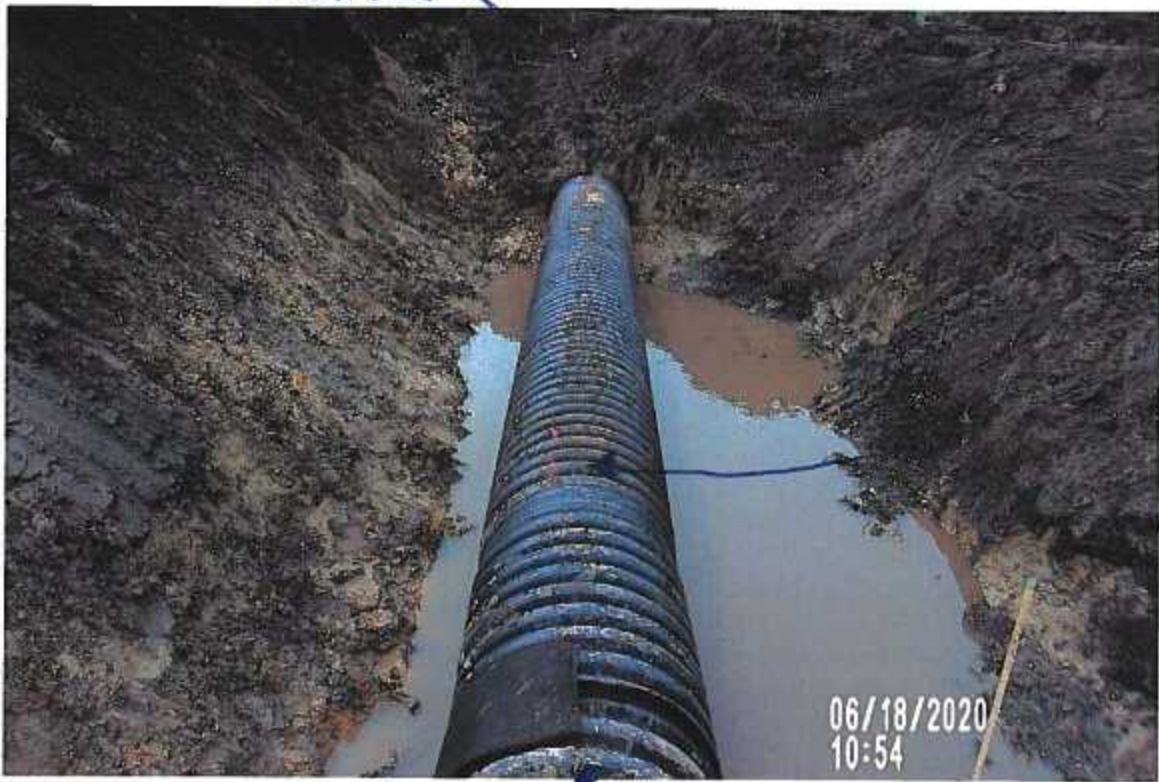
PICTURE # 3821 IS LOOKING SW AT FULL SECTION INSTALLED FROM
 DOWNSTREAM END (BELL END AT CLAY TILE TIE IN) WITH BELL END OF SMALL
 SECTION OF 24" DW HDPE NONPERF TILE INSTALLED ON SPIGOT END OF UPSTREAM SECTION
 & BUTT CONNECTION ON SPIGOT END FROM DOWNSTREAM FULL SECTION

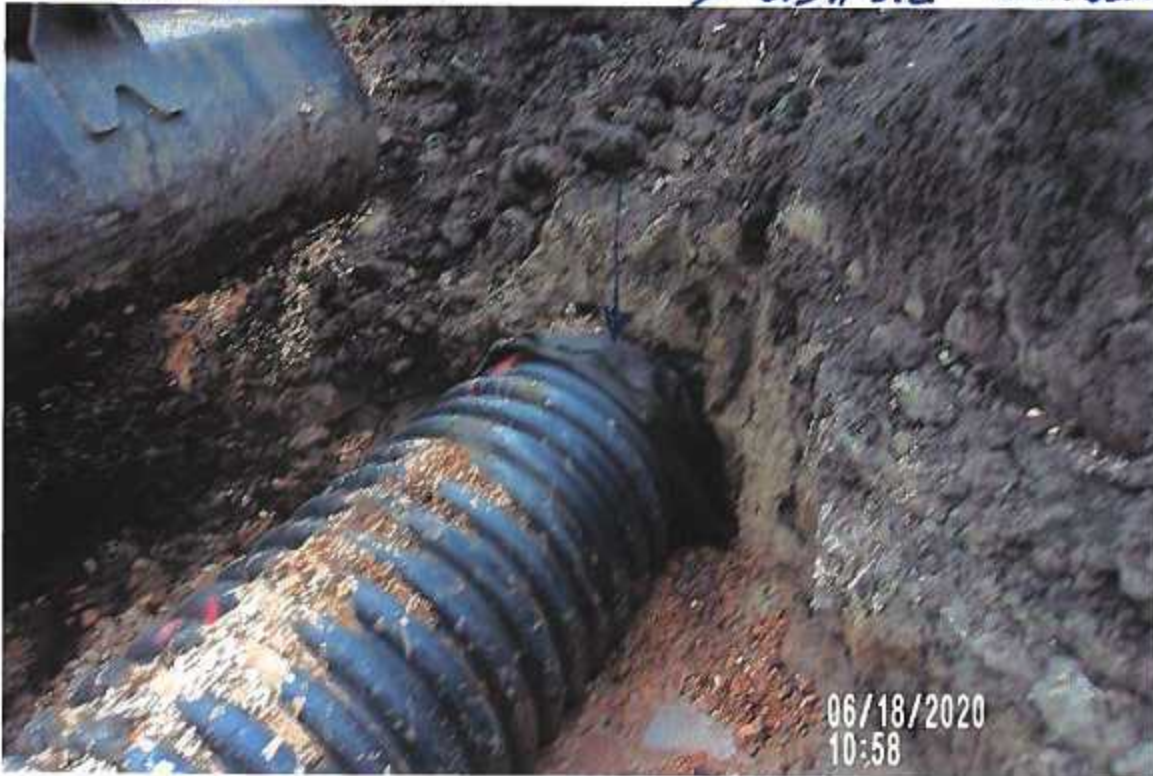
PICTURE #. 3822 IS LOOKING SE SHOWING BELL END OF 24" DW
HDPE NONPERF TILE AT UPSTREAM TIE IN CONNECTION
WITH FABRIC STUFF BETWEEN INSIDE BELL & OUTSIDE OF CLAY
GPS # 392 WITH BEDDING ROCK

TAMPED
IN UNDER
HDPE TILE
AND 2.0'
X 5.0' PLEGE
ENGINEERING
FABRIC OVER
JOINT
N
↓

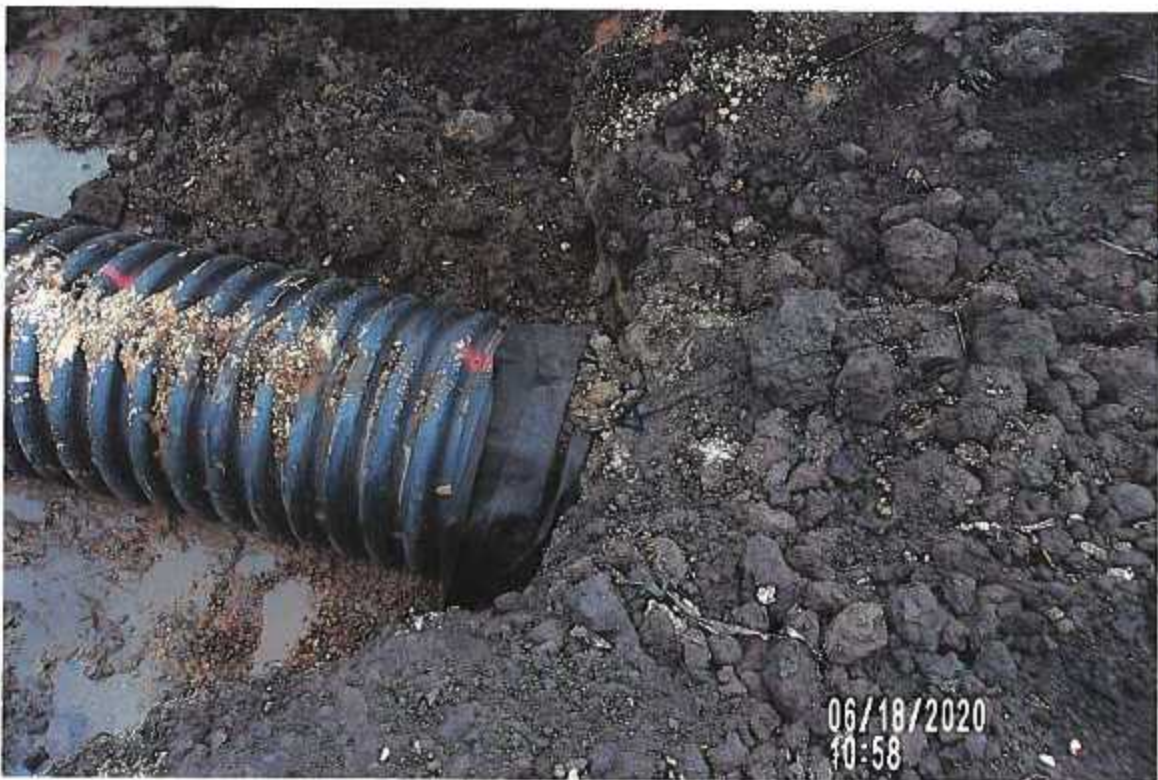
PICTURE # 3823 IS LOOKING EAST AT ENGINEER FABRIC STUFFED
IN JOINT & OVER JOINT. CREW STOMPED IN CLAY AROUND
HDPE EDGE BEFORE BACK FILLING SOIL IN TRENCH. BEDDING ROCK
TAMPED IN UNDER TILE TO KEEP IT IN PLACE;

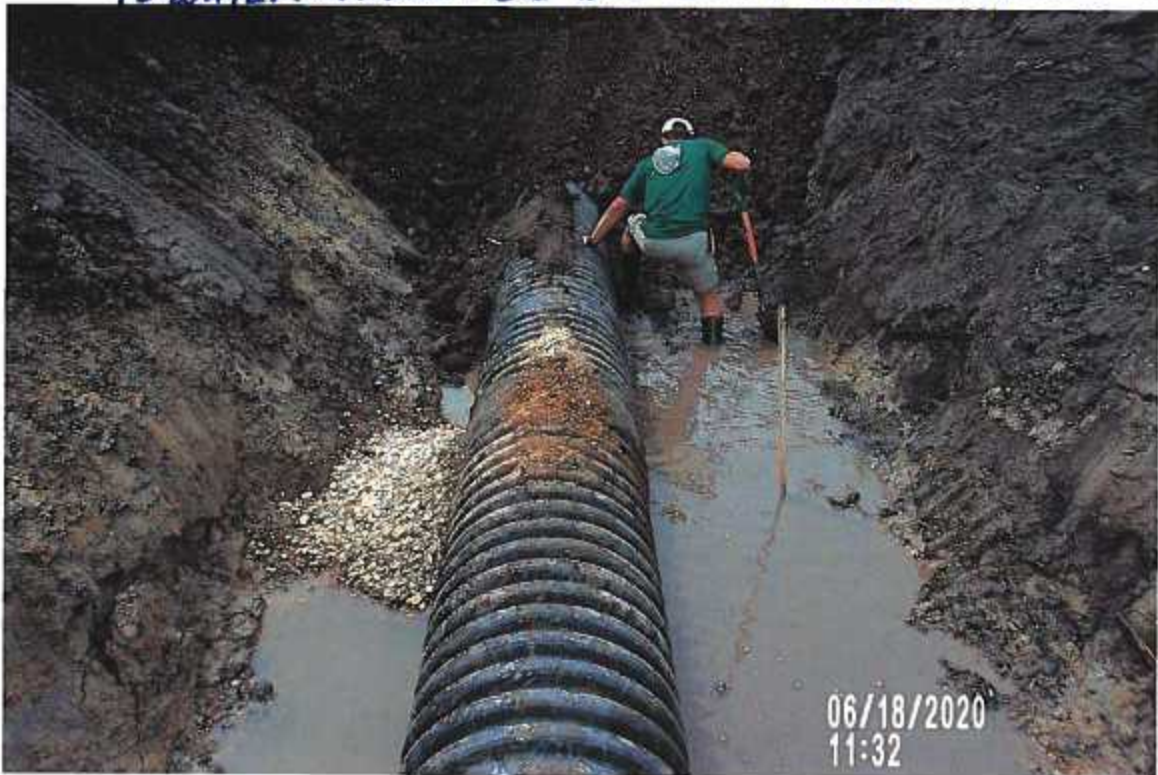
PICTURE# 3824 IS LOOKING SW SHOWING CREW BACKFILLING SOIL AROUND NEW TILE WITH CREW TAMPING IN SOIL AROUND HAUNCH OF TILE. SOIL IS GETTING LITTLE MULKY DUE TO WATER AROUND TILE BUT WITH FIRM BOTTOM UNDER TILE.

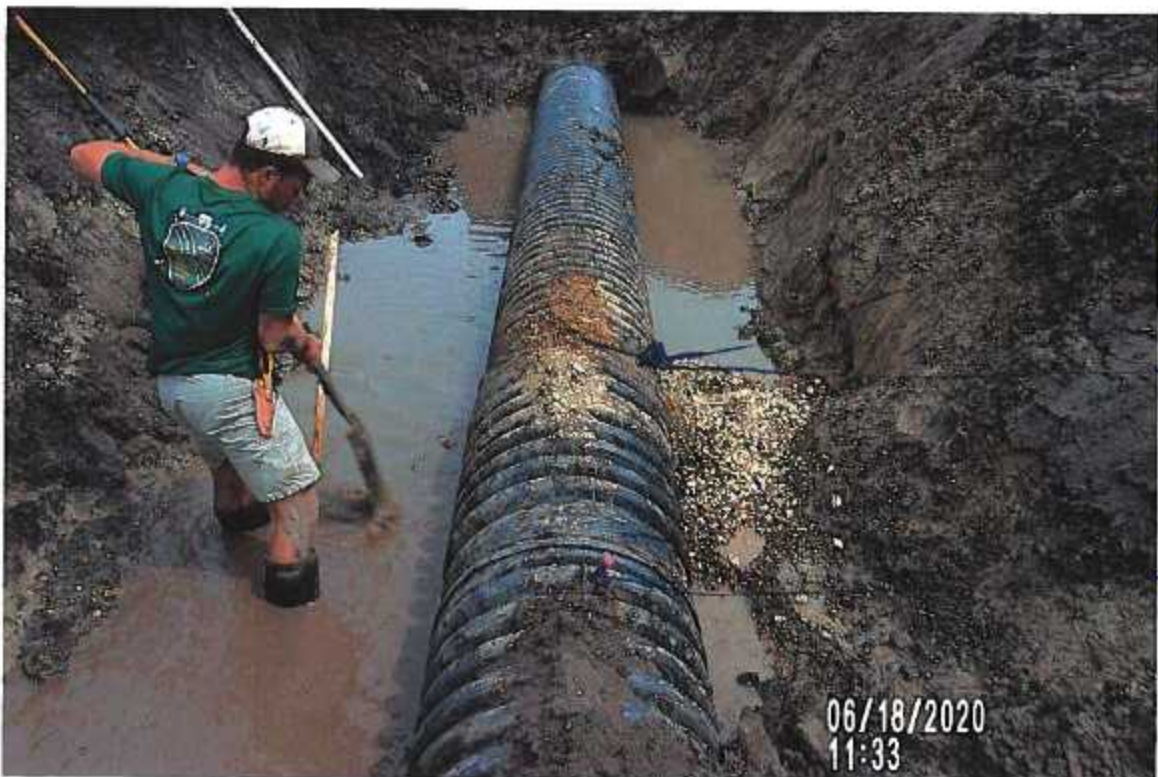
BUTT JOINT CONNECTION WRAPPED WITH FABRIC

PICTURE#3825 IS LOOKING NE SHOWING SMALL SECTION 24" DW HDPE NONPERF TILE WITH BELL-SPIGOT CONNECTION & SPIGOT BUTT CONNECTION ON DOWNSTREAM END WITH JOINT WRAPPED WITH FABRIC & BEDDING ROCK TAMPED UNDER CONNECTION

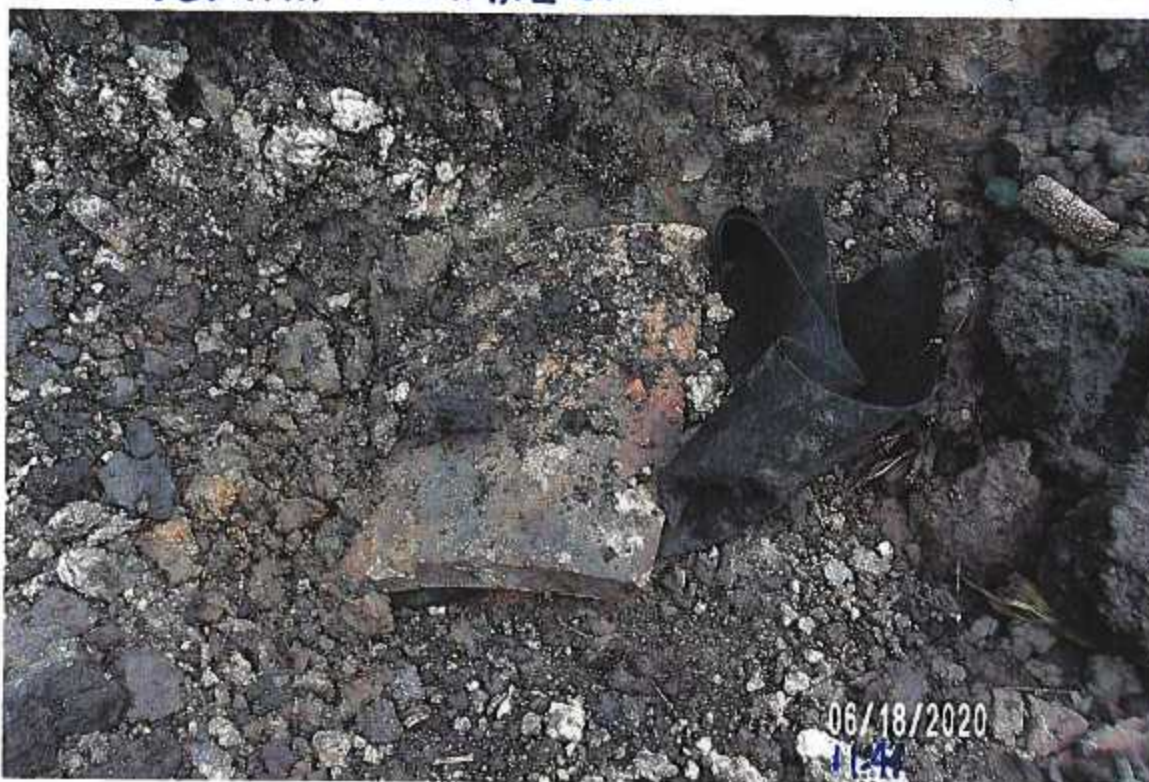
PICTURE # 3826 SHOWING A PIECE OF FABRIC WITH CLAY TILE PIECES OVER A EXPOSED TILE JOINT THAT IS WIDER THAN NORMAL JOINT FOR NEXT JOINT NORTH OF TIE IN

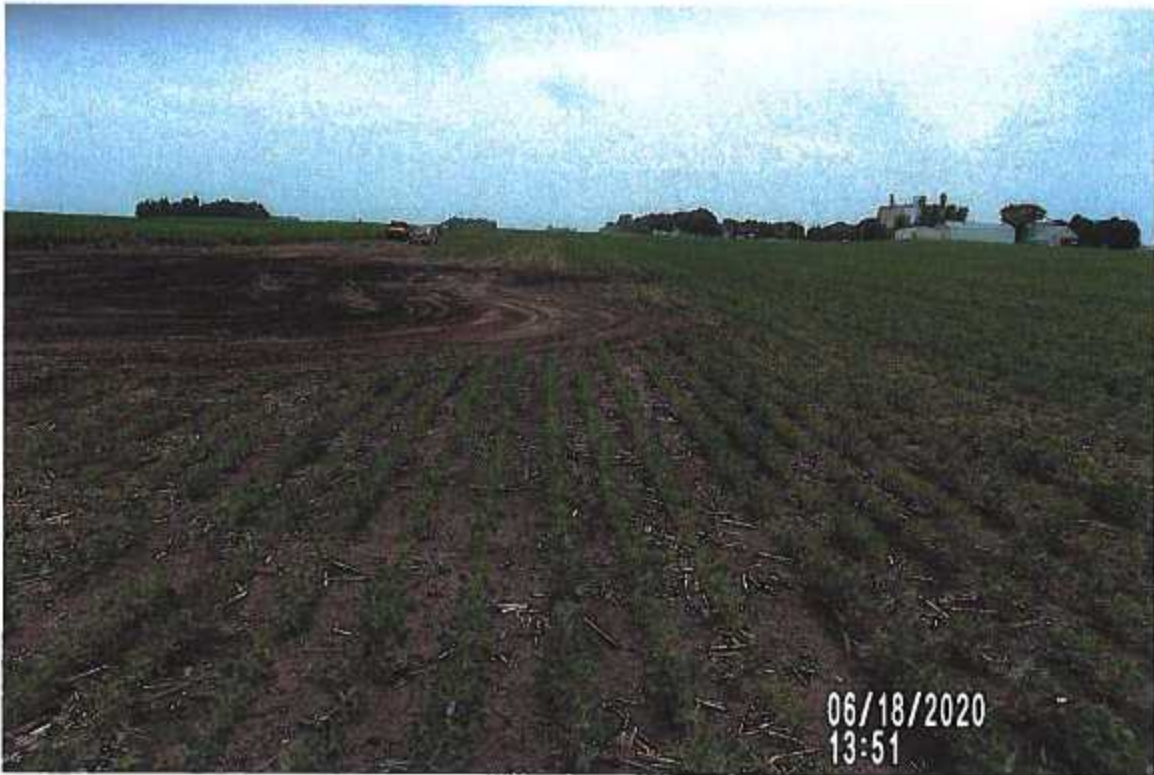
PICTURE # 3842 IS LOOKING SOUTH SHOWING BEAN DAMAGE
IN REPAIR WITH AREA CLEANED UP.

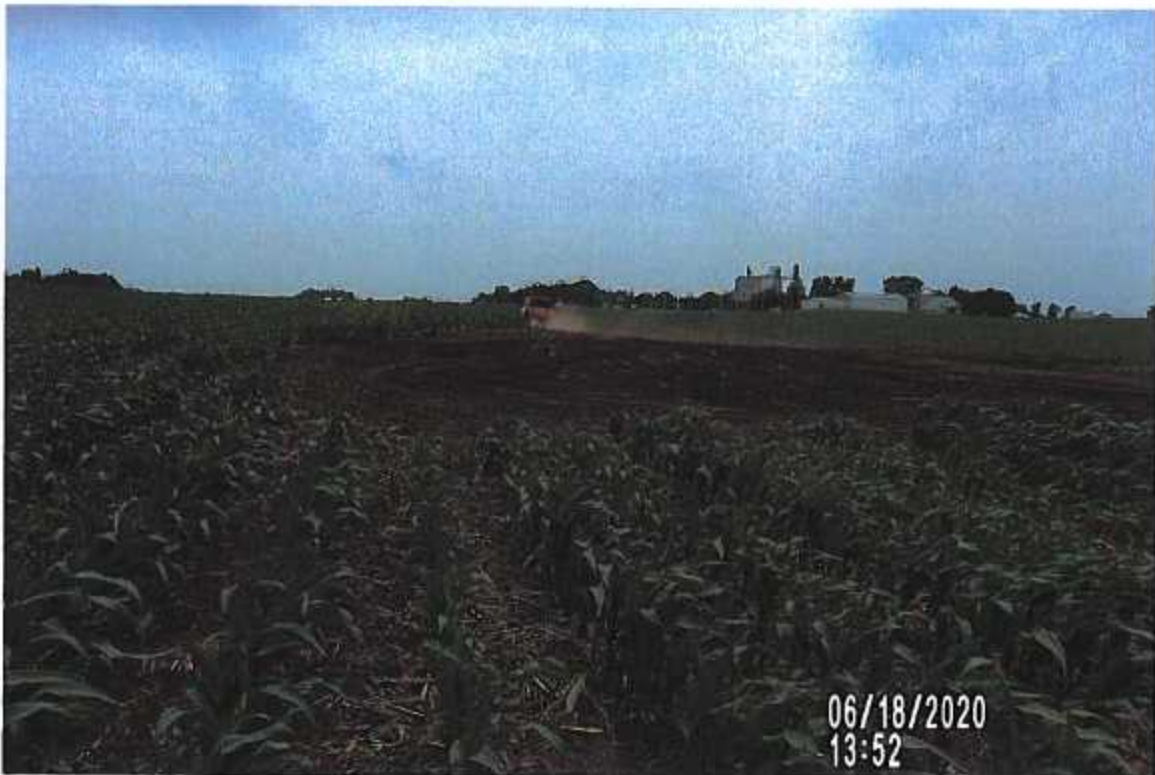
PICTURE # 3843 IS LOOKING SOUTH SHOWING CORN DAMAGE
IN REPAIR AREA WITH AREA CLEANED UP

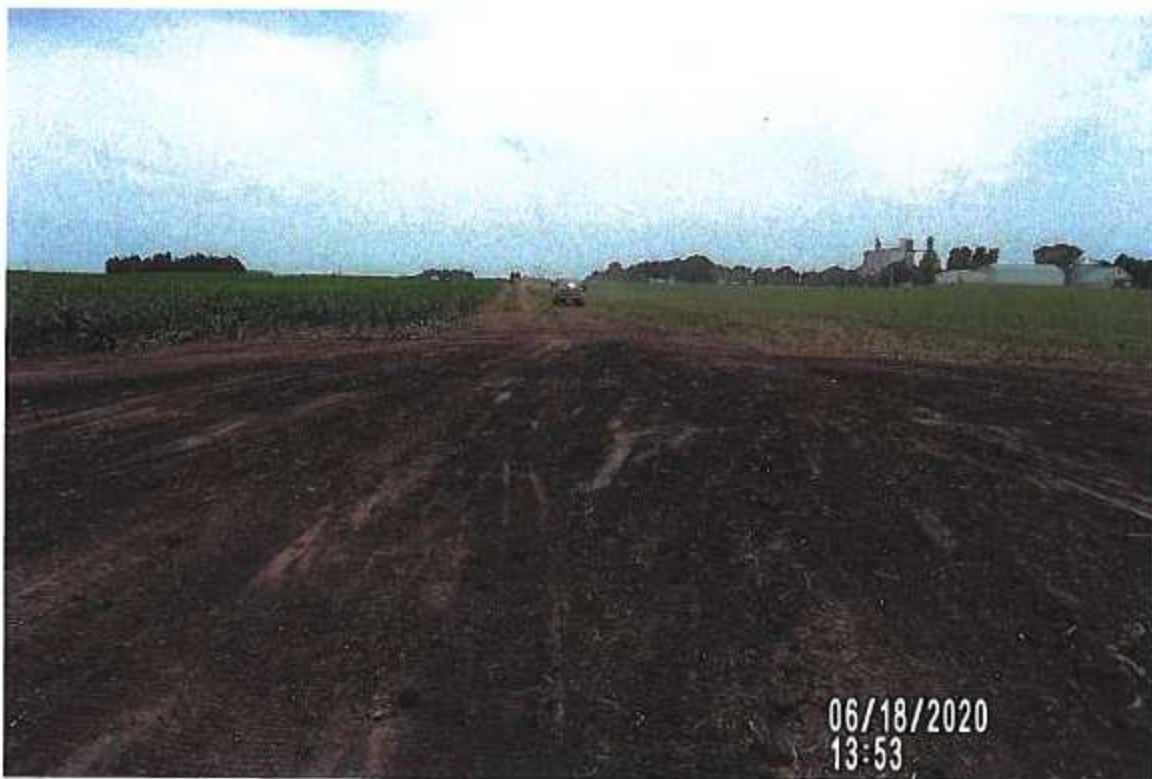
PICTURE# 3844 IS LOOKING SOUTH AT BEAN/CORN
DAMAGE TO ACCESS LANE WITH AREA CLEANED
UP

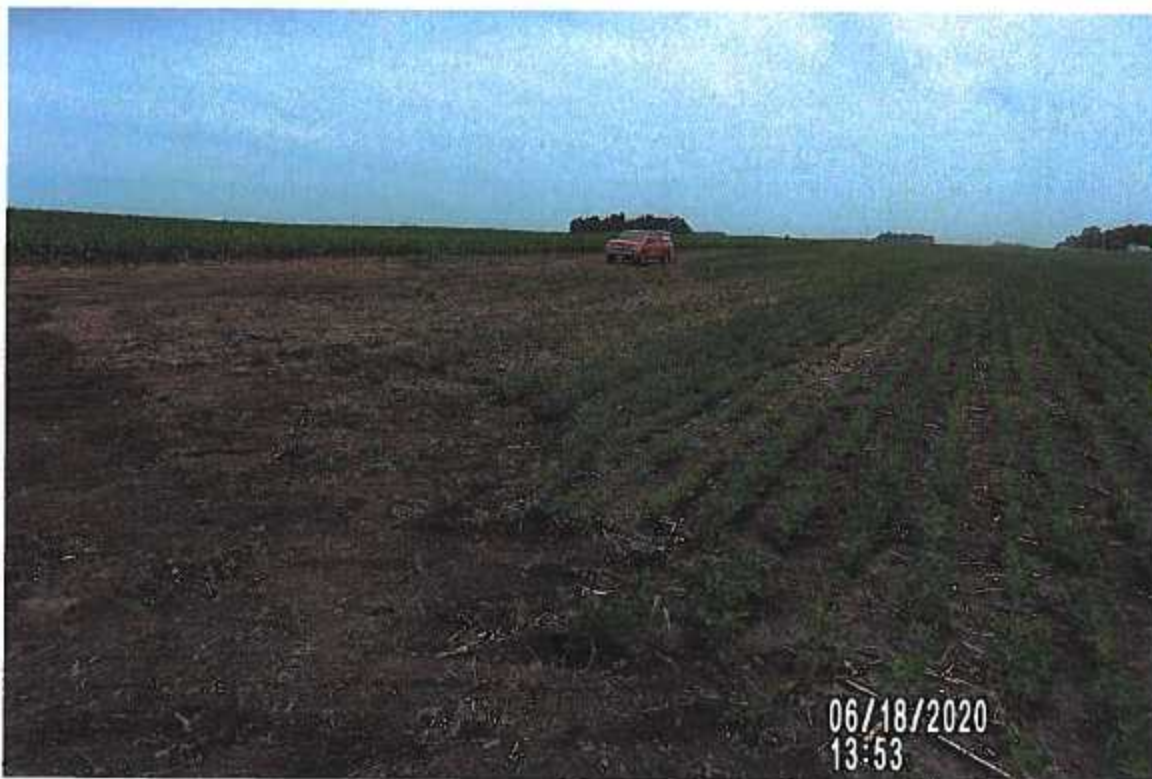
PICTURE# 3845 IS LOOKING SE SHOWING BEAN DAMAGE
TO ACCESS LANE WITH AREA CLEANED UP

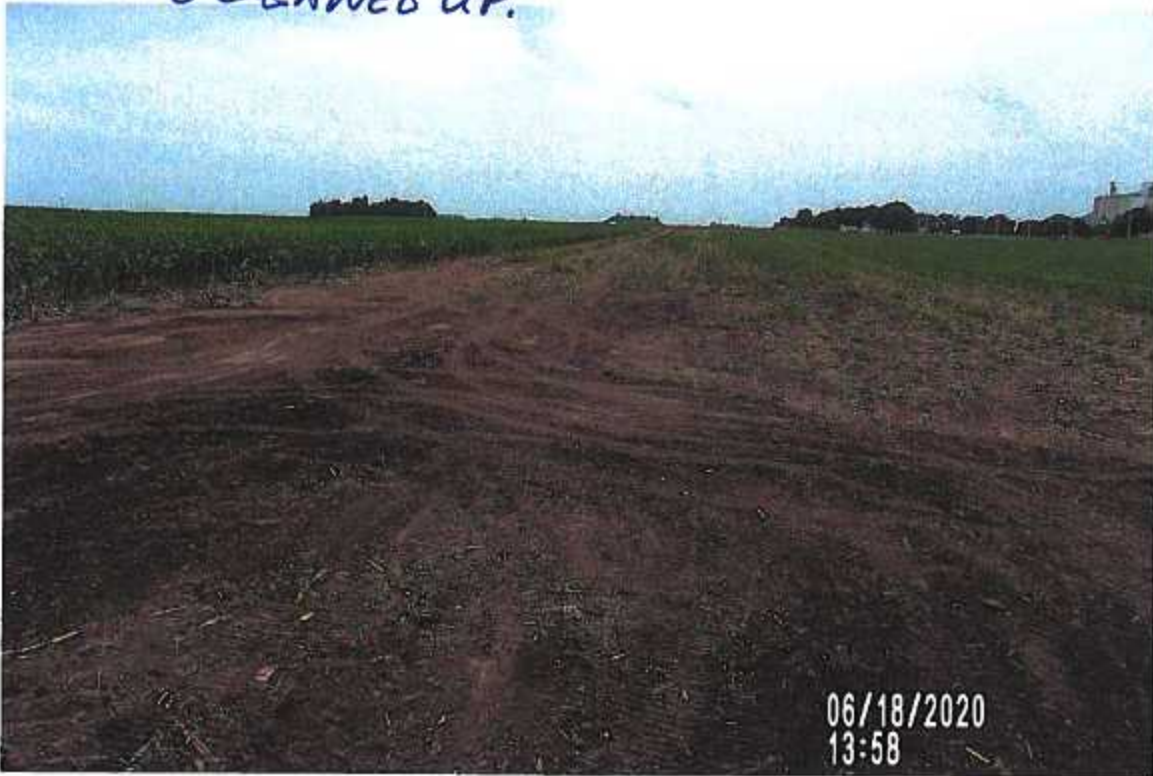
PICTURE # 3846 IS LOOKING SOUTH AT BEAN
DAMAGE TO ACCESS LANE WITH AREA
CLEANED UP.

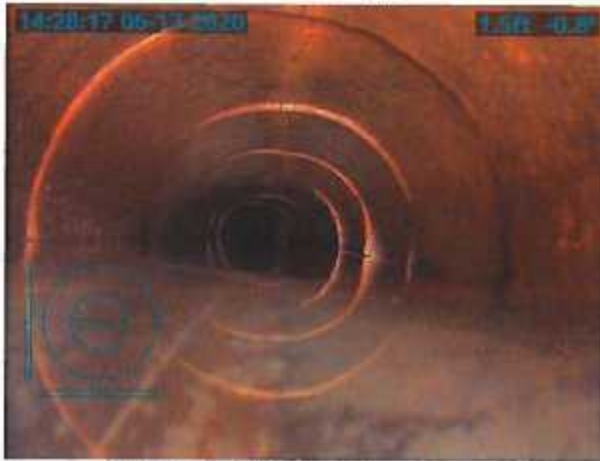
CL 2020_06_17-14_28_17_621.jpg

12				CRACKED AT 12 AND 3

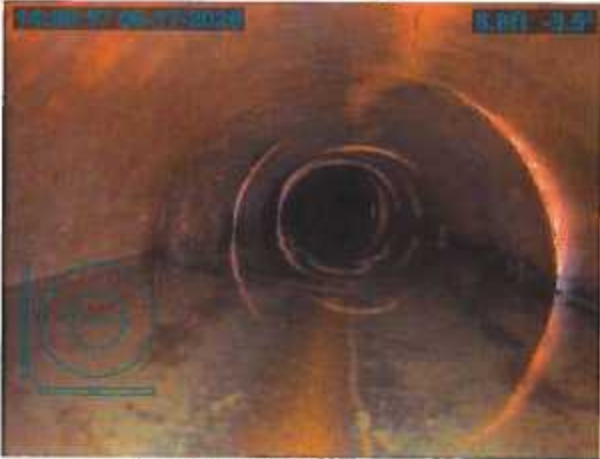
0:02:19	8.8		CL	2020_06_17-14_30_17_404.jpg  		06				VISIBLE CRACK UNDER WATER AT 6
0:03:15	15.7		CL	2020_06_17-14_31_45_663.jpg  		11				CRACKED AT 11
0:07:08	57.5		CL	2020_06_17-14_36_00_095.jpg

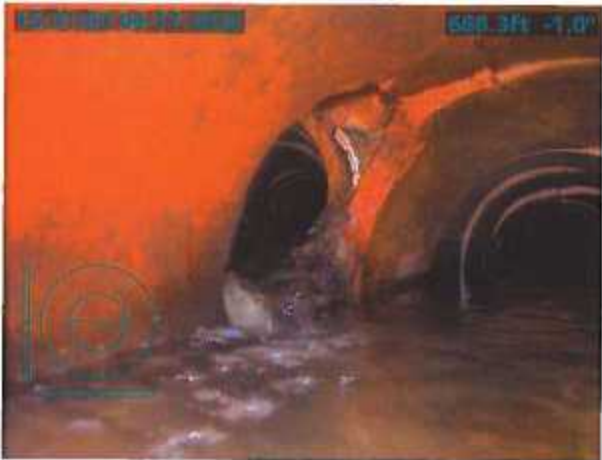
06	05			MULTIPLE CRACKS AND SQUAT
0:55:10	668.3		CN	2020_06_17-15_31_02_162.jpg
