Drainage Work Order Request For Repair

Drainage District: DDs\DD 14 (51027)

CONSTRUCTION ENGINEERING
OBSERVATION REPORT

LOCATION: DD#14 MAIN LOCATED SWNE & NWSE 34-88-22 HARDIN COUNTY. INVESTIGATE & TEMPORARILY REPAIR 3 TILE BLOWOUTS

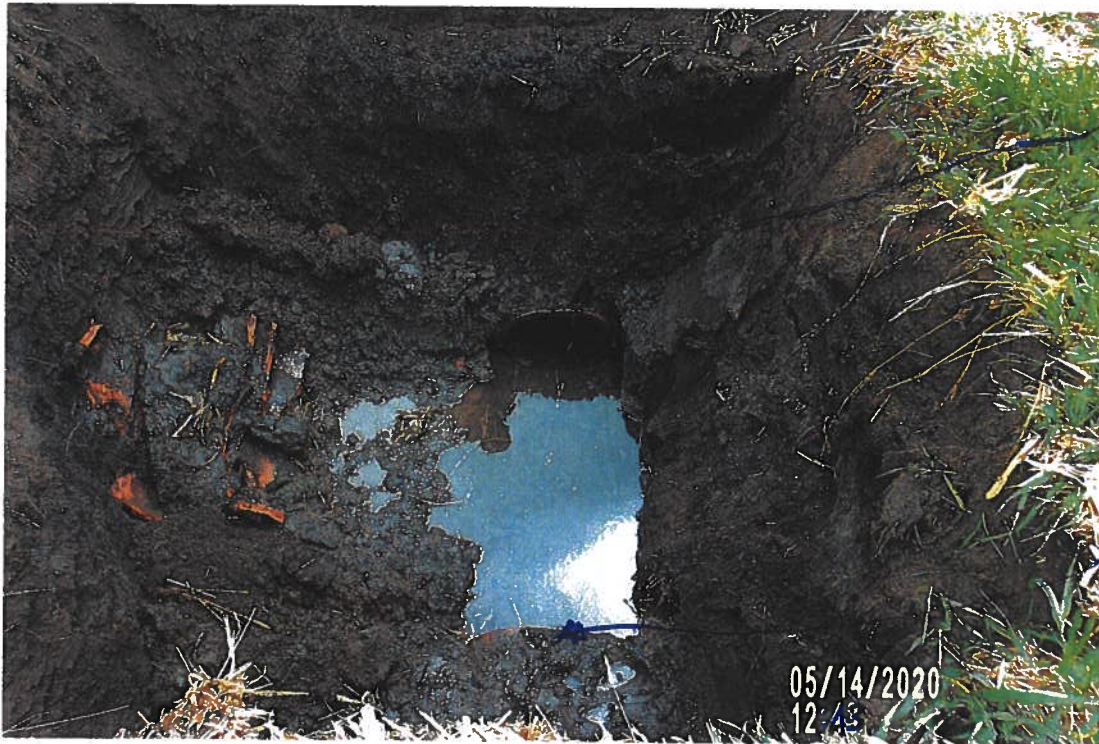
PICTURE # 3547 IS LOOKING UPSTREAM AT COMPLETELY COLLAPSED
SECTION OF CLAY TILE @ 537.2' WHICH HAD NOT SURFACED
YET & SOUTH OF TILE BLOWOUT # 2N,

GPS# 139
13" TALL
18" WIDE
SQUARED
1.25' TOPTOFL
(3.6' ± DEEP)

GPS# 138
12" TALL
17" WIDE
SQUARED
1.09' TOPTOFL
(3.8' ± DEEP)

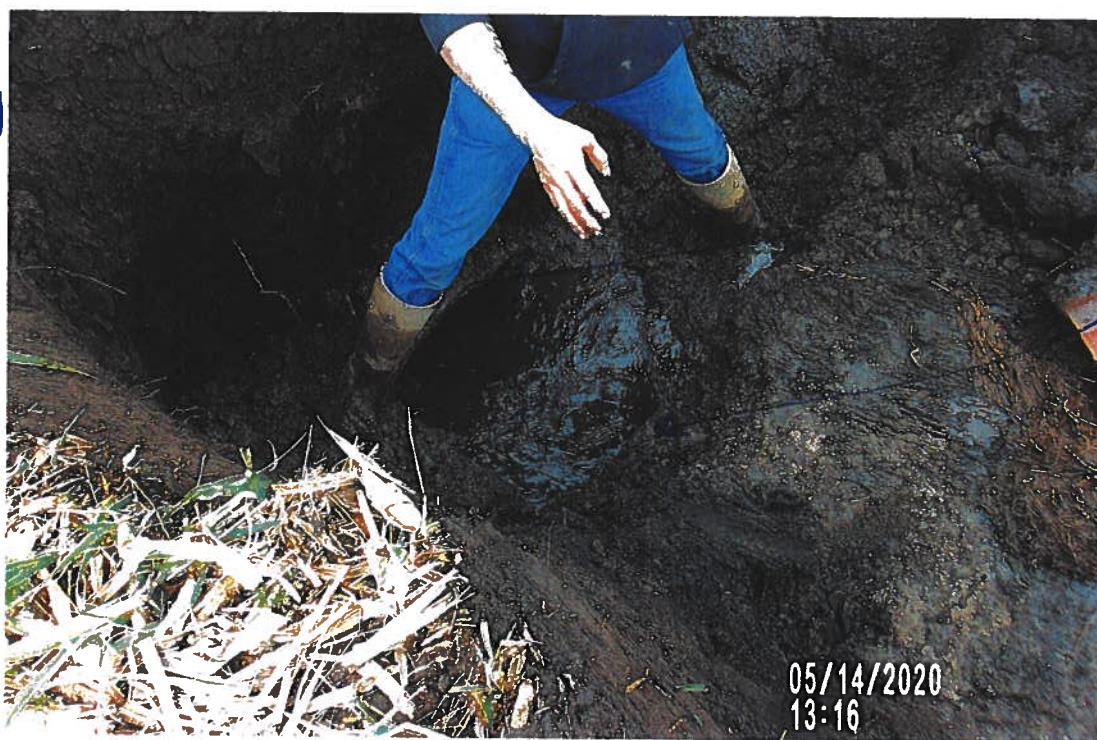
CPS# 147
12" TALL
19" WIDE
SQUATTY CLAY
1.05' TOP TO FL:
3.5' ± DEEP

PICTURE # 3553 IS LOOKING NE SHOWING COLLAPSED SECTION OF TILE REMOVED AND NOW FLOWING GOOD IN BLOWOUT. IN

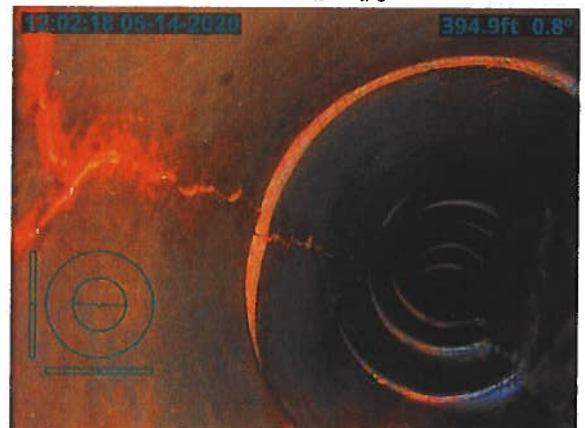
CM 2020_05_14-12_02_18_136.jpg

| Video Ref | Dist (ft) | Cont Defect | Code | Photo Ref | Diameter/ Dimension | Clock | | Intrusion | | Remarks |
|---|---|---|---|--|---|---|---|---|---|---|
| 0:39:47 | 394.9 | | CM | 2020_05_14-12_02_18_136.jpg | | 11 | 12 | | | CRACKS |

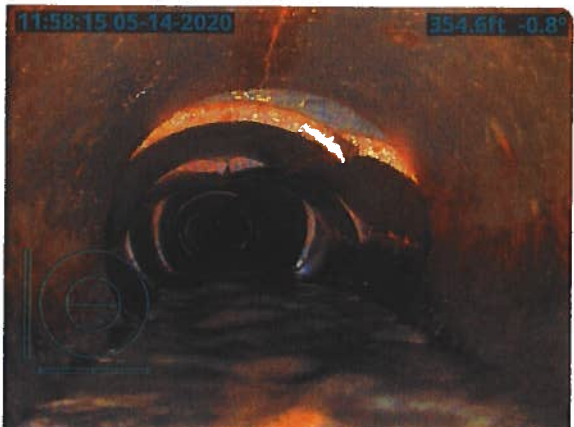
B 2020_05_14-11_58_15_678.jpg

| Video Ref | Dist (ft) | Cont Defect | Code | Photo Ref | Diameter/ Dimension | Clock | | Intrusion | | Remarks |
|---|---|---|---|--|---|---|---|---|---|---|
| 0:36:50 | 354.6 | | B | 2020_05_14-11_58_15_678.jpg | | 11 | 12 | | | MORE STELLAR CONDITION PIPE |

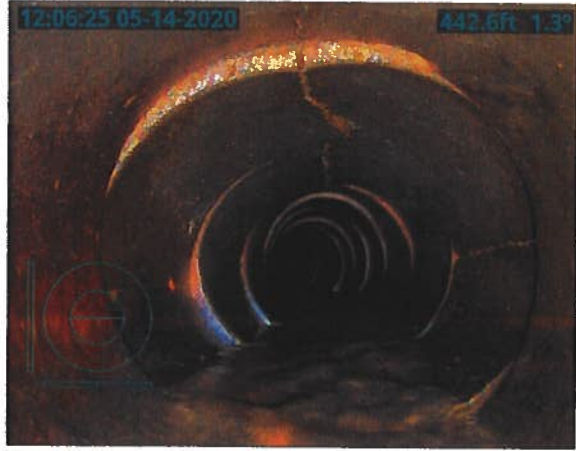
CM 2020_05_14-12_06_25_077.jpg

| Video Ref | Dist (ft) | Cont Defect | Code | Photo Ref | Diameter/ Dimension | Clock | | Intrusion | | Remarks |
|---|---|---|---|--|---|---|---|---|---|---|
| 0:42:27 | 442.6 | | CM | 2020_05_14-12_06_25_077.jpg | | 11 | 12 | | | CRACKS ALL AROUND |

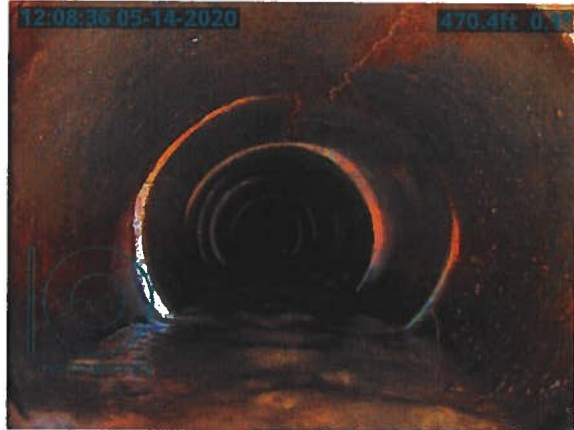
CM 2020_05_14-12_08_37_024.jpg

| Video Ref | Dist (ft) | Cont Defect | Code | Photo Ref | Diameter/ Dimension | Clock | | Intrusion | | Remarks |
|---|---|---|---|--|---|---|---|---|---|---|
| 0:44:01 | 470.4 | | CM | 2020_05_14-12_08_37_024.jpg | | 12 | 02 | | | CRACKED TOP |

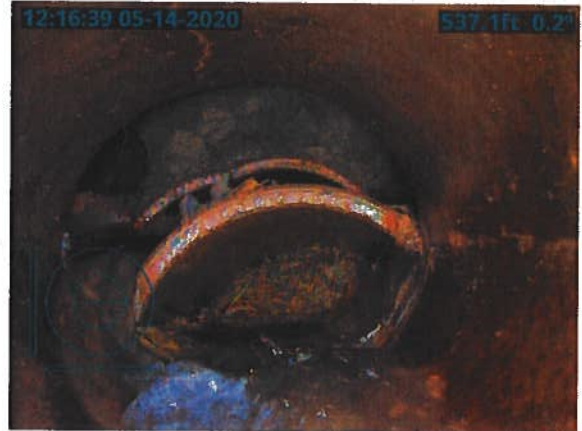
B 2020_05_14-12_16_39_476.jpg

| Video Ref | Dist (ft) | Cont Defect | Code | Photo Ref | Diameter/ Dimension | Clock | | Intrusion | | Remarks |
|---|---|---|---|---|---|---|---|---|---|---|
| 0:50:12 | 537.1 | | B | 2020_05_14-12_16_39_476.jpg | | 08 | 03 | | | BROKEN AND COLLAPSED |

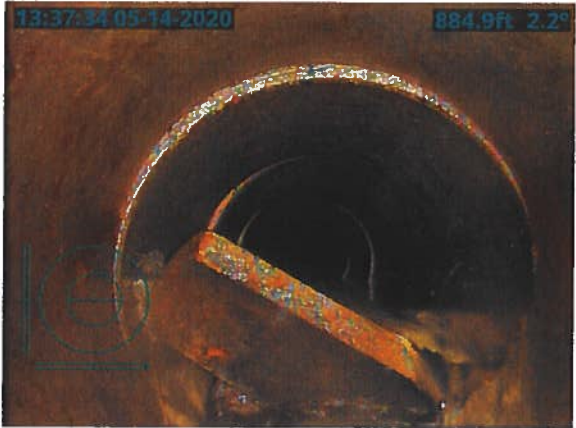
DE 2020_05_14-13_37_34_943.jpg

| Video Ref | Dist (ft) | Cont Defect | Code | Photo Ref | Diameter/ Dimension | Clock | | Intrusion | | Remarks |
|---|---|---|---|---|---|---|---|---|---|---|
| 1:31:25 | 884.9 | | DE | 2020_05_14-13_37_34_943.jpg | | | | 50% | | BROKEN TILE IN FLOW LINE |
