## Drainage District:

#14

## Investigation/Repair Summary:

# Drainage Work Order Request For Repair

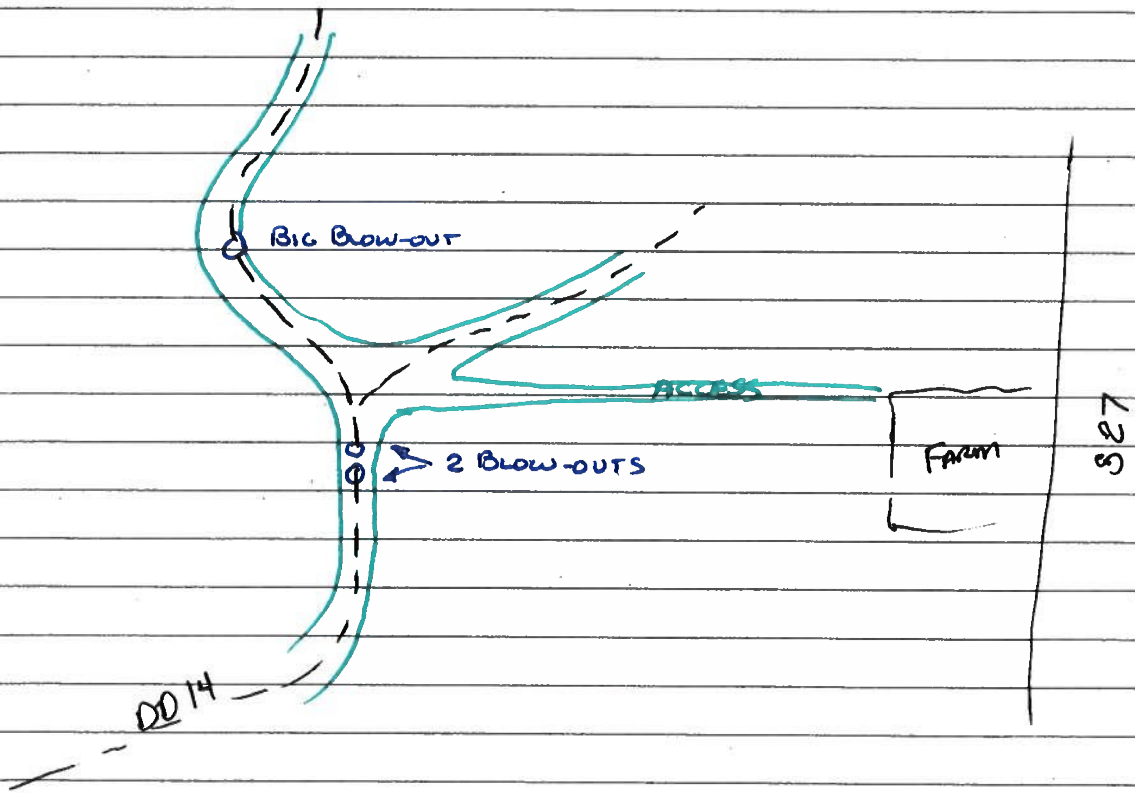
ARRIVED @ DAVID SWEENEY HOUSE, TALKED TO HIM, HE GAVE INSTRUCTION  
TO TAKE GRASS DRIVE OUT TO SWALE WITH BROKEN CLAY TILE ON  
DD 14. LOOKS LIKE 15"±. 3 BLOW-OUTS

REPAIR ASAP.
