Drainage District:

#14 Main and Lateral 2

Investigation/Repair Summary:

CONSTRUCTION ENGINEERING
OBSERVATION REPORT

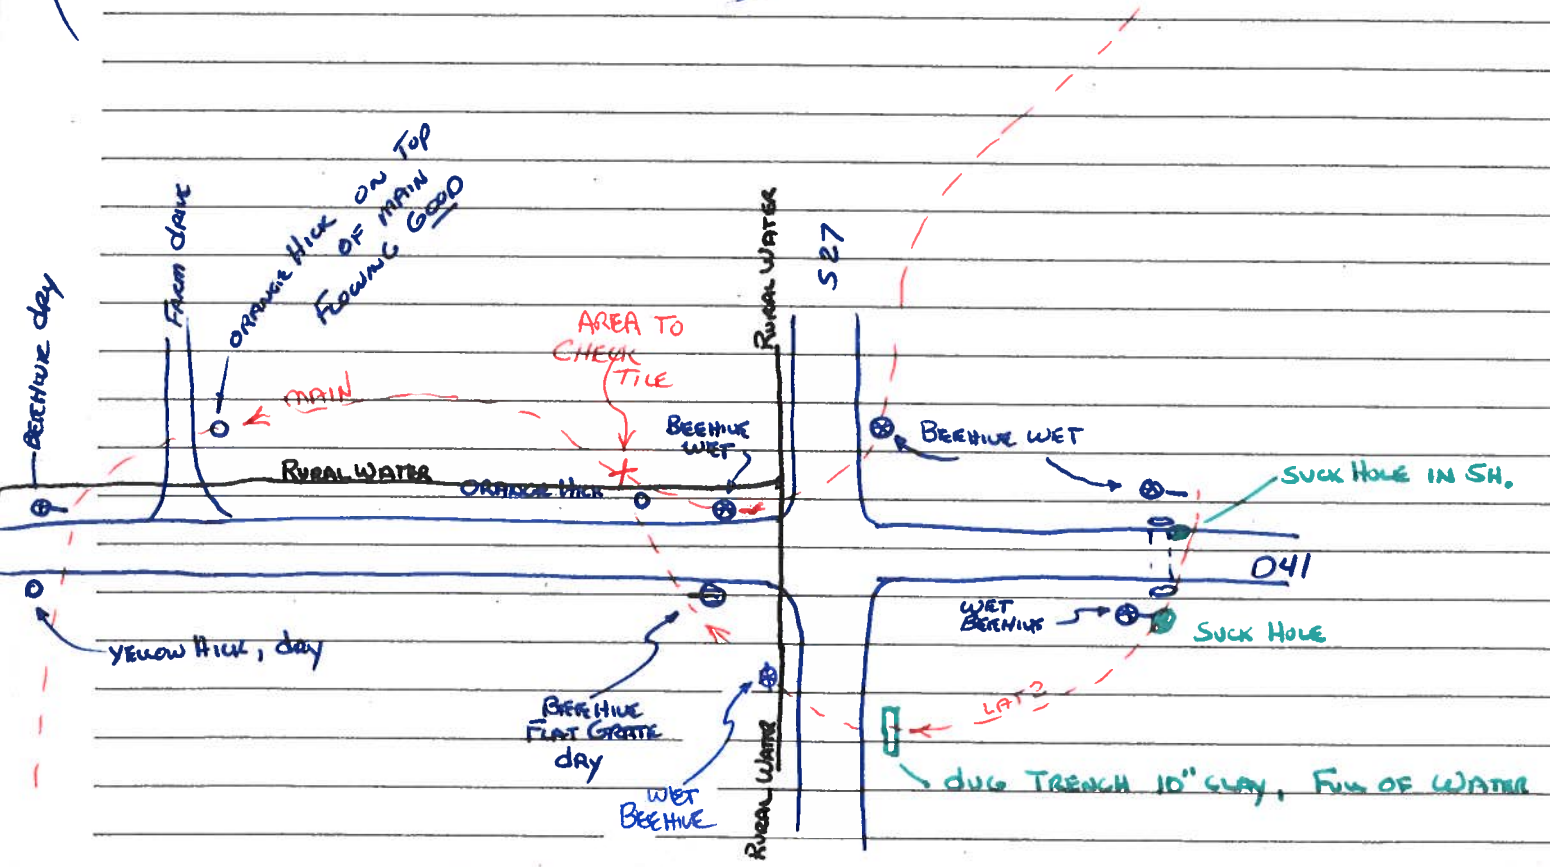
LAT 2 HAS RESTRICTION @ D41 (N. OR S. SIDE?). NEED TO DIG ON NORTH SIDE 1ST, TRY AND FIND LAT 2 CONNECTION TO MAIN. INTAKES ON MAIN @ FARM DRIVE LOOK GOOD WITH FLOWING WATER IN MAIN

TALKED TO RON VIKRAMA (80 YRS OLD) HE AGREED WITH ME THAT THE LAT 2 CONNECTION SHOULD BE CHECKED, BUT HE HAD NO IDEA WHERE IT WAS AT.
