# Drainage Work Order Request For Repair

## Hardin County

### Investigation and Repair Summary:

JOB # 6844 DD14 SURVEY

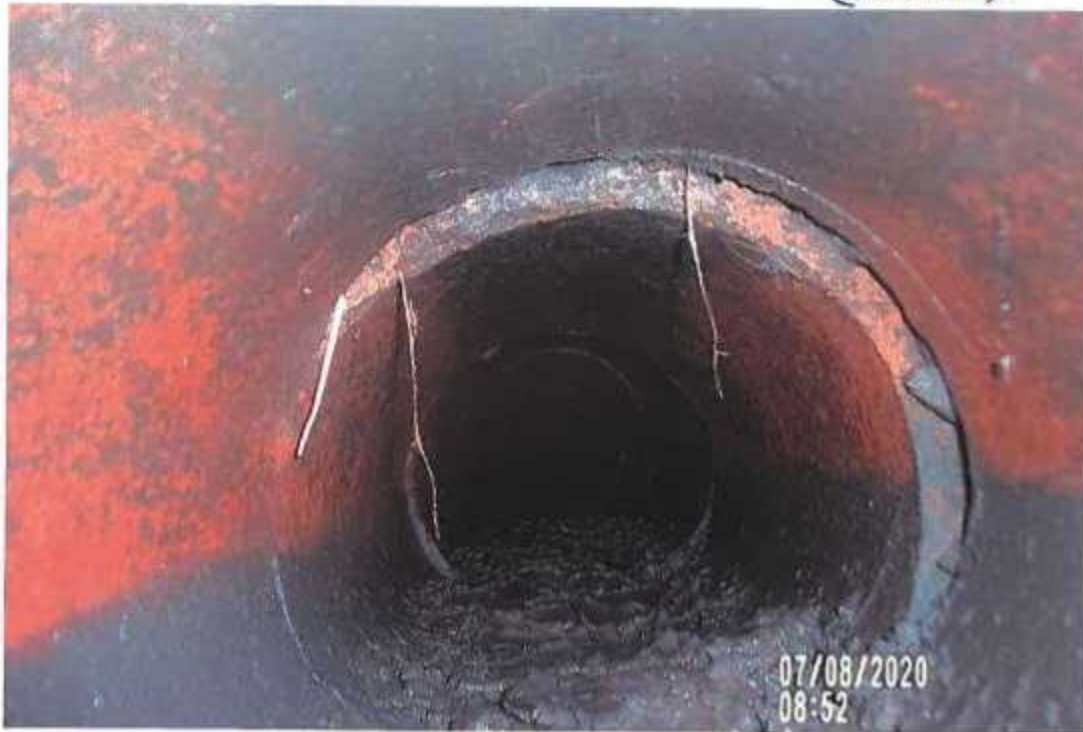
PICTURE# 4052 IS LOOKING NW UPSTREAM INSIDE 8" CLAY TILE WITH 2" ± OF MUD IN FLOWLINE FROM GPS# 250. TILE IS IN GOOD SHAPE WITH FEW FINE ROOTS AND A FEW OFFSET JOINTS

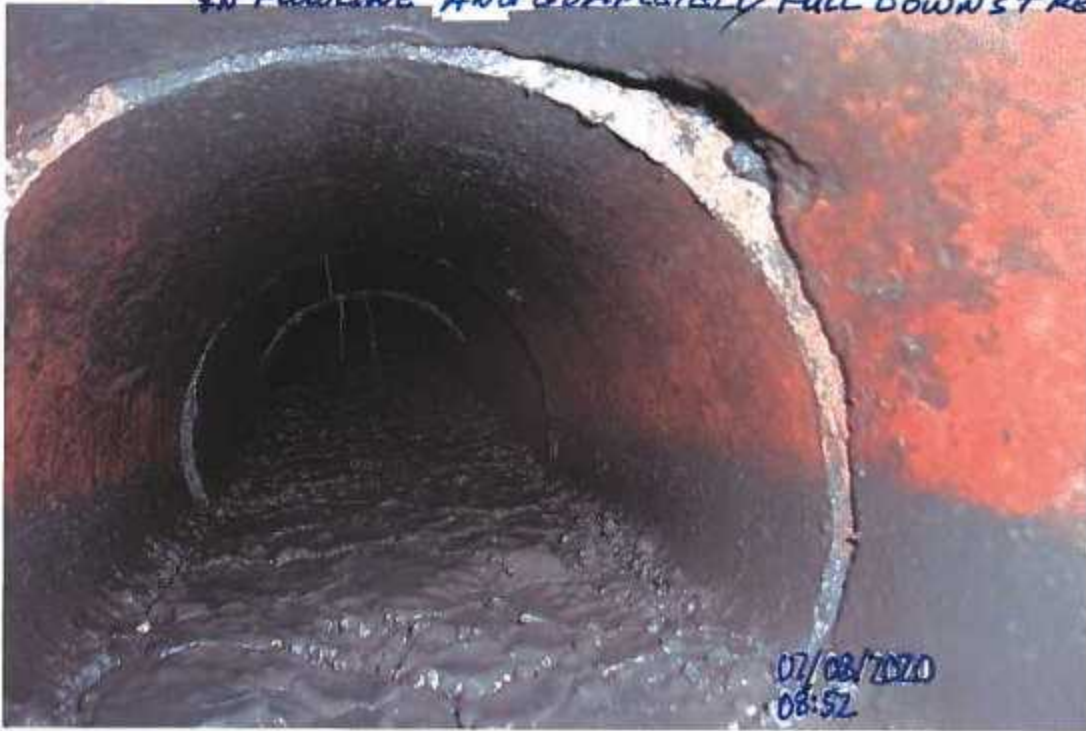
PICTURE # 4053 IS LOOKING SE DOWNSTREAM INSIDE 8" CLAY TILE  
WITH 2"± OF MUD IN FLOWLINE FROM GPS # 251. TILE HAS A  
LITTLE POPOUT AT NEXT JOINT AND IS IN GOOD SHAPE WITH 2" MUD  
IN FLOWLINE AND COMPLETELY FULL DOWNSTREAM. RON

THINKS  
THIS TILE  
IS  
ABANDONED.

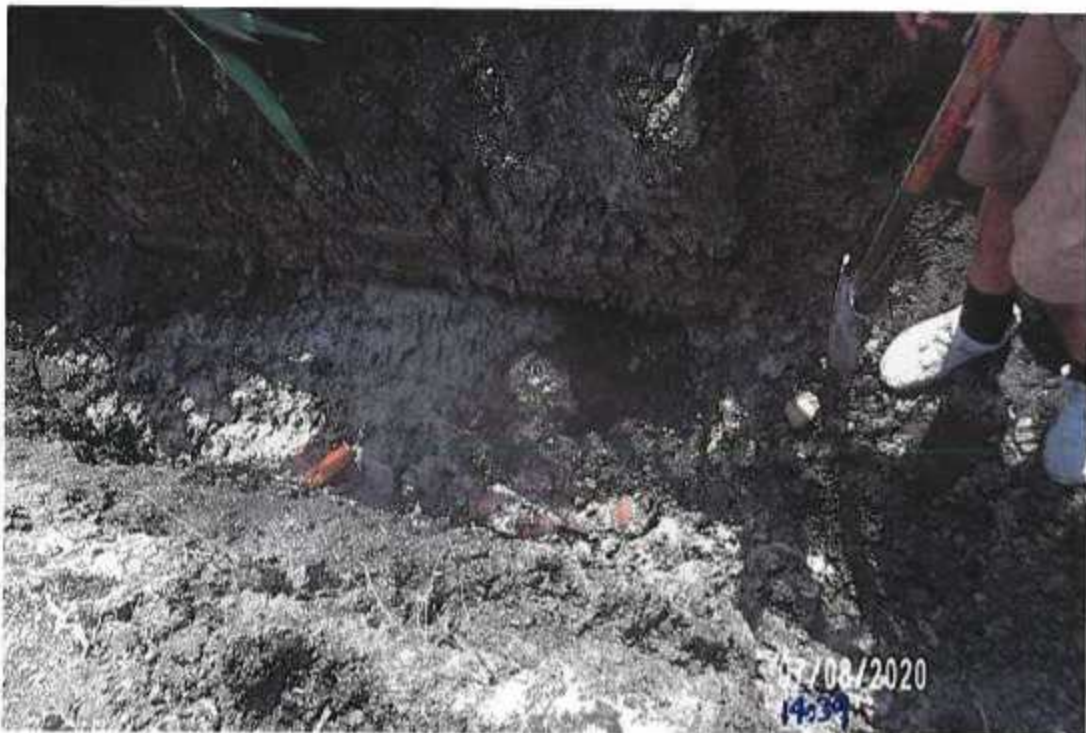
PICTURE # 4060 IS LOOKING UPSTREAM INSIDE 8" CLAY TILE @ 2 1/3' UPSTREAM FROM BEEHIVE INTAKE SHOWING 5" PERF SW HOPE TILE FROM EAST & FROM WEST CONNECTING AT SAME LOCATION WITH SIDES CRACKED AND TOP CAVING DOWN WITH TILE PLUGGED UPSTREAM WITH SOIL & ROOTS

WITH SOIL & ROOTS

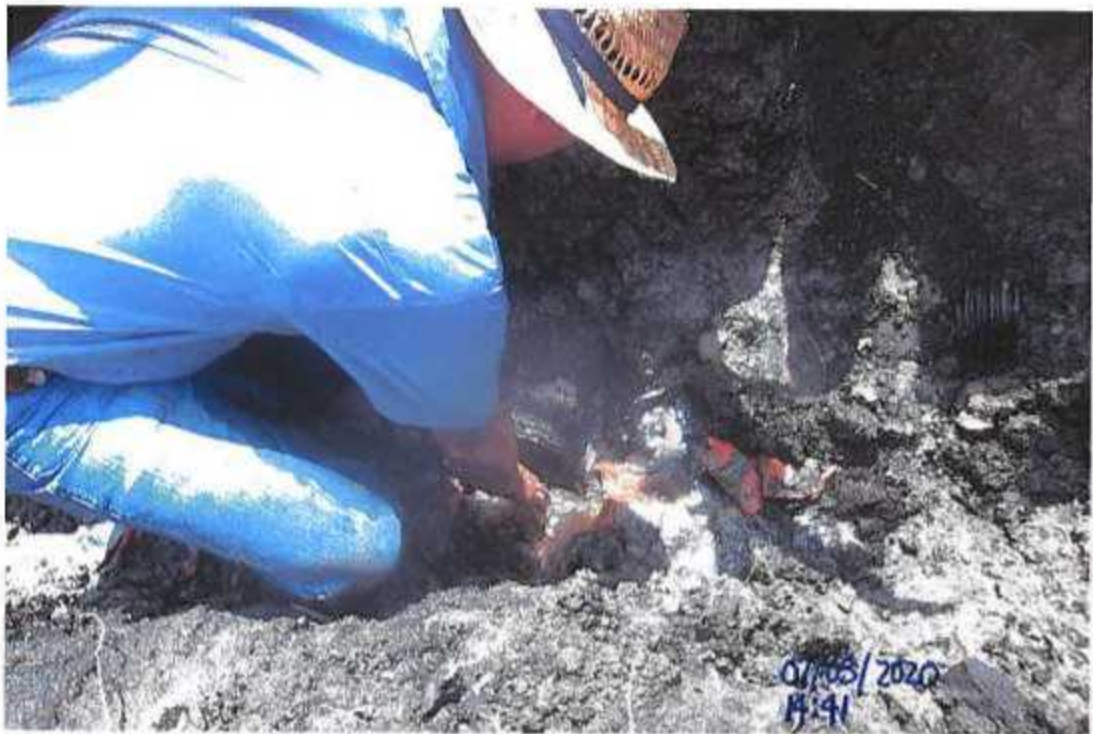
PICTURE # 4064 IS LOOKING SW SHOWING WATER GUSHING FROM  
UPSTREAM END OF 8" CLAY TILE AT 5" HDPE TILE CONNECTIONS  
AFTER BLOCKAGE REMOVED

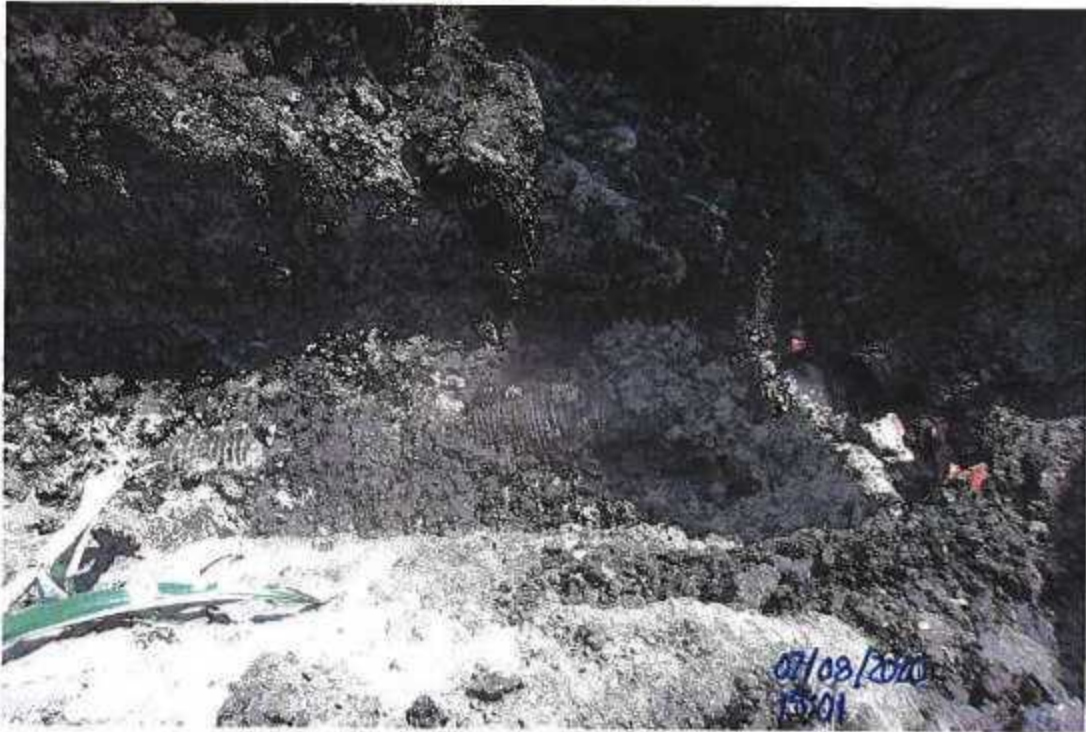
PICTURE# 4065 IS LOOKING SOUTH SHOWING 5" HOPE TILE CONNECTION WITH 5" HOPE TILE FROM WEST HAVING A SAC OR HUMPE UP IN A SPOT.

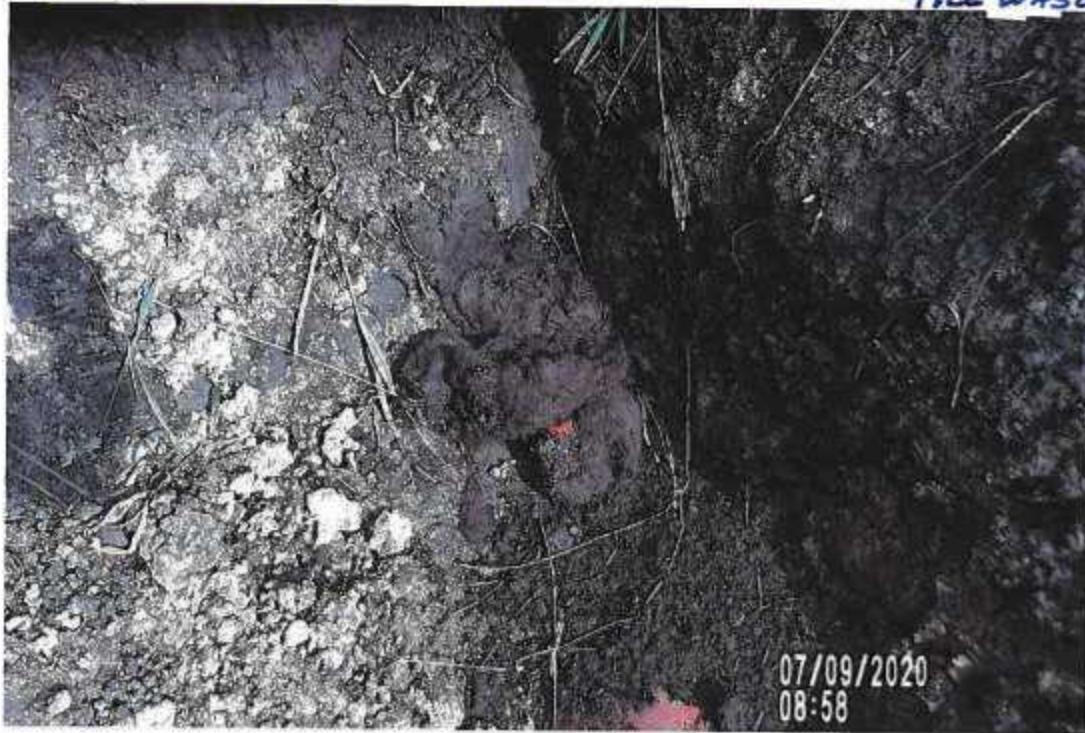
PICTURE # 4088 SHOWING PILE OF DEBRIS PULLED OUT OF THE  
(WHERE 8" CLAY TILE SECTION WAS ROLLED OUT IN SOUTH DITCH OF  
CO HWY 041) BEFORE IT WENT DOWNSTREAM AFTER PLUGGED  
TILE WAS OPENED

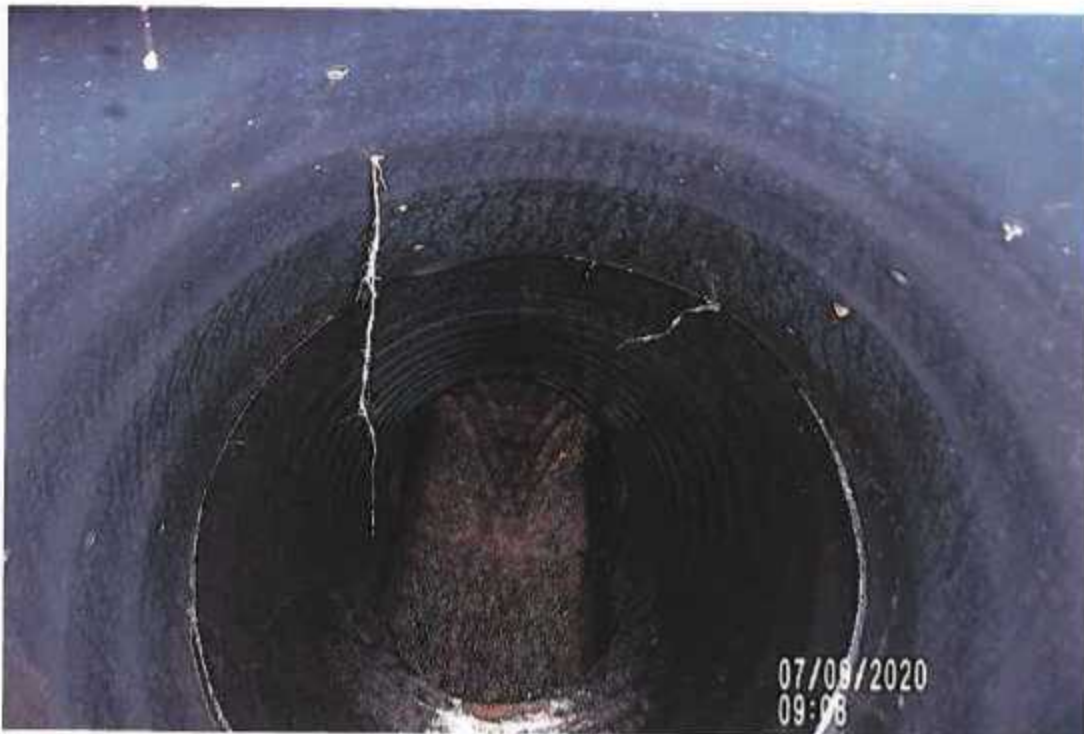
GPS# 88  
PICTURE # 4089 IS LOOKING NE INSIDE TILE WYE ACCESS LID  
ON SOUTH SIDE OF CO HWY 041 1195.6' ± WEST OF E CO HWY 527  
SHOWING TILE IS STILL FLOWING GOOD AT THIS LOCATION

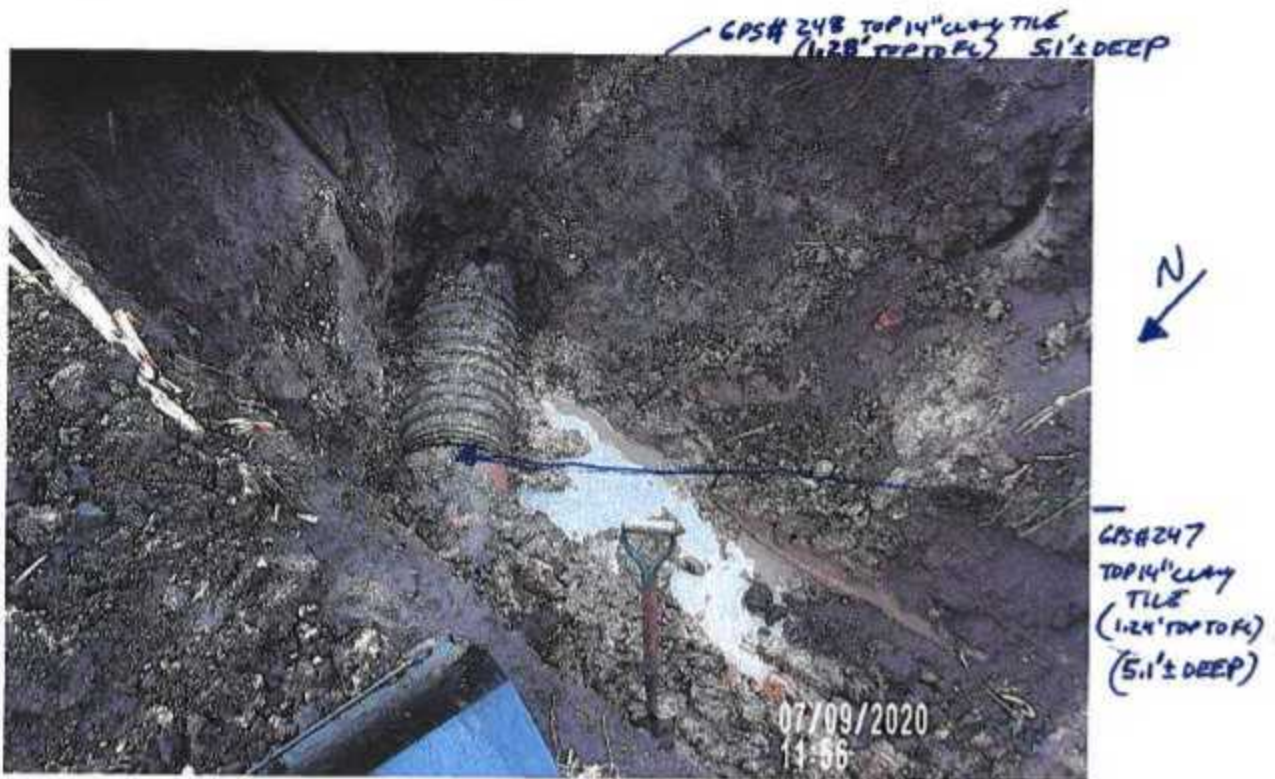
PICTURE # 4095 IS LOOKING SE SHOWING 2.6 LF. PIECE  
OF 15" Ø DW HDPE NONPERF TILE IN PLACE FOR REPAIR  
WITH BEDDING ROCK UNDER TILE

① 14" CLAY TILE REPAIR (NORTH OF 041) 2.6 LF 15" Ø DW HOPE NON PERF TILE  
2- 2.0 X 3.5' ENGINEERING FABRIC  
11'0" X 4.0' & 1.5' X 4.0' 6" X 6" SQUARE WIRE MESH

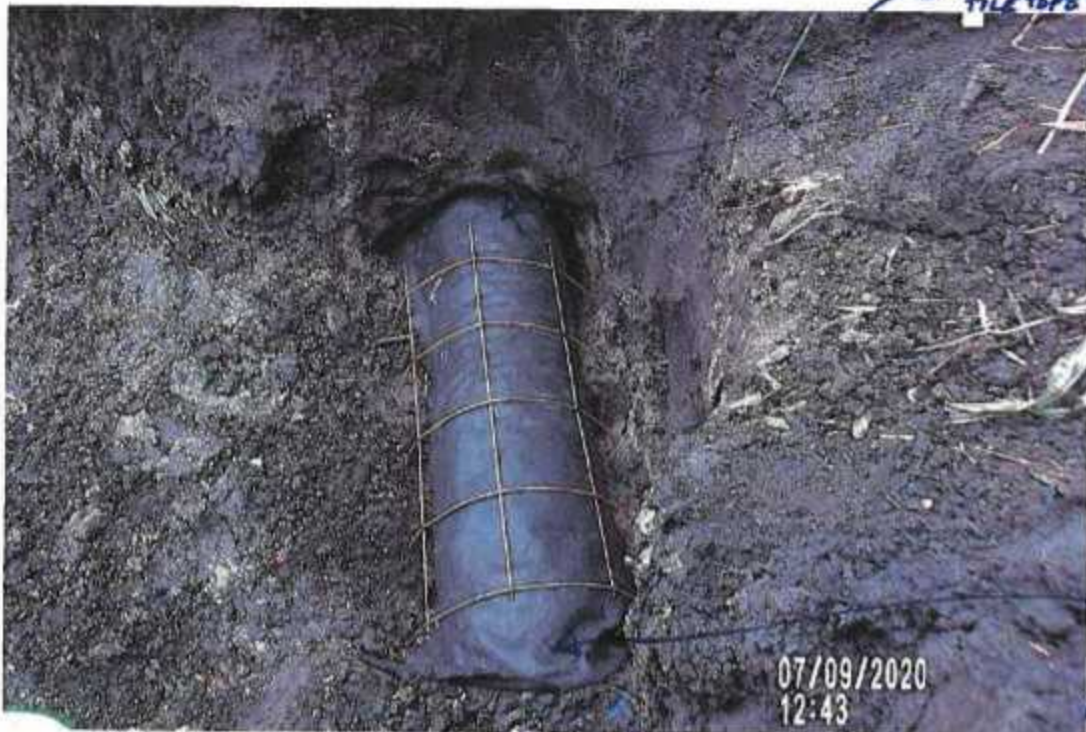
GPS #251  
 TILE TOP 8" CLAY  
 0.75' TOP TO FL  
 2" MUD IN FL  
 (3.7' ± DEEP)

PICTURE #4098 IS LOOKING SE DOWNSTREAM - FROM GPS #251  
 TOP 8" CLAY TILE (0.75' TOP TO FL) AFTER ANOTHER DAMAGED  
 4.0' SECTION OF TILE WAS REMOVED. 2" MUD IN FL TO COMPLETELY  
 FULL OF MUD. RON SAYS TILE HAS BEEN ABANDONED BUT

WILL CONNECT  
 TOGETHER  
 IN CASE  
 ANY TILE  
 UPSTREAM  
 IS CONNECTED  
 YES  
 N  
 ↓

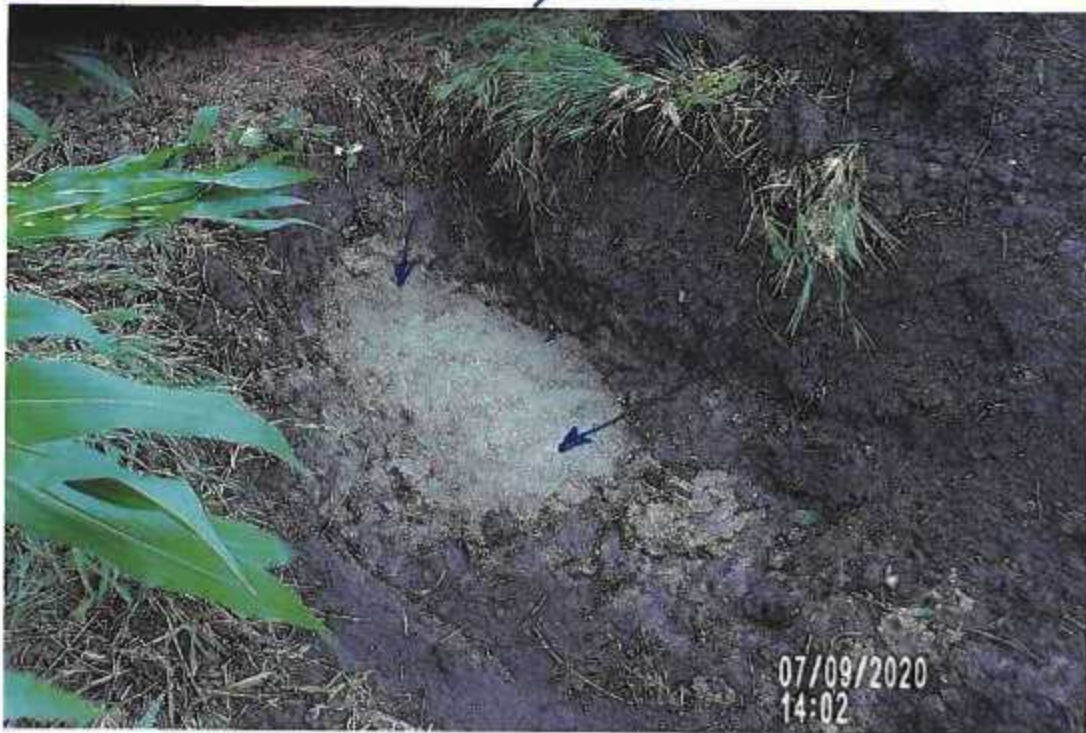
PICTURE # 4106 IS LOOKING NORTH SHOWING 3/4" CONCRETE COLLAR POURED FOR 8" CLAY TILE SECTION ROLLED BACK INTO PLACE 9'5" WEST OF BEHIND ENTIRE. CREW USED 5-6018 BAGS OF QUIKRETE HIGH STRENGTH.

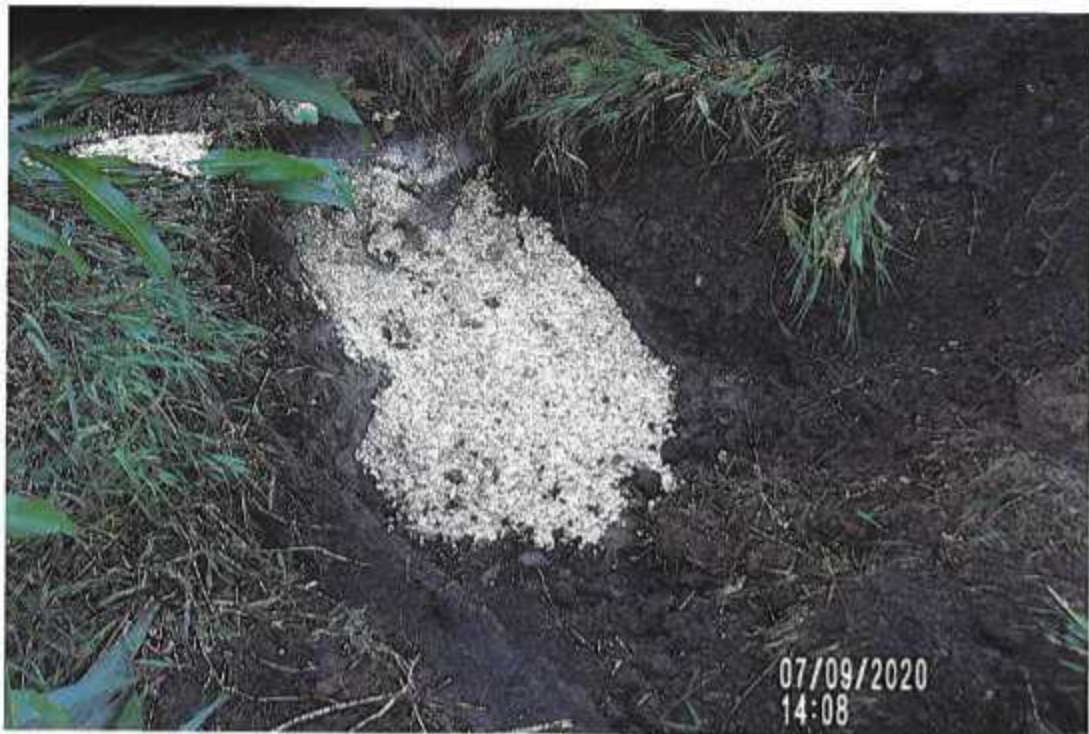
PICTURE # 4107 IS LOOKING NORTH SHOWING BEDDING ROCK BACK FILLED AROUND 3/4" CONCRETE COLLAR IN SOUTH DITCH OF COUNTY D41 FOR 8" CLAY TILE SECTION ROLLED BACK INTO PLACE.

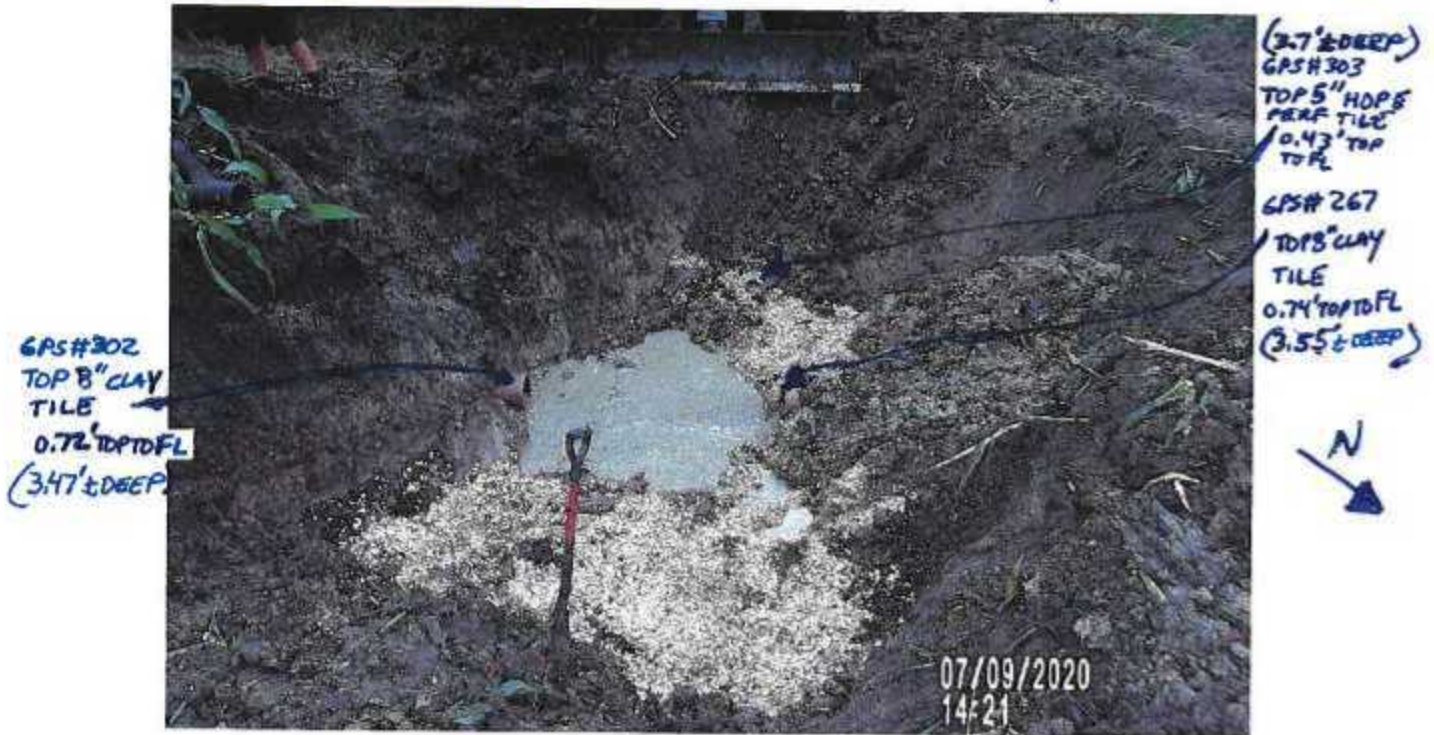
PICTURE # 4108 IS LOOKING SW SHOWING 8" CLAY TILE REMOVED WITH BEDDING ROCK IN PLACE TO TIE IN 5" SW HOPE PERF TILE LINES INTO 8" CLAY TILE LATERAL

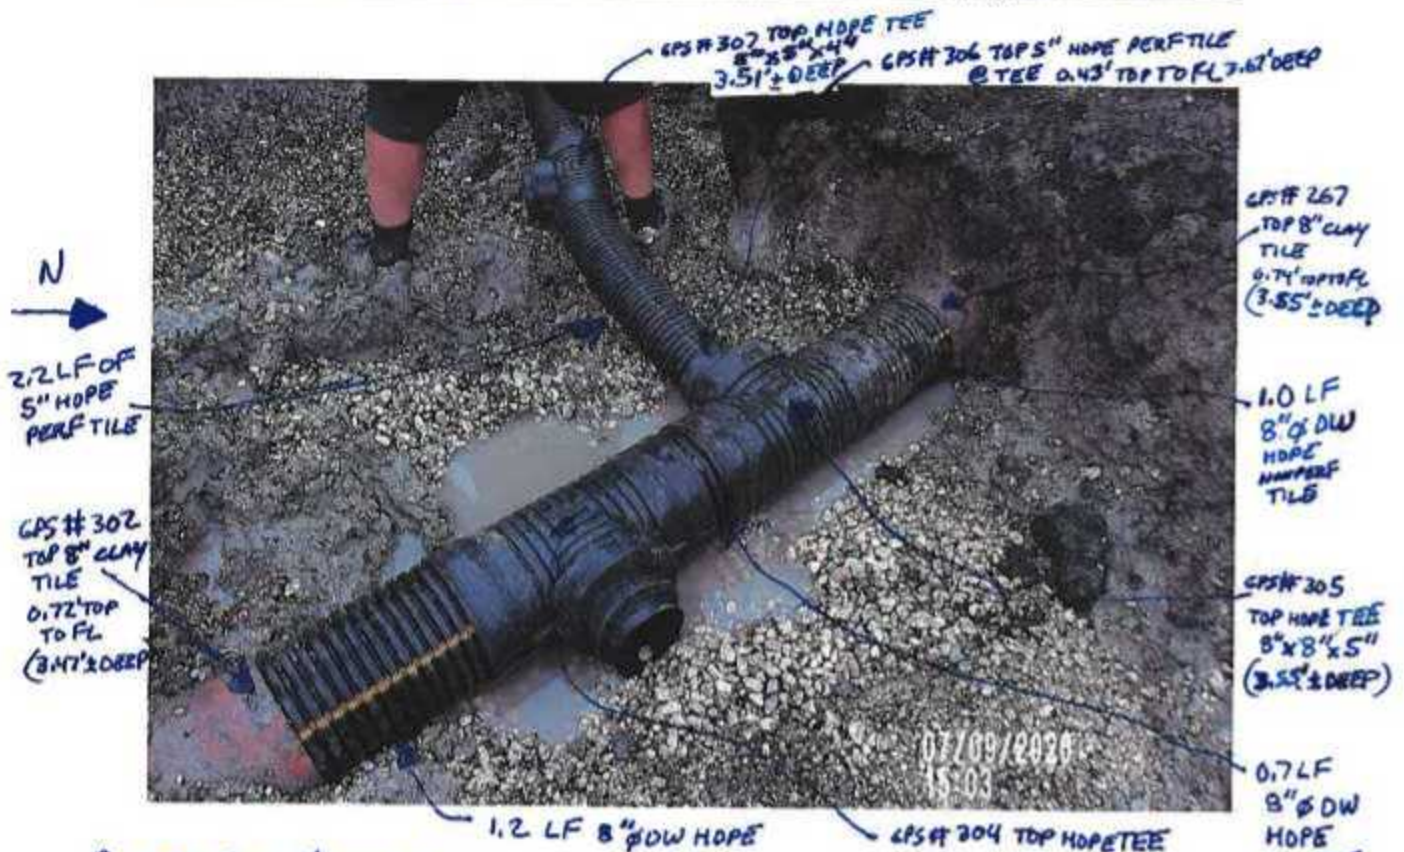
PICTURE # 4109 IS LOOKING WEST AT 8" DW HOPE NONPERF TILE INSTALLED WITH A 8" x 8" x 5" HOPE TEE EAST & WEST & 5" HOPE PERF TILE INSTALLED INTO TEE WITH 5" x 5" x 4" HOPE TEE INSTALLED ON IT WITH BEDDING ROCK UNDER CONNECTION.

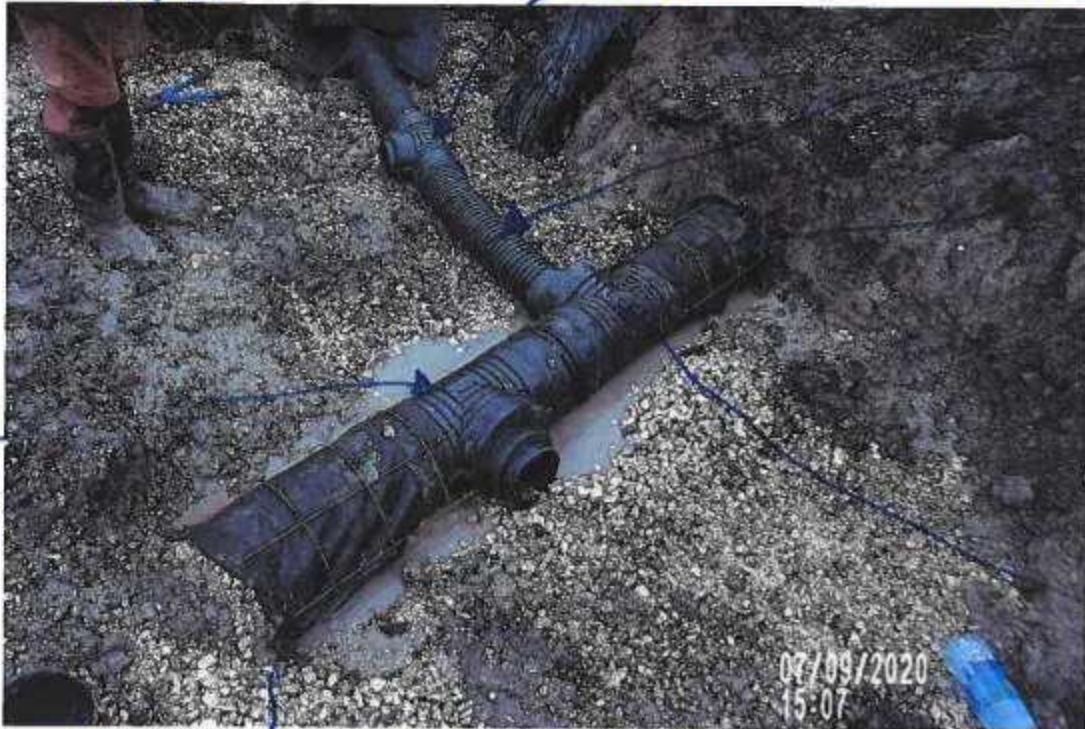
PICTURE #4110 IS LOOKING WEST AT NORTH & SOUTH TIES  
IN CONNECTIONS ON 8" LATZ BEFORE 3/4 CONCRETE COLLARS  
POURED

GPS# 267  
TOP 8" CLAY  
0.74' TO TOP FL  
1.5' X 11.5'  
6" X 6"  
WIRE MESH  
2.0' X 2.0'  
FABRIC  
OVER JOINT  
BEFORE 3/4  
CONCRETE  
COLLAR  
POURED

GPS #302  
TOP 8" CLAY 0.85' TO TOP FL  
& 2.0' X 2.0' FABRIC OVER  
JOINT BEFORE 3/4 CONCRETE COLLAR POURED

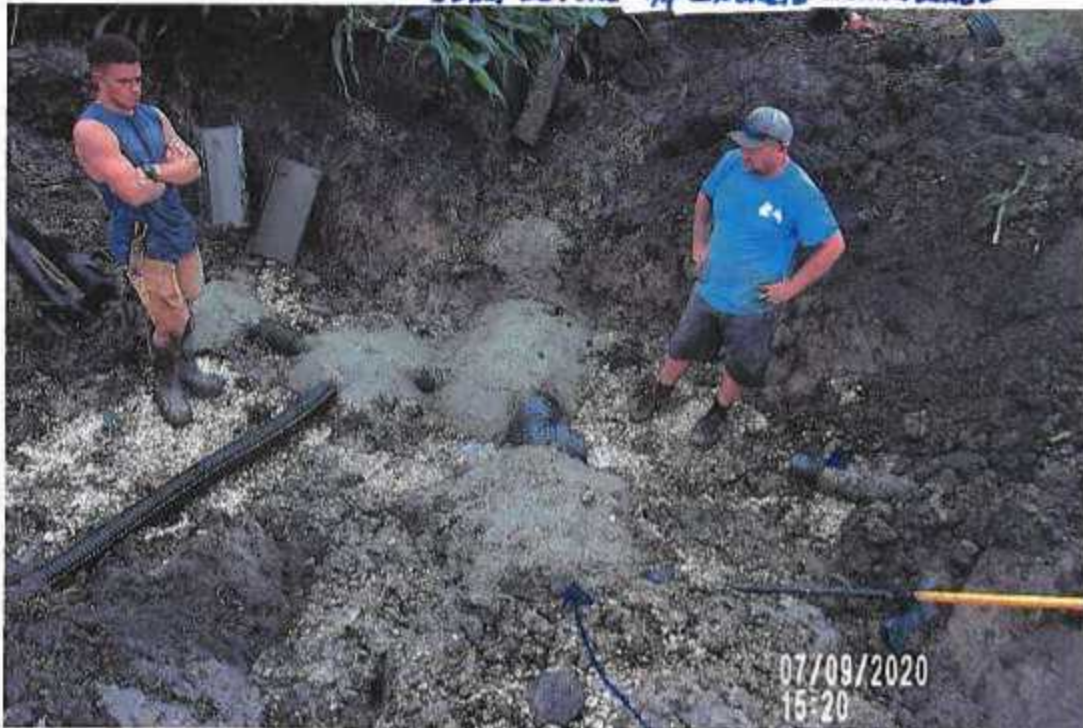
PICTURE #4111 IS LOOKING NW SHOWING 3/4 CONCRETE COLLARS  
POURED AT CONNECTIONS FOR 5" HOPE SW PERF TILE TIE  
INS. CREW USED 17-60 LB BAGS OF QUIKRETE HIGH STRENGTH

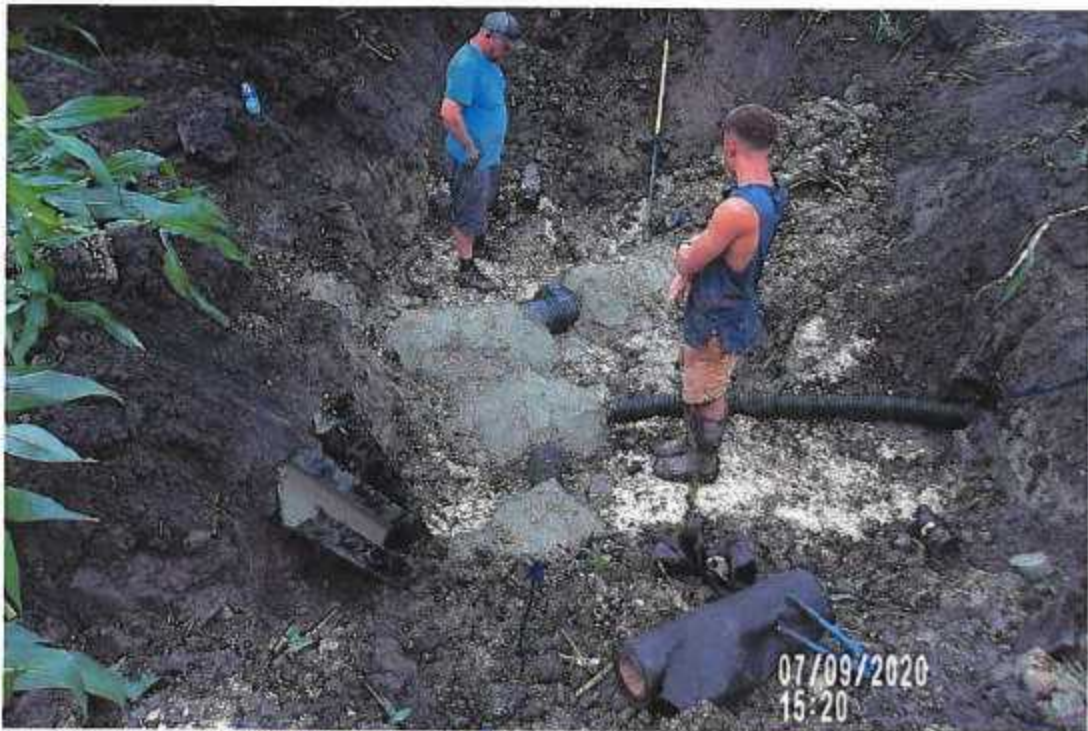
PICTURE #4112 IS LOOKING EAST SHOWING 3/4 CONCRETE COLLARS POWAED (USED 17 QUIKRETE HIGH STRENGTH CONCRETE BAGS

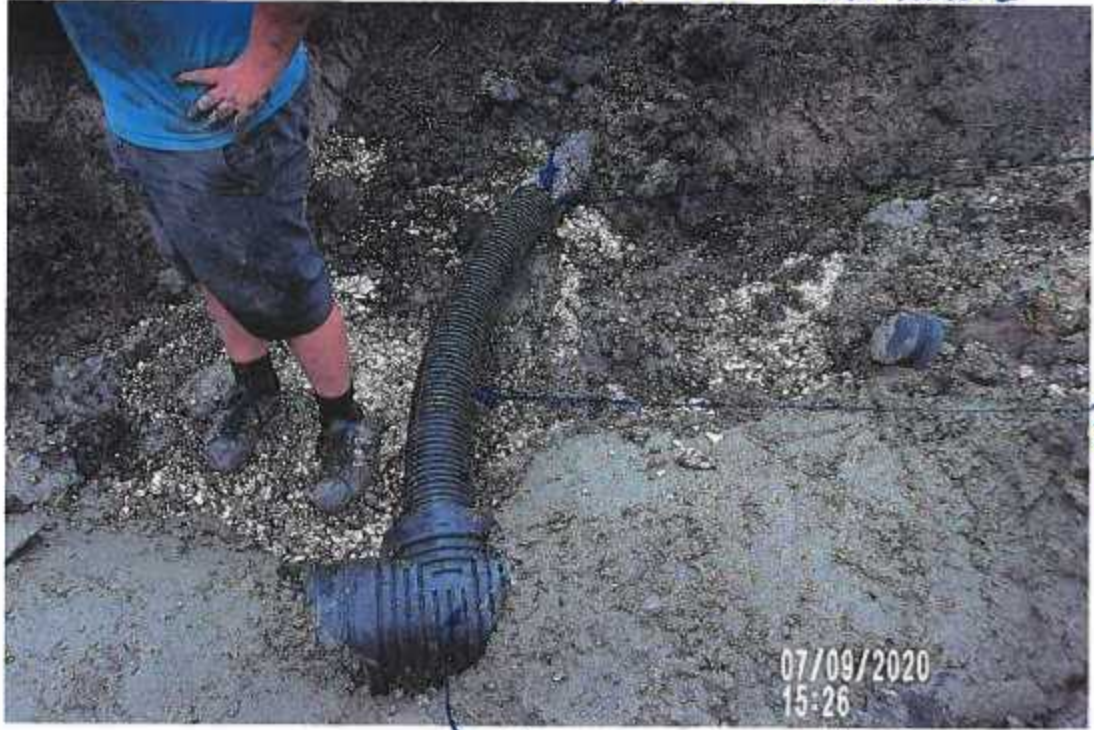
PICTURE #4114 IS LOOKING NE SHOWING 5" HDPE SW PERF TILE TIE IN CONNECTION INTO 8" HDPE LATERAL #2.

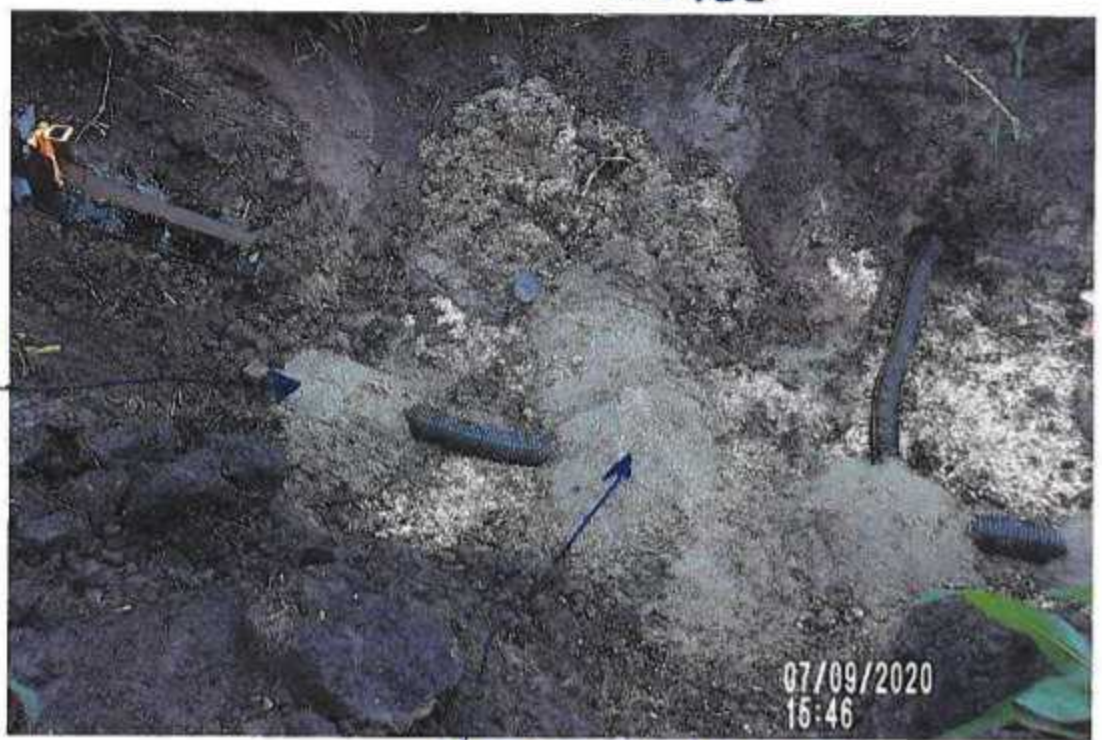
PICTURE #4115

IS LOOKING SE AT 5" HDPE SW PERF TILE TIE IN CONNECTIONS  $\frac{3}{4}$  CONCRETE COLLARS. (USED 9-6016 BAGS OF QUIKRETE HIGH STRENGTH CONCRETE)

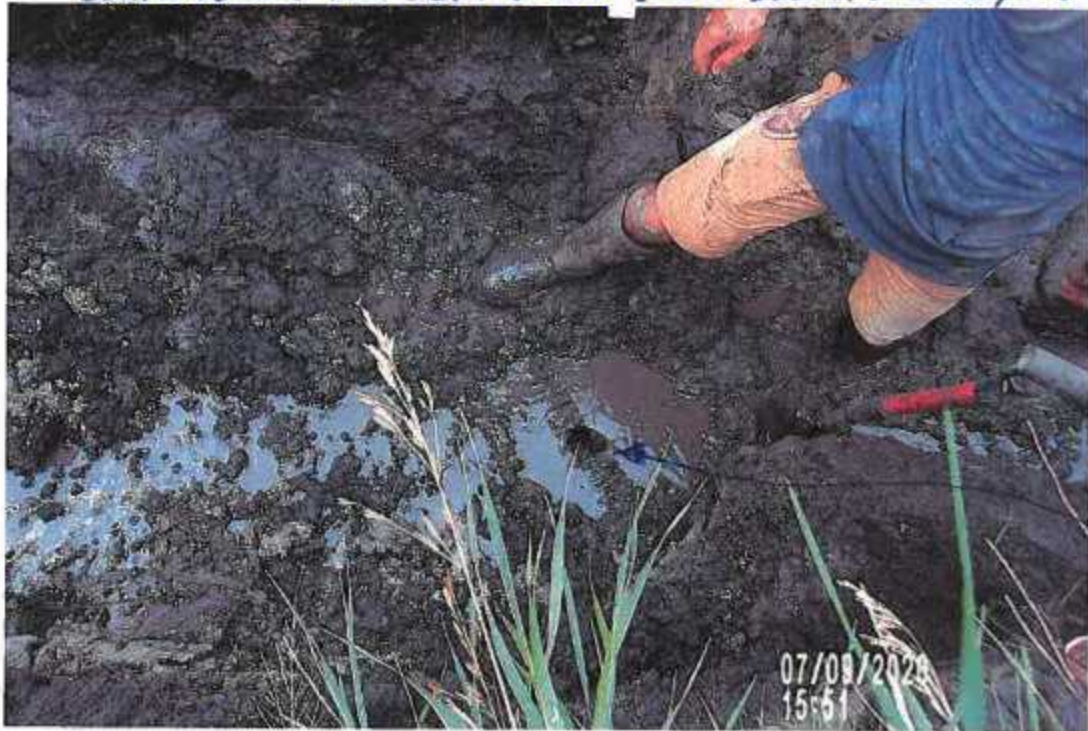
PICTURE # 4116 IS LOOKING EAST SHOWING HOLE IN TOP OF 8" HOPE NONPERF TILE EXCAVATED BY ANOTHER CONTRACTOR AND LEFT OPEN 322'E SOUTH OF HWY 041 & 9.6'±

EAST OF  
EAST ROW  
FENCE  
HWY  
S-27  
IN WISLAND  
AREA

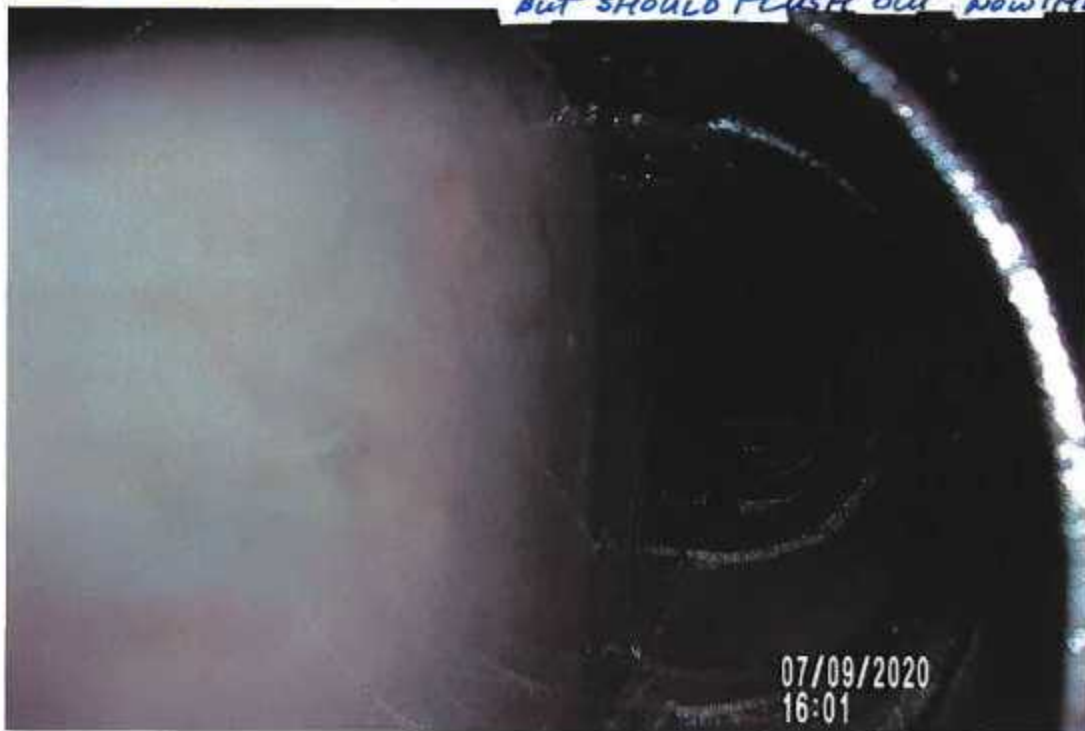
PICTURE # 4117 IS LOOKING DOWNSTREAM (FROM GPS # 311) INSIDE 8" TILE SHOWING CHANGE OF MATERIAL. TILE LOOKS GOOD SHAPE WITH WATER LEVEL AT 4" (SLOW FLOW). ALSO FLOWLINE HAS SOFT MUCK BUT SHOULD PUSH OUT NOW TILE OPEN.

PICTURE # 4119 IS LOOKING UPSTREAM (FROM CPS#311) INSIDE 2" TILE  
SHOWING TILE IN GOOD SHAPE BUT CHANGED TO CLAY WITH  
WATER LEVEL AT 4" (SLOW FLOW). ALSO FLOWLINE HAS SOFT MUCK  
BUT SHOULD FLUSH OUT NOW THAT IT IS  
OPEN.

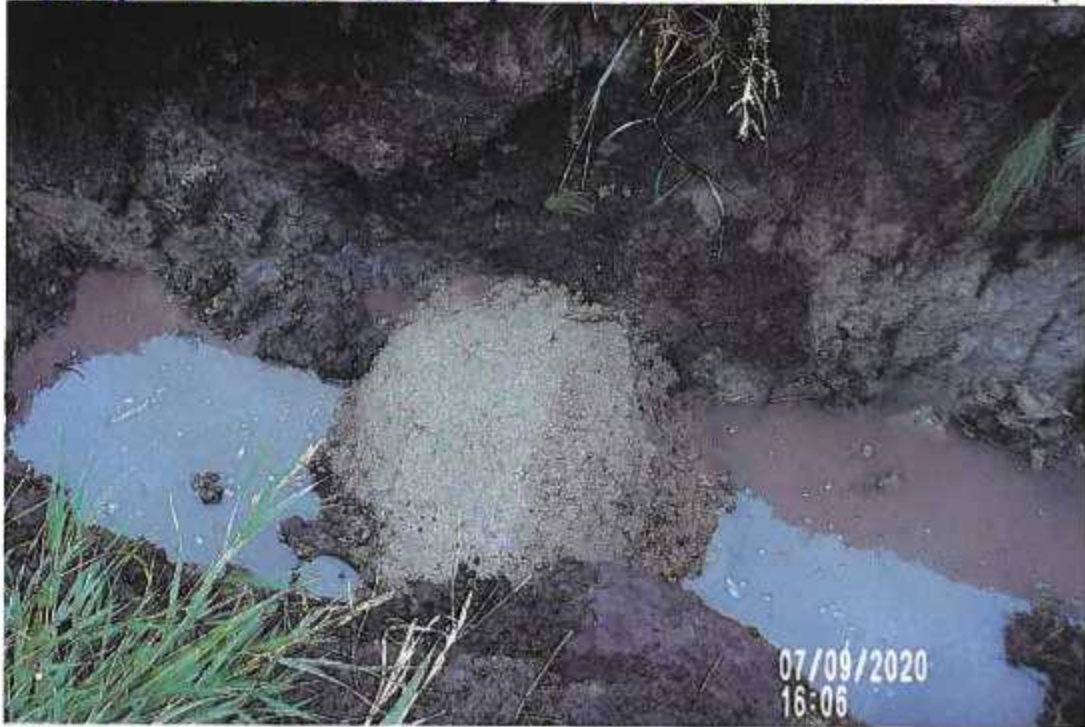
PICTURE # 4120 IS LOOKING EAST SHOWING FABRIC &  
1.0' X 1.5' WIRE MESH OVER HOLE BEFORE 3/4 CONCRETE  
COLLAR POURED OVER HOLE IN TILE.

PICTURE #4121 IS LOOKING AT FINISHED 3/4 CONCRETE COLLAR OVER HOLE IN 8" SW HOPE NON PERF TILE. CREW USED 4 - 60 LB BAGS OF QUIKRETE HIGH STRENGTH CONCRETE ON COLLAR

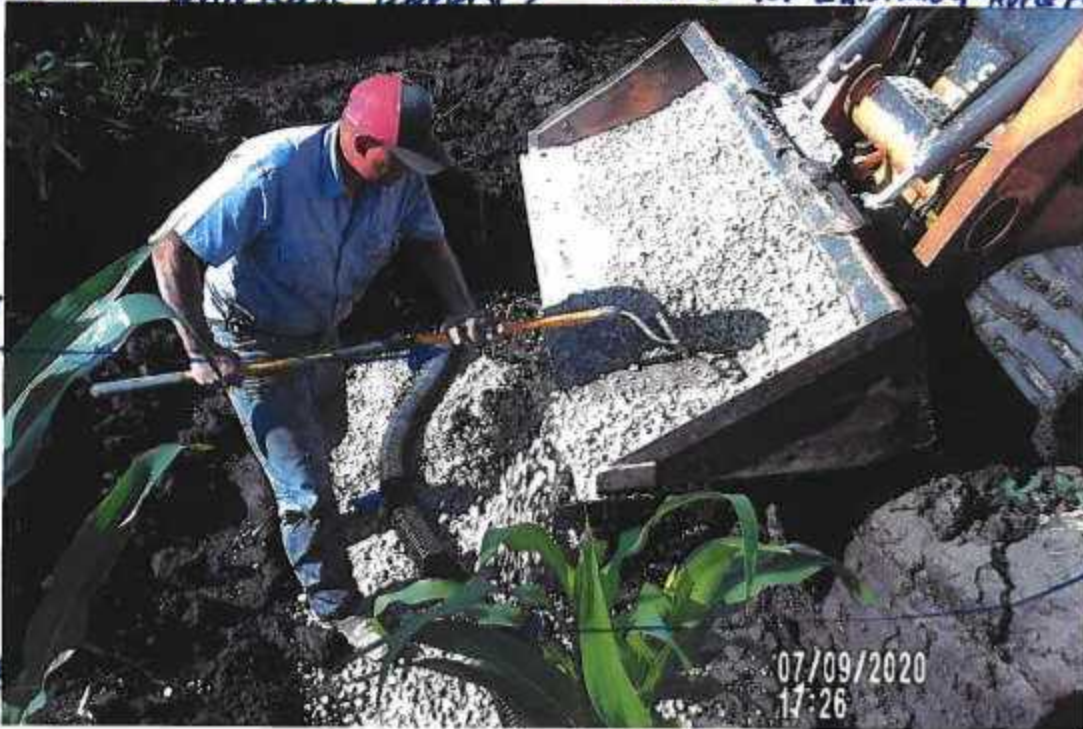
PICTURE #4122 IS LOOKING NW SHOWING 4" SW HOPE PERF TILE THAT NEEDS REPLACED AFTER CUTTING TILE WHILE EXCAVATING TO CHECK LAT #2 TILE FLOW STATUS ON EAST SIDE OF CO HWY S-27.

PICTURE # 4123 IS LOOKING NORTH SHOWING 9.8 LF OF 4" HDPE SW PERF TILE INSTALLED WITH 4" HDPE INTERNAL COUPLERS AND OFF TO SIDE SOME FOR FIRMER GROUND & BEDDED WITH ROCK UNDER. GPS # 312 TOP EXISTING 4" HDPE PERF TILE

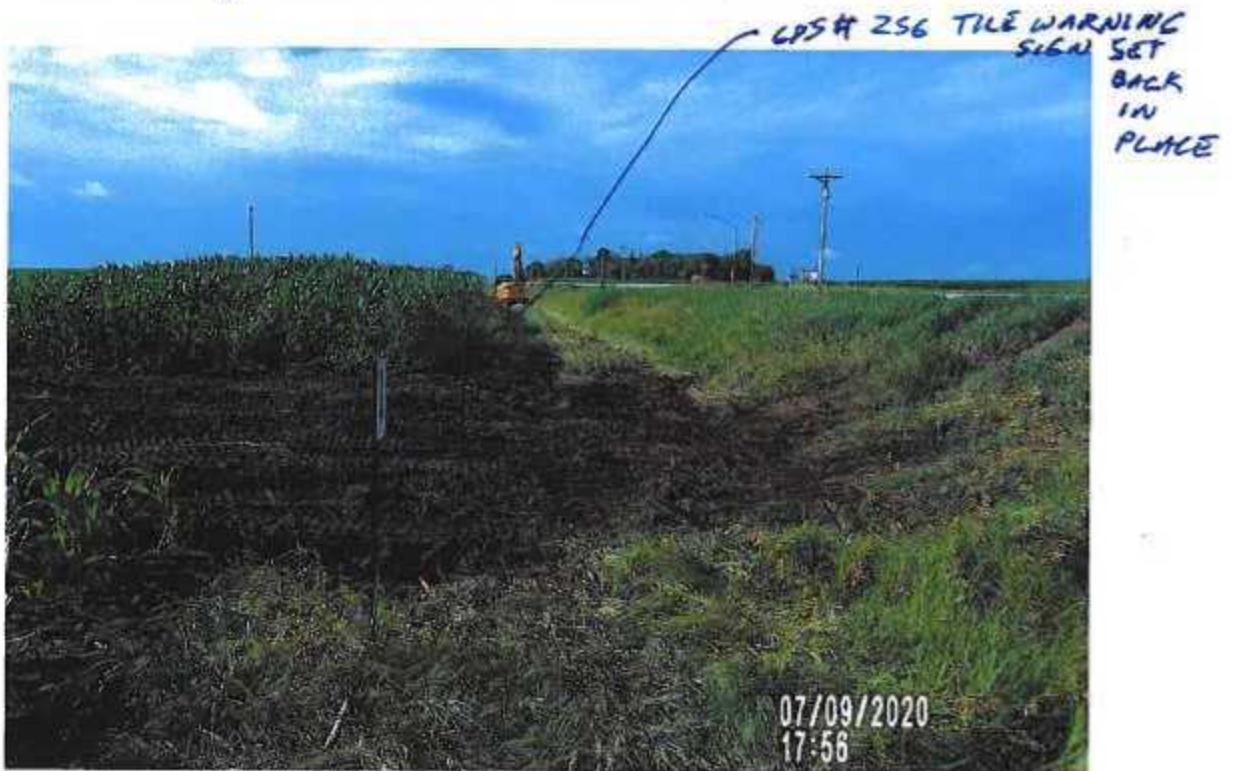
PICTURE # 4124 IS LOOKING NORTH WEST SIDE OF CO HWY 327 SHOWING 4" HDPE PERF TILE REPAIR BEDDED WITH ROCK.

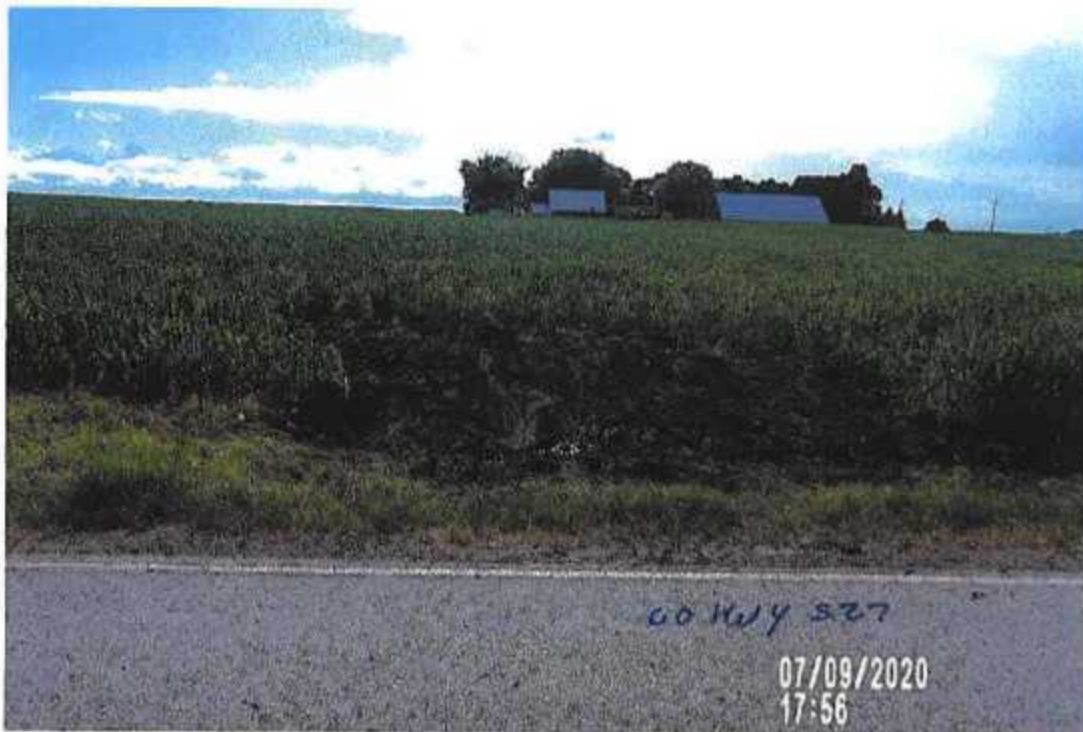
PICTURE#4125 IS LOOKING NORTH SHOWING DITCH WEST SIDE CO HWY S-27 BACK FILLED & GRADED.

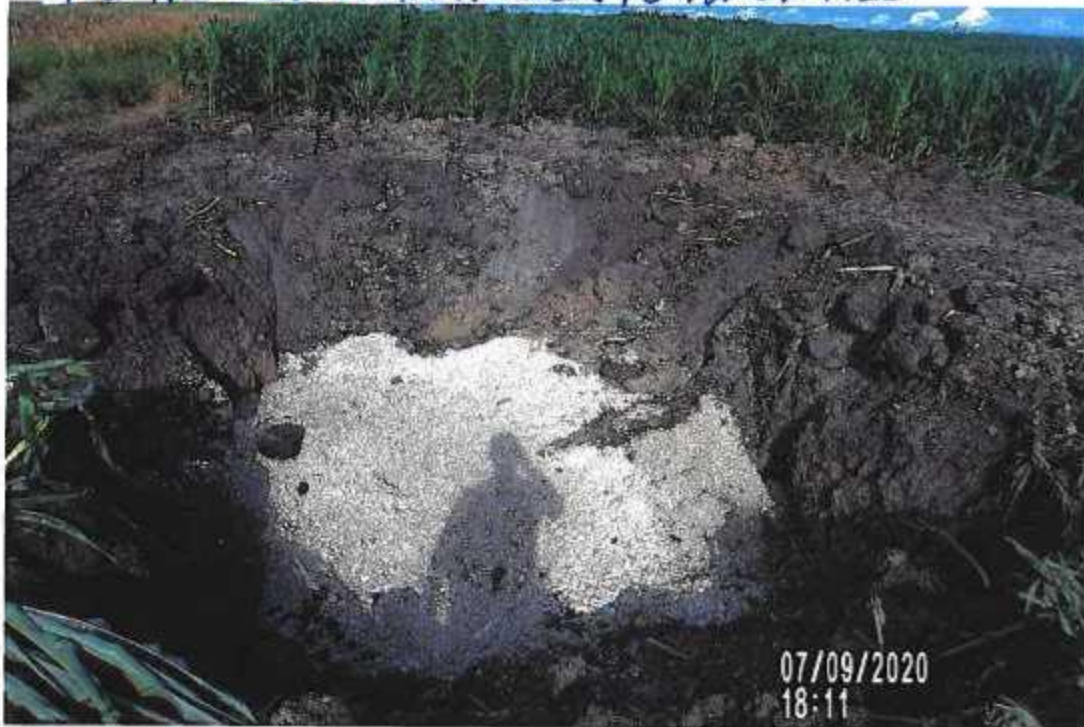
PICTURE#4126 IS LOOKING WEST FROM CO HWY S27 ABOUT 330'± SOUTH E CO HWY D41 SHOWING 4" HDPE SUPER TILE REPAIR BACK FILLED & GRADED. ALSO SHOWS 0.043 AC CORN DAMAGE (GPS# 320 - #324) DURING REPAIR.

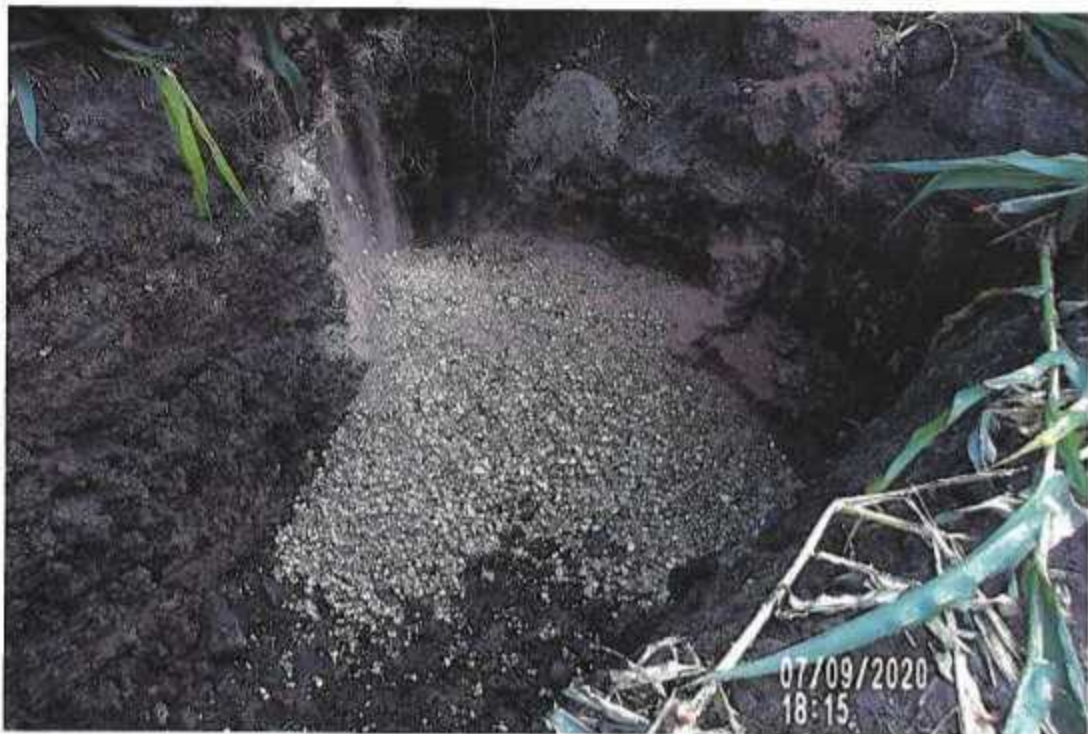
PICTURE# 4127 IS LOOKING EAST SOUTH OF SOUTH  
ROW OF COM.WY D41 SHOWING A 5" HDPE PERF TILE  
THE INS BEDDED WITH ROCK TO TOP OF TILE
