# Drainage Work Order Request For Repair

## Hardin County

### Investigation and Repair Summary:

JOB # 6844 DD14 SURVEY

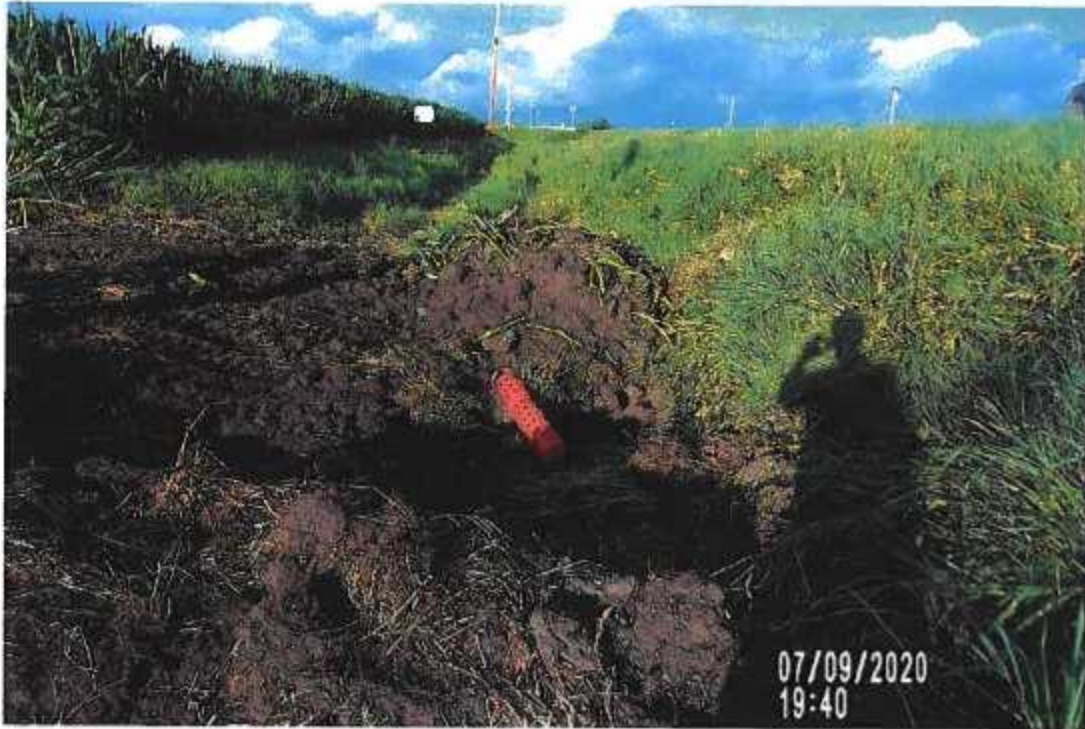
PICTURE# 4128 IS LOOKING NW SHOWING NORTH 14"  
CLAY TILE EXPOSED TRENCH WITH TILE BEDDED  
WITH ROCK TO TOP OF TILE

PICTURE# 4129 IS LOOKING EAST IN NORTH DITCH OF  
CO HWY D41 SHOWING DITCH STILL NEEDS GRADED.

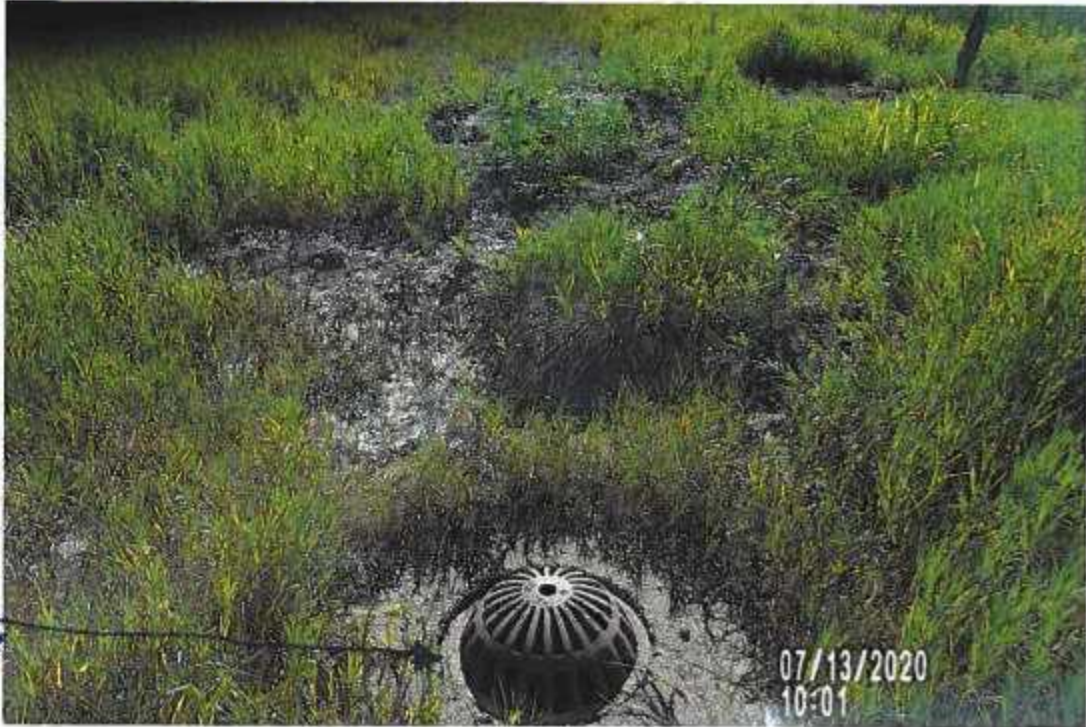
PICTURE# 4138 IS LOOKING EAST SHOWING SMALL  
SINKHOLE ON EAST SIDE OF BEEHIVE INTAKE PER RANDY'S REPORT  
AREA LOOKED LIKE IT HAD BEEN EXCAVATED AT ONETIME

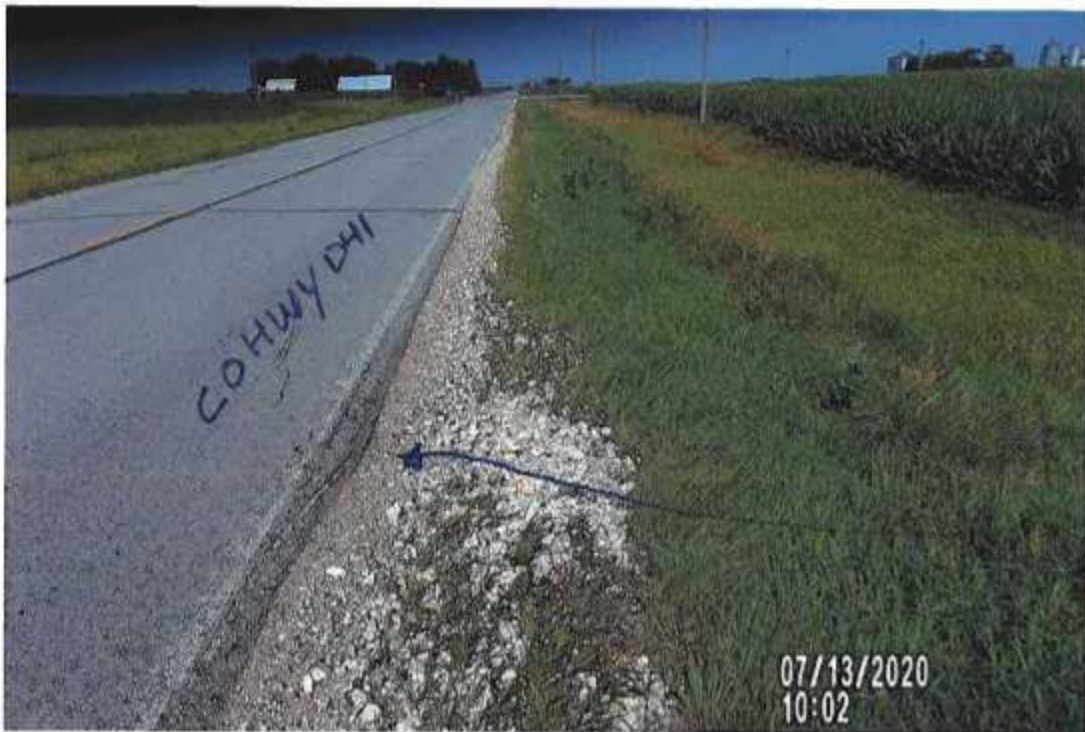
N  
DIP IN  
GRAVEL  
SHOULDER  
WITH  
FRESH  
ROCK

PICTURE#4139 IS LOOKING WEST ON NORTH SHOULDER  
OF CO HWY D41 SHOWING SINK HOLE PER RANDY'S REPORT  
WITH A LITTLE DIP IN ALL 2 GRAVEL AND APPEARS SOMEONE HAS  
PUT FRESH ROCK IN SINK HOLE.

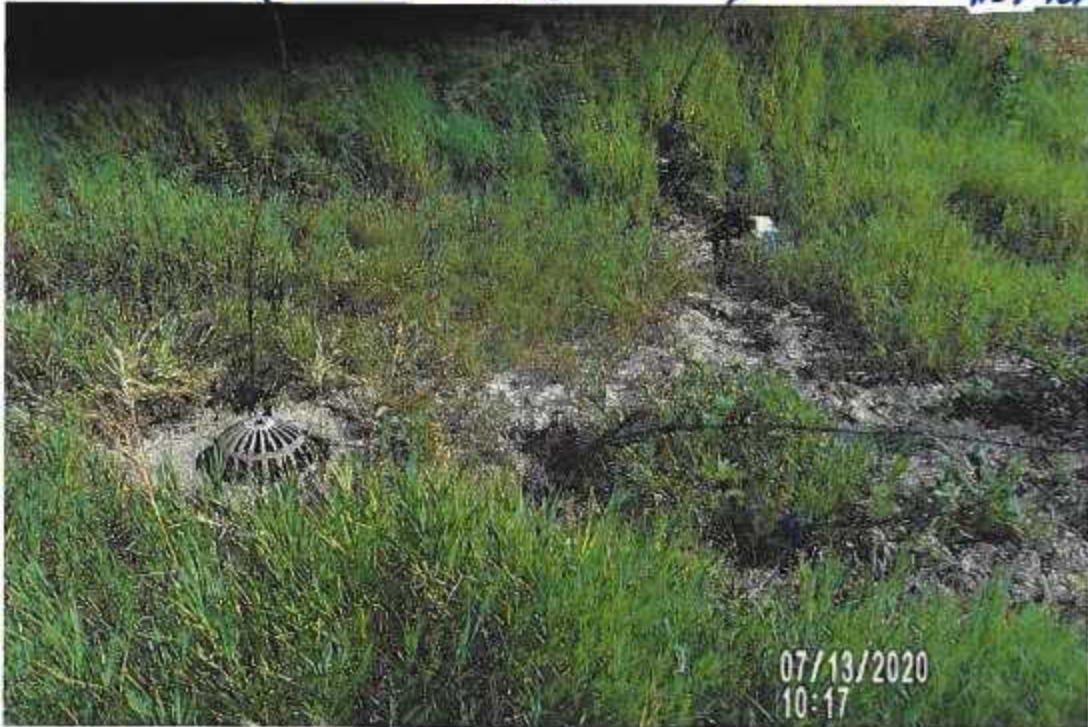
PICTURE# 4140 IS LOOKING NORTH TOWARDS S. HWY D41  
 SHOWING 18" CMP OUTLET FOR CULVERT UNDER CO HWY D41  
 & 18" BEEHIVE INTAKE IN SOUTH DITCH OF CO HWY D41 WITH SINKHOLE  
 GPS# 337 NRM BEEHIVE INTAKE / GPS# 338 TOP 18" CMP TO EAST,  
 1.54' TO TOFL

SINKHOLE  
 EAST OF  
 BEEHIVE  
 INTAKE

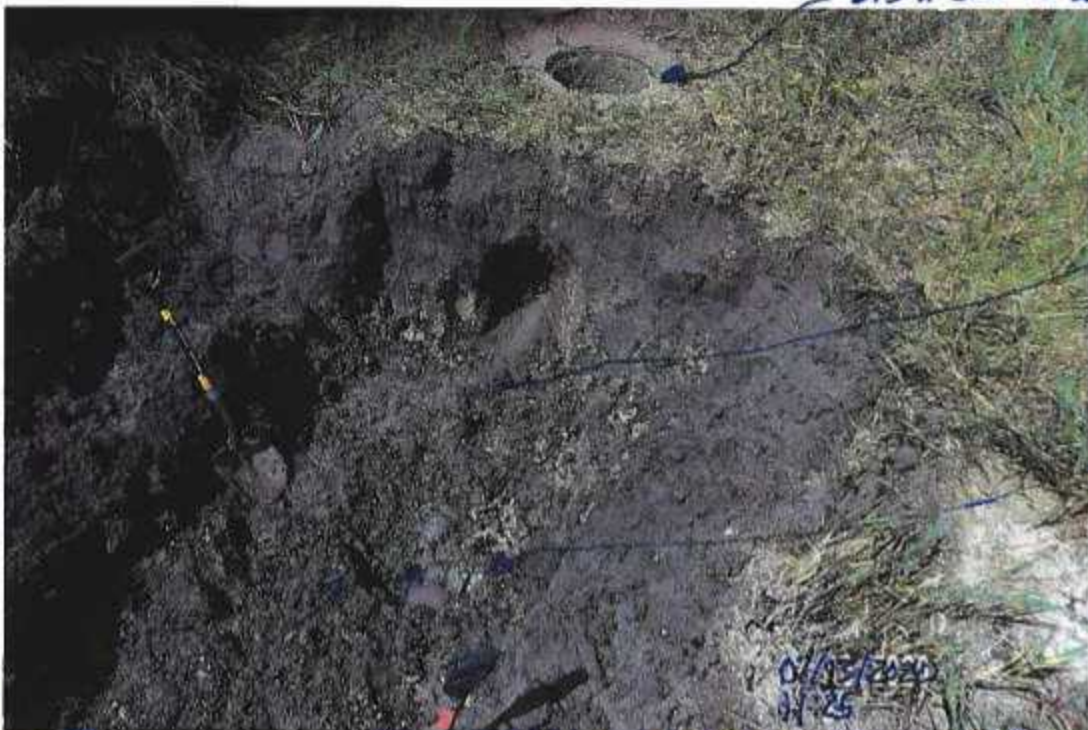
PICTURE# 4141 IS LOOKING EAST ON EAST SIDE OF  
 BEEHIVE INTAKE SHOWING 6" HDPE PERF TILE CONNECTION  
 TO 6" CLAY TILE OUTLET EAST FROM BEEHIVE INTAKE,

PICTURE# 4142 IS LOOKING SE SHOWING 6" HDPE PERF TILE CONNECTION TO 6" CLAY TILE EAST OF BEEHIVE INTAKE. PICTURE SHOWS CREW EXCAVATING TO CHECK ON TILE CONNECTION. 6" HDPE / 6" CLAY TILE CONNECTION CLAY TILE BROKE & WILL NEED REPLACED.

TILE BROKE & WILL NEED REPLACED.

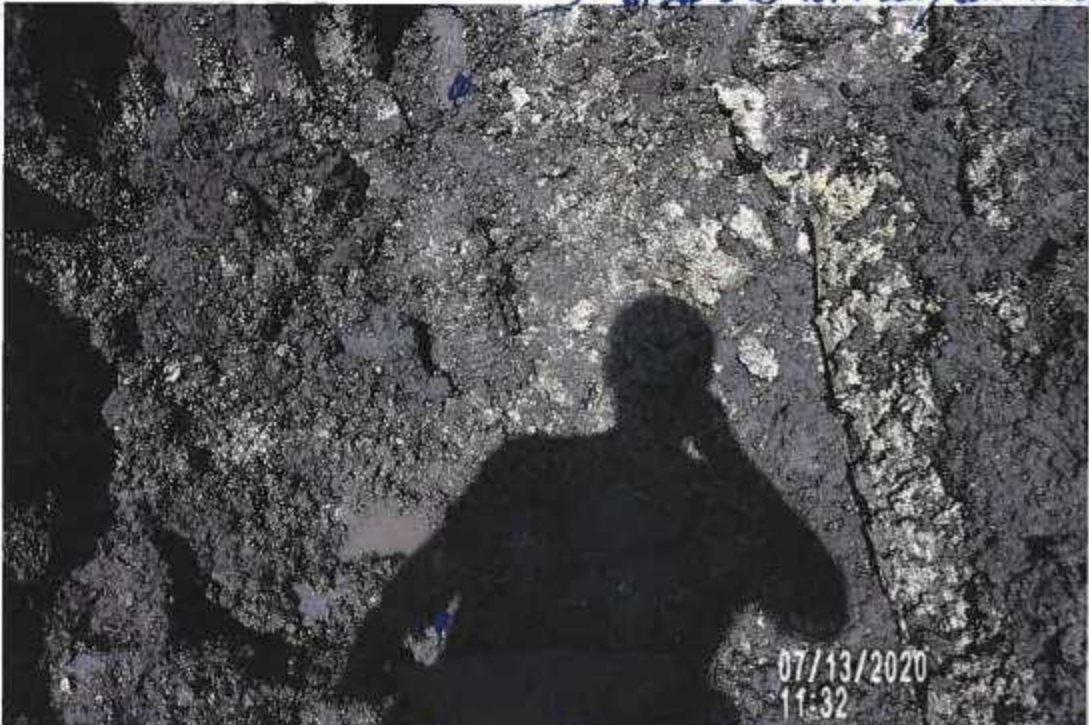
PICTURE# 4143 IS LOOKING AT 6" x 6" x 6" HDPE TEE CONNECTION WITH 6" HDPE / 6" CLAY CONNECTION DAMAGE AND NEEDS REPLACED

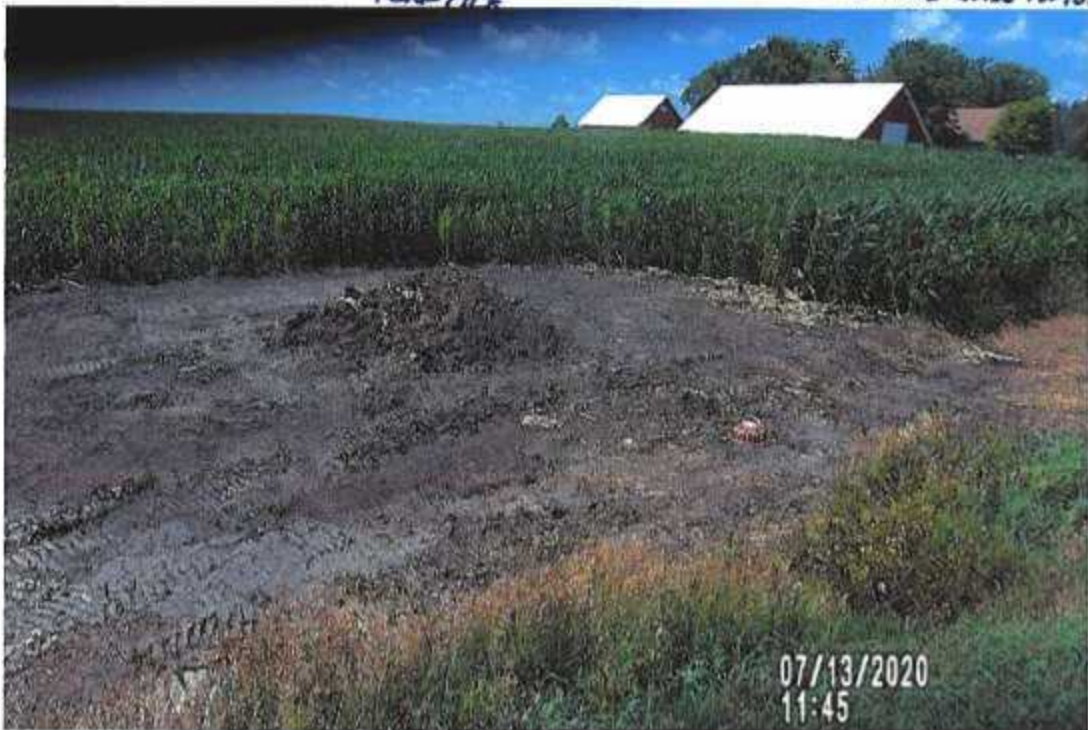
PICTURE # 4144 IS LOOKING WEST SHOWING 6"X6"X6" HOPE TEE CONNECTION & 6" HOPE PER TILE / 6" CLAY TILE WITH ISSUE BETWEEN PLASTIC & CLAY TILE

GPS # 344 TOP 6" HOPE PER TILE  
GPS # 343 TOP 6"X6"X6" HOPE (0.56' TOP TO FC)  
GPS # 342 TOP 6" CLAY (0.57' TOP TO FC)

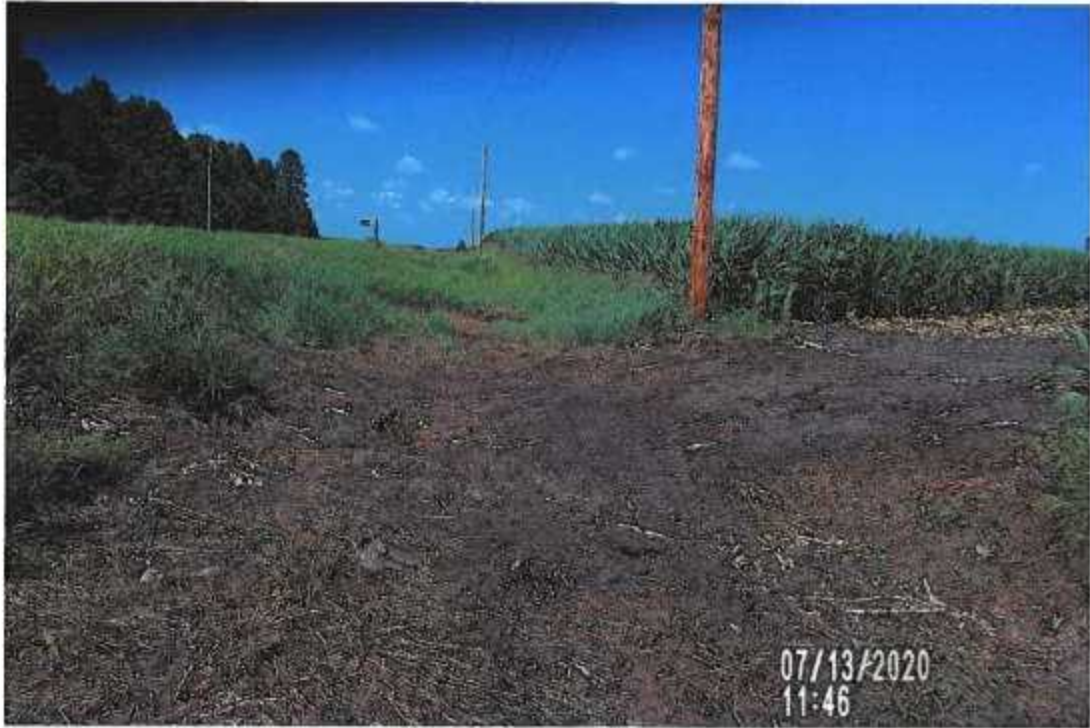
PICTURE # 4145 IS LOOKING SW ON SOUTH SIDE OF HWY 041 SHOWING DITCH GRADED TO INTAKE & TRENCH BACKFILL & GRADED. EXTRA SOIL PILED UP. BLEND EXTRA SOIL AROUND

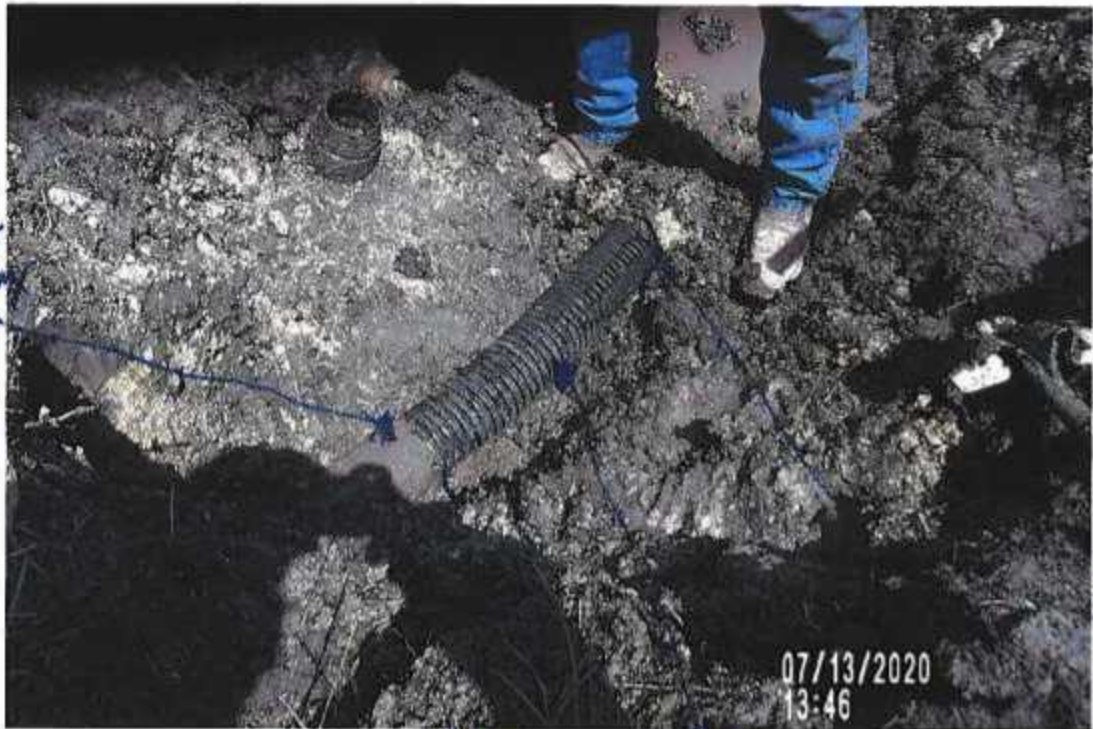
PIICTURE #4147 IS LOOKING WEST SHOWING NORTH DITCH  
GRADED ABOVE TRENCH

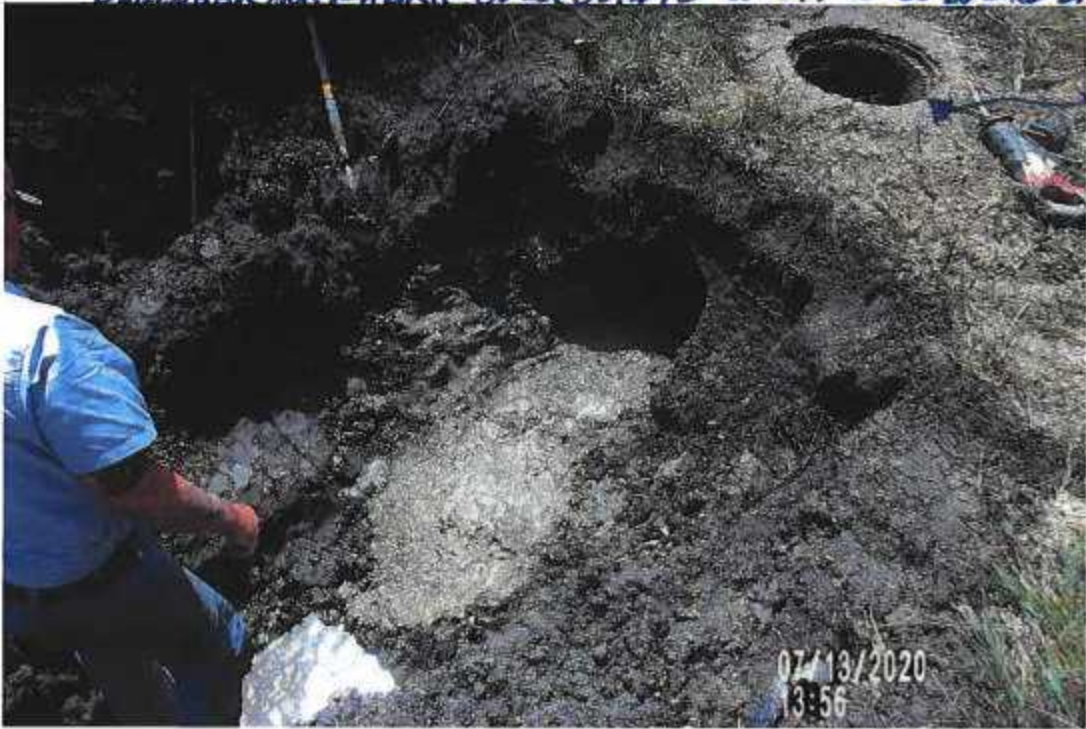
PIICTURE # 4148 IS LOOKING NE SHOWING 6" HDPE<sup>PERF</sup> TILE  
SLIDE INTO TEE & TIED UPSTREAM INTO 6" CLAY TILE WITH  
6" HDPE INTERNAL COUPLER. 2.4 LF OF 6" HDPE<sup>PERF</sup> TILE

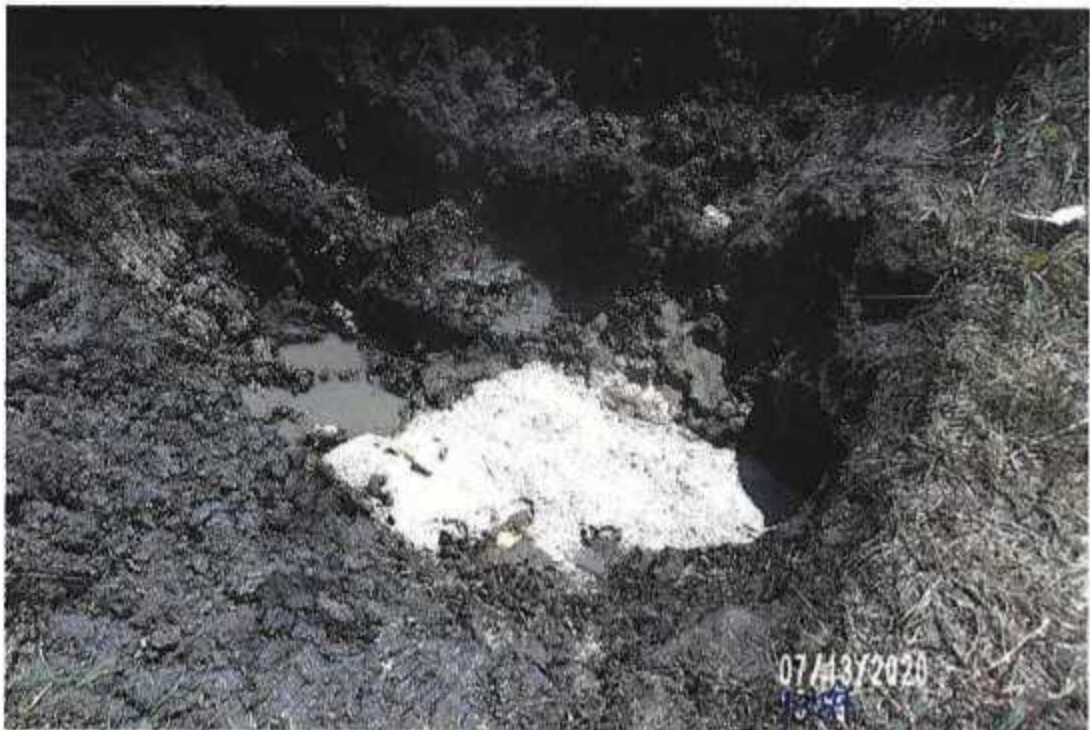
PICTURE# 4149 IS LOOKING SW SHOWING  $\frac{3}{4}$  CONCRETE COLLAR  
 POURED ON BEEHIVE INTAKE TILE OUTLET TIE IN WITH  
 3 - 20 X 15' 6" X 6" WIRE MESHES OVER JOINTS & 3 - 1.5 X 20'  
 DIMENSION FABRIC OVER JOINTS WITH 5-60 LB BAGS OF HIGH STRENGTH  
 CONCRETE

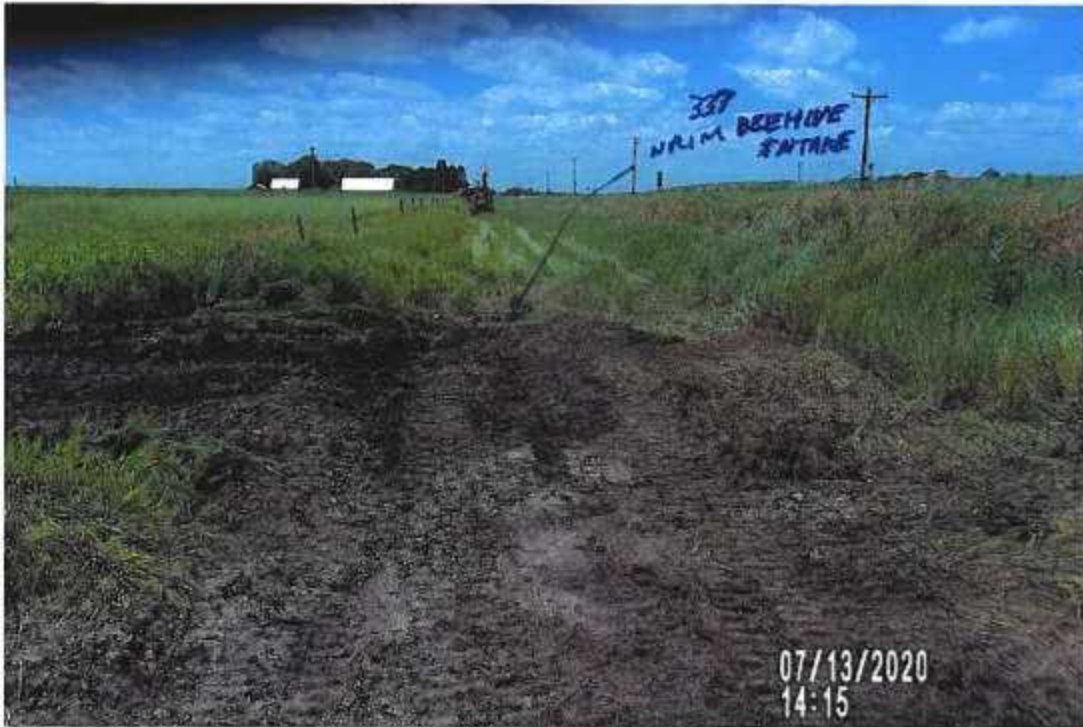
PICTURE# 4150 IS LOOKING SE SHOWING:  $\frac{3}{4}$  CONCRETE COLLAR  
 POURED OVER BEEHIVE OUTLET TILE TIE IN CONNECTION

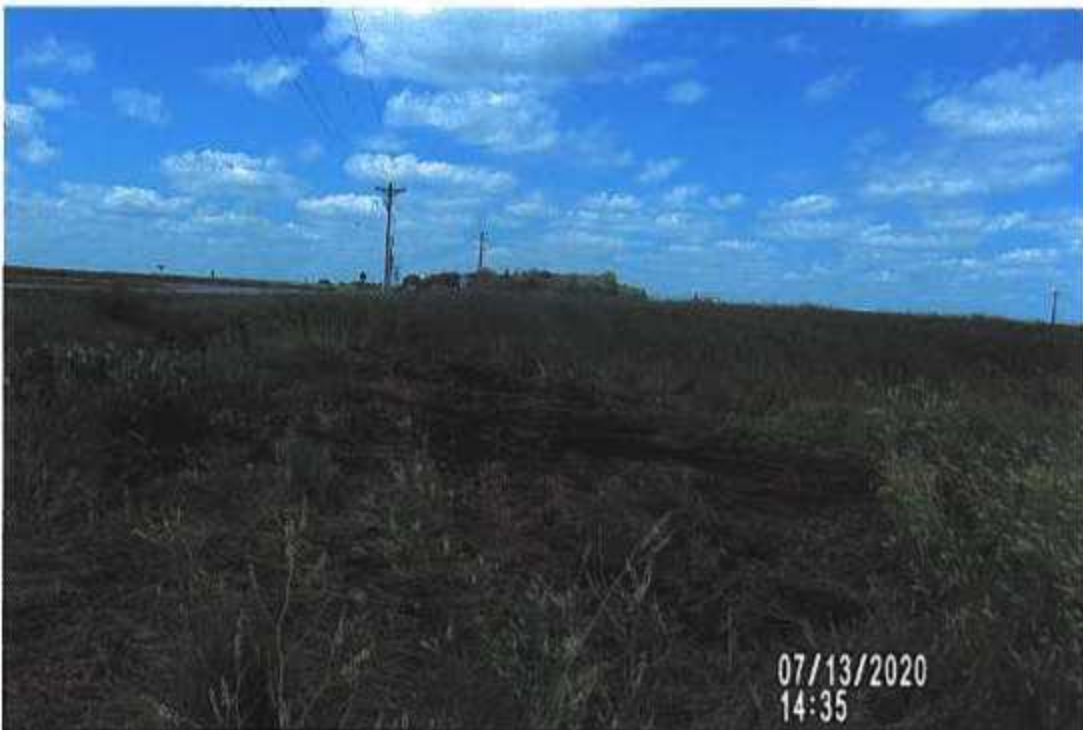
PICTURE# 4151 IS LOOKING WEST SHOWING DITCH  
GRADED TO BEEHIVE INTAKE

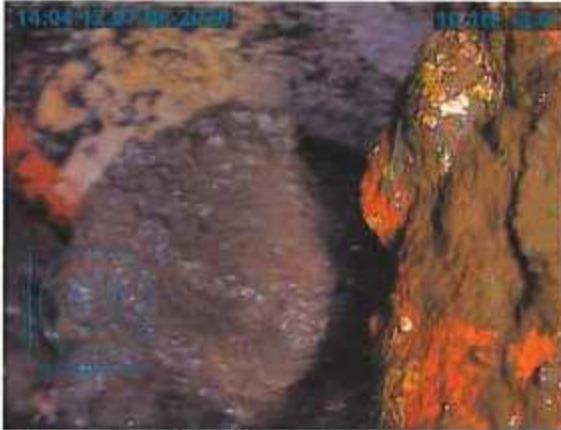
CN 2020\_07\_08-14\_04\_12\_399.jpg

Video Ref	Dist (ft)	Cont Defect	Code	Photo Ref	Diameter/ Dimension	Clock		Intrusion		Remarks
						At	To	%	mm	
0:00:00	10.1		CN	2020_07_08- 14_04_12_399.jpg
