**ENGINEER'S
REPORT ON
REPAIRS TO
MAIN TILE,
DRAINAGE
DISTRICT NO. 67
HARDIN COUNTY**

Engineer's Report on Repairs to Main Tile, Drainage District No. 67 Hardin County, Iowa

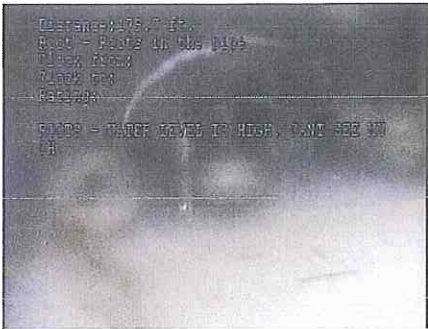
Distance	Dire Length	From/To Code	Modifier/Severity	Rating	Comments
179.7 ft.	U	/	Root		ROOTS - WATER LEVEL IS HIGH. CANT SEE MUCH

1+82 COLLAPSE LIKELY - PIPE V SHAPED

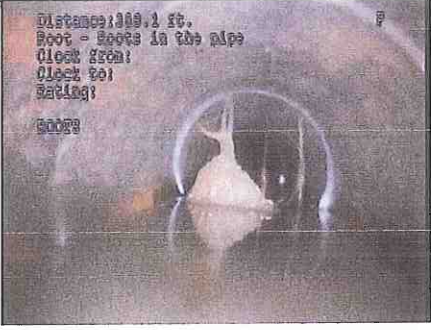
308.1 ft.	U	/	Root	3+19 PIPE SAGGING, SOIL VISIBLE IN JOINT - PIPE V SHAPED	ROOTS

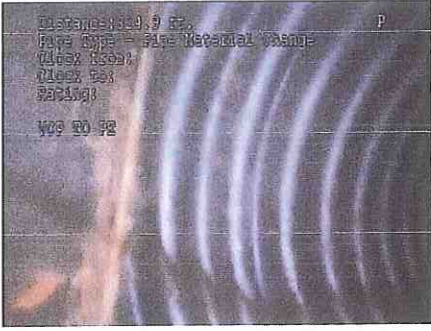
324.9 ft.	U	/	Pipe Type	VCP -> SW HDPE - PIPE EGG SHAPED	VCP TO PE

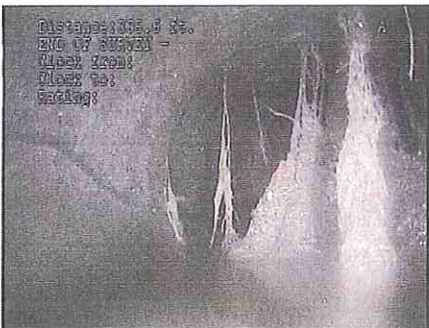
335.6 ft.	U	/	END OF SURVEY		
-----------	---	---	---------------	--	--

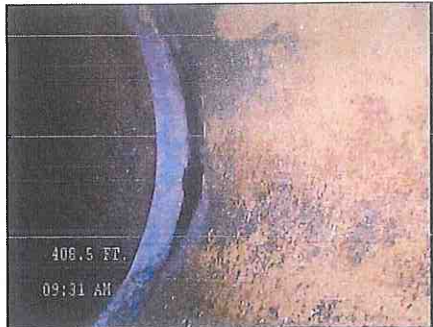
3+99 JOINT OFFSET, SOIL VISIBLE IN GAP - PIPE ROUND

408.5 ft.	D	/	Joint Offset, JOINT OFFSET, SOIL VISIBLE IN GAP (THREE IN A ROW) - PIPE ROUND		WIDE
-----------	---	---	---	--	-------------

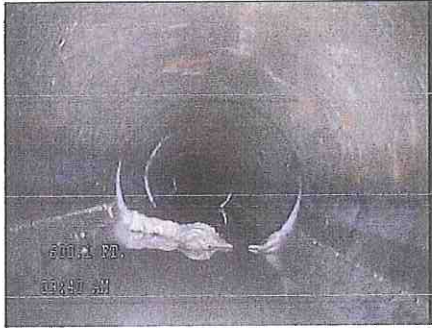
600.1 ft.	D	5 / 8	Root	- PIPE ROUND		ROOTS

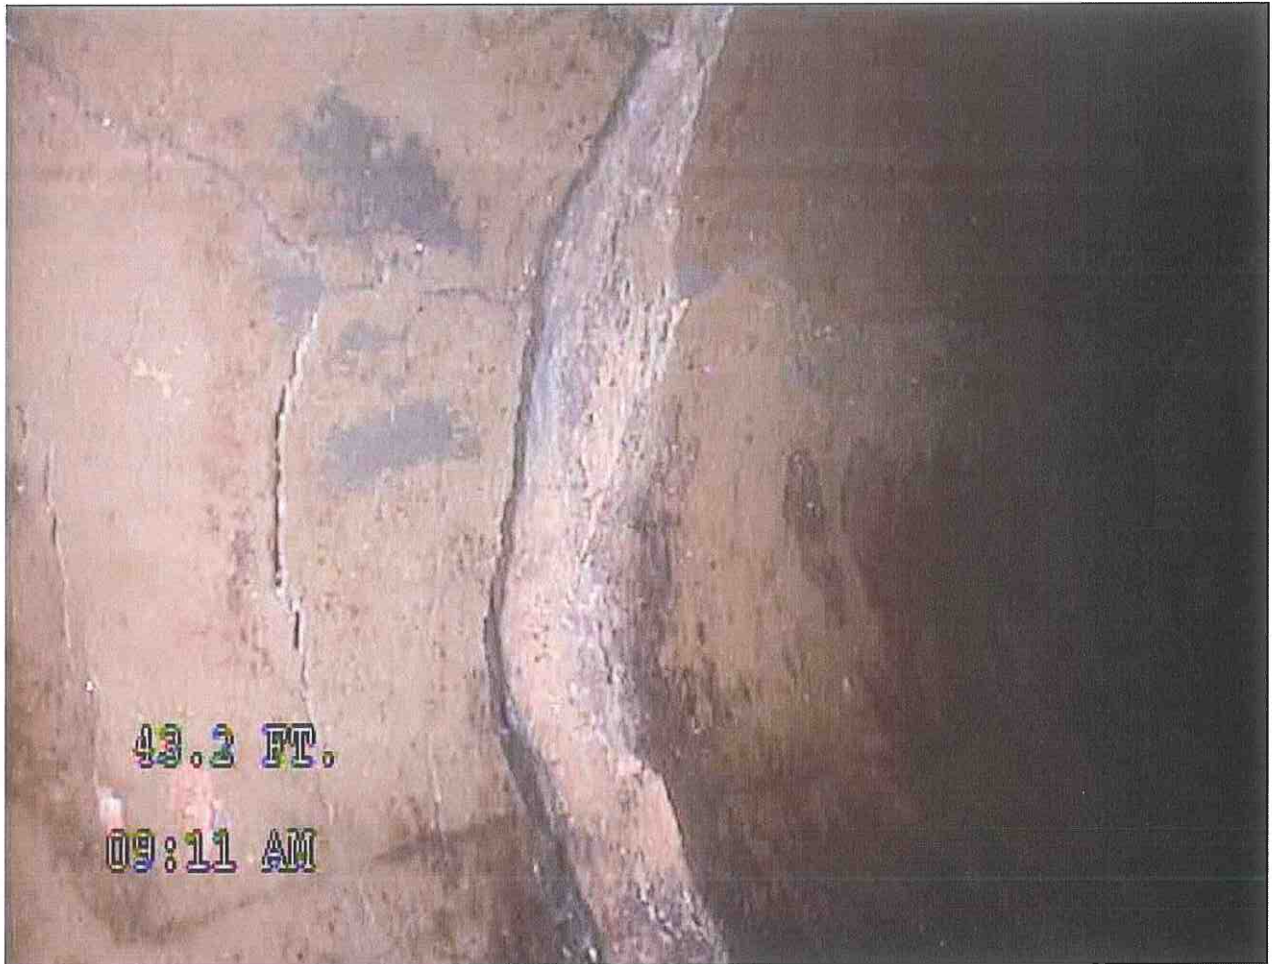
43.2 FT.

<p>0+04 MULTIPLE CRACKS, PIPE SAGGING - PIPE V SHAPED 0+18 JOINT OFFSET (VERT) - PIPE ROUND 0+20 JOINT OFFSET (VERT) - PIPE ROUND 0+33 TILE SAGGING, JOINT OFFSET - PIPE V SHAPED</p>					
37.0 ft.	D	/	Joint - Separated, SOIL VISIBLE IN JOINT - PIPE ROUND		WIDE JOINT

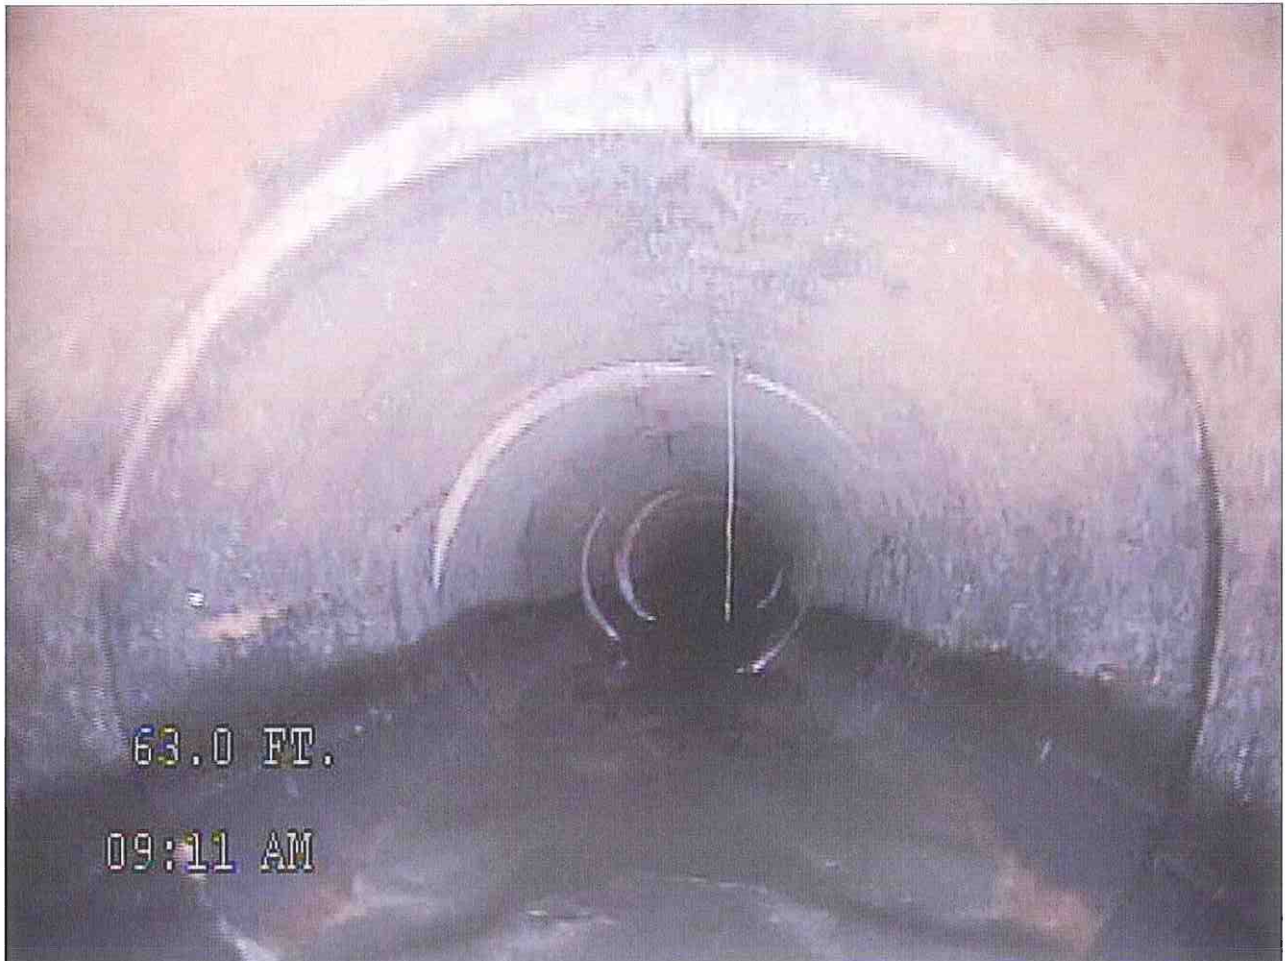
63.0 FT.

<p>0+43 JOINT OFFSET, RADIAL CRACK - PIPE ROUND 0+46 CRACKS END - PIPE ROUND 0+58 TOP CRACK (START) - PIPE ROUND 0+63 TILE SAGGING (ONE) - PIPE V SHAPED</p>					
71.5 ft.	D	7 / 11	Joint - Separated, SOIL VISIBLE, TILE SAGGING - PIPE EGG SHAPED		WIDE JOINT - SOIL SHOWING

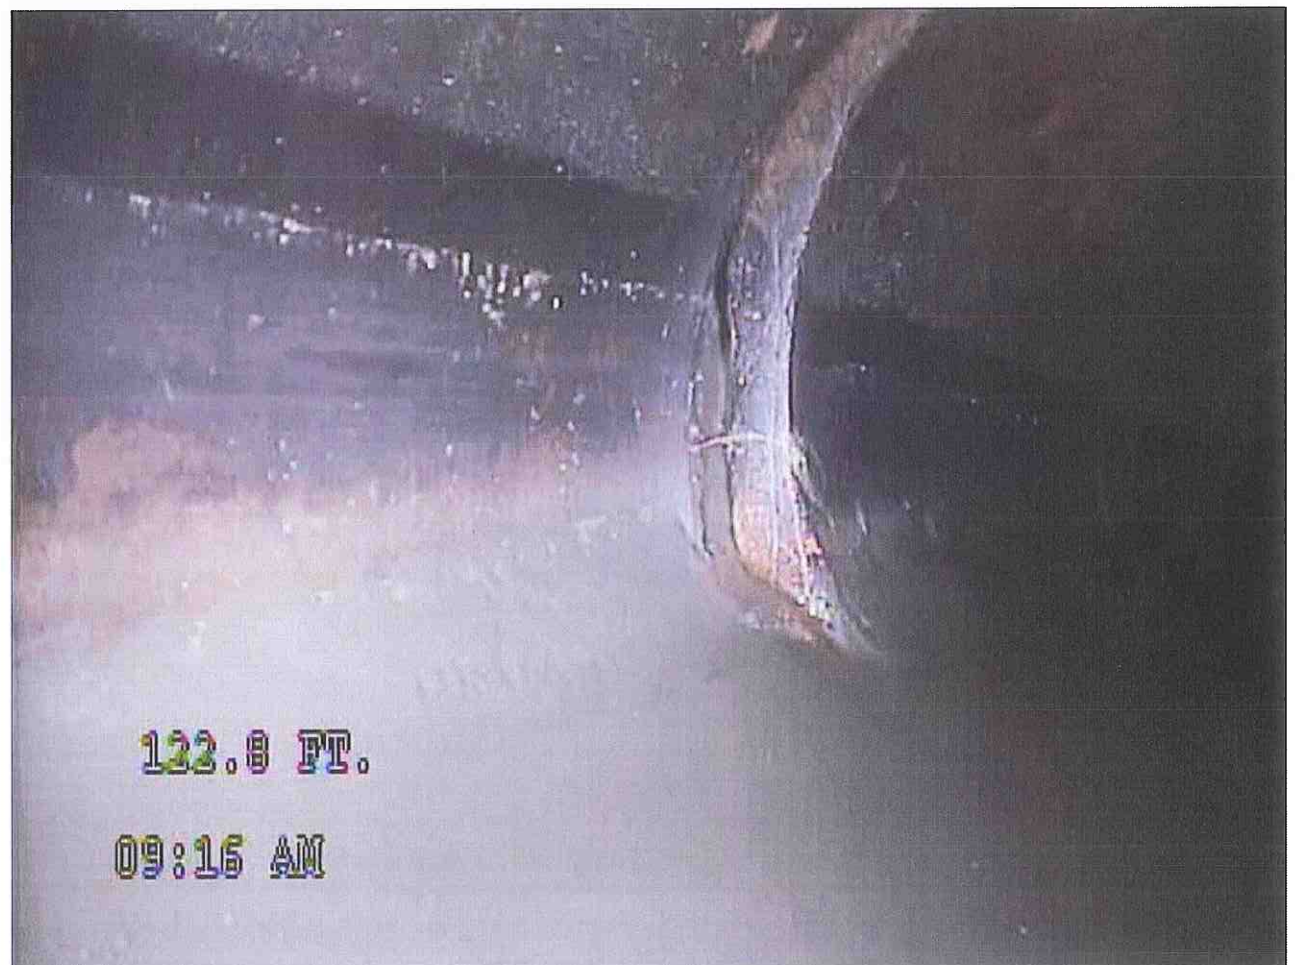
122.8 FT.

122.8 ft. D **7 / 10** **Joint Offset**, SOIL VISIBLE IN GAP (TWO IN A ROW), TOP CRACK (END) - PIPE ROUND **OFFSET**

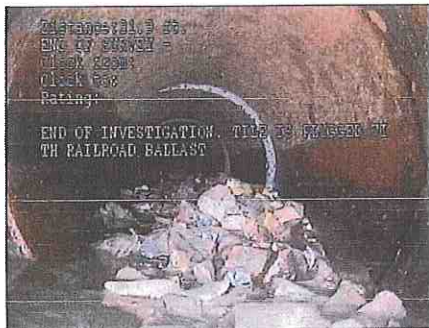
31.9 ft.	U	/	END OF SURVEY, DEBRIS TOO DEEP.		END OF INVESTIGATION. TILE IS PLUGGED WITH RAILROAD BALLAST
----------	---	---	---------------------------------	--	---
