9

## Repair Summary:

**DRAINAGE DISTRICT #9**  
 HARDIN, IOWA

**SPOT REPAIRS**

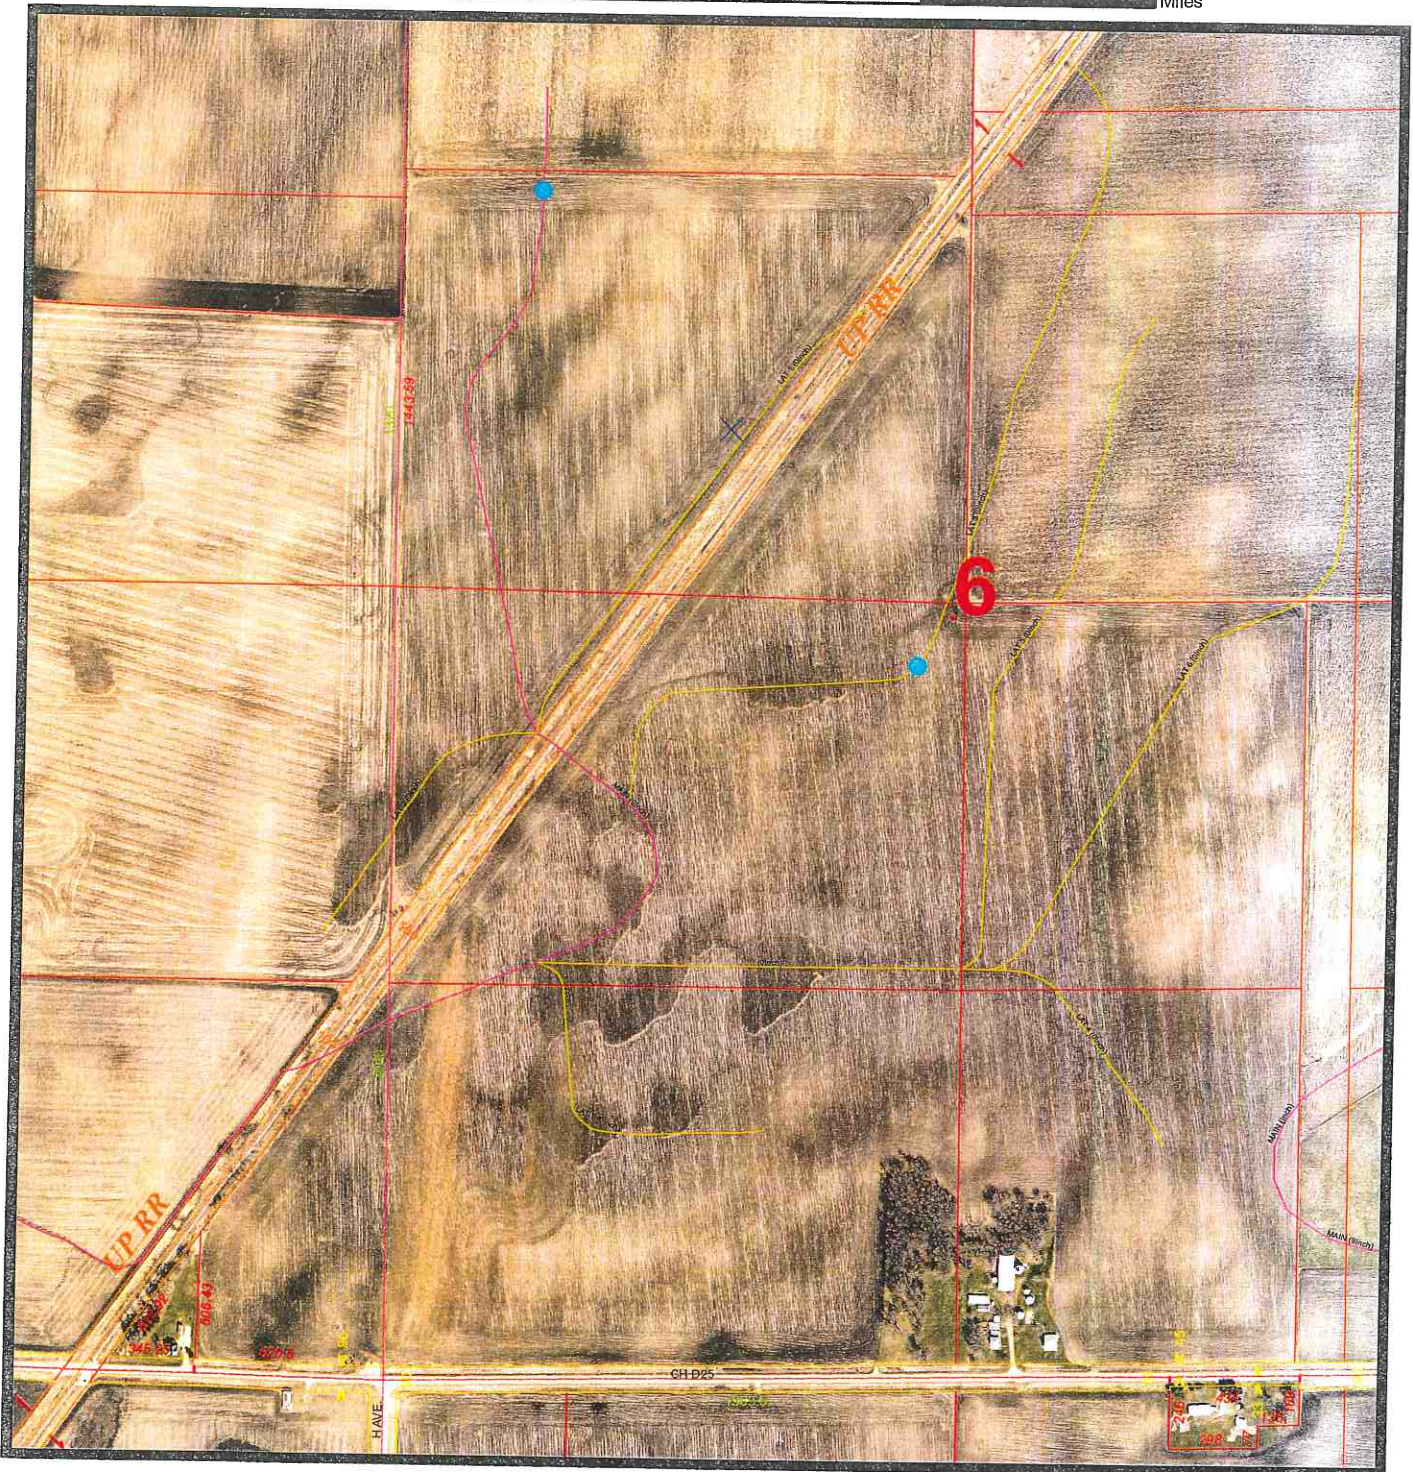
- Tenant in SW¼ Section 6, Township 89 North, Range 22 West reported two blowouts/sinkholes on Main tile.
- Visually searched area and found one blowout/sinkhole, approximately 225 feet southeast of railroad right of way (see attached spot repair map).

- Upstream found broken VCP tile in sinkhole/blowout just downstream of railroad. The tile appears to have possibly been broken when fiber optic line was installed (see attached spot repair map).

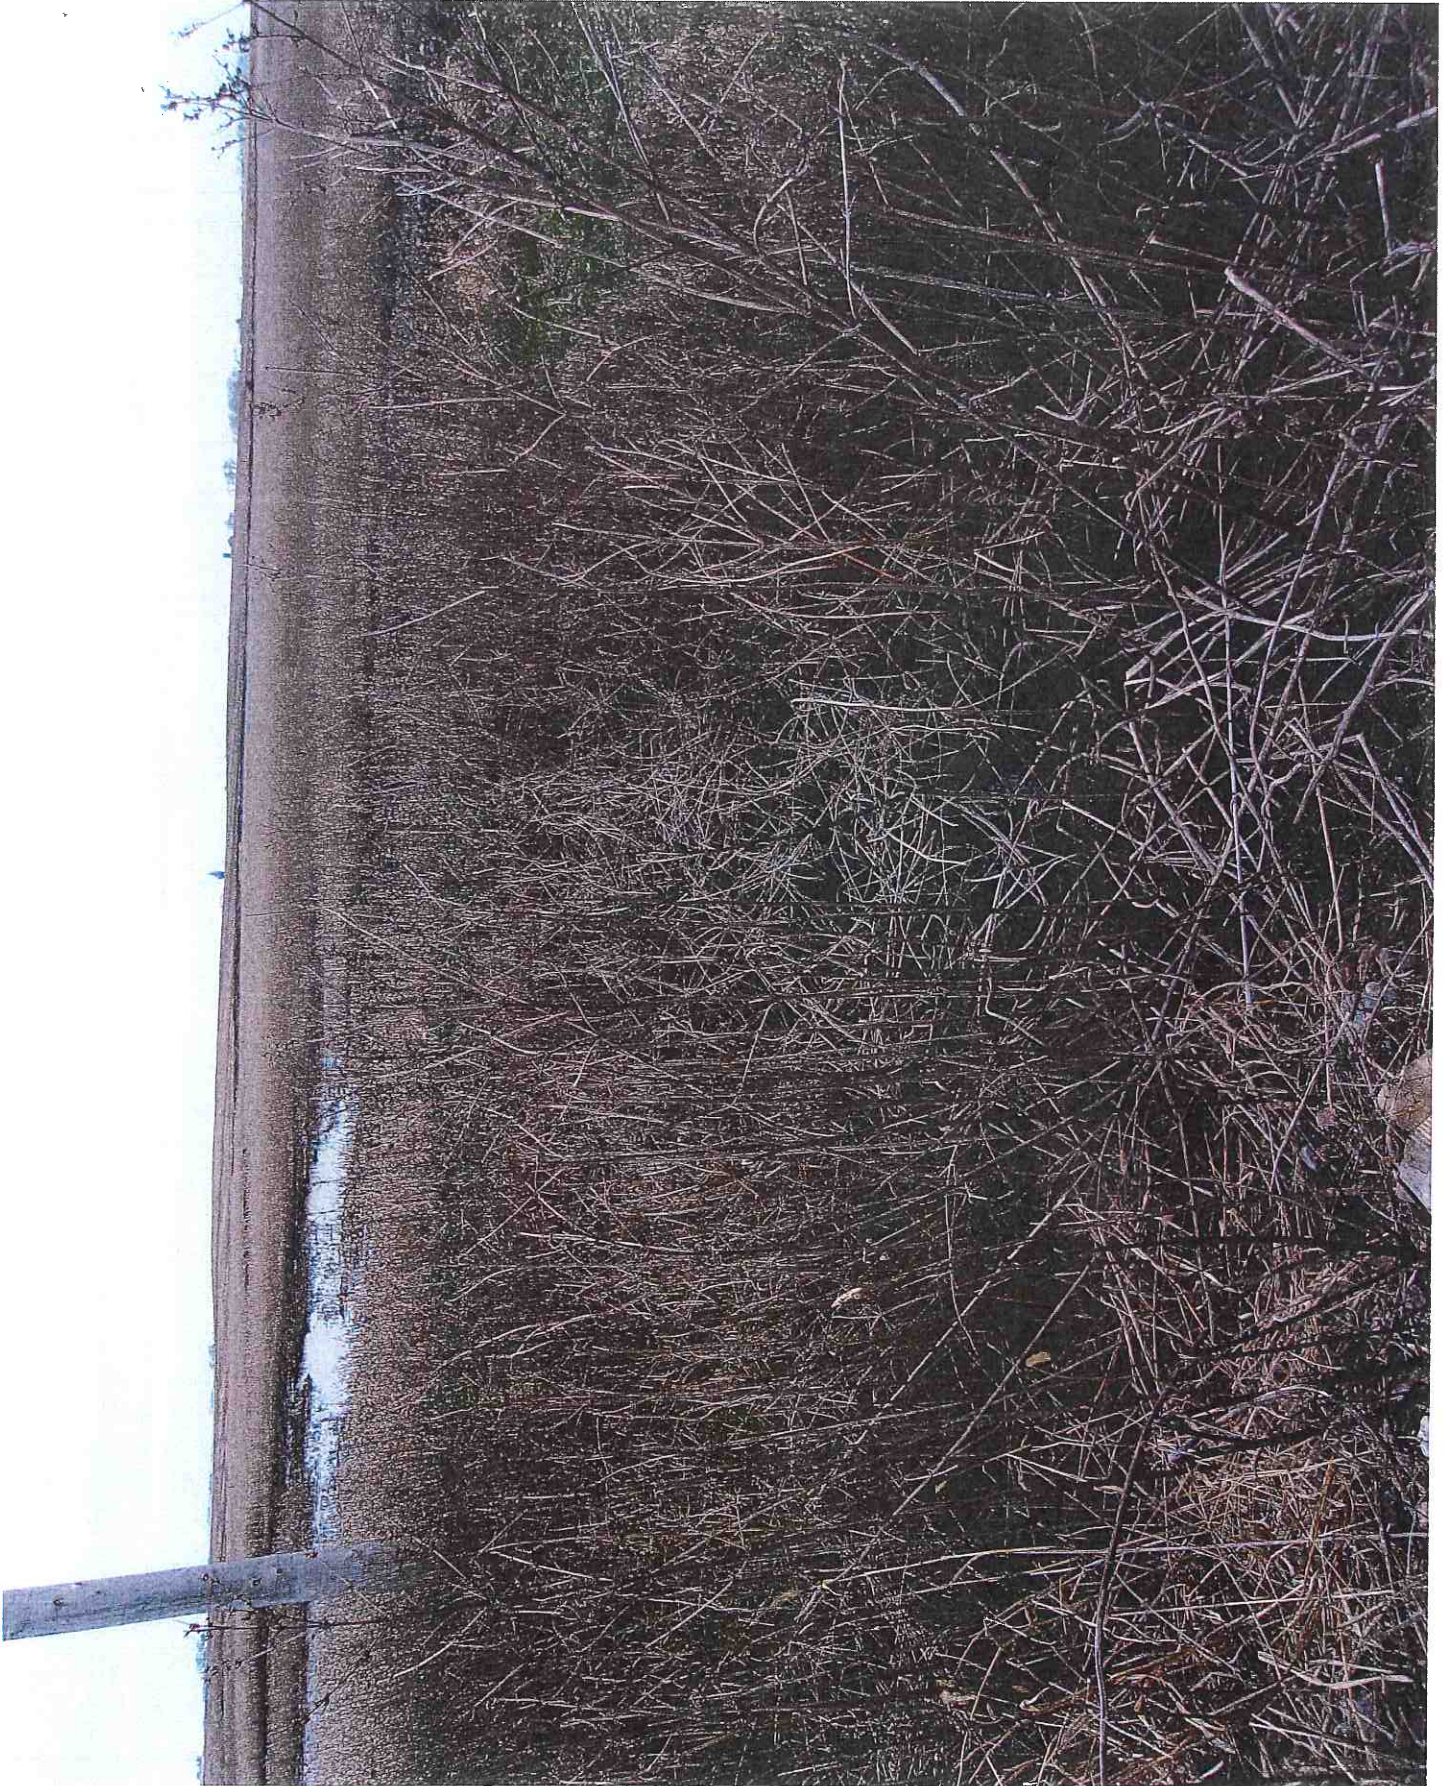
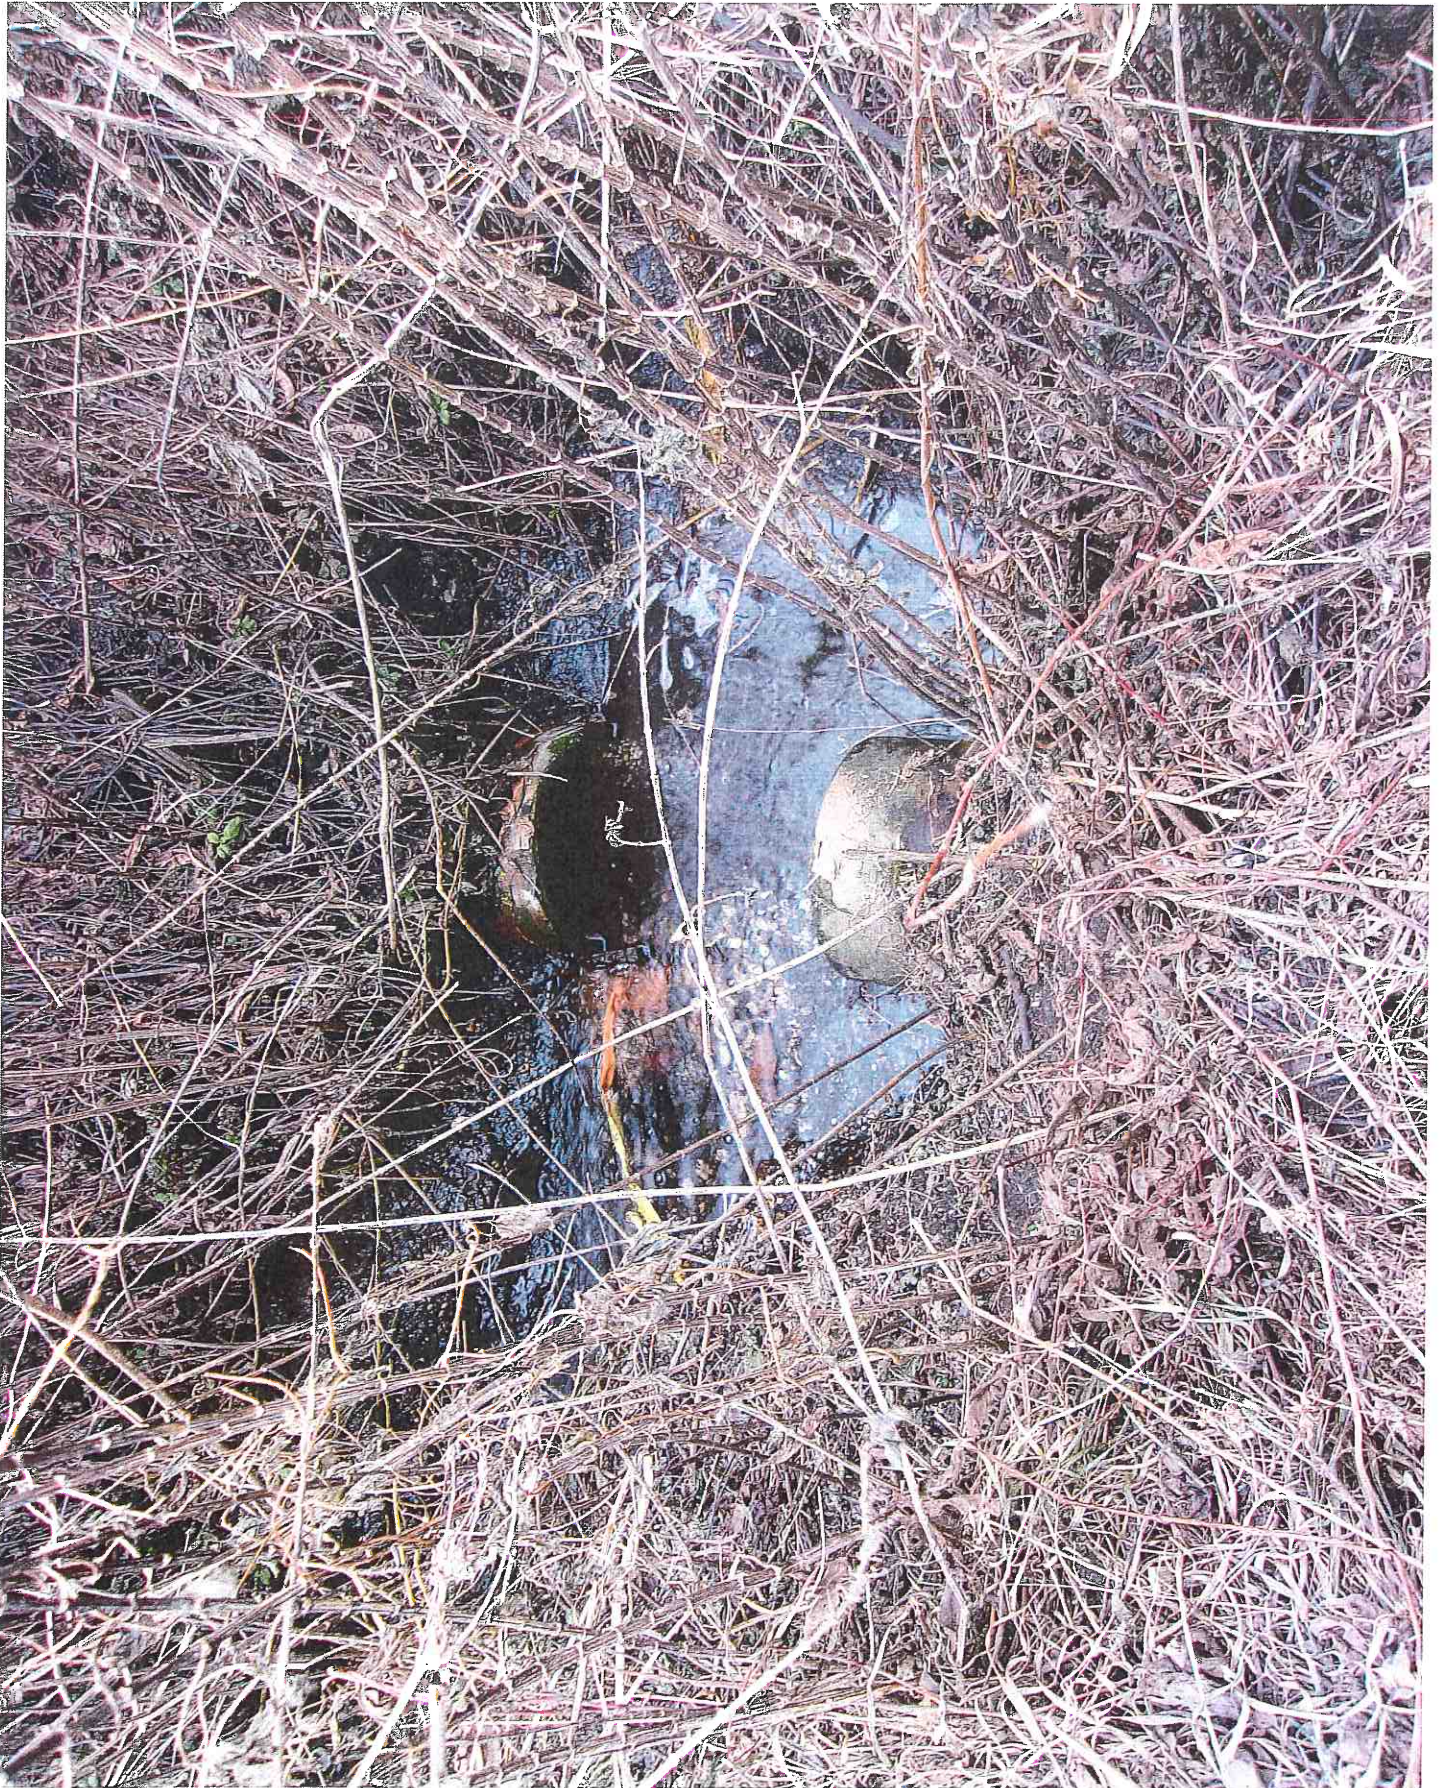
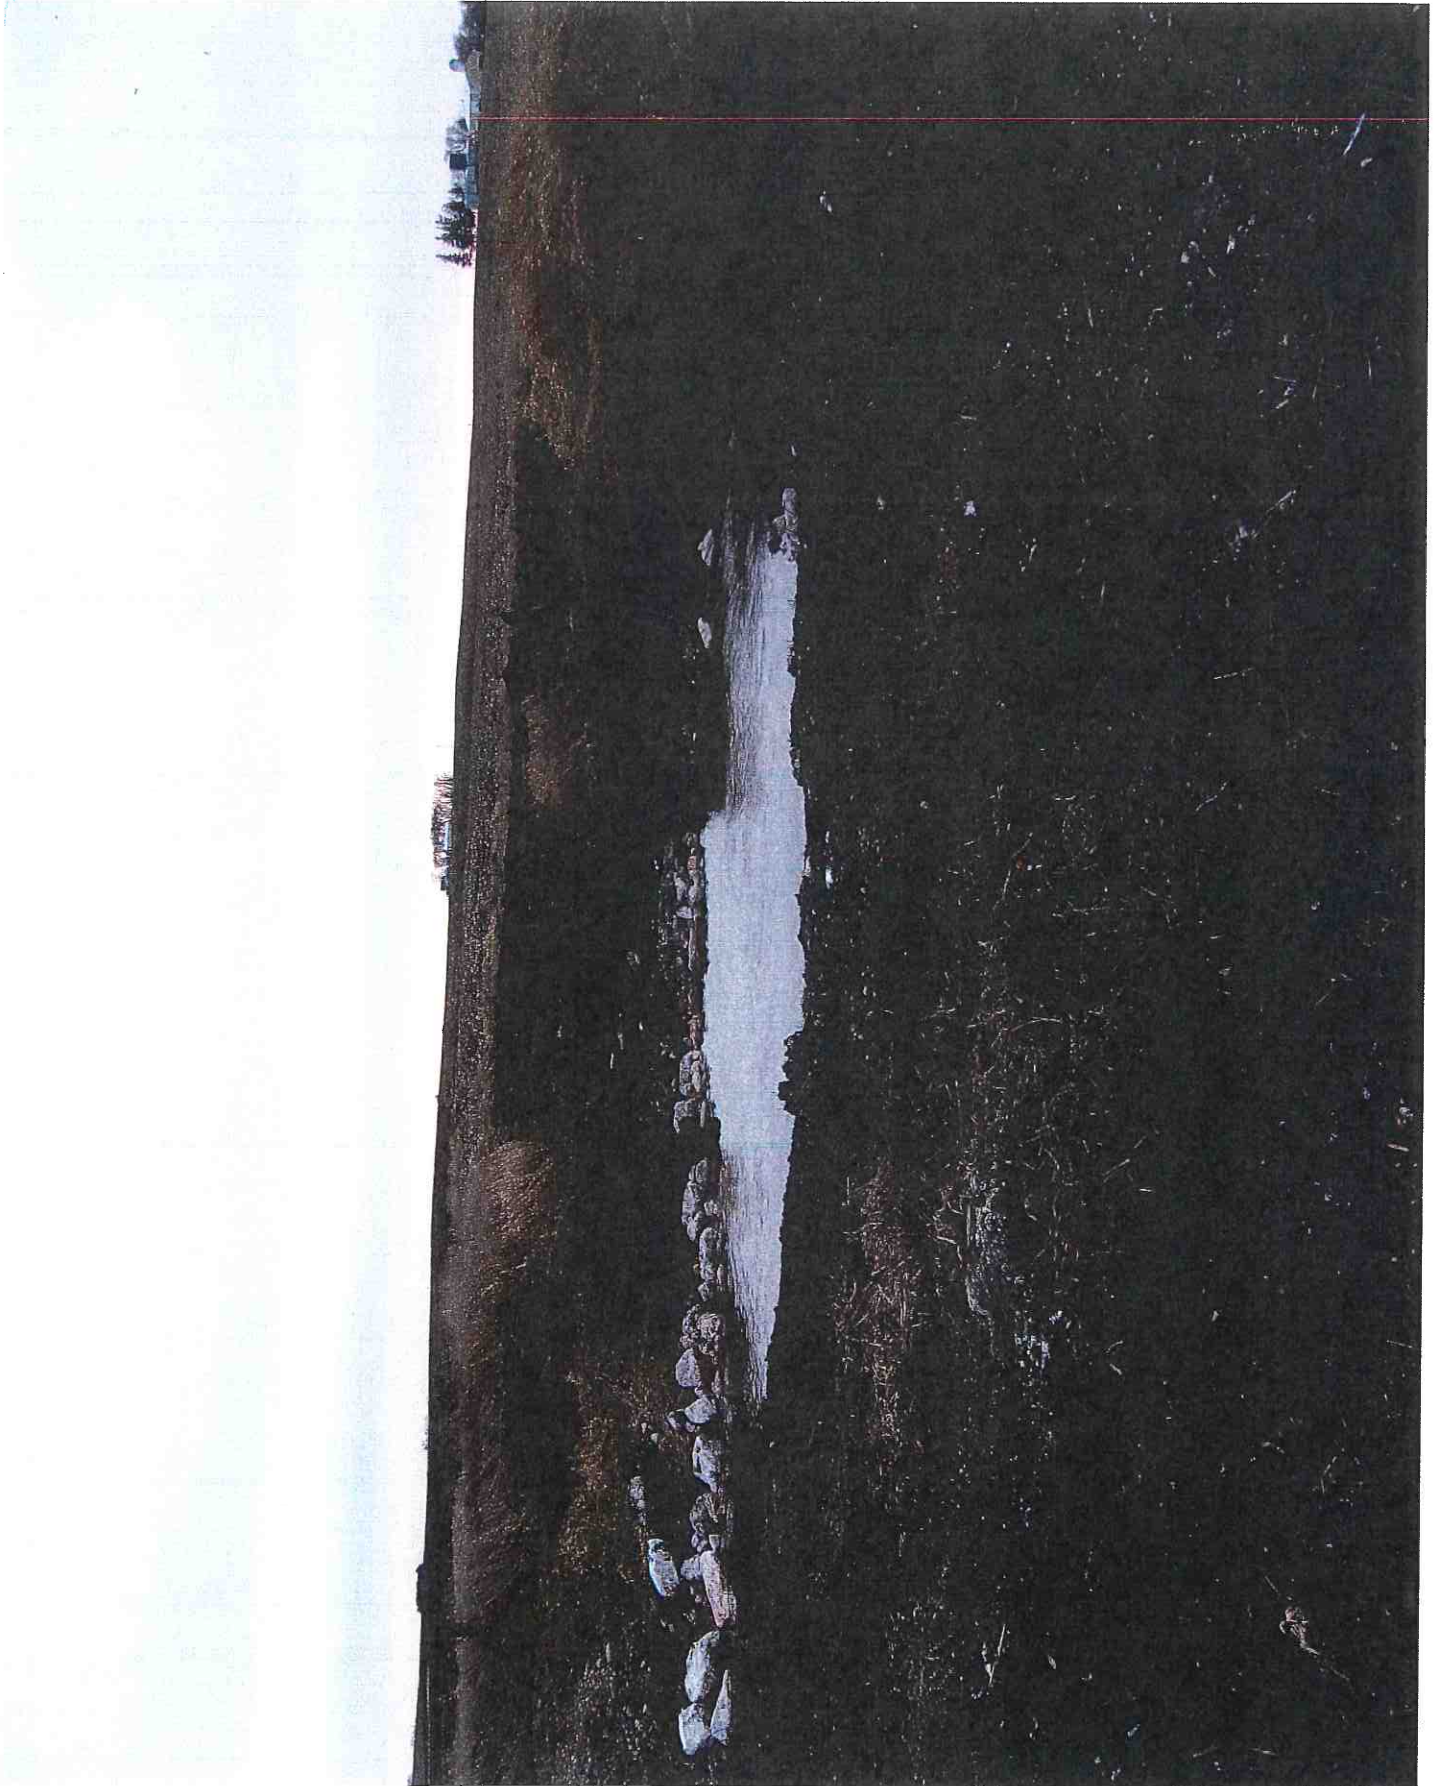
Blow-out Hole @ #340

- Tile blowout/sinkhole is missing one section of VCP tile and is 1/3 full of debris.
- Located Main tile upstream for 590'± and downstream for 1430'± from blowout/sinkhole.

- Repaired first blowout/sinkhole with 18.3' of 15" Dual Wall HDPE tile with concrete collars.
- Repaired observation hole approximately 150' south railroad right of way with 6.25' of 15" Dual Wall HDPE tile with fabric wrapped joints.
