Drainage District 14 Public Hearing On Engineer's Report On Repairs Or Improvements To The Main Tile Of DD 14

**ENGINEER'S REPORT
ON REPAIRS OR
IMPROVEMENTS TO
THE MAIN TILE
DRAINAGE DISTRICT
NO. 14
HARDIN COUNTY,
IOWA**

**Engineer's Report on Repairs or Improvements
to the Main Tile, Drainage District No. 14
Hardin County, Iowa**

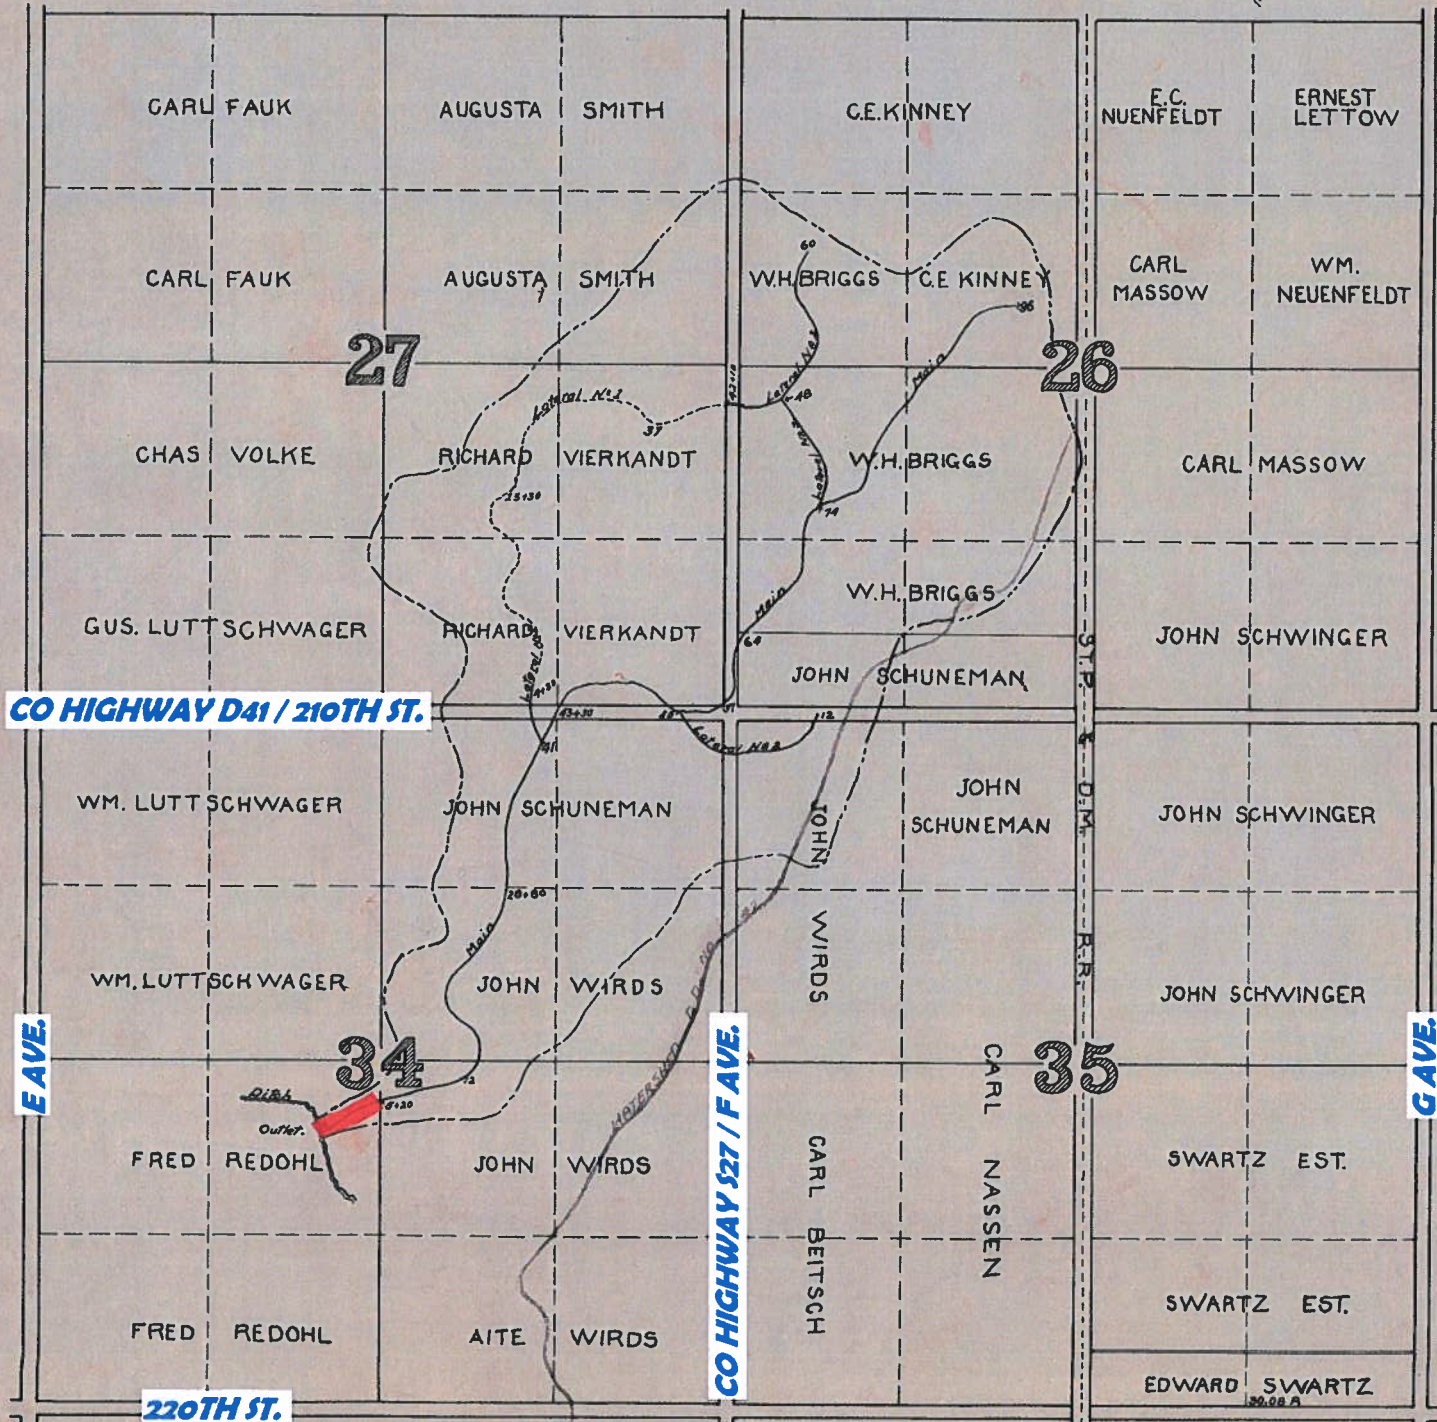
PLAT OF THE WIRDS DRAINAGE DISTRICT No 14

HARDIN COUNTY IOWA
CONTAINING 495 ACRES
S.B.GARDNER, ENGR. 1909 ELDORA IOWA.

SCALE
1 in. = 600 FT.

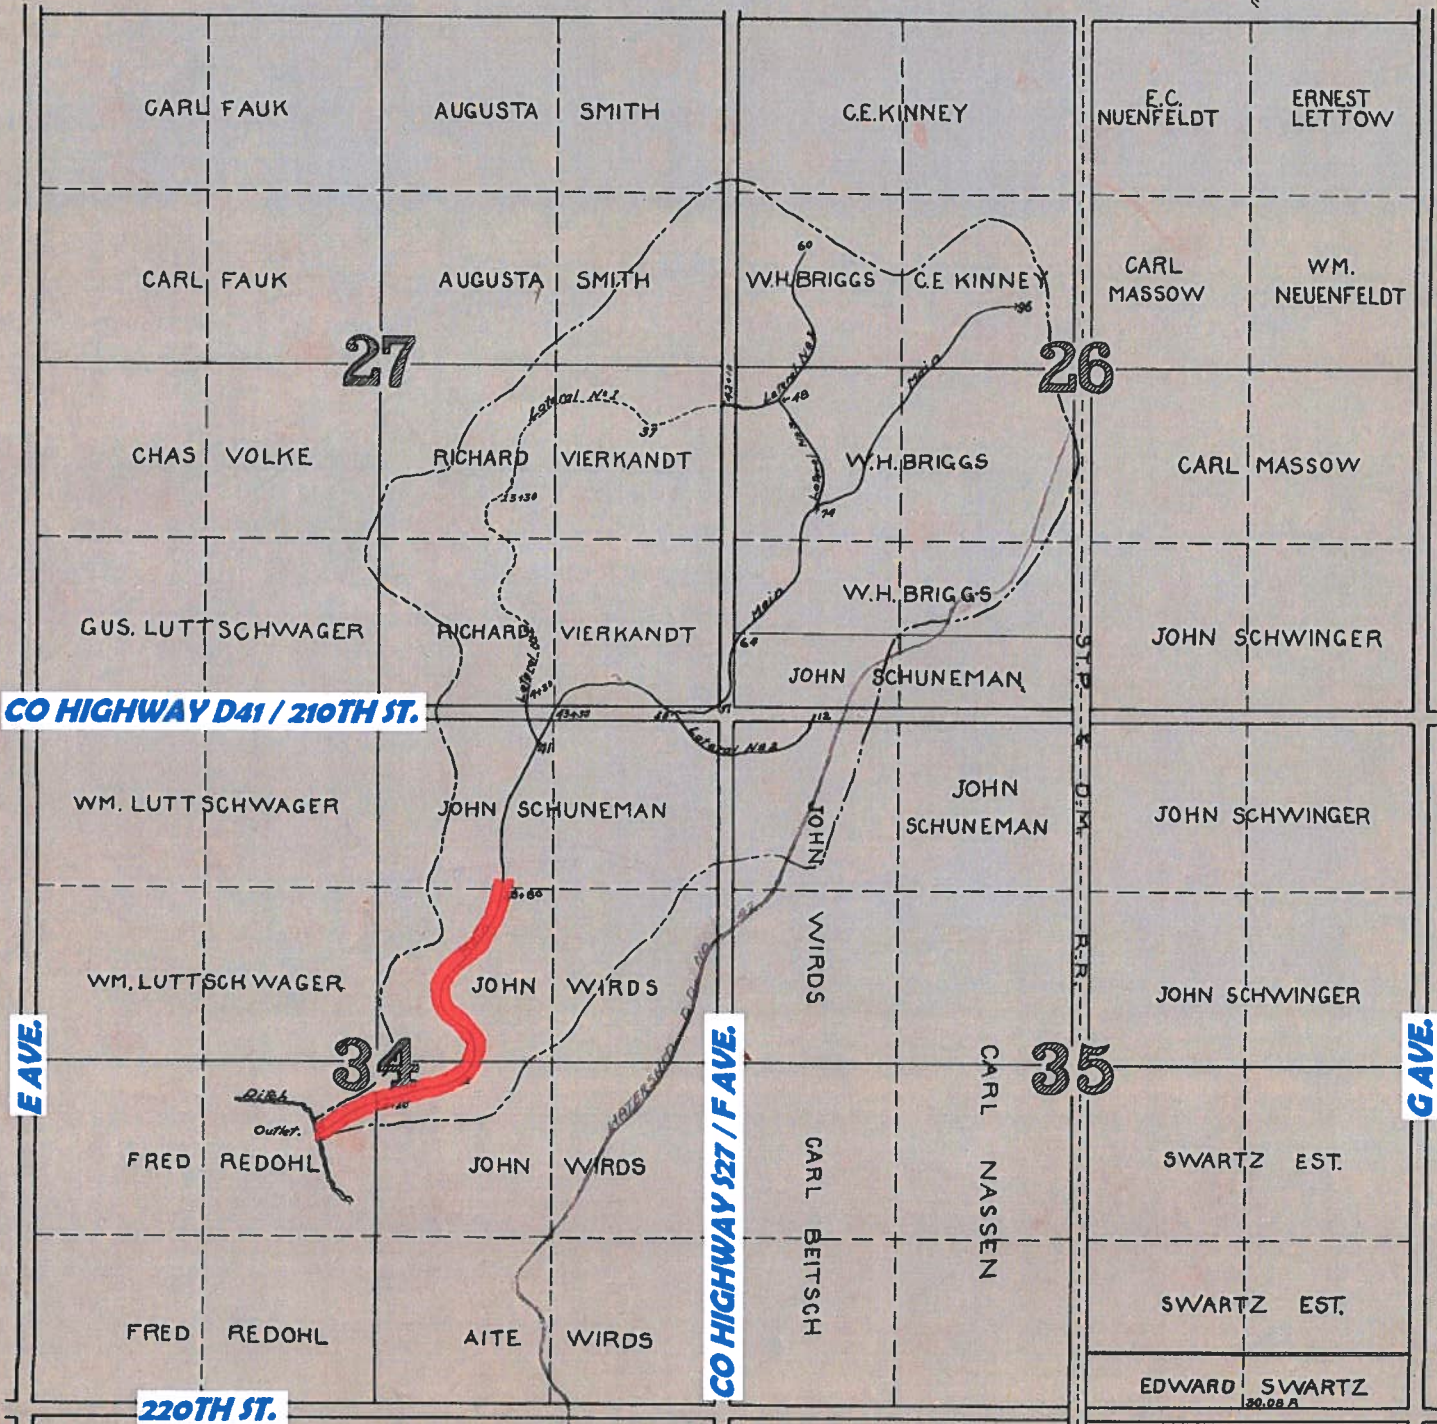
REPAIR / IMPROVEMENT

HARDIN COUNTY IOWA
CONTAINING 495 ACRES
S.B.GARDNER, ENGR. 1909 ELDORA IOWA.

SCALE
1 in. = 600 ft.

BUCKEYE TOWNSHIP
88-22
