Drainage District:

#48

Investigation Summary:

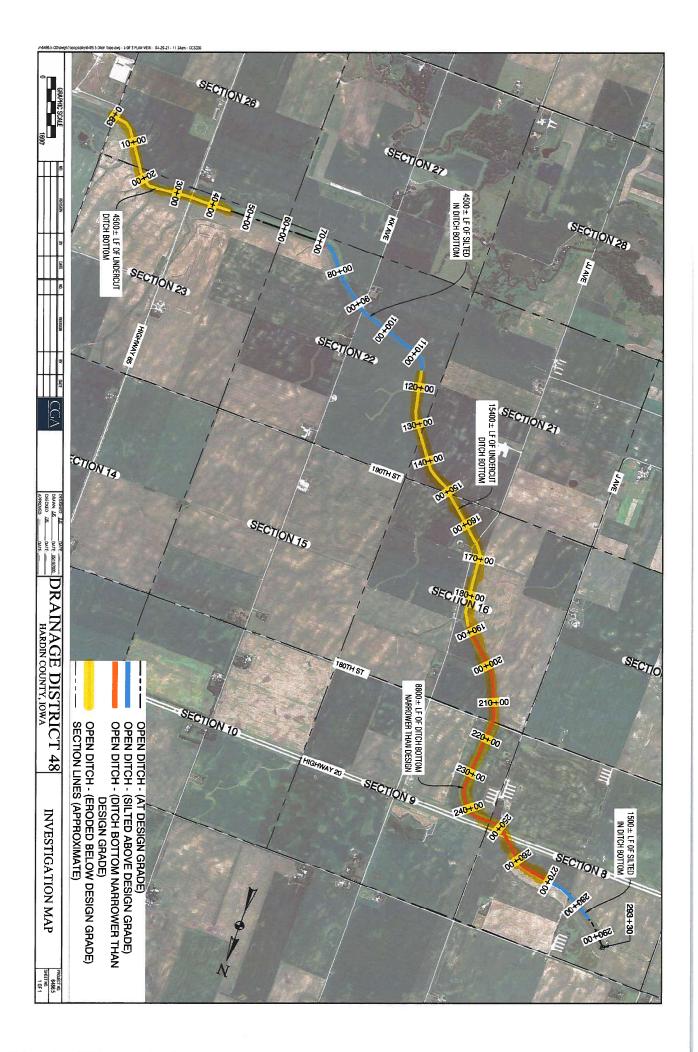
- 6,000± feet of the main open ditch that has silt accumulation of ½± feet to 1½± feet (see attached map for locations).
- 2. 15,460± feet of the main open ditch that has eroded below the original design grade (see attached map

- 8.800± feet of the main open ditch that has a bottom width narrower than the original design (see attached map for locations).
- 4. Erosion around the outlet of the main tile at the upper end of the main open ditch.
