**AGENDA**  
**REGULAR DRAINAGE MEETING**  
**February 12, 2020 9:30 AM**

**ENGINEER'S REPORT  
ON REPAIRS  
TO MAIN TILE  
DRAINAGE DISTRICT  
NO. 86  
HARDIN COUNTY,  
IOWA**

**SUPPLEMENT TO  
ENGINEER'S REPORT  
ON REPAIRS  
TO MAIN TILE  
DRAINAGE DISTRICT  
NO. 86  
HARDIN COUNTY,  
IOWA**

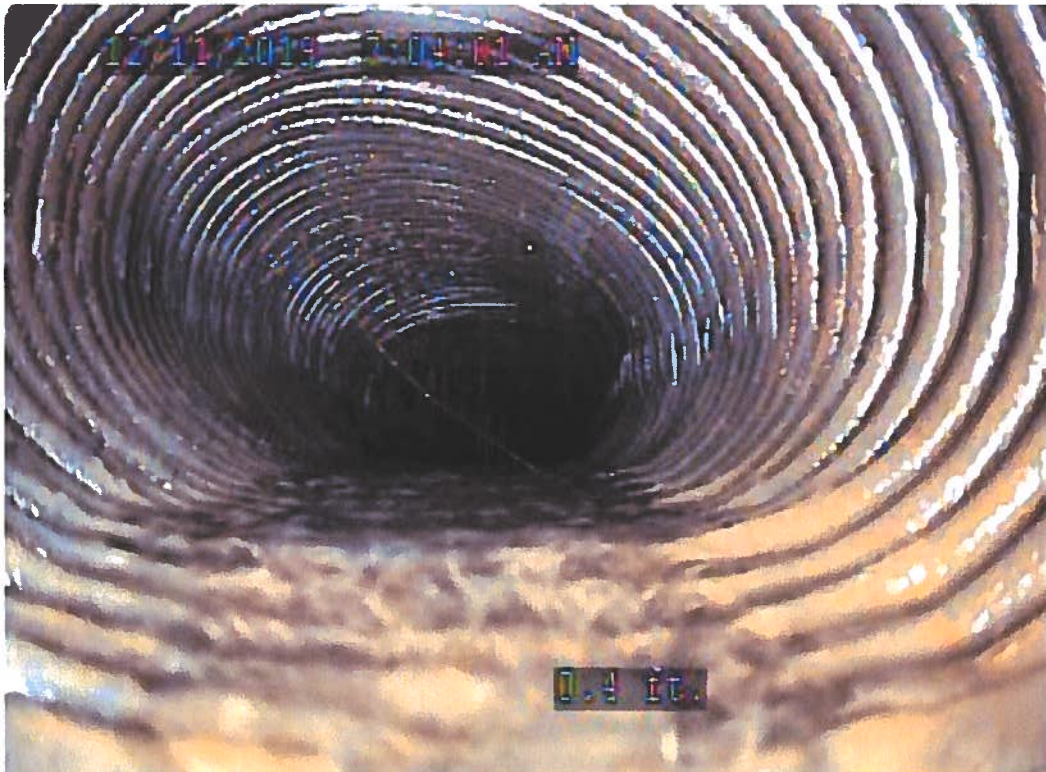
Figure 6: Tap from unknown origin to the north.

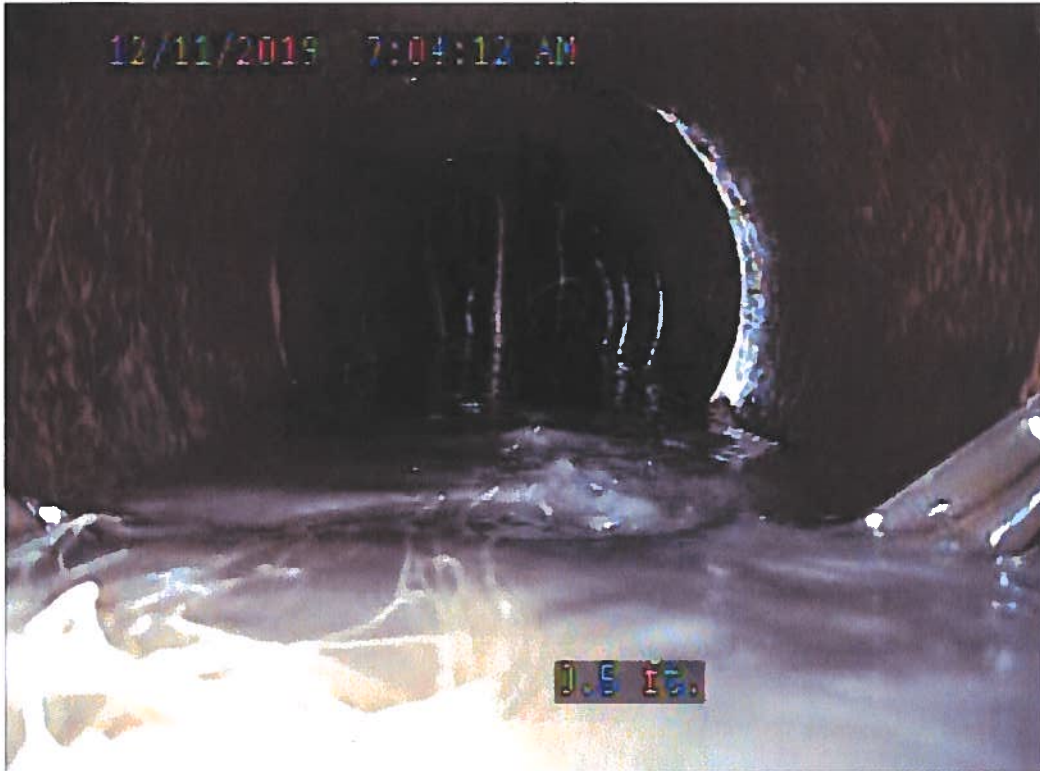
Figure 7: Single wall HDPE to VCP.

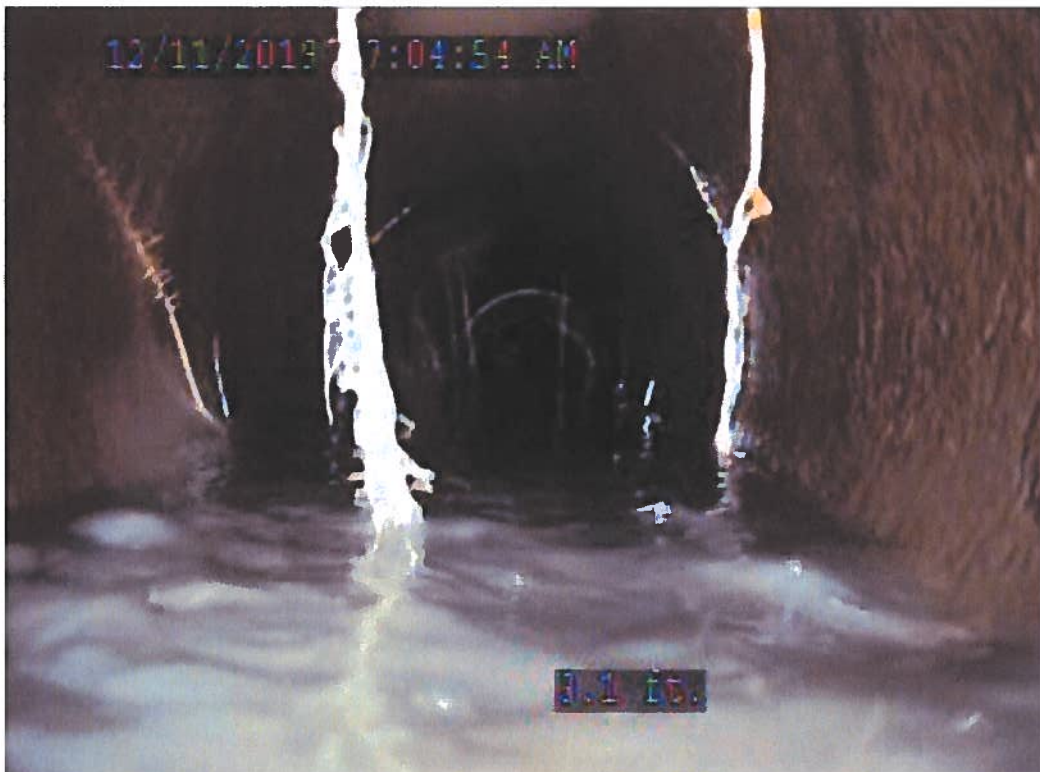
Figure 8: Intermittent, light roots.

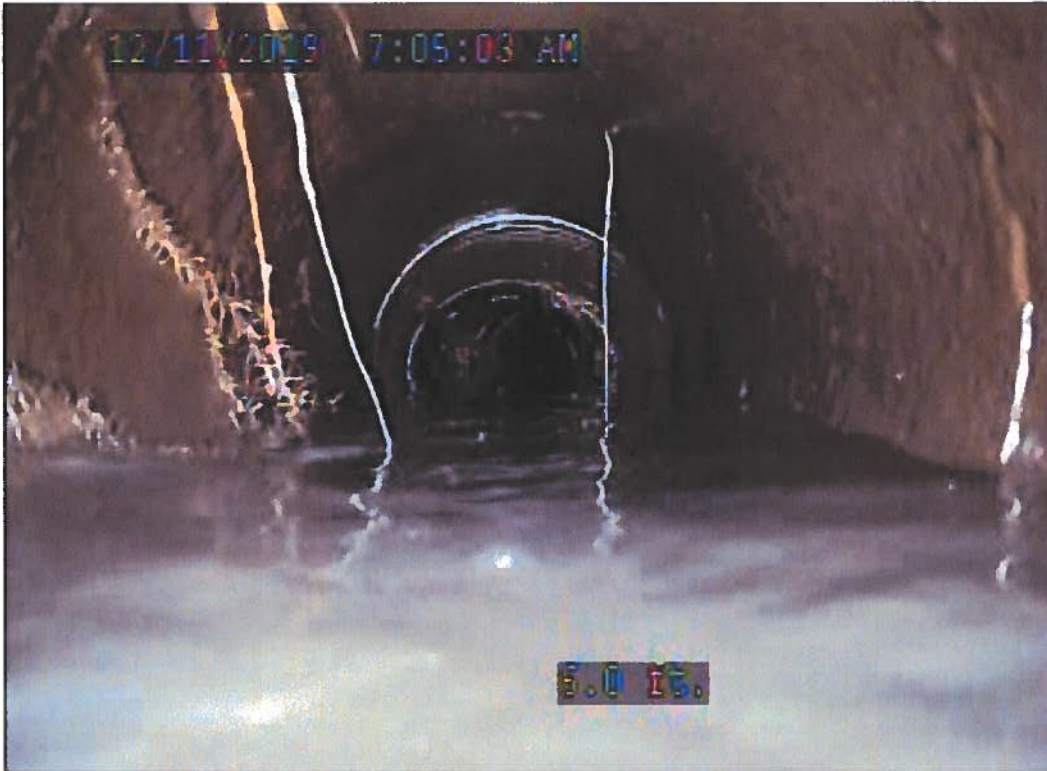
Figure 9: Intermittent roots.

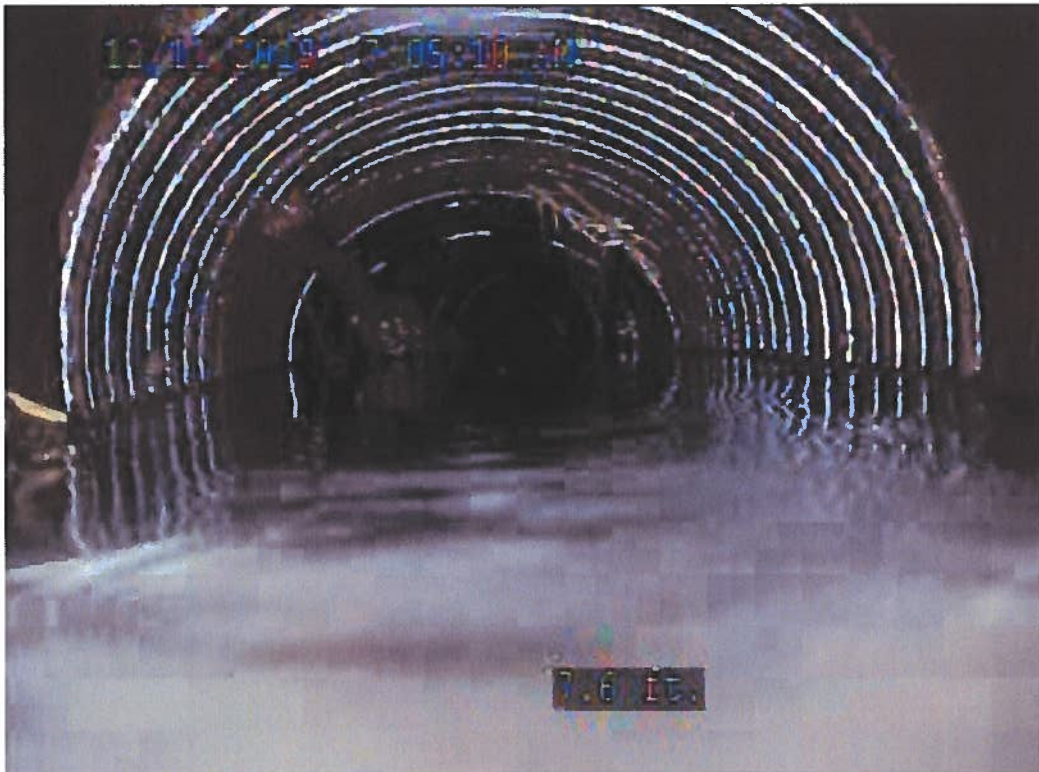
Figure 10: VCP to single wall HDPE.

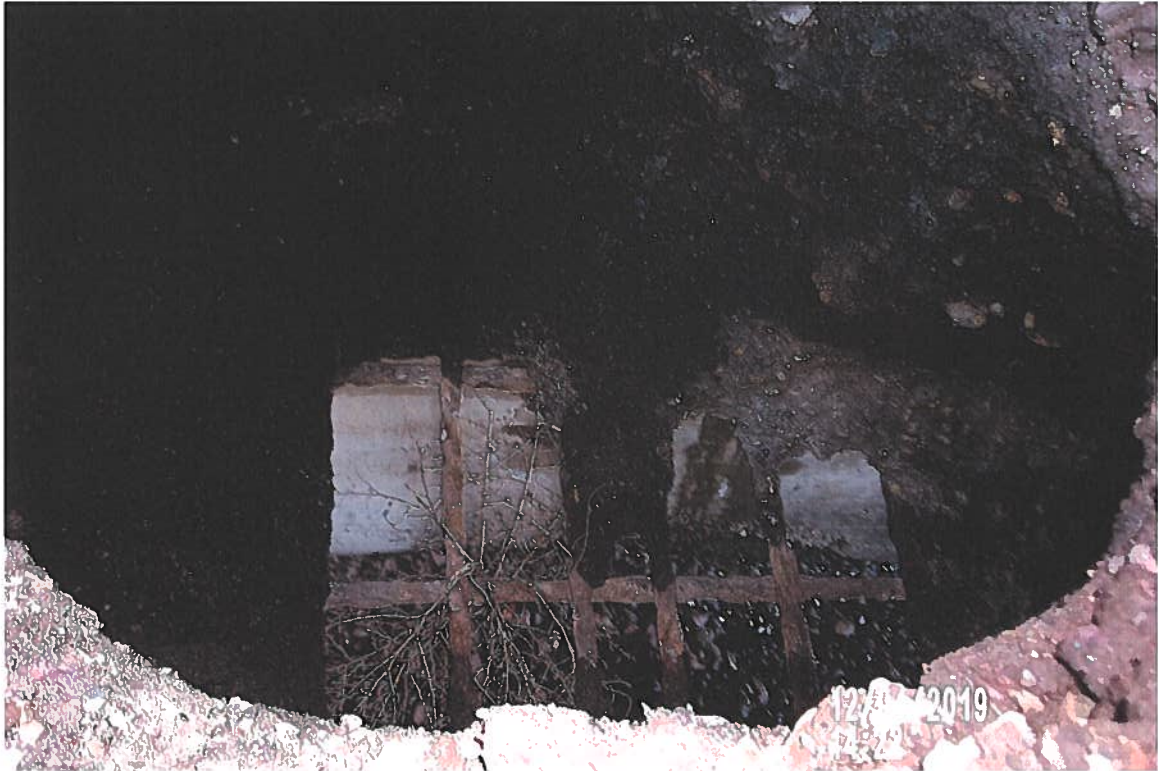
PICTURE # 2458

HOLE IN BOX CULVERT BELOW TRACKS

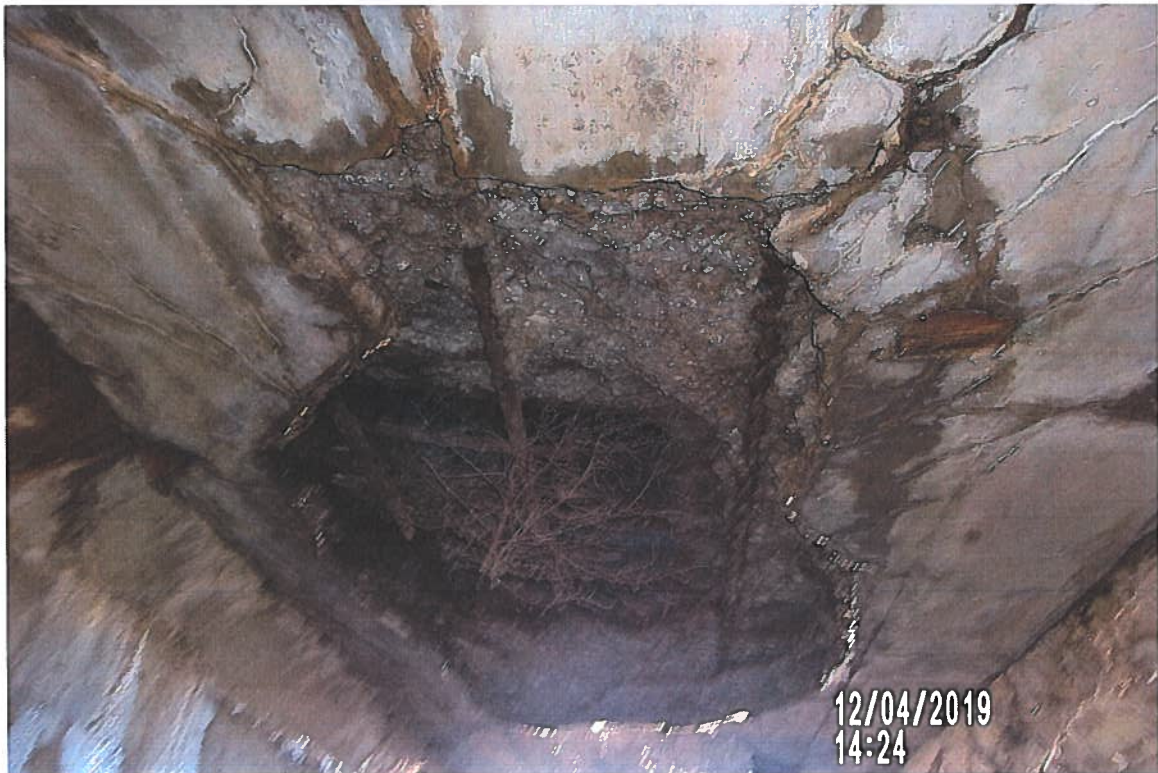
PICTURE # 2461  
HOLE IN TOP BOX CULVERT

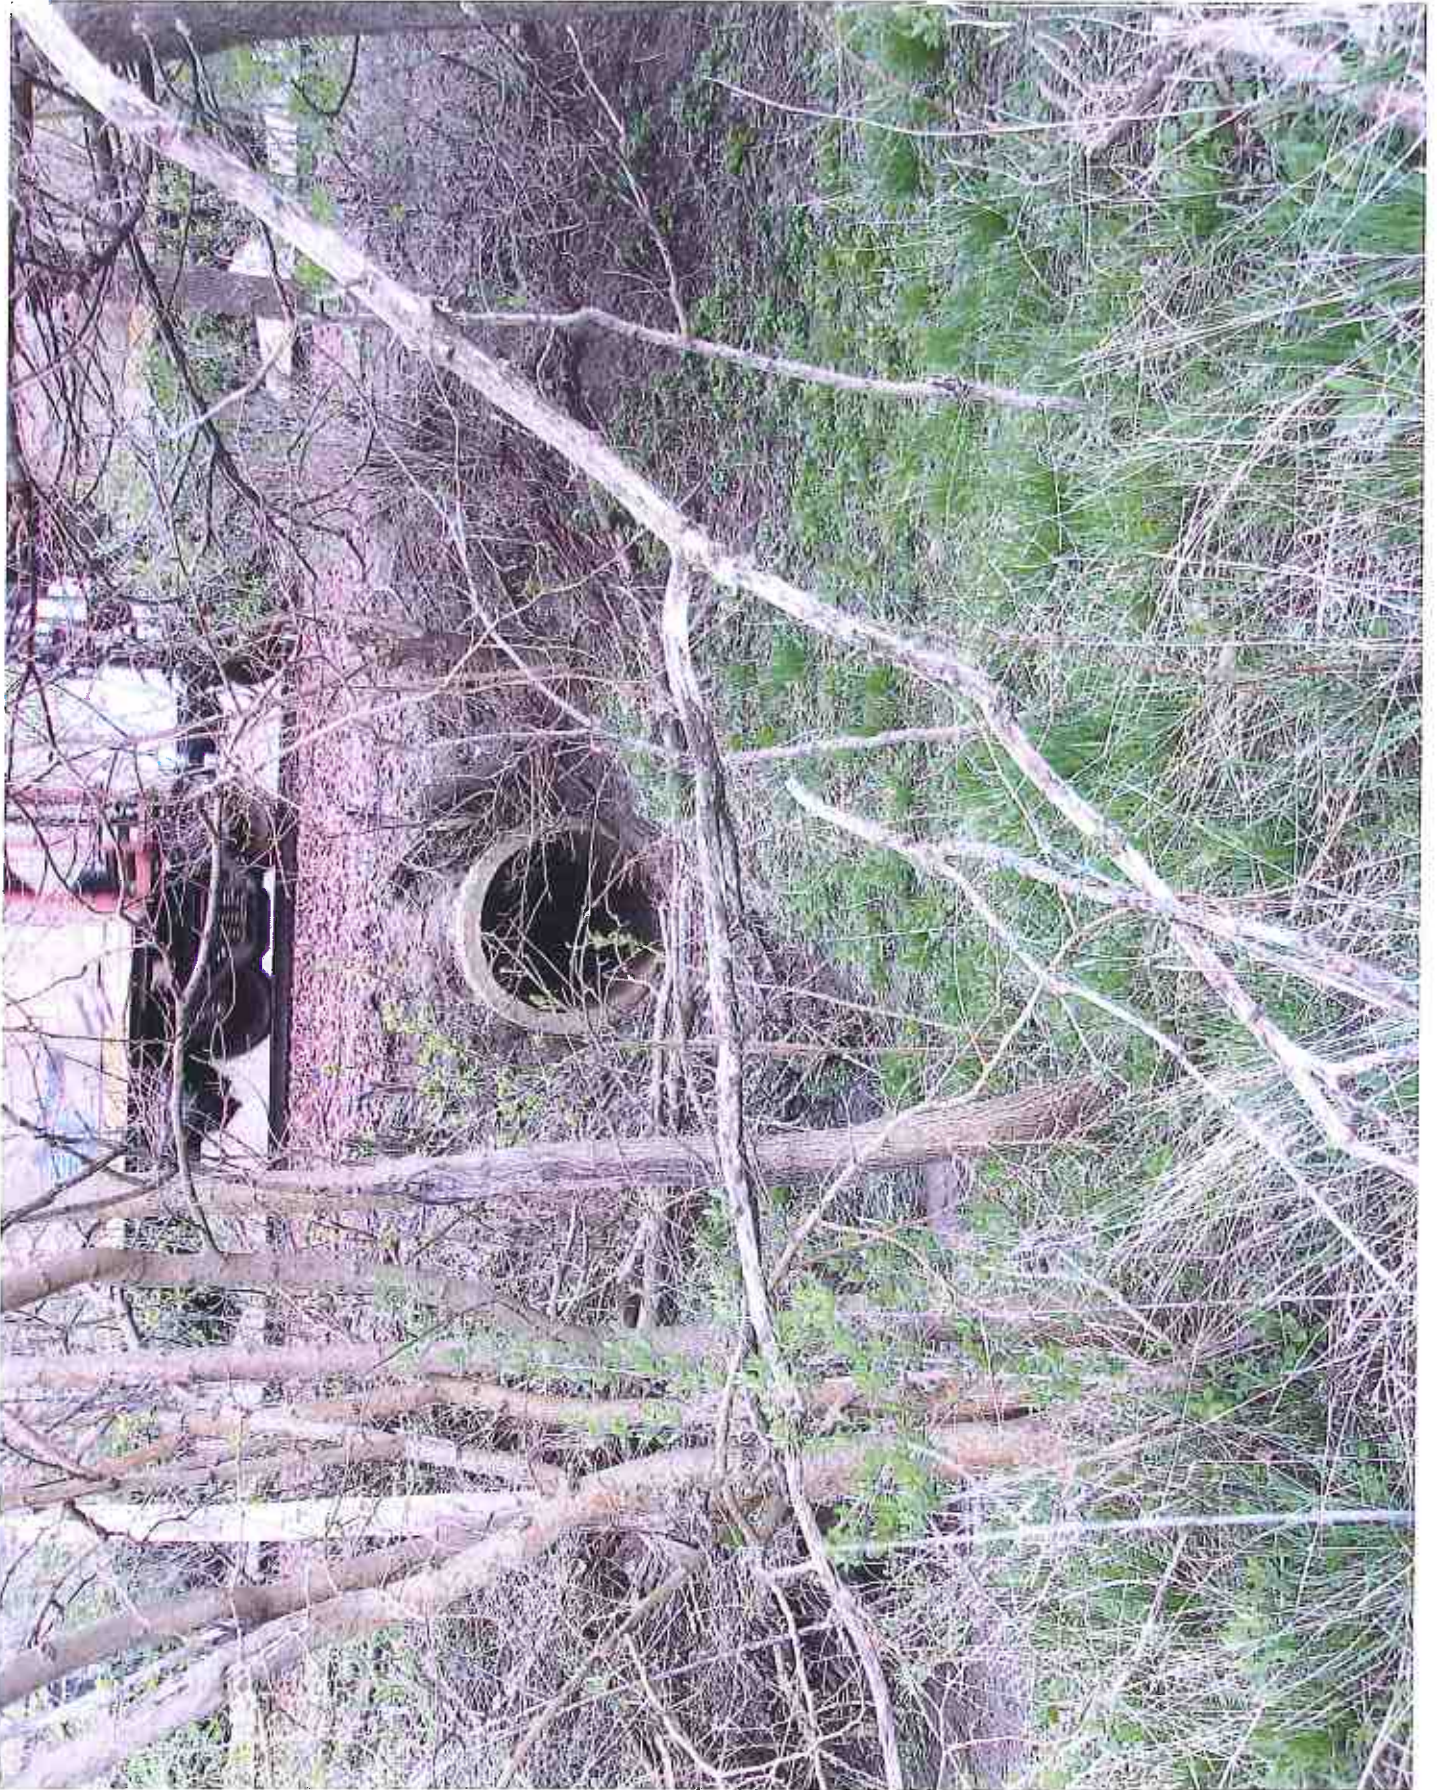
LOOKING E. ON N. R/W RR @ S. EDGE MONARCH PROP.

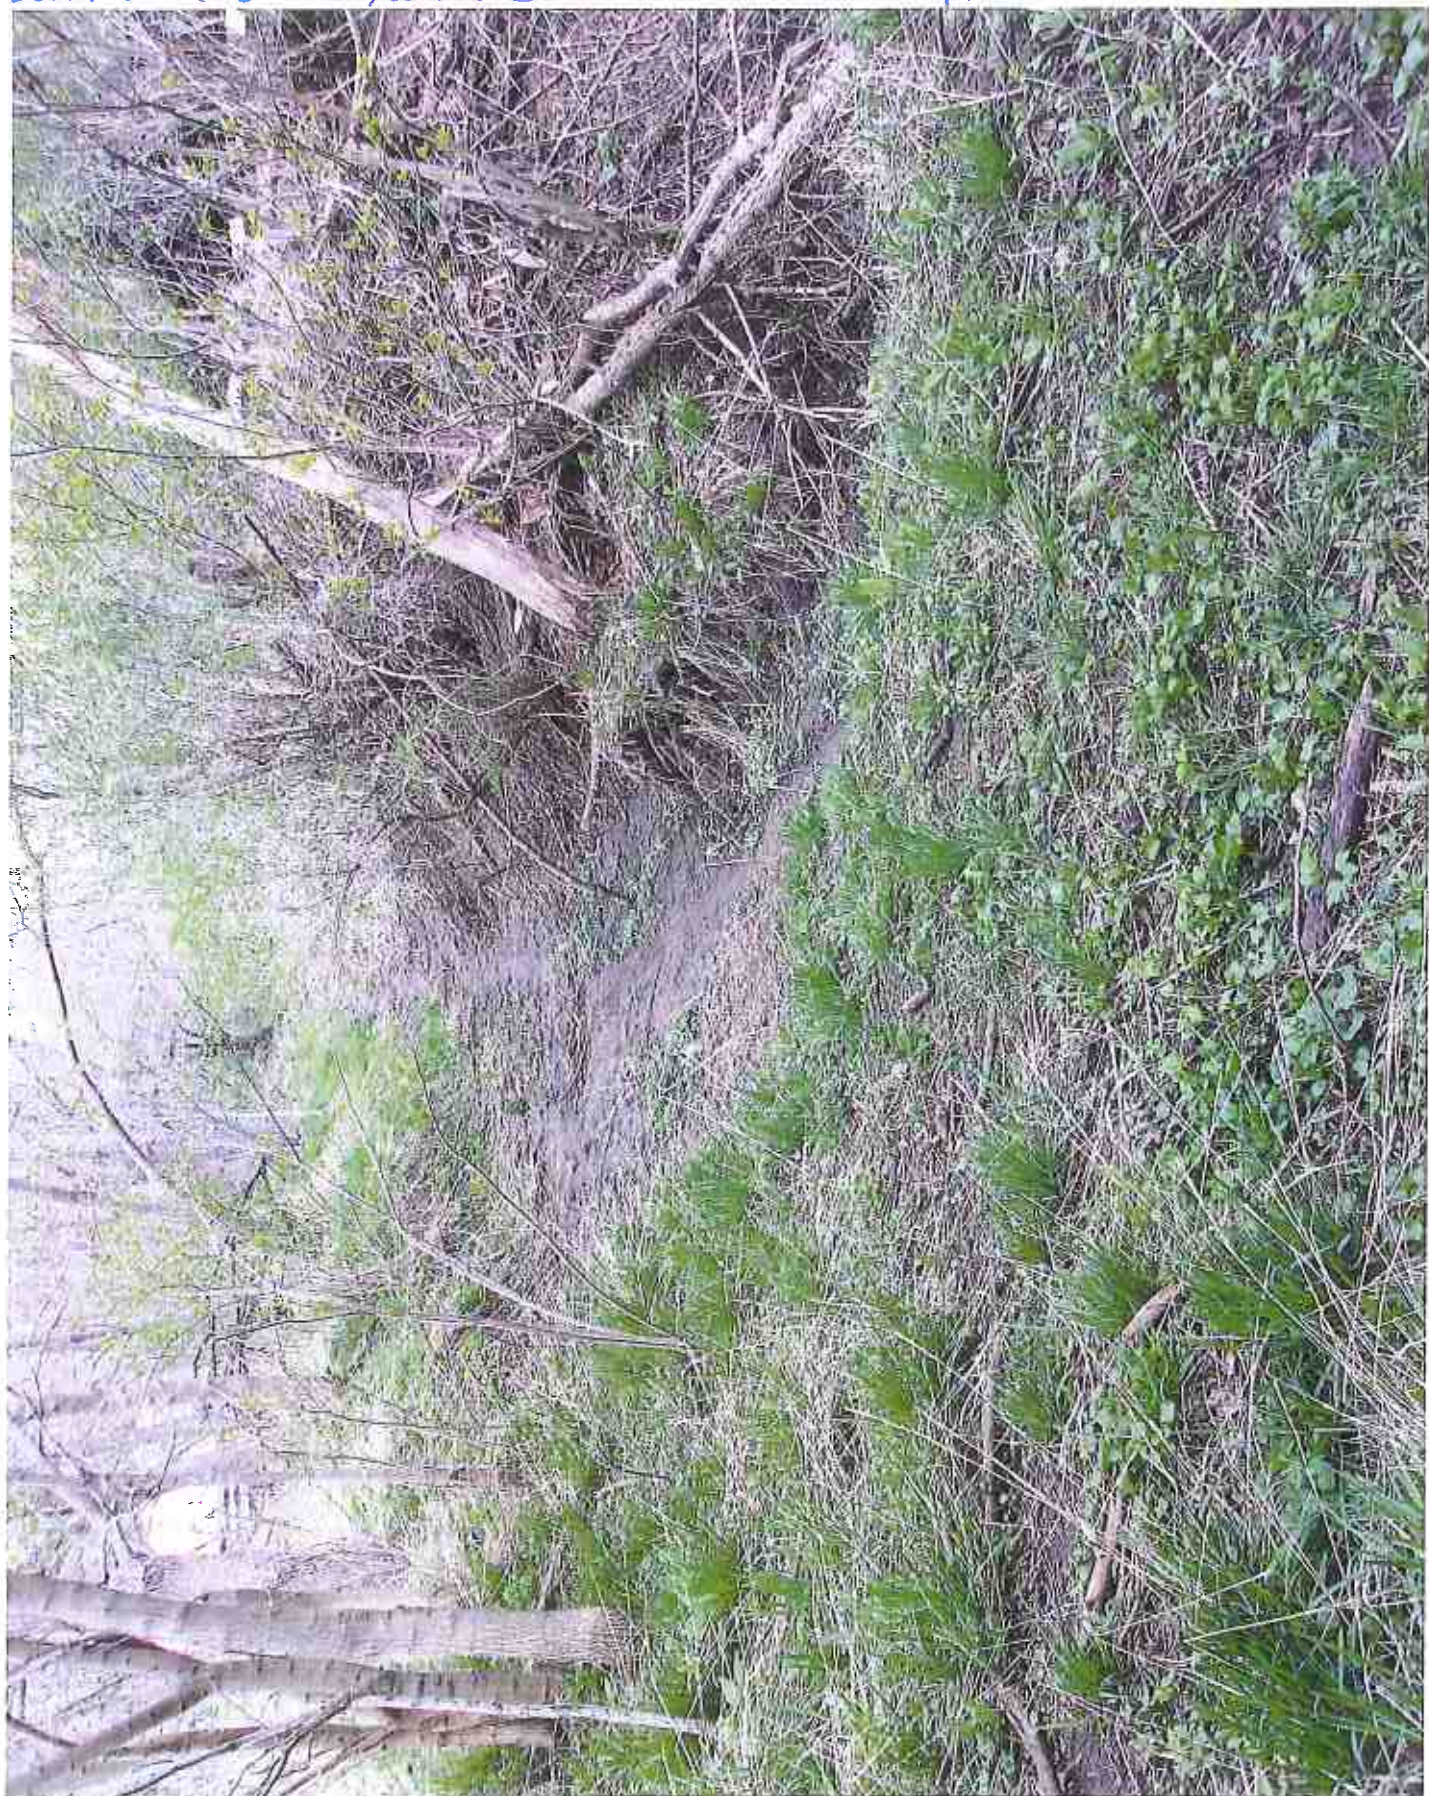
Looking upstream From Georgetown Road

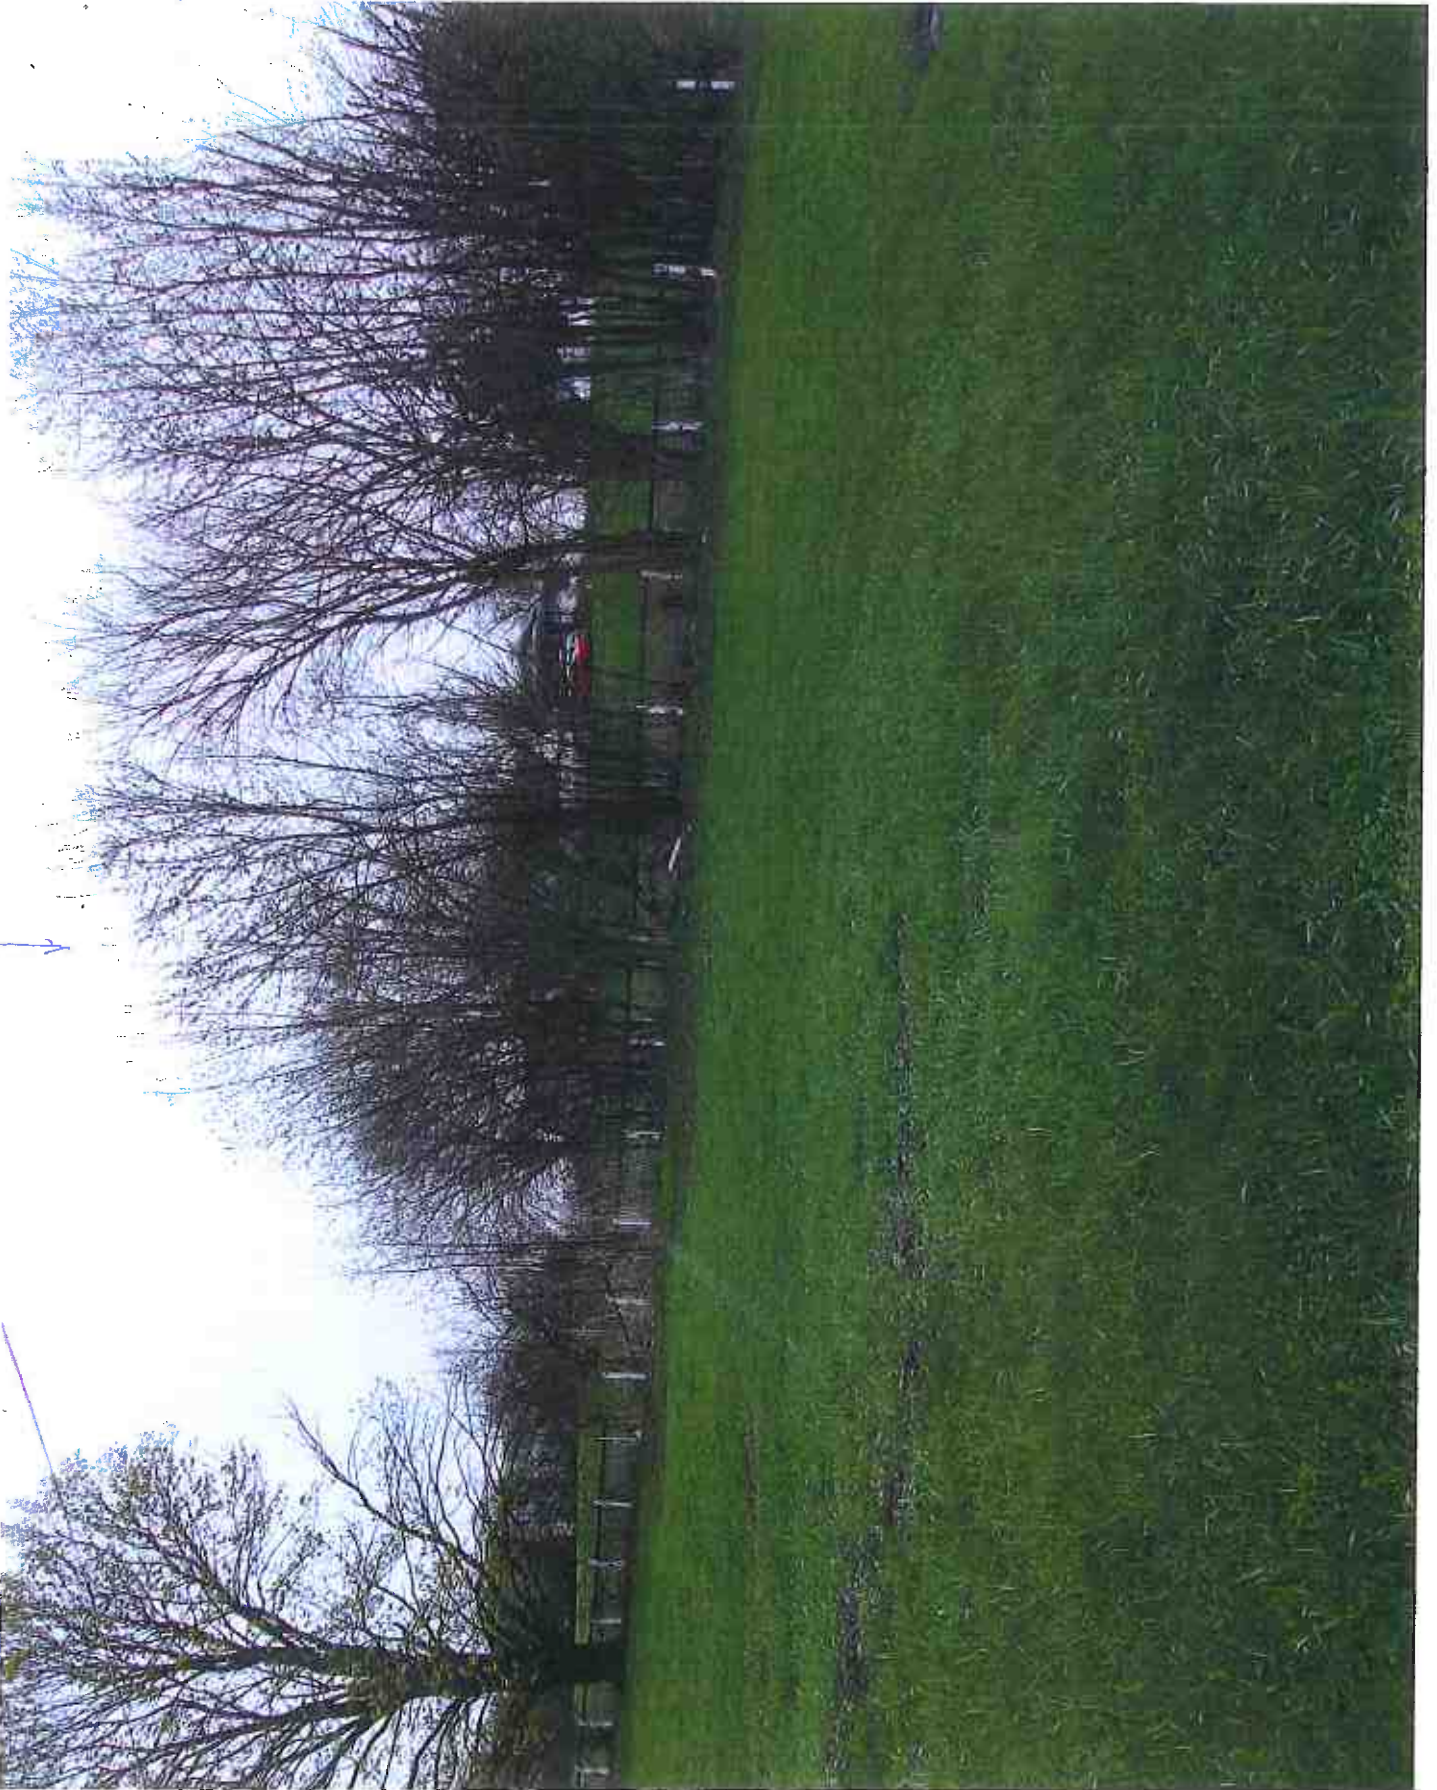
Looking upstream From S. Side RR To Georgetown Road

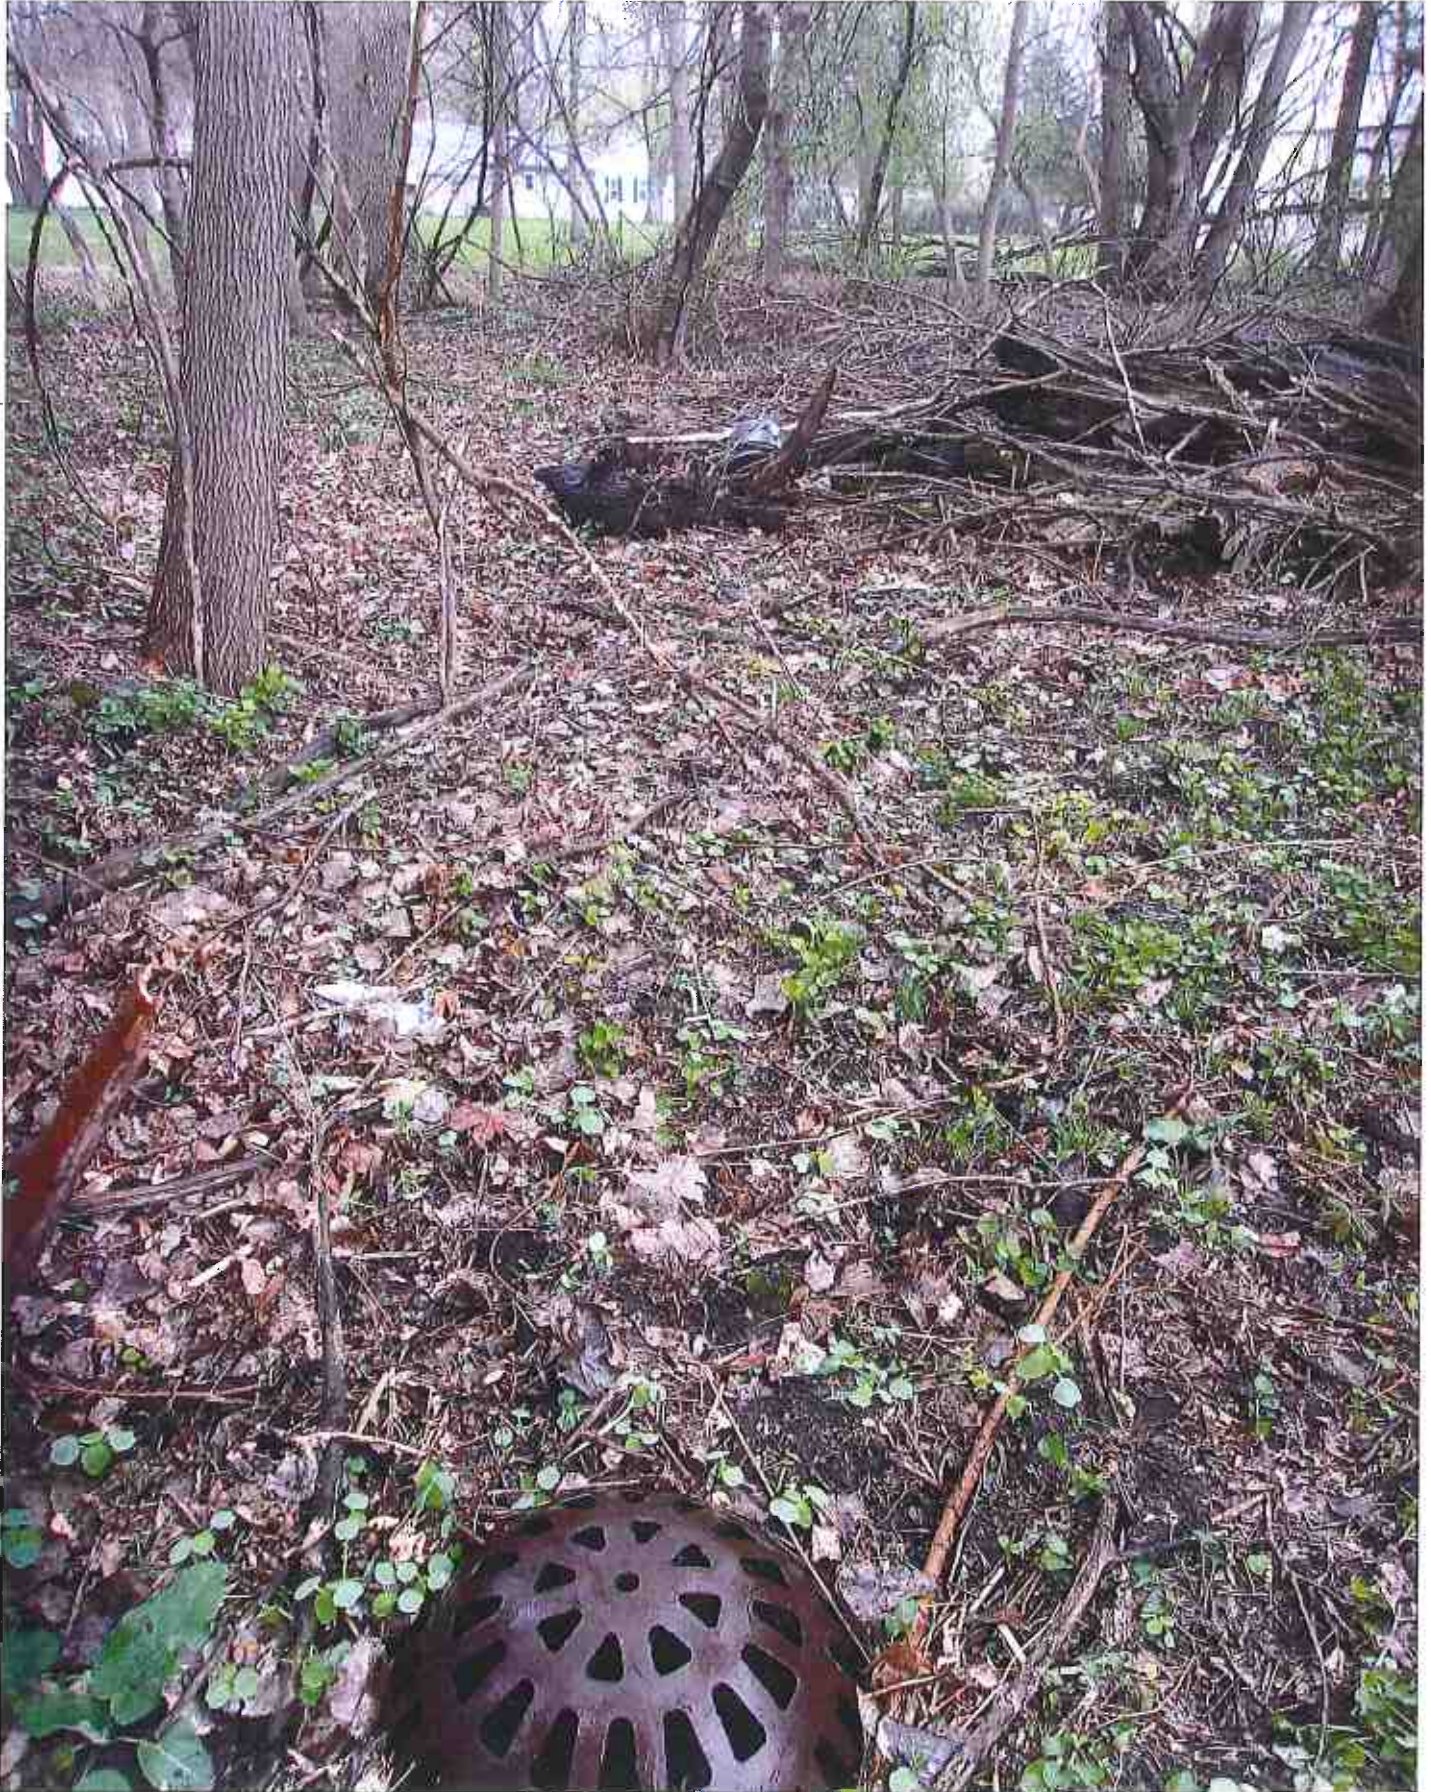
CITY STORM SEWER OUTLET

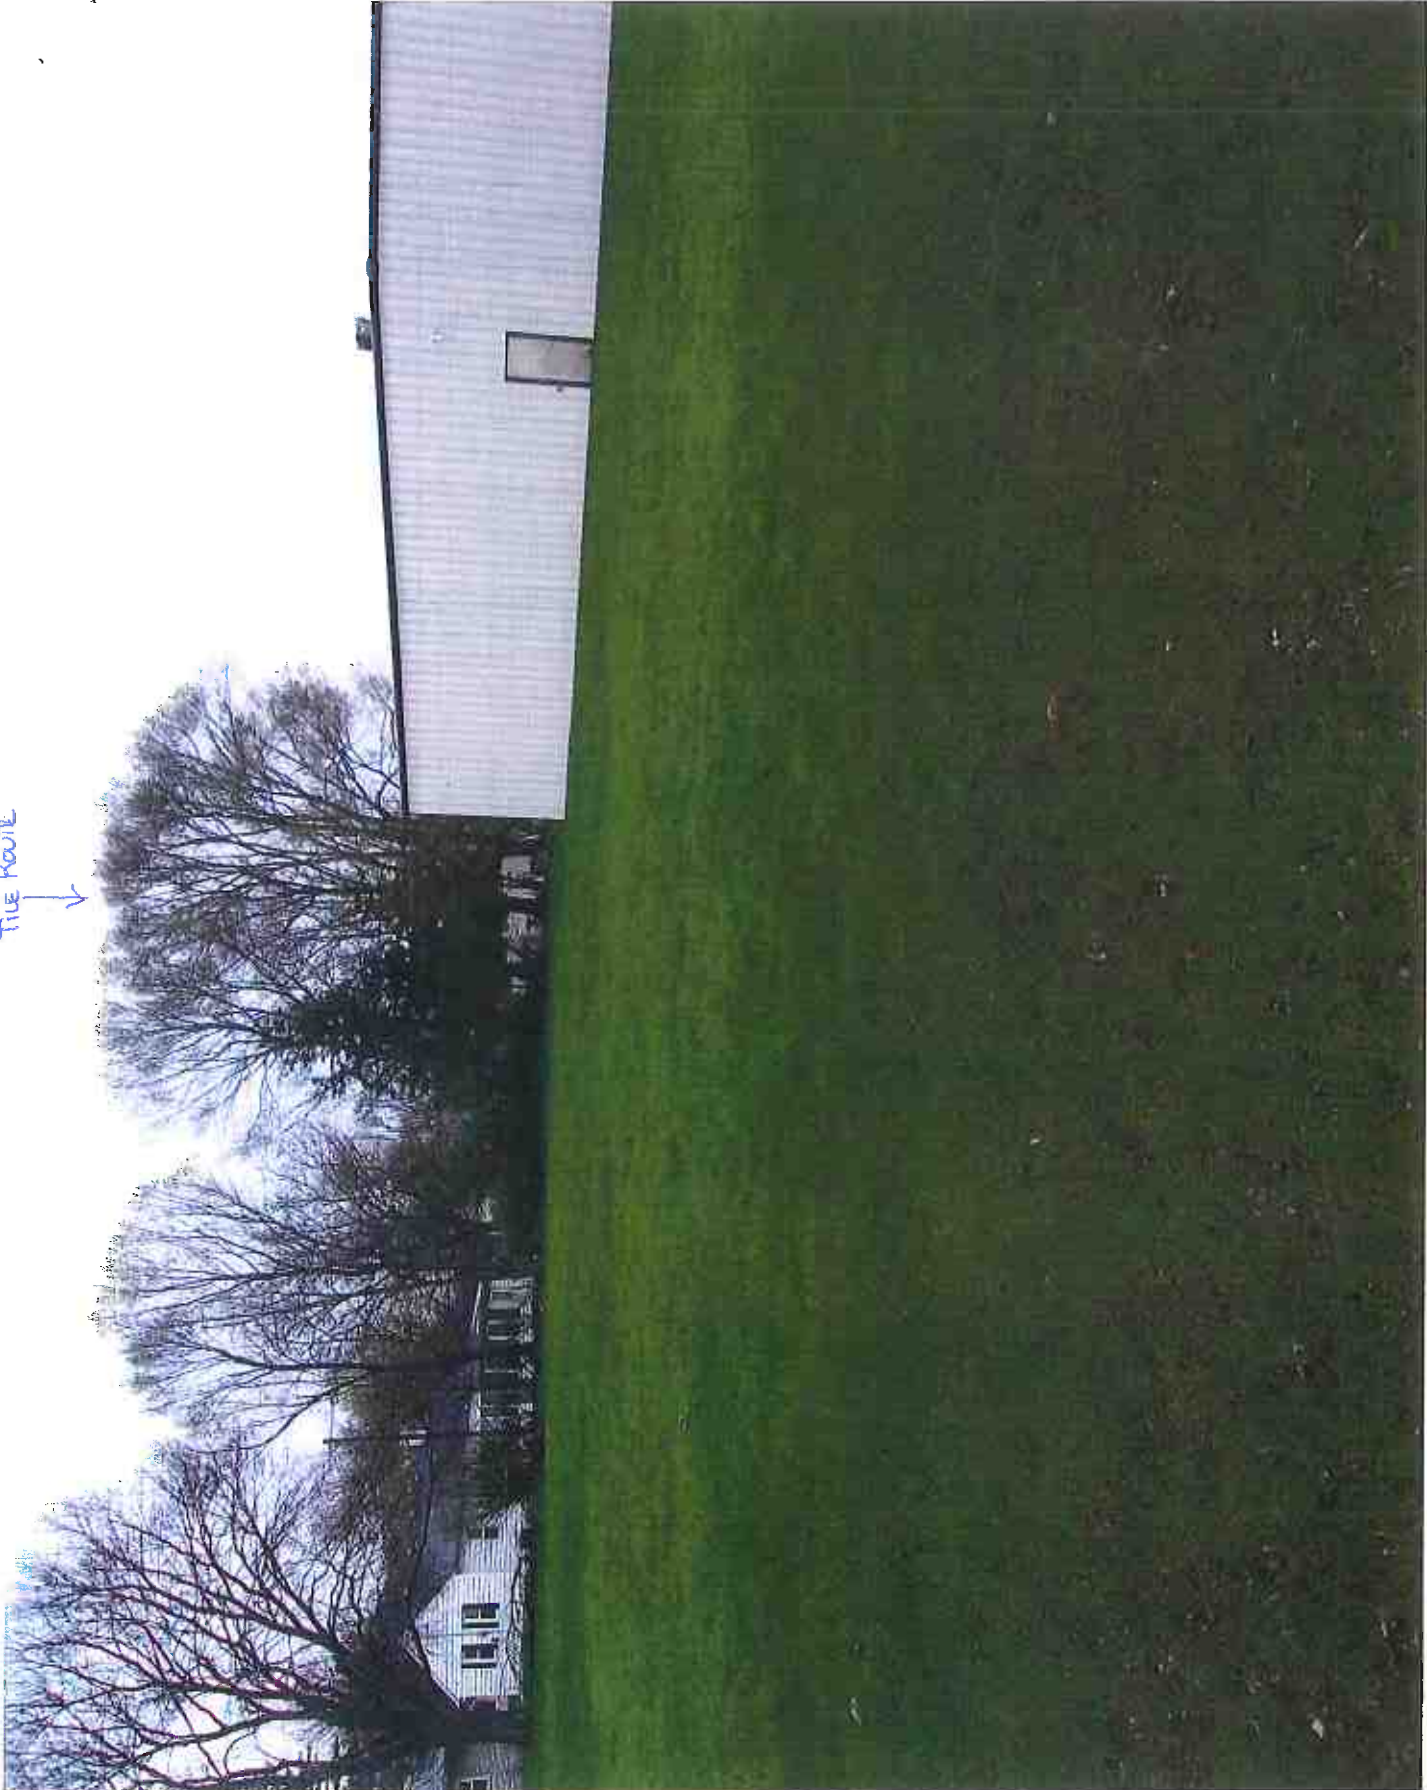
Looking upstream From where surface water dumps into TIE (I'm standing on it)

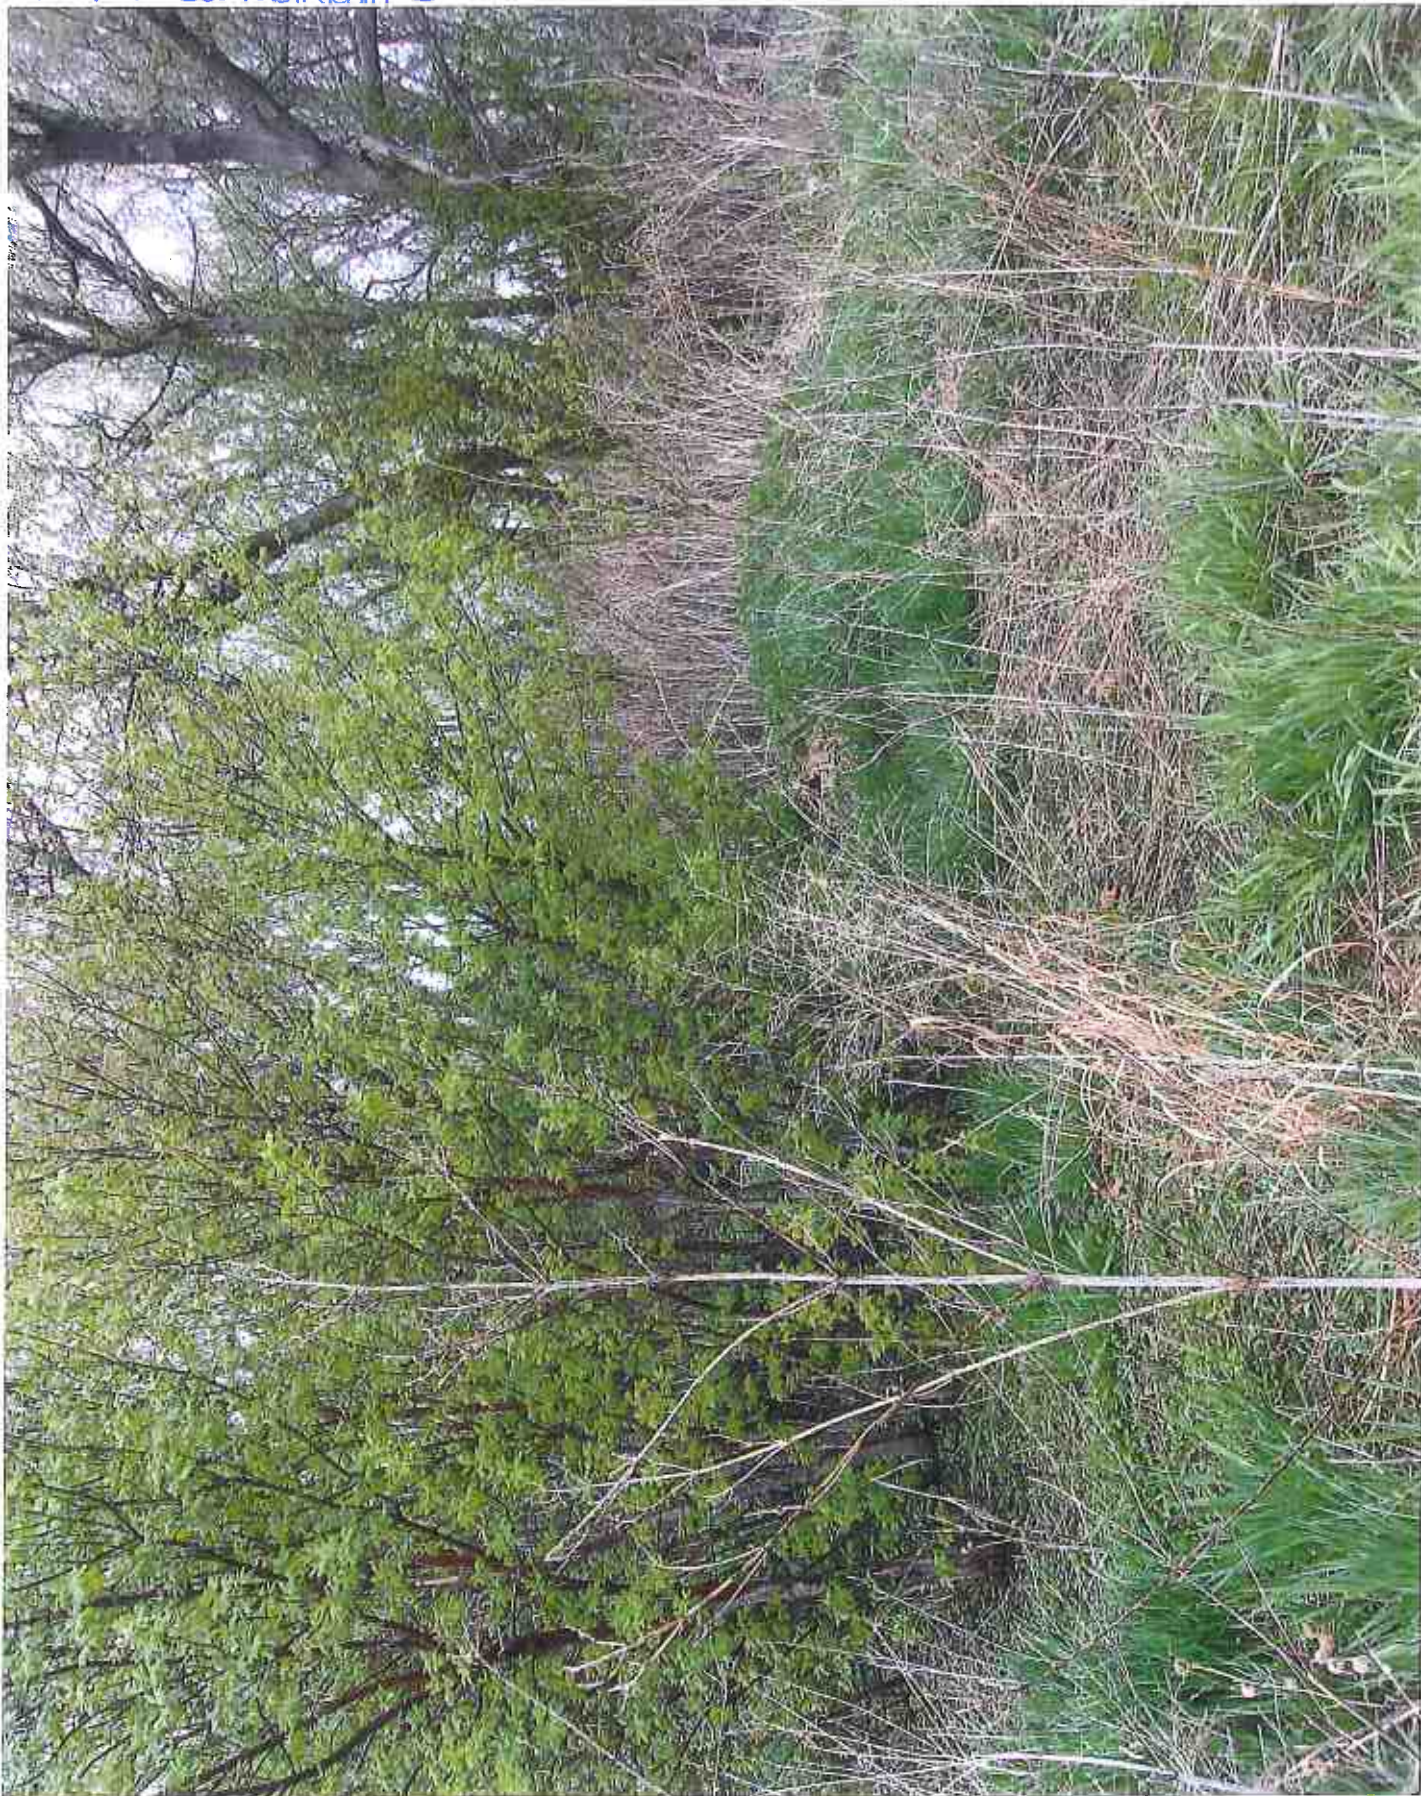
12" HICK INTAKE FULL OF WATER, SWIRLING
