**AGENDA**  
**REGULAR DRAINAGE MEETING**  
**February 12, 2020 9:30 AM**

**ENGINEER'S REPORT  
ON REPAIRS  
TO MAIN TILE  
DRAINAGE DISTRICT  
NO. 86  
HARDIN COUNTY,  
IOWA**

**SUPPLEMENT TO  
ENGINEER'S REPORT  
ON REPAIRS  
TO MAIN TILE  
DRAINAGE DISTRICT  
NO. 86  
HARDIN COUNTY,  
IOWA**

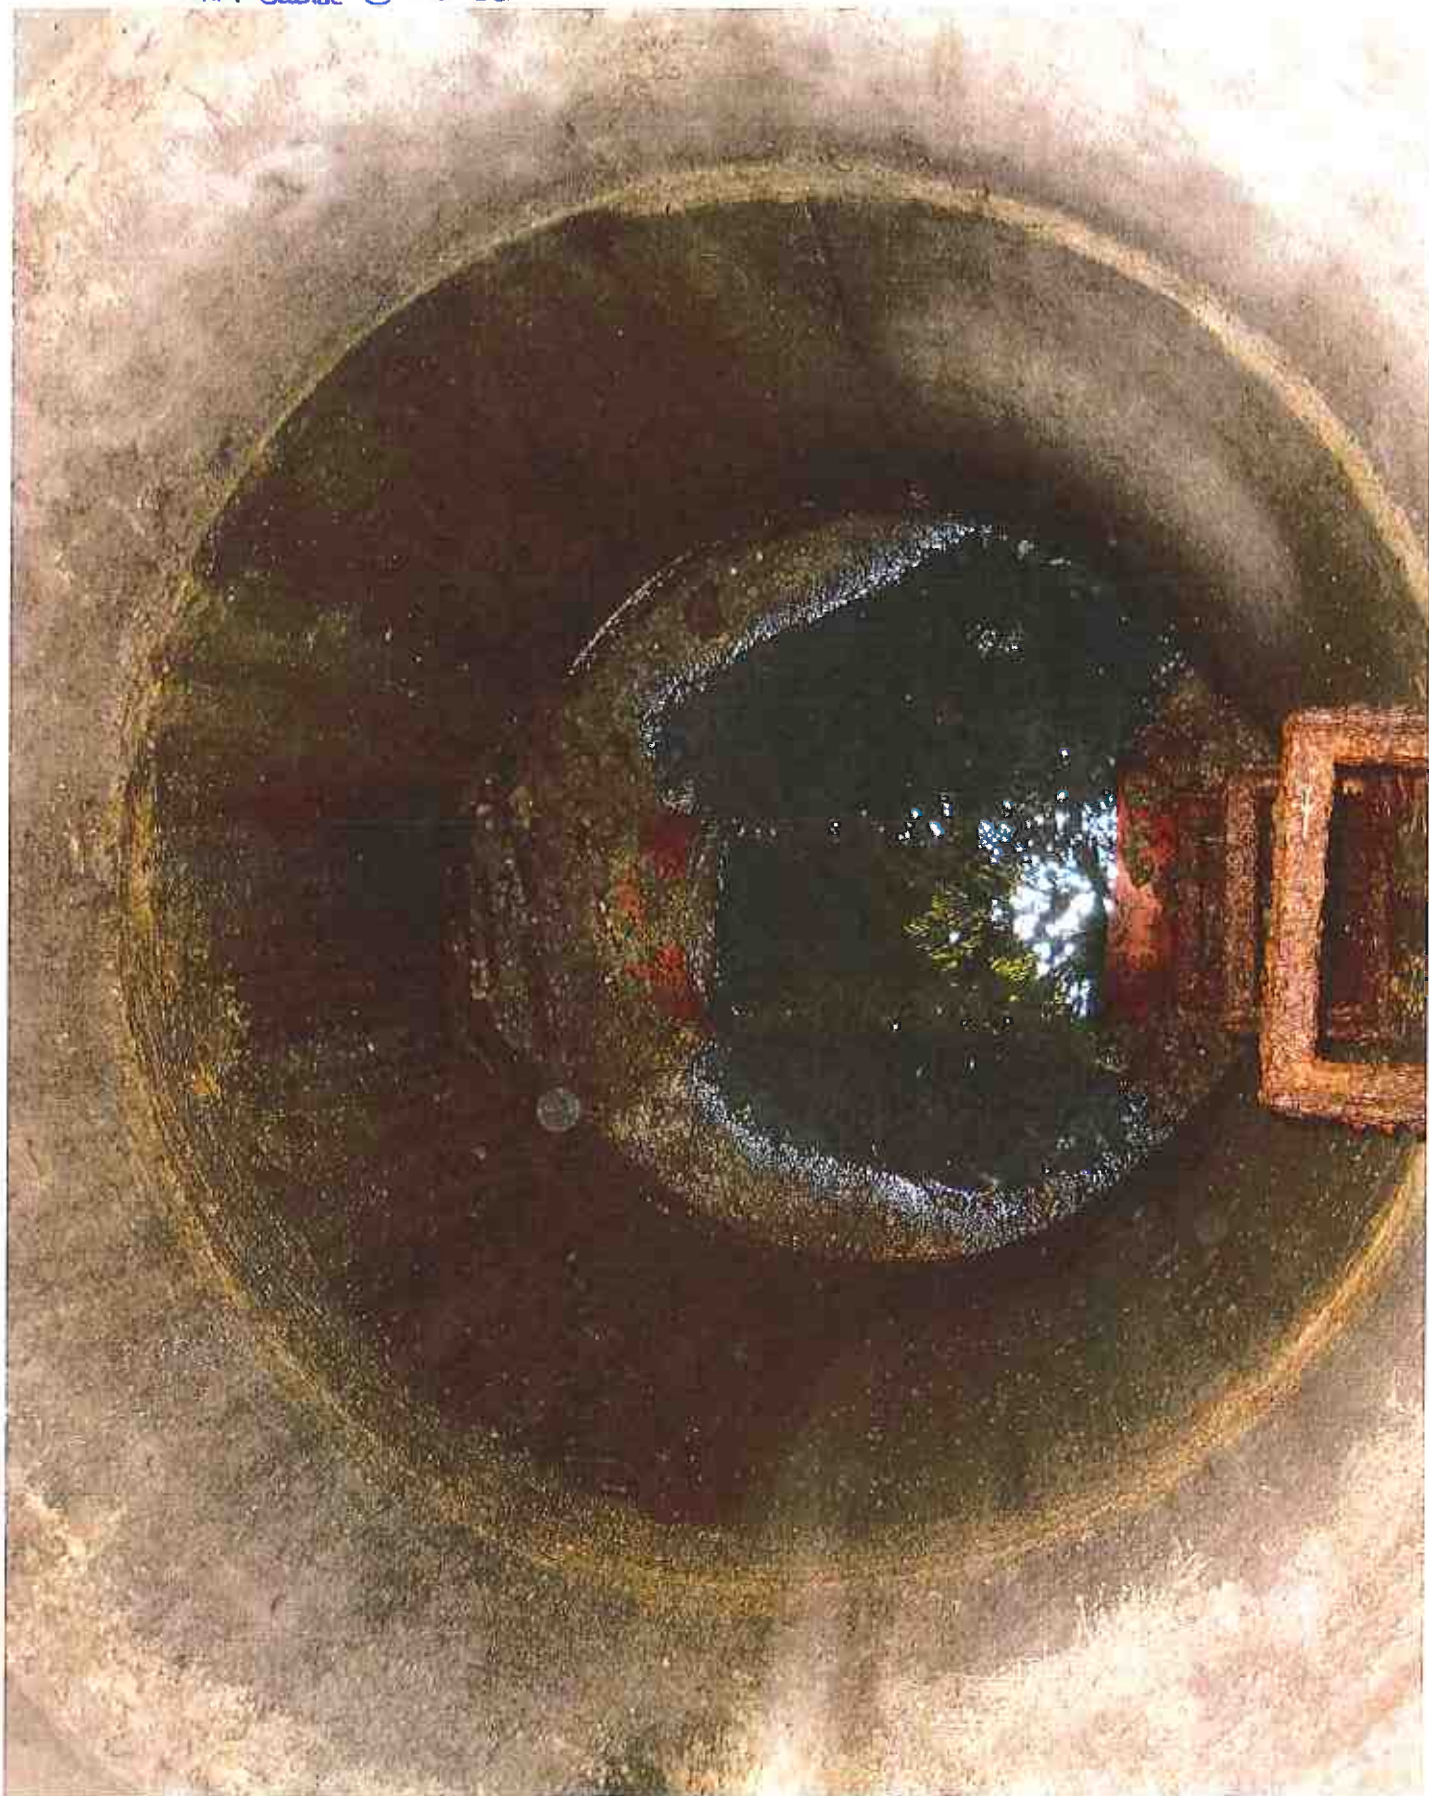
Looking S. (upstream) @ Hicc Intake on Clay Tive @ #3491

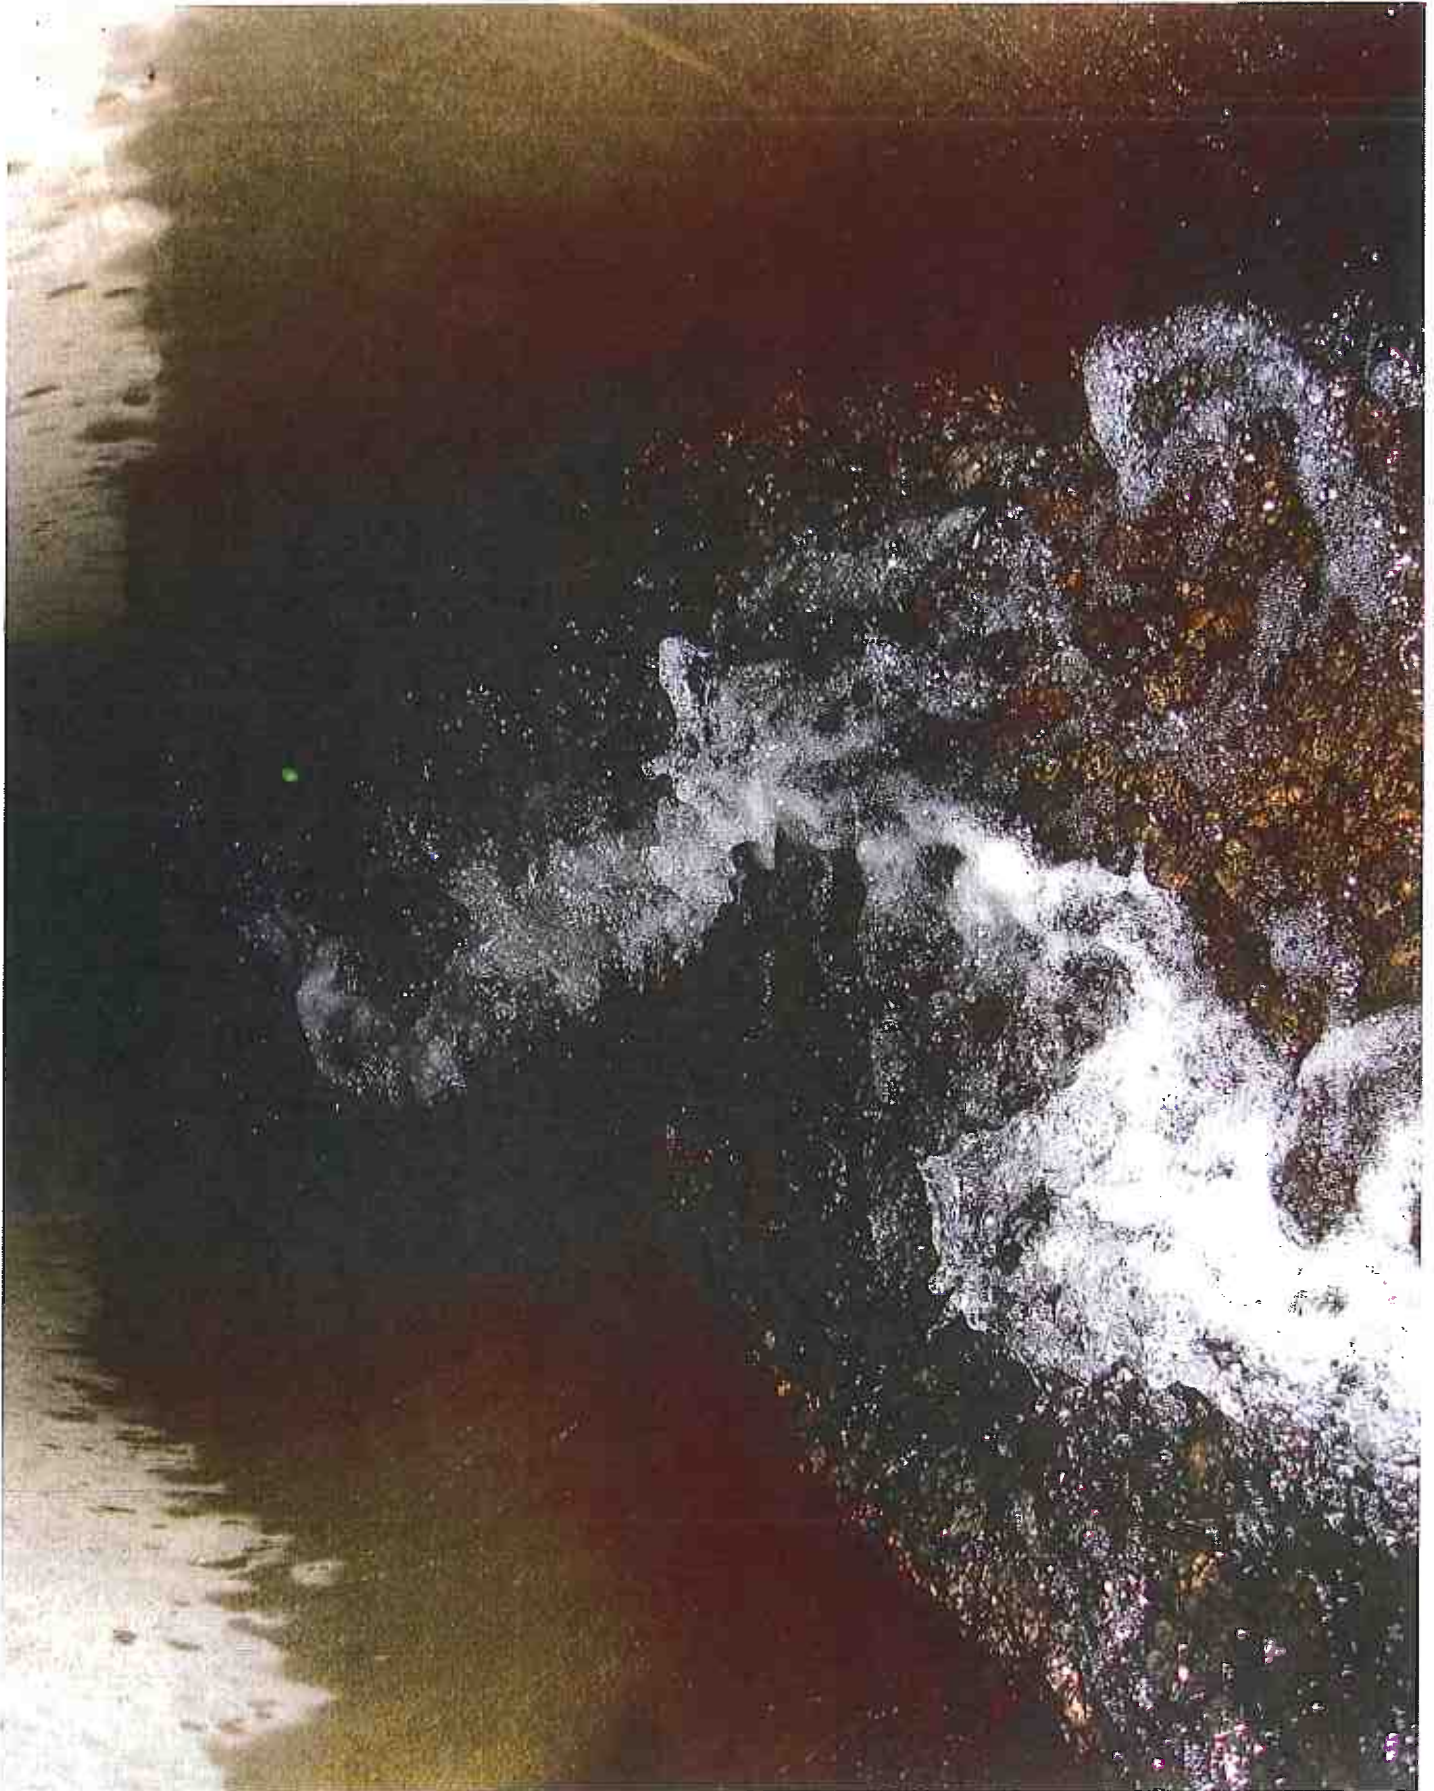
LOOKING @ DD68 OUTLET @ SIDE OF RR CASING

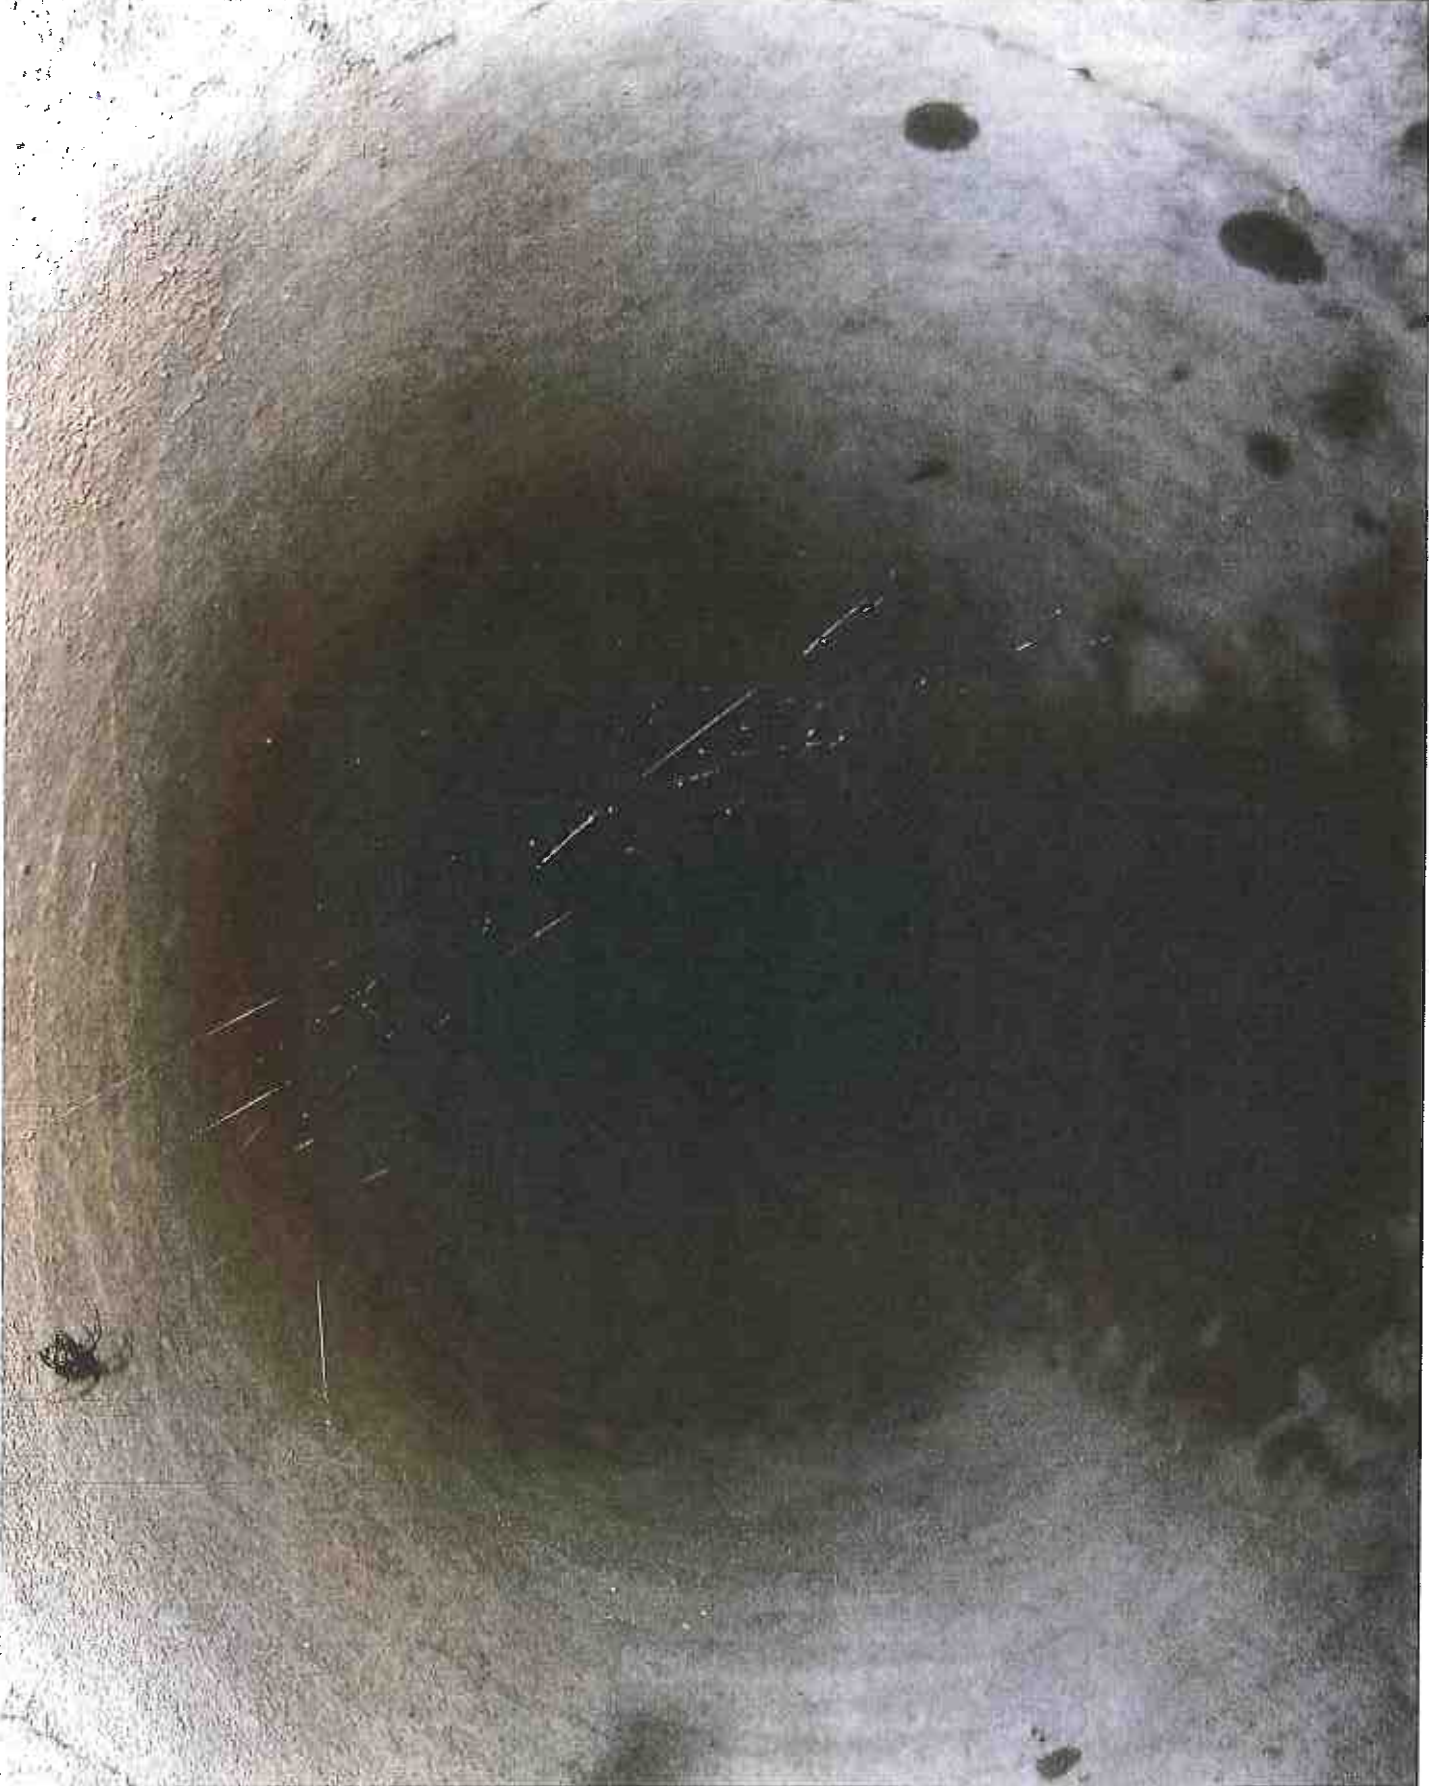
Looking WEST From MH#3487

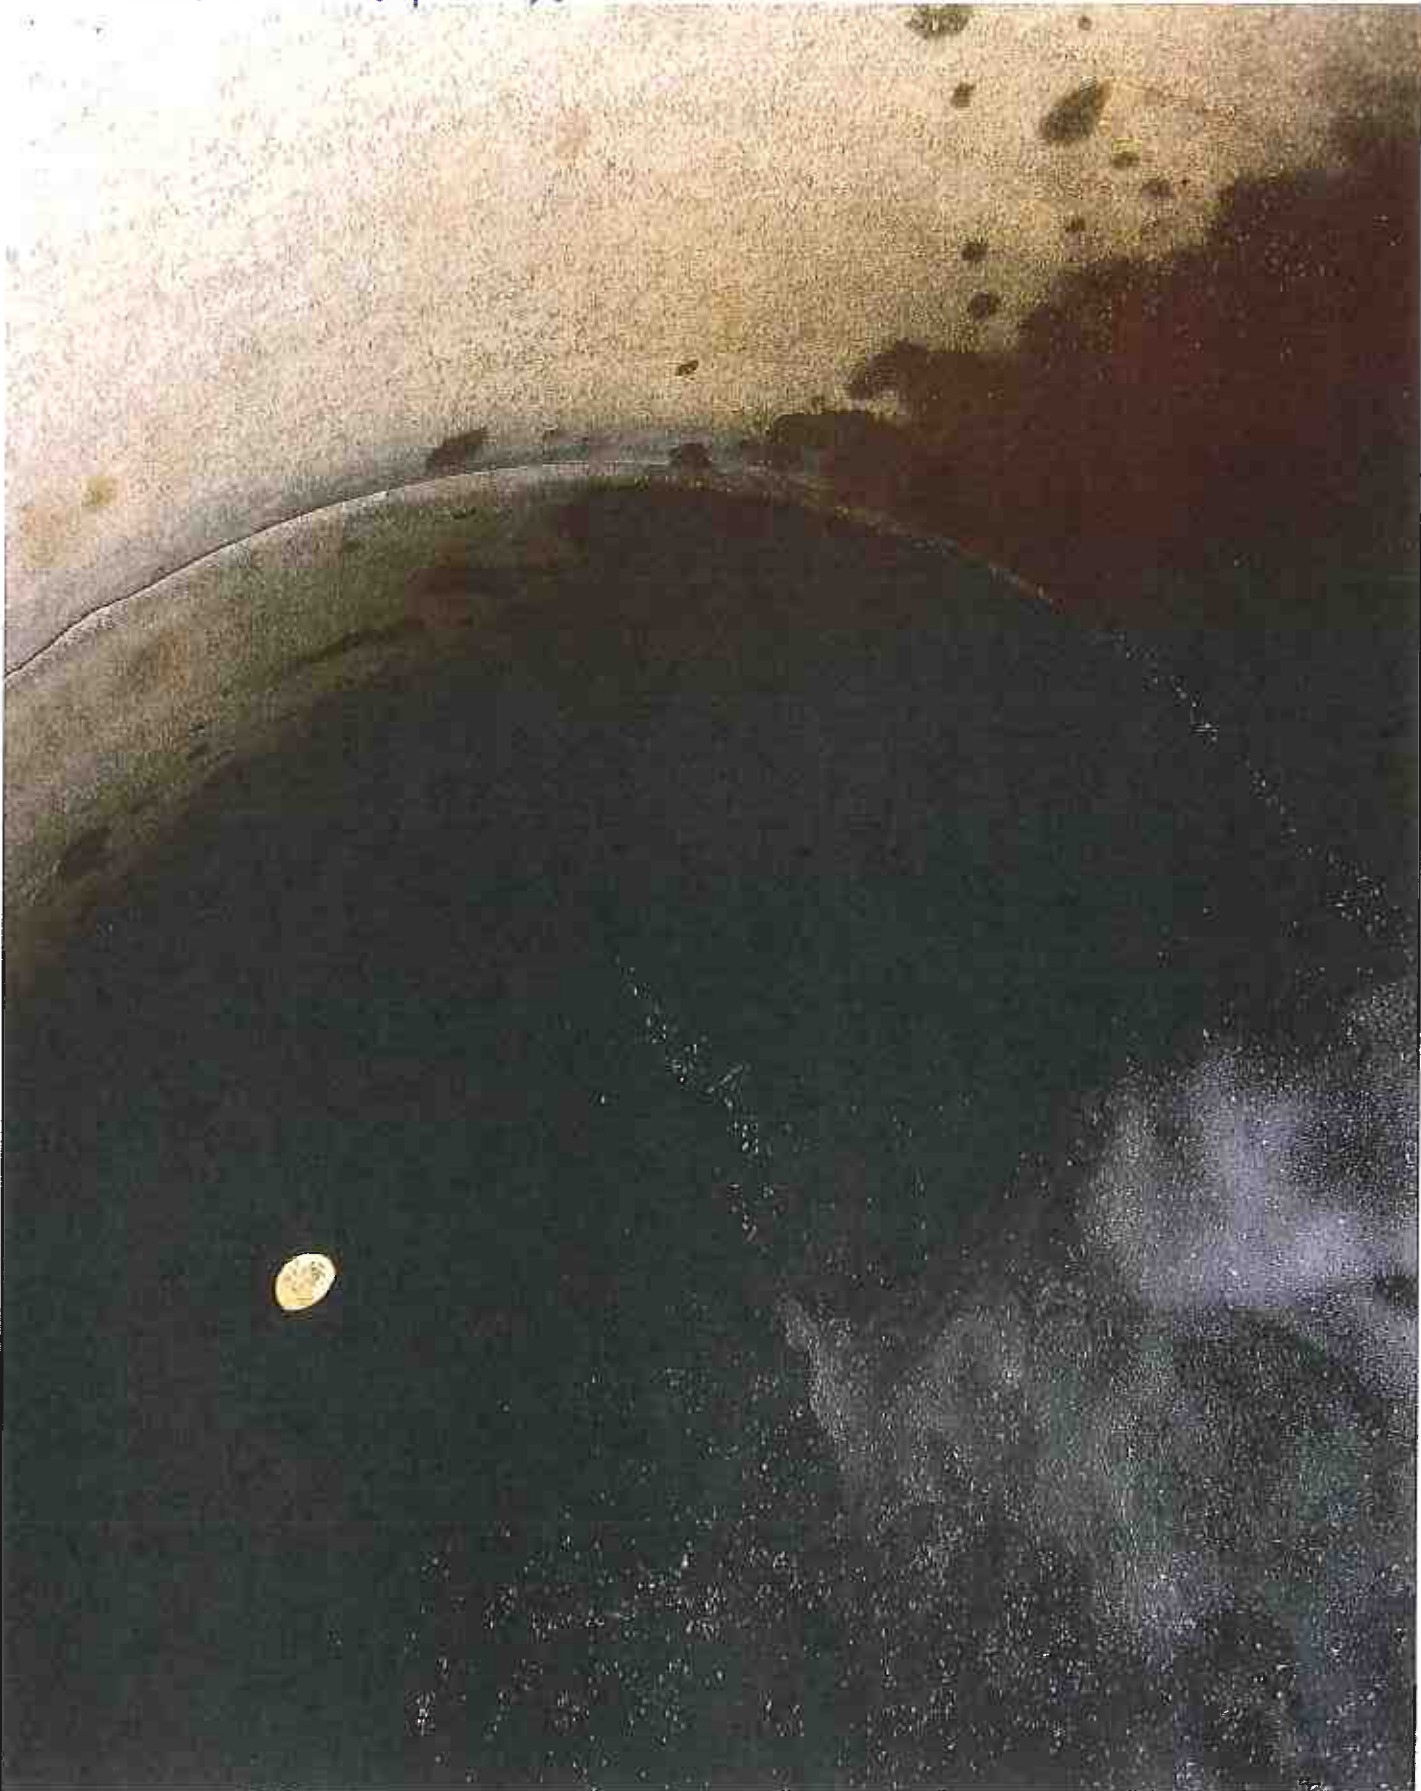
LOOKING SOUTH (UPSTREAM) @ MH #3487 . NOTE: OUR TILE OUTLET ON RT. SIDE.

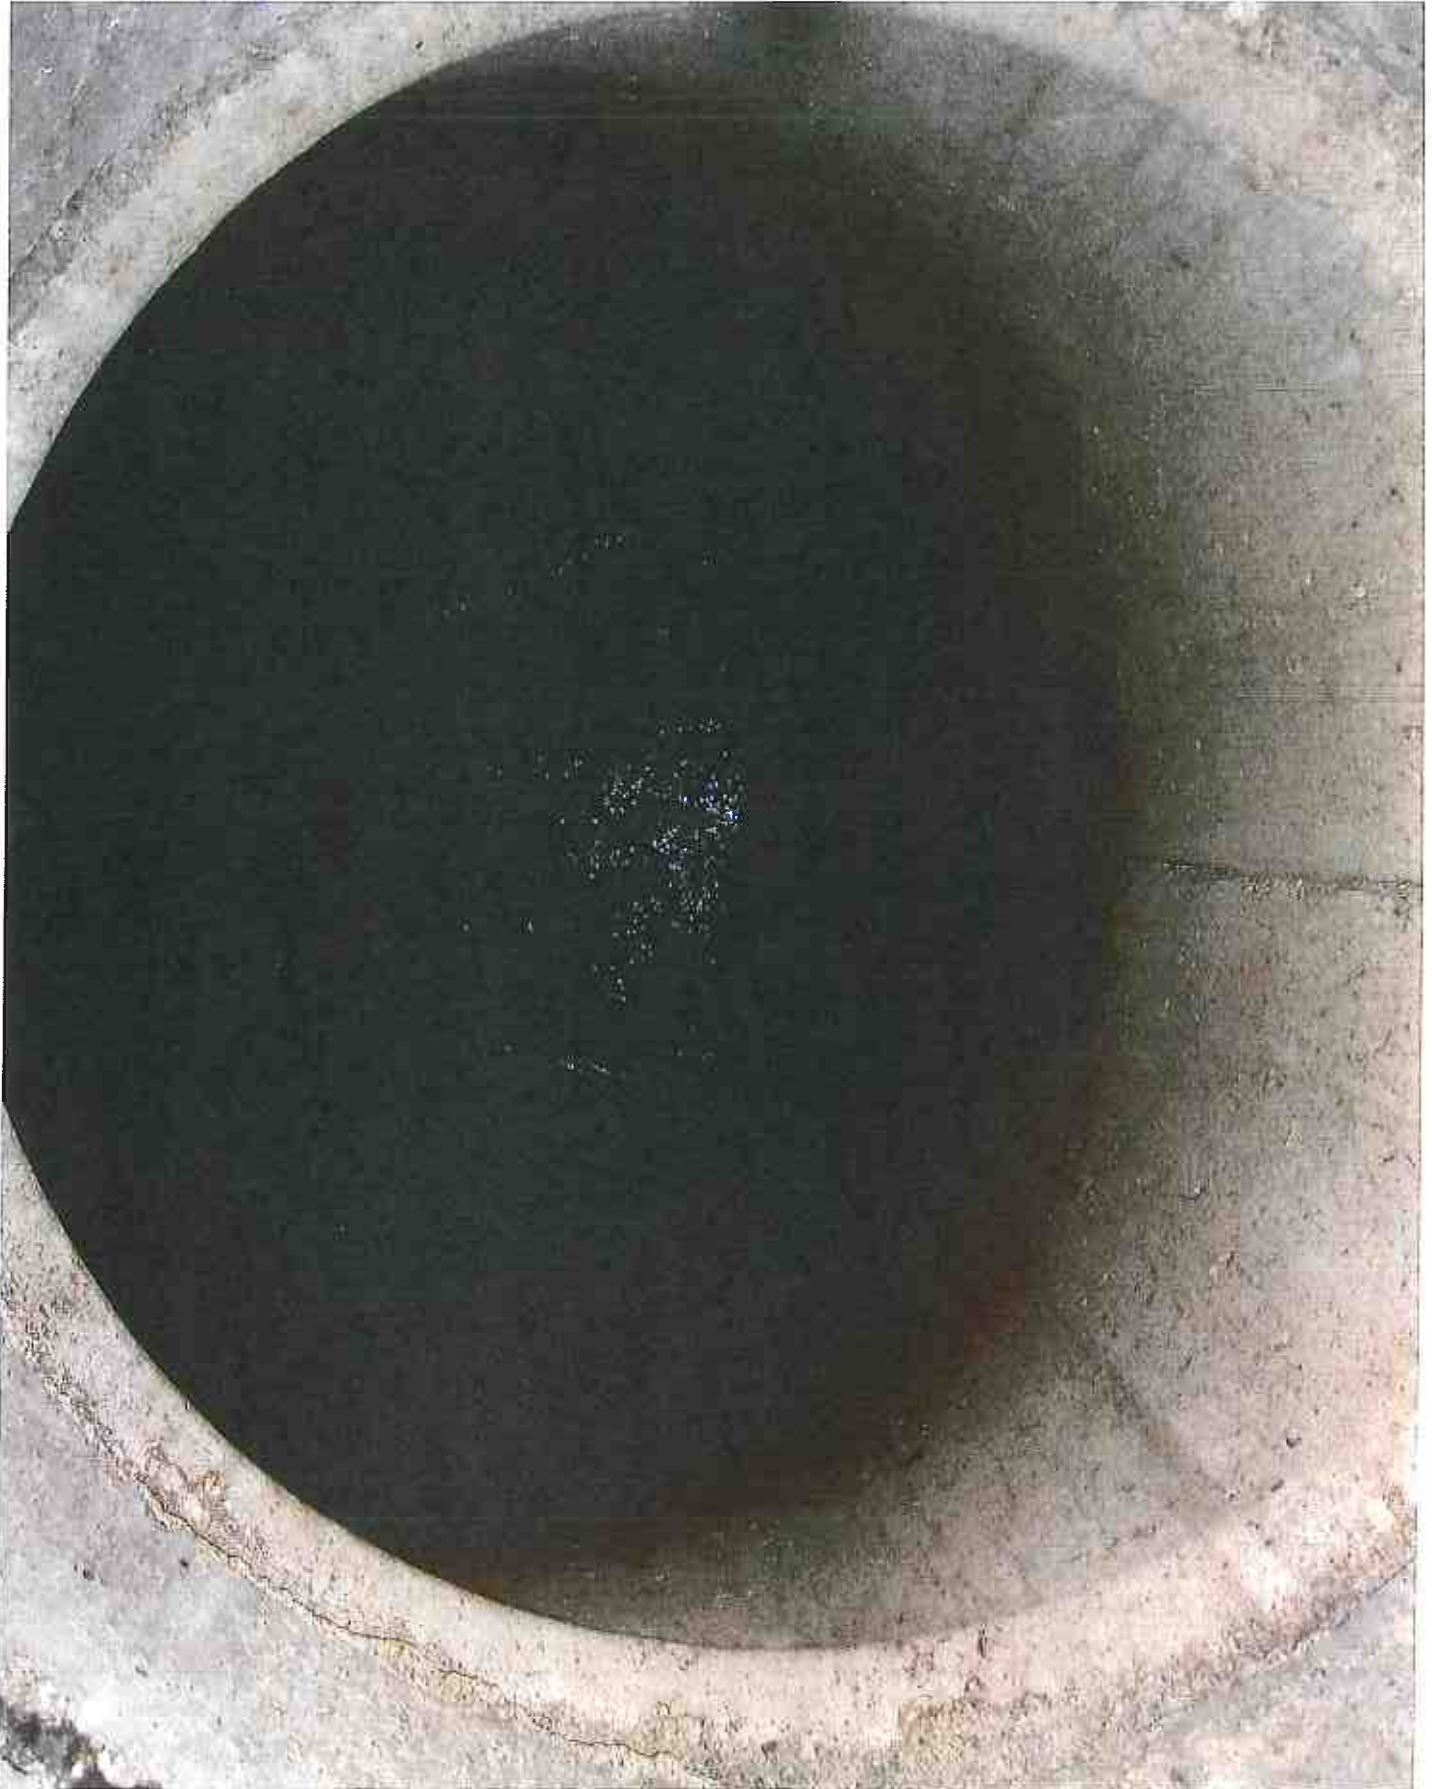
MH. #3488 SAN.?
