**AGENDA**  
**REGULAR DRAINAGE MEETING**  
**Wednesday, September 2, 2020 9:30 AM**  
**Large Conference Room**

4. DD 14 WO 290 - Discuss W Possible Action - Investigation Summary

[DD 14 WO 290 - 6844.4 - INVESTIGATION REPORT - 2020-08-31.PDF](#)

**COMPLETION REPORT ON  
MAIN TILE REPAIRS TO  
DRAINAGE DISTRICT 22  
FACILITIES  
HARDIN COUNTY, IOWA  
(PROJECT NOS. DD-6532.2 AND 8712)**

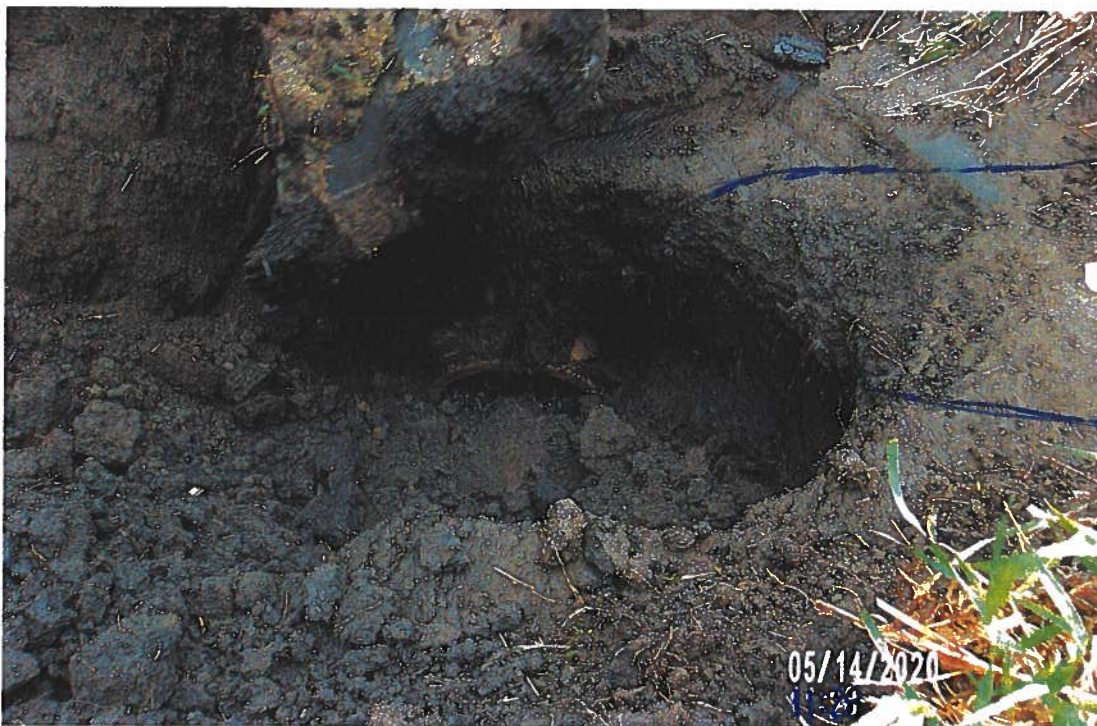
ERODED  
SOIL  
CAVITY

PICTURE # 3539 IS LOOKING NE @ BLOWOUT # 25 SHOWING A 5.0'  
LONG CAVITY ON EAST SIDE OF TILE WHERE SOIL ERODED  
AWAY

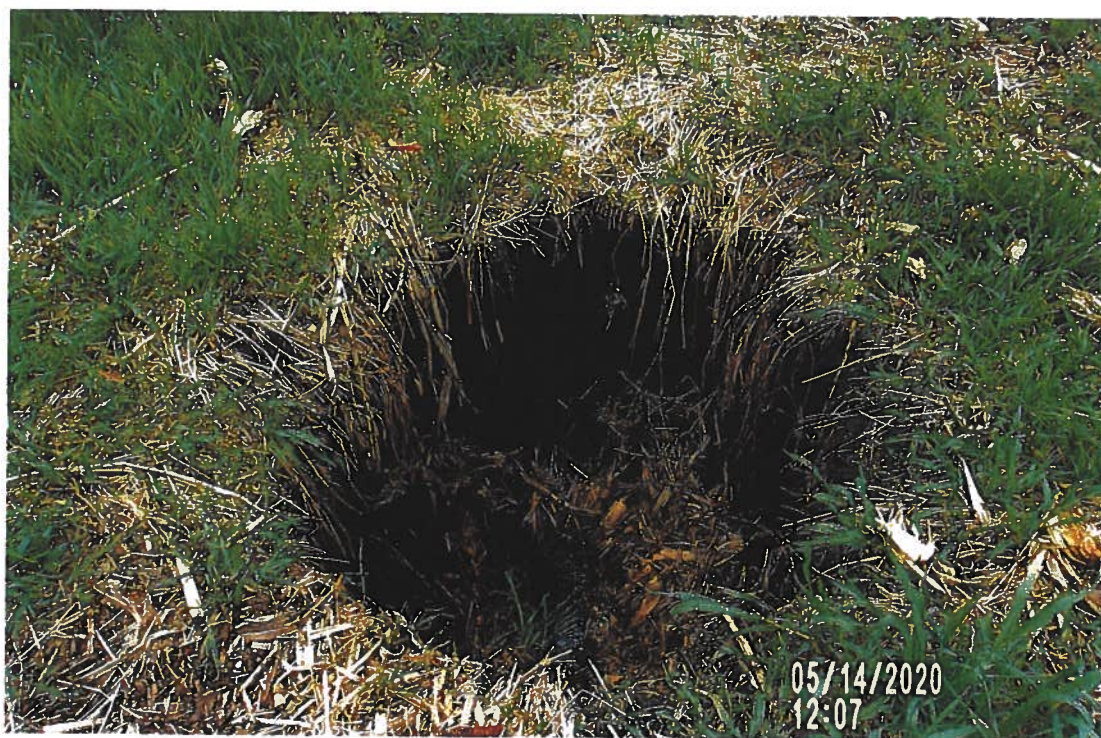
PICTURE # 3545 IS LOOKING NW INSIDE BLOWOUT 2 IN 5.0'  $\phi$  HOLE  
WITH CORNSTALKS AND SOIL IN BOTTOM.

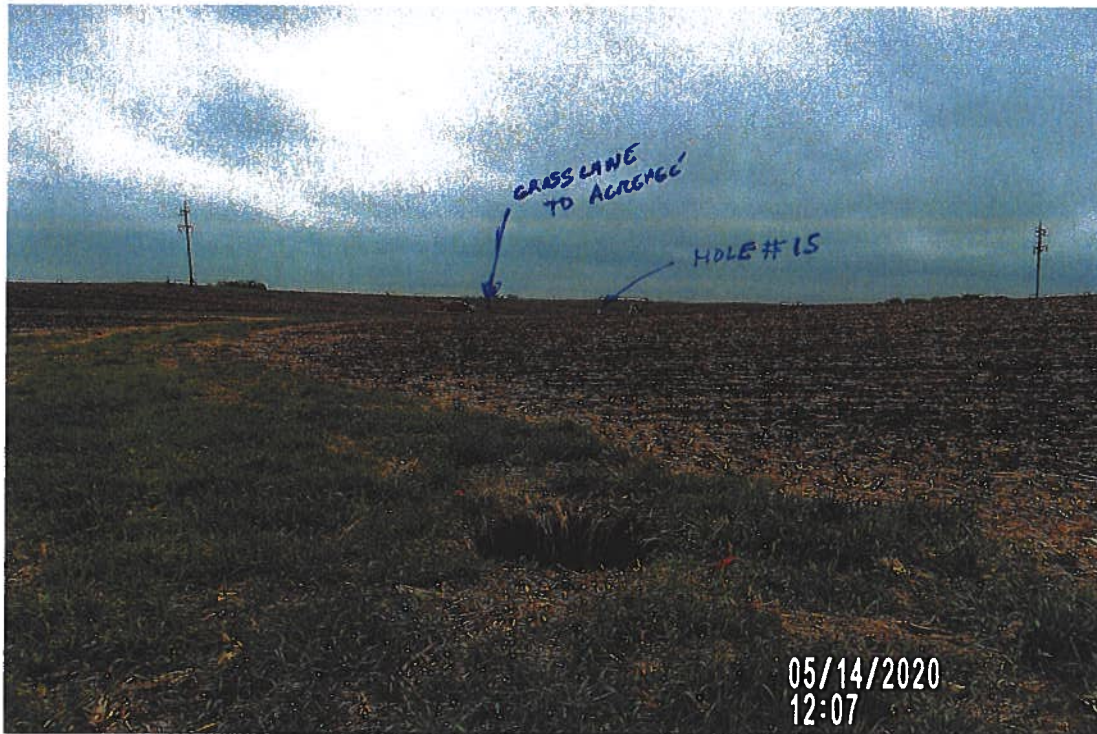
PICTURE # 3547 IS LOOKING UPSTREAM AT COMPLETELY COLLAPSED  
SECTION OF CLAY TILE @ 537.2' WHICH HAD NOT SURFACED  
YET & SOUTH OF TILE BLOWOUT # 2N,

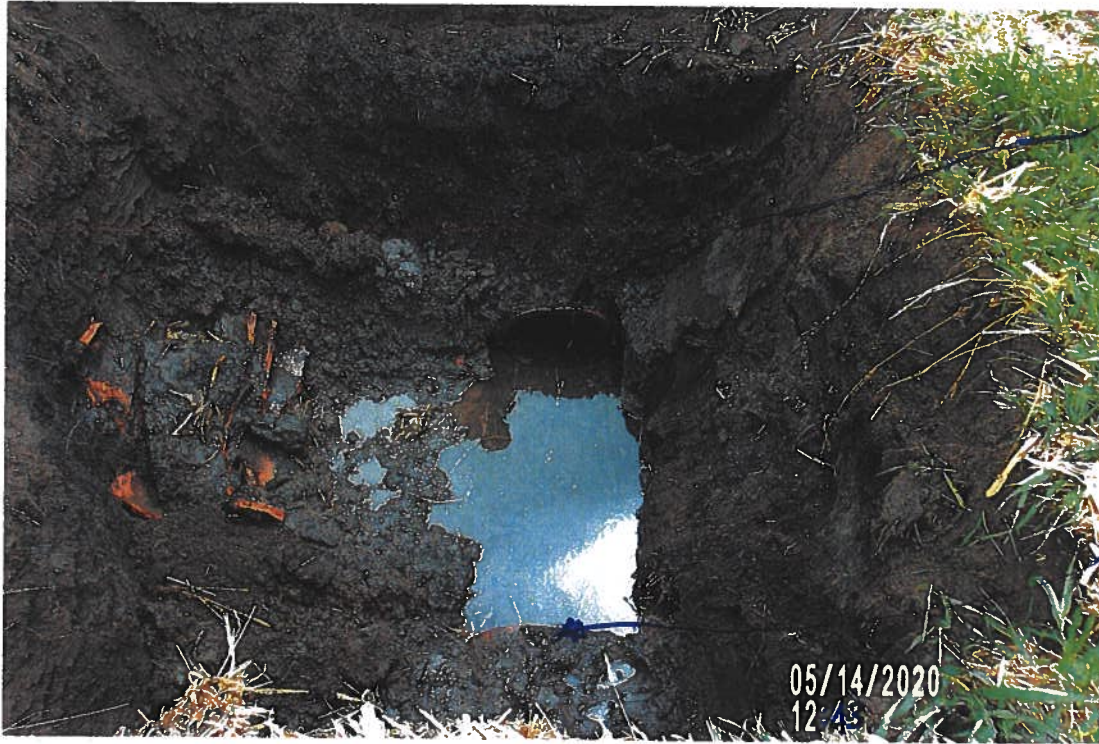
PICTURE# 3549 IS LOOKING NW SHOWING VOID UNDER GRASS WATERWAY THAT HAD NEVER SURFACED YET. ONLY 1.0' TO 1.5' OF SOIL OVER VOID @ 537.1' WHERE TILE COMPLETELY

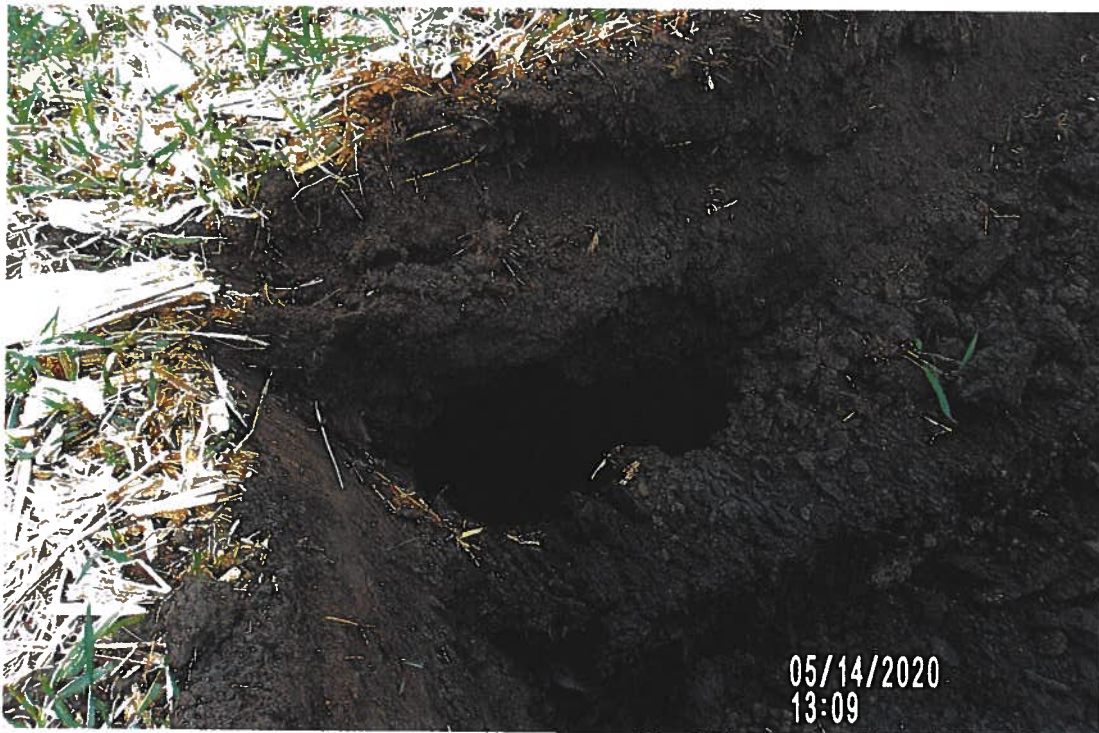
PICTURE # 3550 IS LOOKING NW SHOWING VOID UNDER GRASS WATERWAY @ 537.1' WHERE TILE COMPLETELY COLLAPSED.

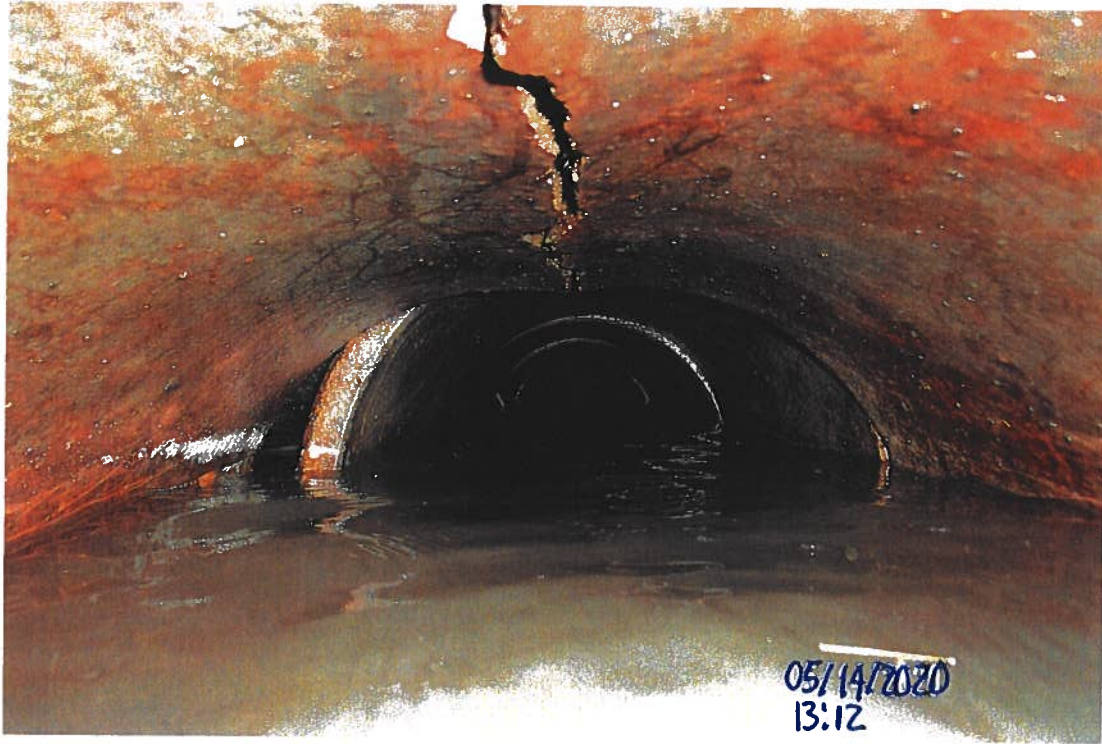
PICTURE # 3551 IS LOOKING NW SHOWING 1ST SECTION OF TILE WITH SEVERE LONGITUDINAL CRACK AND CAVING DOWN. UPSTREAM FROM GPS# 138 WITH SEVERAL OTHER TILE CRACKED AND CAVING DOWN SEVERAL FEET UPSTREAM.

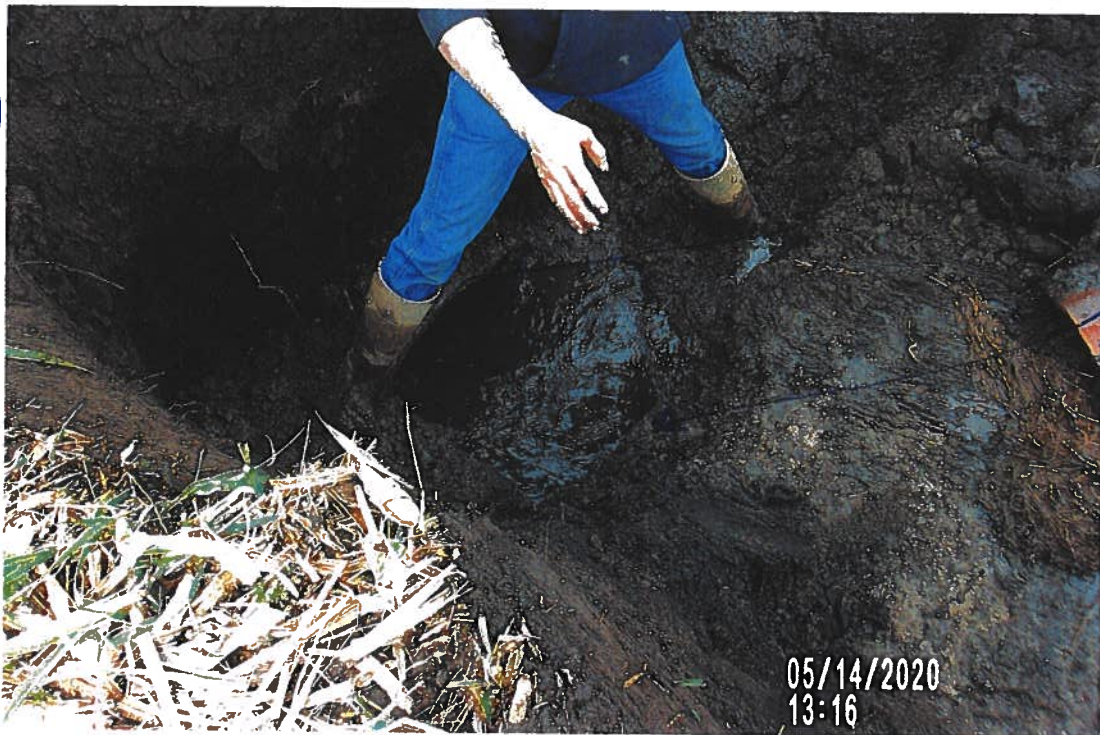
PICTURE # 3552 IS LOOKING SE SHOWING 1ST SECTION OF CLAY TILE WITH LONGITUDINAL CRACKS AND CAVING DOWN DOWNSTREAM FROM CPS# 139 WITH REST OF SECTIONS OF TILE NOT LOOKING TOO BAD

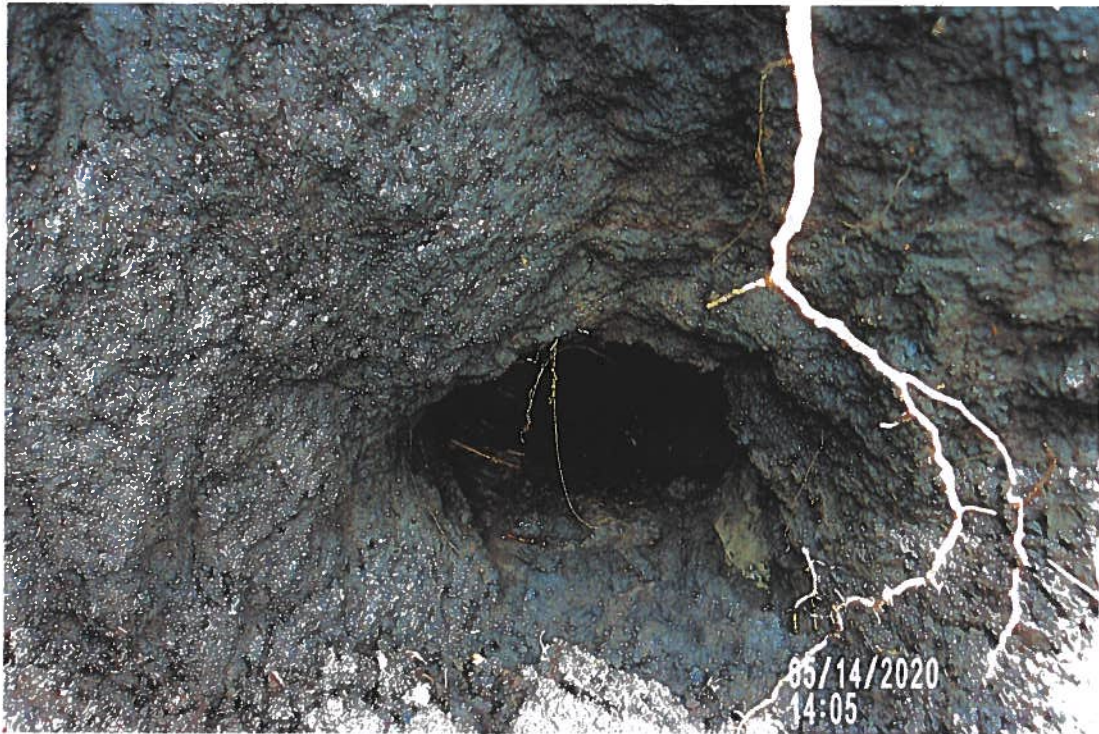
PICTURE# 3557 IS LOOKING NW SHOWING 4.0' LONG ERODED SOIL CAVITY ON WEST SIDE OF TILE IN IN TILE BLOWOUT # IN FROM GPS# 147

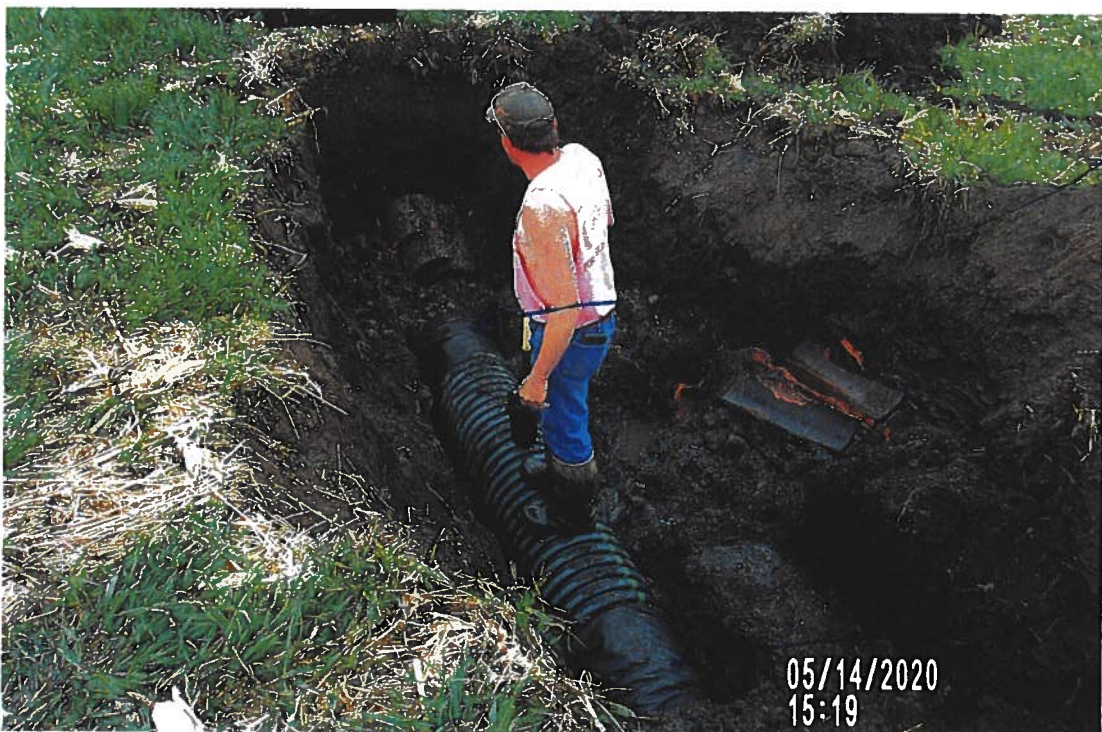
PICTURE #3563 IS LOOKING NW INSIDE CLAY TILE FROM GPS #176  
 IN TILE BLOWOUT # 2N SHOWING TILE WITH FINE CRACKS BUT  
 NOT CAVING DOWN IN 1ST TWO SECTIONS BUT NEXT TWO SECTIONS  
 APPEAR TO BE CAVING DOWN. CREW ENDED UP REMOVING

2 SECTIONS  
 OF CLAY  
 TILE ON  
 NORTH END  
 DUE TO NEXT  
 SECTION  
 COLLAPSING  
 DURING  
 REMOVAL  
 N ↑

PICTURE # 3564 IS LOOKING NORTH SHOWING CREW INSTALLED 8.5 LF  
 OF 15" Ø DUAL WALL NONPERF TILE IN BLOWOUT # 2N WITH BOTH  
 JOINTS WRAPPED WITH FABRIC FOR TEMPORARY REPAIR UNTIL DISTRICT

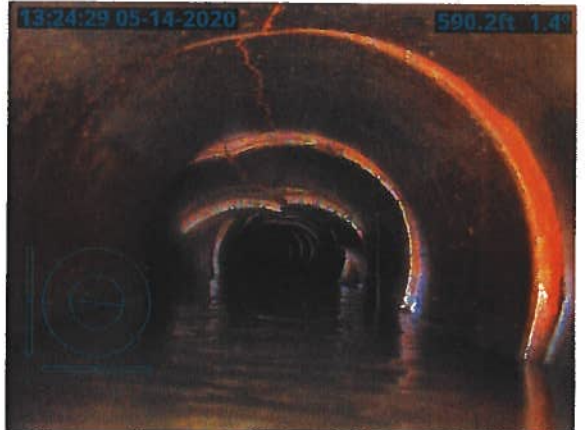
B 2020\_05\_14-13\_24\_29\_424.jpg

08	03			BROKEN AND COLLAPSED
1:19:44	590.2		B	2020_05_14-13_24_29_424.jpg
