**AGENDA**  
**REGULAR DRAINAGE MEETING**  
**Monday, February 8, 2021 9:30 AM**  
**Large Conference Room**

**This will be a joint meeting with the Franklin County Board of Supervisors acting as Drainage Trustees for DD H-F 4-53.**

## Drainage District:

## Investigation Summary:

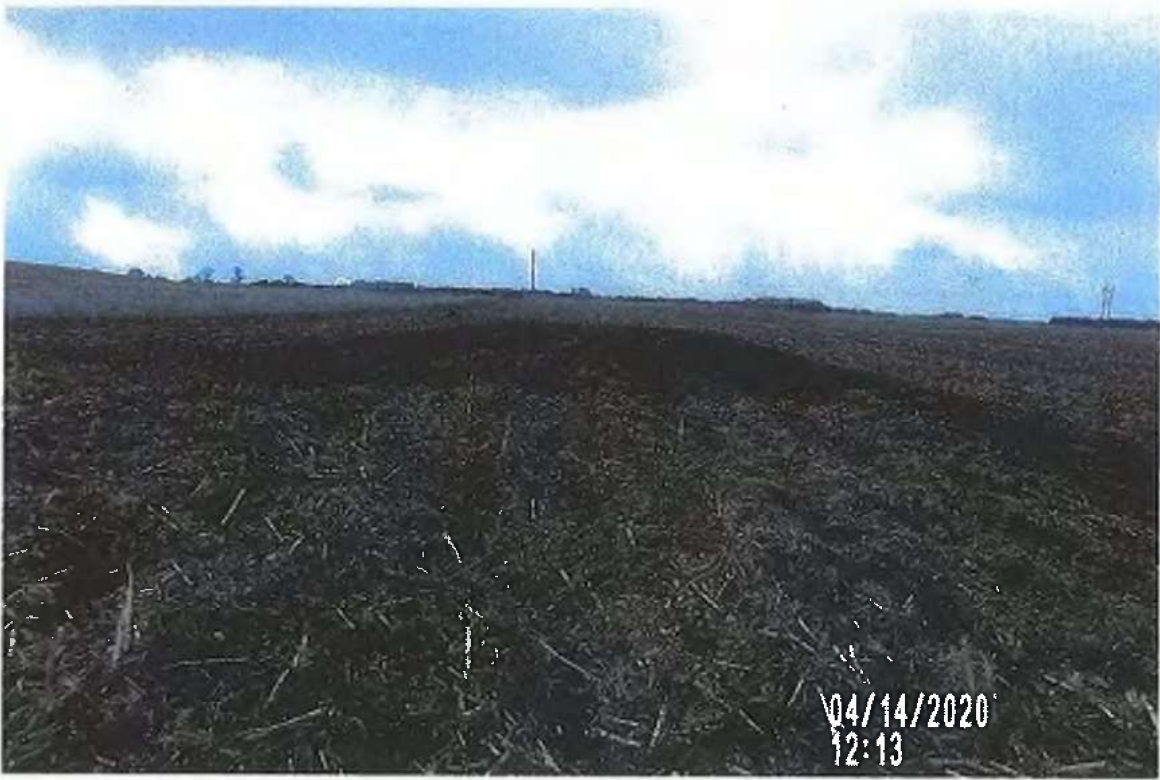
04/14/2020  
12:13

N-S SEE SHEET #2  
PICTURE # 3347 IS LOOKING SOUTH AT 255' X 72' E-W WET  
AREA THAT WAS REWORKED & WET AT ONE TIME, LAT 4-BZ OR  
LAT 4-B NOT NEAR THIS AREA ACCORDING TO MAP

PICTURE # 3348 IS LOOKING NORTH AT 72' E-W X 255' N-S  
AREA THAT WAS WET AND HAS BEEN REWORKED. LAT4B-2  
OR LAT4B NOT IN THIS AREA

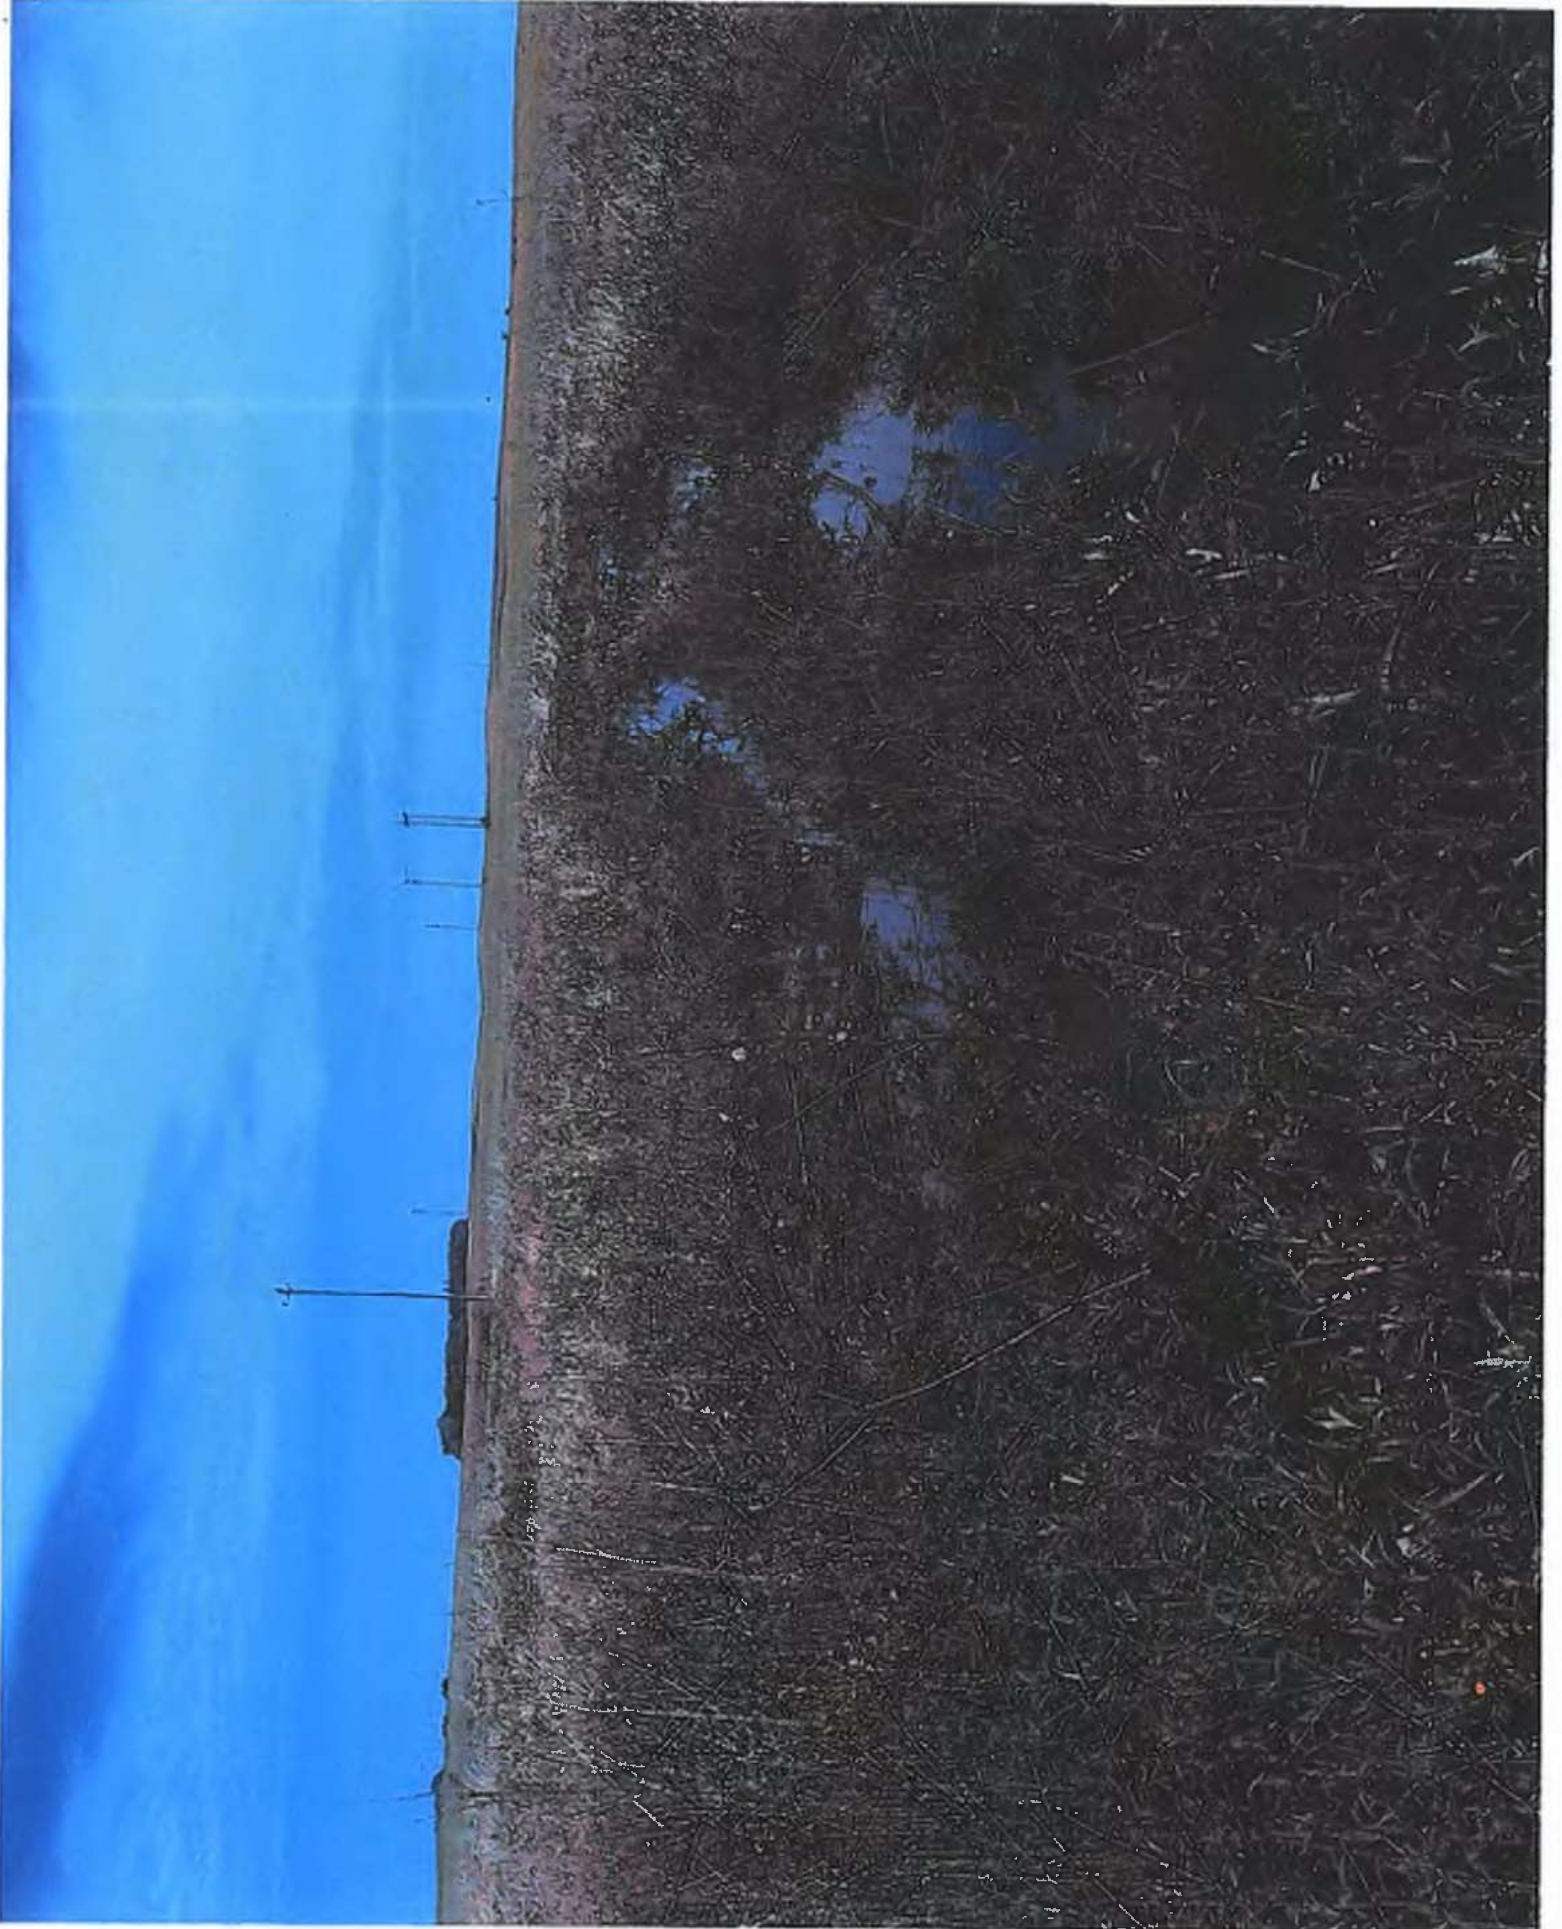
LOOKING UPSTREAM ON PRIVATE LINE IN DD5 @ 30TH ST.

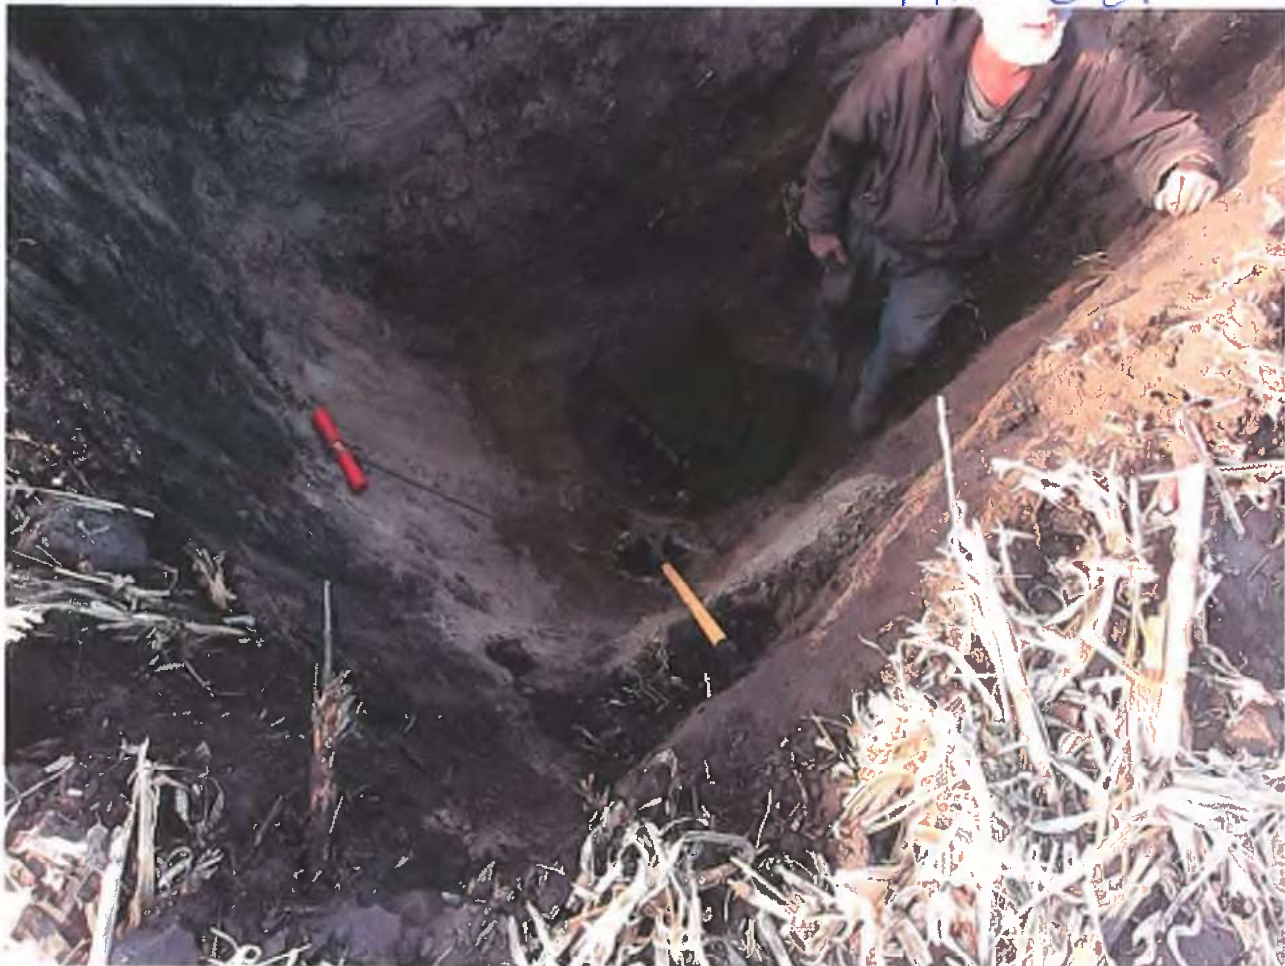
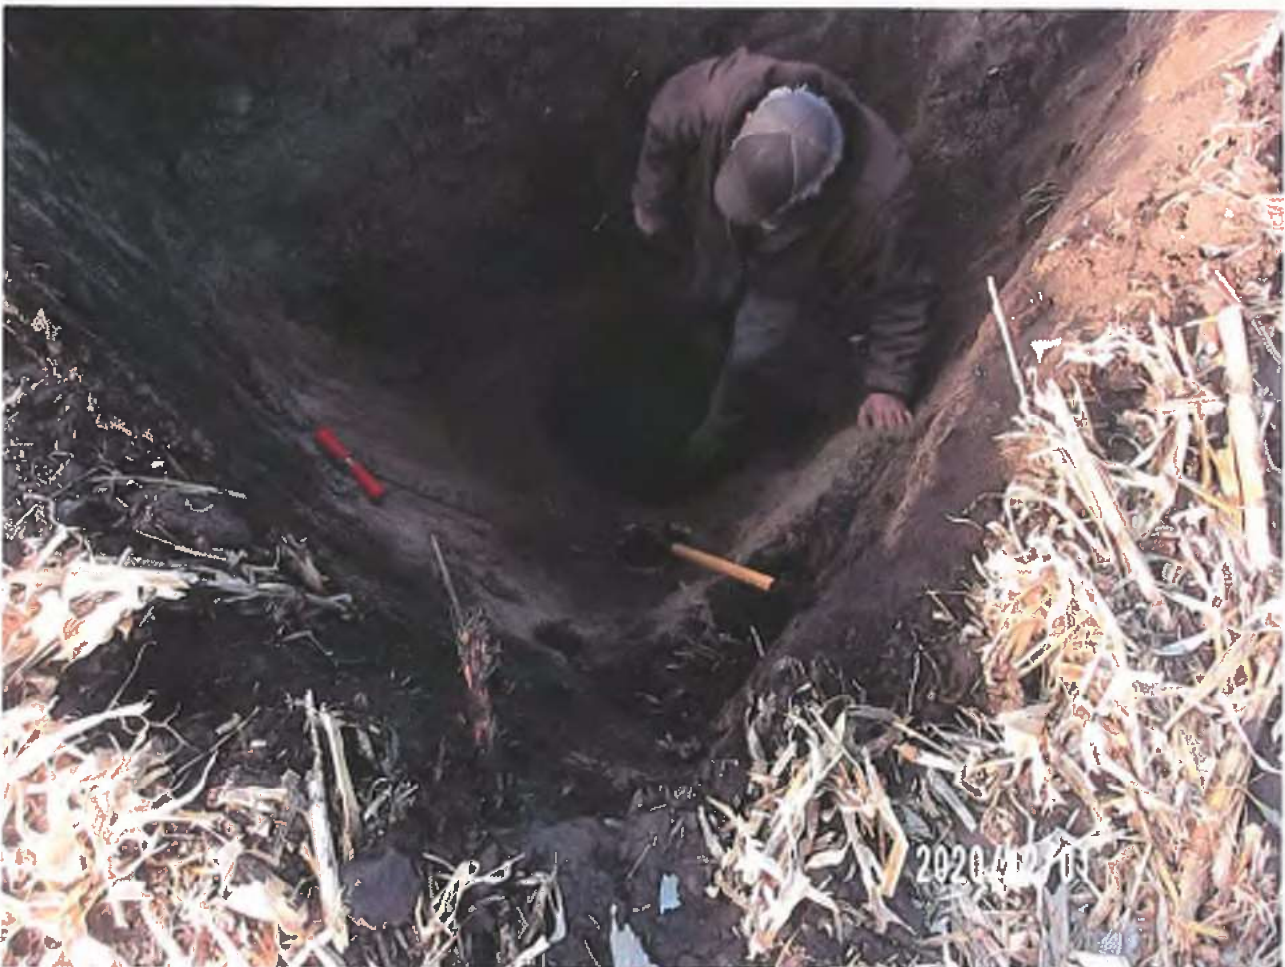
HOE @ 89

PATCH @ 89

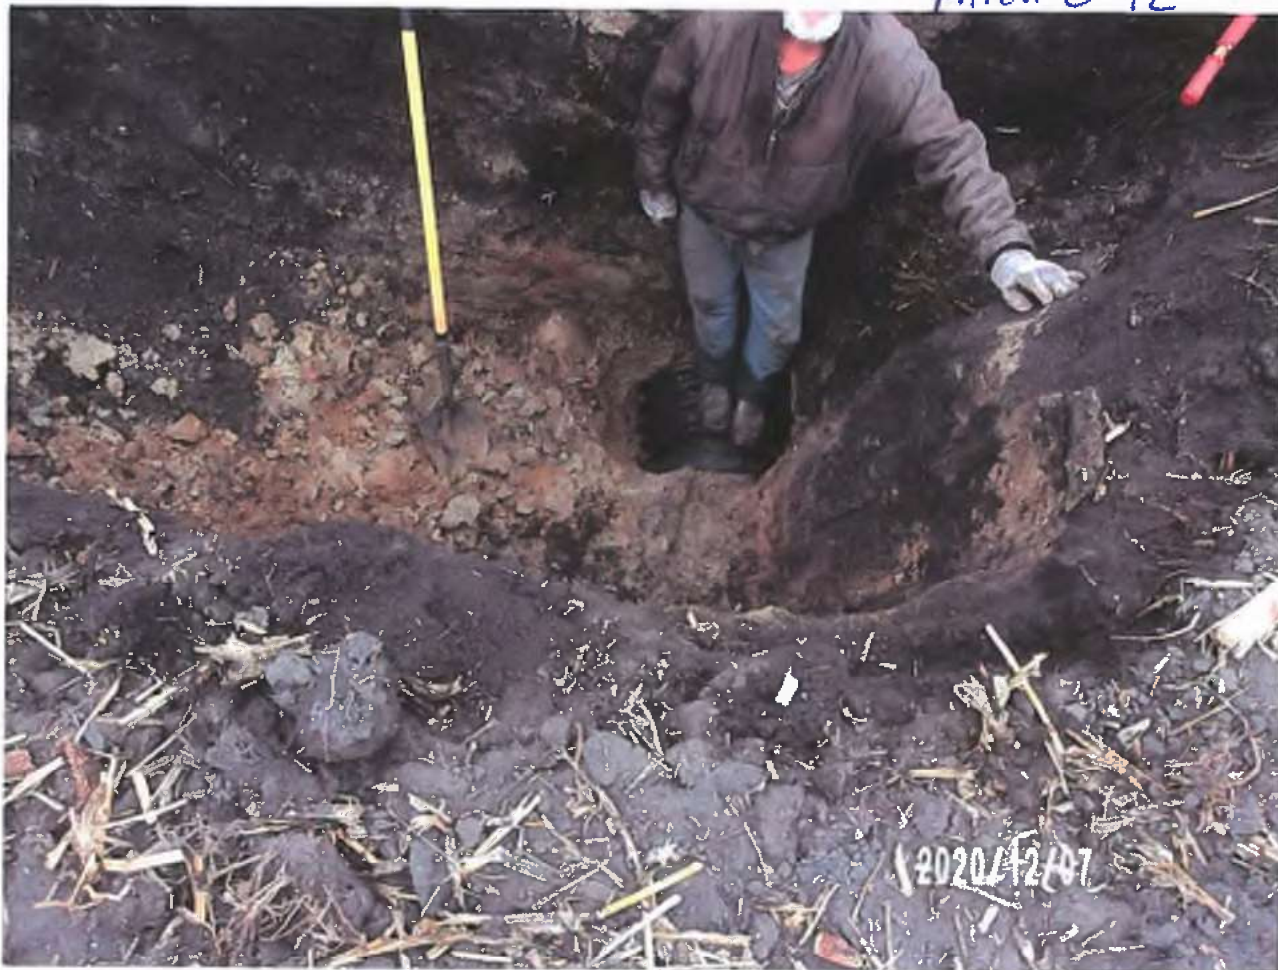
CLEARING DIRT AROUND #92

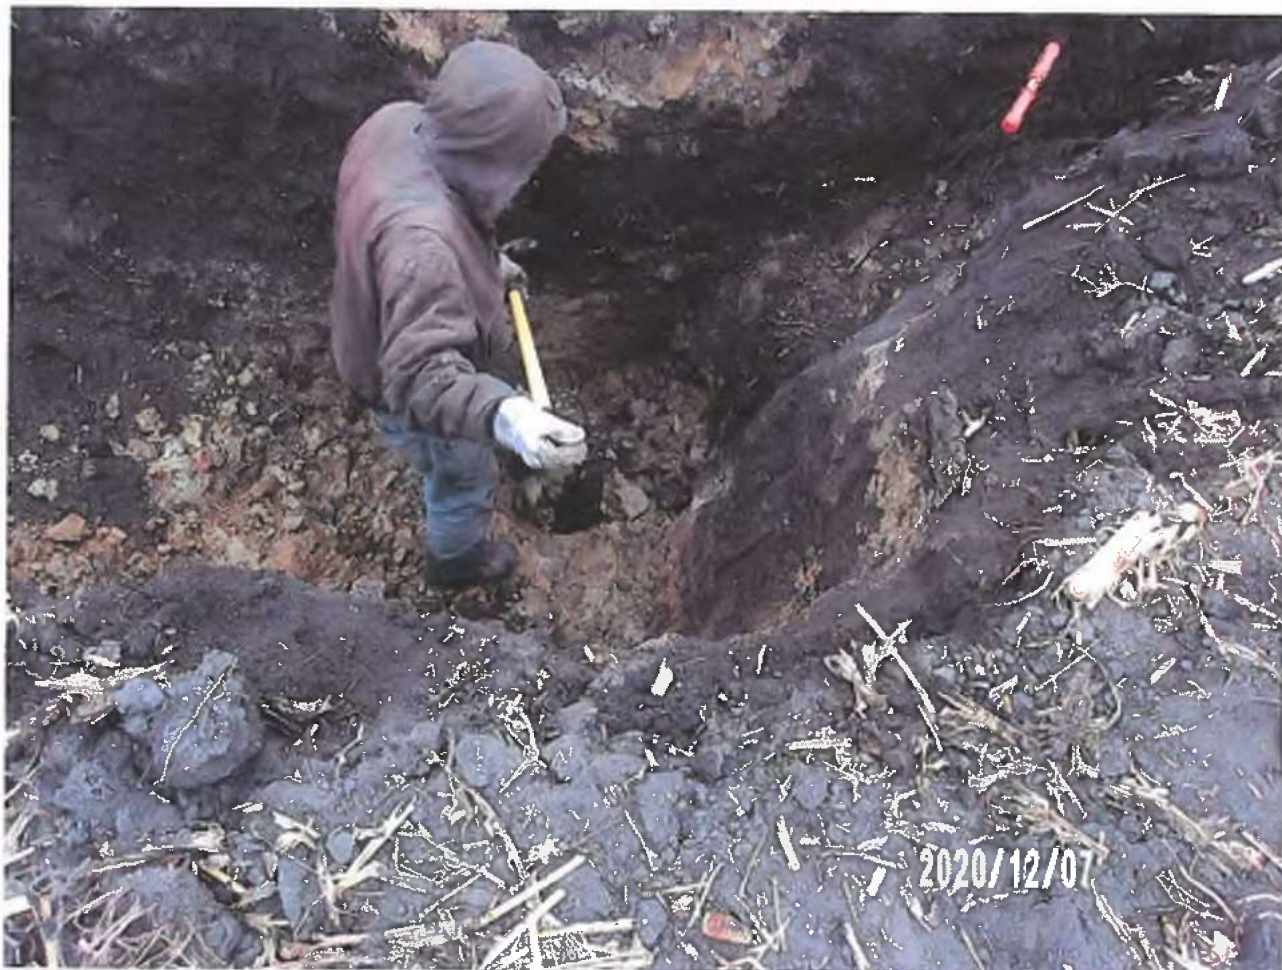
9:15 CREW STARTED DIGGING ON OF RR + FND A 10" CLAY (#91) RUNNING N-S THIS TILE IS FULL OF DIRT FND 15" CLAY TILE RUNNING N-S OPENED TILE @ 92 TILE HAS 1-2" OF DEBRIS + WATER IN THE BOTTOM OF TILE THE REST OF THE TILE IS IN GOOD CONDITION. CREW PATCHED TILE @ 92

PATCH @ 92

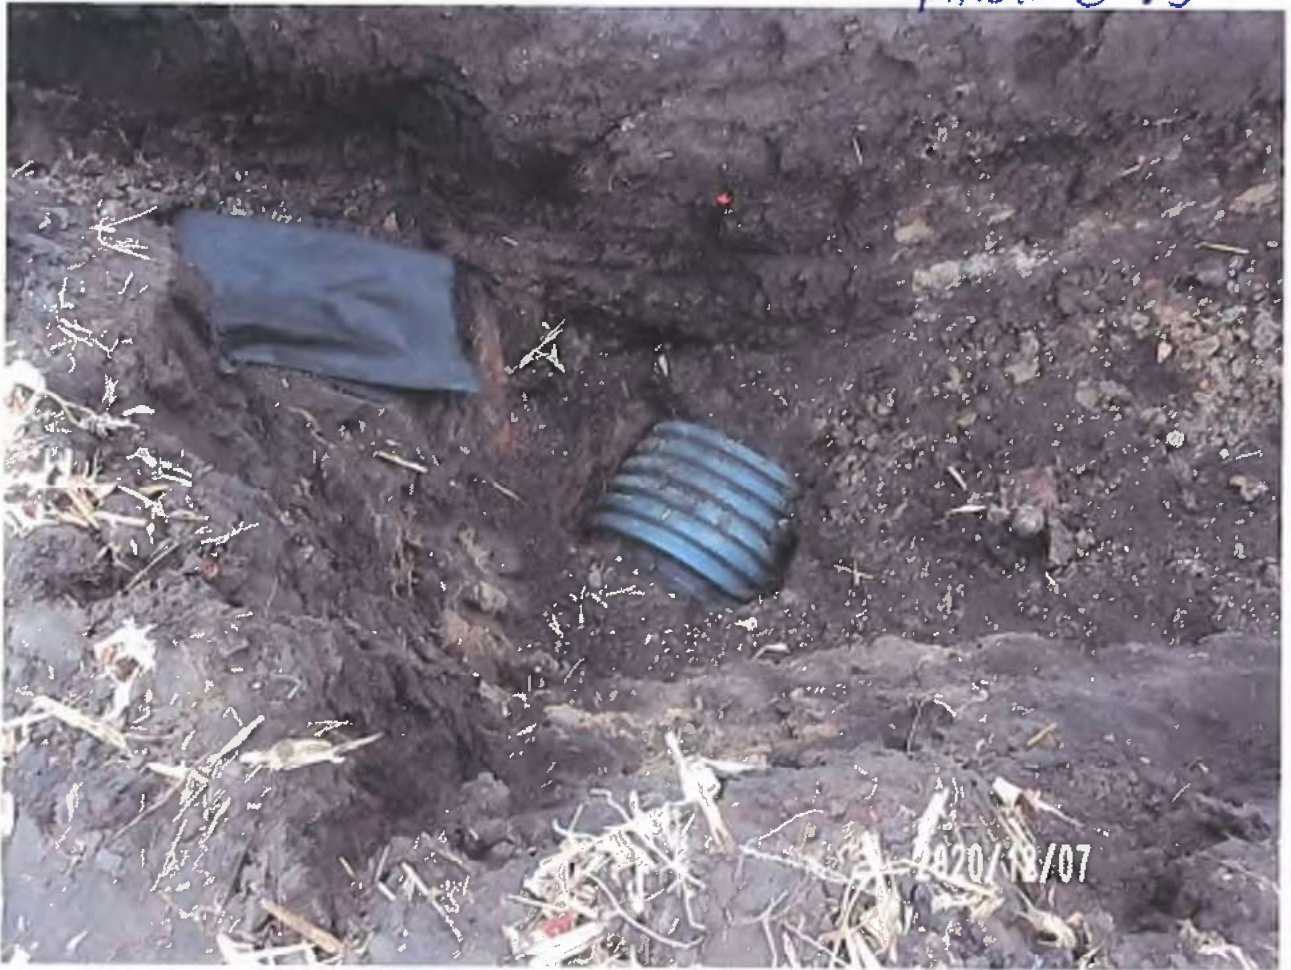
PATCH @ 73

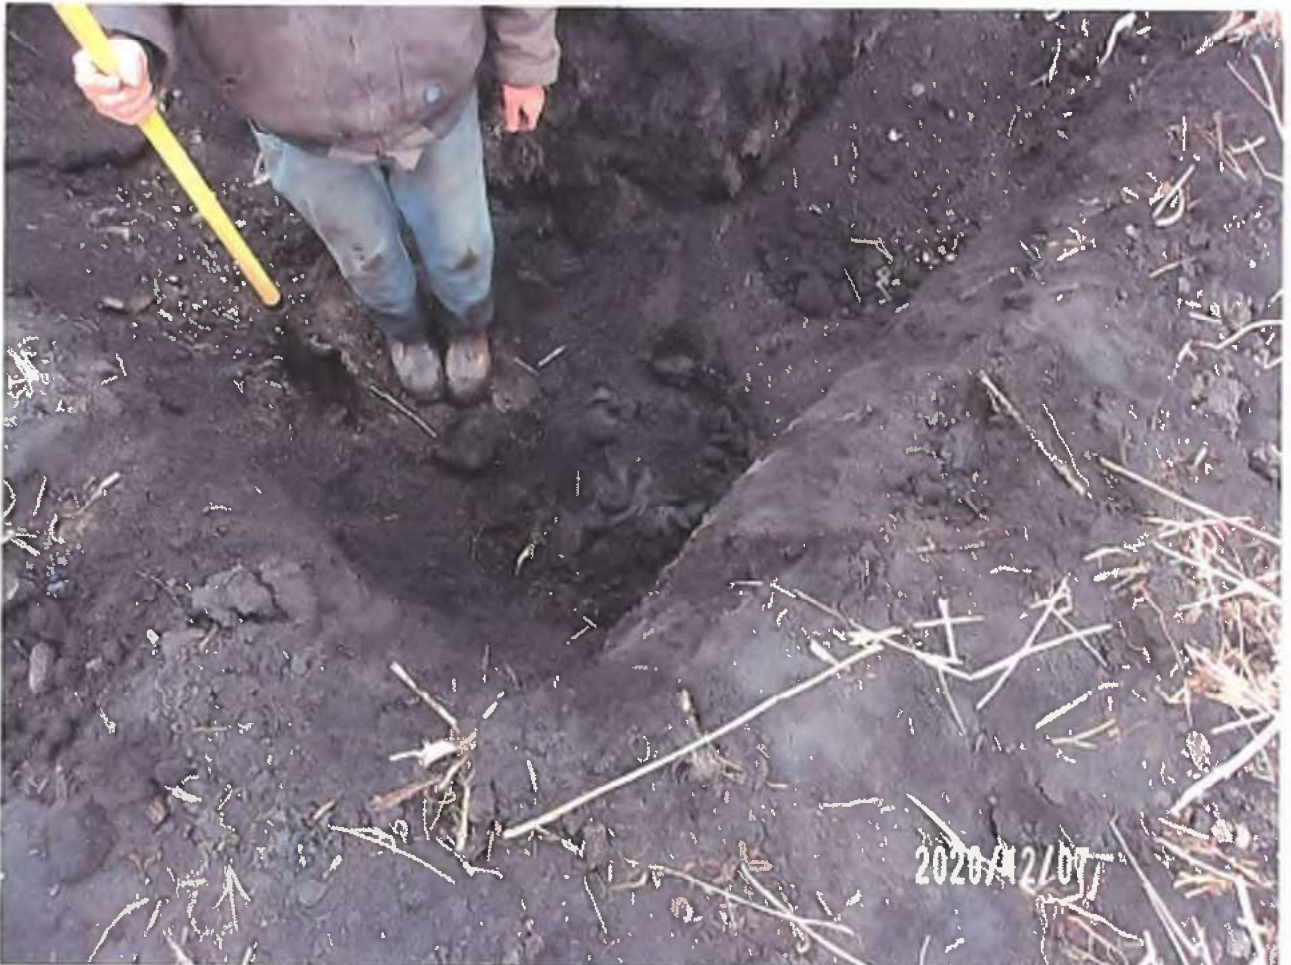
PATCH @ 69

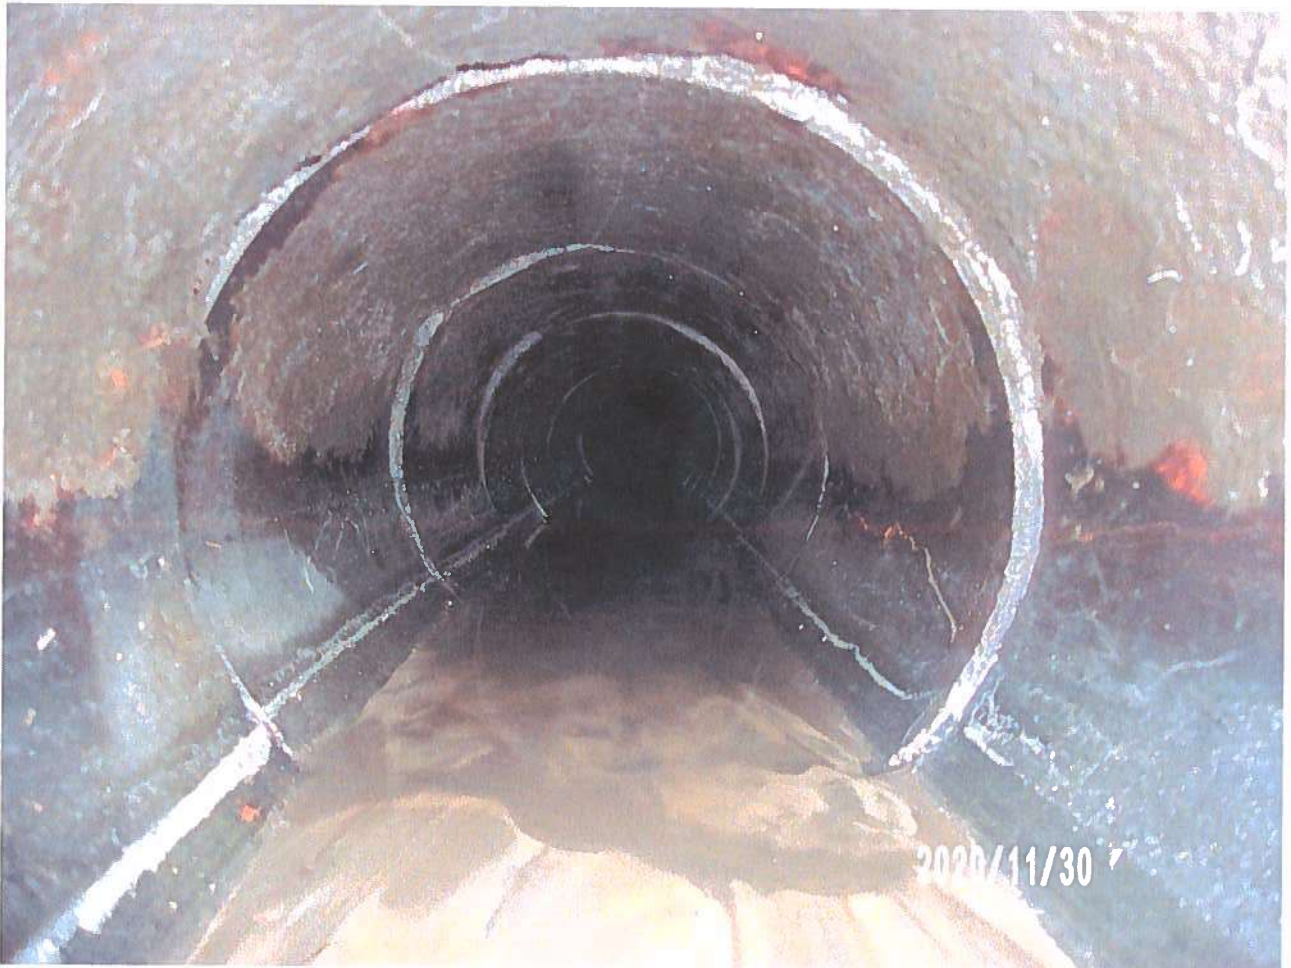
@ 70 LOOKING @ 71 + 72

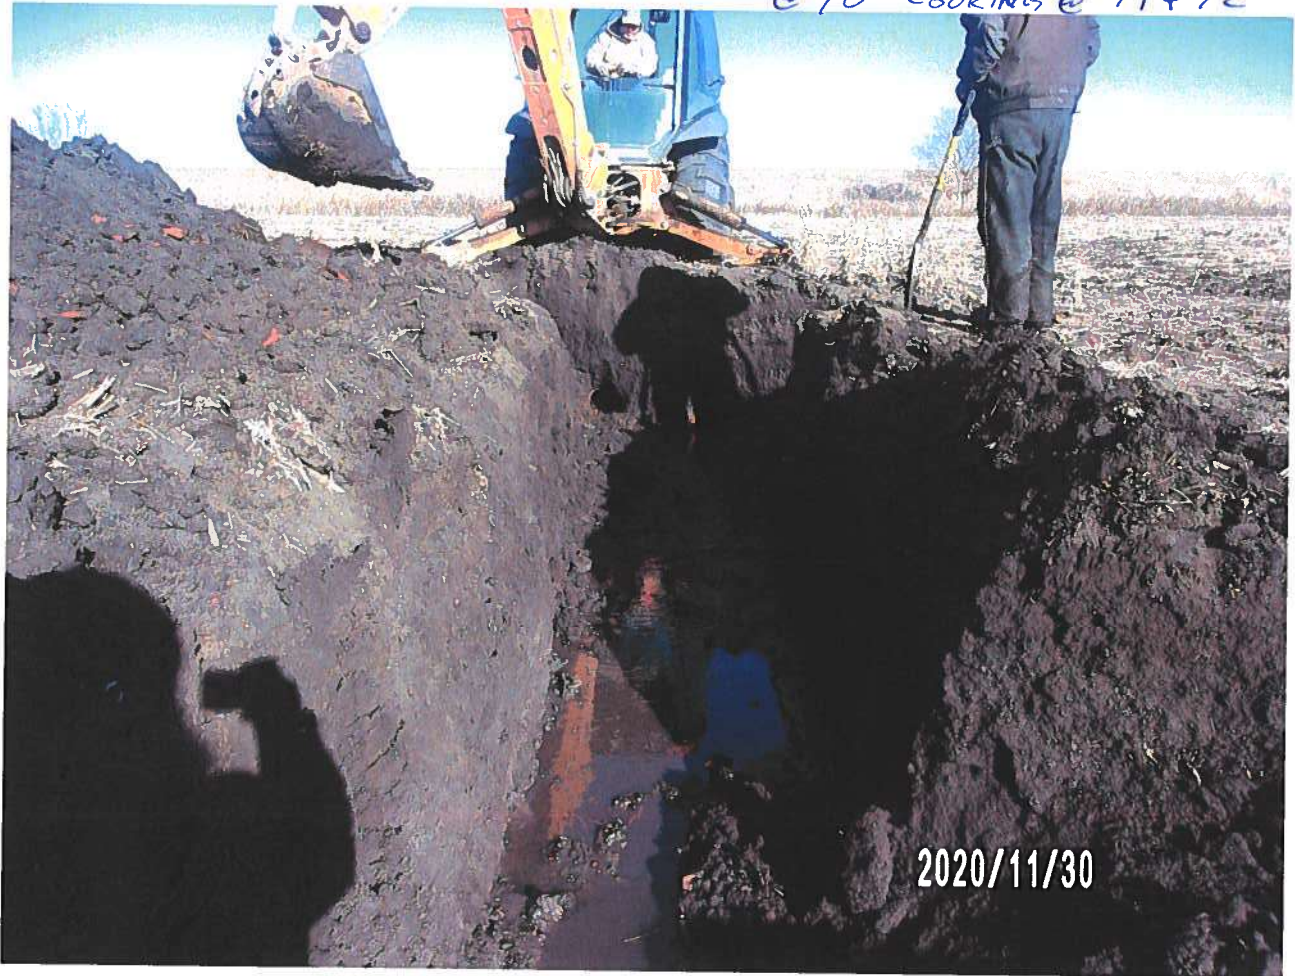
LOOKING N. DOWN @ 71

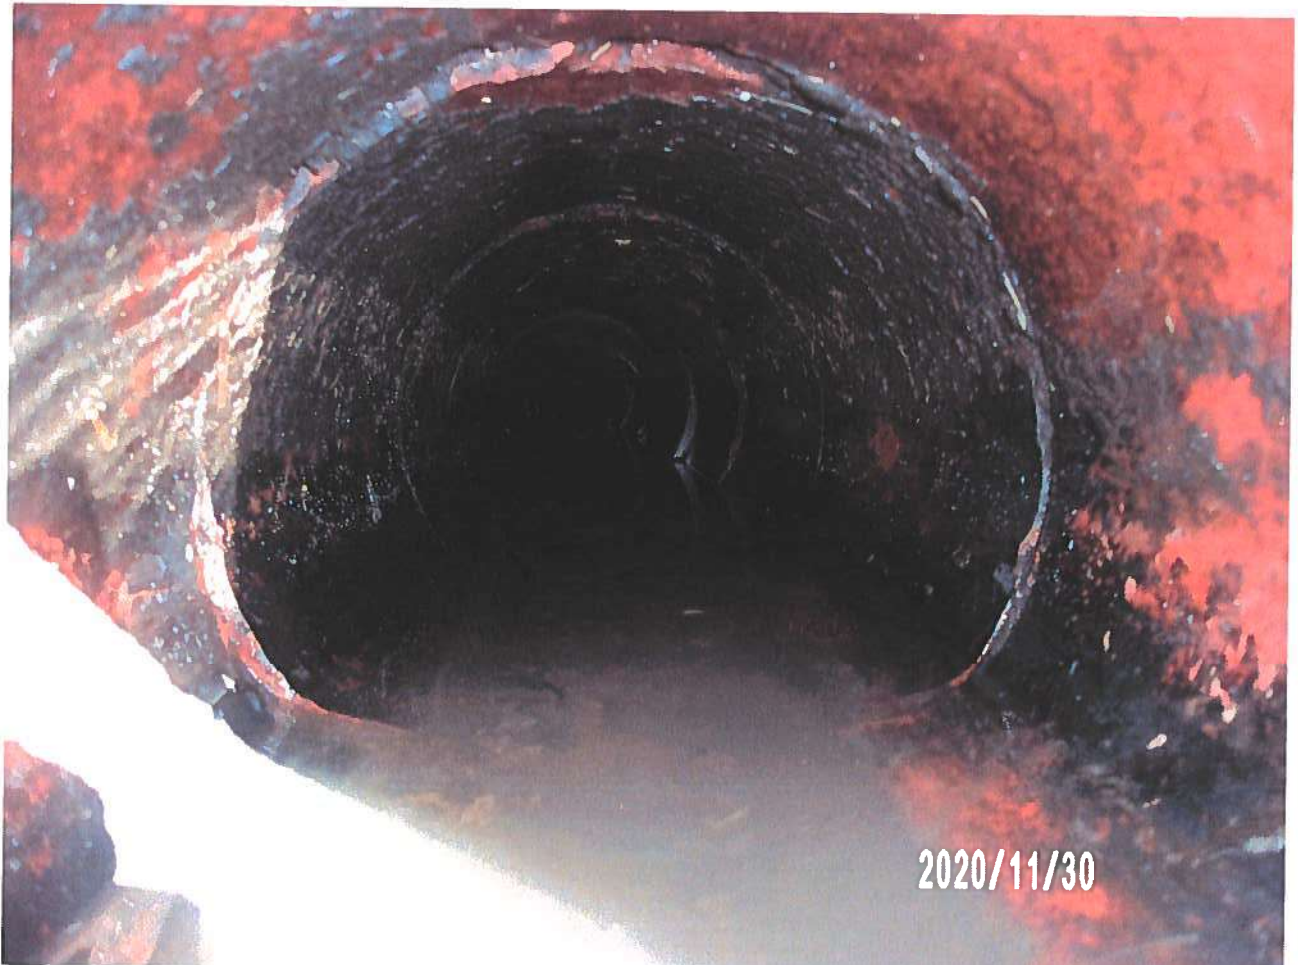
LOOKING N. @ 72

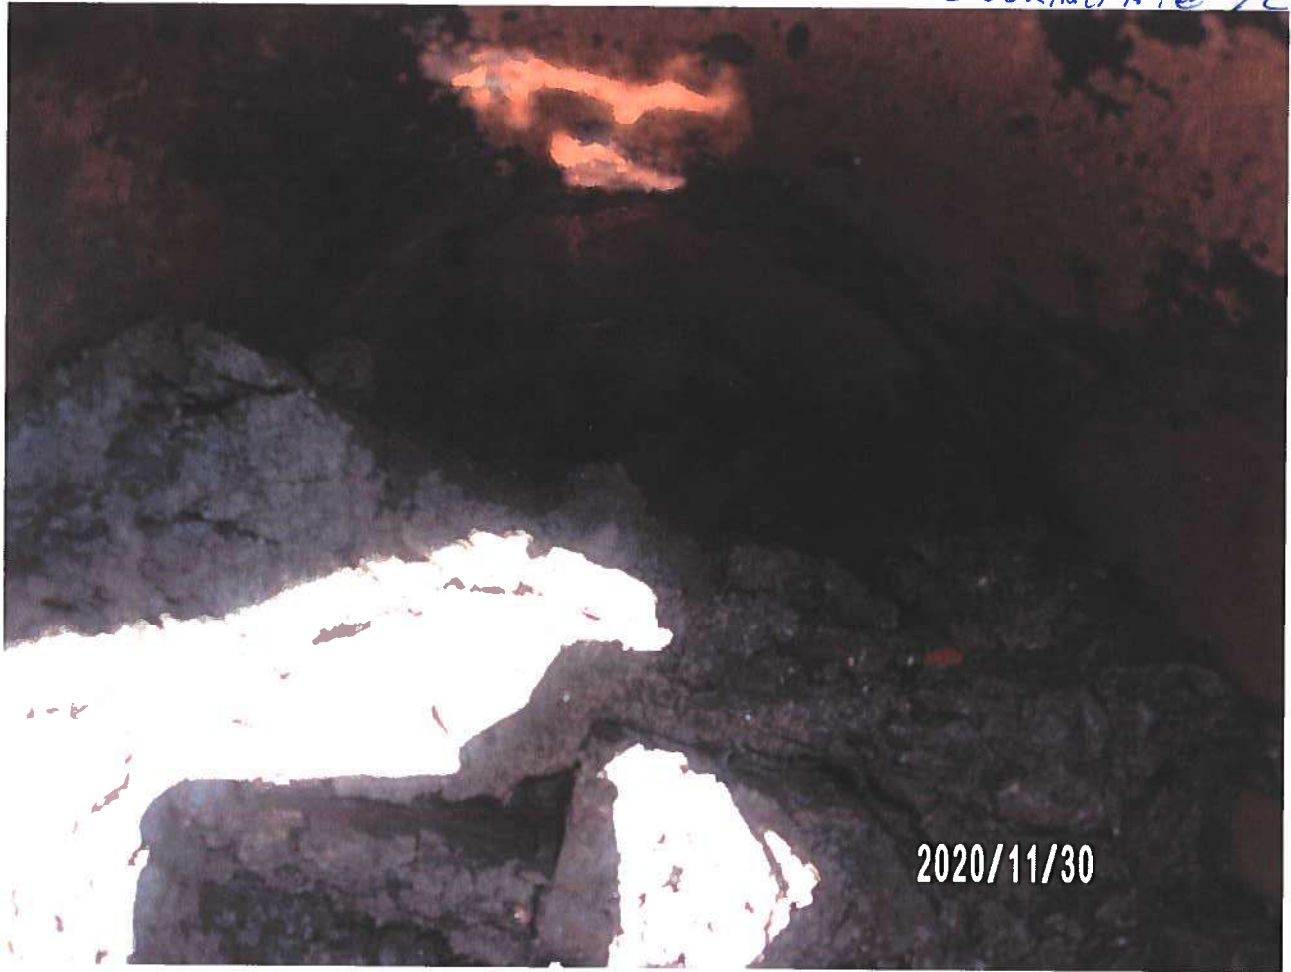
LOOKING N. @ 72

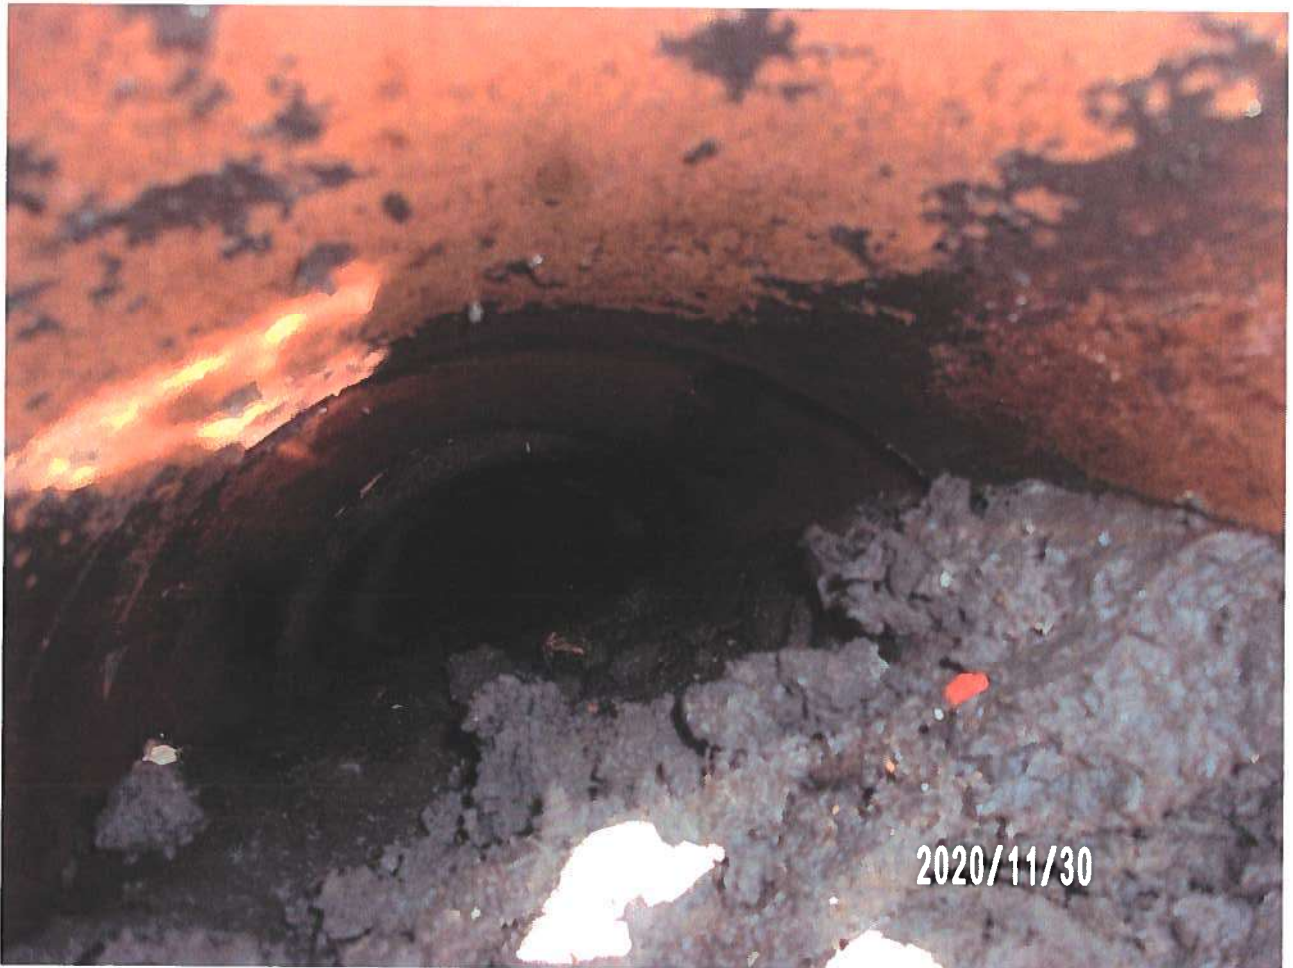
@ 72 Looking S. to 70

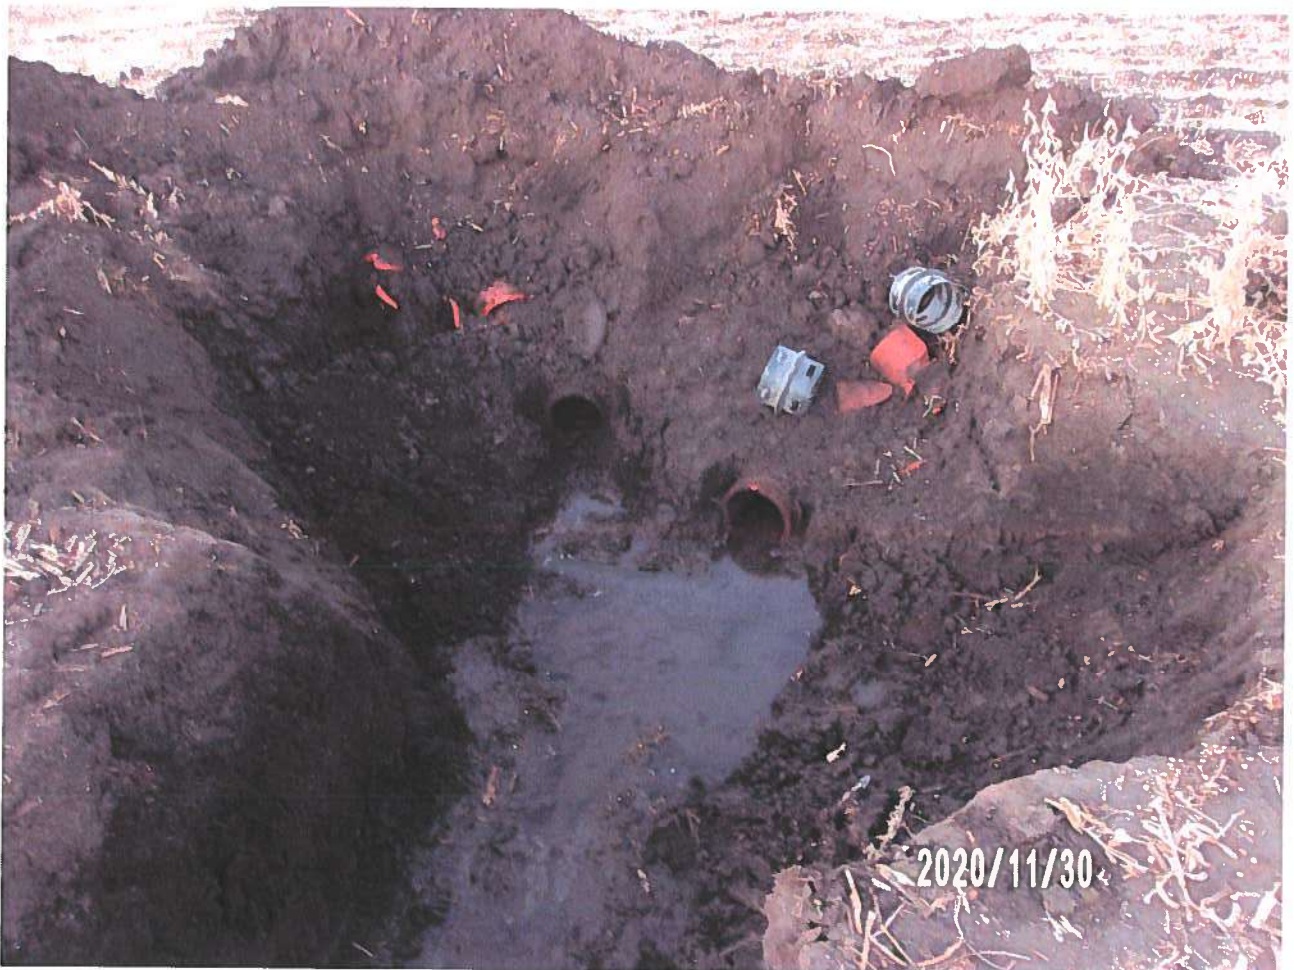
Looking NW @ 71 + 72

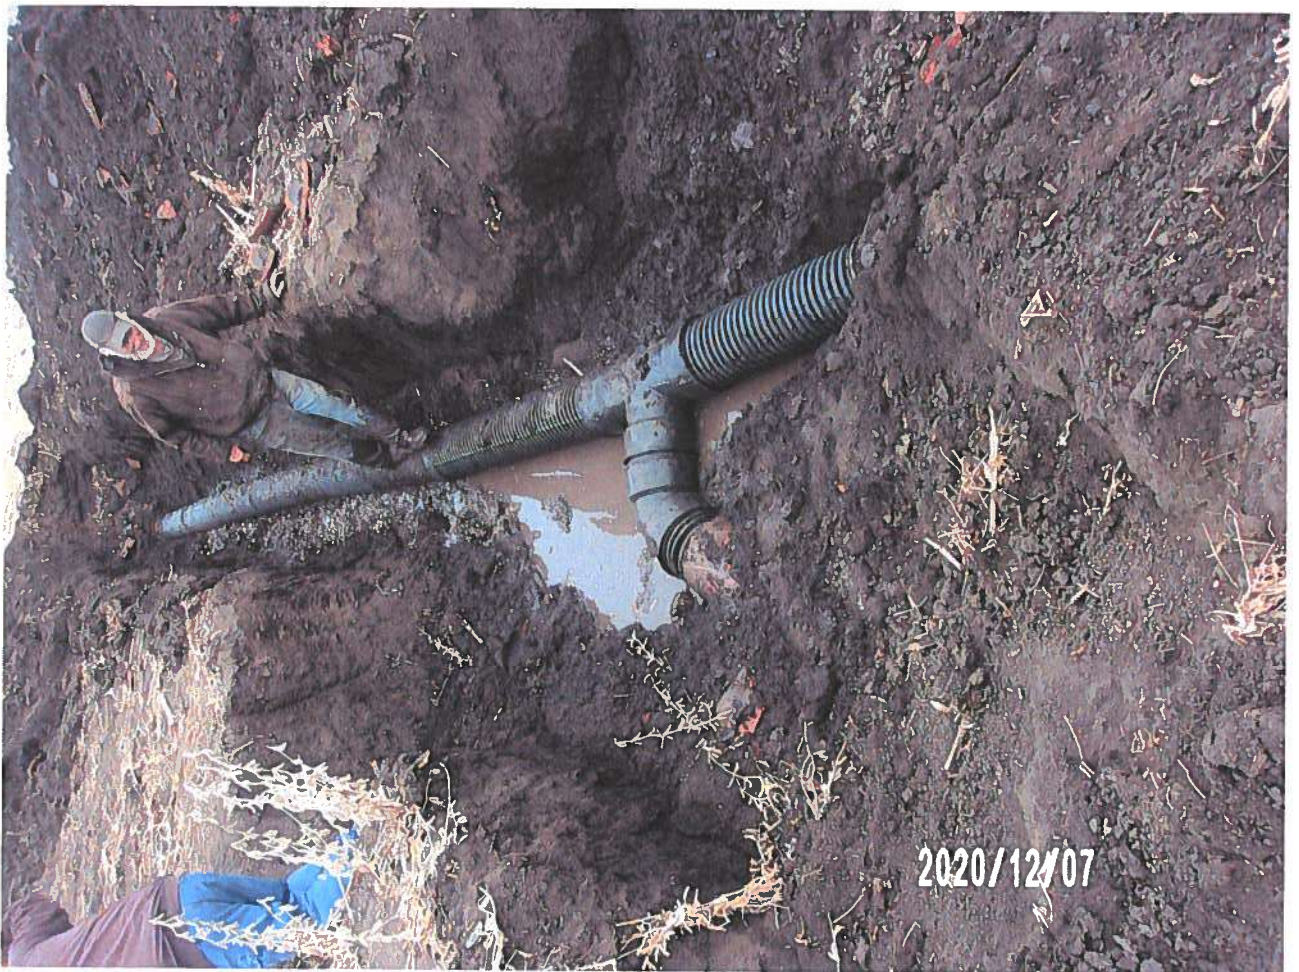
PIPE DRY FIT

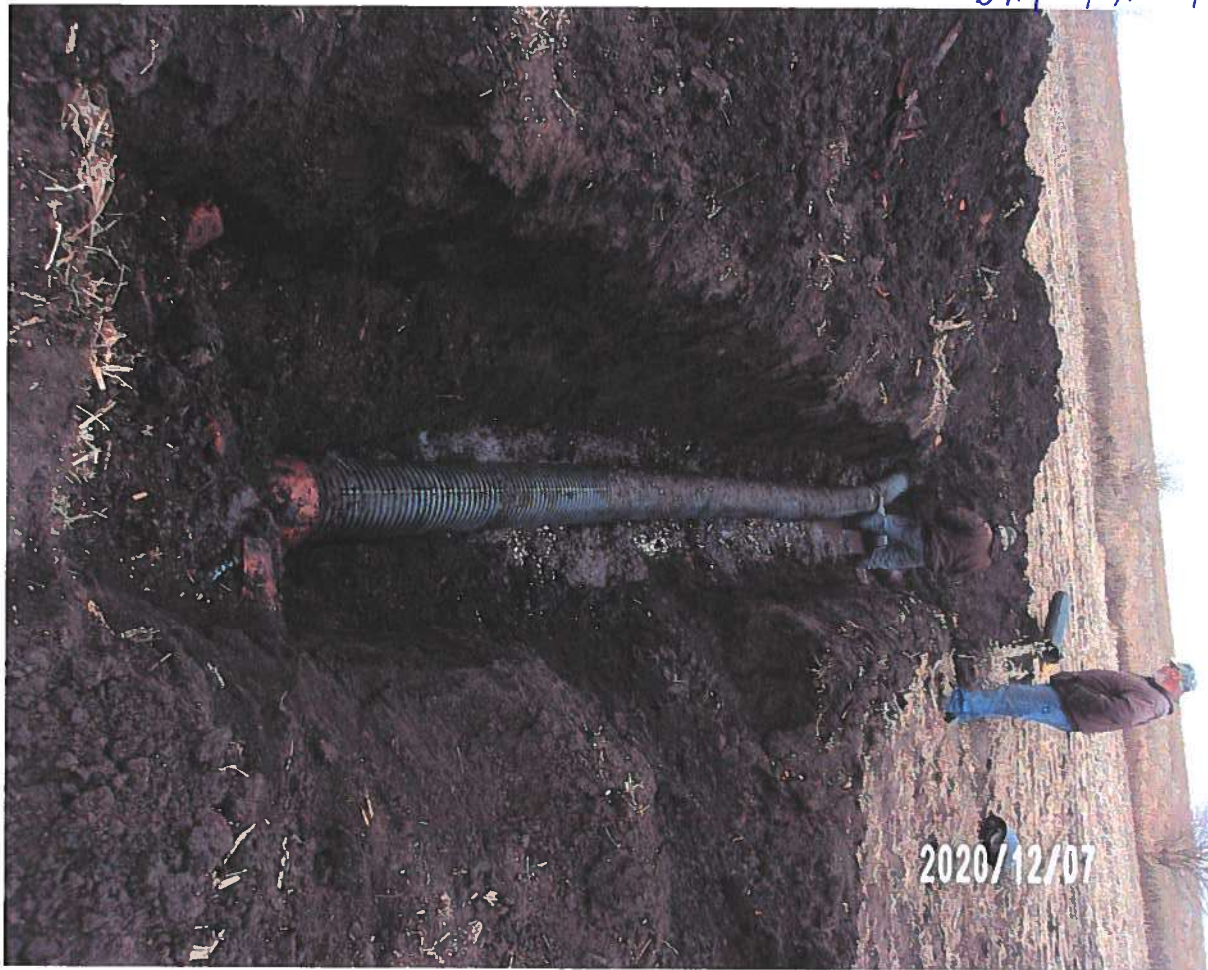
DRY FIT TILE

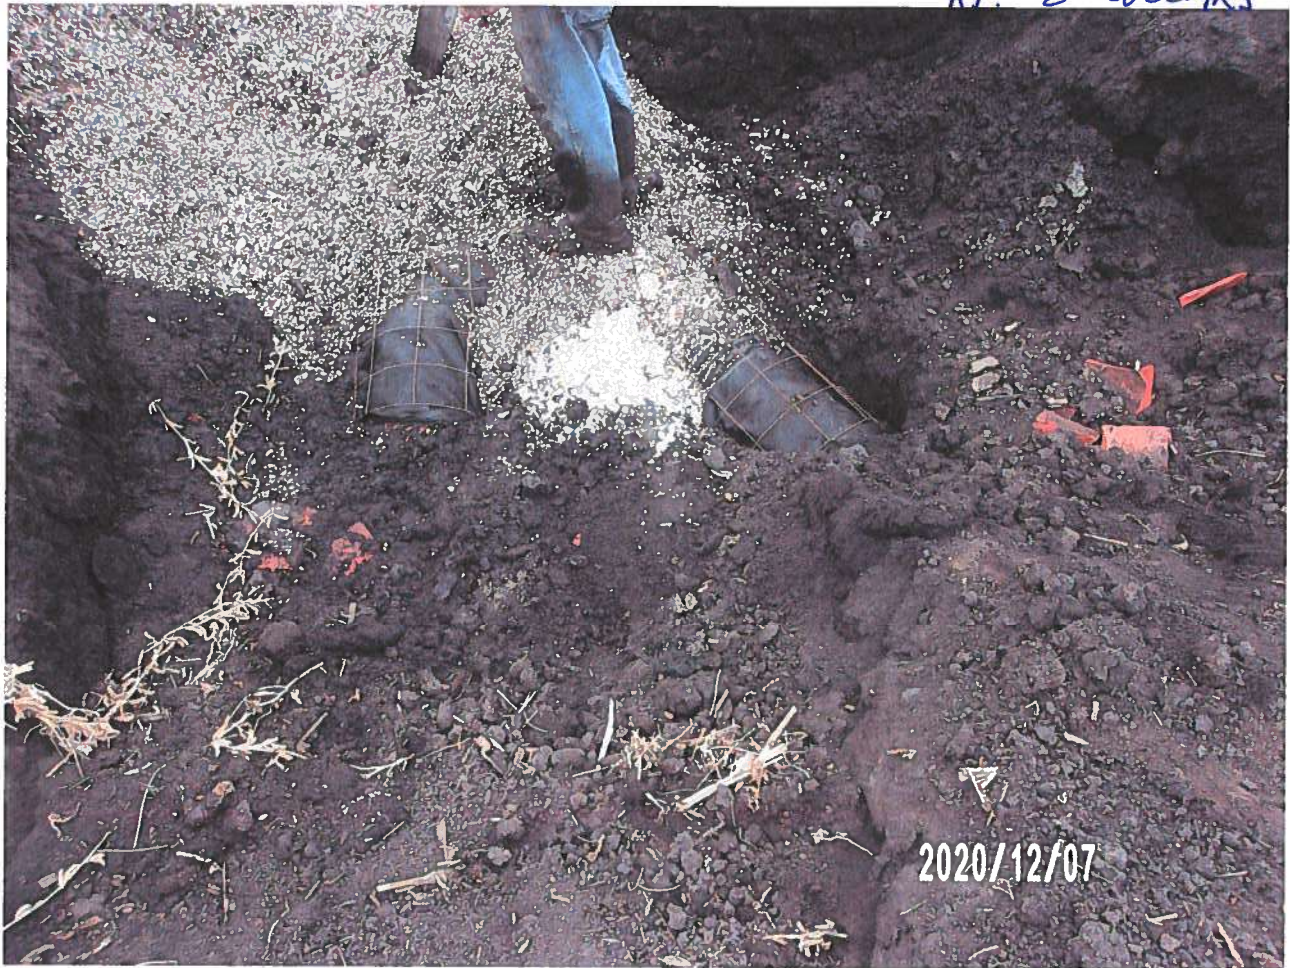
N. 2 COLLARS
