**AGENDA**  
**REGULAR DRAINAGE MEETING**  
**Monday, February 8, 2021 9:30 AM**  
**Large Conference Room**

**This will be a joint meeting with the Franklin County Board of Supervisors acting as Drainage Trustees for DD H-F 4-53.**

## Drainage District:

## Investigation Summary:

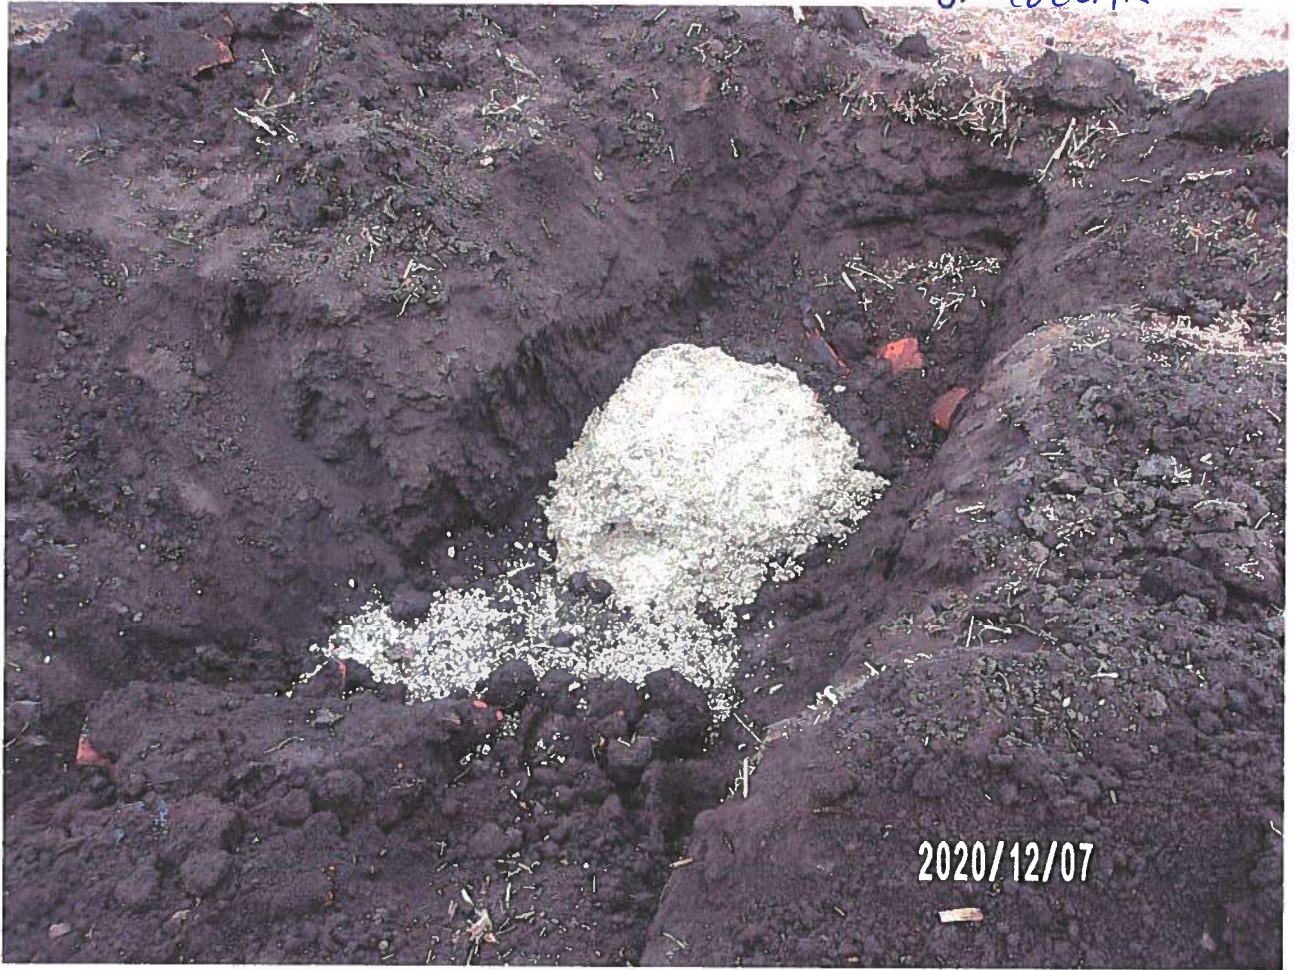
S. COLLAR

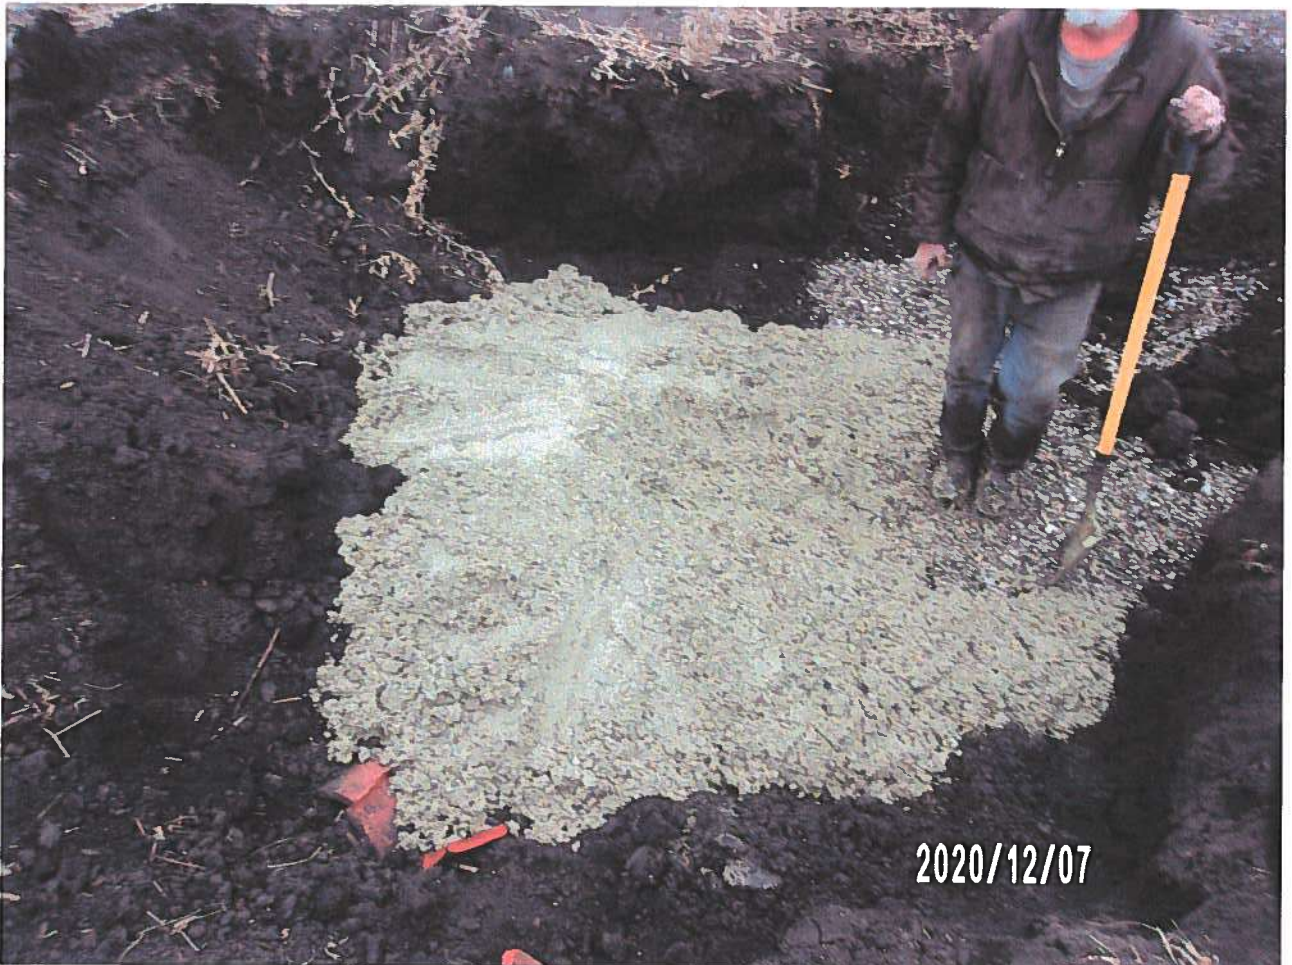
N. 2 COLLARS
