**AGENDA**  
**REGULAR DRAINAGE MEETING**  
**Wednesday, March 3, 2021 9:30 AM**  
**Large Conference Room**

5. DD 14 WO 290 - Discuss W Possible Action - Landowner Concerns

[DD 14 WO 290 INVESTIGATION SUMMARY 05\\_11\\_20.PDF](#)  
[DD 14 WO 290 - 6844.4 - INVESTIGATION REPORT - 2020-08-31.PDF](#)

CONSTRUCTION ENGINEERING  
OBSERVATION REPORT

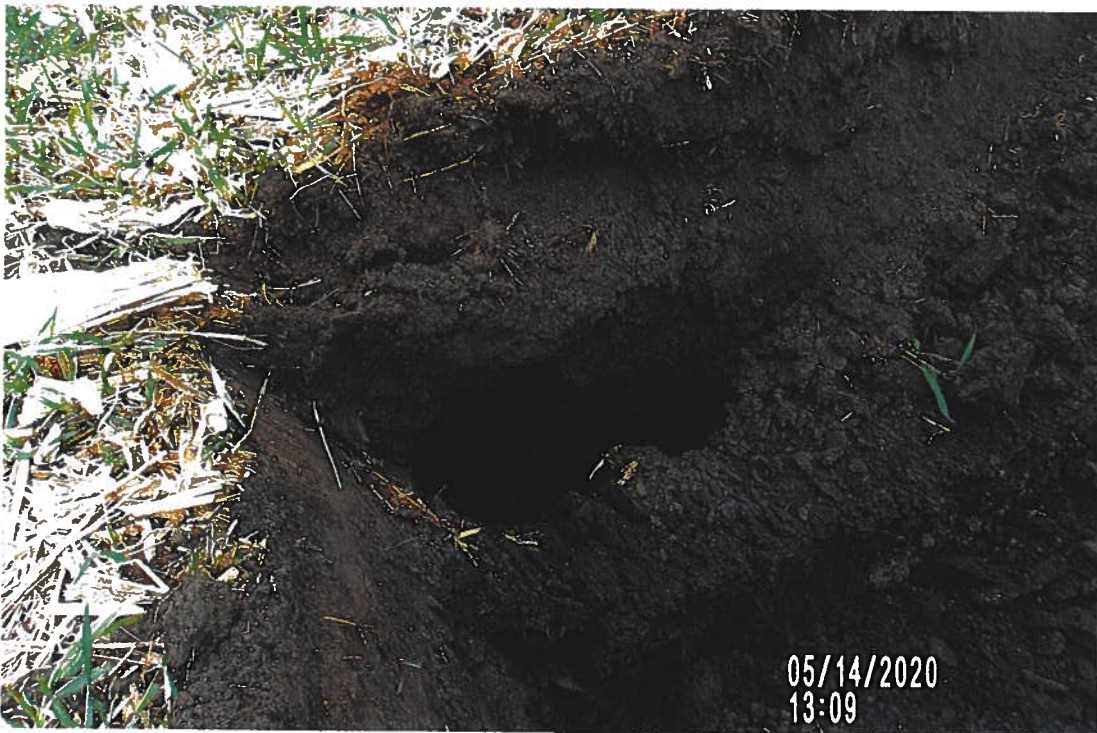
PICTURE# 3549 IS LOOKING NW SHOWING VOID UNDER GRASS WATERWAY THAT HAD NEVER SURFACED YET. ONLY 1.0' TO 1.5' OF SOIL OVER VOID @ 537.1' WHERE TILE COMPLETELY

PICTURE # 3550 IS LOOKING NW SHOWING VOID UNDER GRASS WATERWAY @ 537.1' WHERE TILE COMPLETELY COLLAPSED.

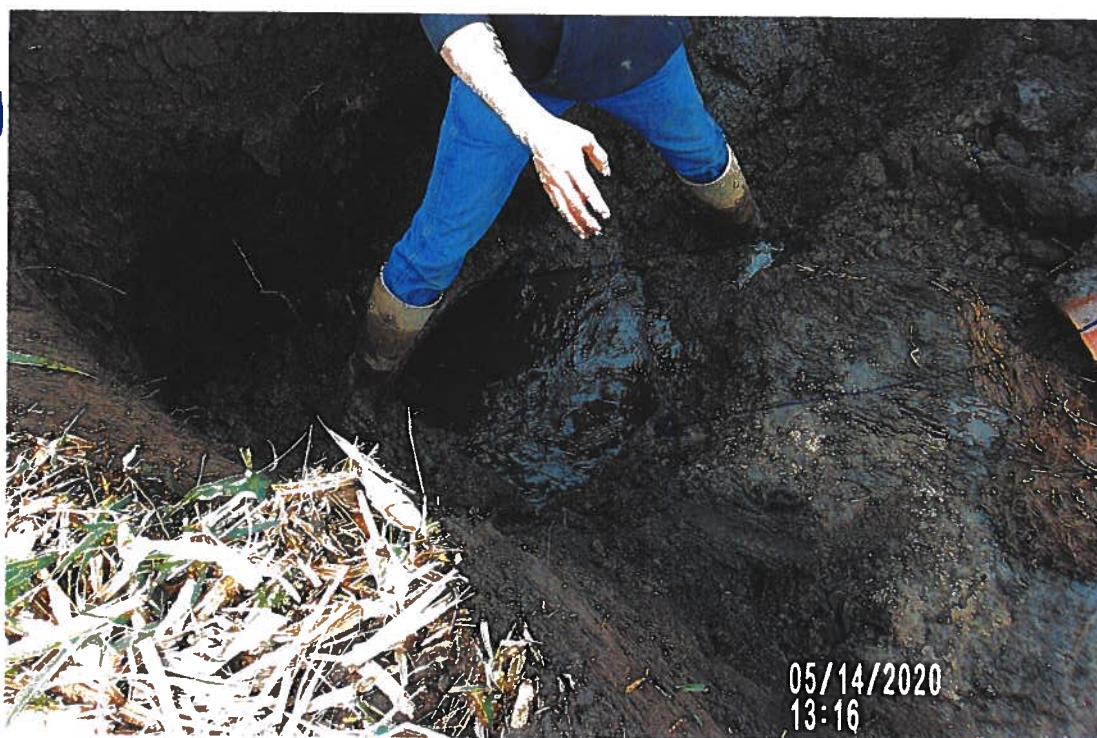
CPS# 147  
12" TALL  
19" WIDE  
SQUATTER CLAY  
1.05' TOP TO FL:  
3.5' ± DEEP

PICTURE # 3553 IS LOOKING NE SHOWING COLLAPSED SECTION OF TILE REMOVED AND NOW FLOWING GOOD IN BLOWOUT. IN

PICTURE# 3557 IS LOOKING NW SHOWING 4.0' LONG ERODED SOIL CAVITY ON WEST SIDE OF TILE IN IN TILE BLOWOUT # IN FROM GPS# 147

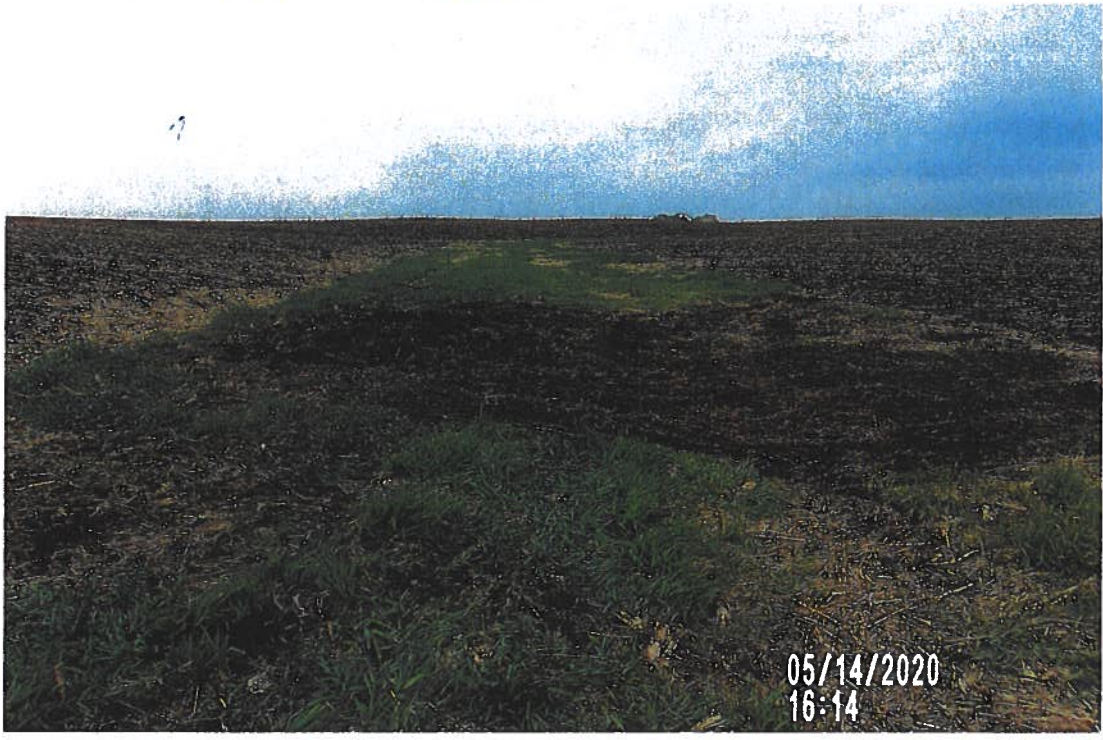
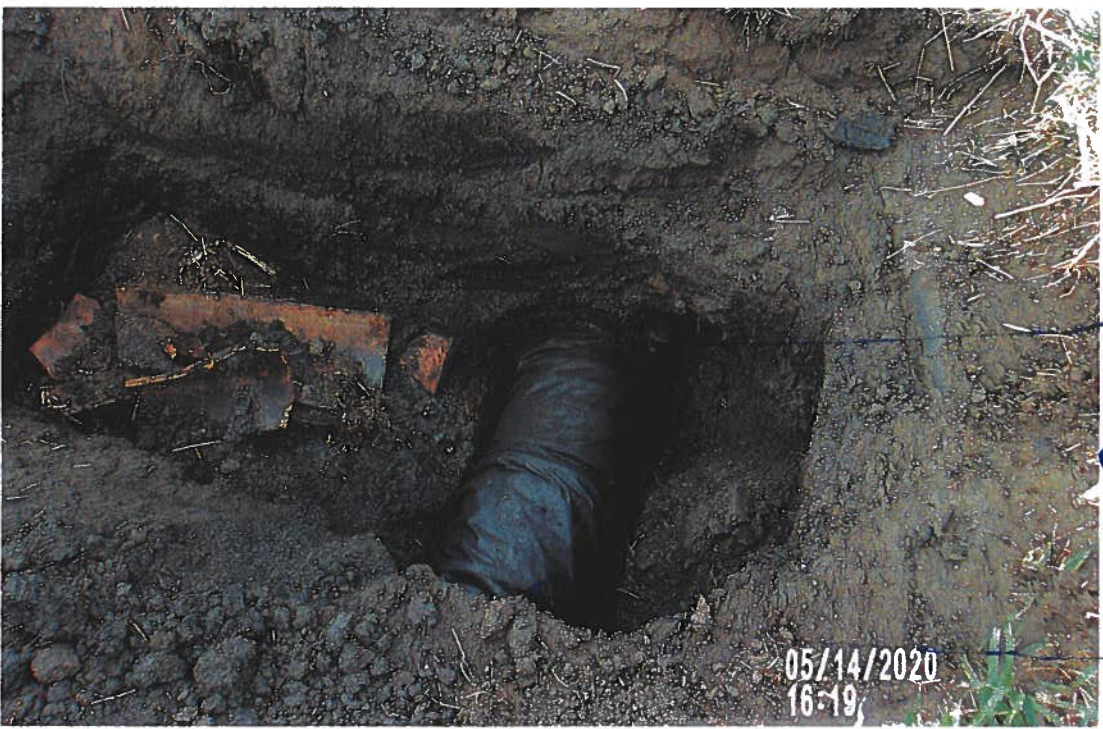
PICTURE # 3567 IS LOOKING NW SHOWING TILE BLOWOUT #2N  
 BACK FILLED AND DRESSED UP IN GRASS WATERWAY BUT  
 STILL NEEDS SEEDED

GPS # 119  
 14" TALL  
 17" WIDE  
 SQUARED CLAY  
 (1.22' TOP TO FL)

GPS # 118  
 14.25" TALL  
 17.25" WIDE  
 SQUARED CLAY  
 (1.25' TOP TO FL)  
 (DUAL)

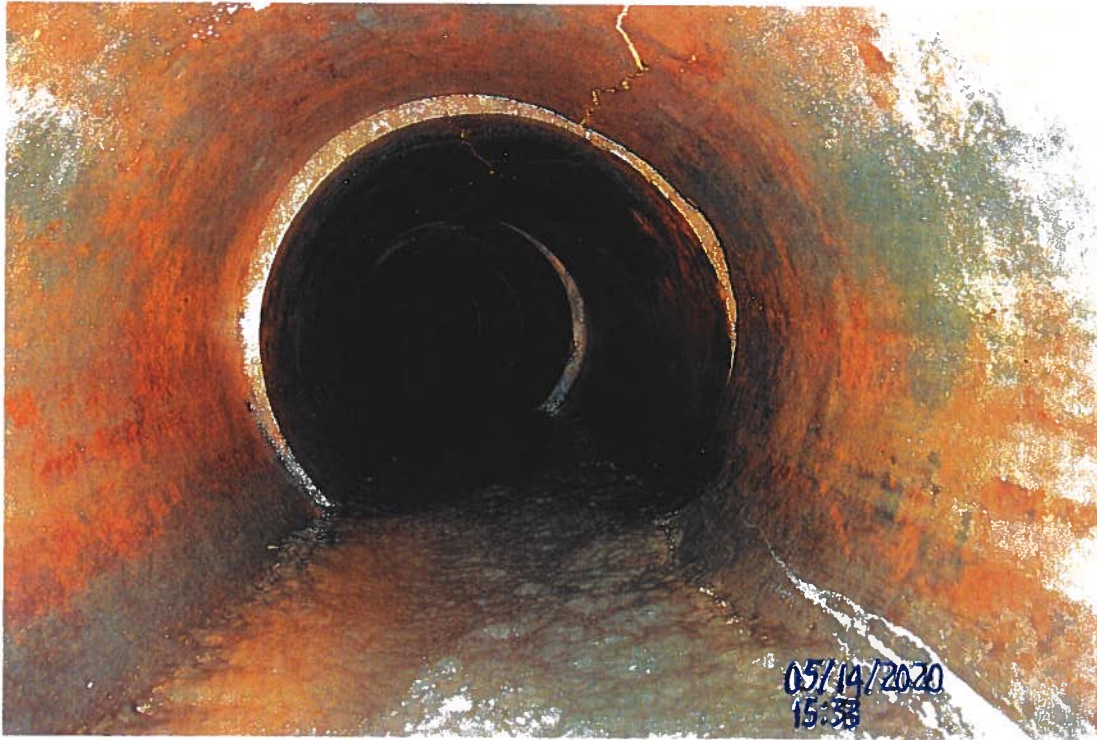
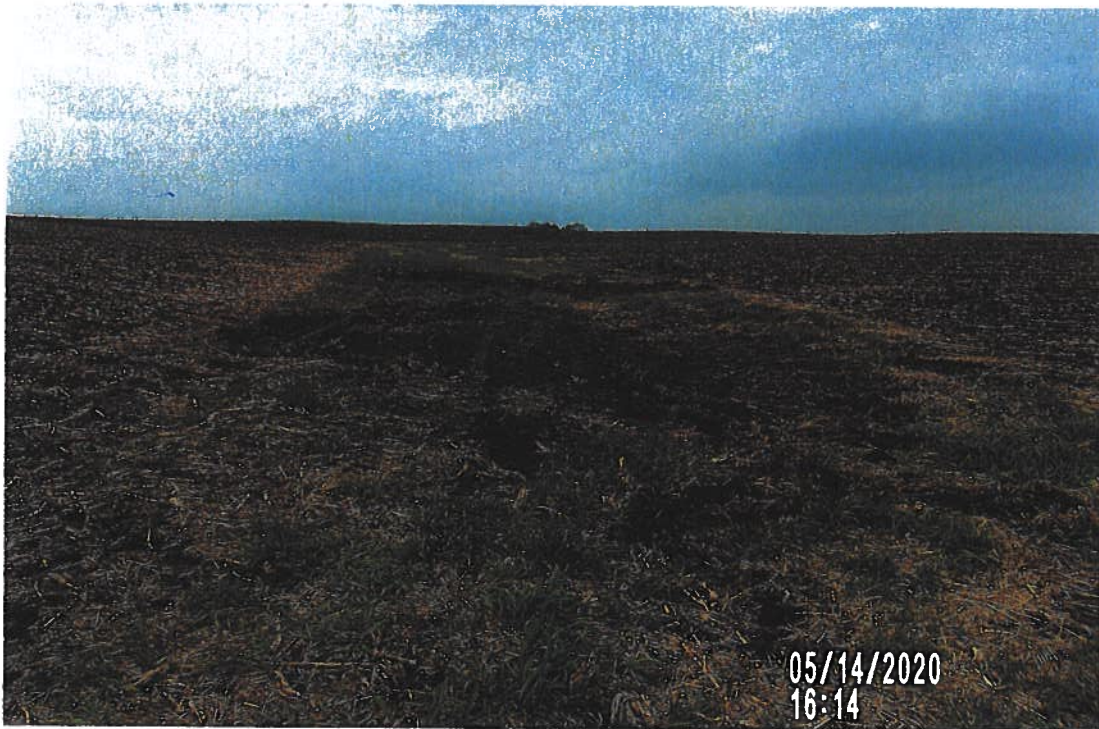
PICTURE# 3565 IS LOOKING NE INSIDE CLAY TILE UPSTREAM INSIDE  
BLOWOUT# 1S SHOWING TILE CRACKED BUT NOT CAVING DOWN FROM  
GPS# 177

PICTURE# 3566 IS LOOKING NW SHOWING TILE BLOWOUT# 1.N  
BACK FILLED AND DRESSED UP IN GRASS WATERWAY BUT  
STILL NEEDS SEEDED

PICTURE#3569 IS LOOKING SW INSIDE CLAY TILE DOWNSTREAM  
 INSIDE BLOWOUT#15 SHOWING TILE CRACKED AND CAVING DOWN  
 SOME FROM GPS# 178

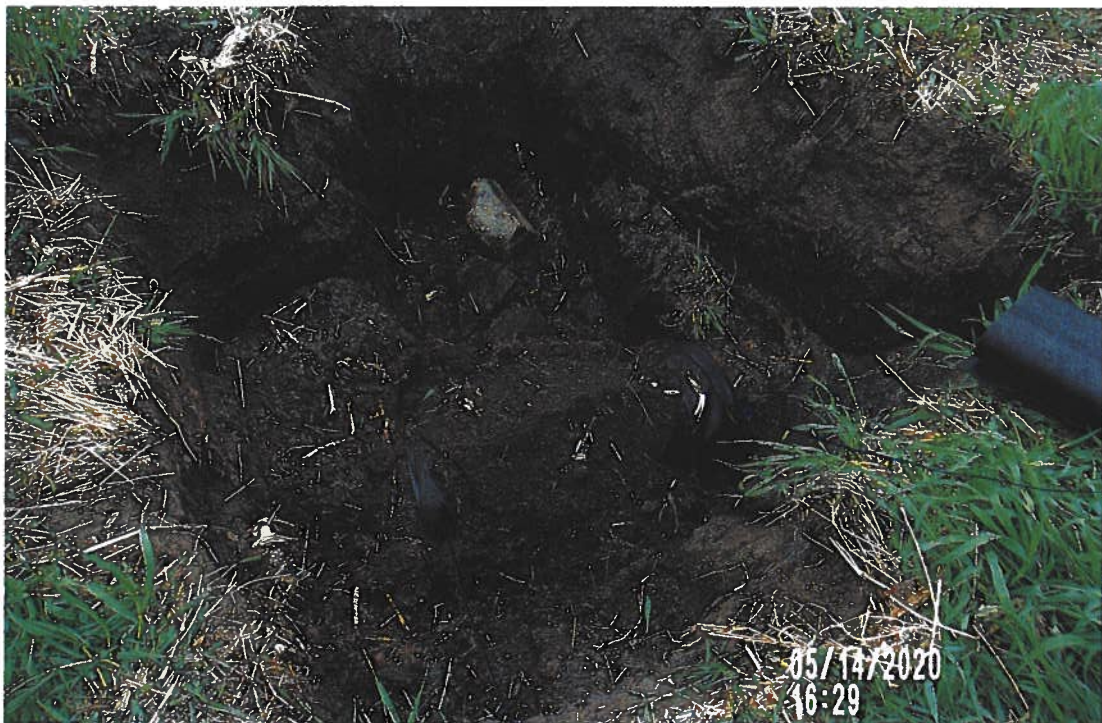
GPS# 177  
 15" TALL  
 16.25" WIDE  
 CLAY  
 (1.35' TOP TO FL)

GPS# 178 14" TALL 17" WIDE CLAY (1.24' TOP TO FL)

PICTURE# 3570 IS LOOKING NW SHOWING 2.5 LF OF 15" Ø  
 DUAL WALL HOPE NONPERF TILE WITH BOTH JOINTS WRAPPED WITH FABRIC  
 FOR TEMPORARY REPAIR IN BLOWOUT # 15.

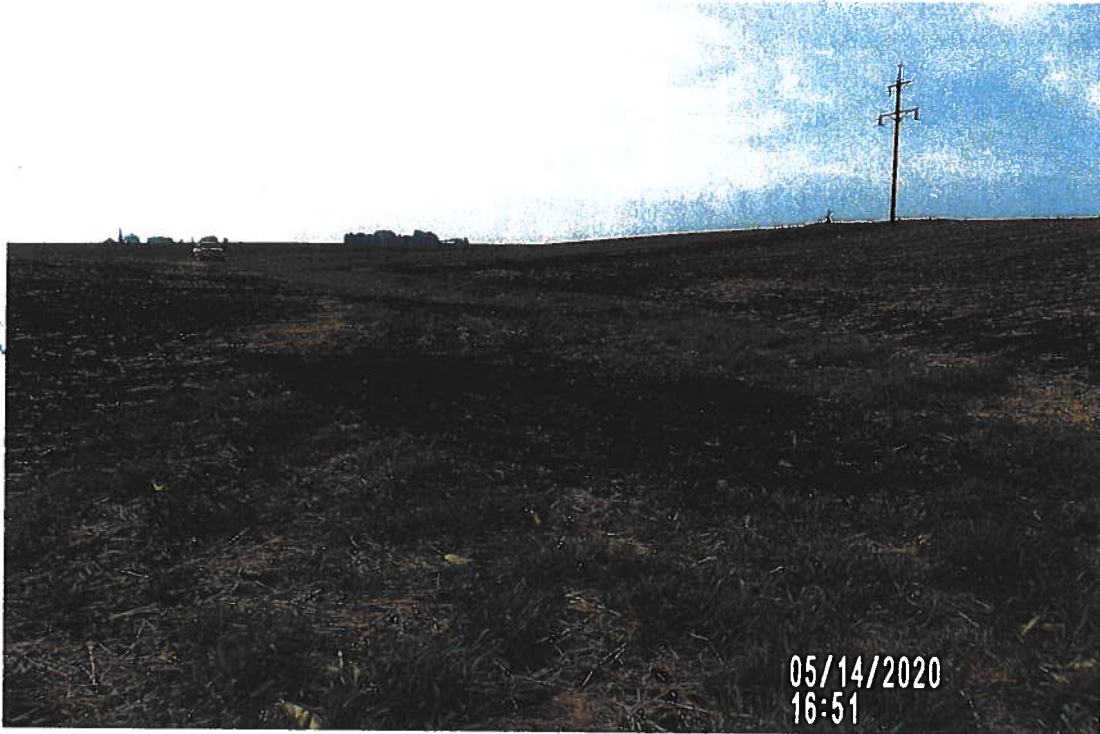
PICTURE # 3571 IS LOOKING NORTH SHOWING BLOWOUT 2S  
BACKFILLED AND DRESSED UP BUT NEEDS SEEDS  
YET.

PICTURE # 3572 IS LOOKING NORTH SHOWING BLOWOUT IS  
BACKFILLED. HOLE IS STILL SHORT OF SOIL IN 6.0' X 6.0'  
& 10'± DEEP AREA. NEED TO BACK FILL MORE SOIL AND SEED

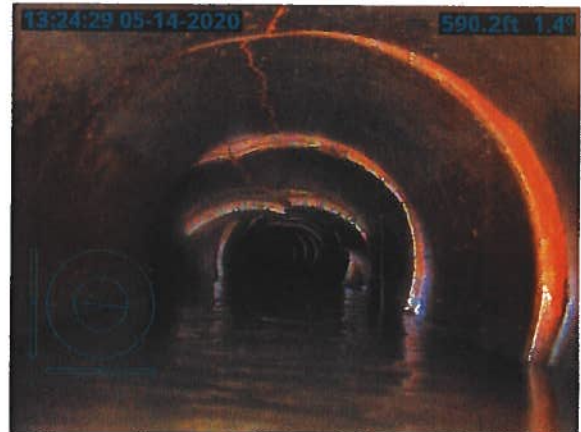
B 2020\_05\_14-13\_24\_29\_424.jpg

08	03			BROKEN AND COLLAPSED
1:19:44	590.2		B	2020_05_14-13_24_29_424.jpg

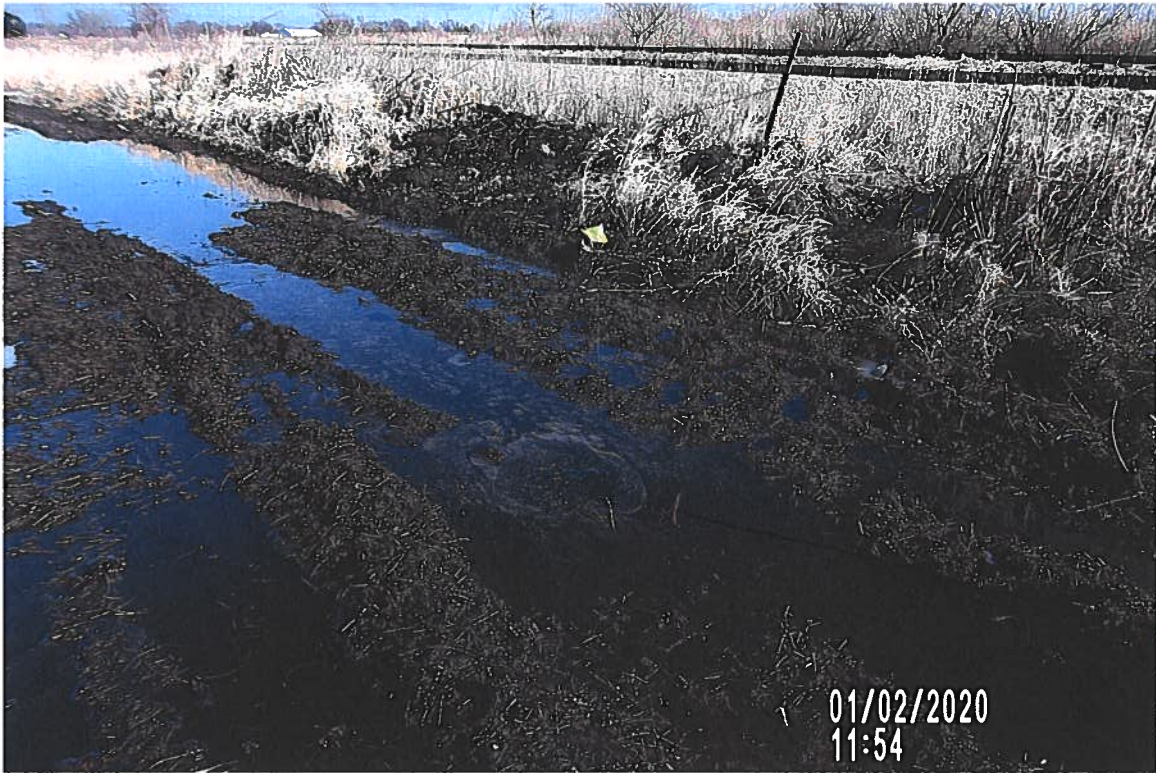
↑ N  
BLOW OUT

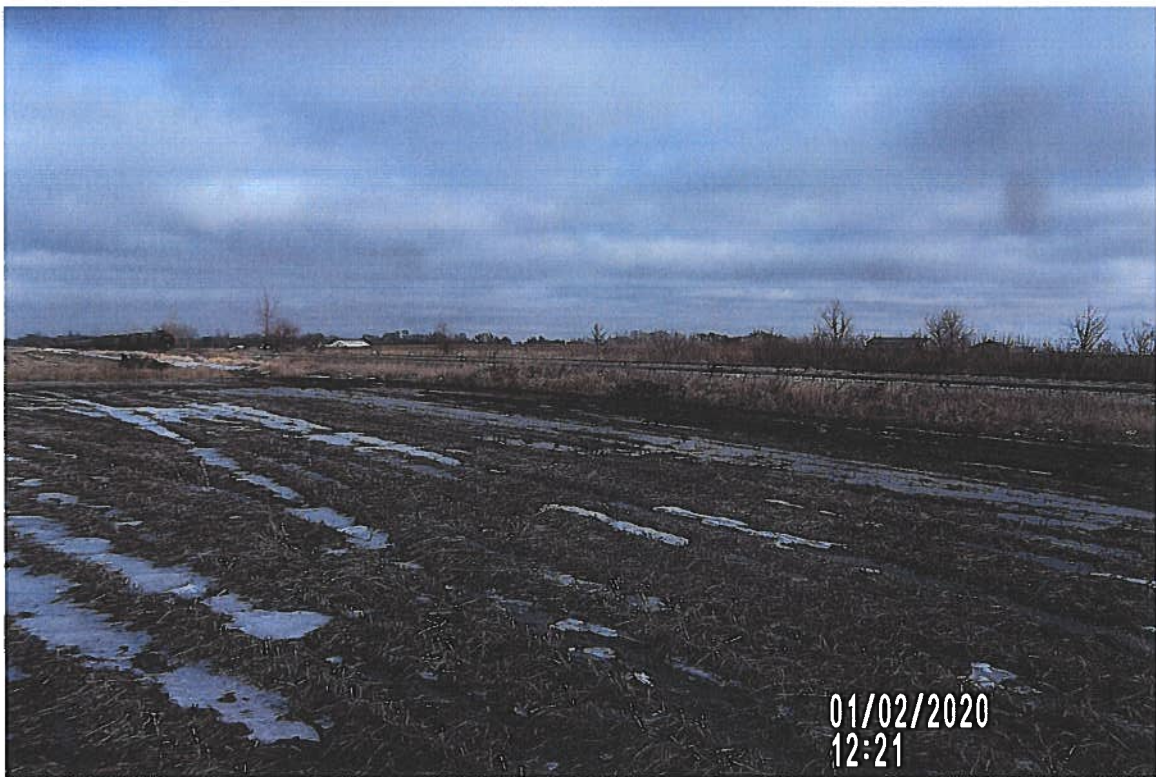
PICT# 2604 IS LOOKING NE SHOW WET AREA WEST OF WEST RR ROW  
FENCE REMNANT & SOUTH OF FENCE LINE WEST.

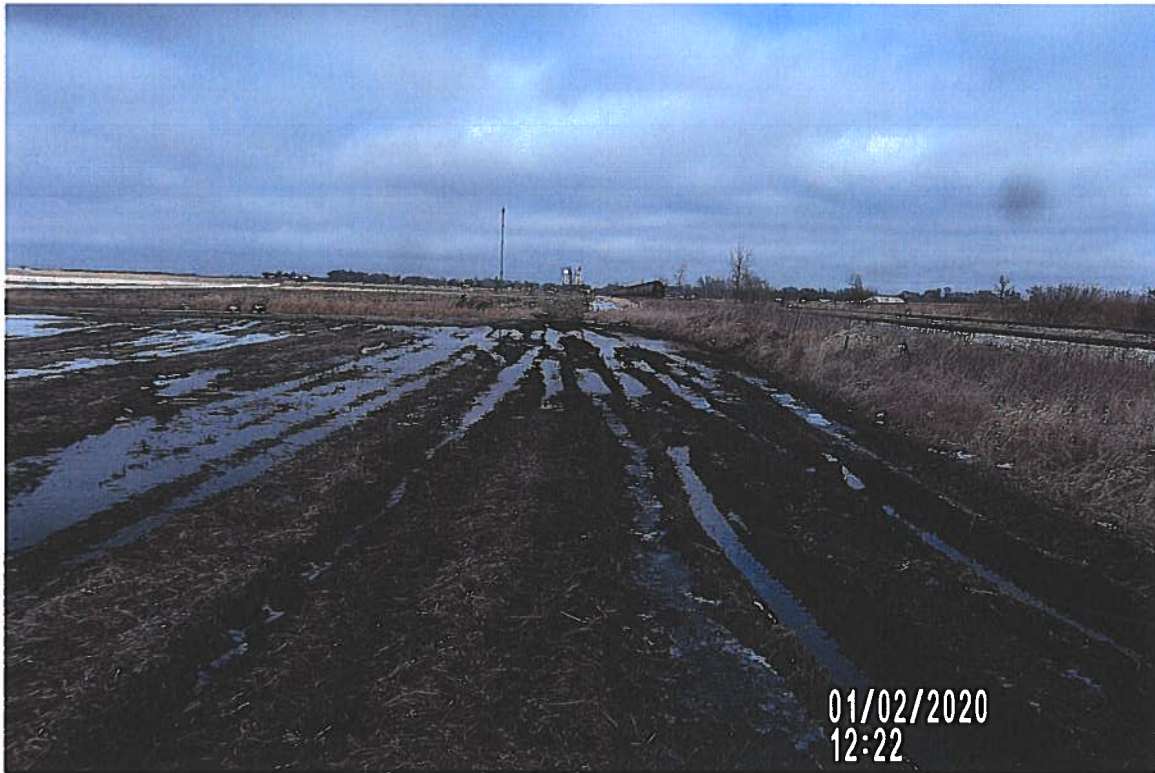
PICT# 2605 IS LOOKING NORTH SHOWING WET AREA WEST OF WEST RR ROW & SOUTH OF FENCE LINE WEST

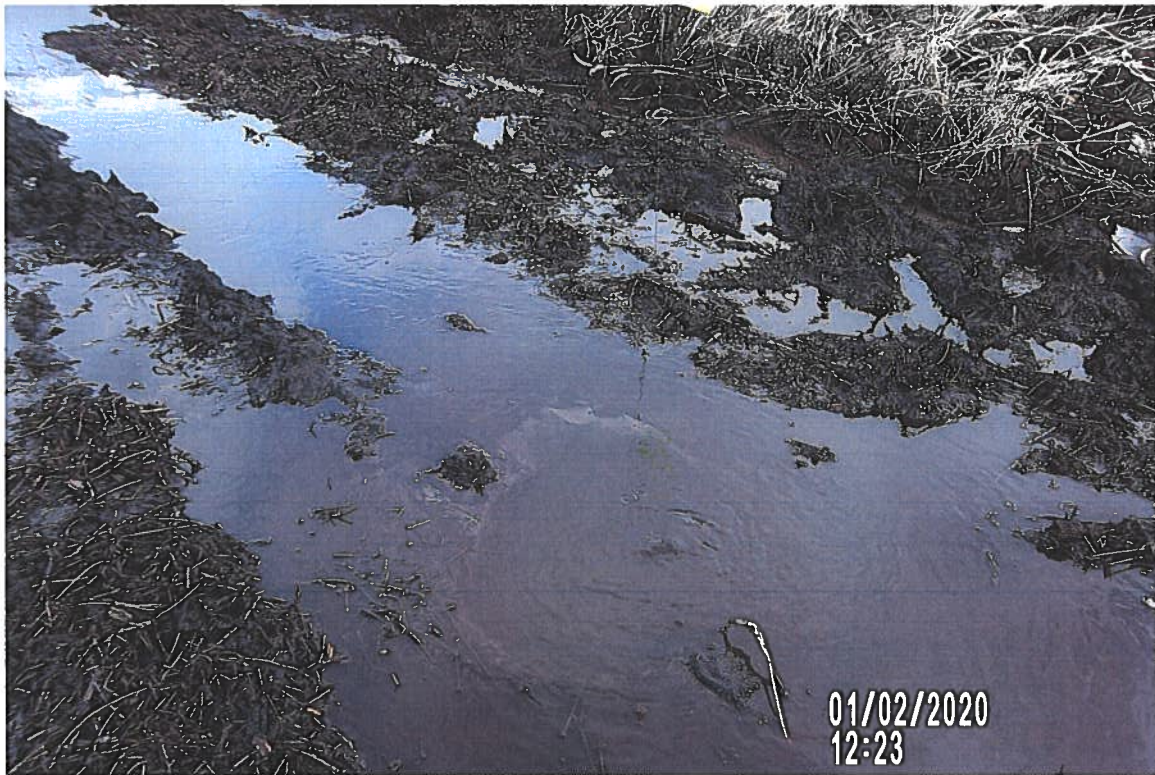
PICT# 2606 LOOKING WE AT 16" Ø HOLE WATER BOILING OUT IN FBLD WEST OF RR ROW

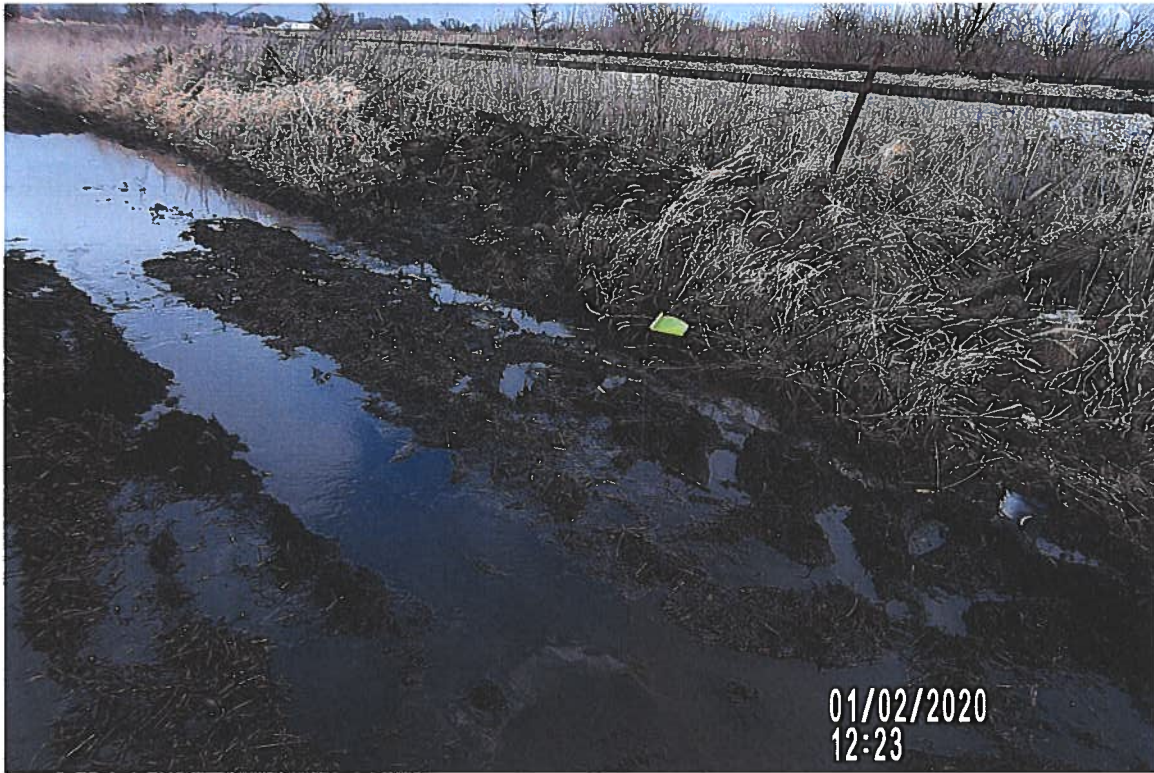
PILT# 2607 IS LOOKING NE OF 16"  $\phi$  TILE BLOWOUT  
SHOWING 12' N-S X 6' E-W DISTURBED AREA IN WEST  
RR ROW FENCE REMNANTS & 129'  $\pm$  SOUTH OF

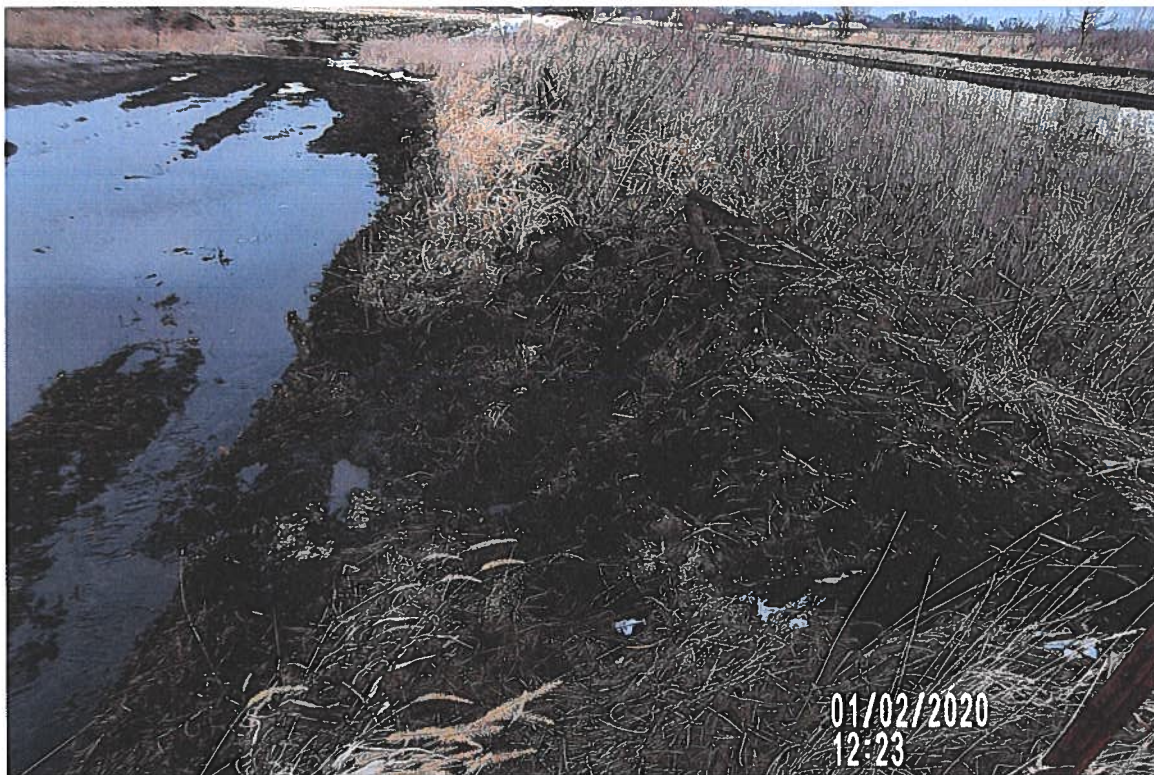
PILT# 2608 LOOKING NE AT 12' NE-SW X 6' SE-NW AREA  
DISTURBED IN WEST RAILROAD ROW FENCE REMNANT.  
(TILE BROKE?)

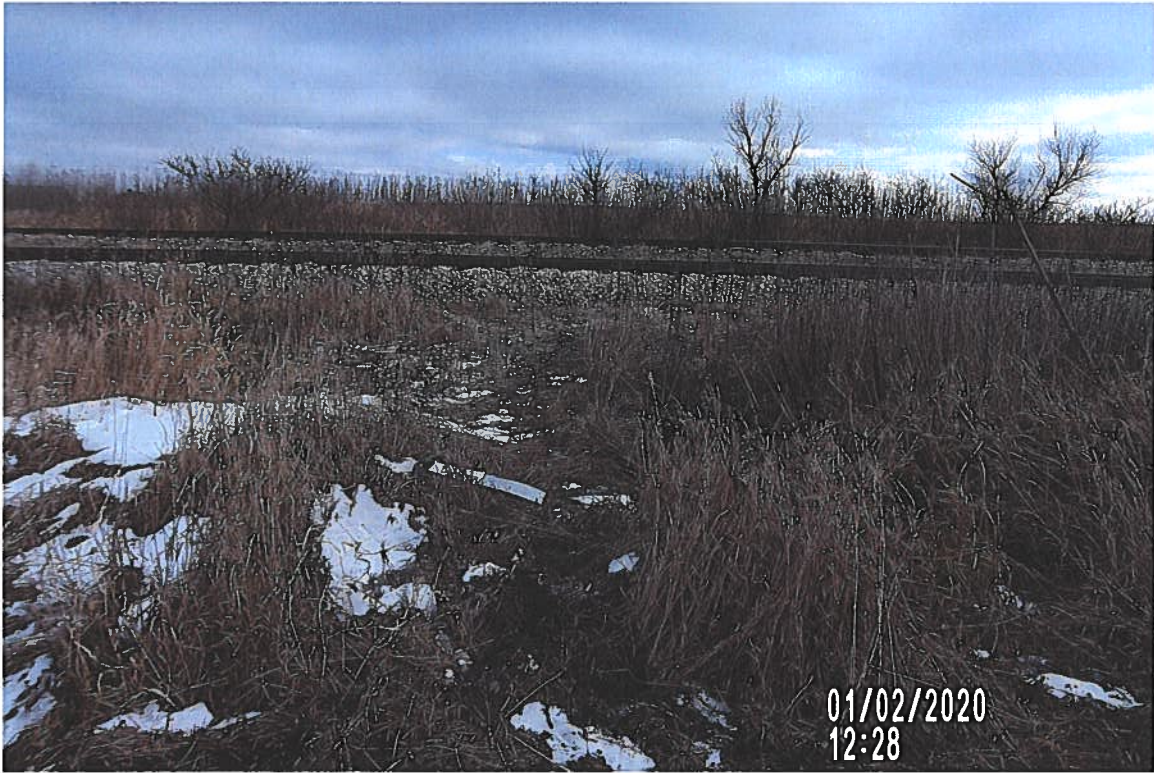
PICT# 2610 IS LOOKING NE AT 2.5' NE-SW X 9.9' NW-SE  
CONCRETE DRAINAGE STRUCTURE ON SW SIDE OF RR ACCESS DRIVE

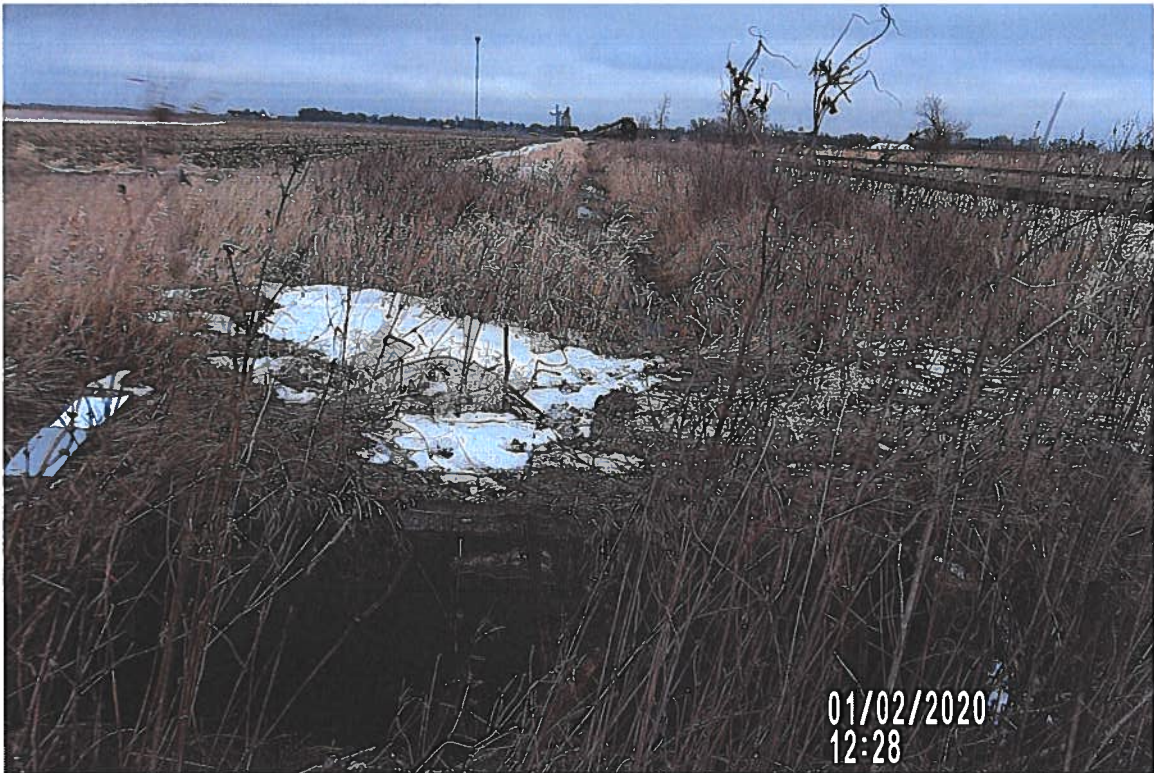
PICT# 2611 IS LOOKING NE AT DRAINAGE STRUCTURE OUTLET  
SHOWING IT IS IN POOR CONDITION.

- Due to the deteriorated condition of the Main tile junction structure, and the mangled and rusted culvert downstream of such, CGA recommends a new outlet structure be considered. The adjacent CMP culvert needs to be either removed or replaced before it collapses and restricts drainage.
- The Main open ditch of D.D. 155 (downstream of the D.D. 160 outlet) appears to be in need of a cleanout due to the buildup of excess sediment (possibly as far north as 110<sup>th</sup> St.). CGA recommends an investigation be conducted to determine the scope and extent of sedimentation within the flowline of said open ditch to determine if a cleanout is needed.

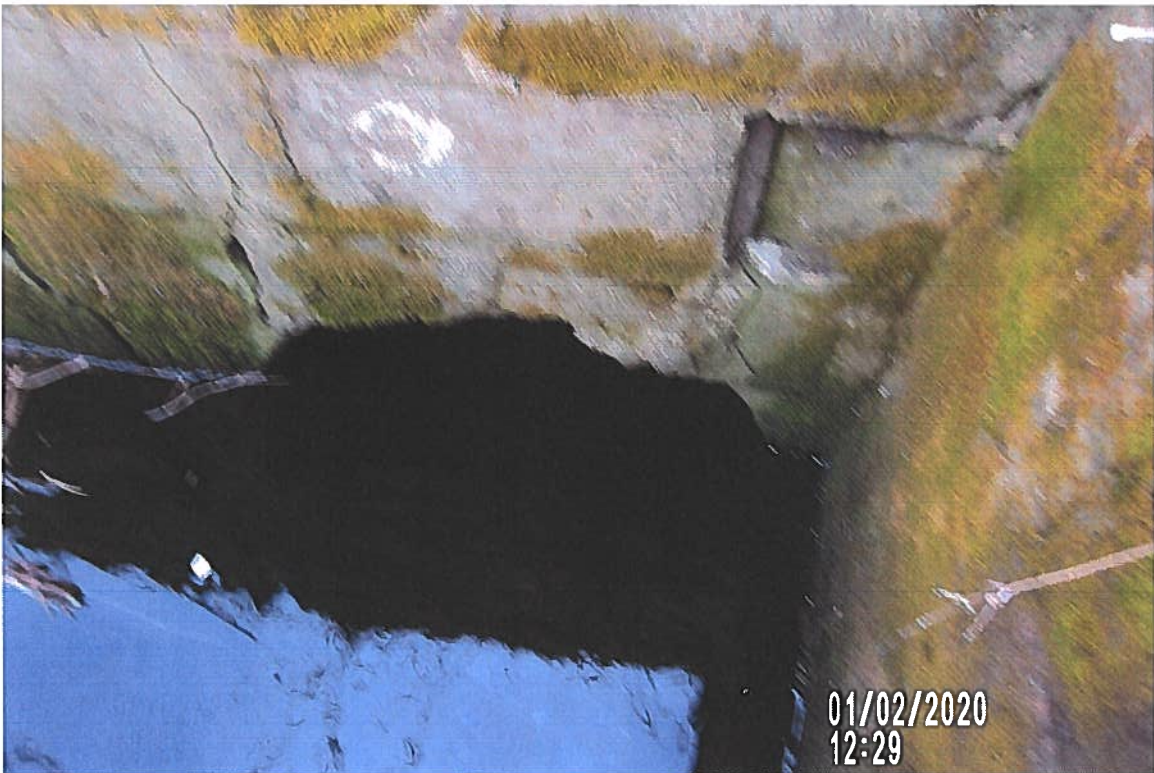
PICT# 2614 IS LOOKING NE AT 30" CMP OUTLET IN DRAINAGE STRUCTURE WITH WATER LEVEL AT 21 1/2"

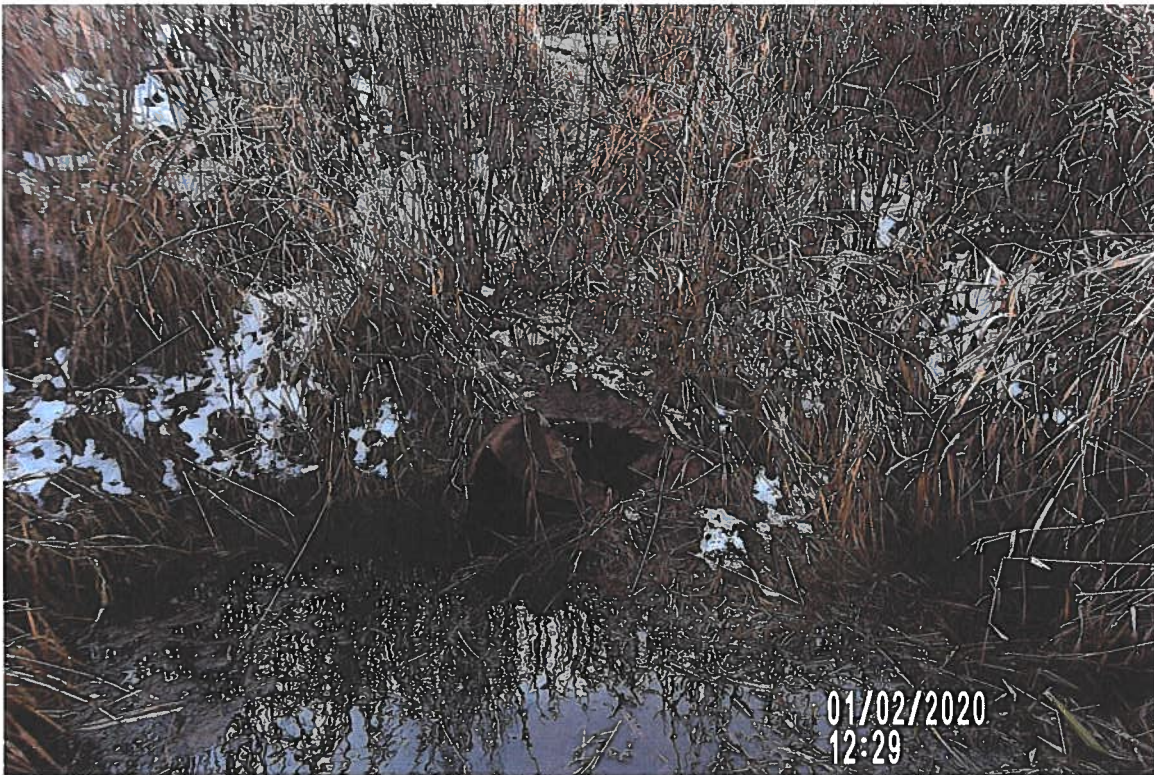
PICT# 2617 IS LOOKING SW SHOWING 30" CMP OUT LET ON NWSIDE OF RR ACCESS DRIVE ON NE SIDE OF DRAINAGE STRUCTURE WITH END CMP ALL MANGLED UP BUT FLOWING WATER LEVEL AT 20"

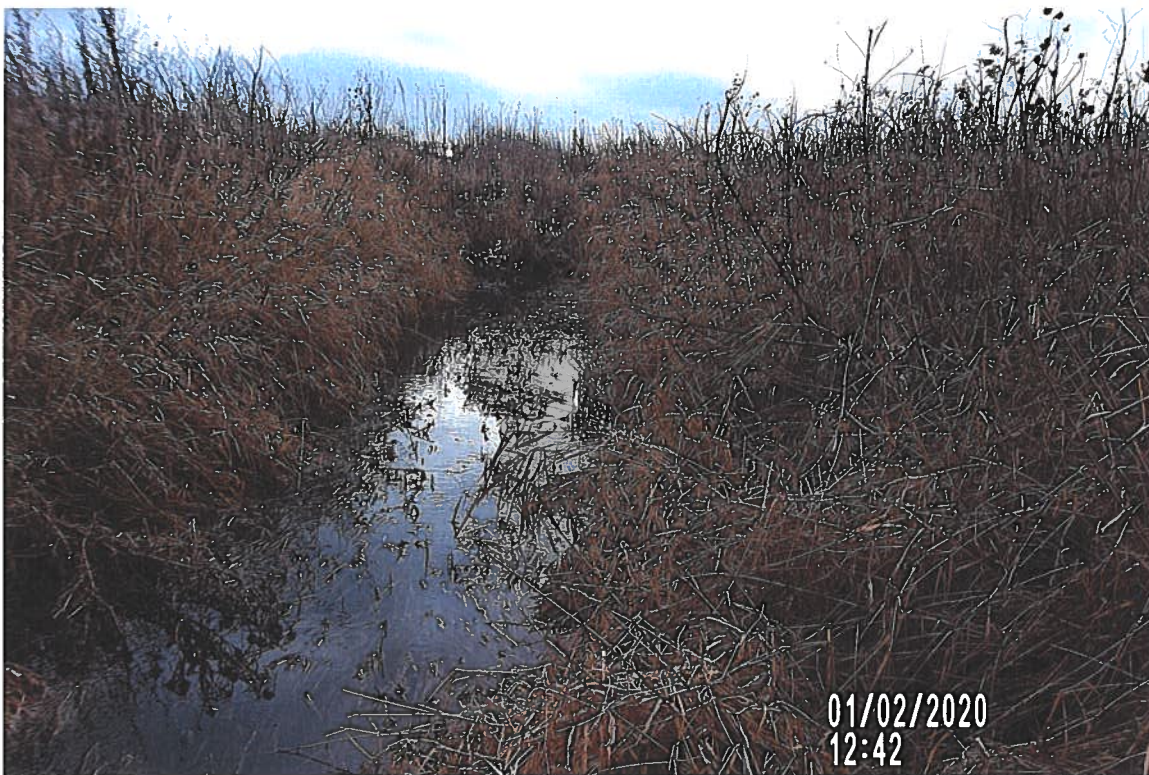
PICT# 2623 IS LOOKING WEST AT DRAINAGE WEIR JUST SW OF  
FENCELINE WEST (MAY NEED CLEANED OUT)

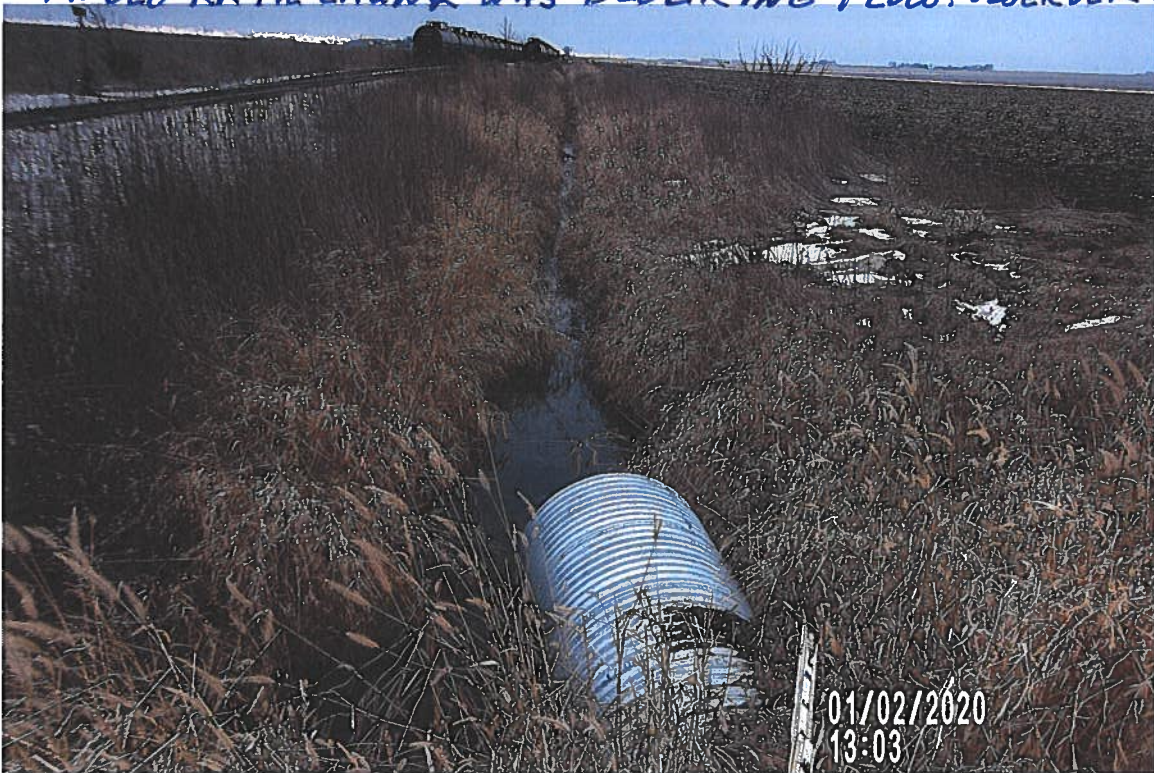
PICT # 2628 (WEST RR TRACKS & SOUTH OF 10TH AVE (110TH STREET))  
 IS LOOKING SW SHOWING 48" CMP INLET 0.85' ABOVE  
 TOP OF WATER & 36" CMP INLET WITH WATER LEVEL AT 15"

WITH 3" MUCK IN FLOWLINE. ALSO NOTE AT 15" UP ON 36" CMP  
 AN OLD RR TIE CHUNK WAS BLOCKING FLOW. OBSERVER CUT IT OUT  
 COULD FLOW YET BUT WAS RESTRICTED

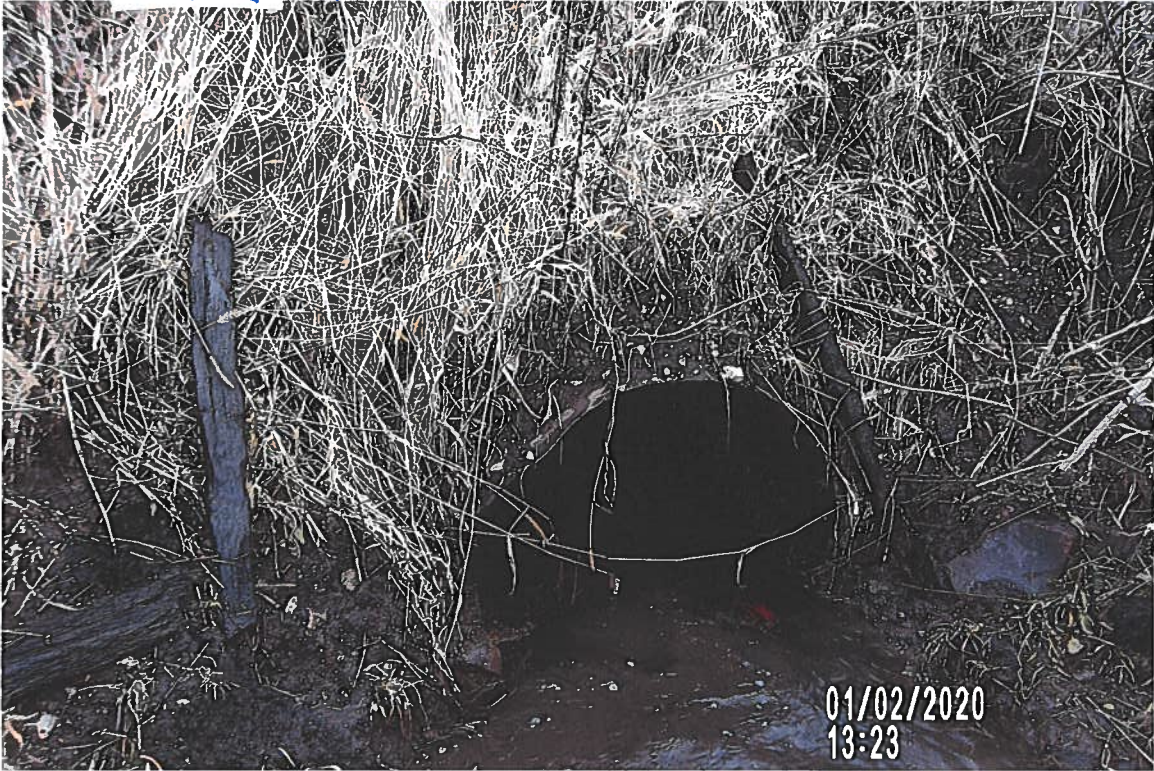
PICT # 2630 IS LOOKING NE AT 36" CMP INLET WEST RR TRACKS  
& SOUTH OF 10TH AVE 110TH STREET. SHOWING RR TIE REMNANT  
THAT RUNNING ACROSS INLET PIPE AT 15" UP (STILL FLOWED).  
OBSERVER CUT IT OUT

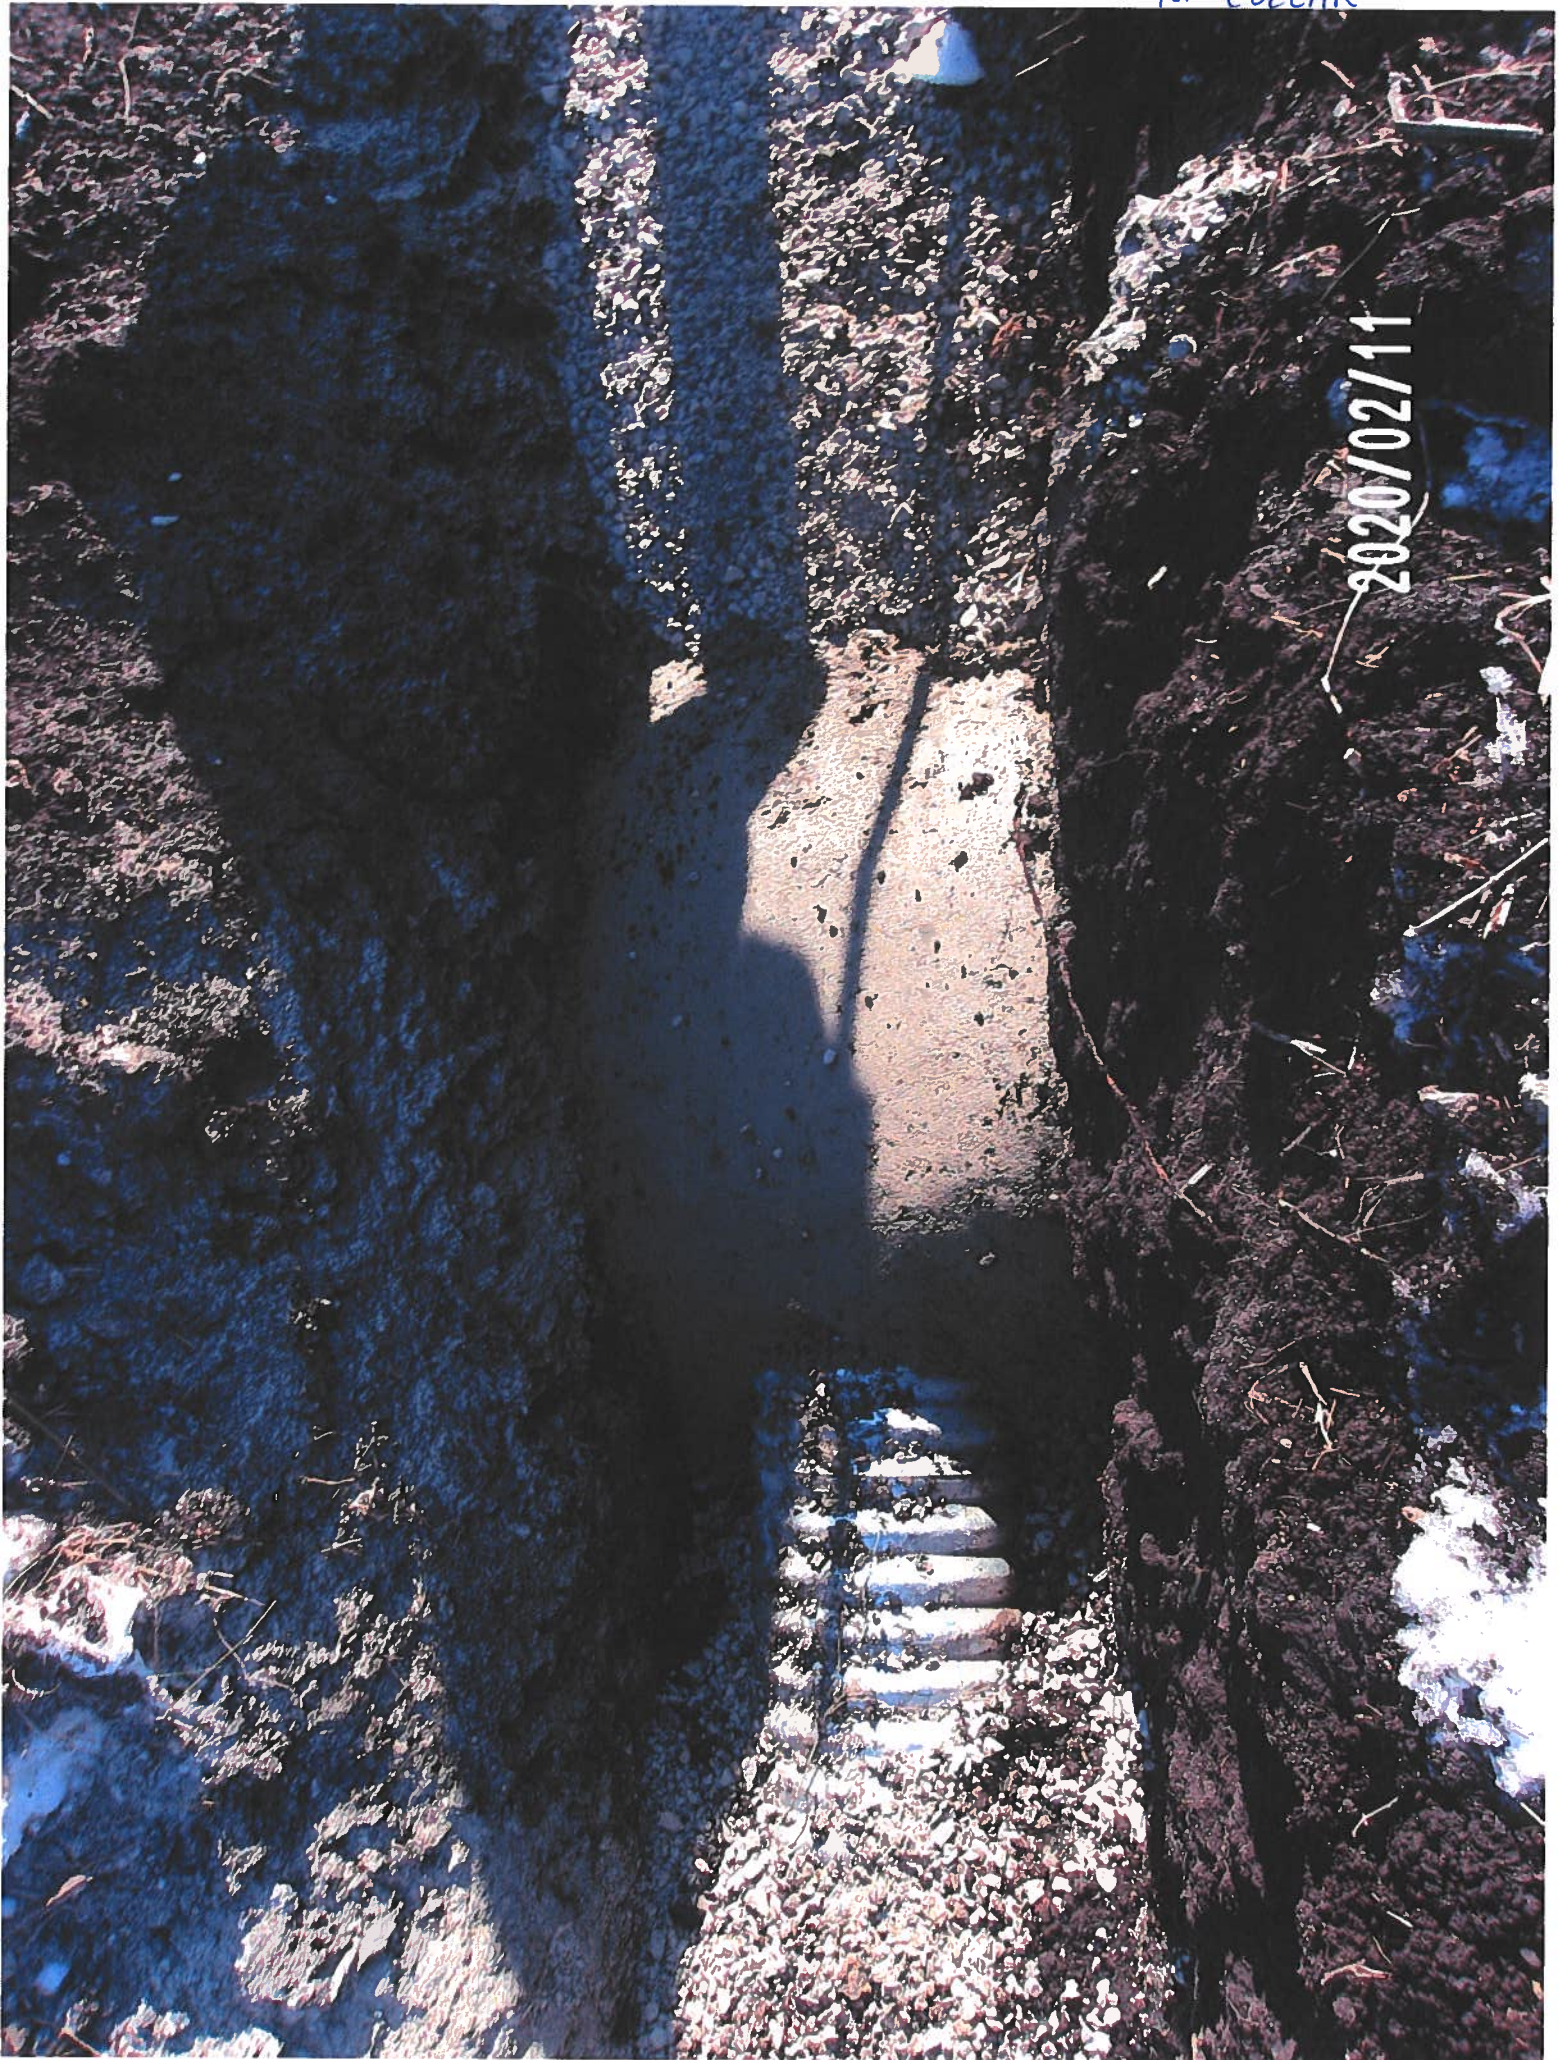
1ST COLLAR
