**AGENDA**  
**REGULAR DRAINAGE MEETING**  
**Wednesday, March 3, 2021 9:30 AM**  
**Large Conference Room**

5. DD 14 WO 290 - Discuss W Possible Action - Landowner Concerns

[DD 14 WO 290 INVESTIGATION SUMMARY 05\\_11\\_20.PDF](#)  
[DD 14 WO 290 - 6844.4 - INVESTIGATION REPORT - 2020-08-31.PDF](#)

CONSTRUCTION ENGINEERING  
OBSERVATION REPORT

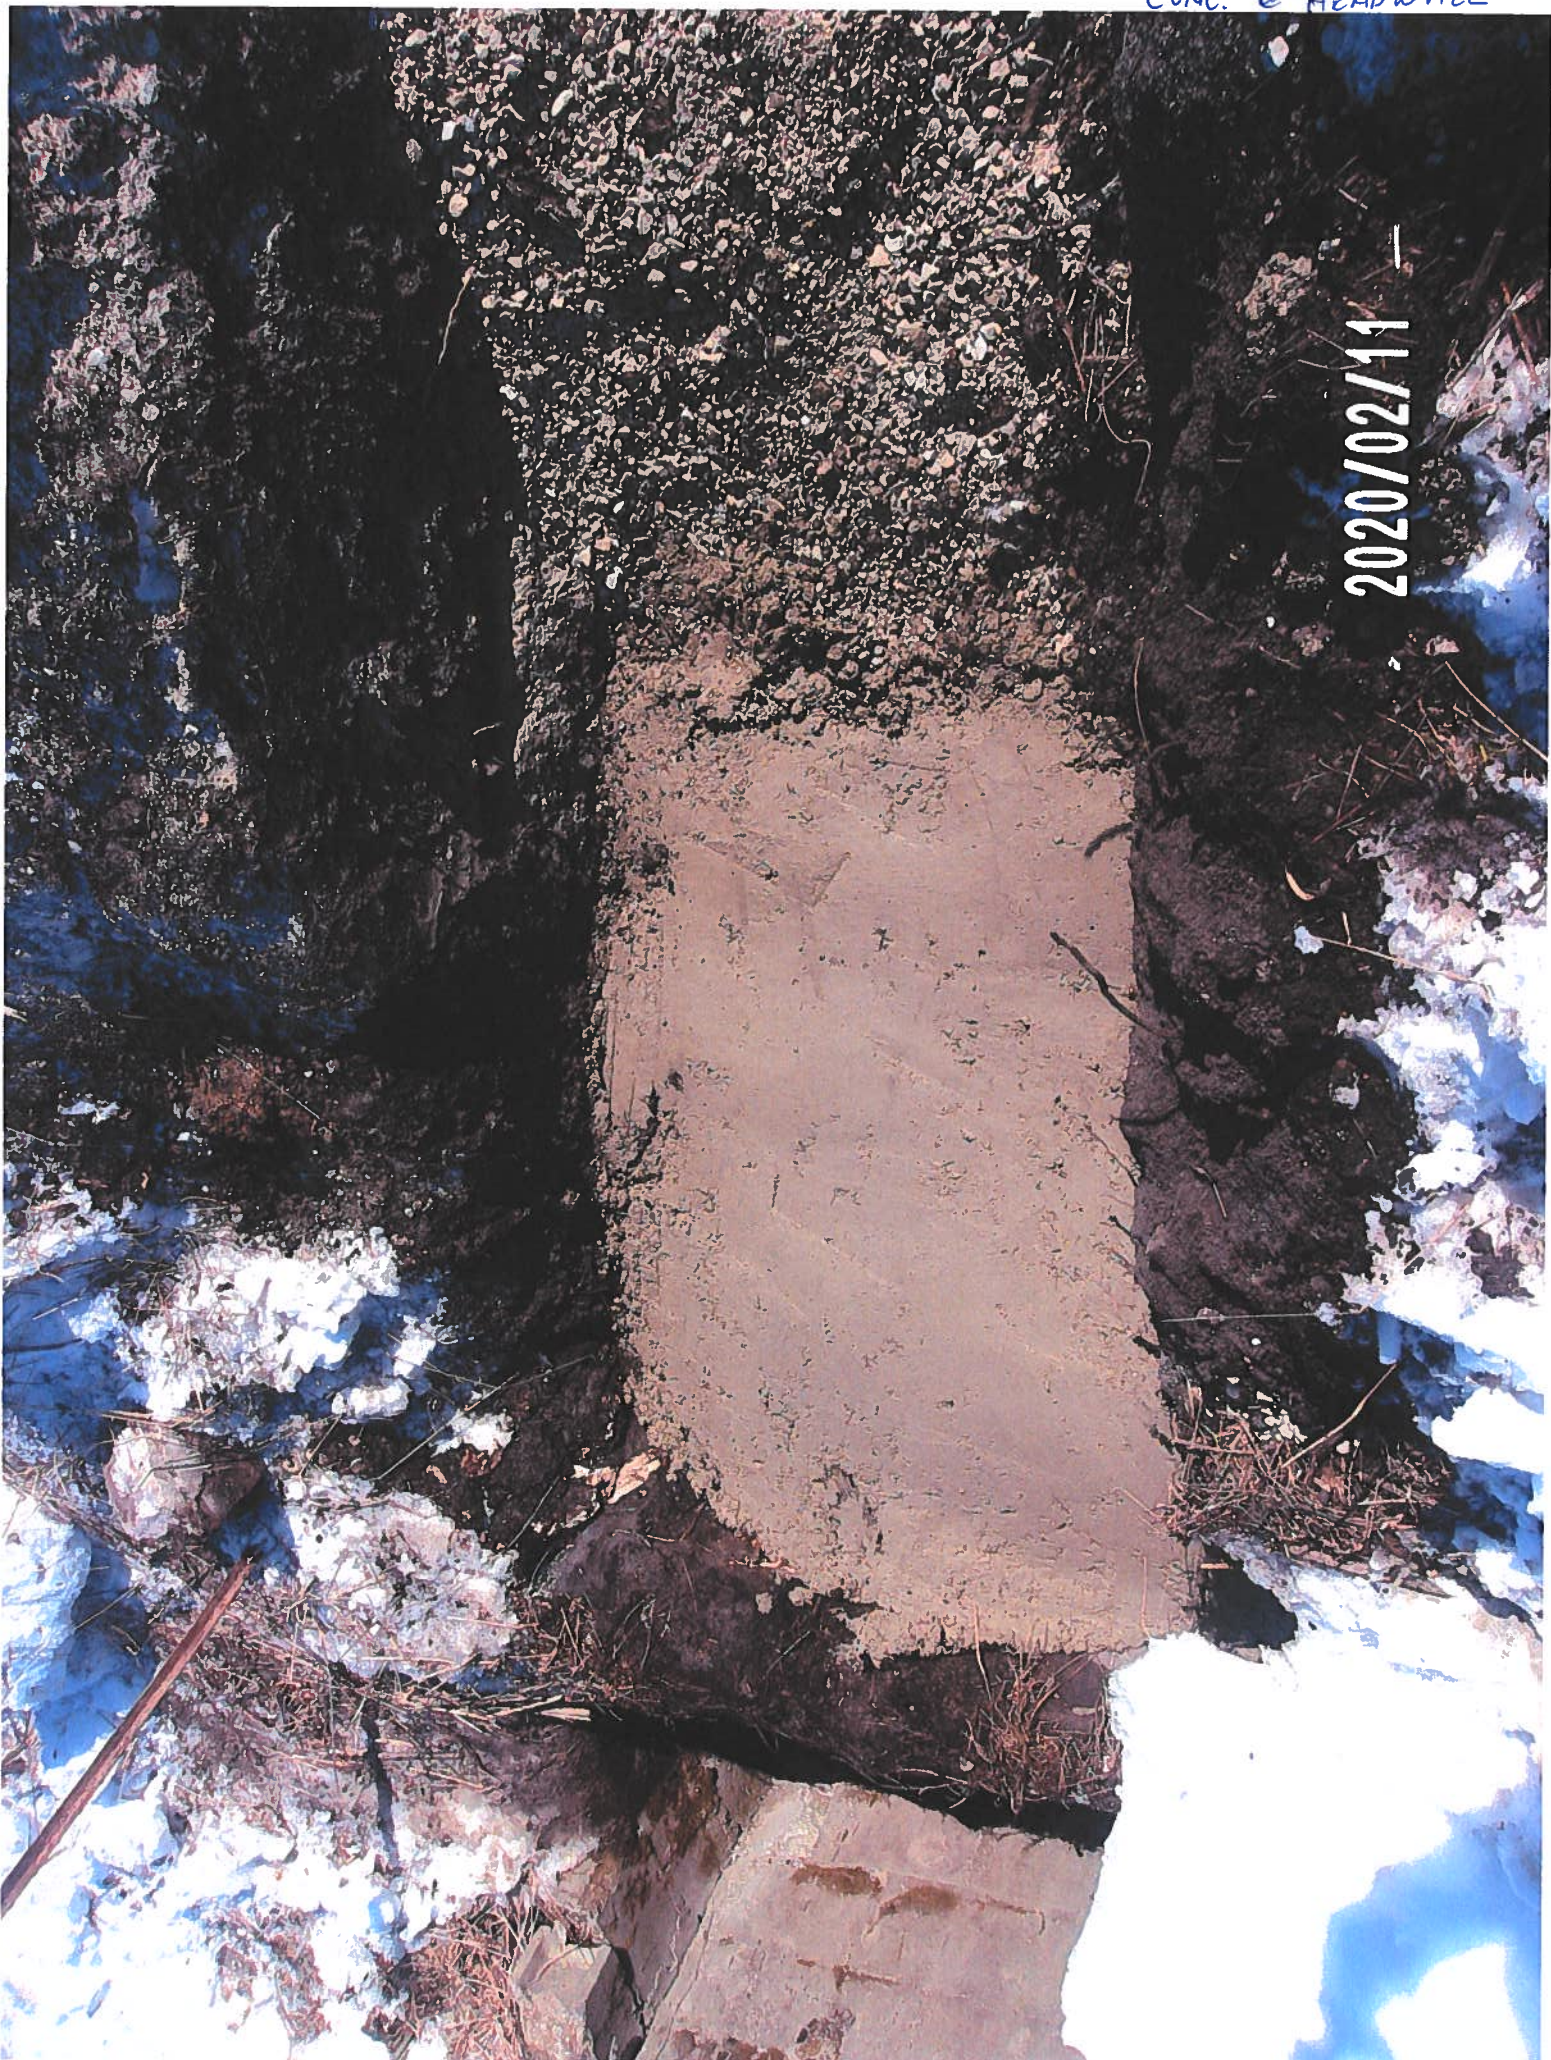
CONC. @ HEADWALL

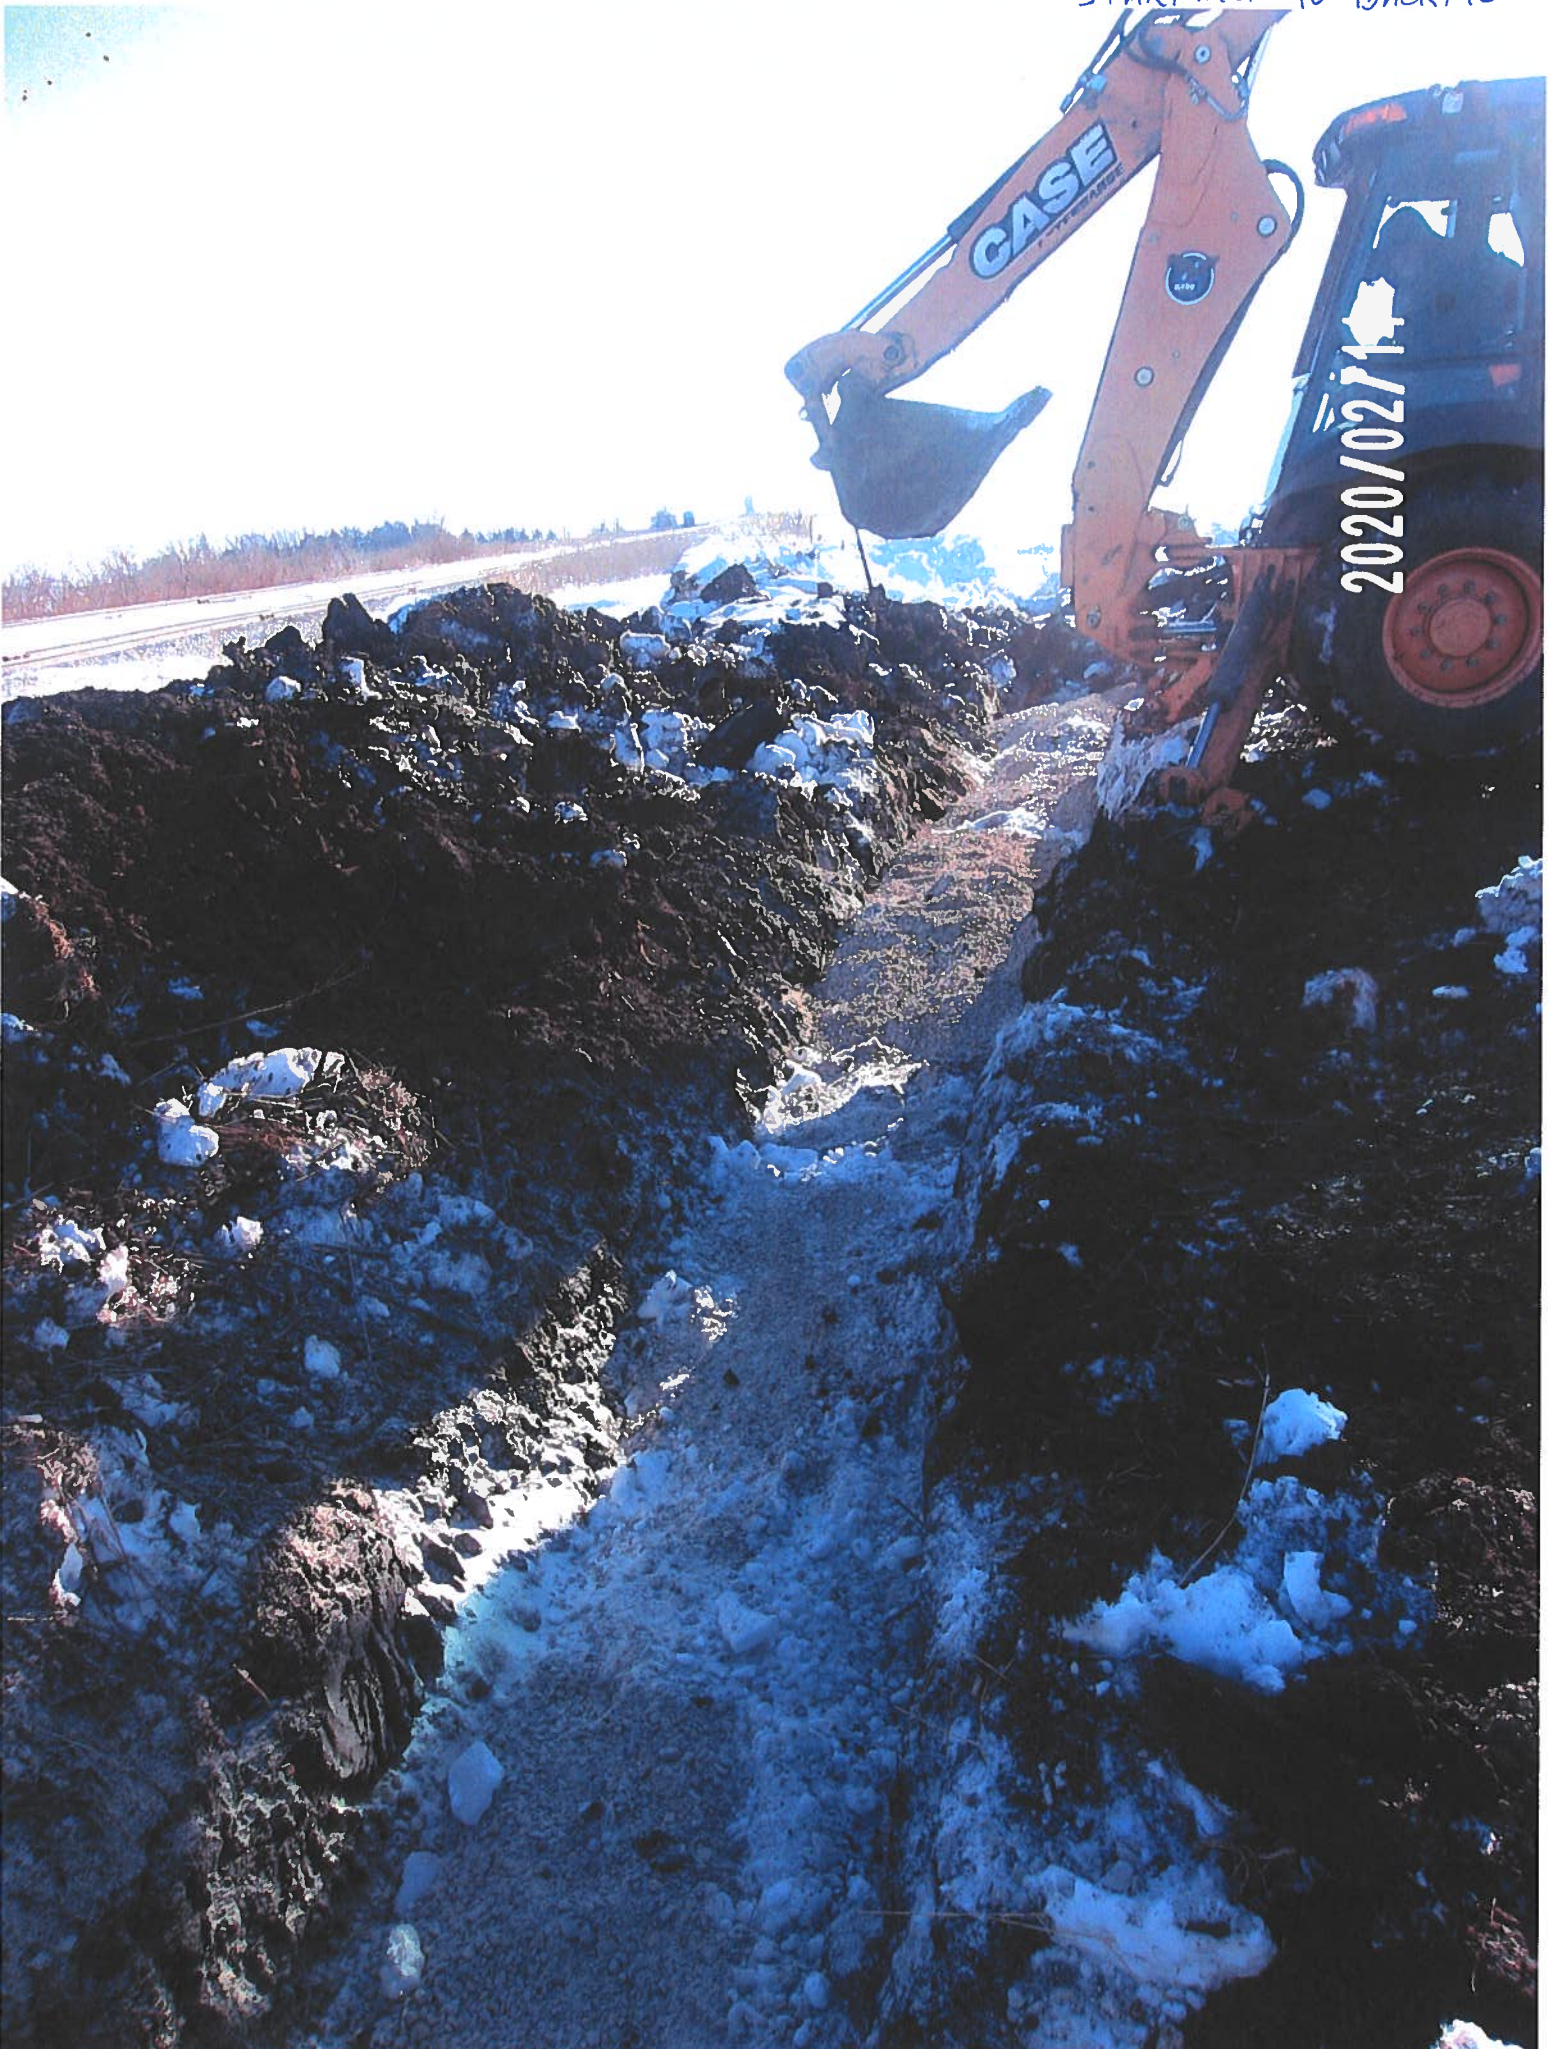
STARTING TO BACKFILL
