**AGENDA**  
**REGULAR DRAINAGE MEETING**  
**Wednesday, January 20, 2021 9:30 AM**  
**Large Conference Room**

[DD 20 WO 302 - 6502.5 - INVESTIGATION-REPAIR SUMMARY 01\\_05\\_20.PDF](#)

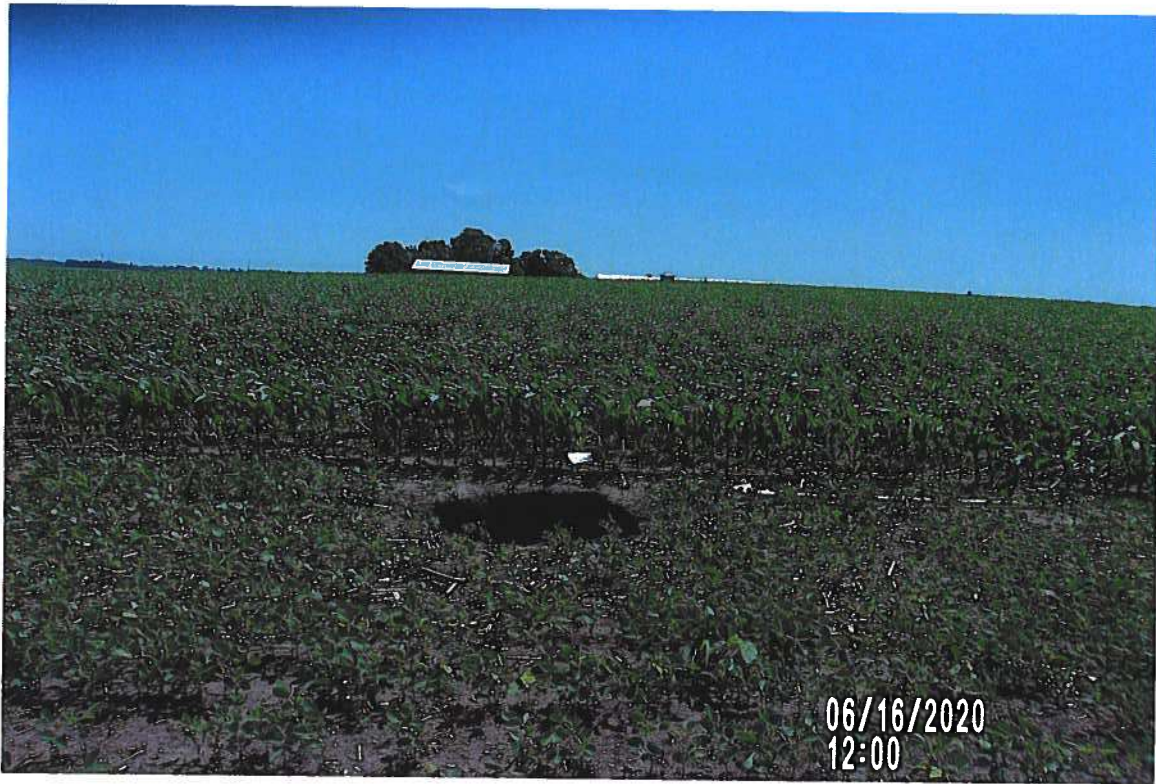
PICTURE#3774 IS LOOKING EAST TOWARDS ACREAGE @19131  
G AVE - SHOWING 5.0'  $\phi$  X 2.0' DEEP BLOWOUT IN BEAN  
GROUND JUST WEST OF CROP CHANGE.

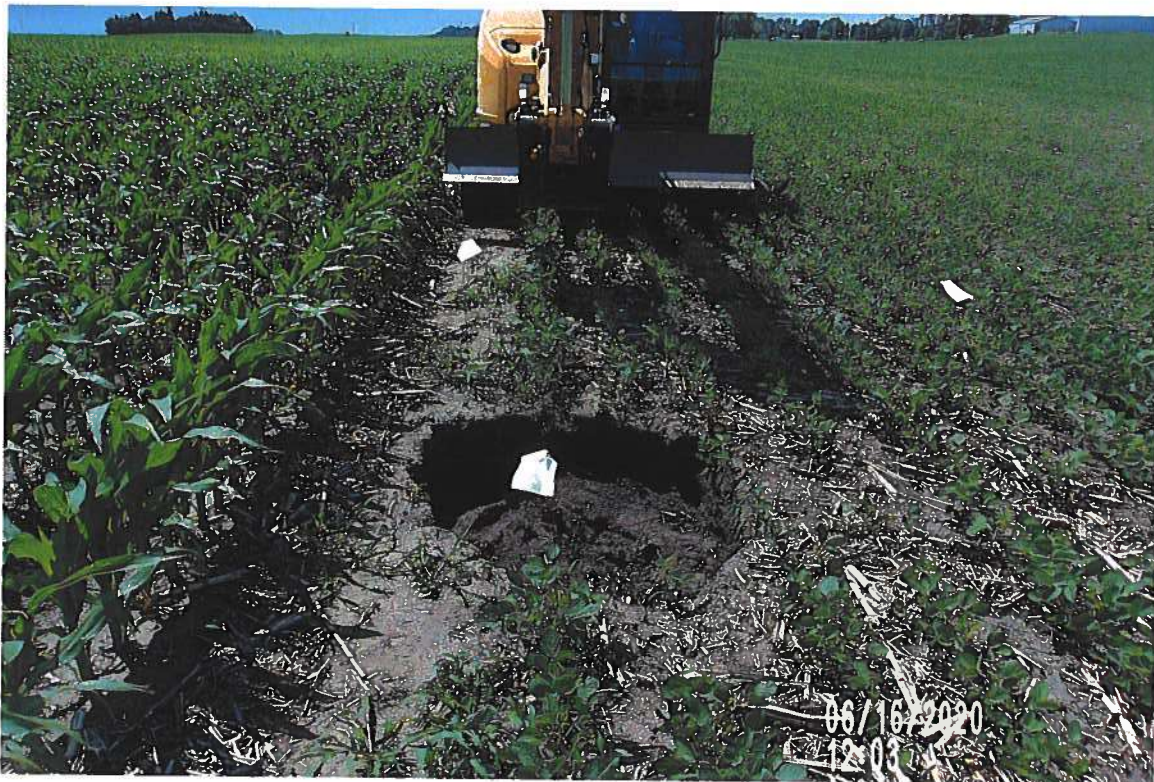
PICTURE#3775 IS LOOKING SOUTH TOWARDS 195TH STREET  
AT 5.0'  $\phi$  X 2.0' DEEP BLOWOUT IN BEAN GROUND  
(WEST SIDE) OF CROP CHANGE

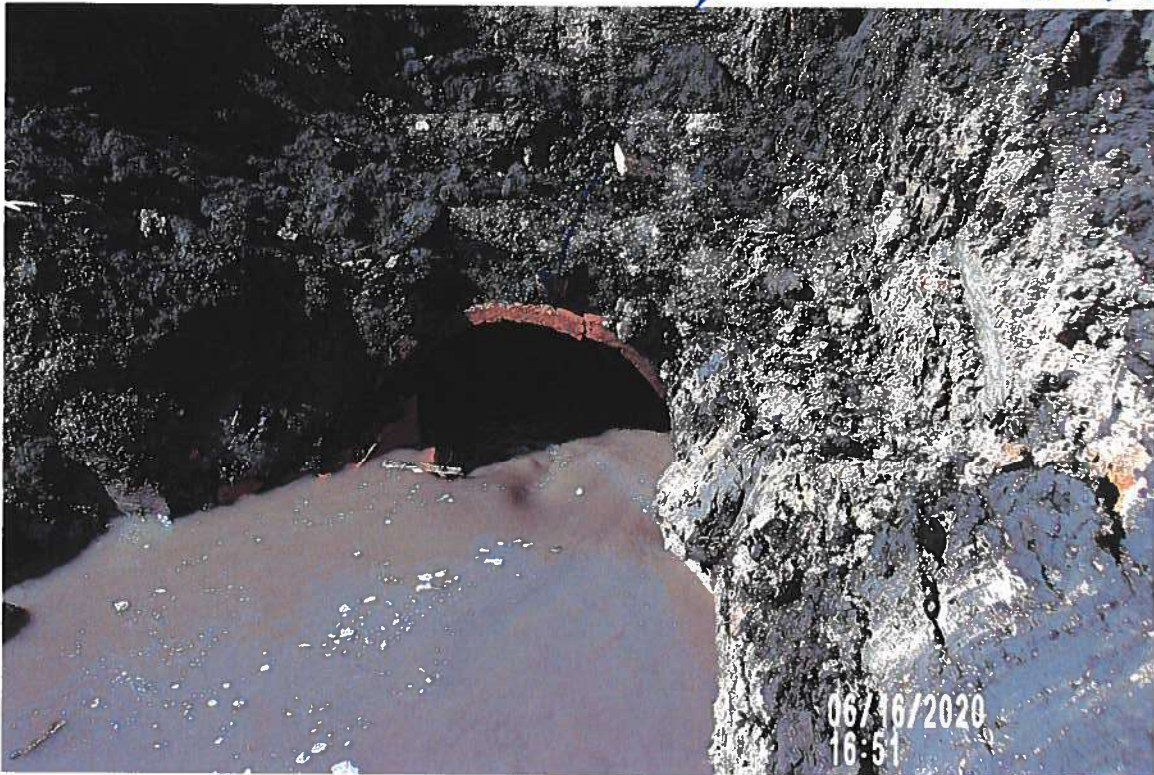
PICTURE# 3794 IS LOOKING NORTH @ 21" CLAY TILE SHOWING  
TILE STILL CRACKED AND CAVING DOWN

31.00' DOWN STREAM FROM GPS#  
392

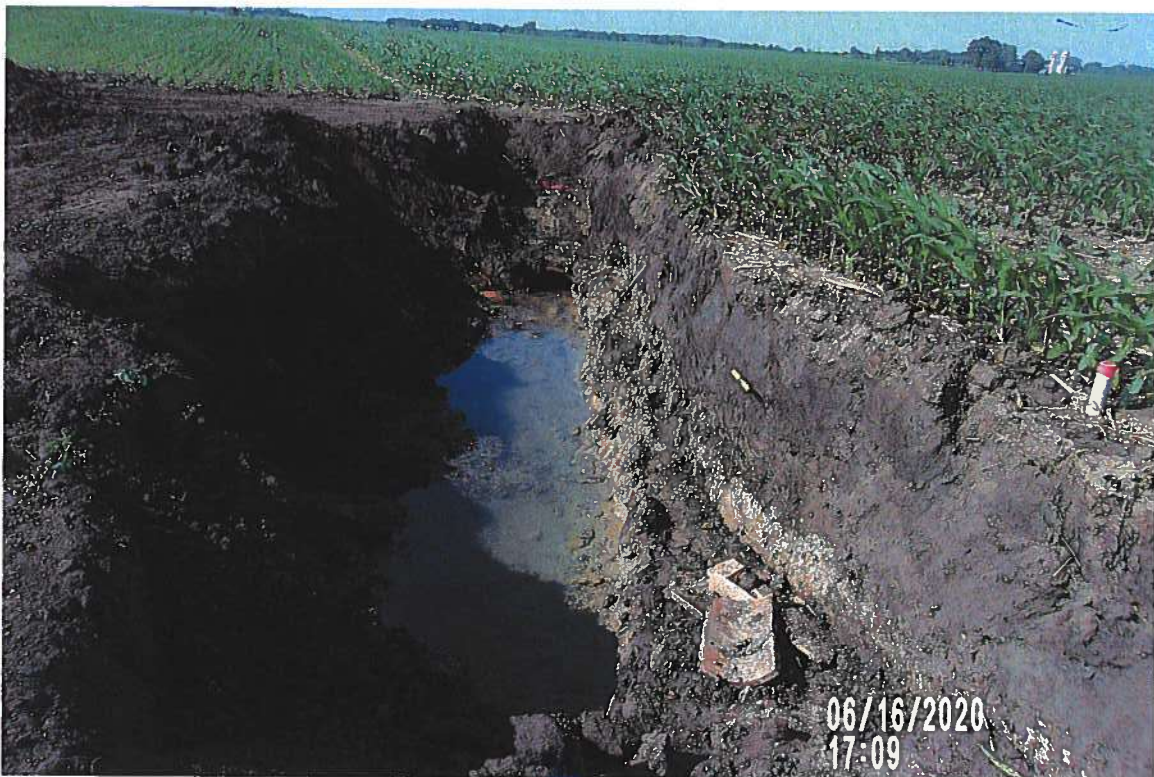
PICTURE# 3795 IS LOOKING NORTH SHOWING TRENCH WITH  
DAMAGED TILE REMOVED.

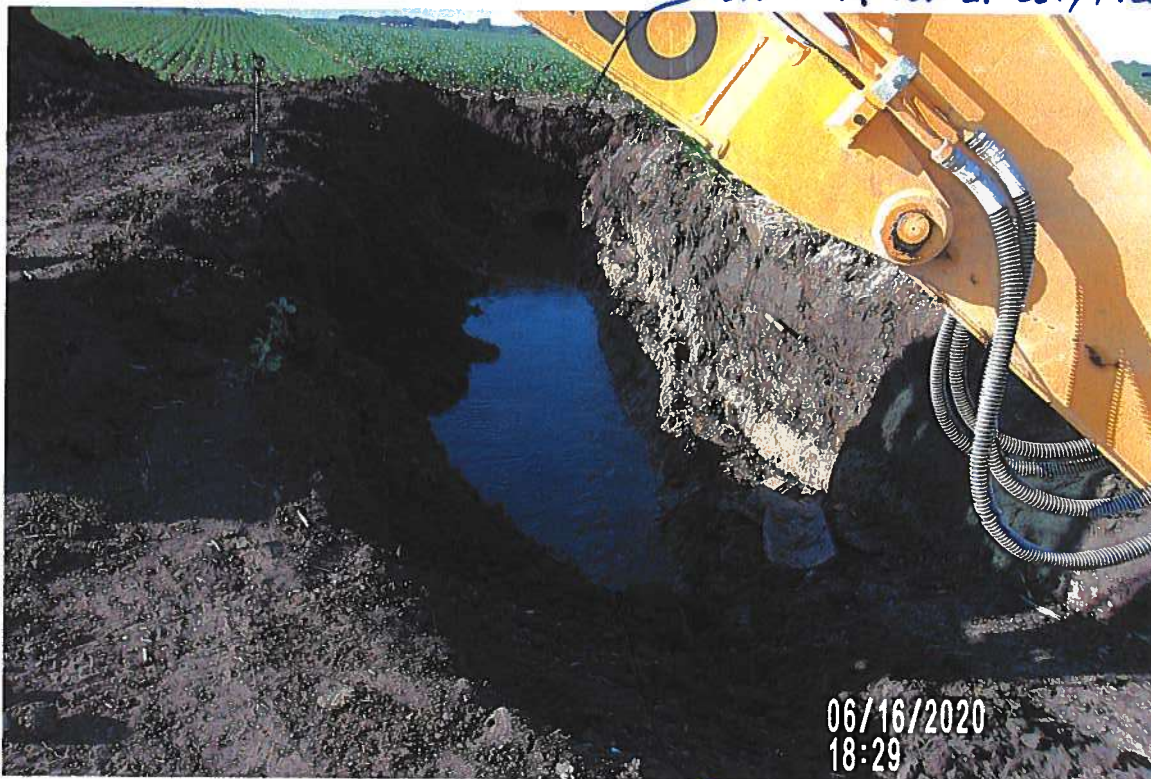
PICTURE # 3803 IS LOOKING NE SHOWING 41.8 LF OF TILE REMOVED WITH NEXT THREE DOWNSTREAM TILE IN SAME CONDITION. CREW IS WAITING ON DECISION FROM DRAINAGE DISTRICT ON HOW FAR TO REPLACE TILE

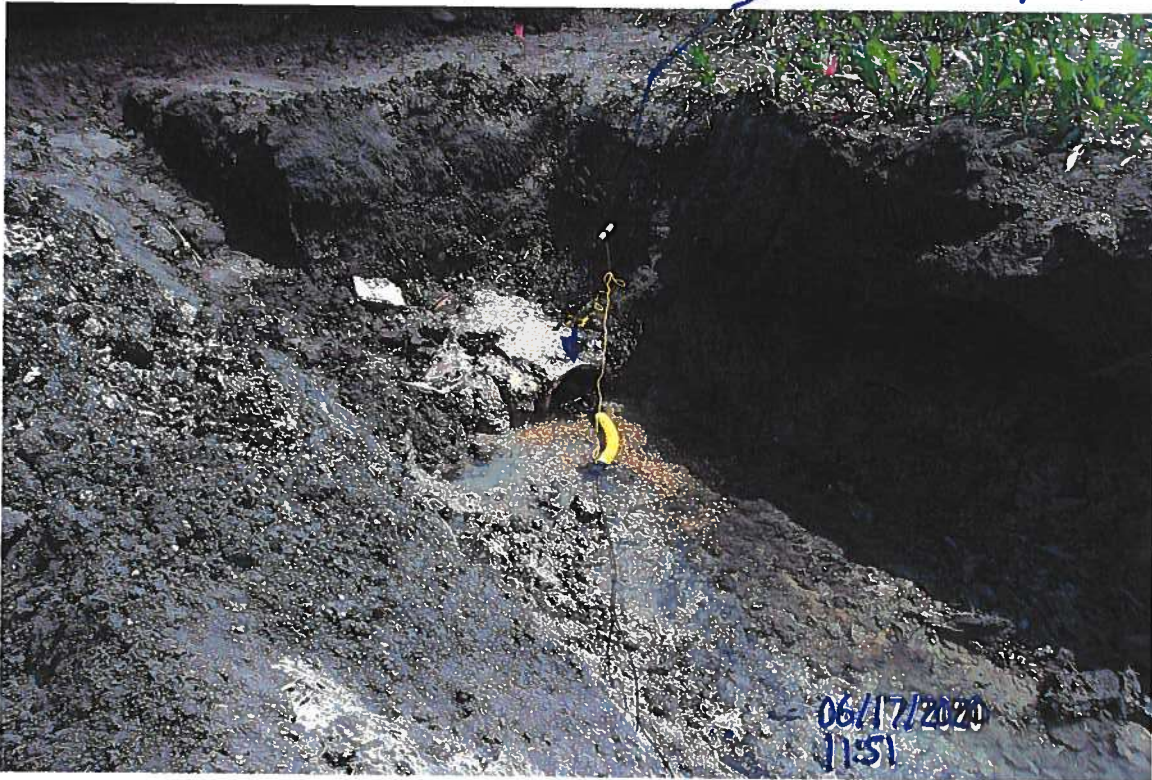
PICTURE# 3809 IS LOOKING NE SHOWING DOWN STREAM  
END OF EXPOSED TILE WHERE PAUL STARTED TELEVISIONING  
DOWN STREAM FROM WITH CAMERA IN TILE READY TO TELEVIEW.

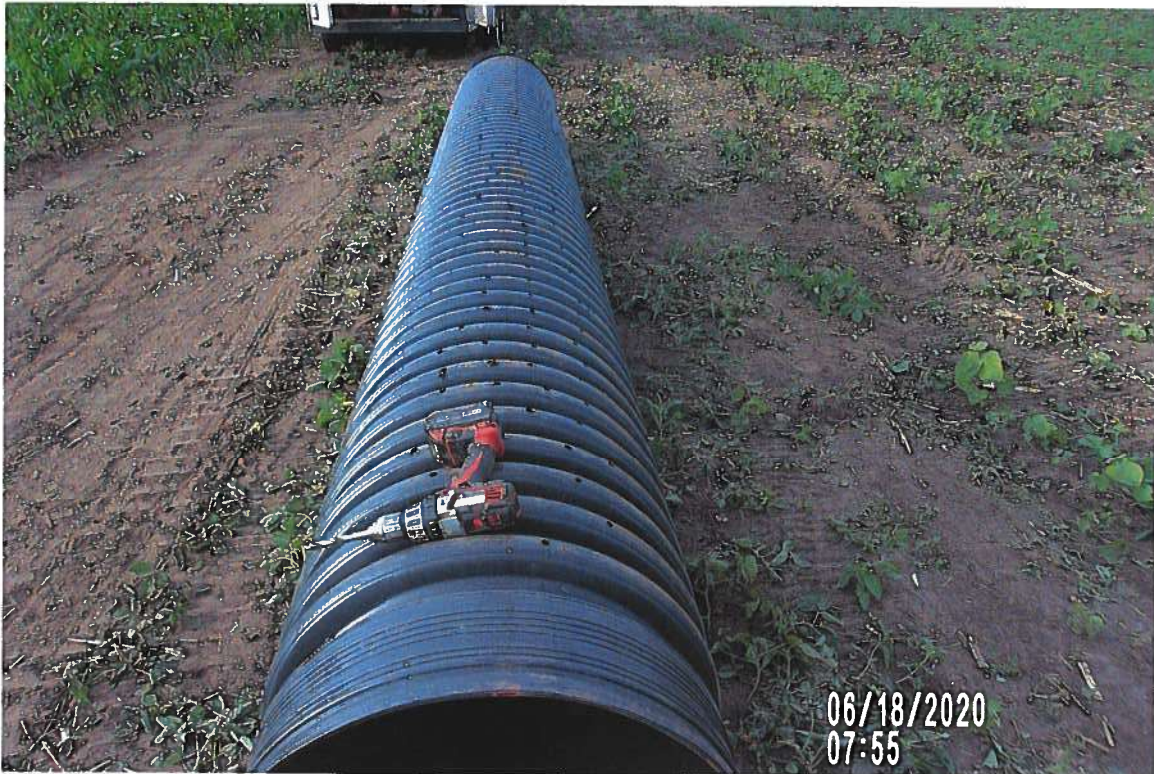
PICTURE# 3818 SHOWING CREW DRILL HOLES IN  
 BOTTOM OF 24" DW HOPE NONPERF TILE BEFORE  
 INSTALLED TO PREVENT TILE FROM FLOATING UP,

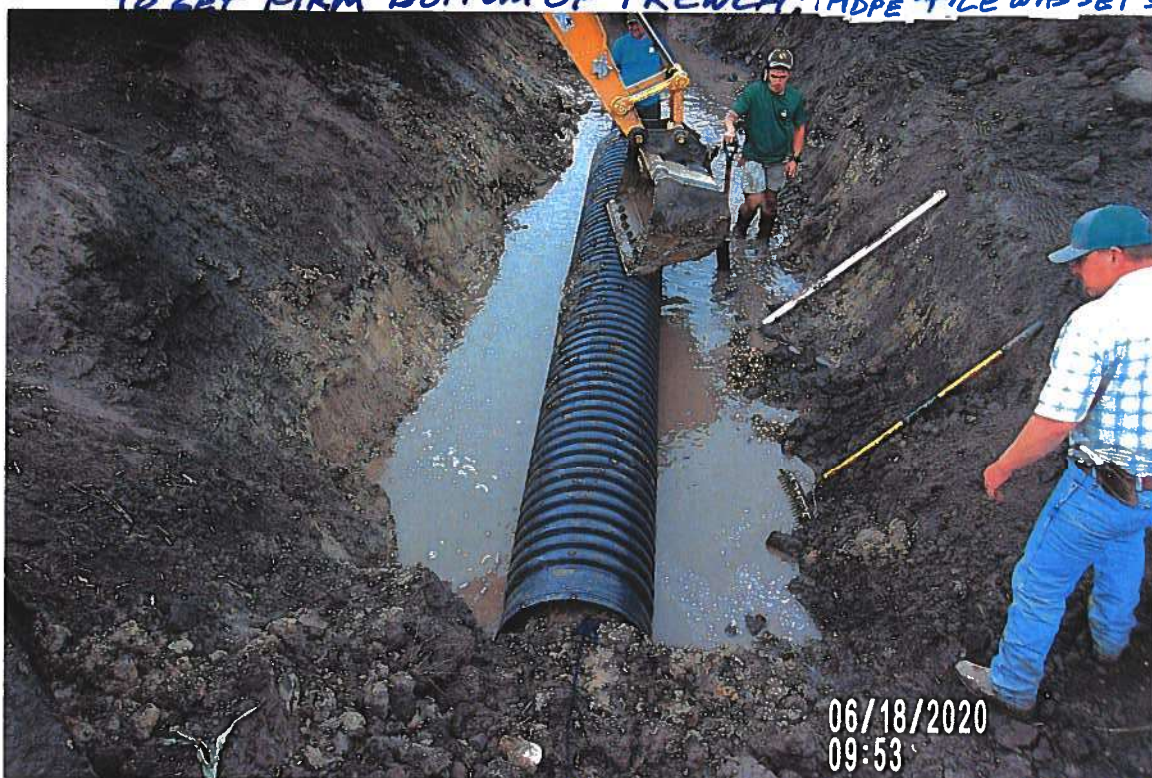
(TEMPORARY REPAIR)  
 PICTURE # 3820 IS LOOKING NE SHOWING FIRST

FULL SECTION OF 24" DW HDPE NONPERF TILE IN PLACE  
 WITH BELL END ON UPSTREAM END WITH JUST ENOUGH ROCK  
 TO GET FIRM BOTTOM OF TRENCH. HDPE TILE WAS SET SO

INSIDE  
 BOTTOM  
 OF BELL  
 IS RESTING  
 ON BOTTOM  
 OF CLAY  
 TILE  
 AT TIE IN

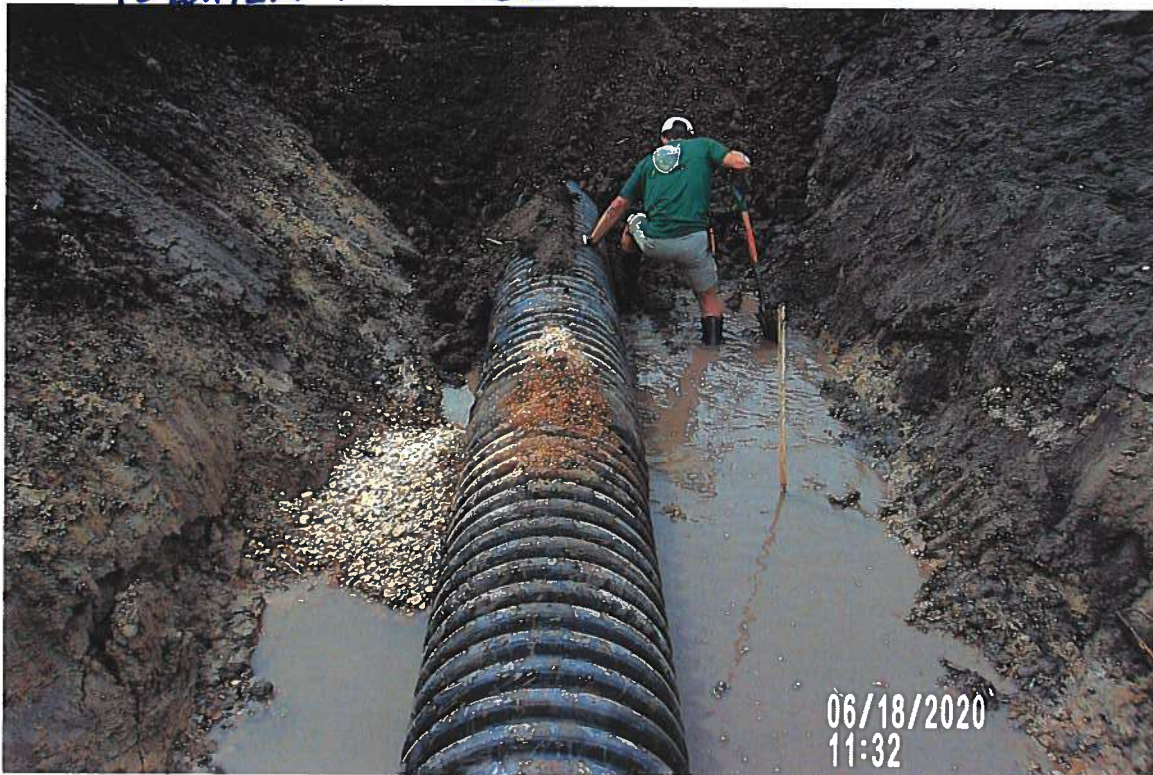
PICTURE# 3824 IS LOOKING SW SHOWING CREW BACKFILLING  
SOIL AROUND NEW TILE WITH CREW TAMPING IN SOIL  
AROUND HAUNCH OF TILE. SOIL IS GETTING LITTLE MURKY DUE  
TO WATER AROUND TILE BUT WITH FIRM BOTTOM UNDER TILE;

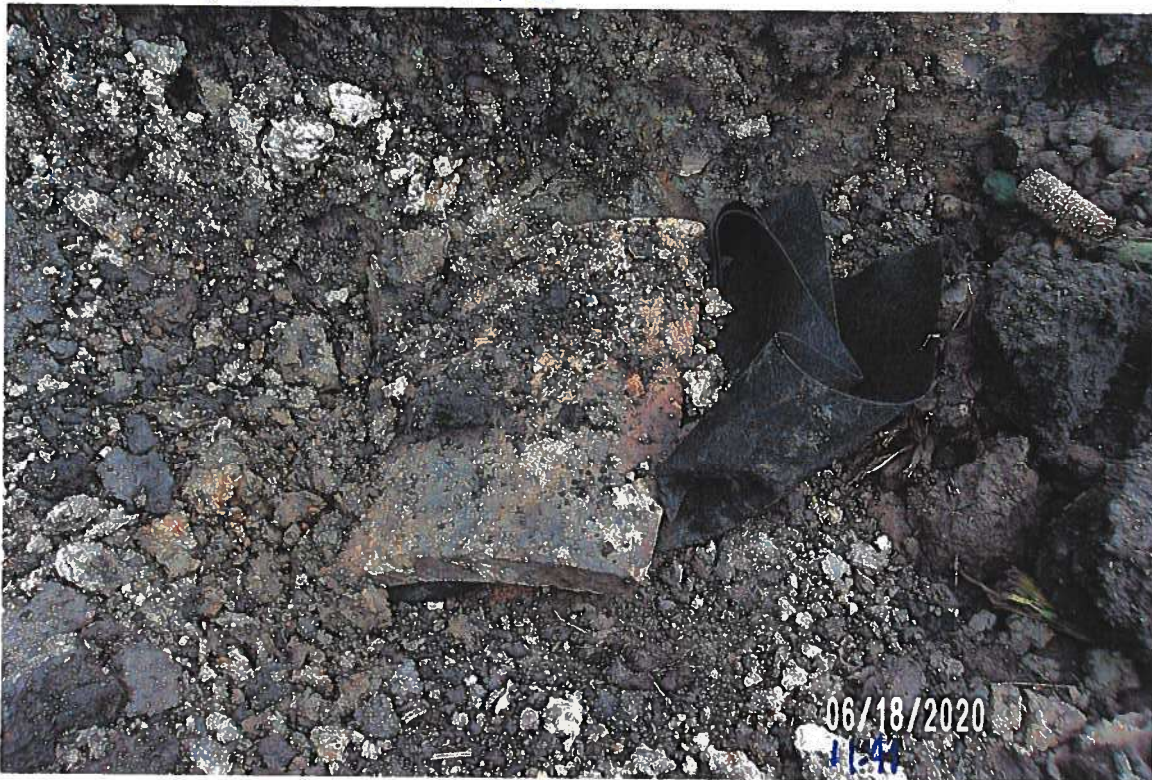
PICTURE # 3826 SHOWING A PIECE OF FABRIC WITH CLAY TILE PIECES OVER A EXPOSED TILE JOINT THAT IS WIDER THAN NORMAL JOINT FOR NEXT JOINT NORTH OF TIE IN

CONNECTION,  
CREW STAMPED  
CLAY OVER  
TOO.

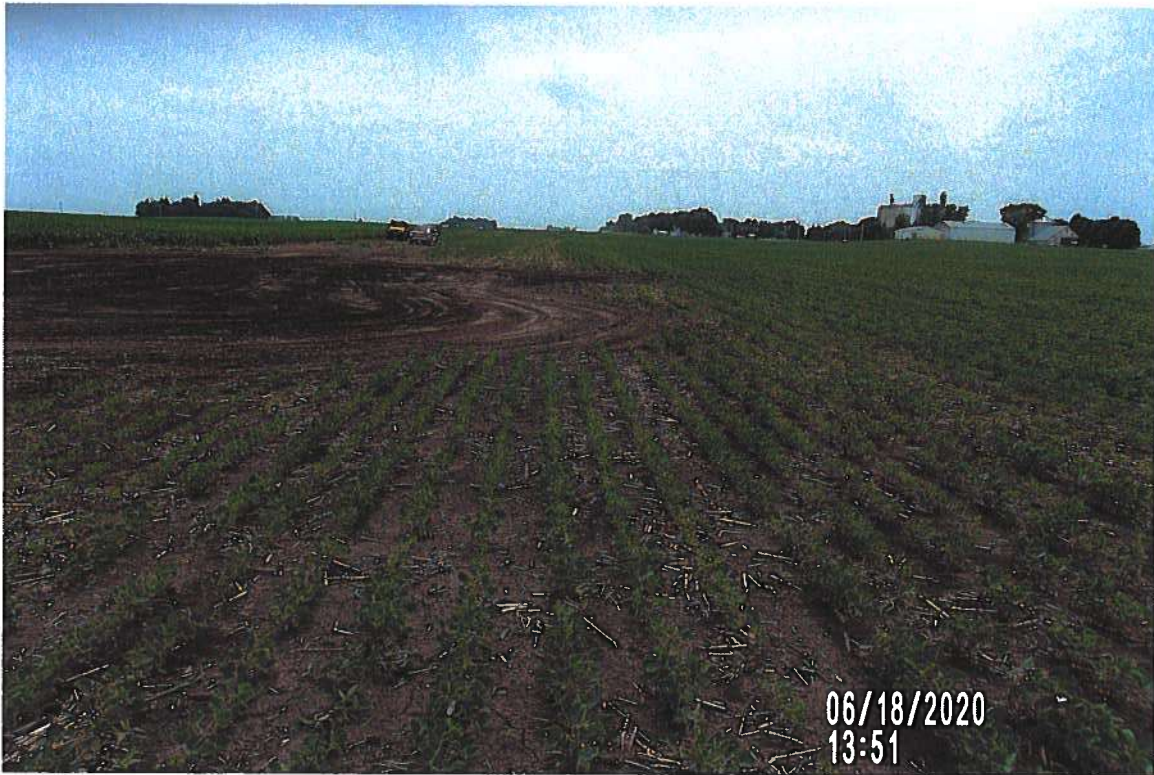
PICTURE # 3842 IS LOOKING SOUTH SHOWING BEAN DAMAGE  
IN REPAIR WITH AREA CLEANED UP.

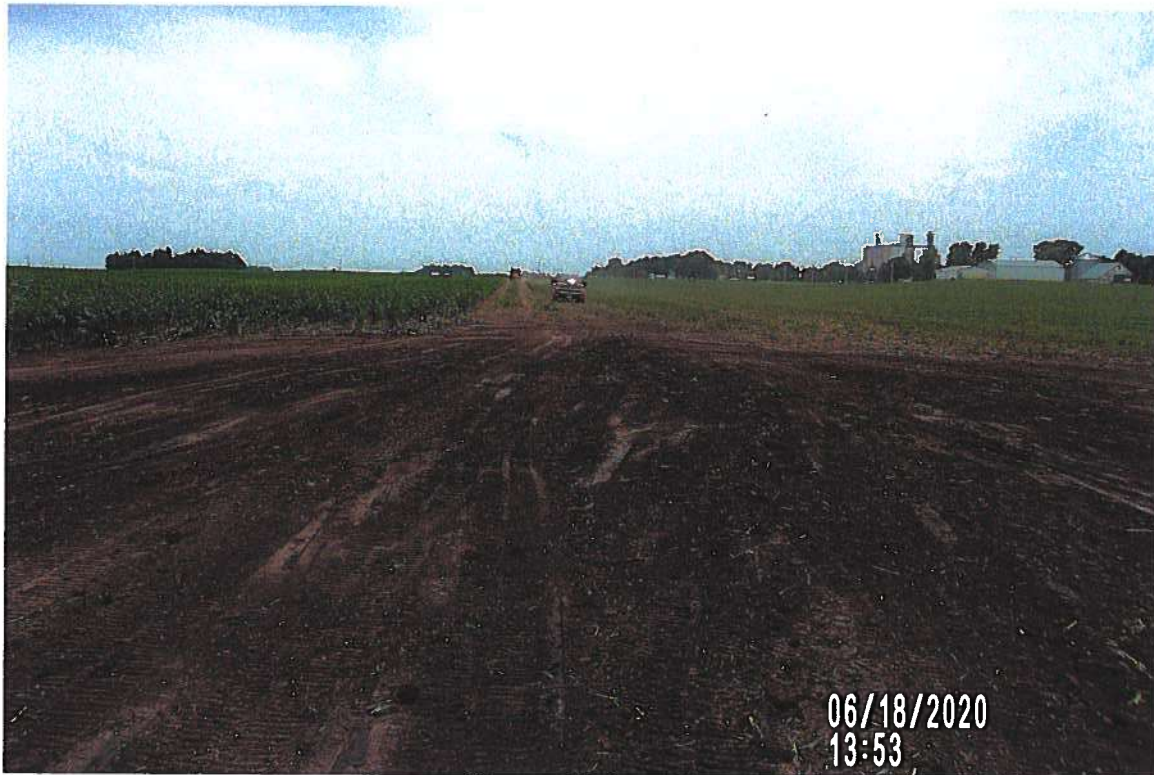
PICTURE # 3843 IS LOOKING SOUTH SHOWING CORN DAMAGE  
IN REPAIR AREA WITH AREA CLEANED UP

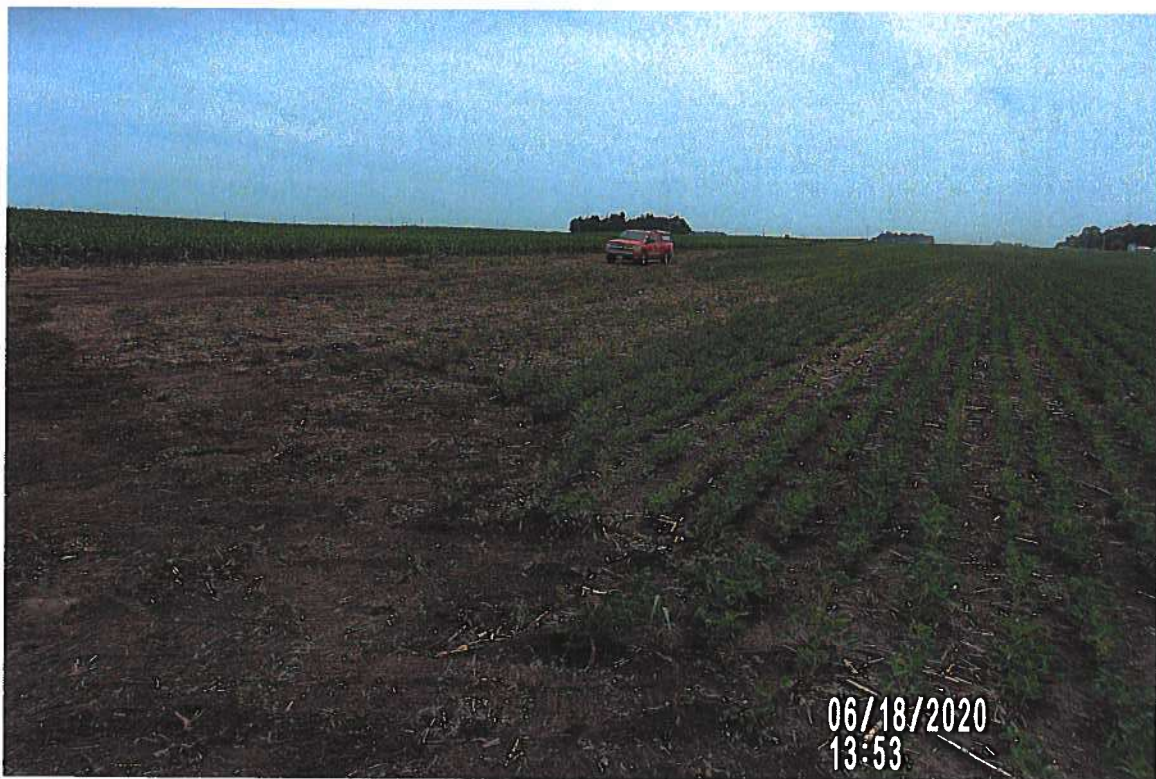
PICTURE# 3844 IS LOOKING SOUTH AT BEAN/CORN  
DAMAGE TO ACCESS LANE WITH AREA CLEANED  
UP

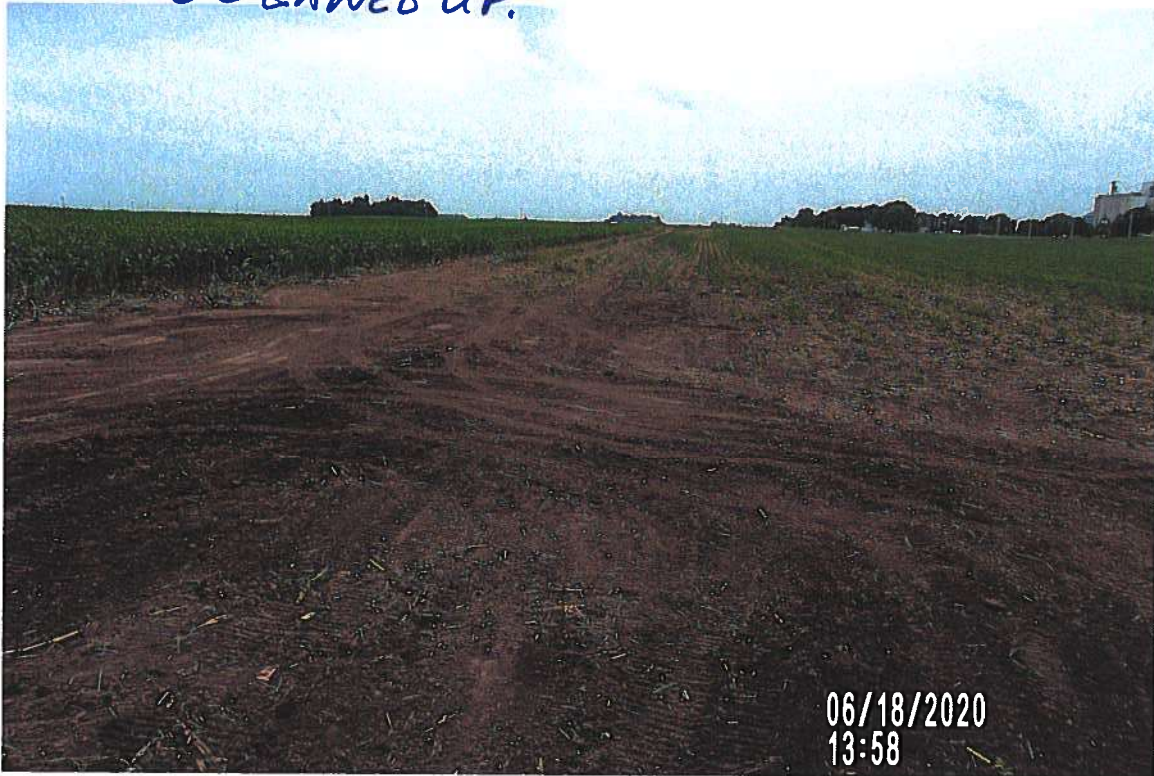
PICTURE # 3846 IS LOOKING SOUTH AT BEAN  
DAMAGE TO ACCESS LANE WITH AREA  
CLEANED UP.

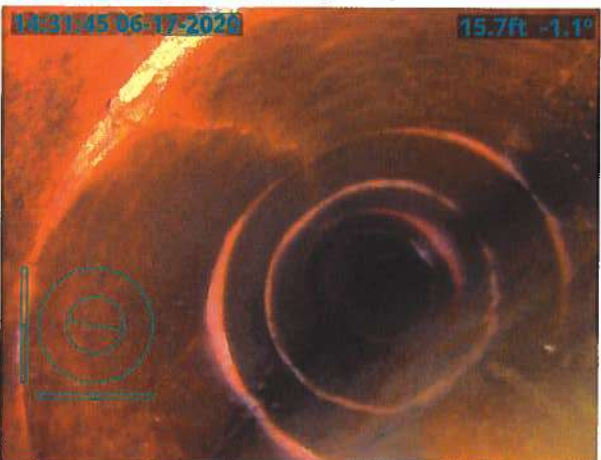
CL 2020\_06\_17-14\_31\_45\_663.jpg

| Video Ref | Dist (ft) | Cont Defect | Code | Photo Ref | Diameter/<br>Dimension | Clock | | Intrusion | | Remarks |
|---|---|---|---|---|---|---|---|---|---|---|
| 0:03:15 | 15.7 | | CL | 2020_06_17-<br>14_31_45_663.jpg<br> | | 11 | | | | CRACKED AT 11 |

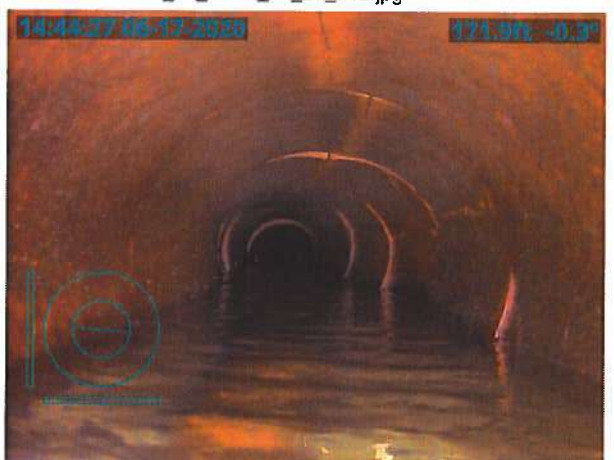
CM 2020\_06\_17-14\_44\_27\_712.jpg

| Video Ref | Dist (ft) | Cont Defect | Code | Photo Ref | Diameter/<br>Dimension | Clock | | Intrusion | | Remarks |
|---|---|---|---|---|---|---|---|---|---|---|
| 0:14:28 | 171.9 | | CM | 2020_06_17-<br>14_44_27_712.jpg<br> | | 12 | 03 | | | MULTIPLE CRACKS AND SQUAT |

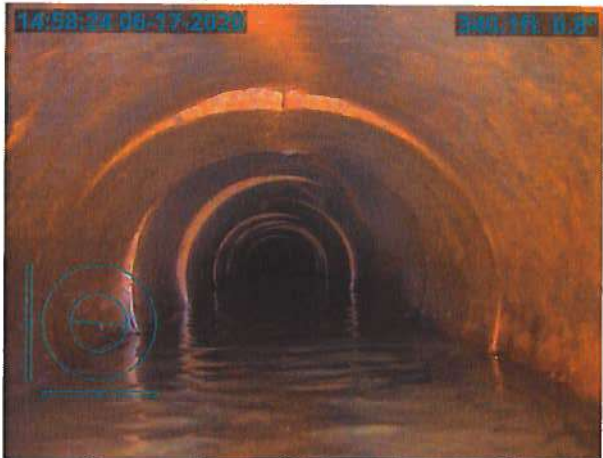
B 2020\_06\_17-14\_58\_24\_390.jpg

| Video Ref | Dist (ft) | Cont Defect | Code | Photo Ref | Diameter/<br>Dimension | Clock | | Intrusion | | Remarks |
|---|---|---|---|---|---|---|---|---|---|---|
| 0:26:54 | 340.1 | | B | 2020_06_17-<br>14_58_24_390.jpg<br> | | 12 | 12 | | | CRACKED TOP |

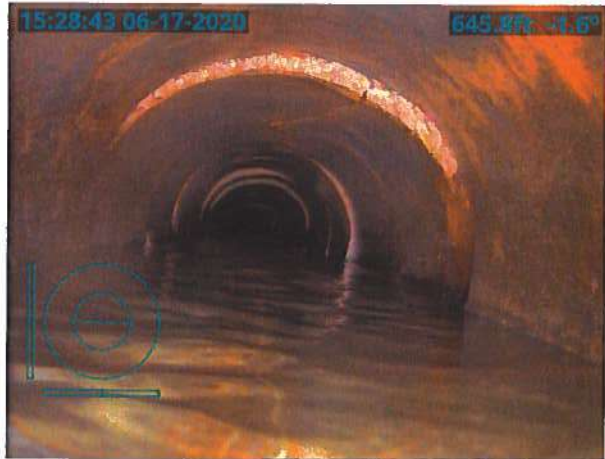
B 2020\_06\_17-15\_28\_43\_526.jpg

| Video Ref | Dist (ft) | Cont Defect | Code | Photo Ref | Diameter/<br>Dimension | Clock | | Intrusion | | Remarks |
|---|---|---|---|---|---|---|---|---|---|---|
| 0:53:26 | 645.8 | | B | 2020_06_17-15_28_43_526.jpg<br> | | 06 | 05 | | | MULTIPLE CRACKS AND SQUAT |

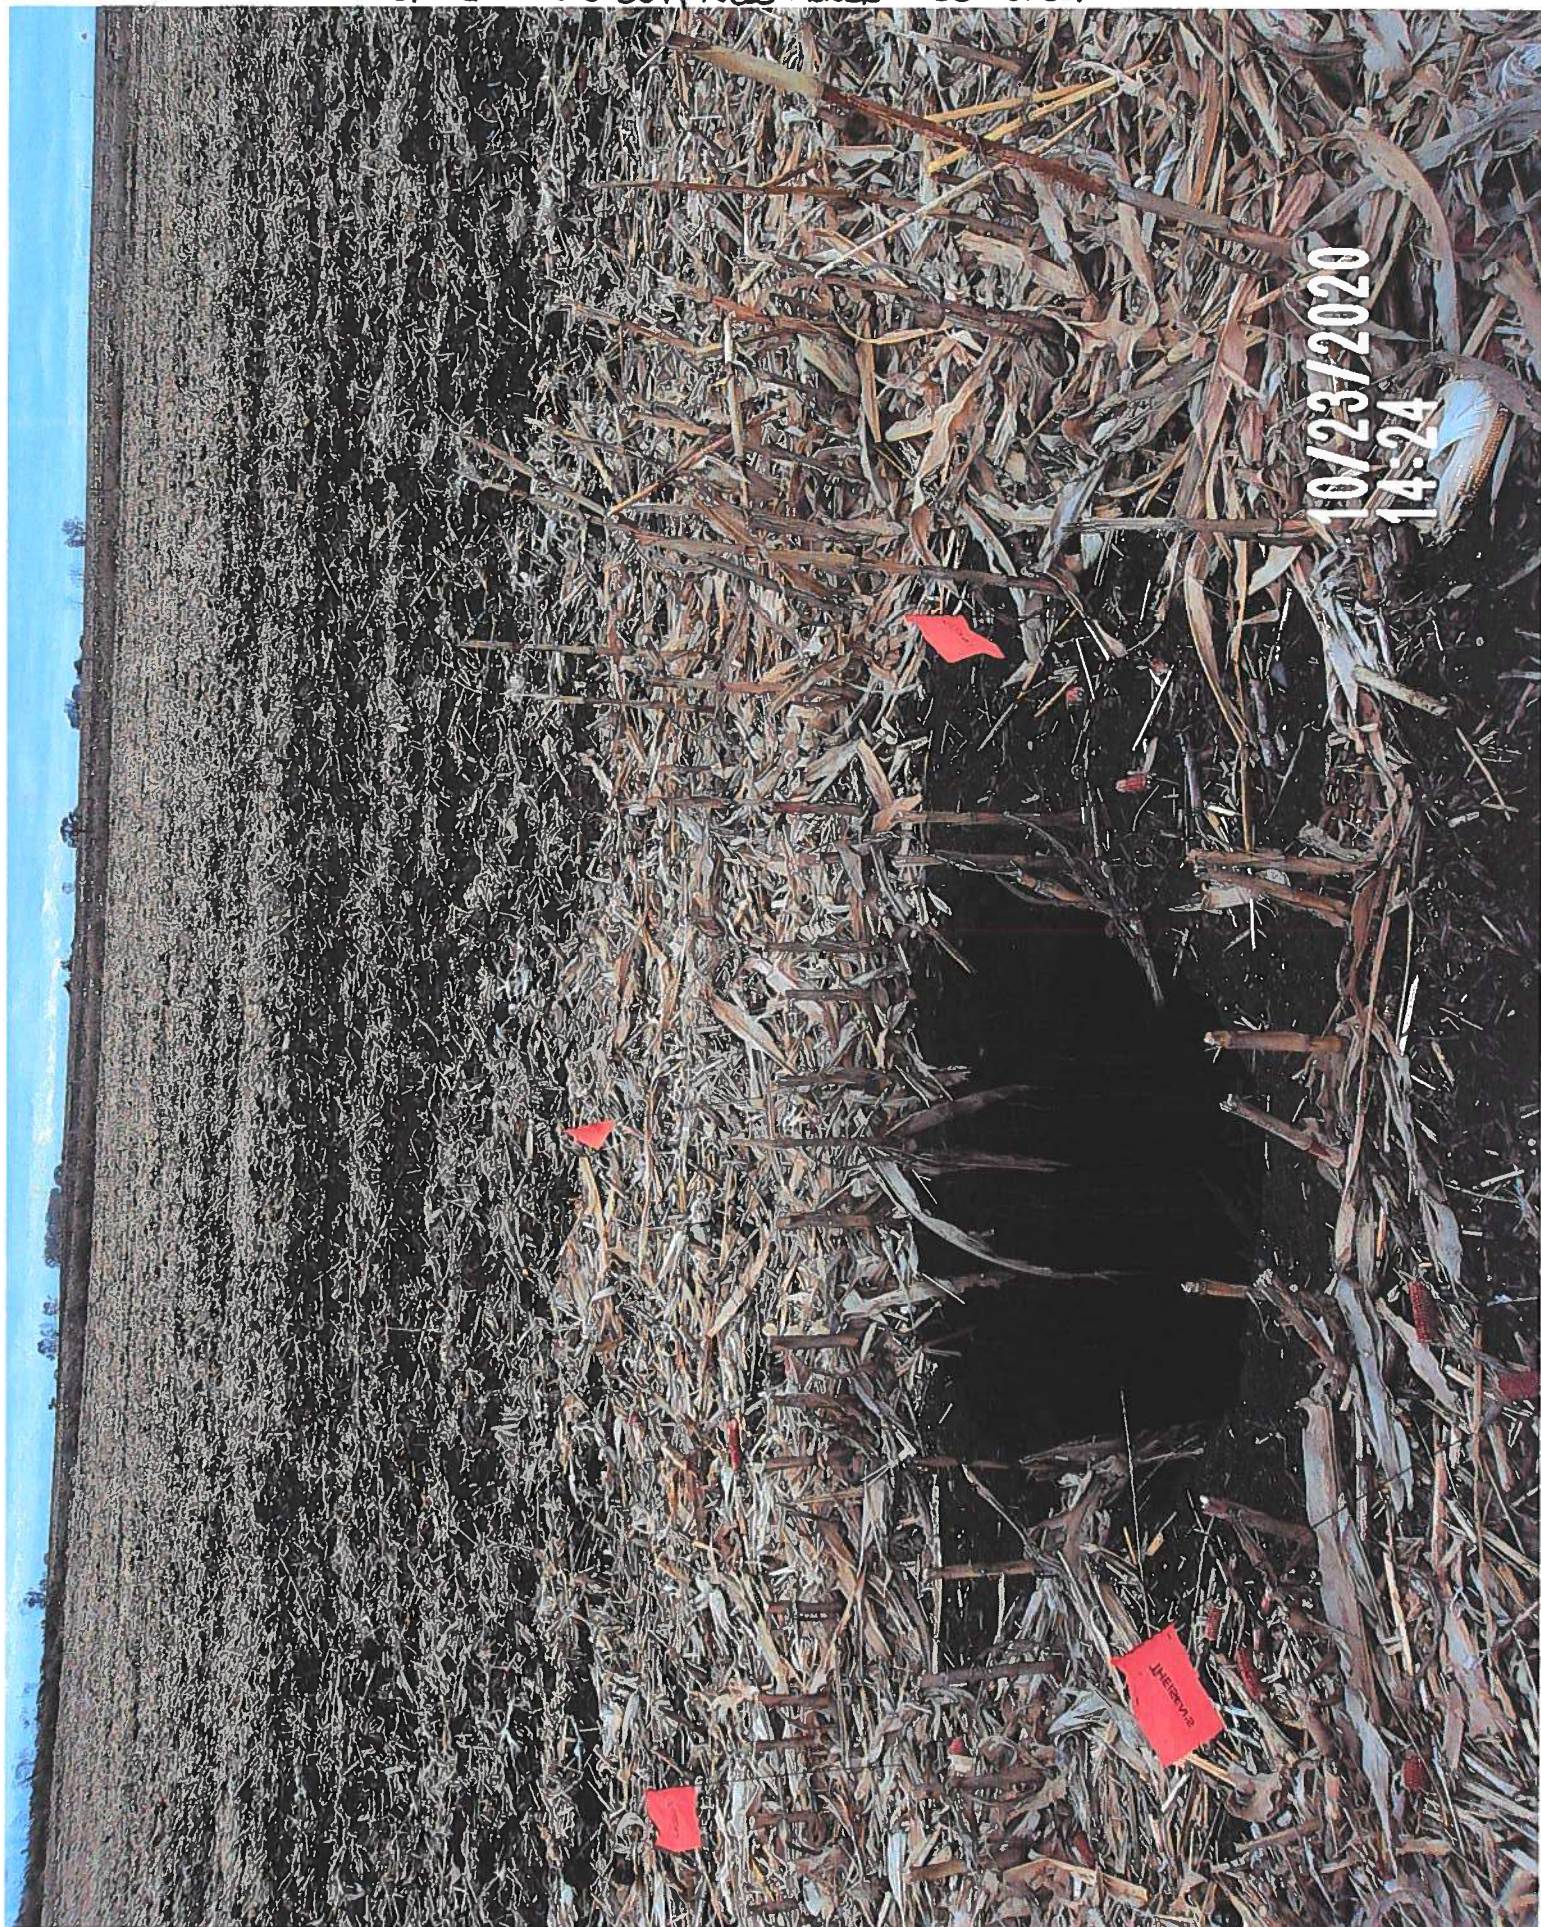
LOOKING WEST @ BLOW-OUT, NEW FENCE 200' WEST IN BACK GROUND

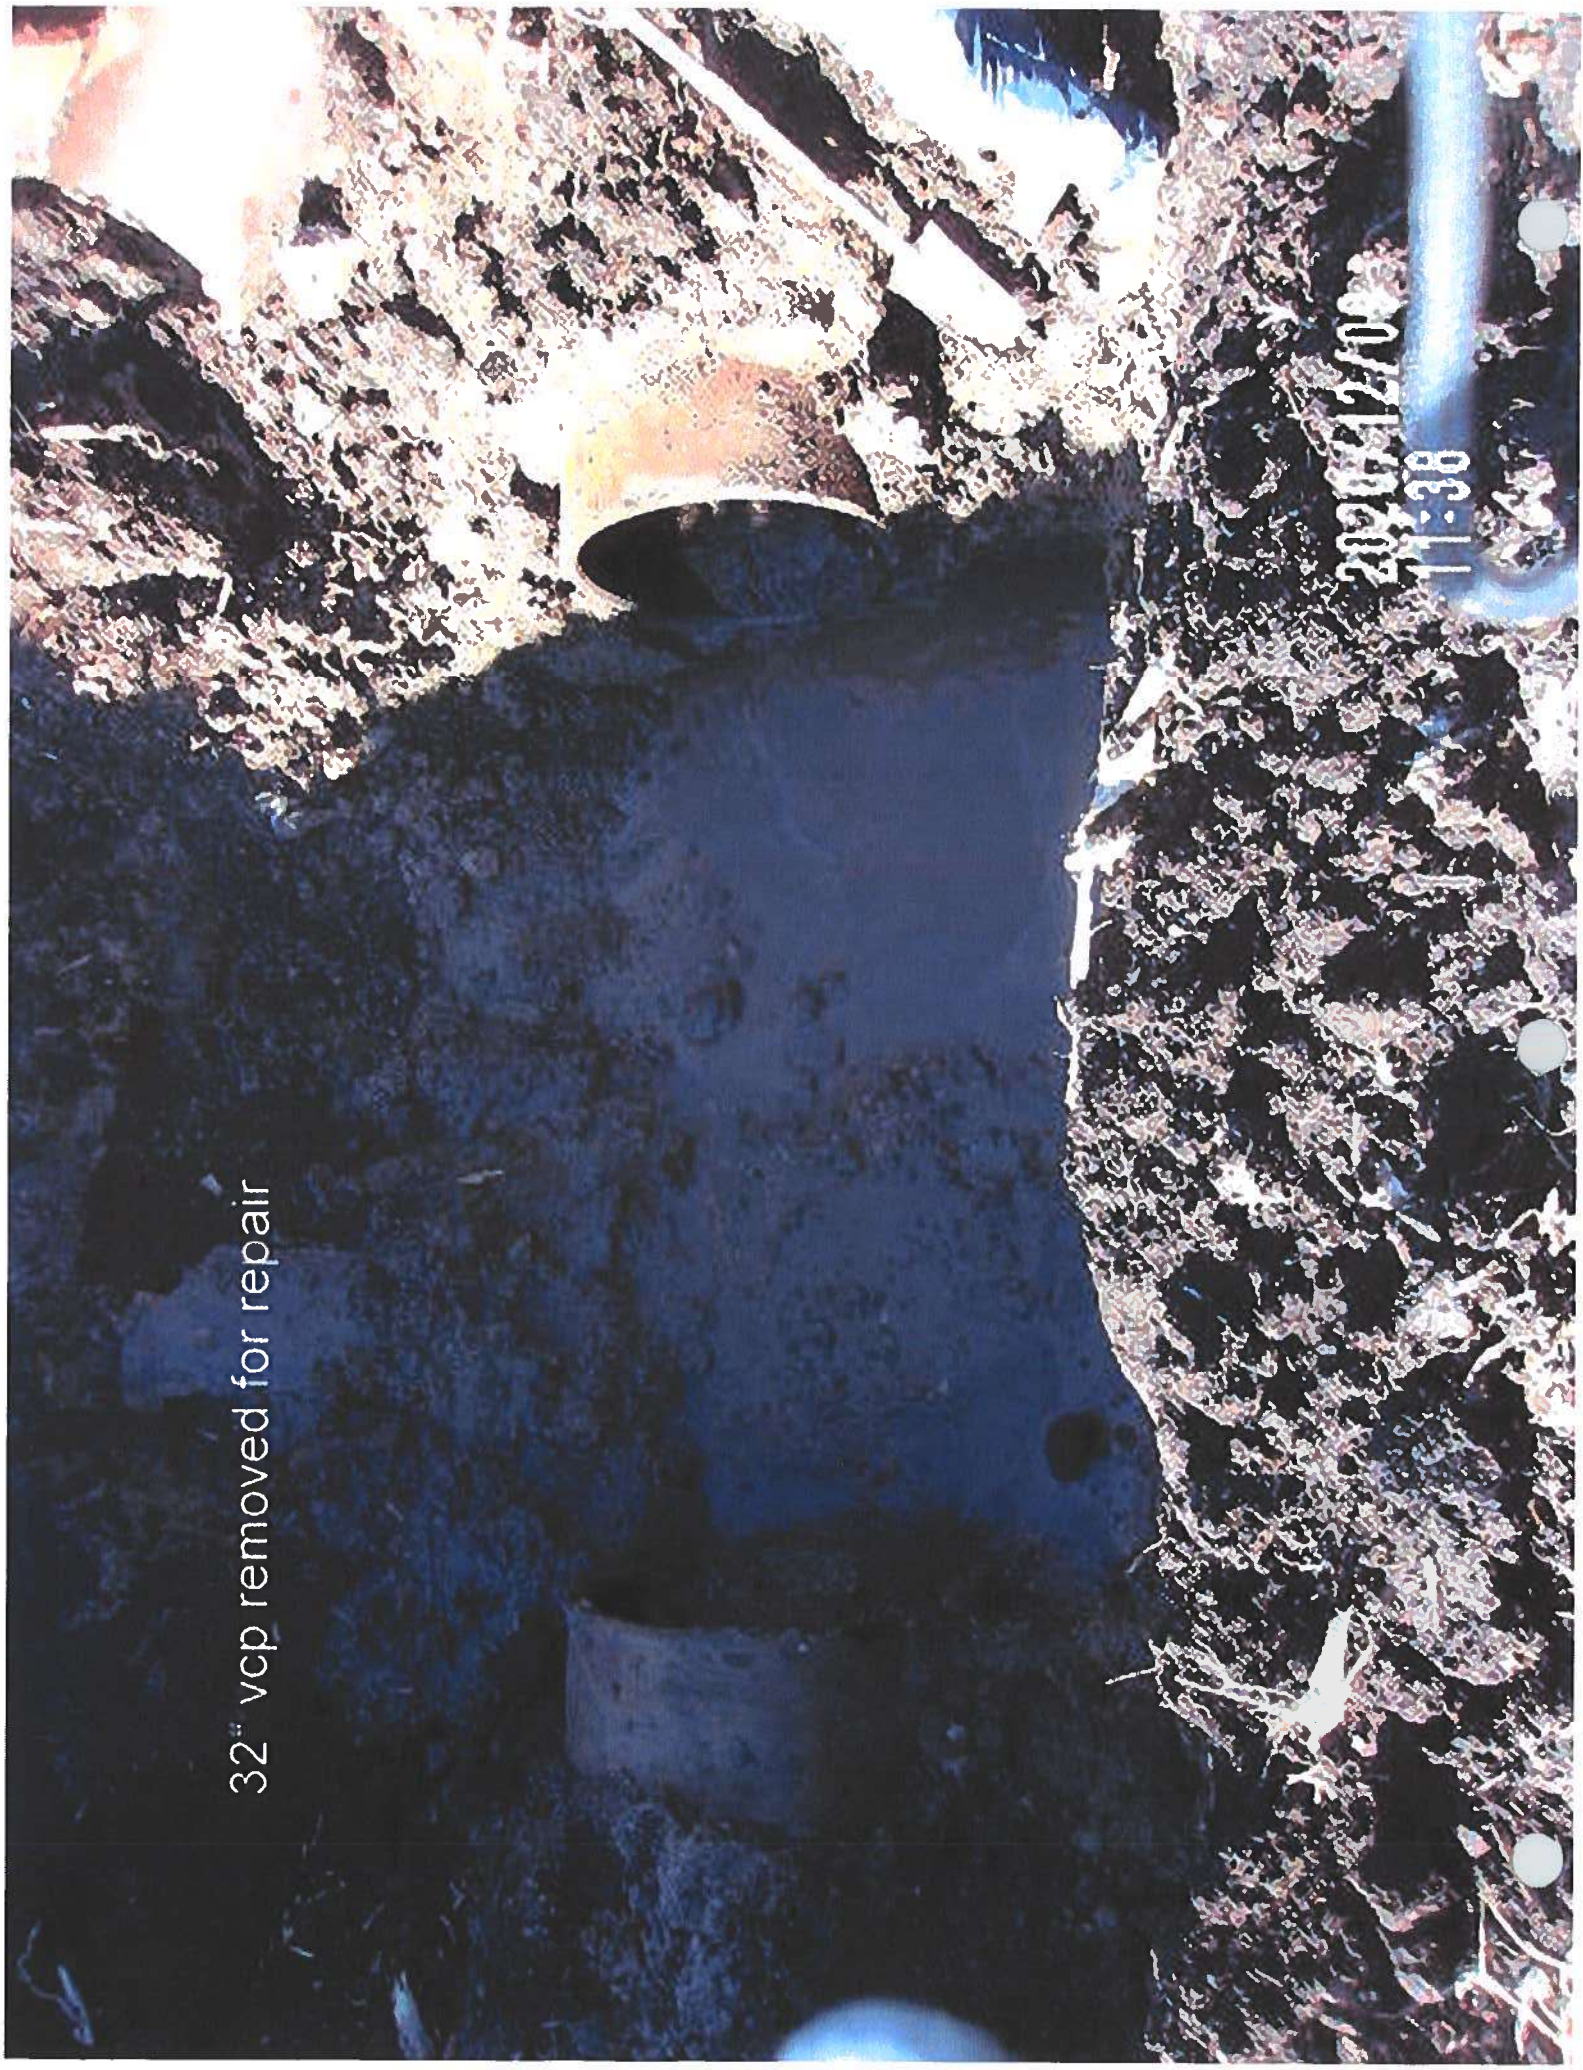
32" vcp removed for repair

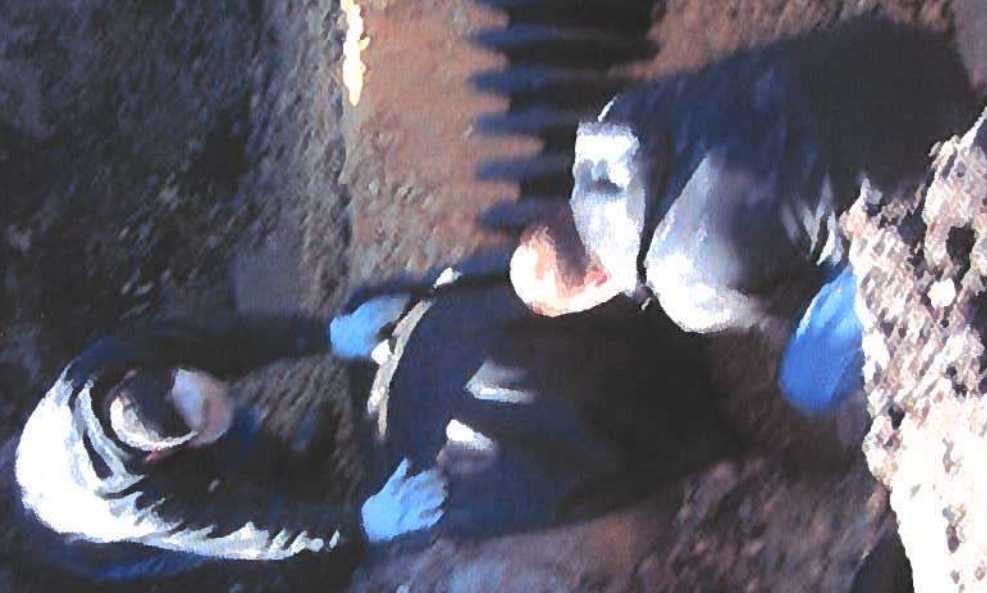
Placing fabric over joints  
for concrete collars
