**AGENDA**  
**REGULAR DRAINAGE MEETING**  
**Wednesday, January 20, 2021 9:30 AM**  
**Large Conference Room**

[DD 20 WO 302 - 6502.5 - INVESTIGATION-REPAIR SUMMARY 01\\_05\\_20.PDF](#)

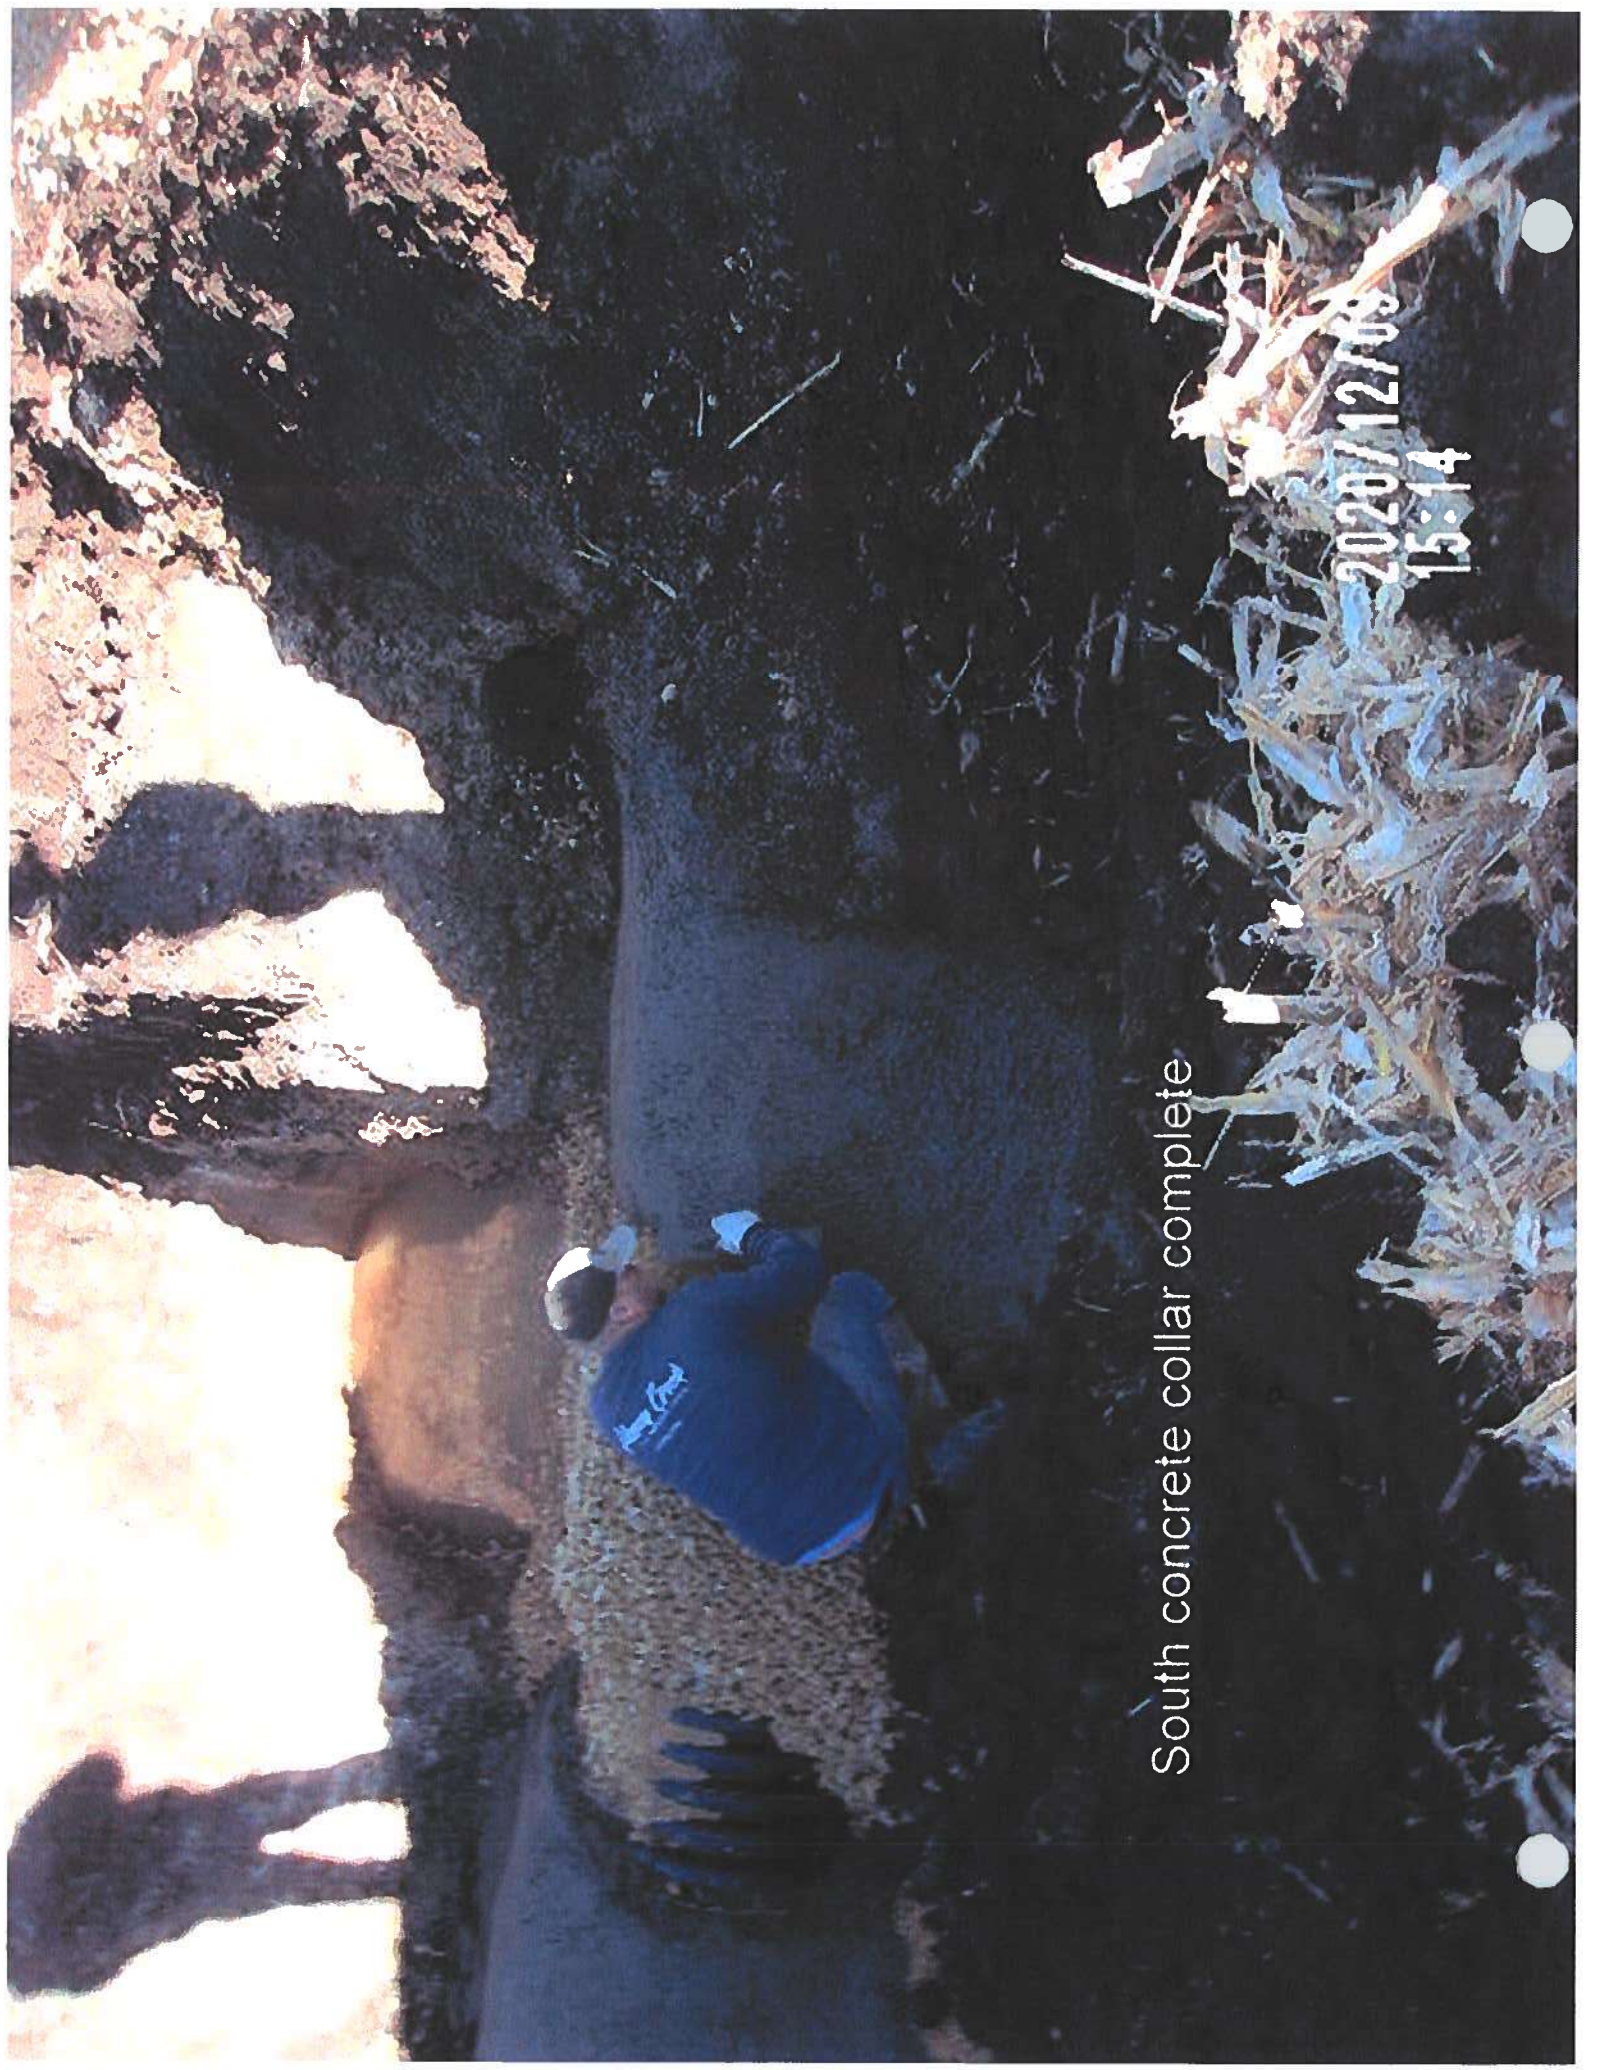
South concrete collar complete

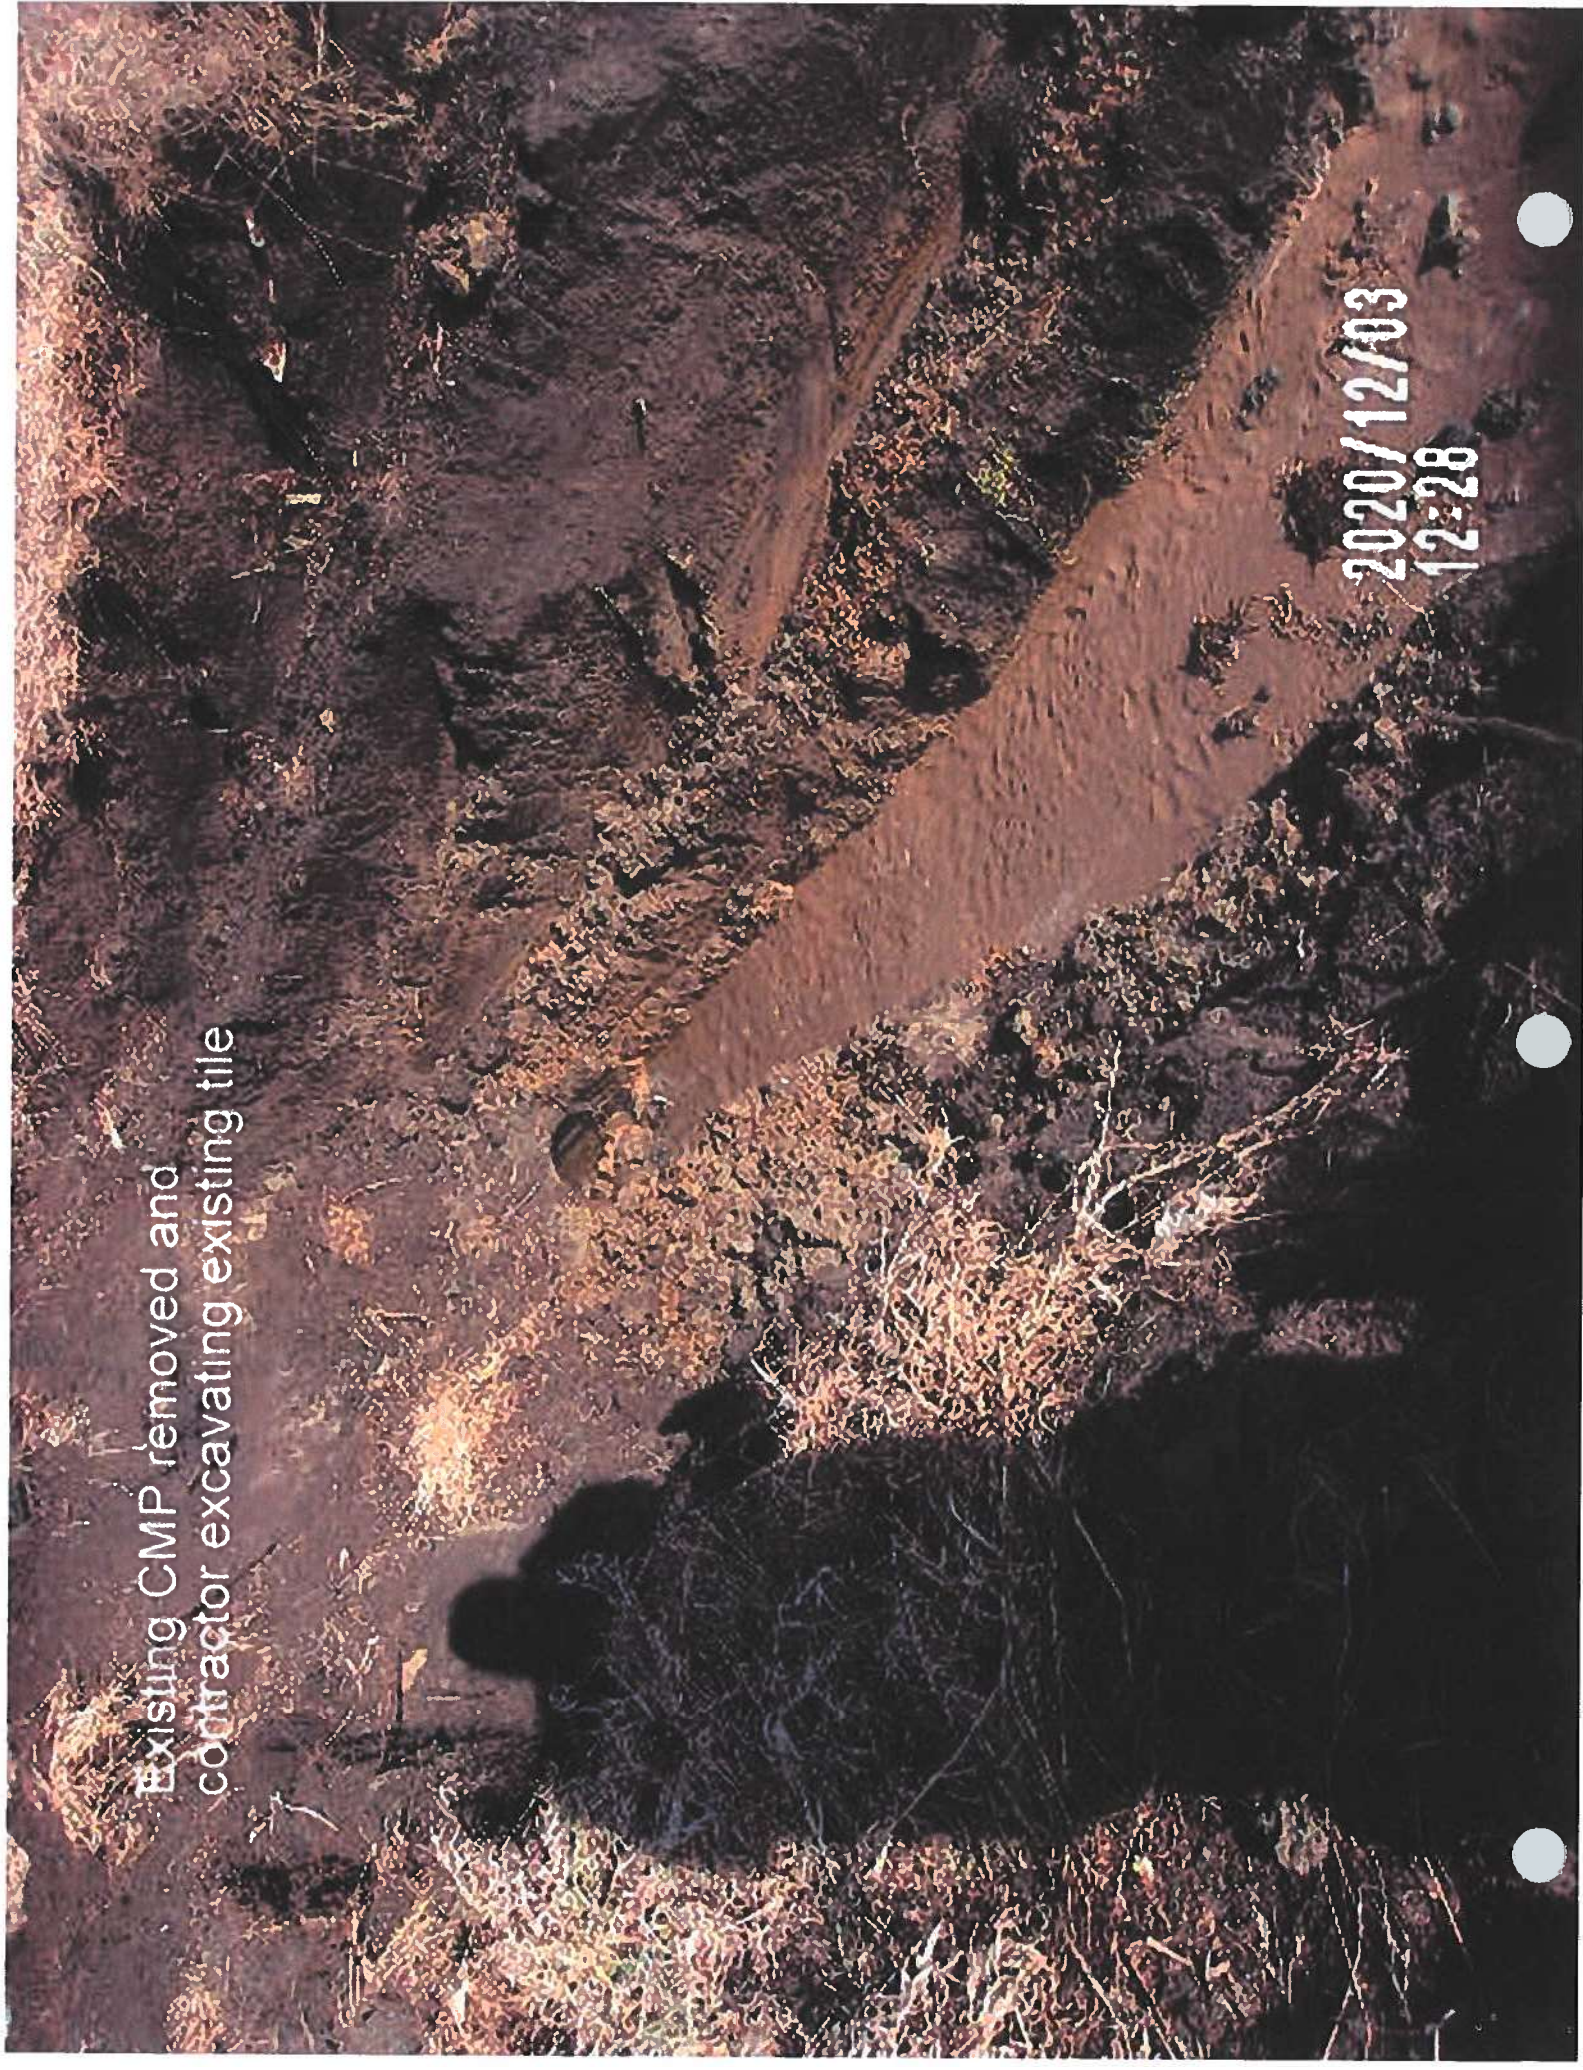
Existing CMP removed and  
contractor excavating existing tile

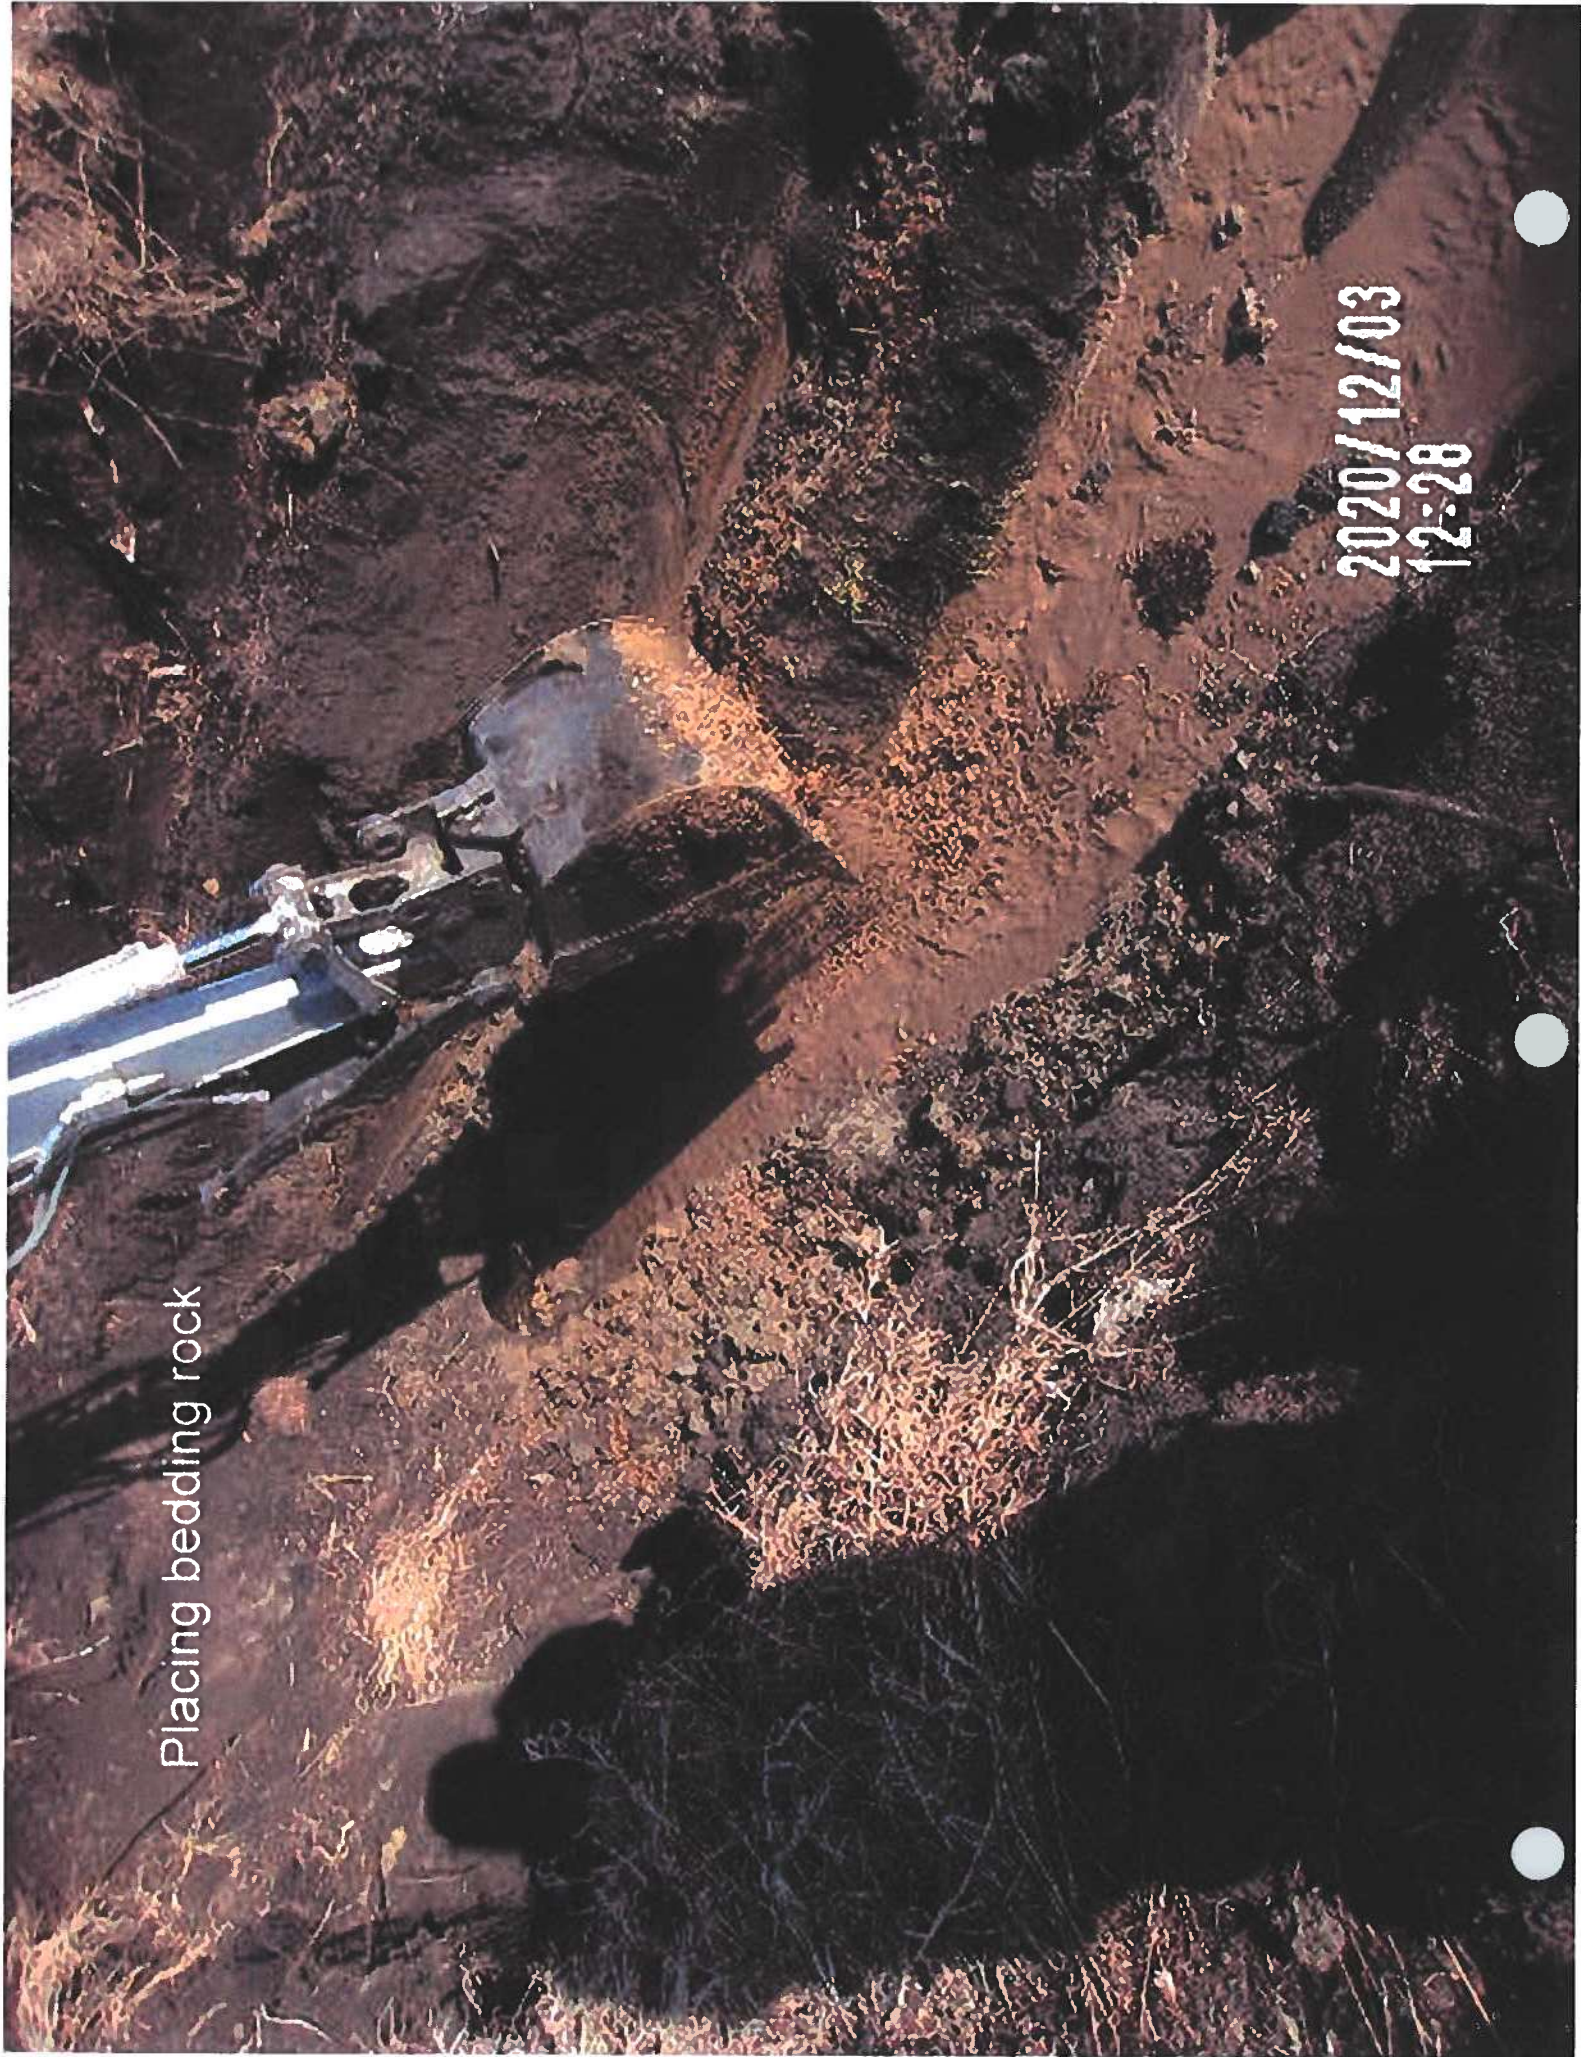
Placing bedding rock

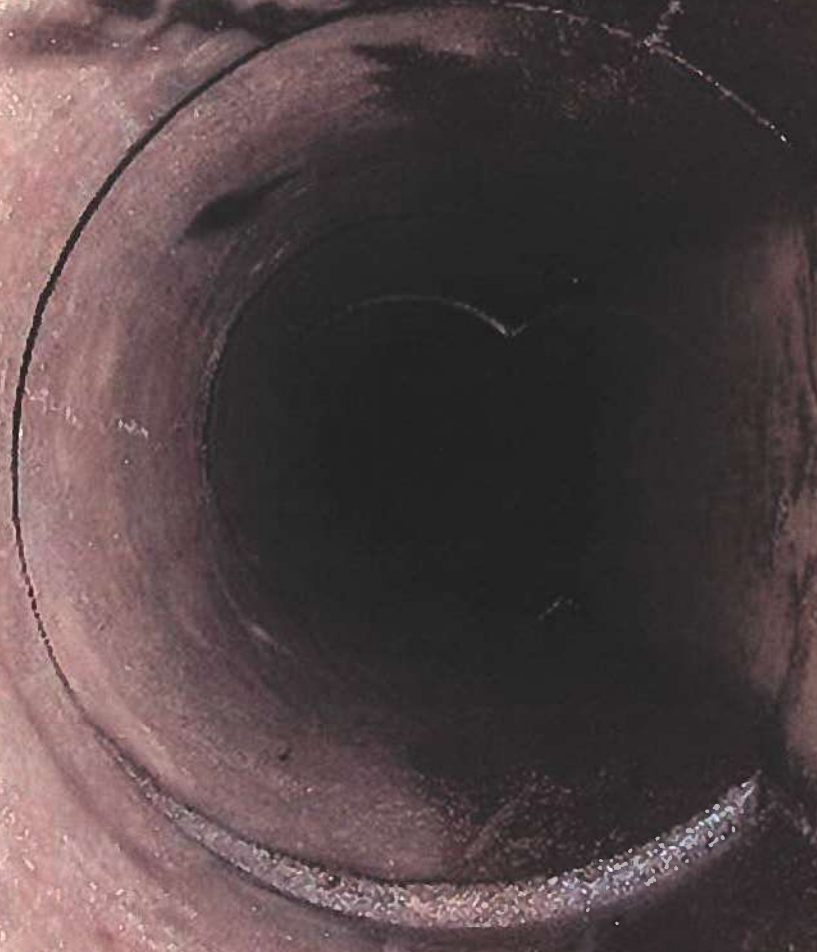
Inside of concrete pipe looking North

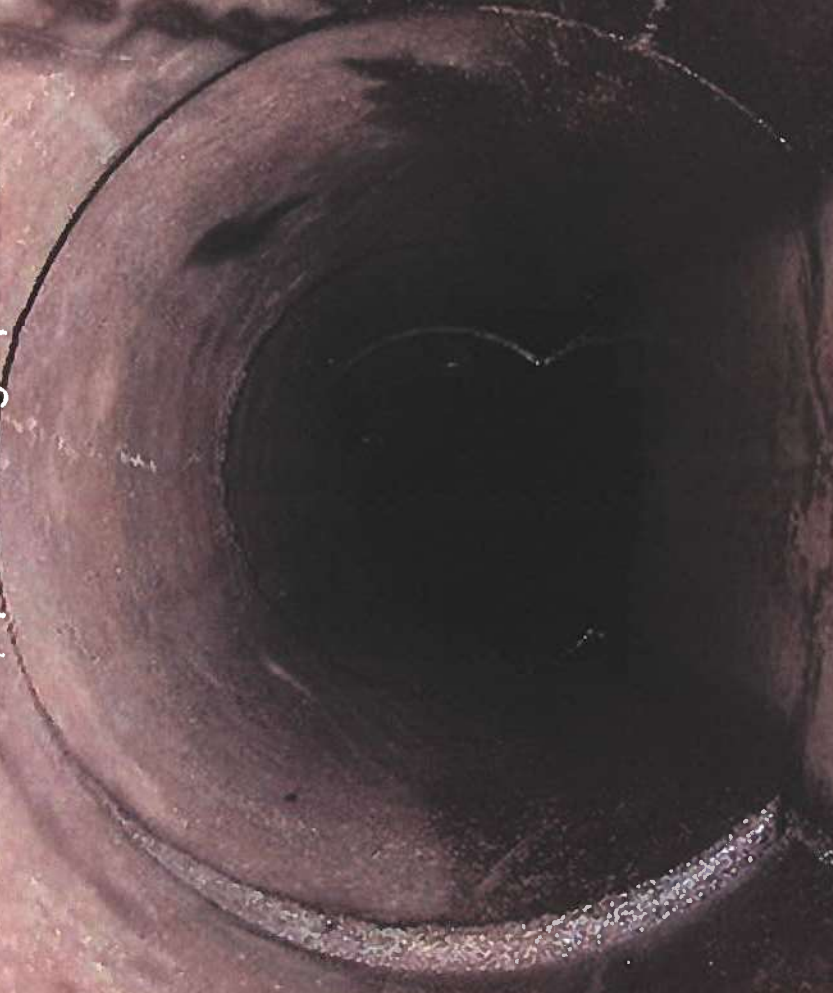
Inside of 18" concrete pipe-looking upstream

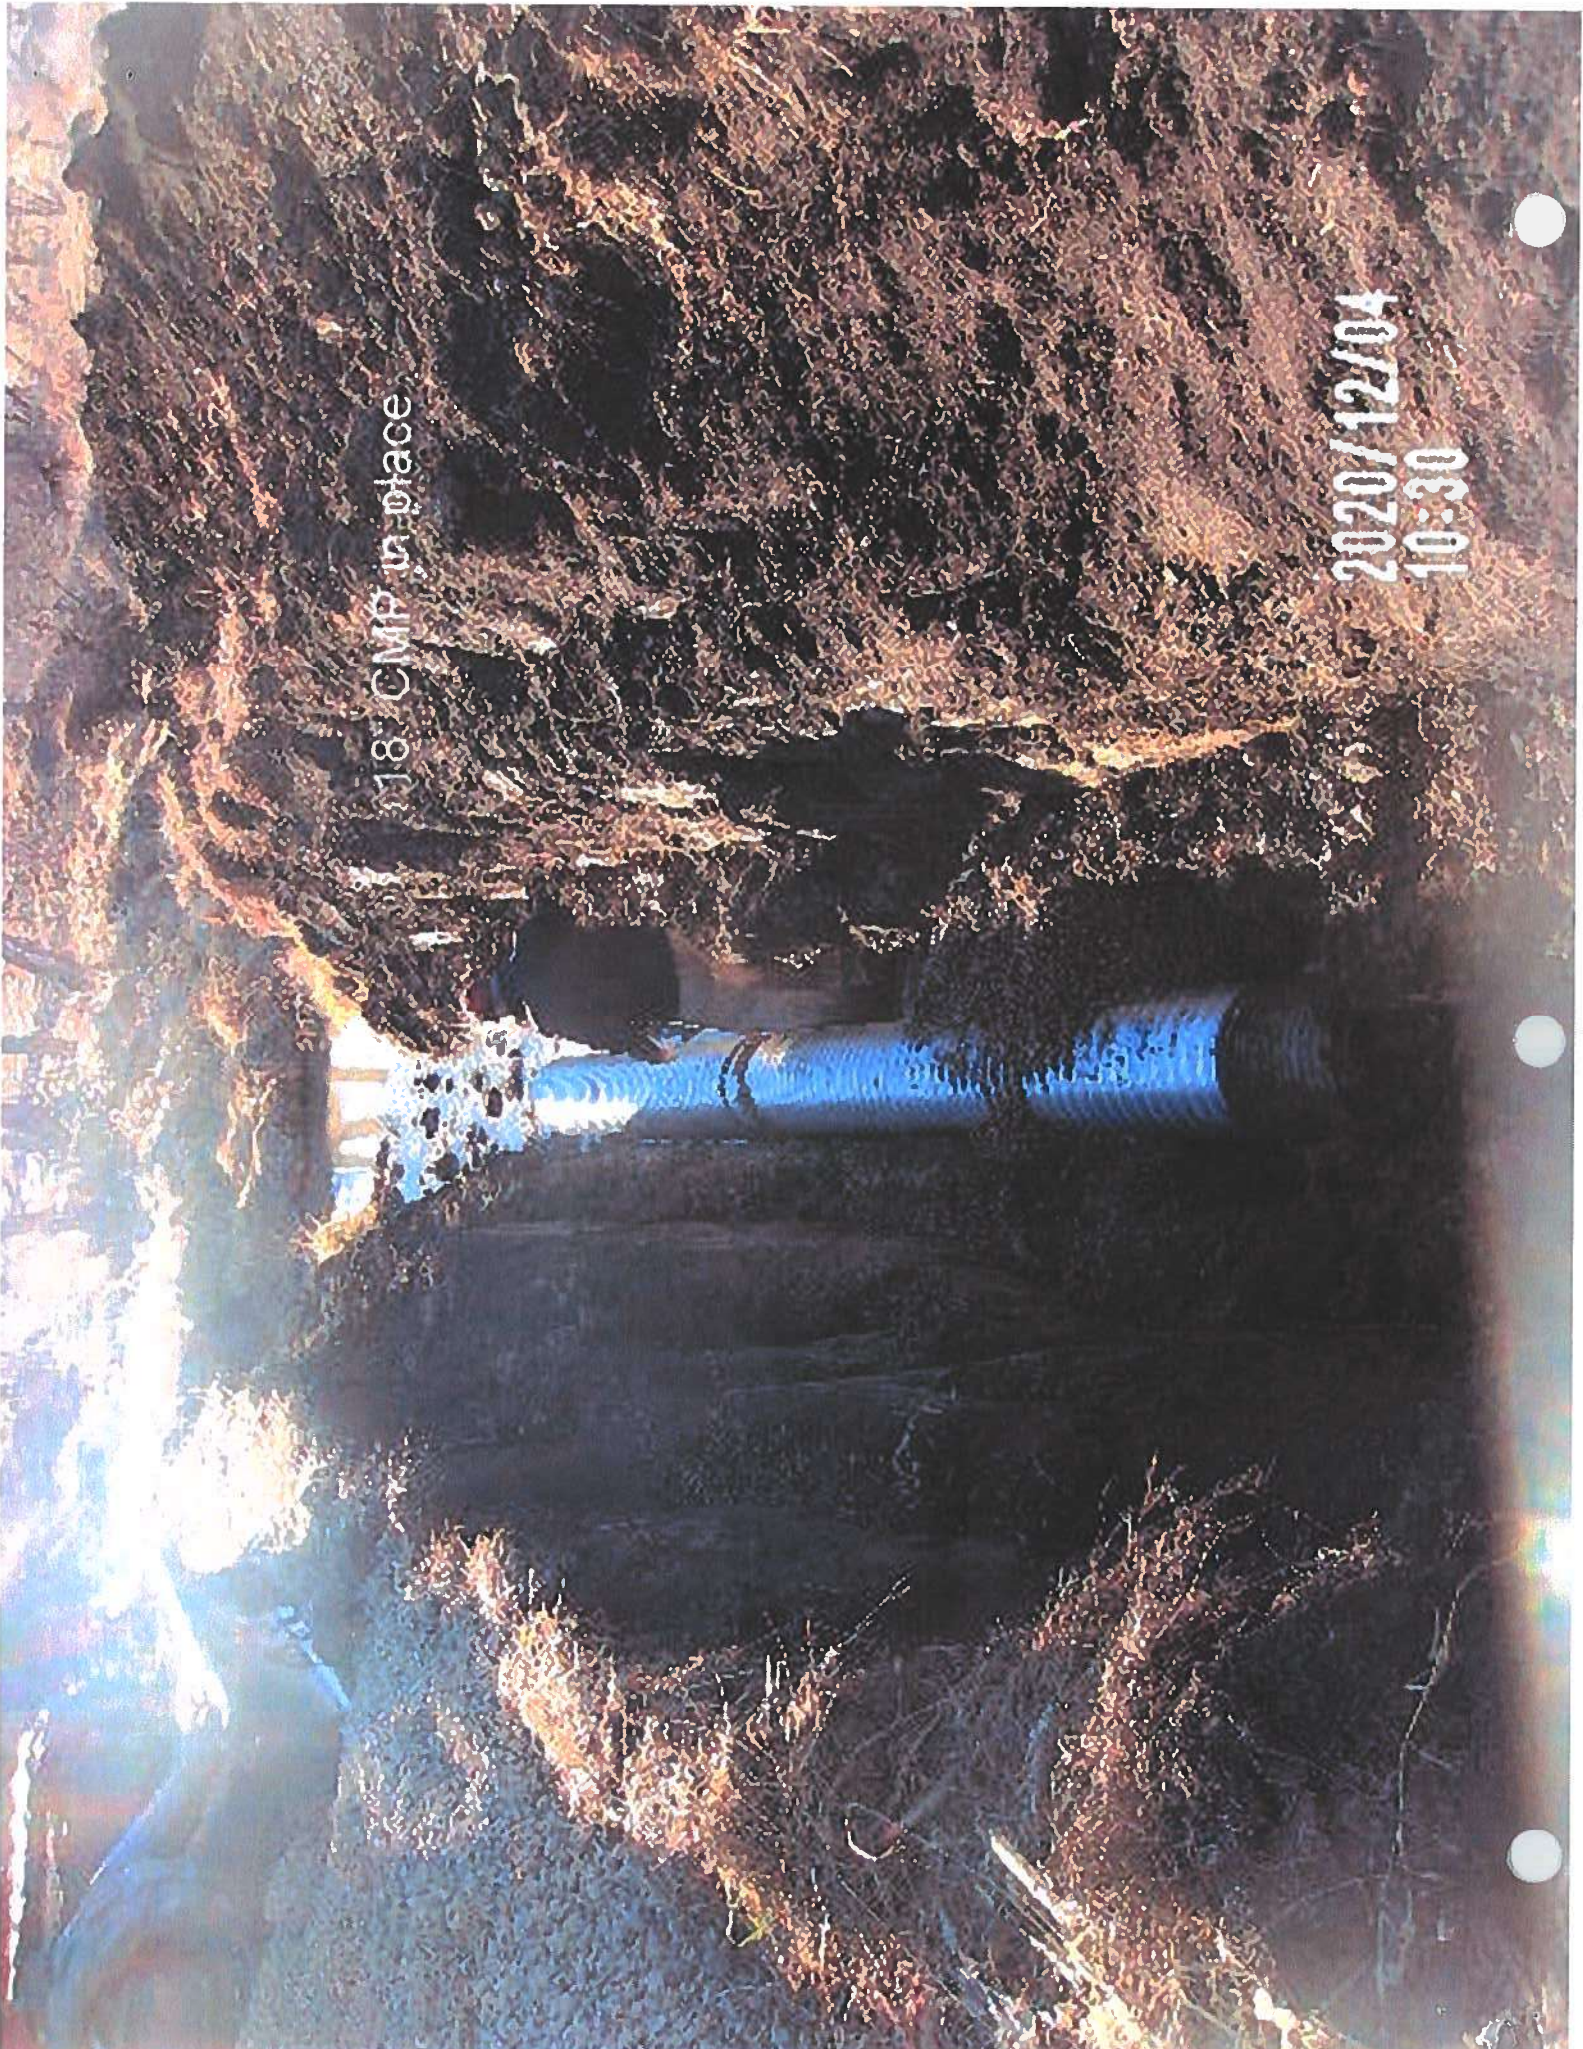
18' CMP in place

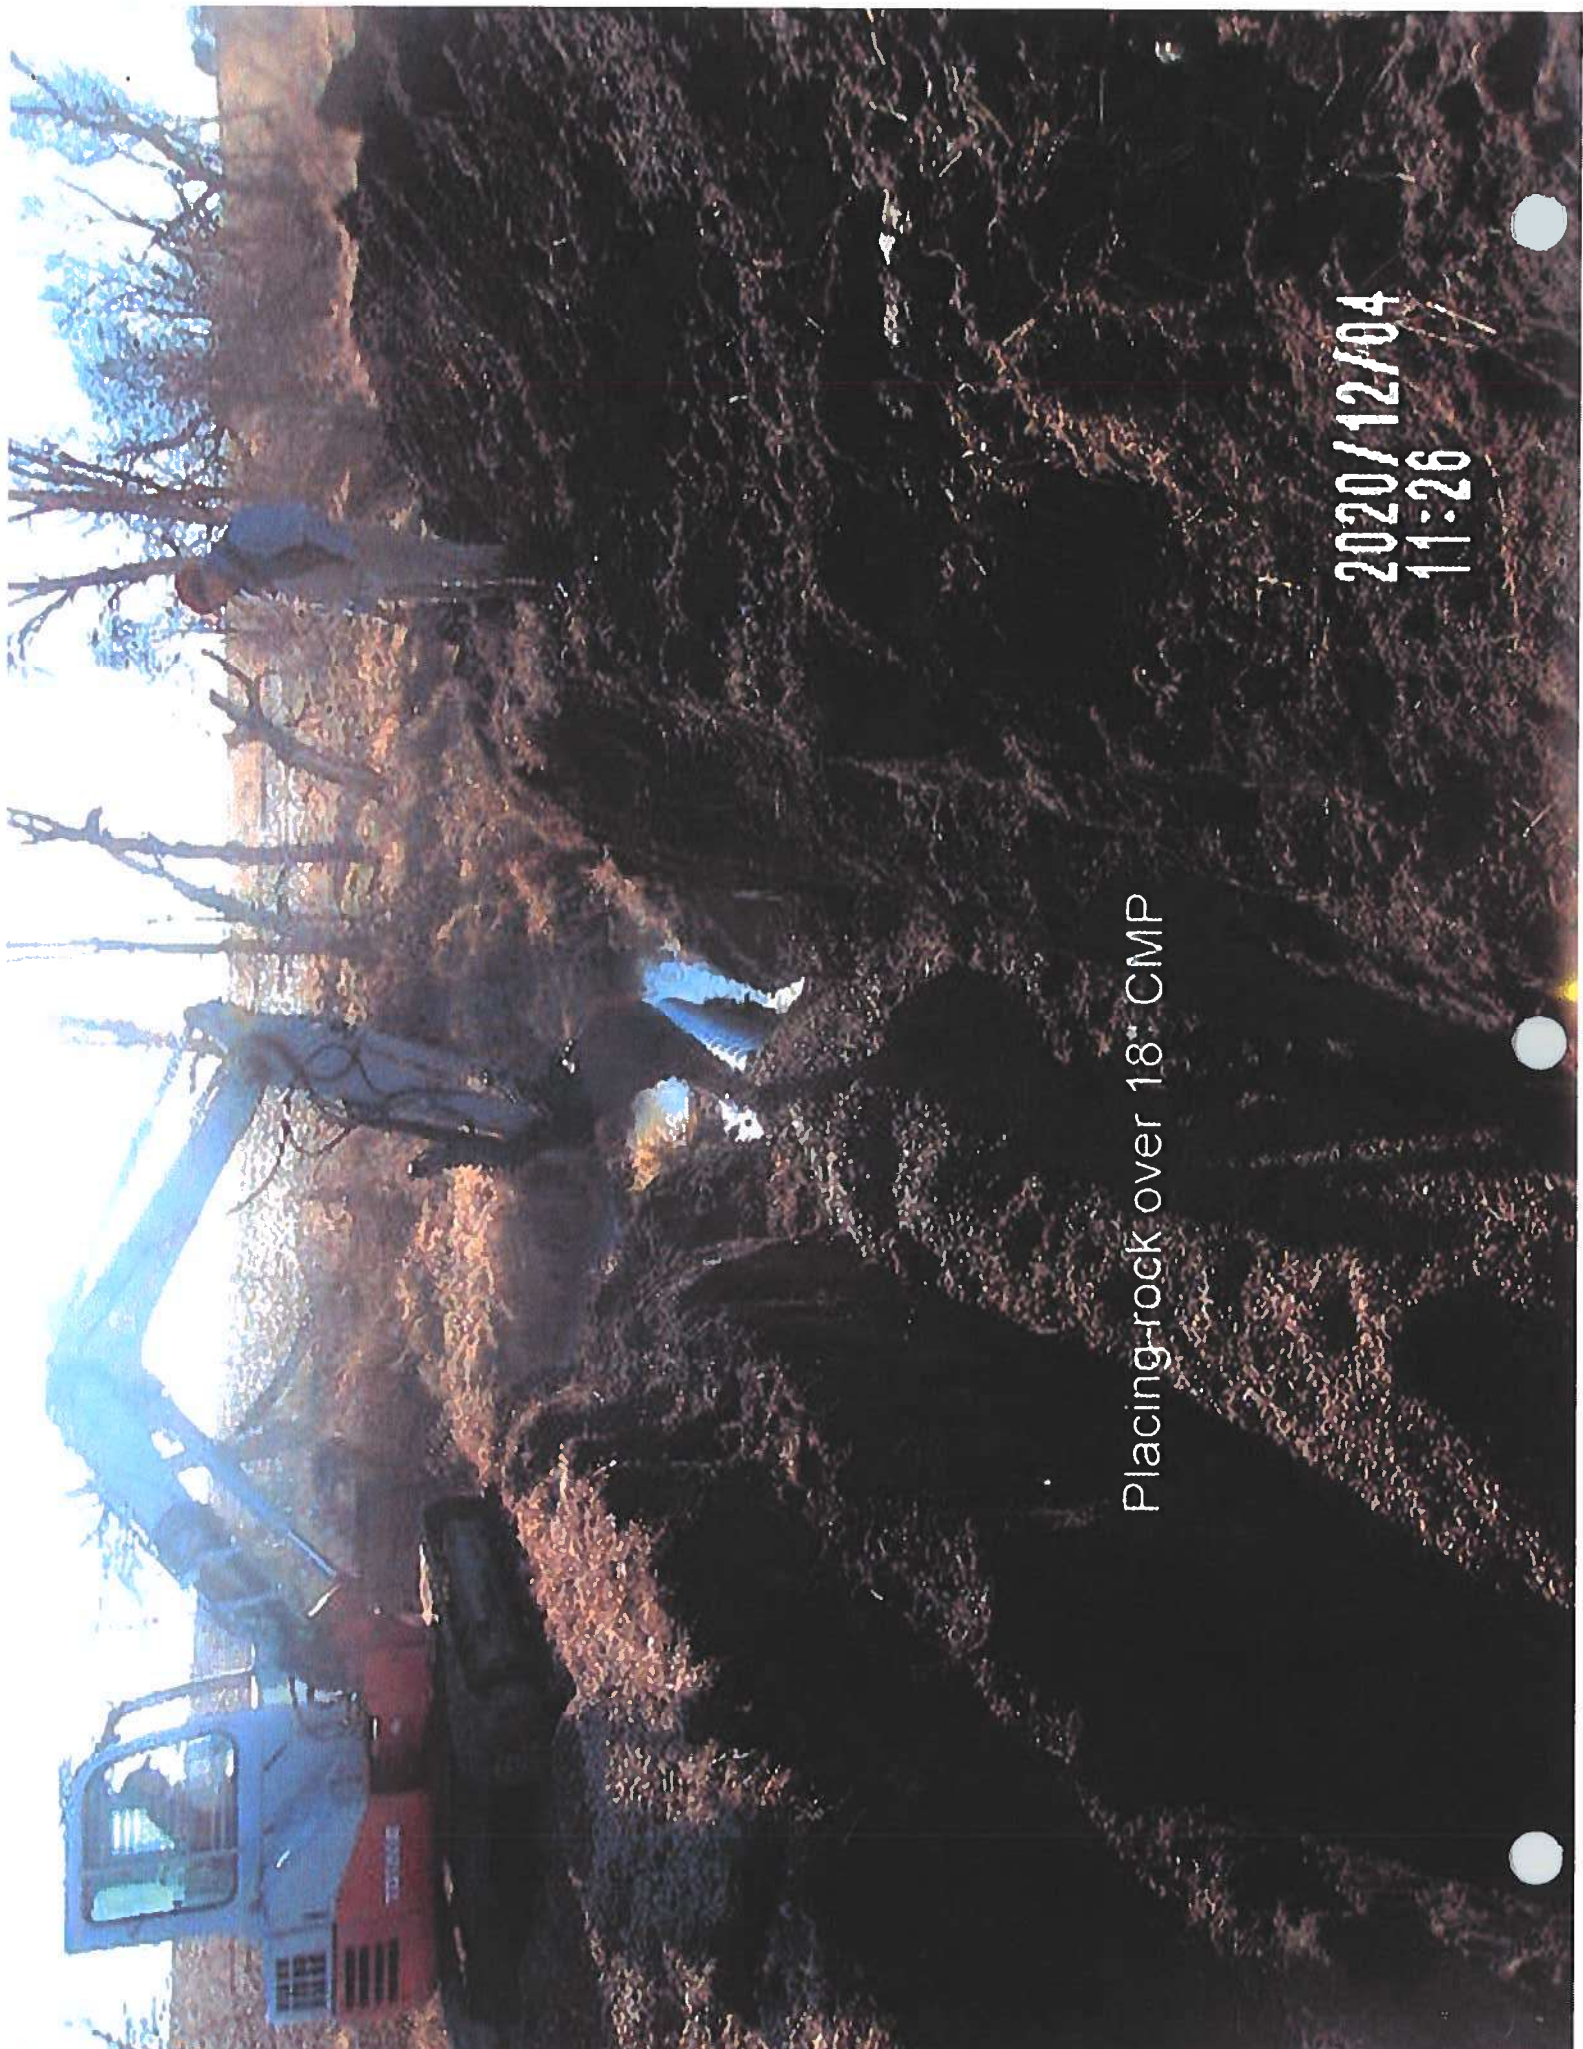
Placing rock over 18' CMP

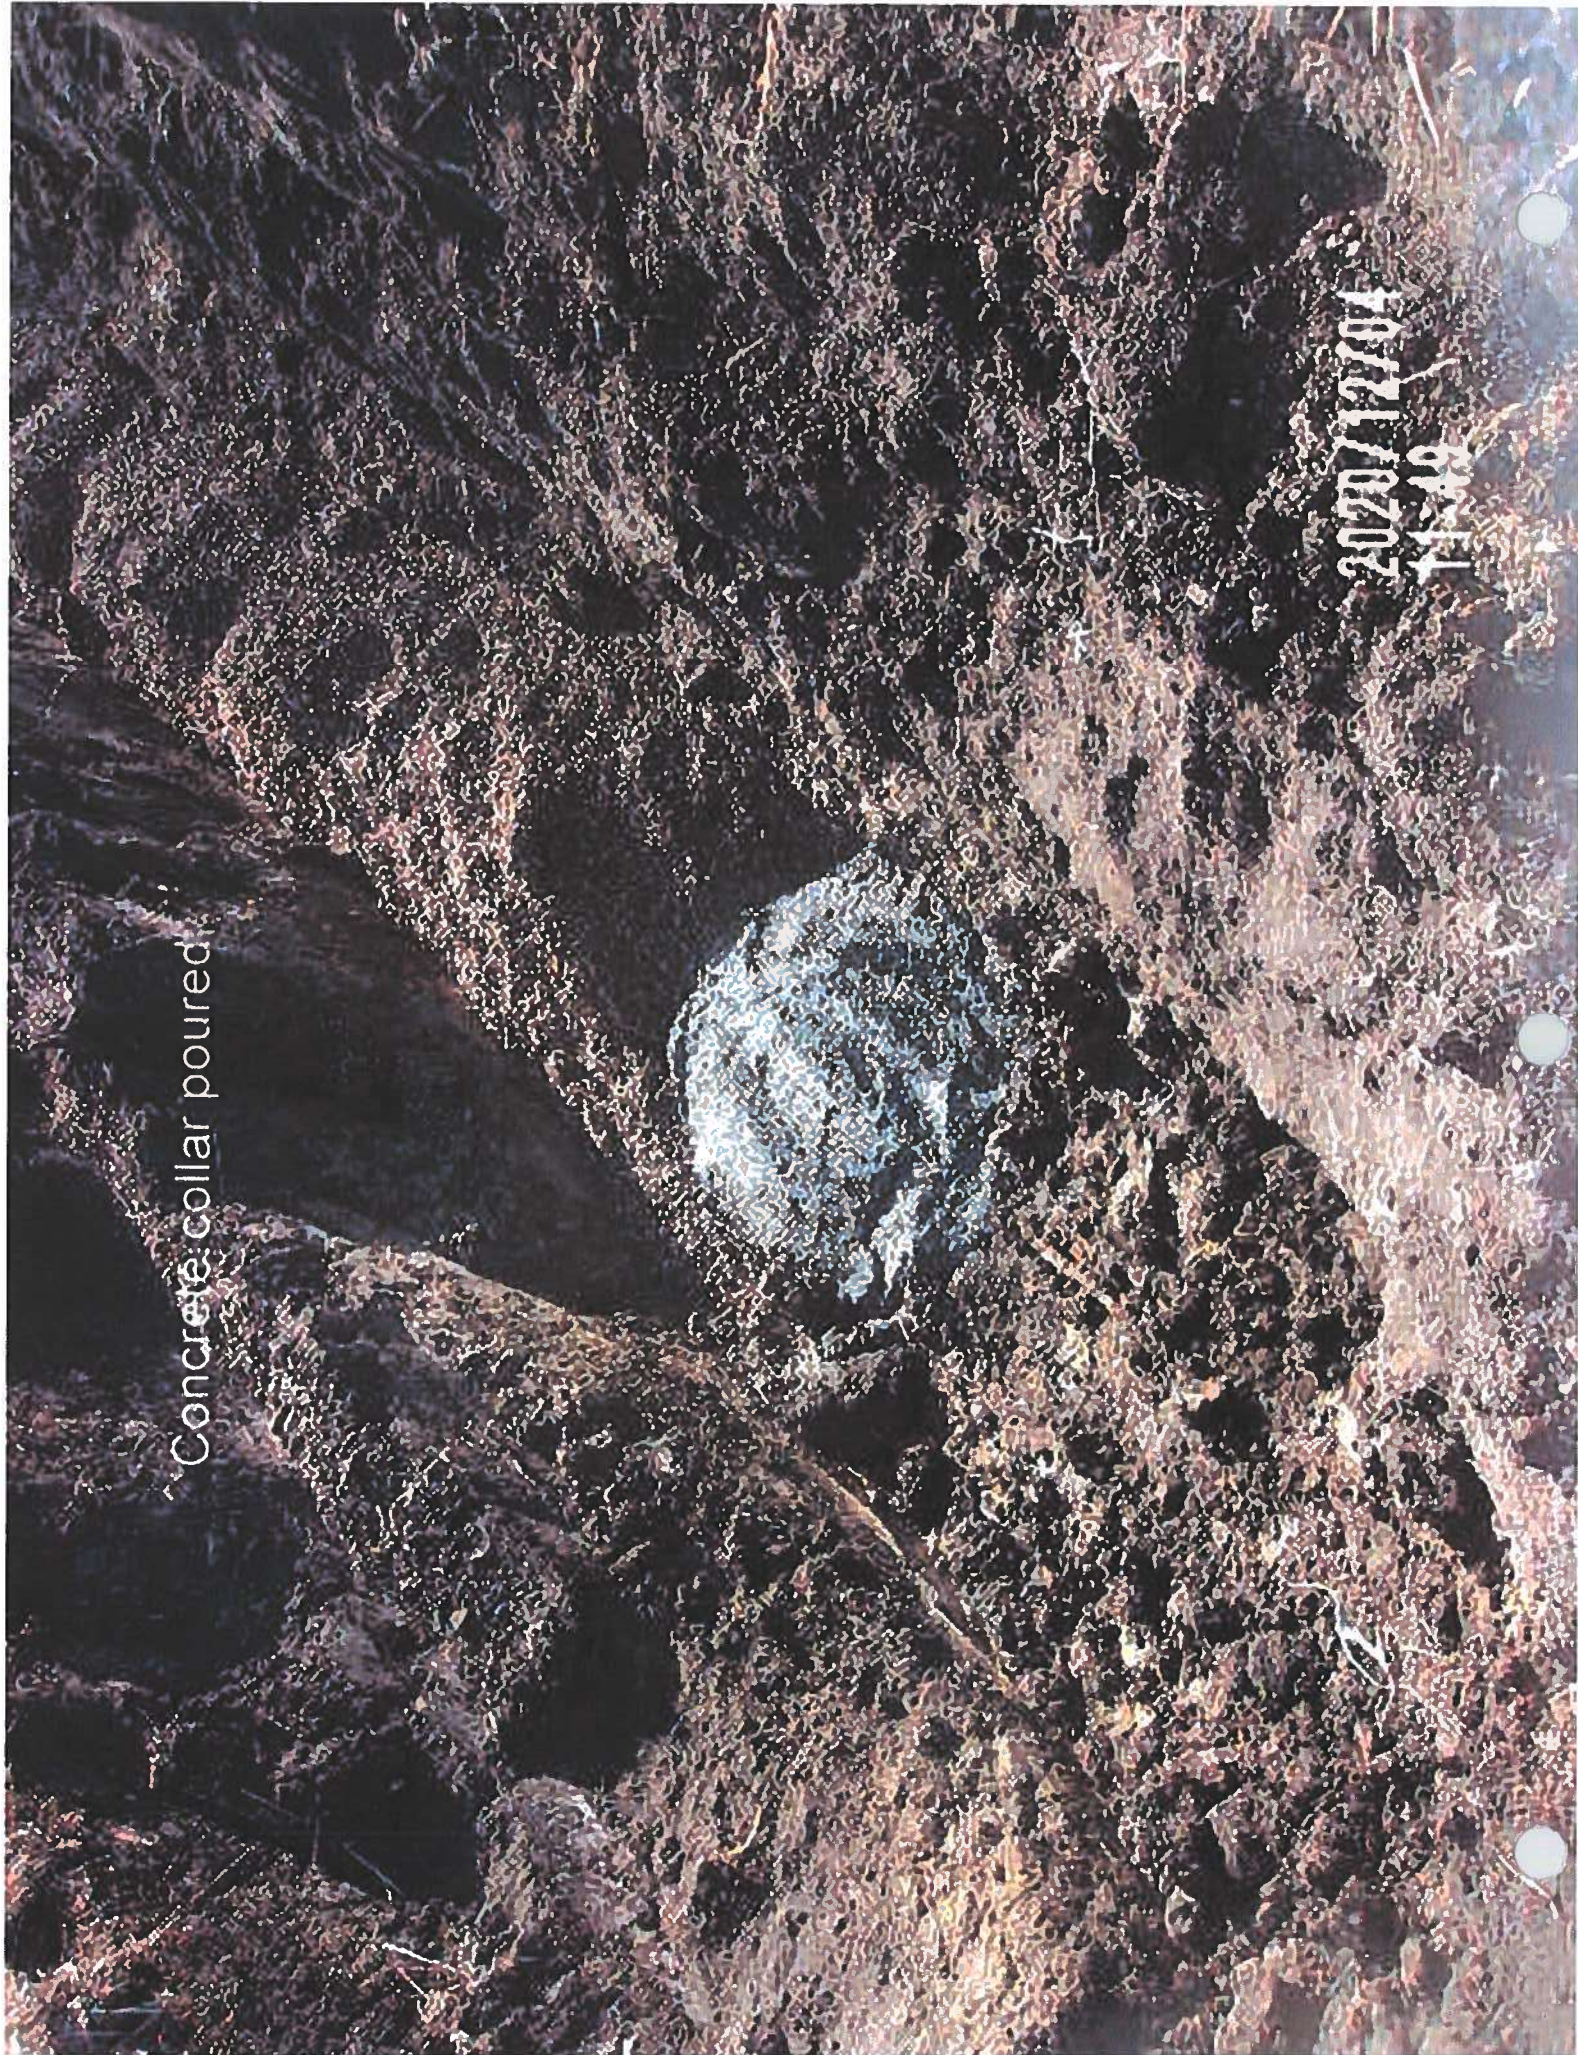
Concrete collar poured
