**AGENDA**  
**REGULAR DRAINAGE MEETING**  
**Wednesday, January 20, 2021 9:30 AM**  
**Large Conference Room**

[DD 20 WO 302 - 6502.5 - INVESTIGATION-REPAIR SUMMARY 01\\_05\\_20.PDF](#)

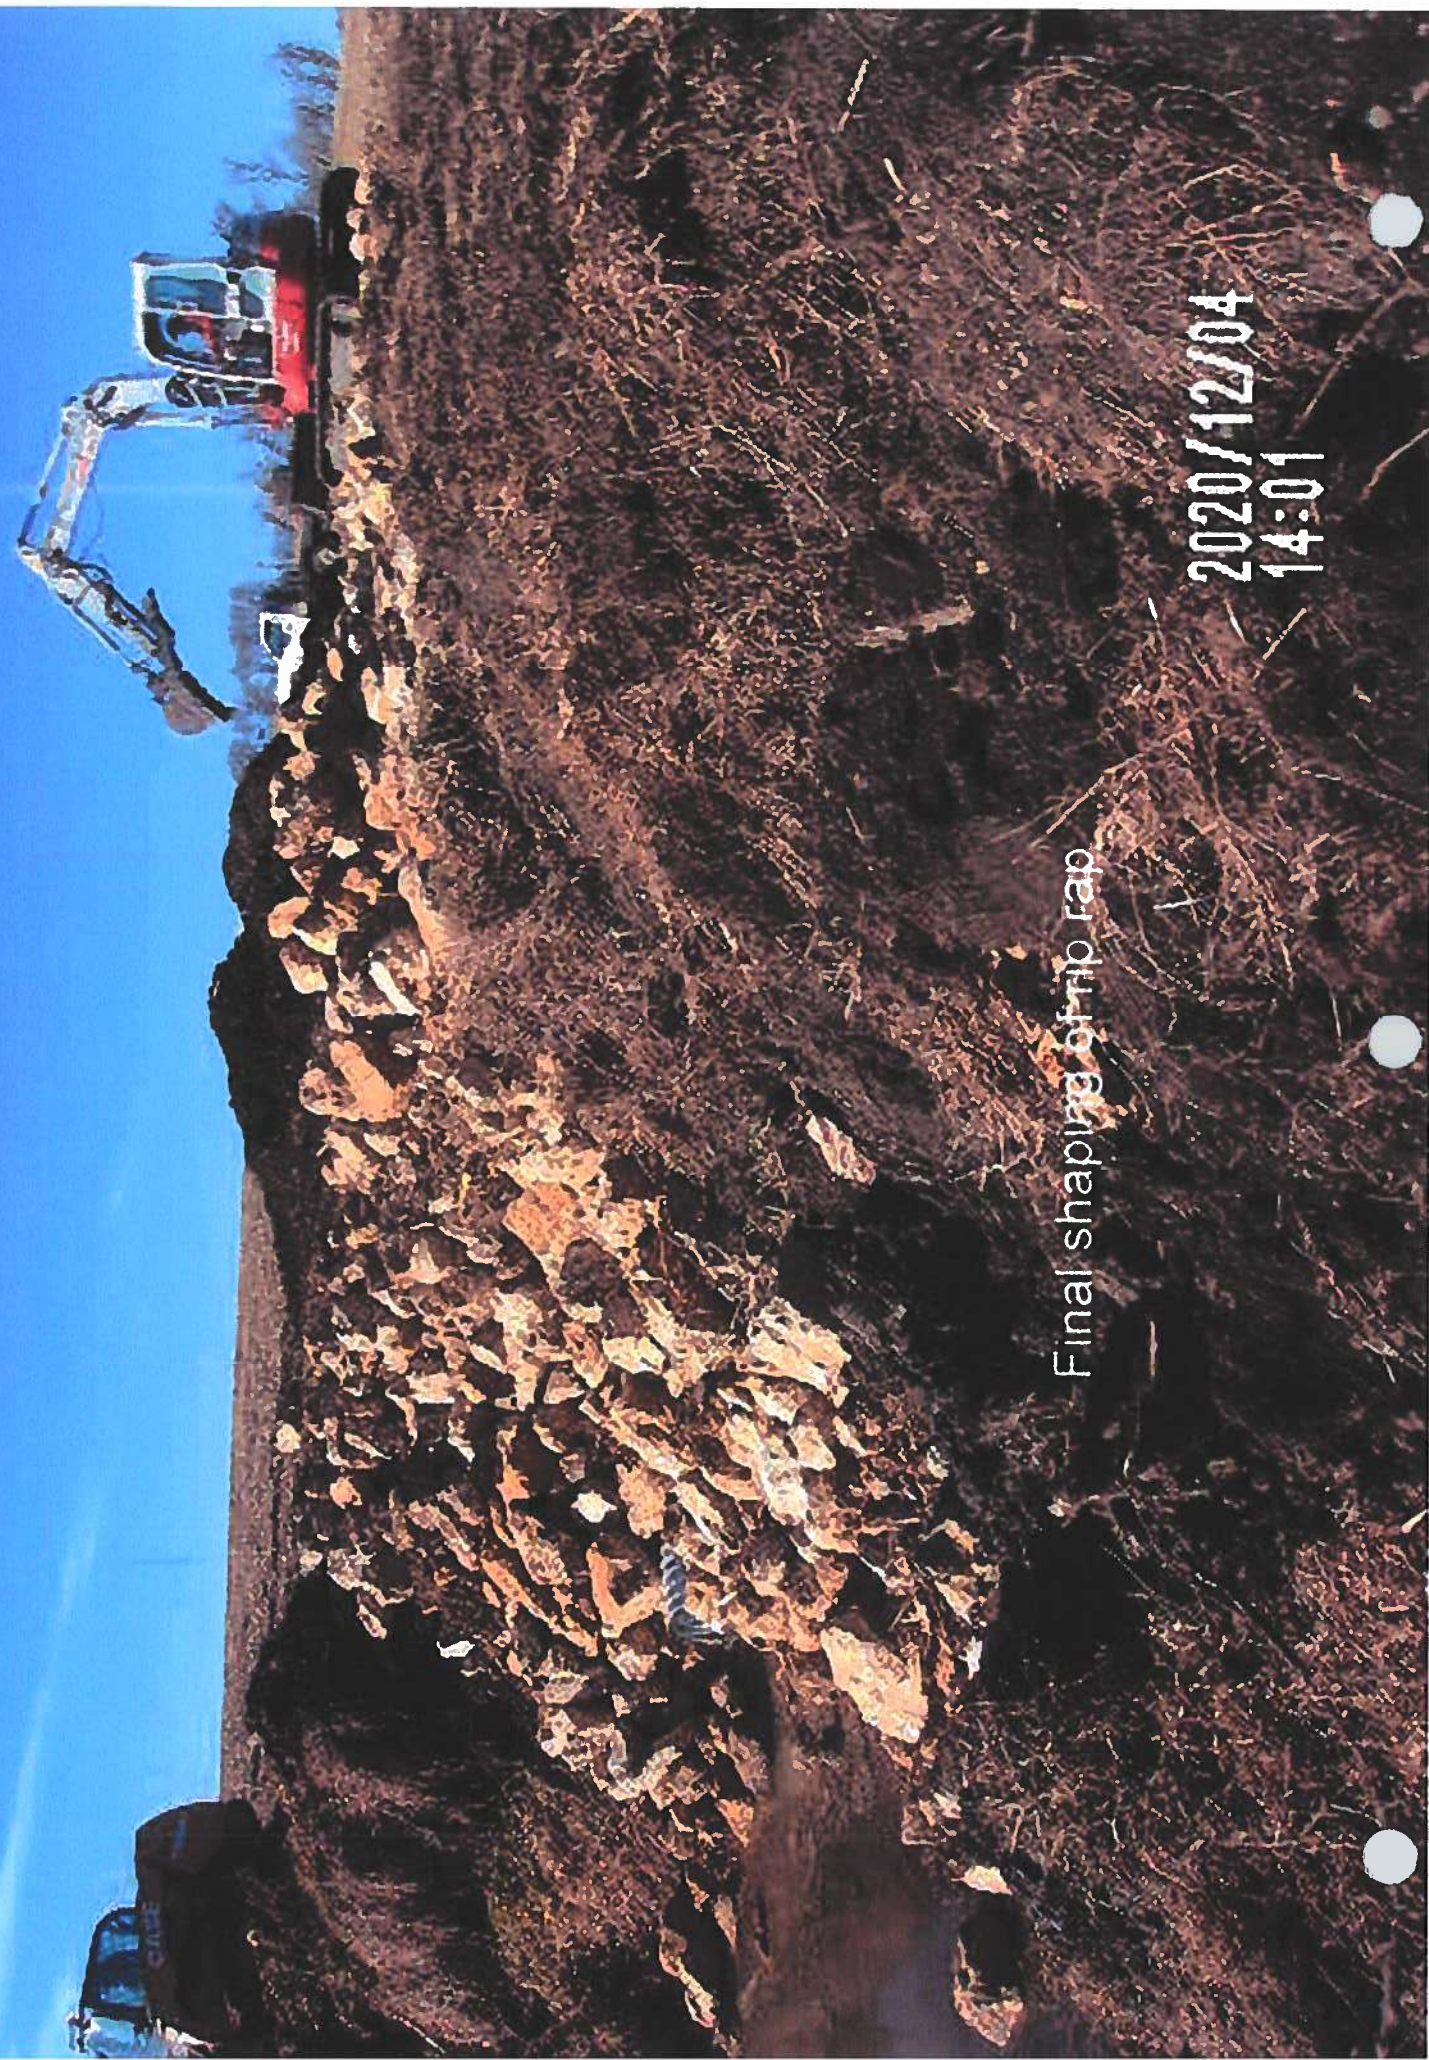
Class E rip-rap installed

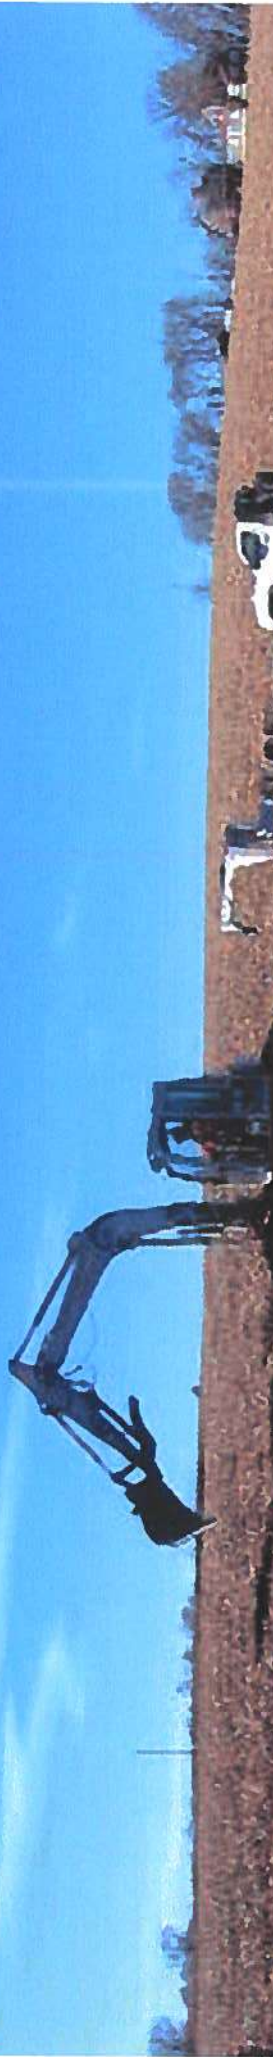
Final shaping of rip rap

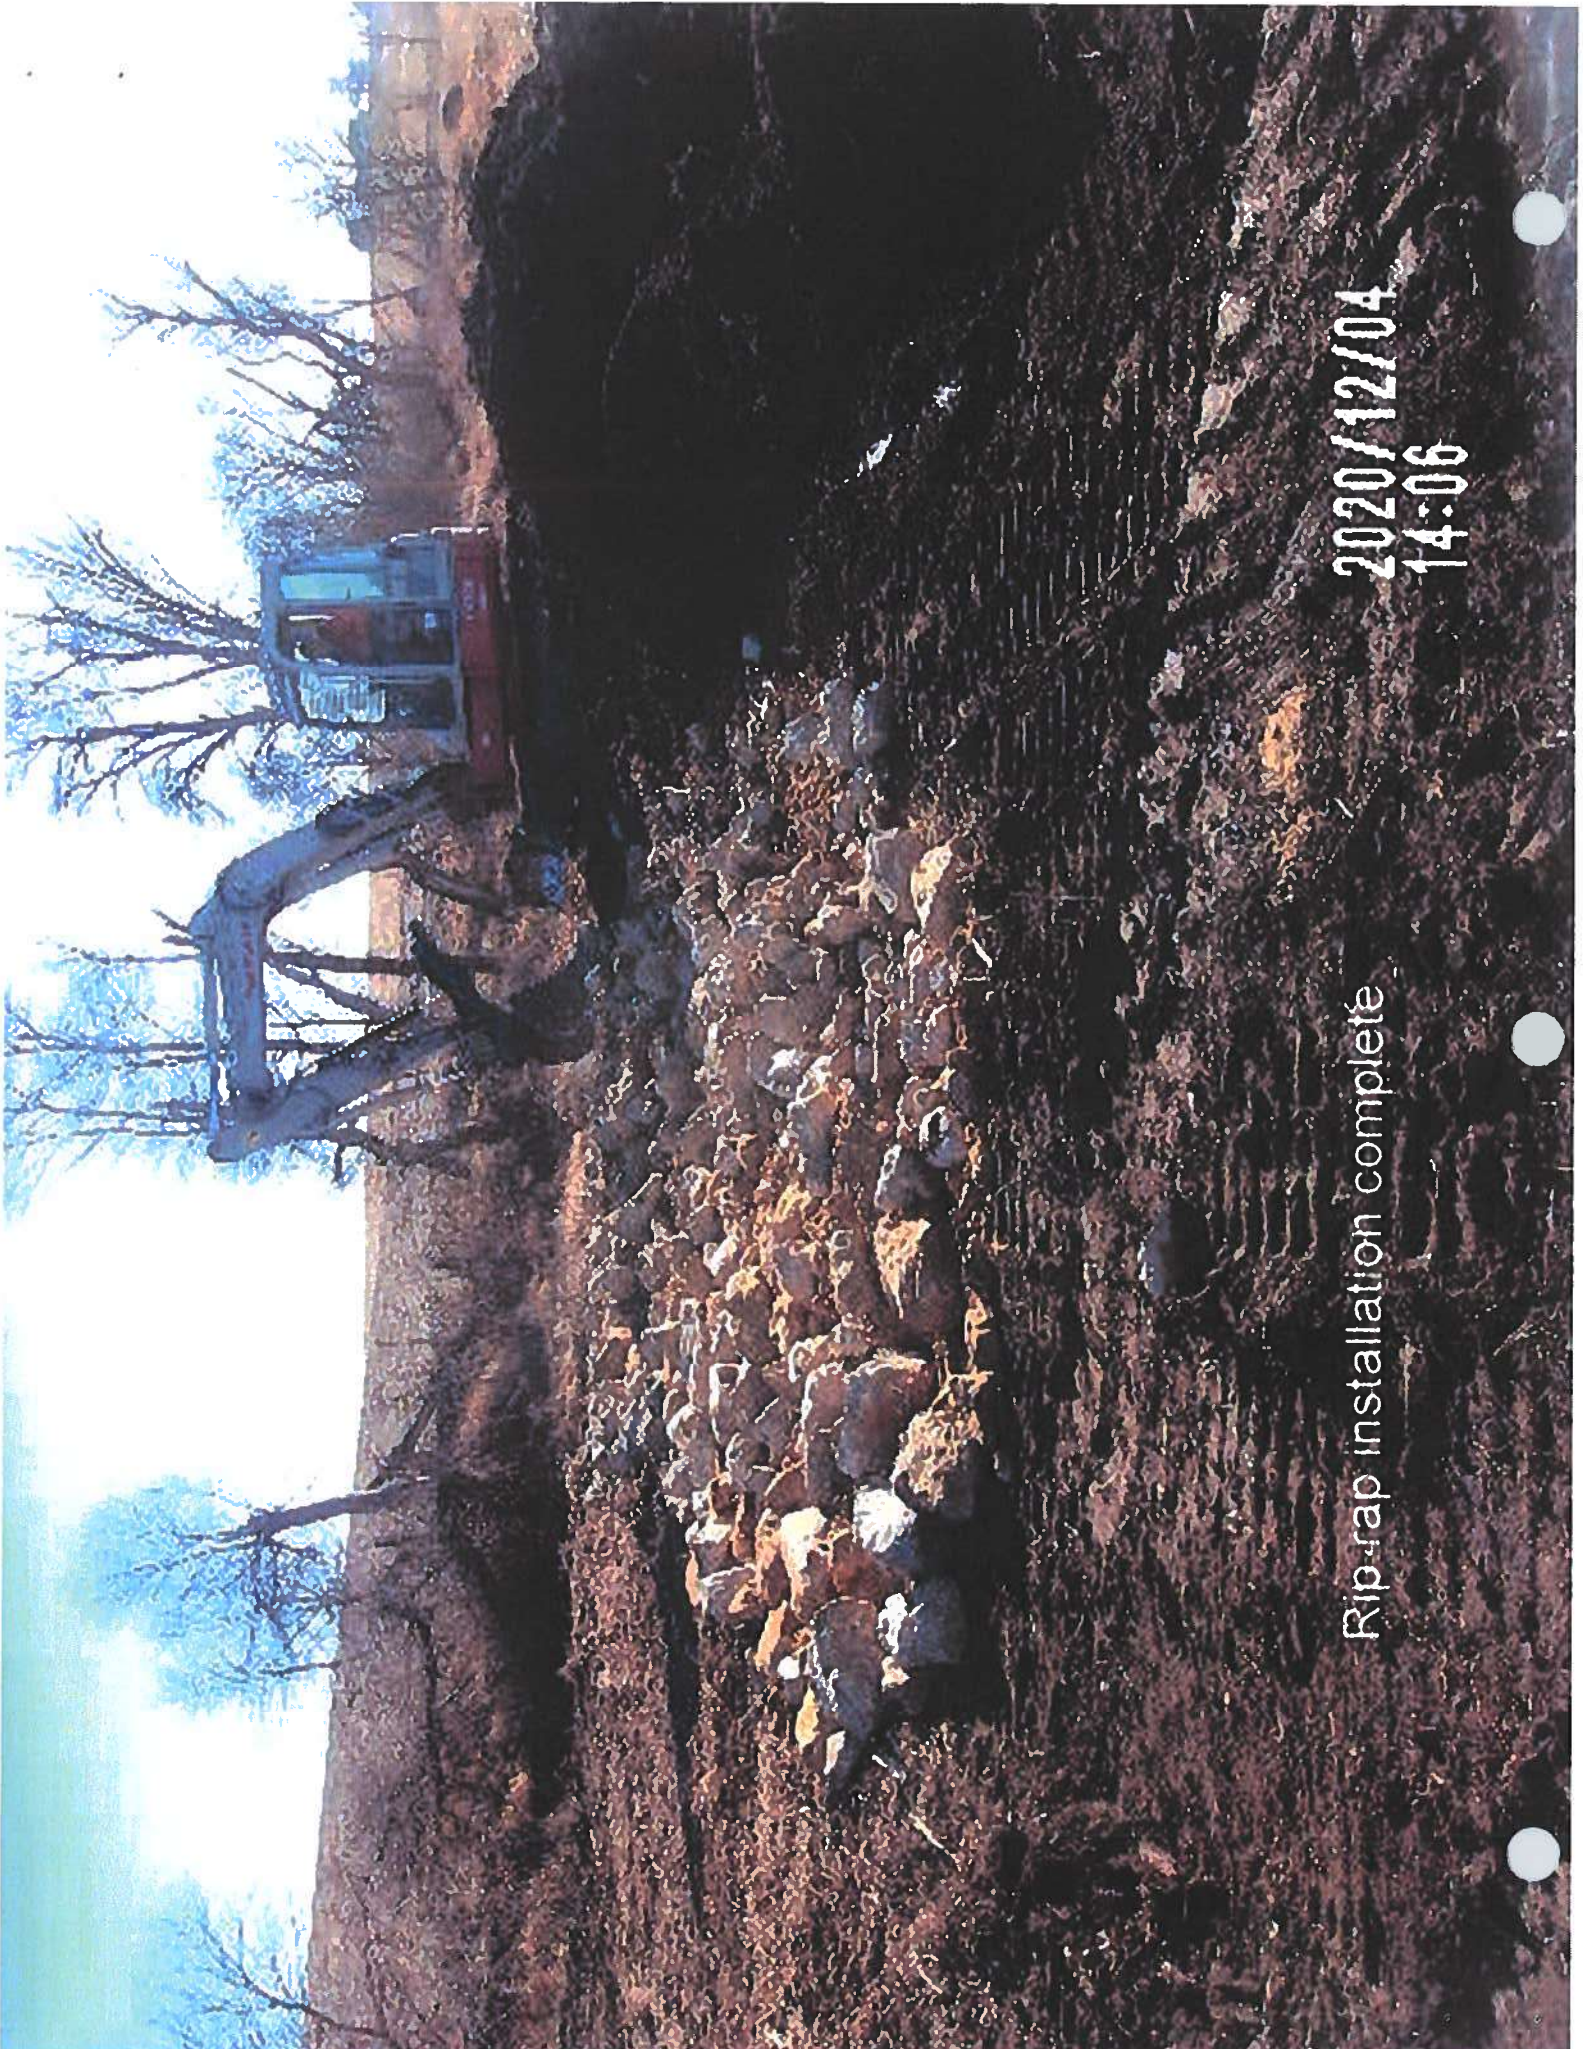
Rip rap placed and continuing to shape

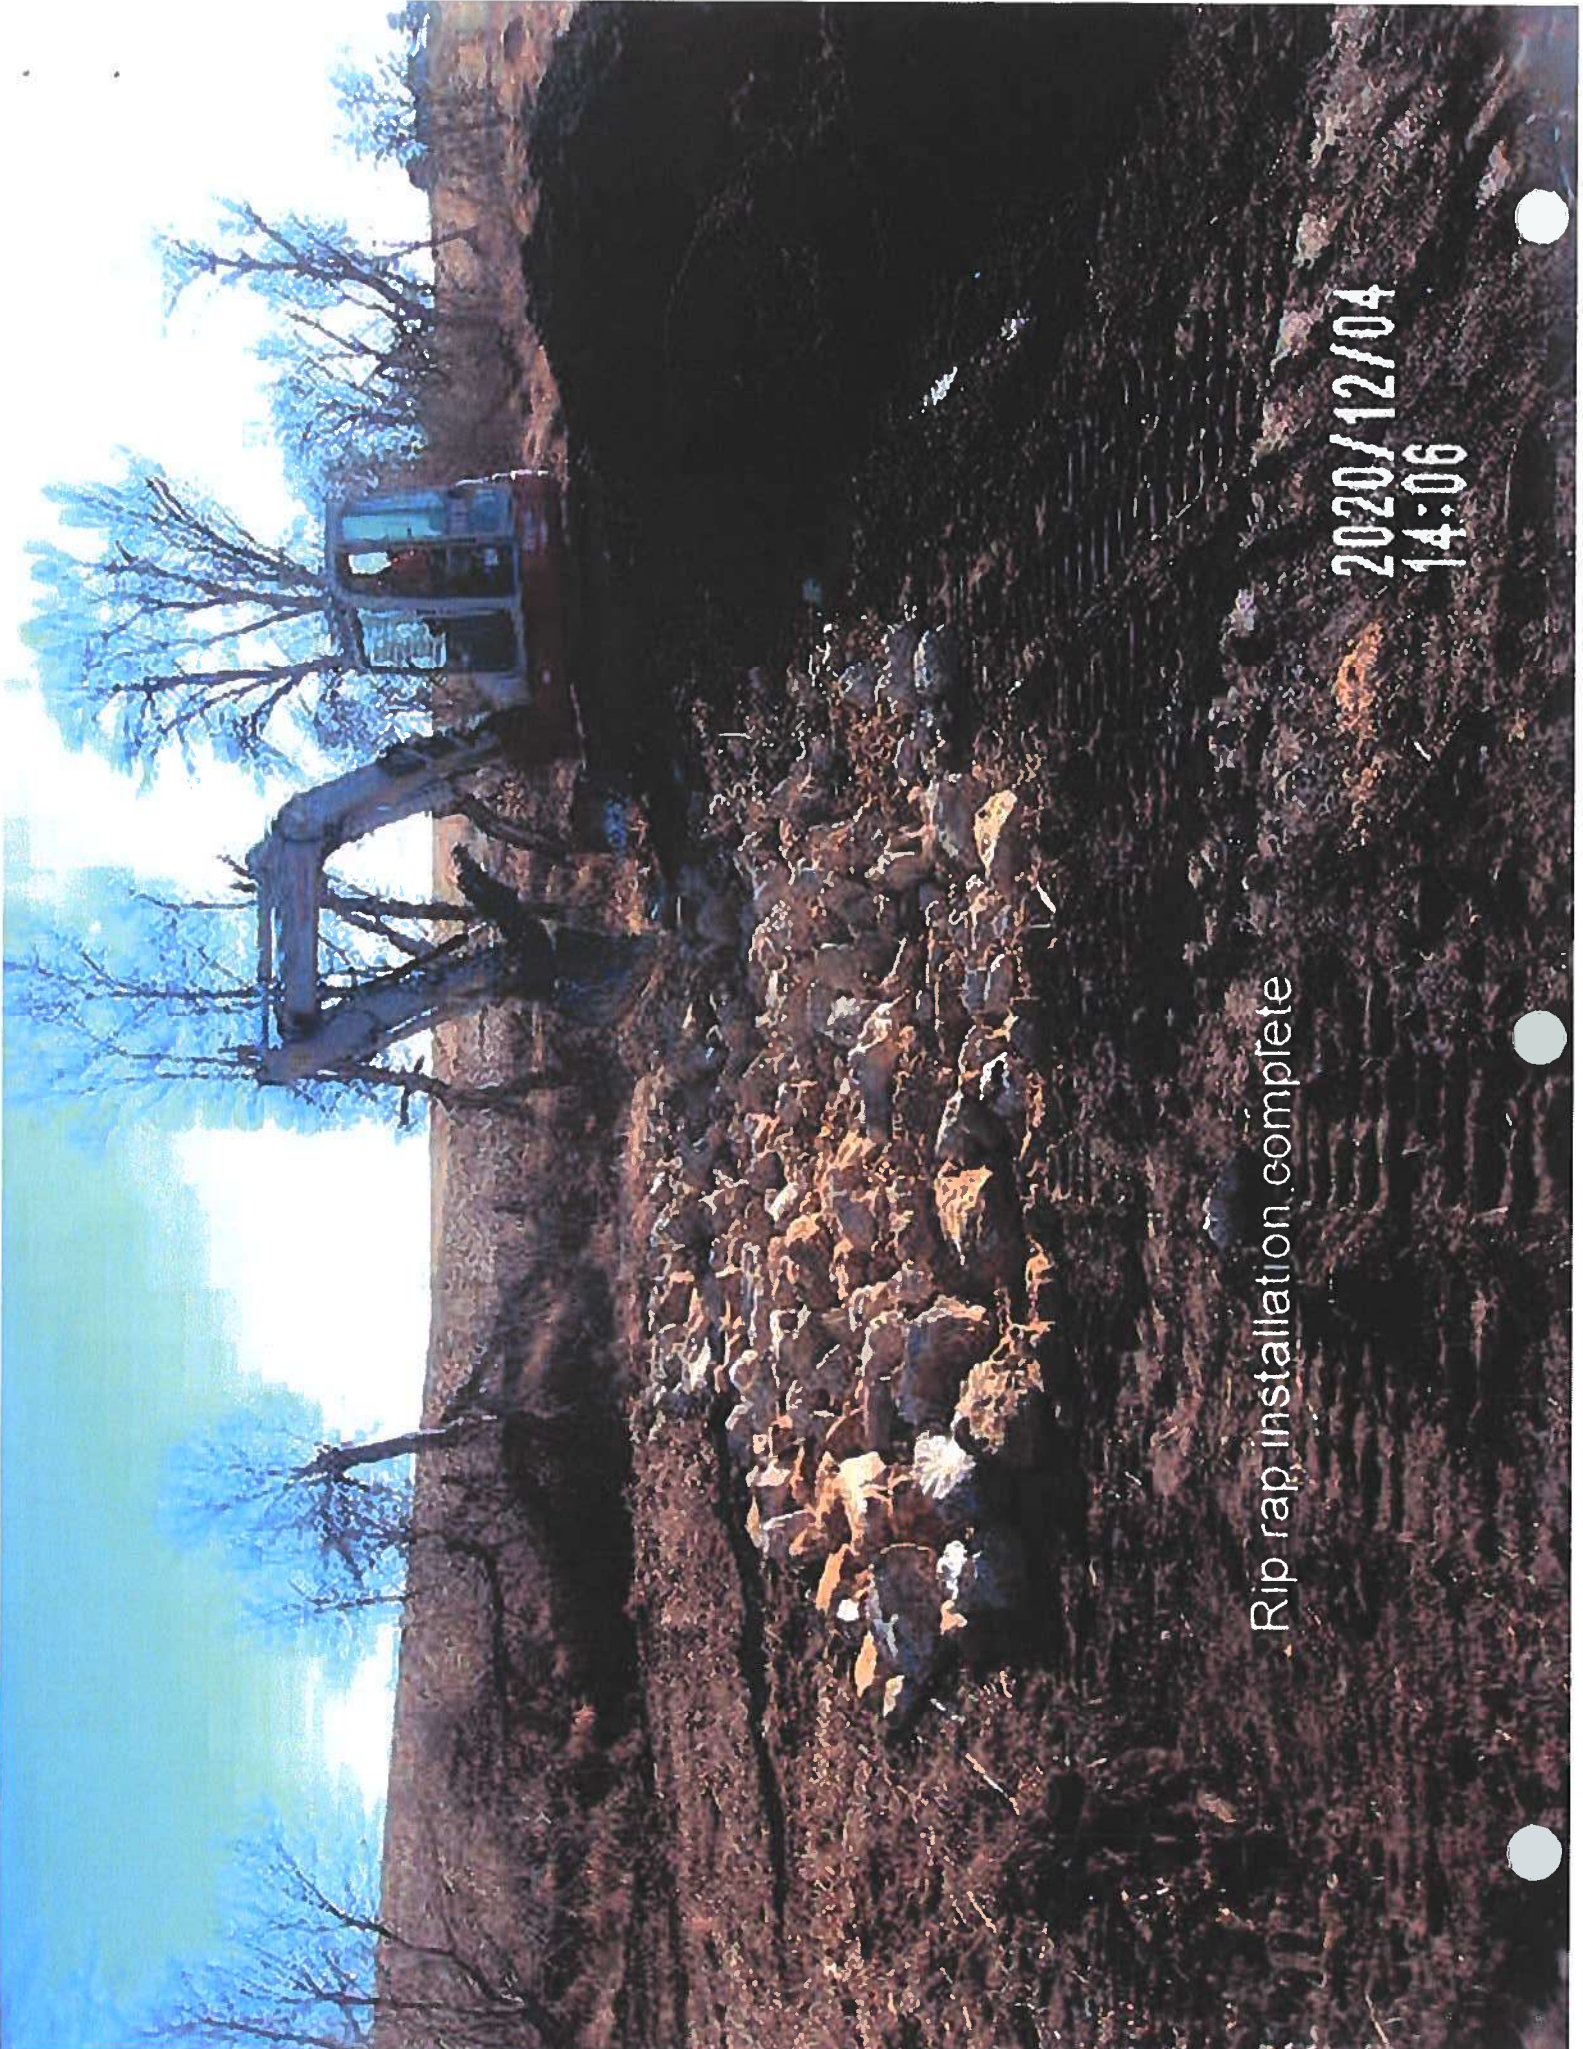
Rip-rap installation complete

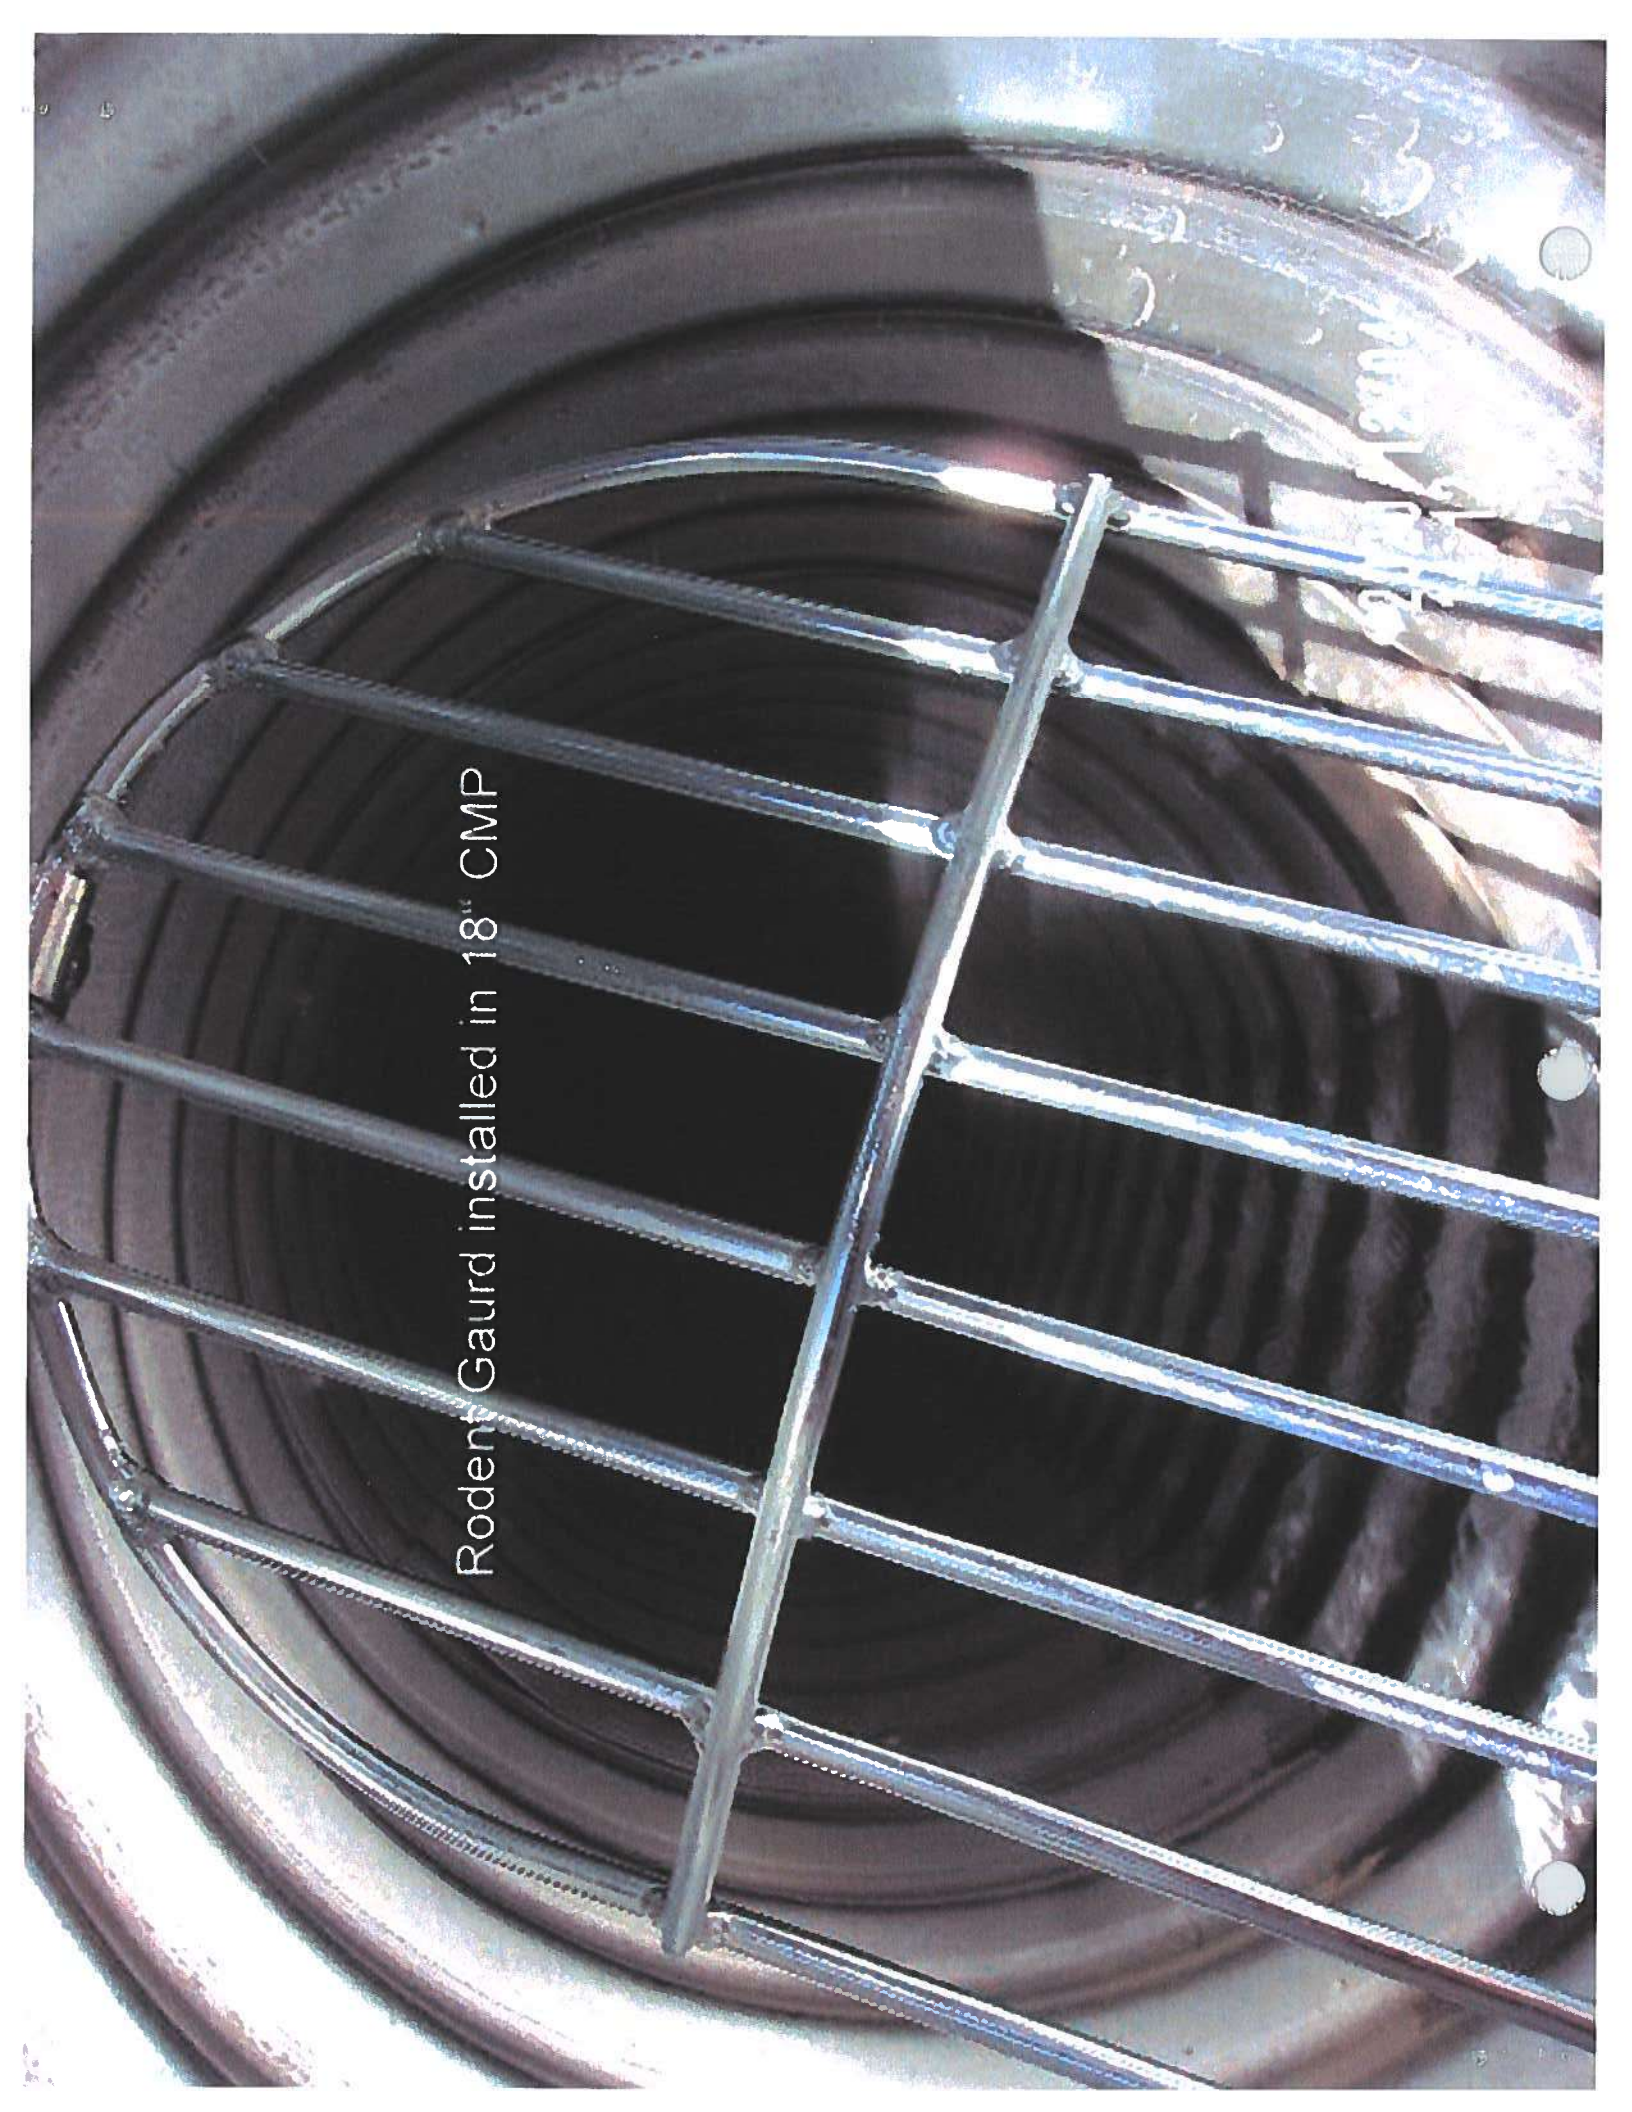
Rodent Gaurd installed in 18" CMP

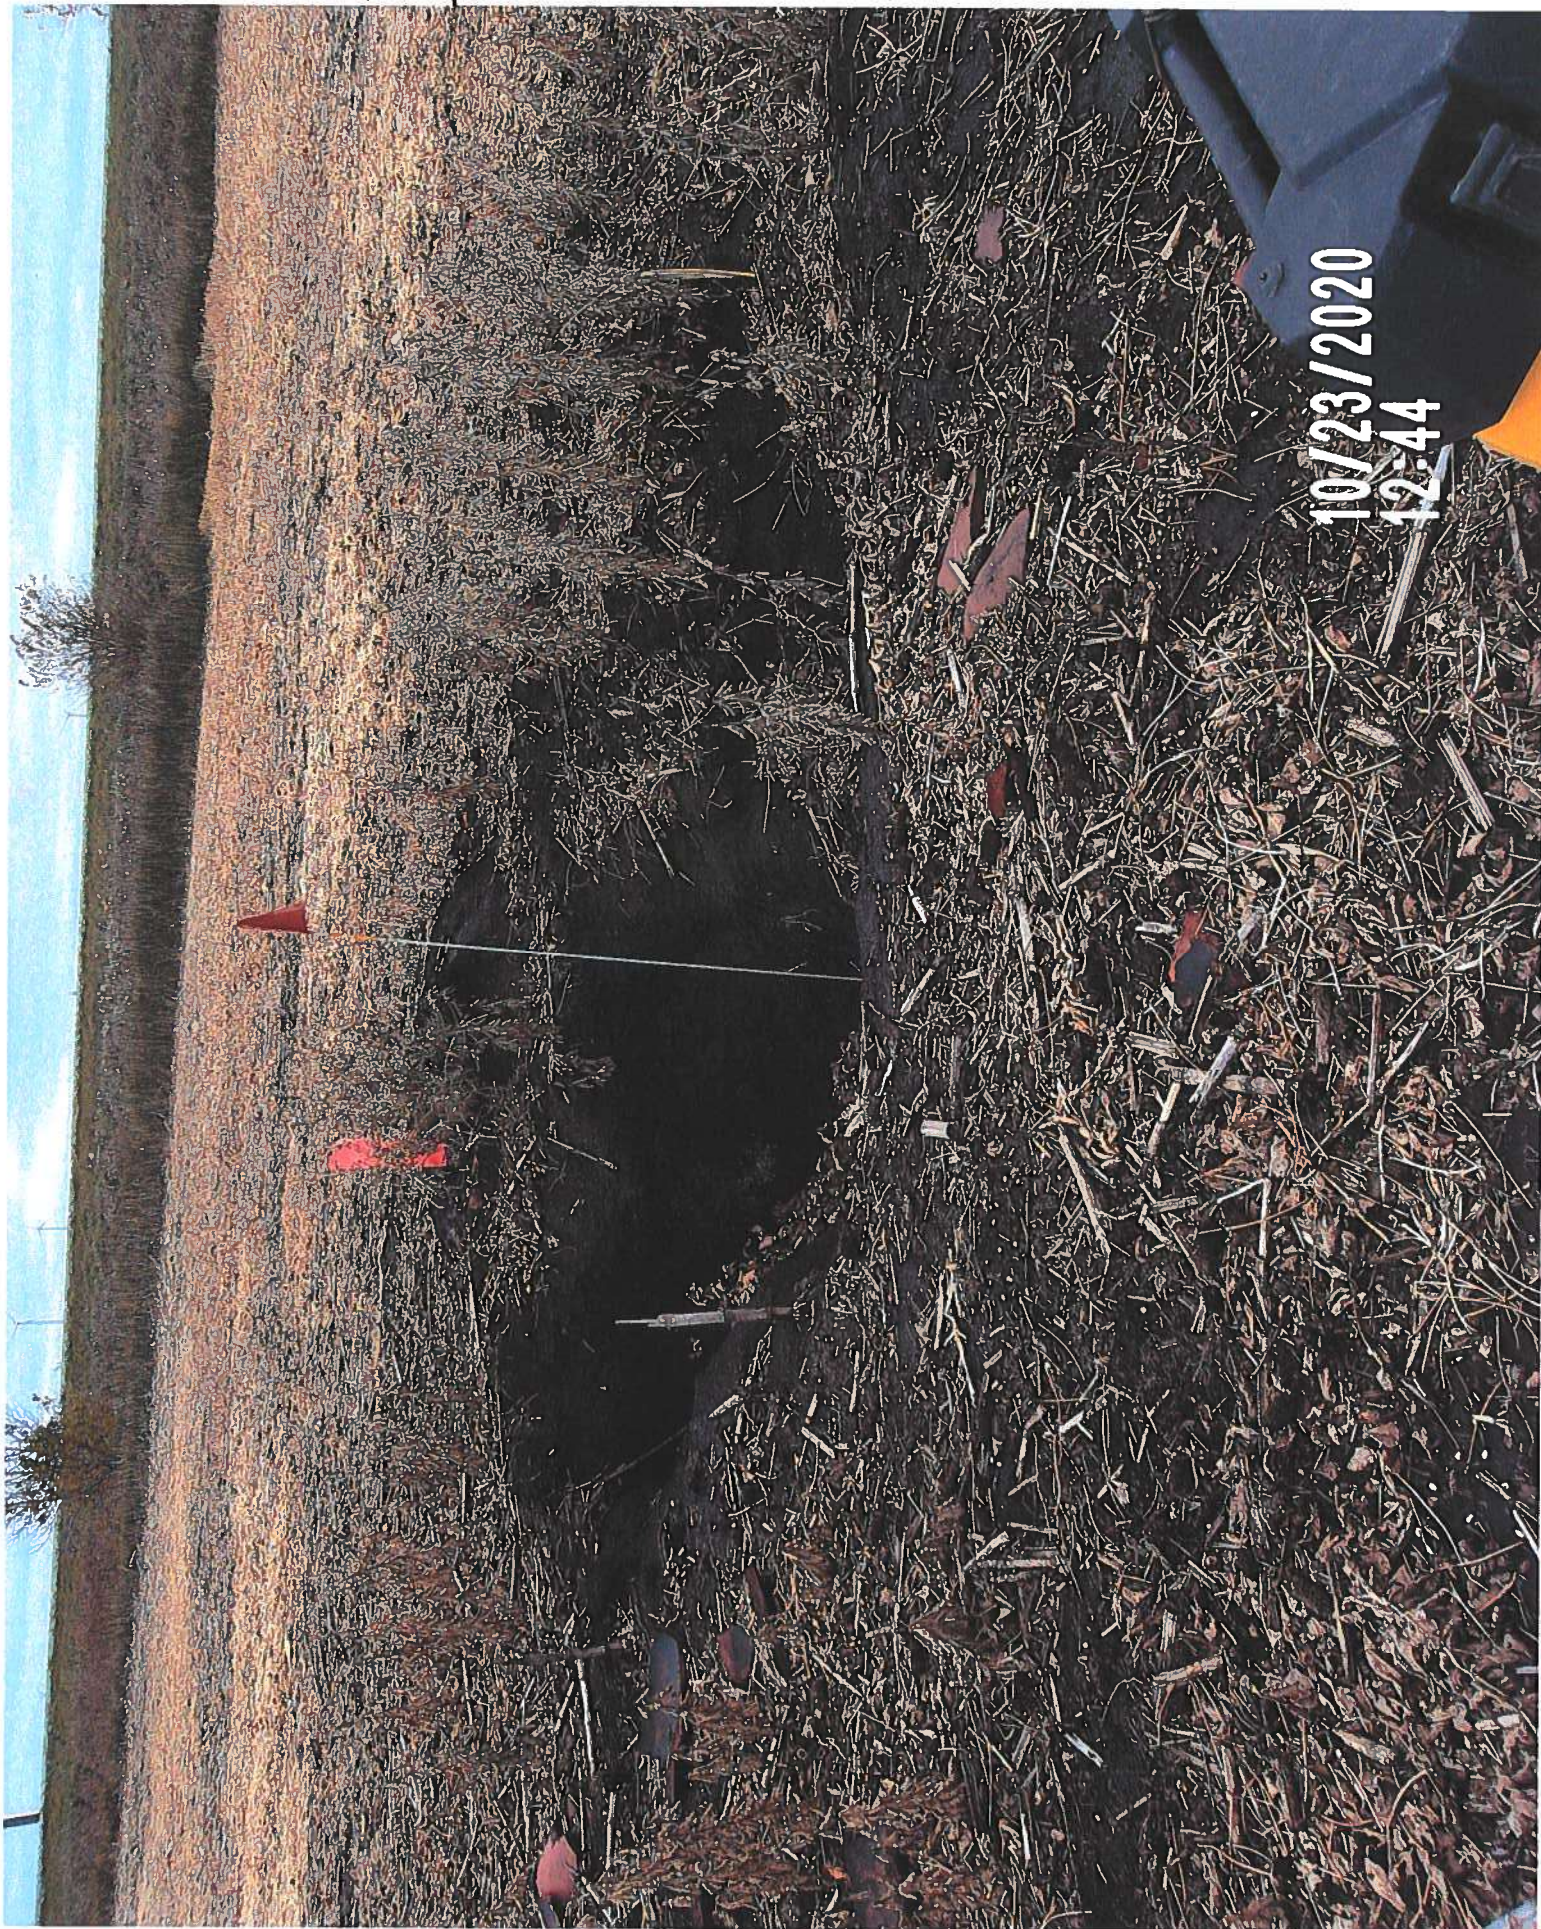
ORIGINAL SPRING 2020 Blow-out #49

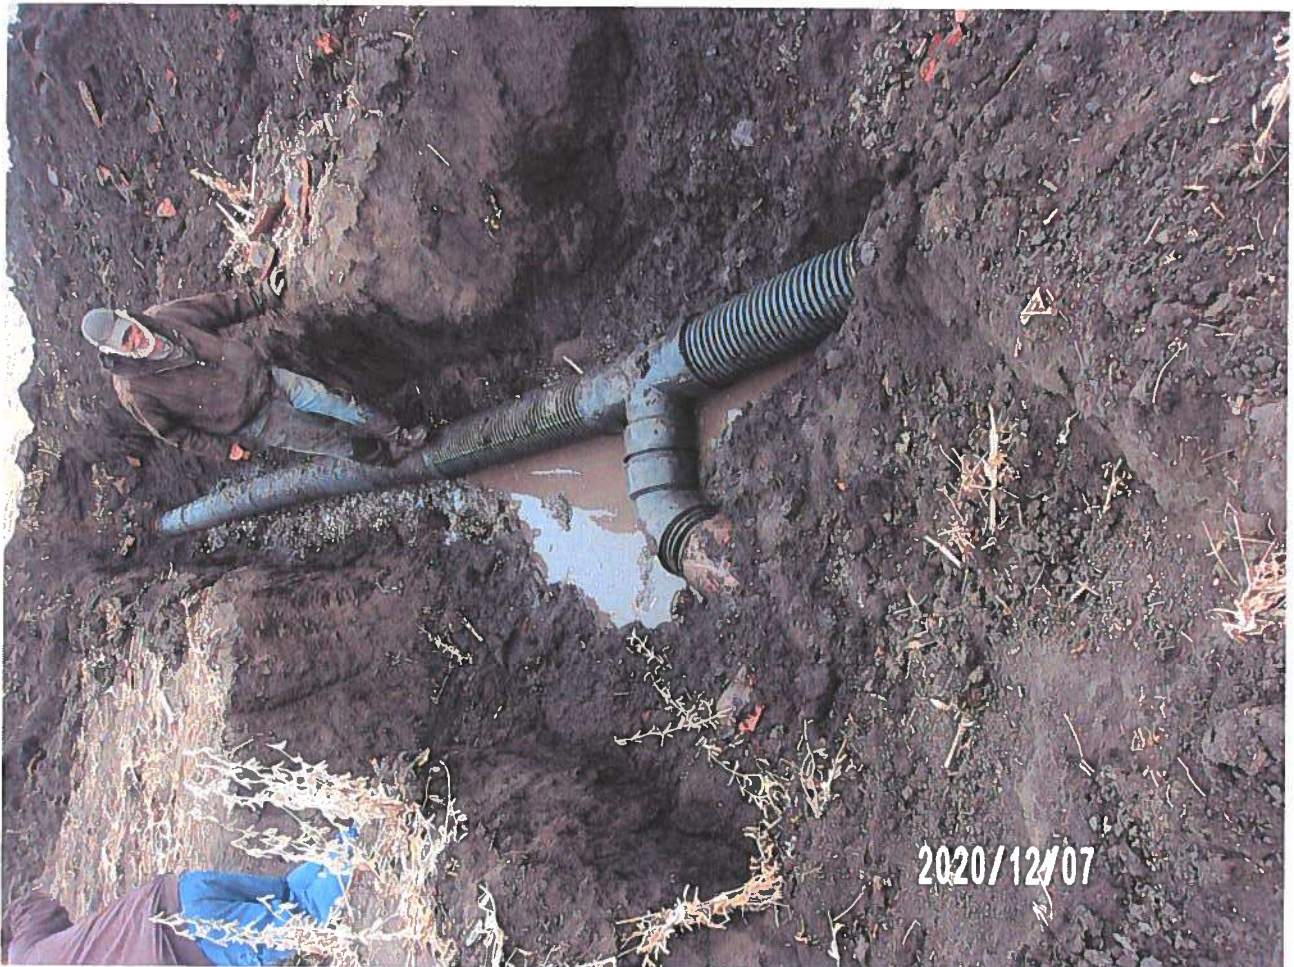
PIPE DRY FIT

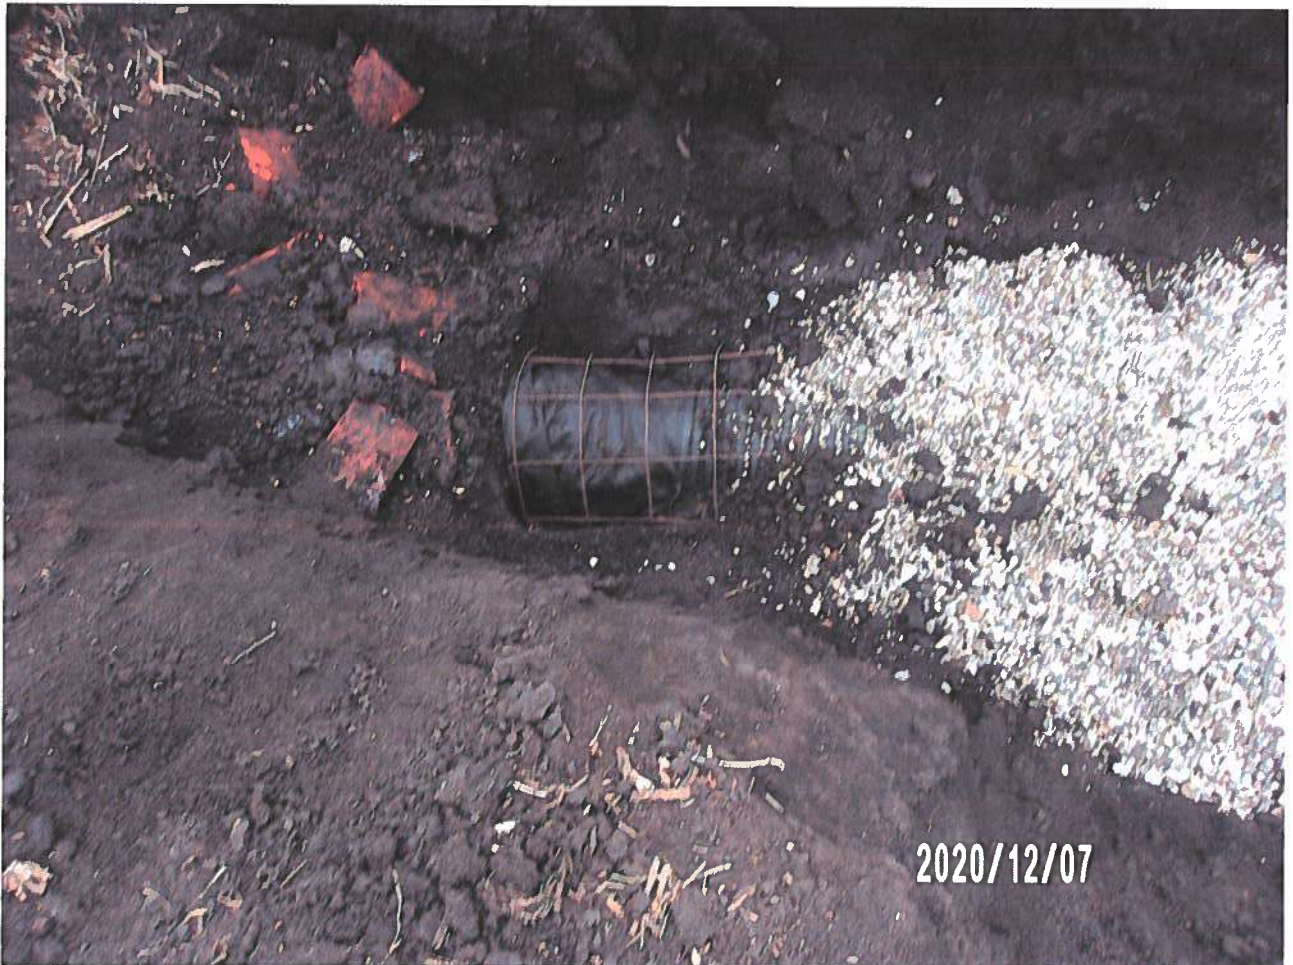
S: COLLAR

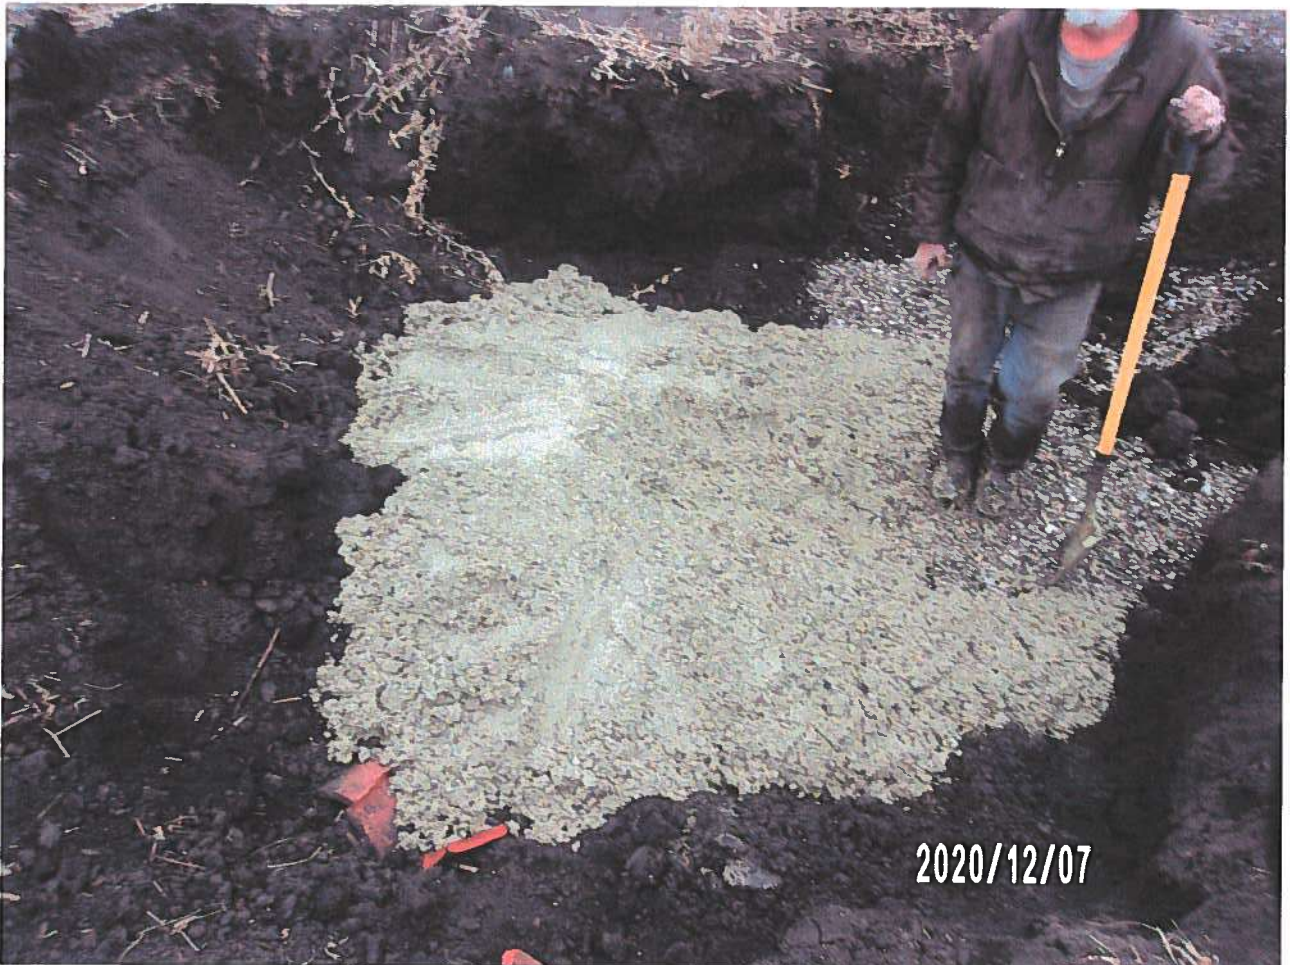
N. 2 COLLARS

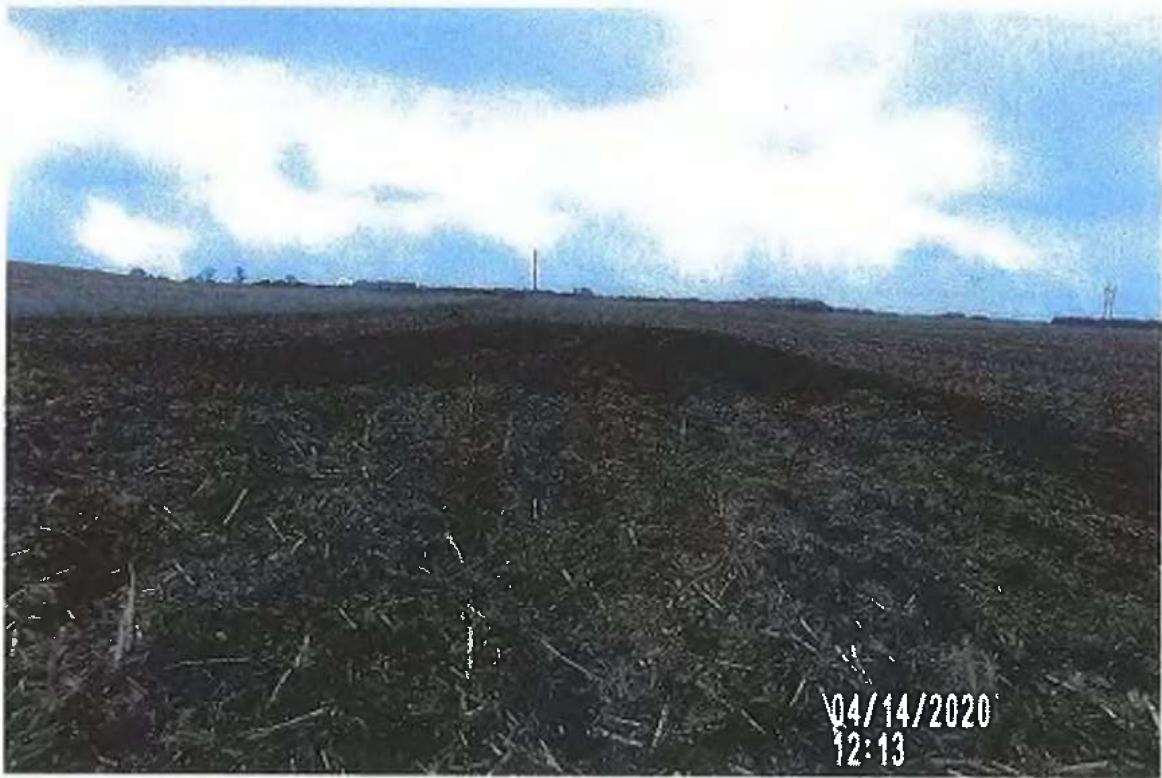
N-S SEE SHEET #2  
PICTURE # 3347 IS LOOKING SOUTH AT 255' X 72' E-W WET  
AREA THAT WAS REWORKED & WET AT ONE TIME, LAT 4-BZ OR  
LAT 4-B NOT NEAR THIS AREA ACCORDING TO MAP

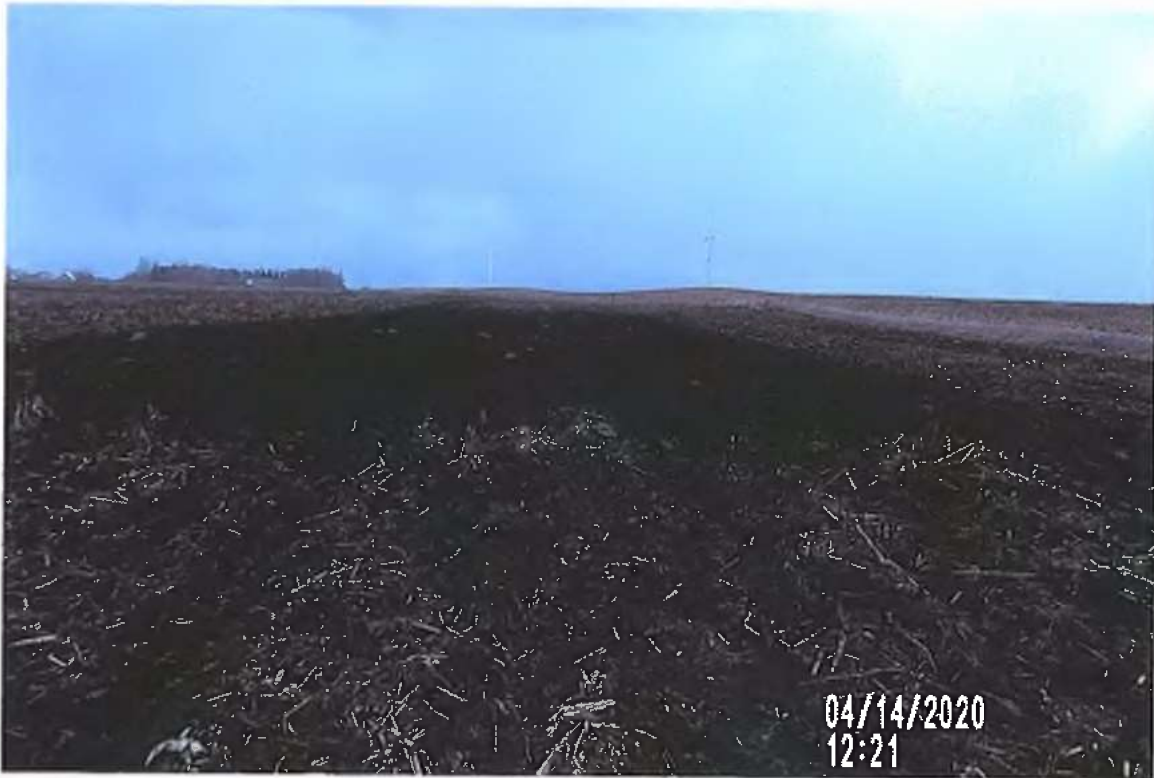
PICTURE # 3348 IS LOOKING NORTH AT 72' E-W x 255' N-S  
AREA THAT WAS WET AND HAS BEEN REWORKED. LAT 4B-2  
OR LAT 4B NOT IN THIS AREA
