**AGENDA**  
**REGULAR DRAINAGE MEETING**  
**Wednesday, January 20, 2021 9:30 AM**  
**Large Conference Room**

[DD 20 WO 302 - 6502.5 - INVESTIGATION-REPAIR SUMMARY 01\\_05\\_20.PDF](#)

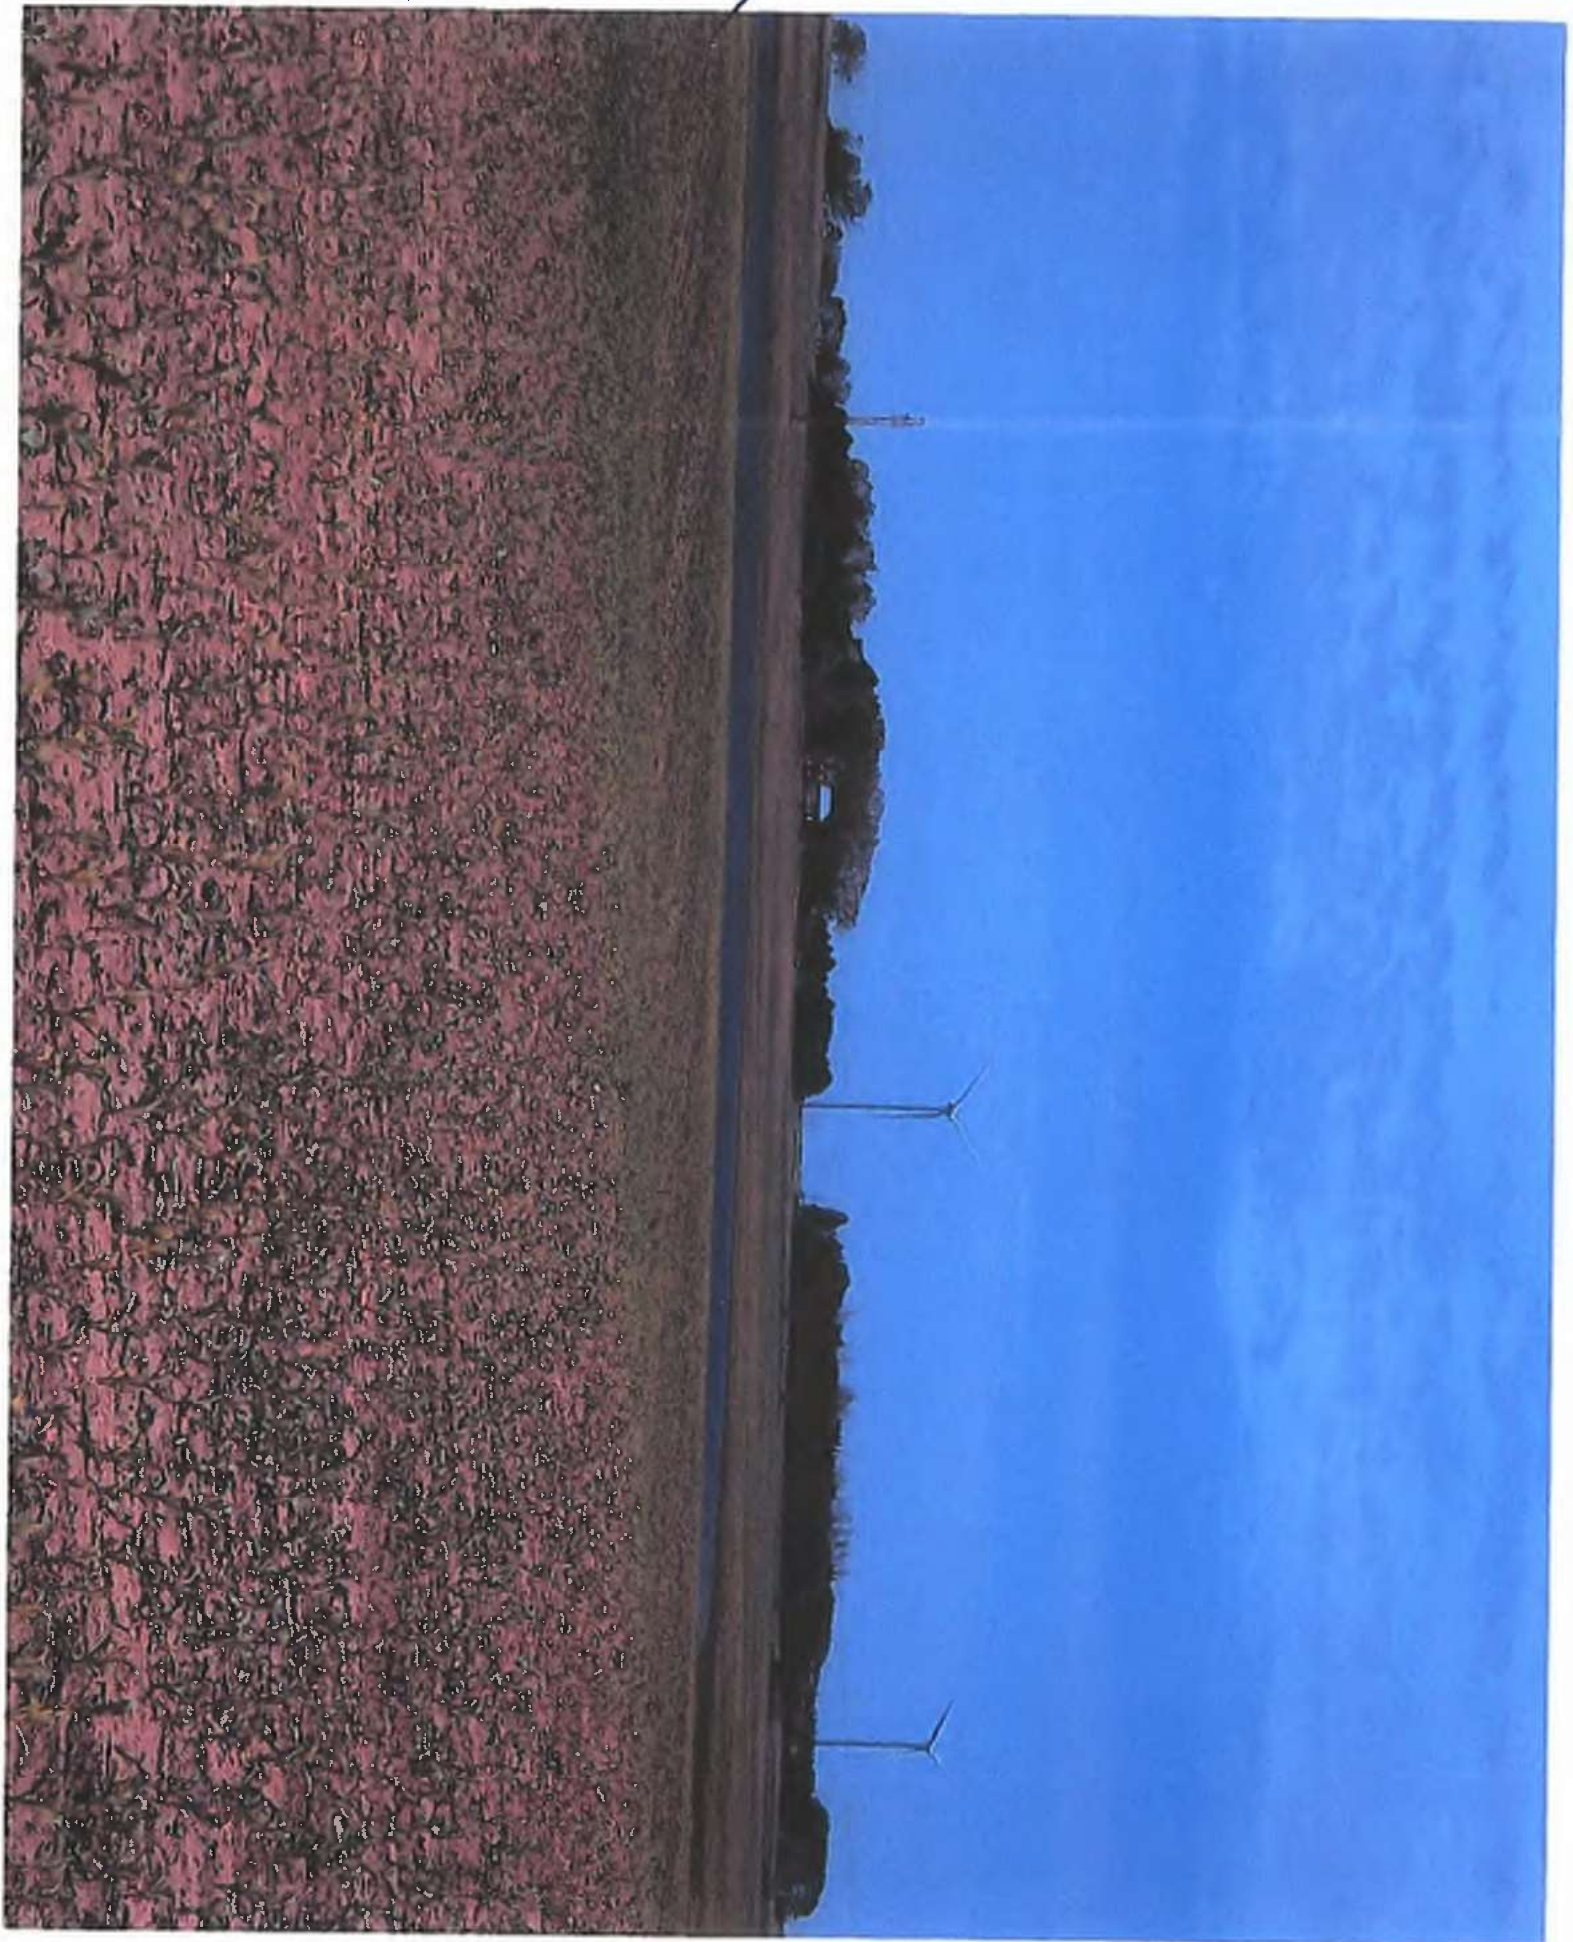
Problem Area @ LAT 4 / LAT 4B CONNECTION

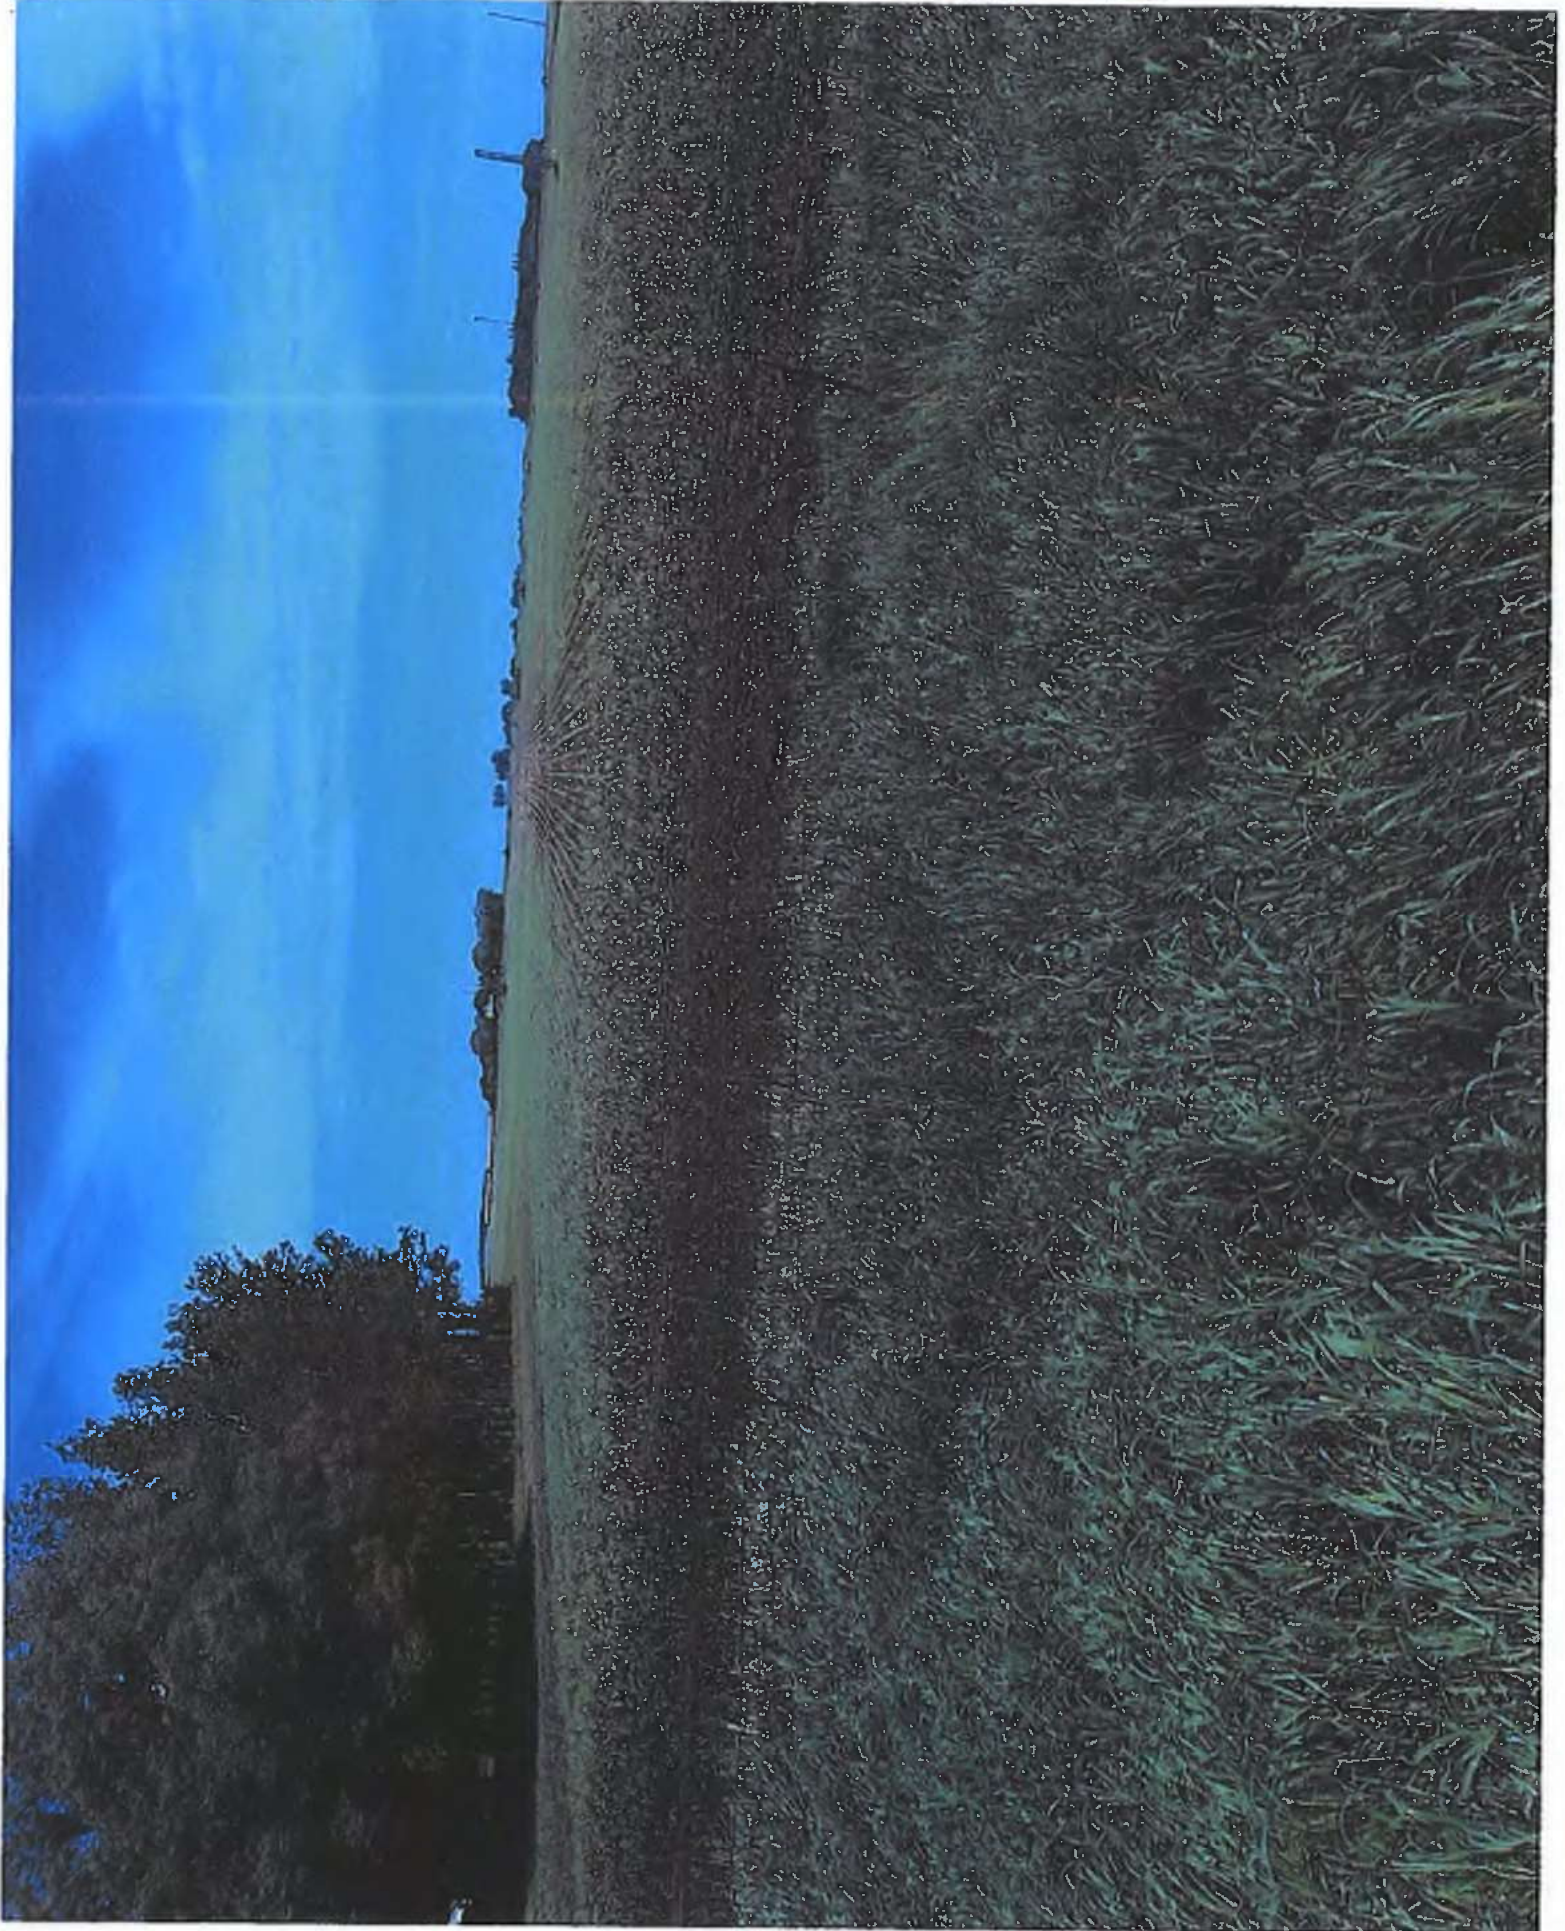
LOOKING DOWNSTREAM ON LAT 4B PASS AUSTREES + COTTONWOOD

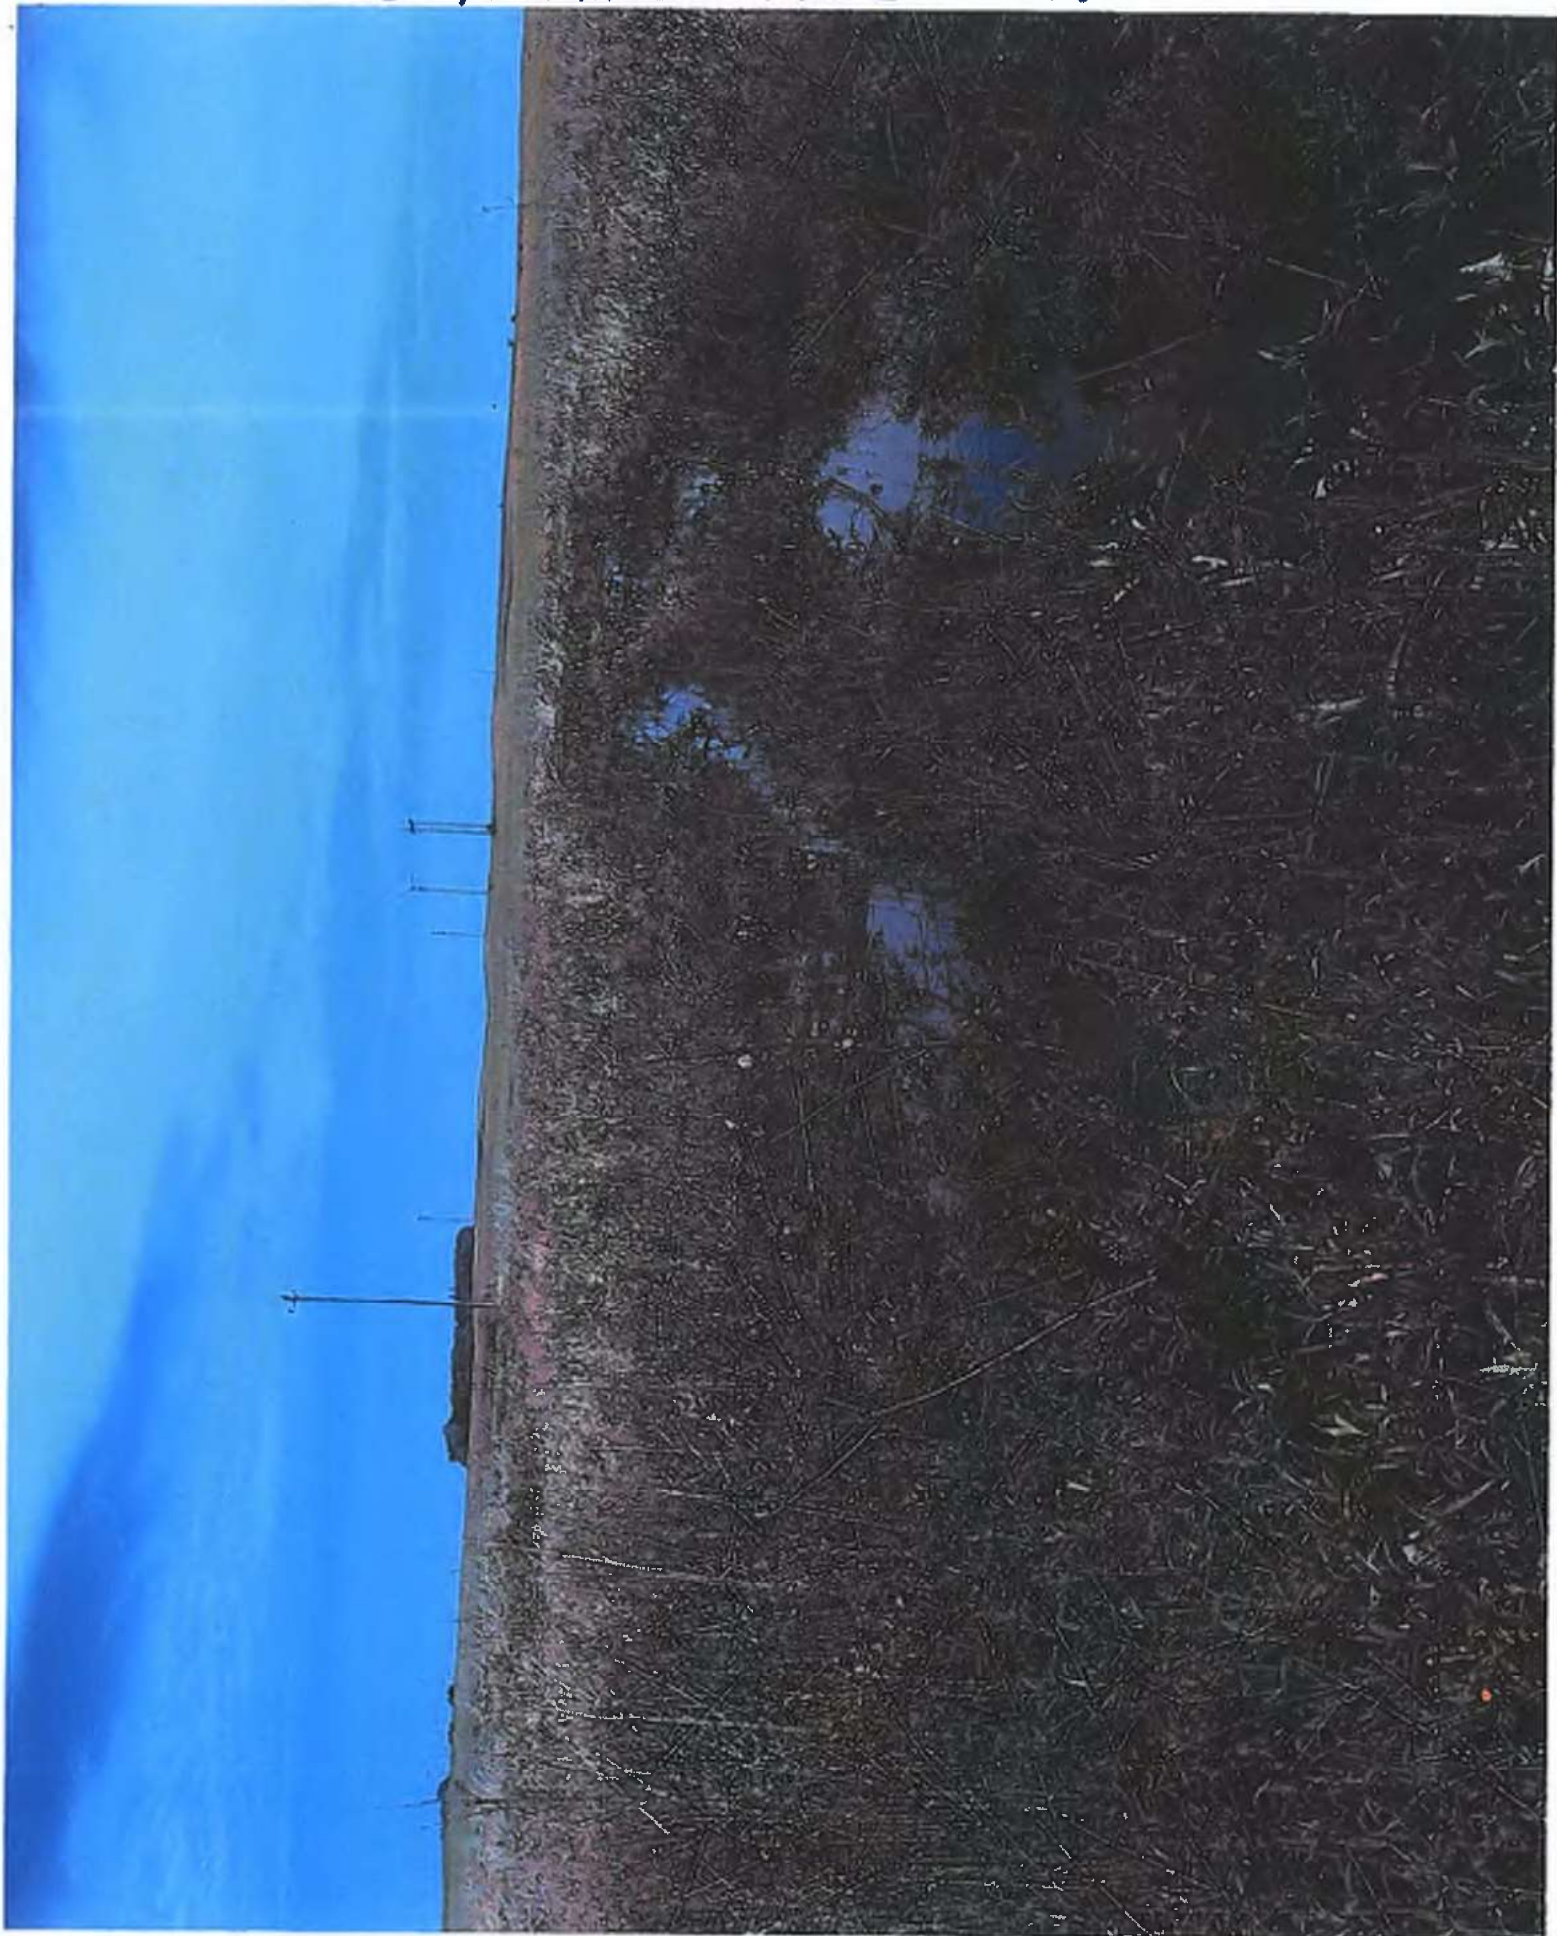
Looking upstream on LAT413 @ OLD RR

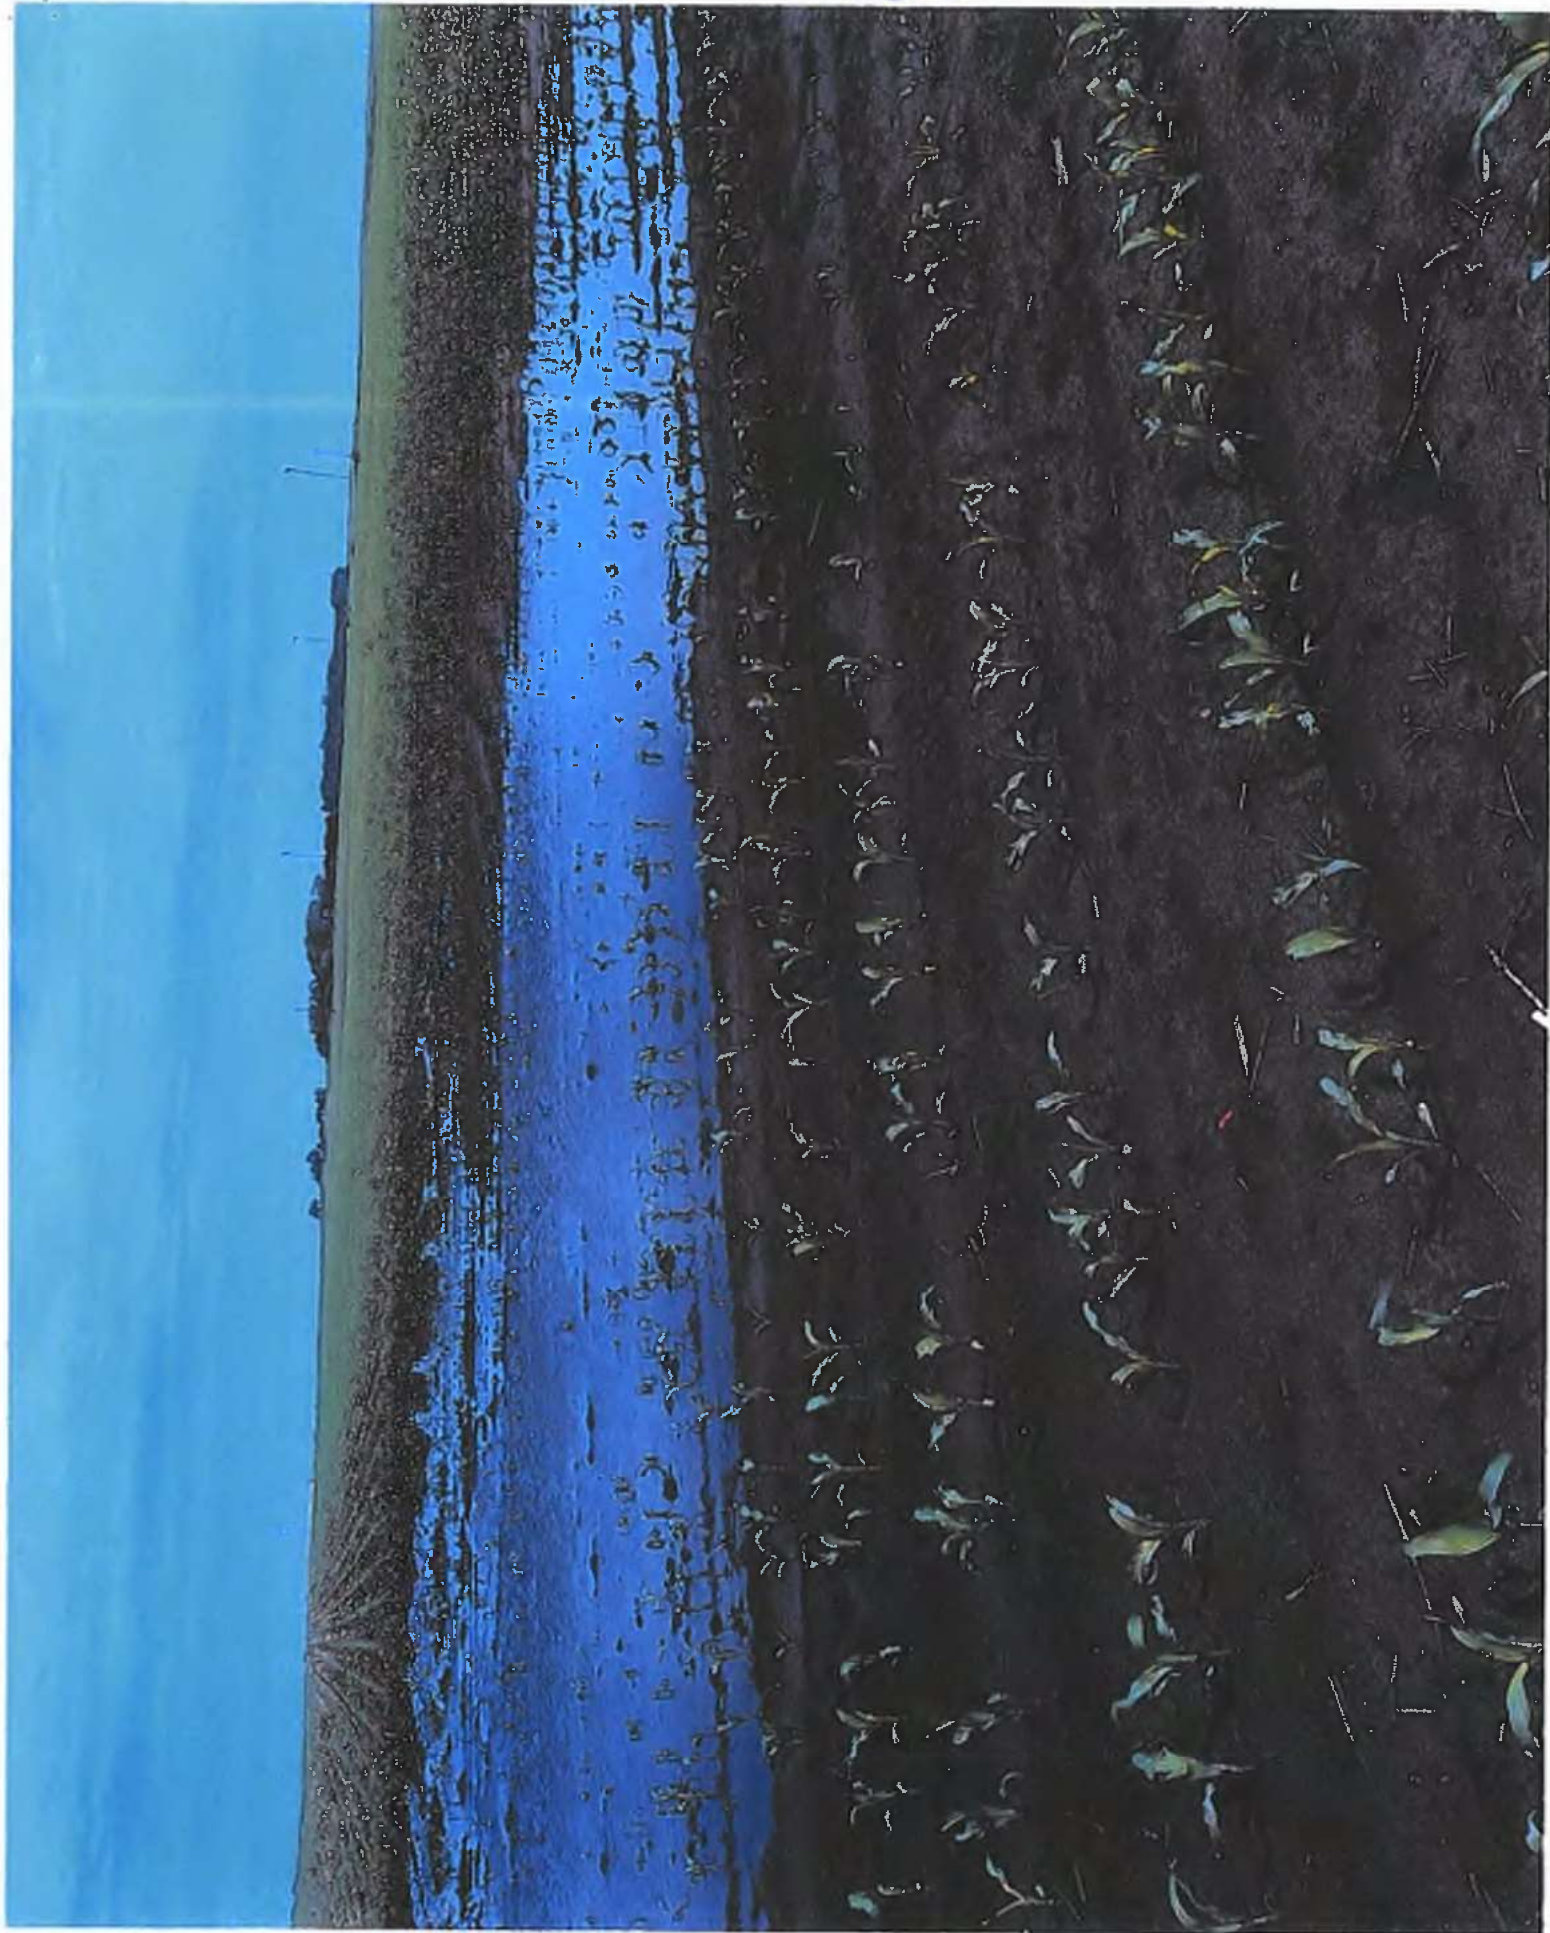
LOOKING UPSTREAM ON LAT 4 @ C73

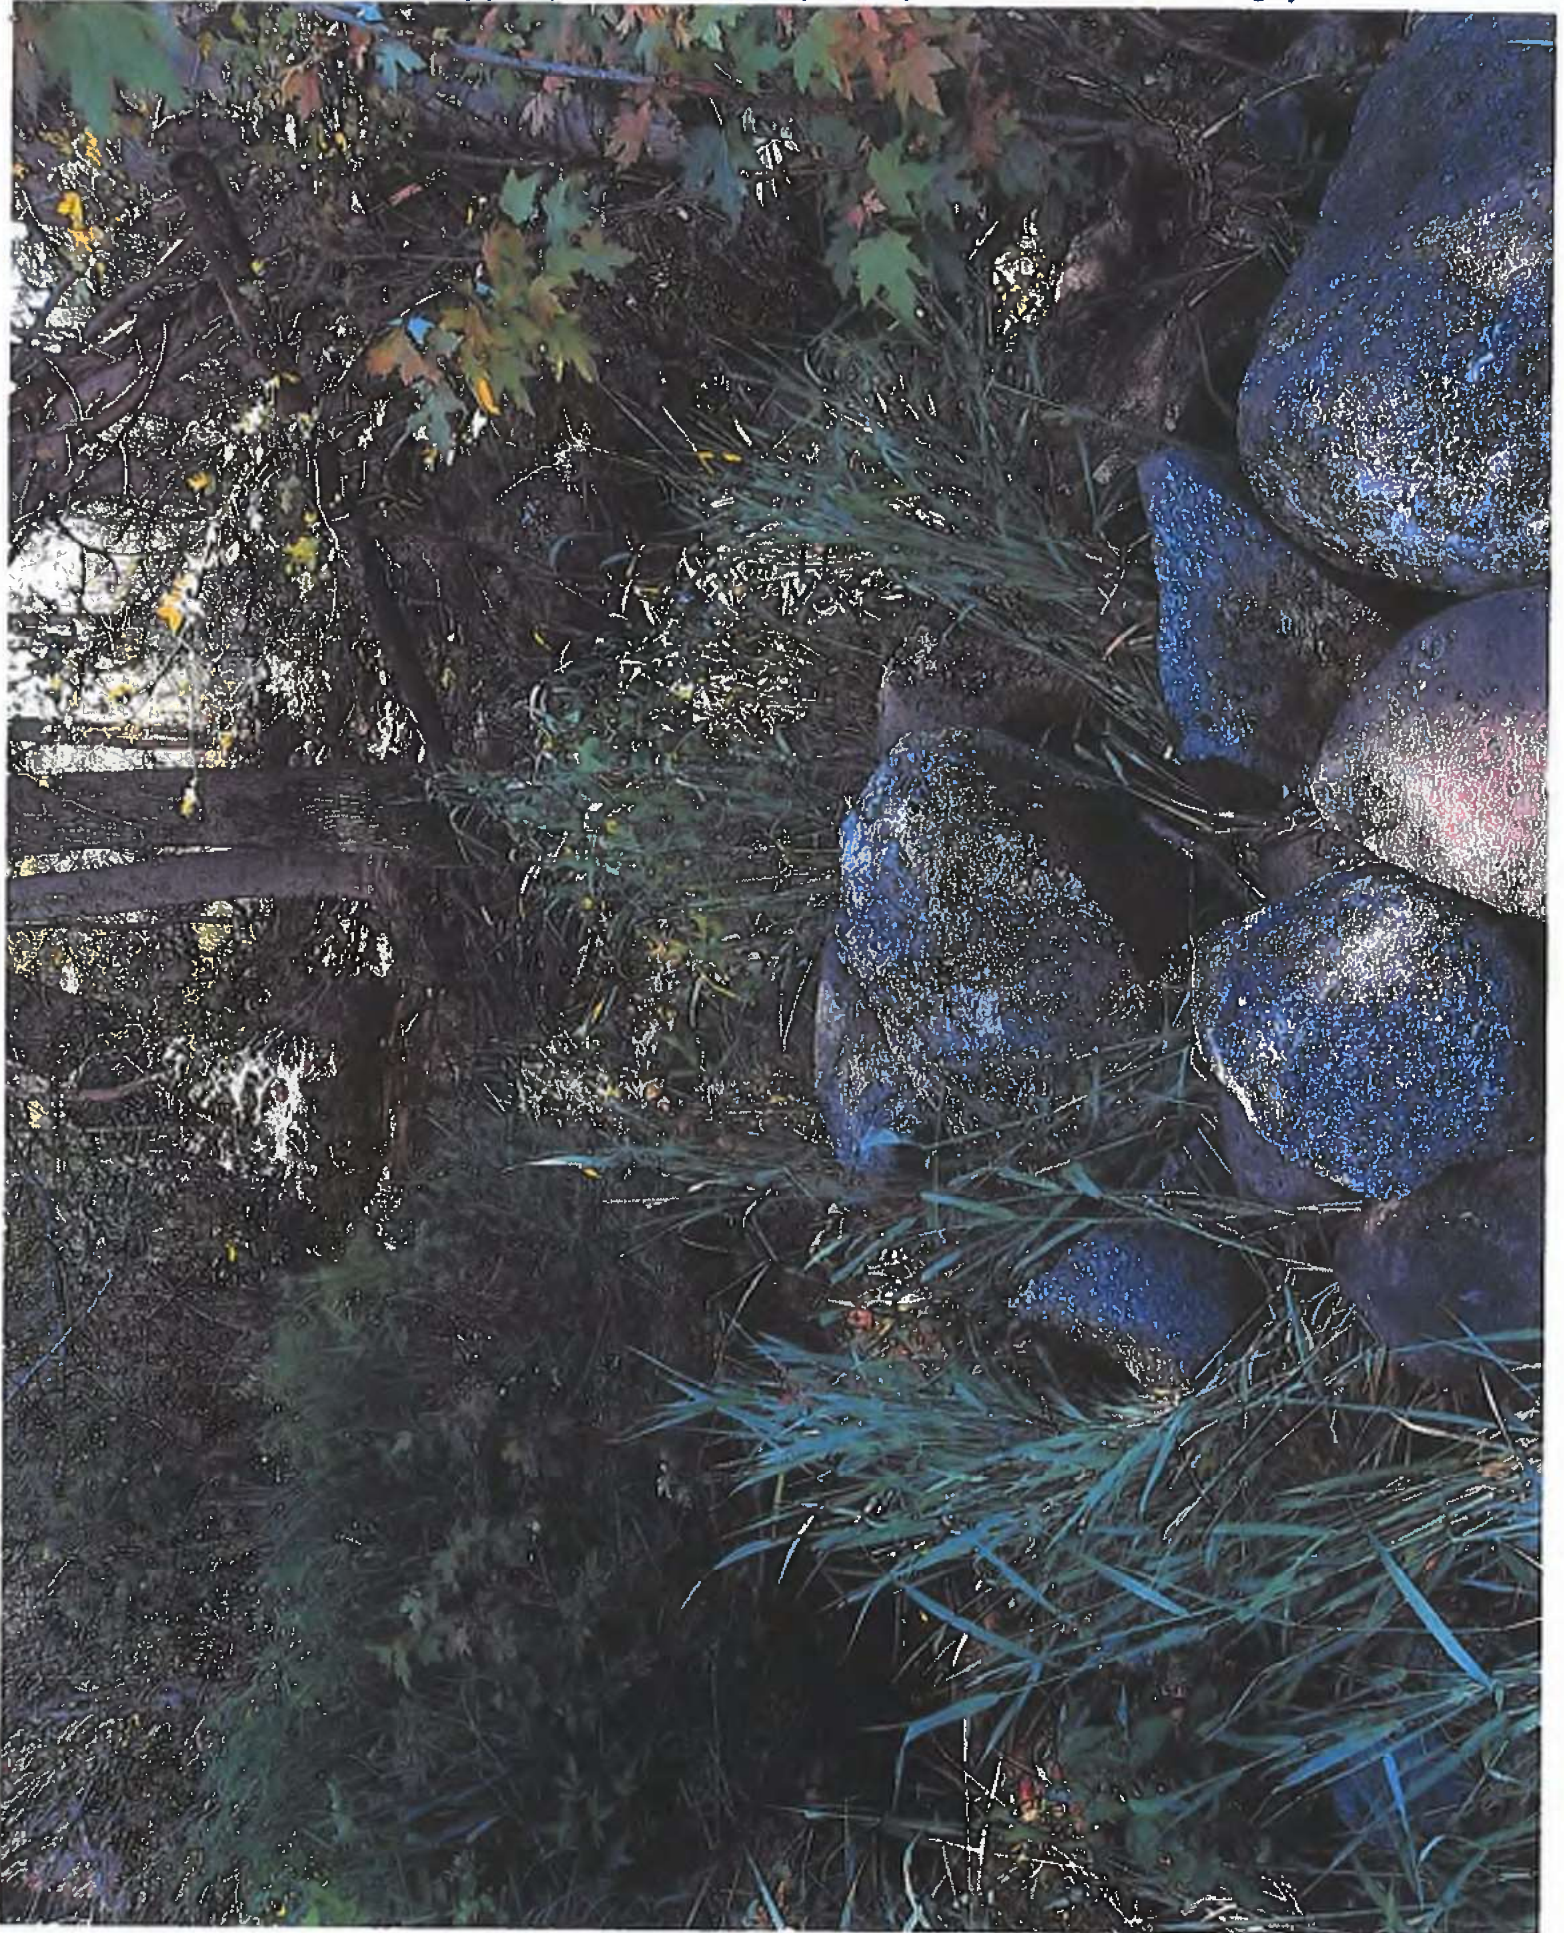
OUTLET AREA FOR JDD 4-53, CAN'T FIND EASILY, CAN'T HEAR WATER

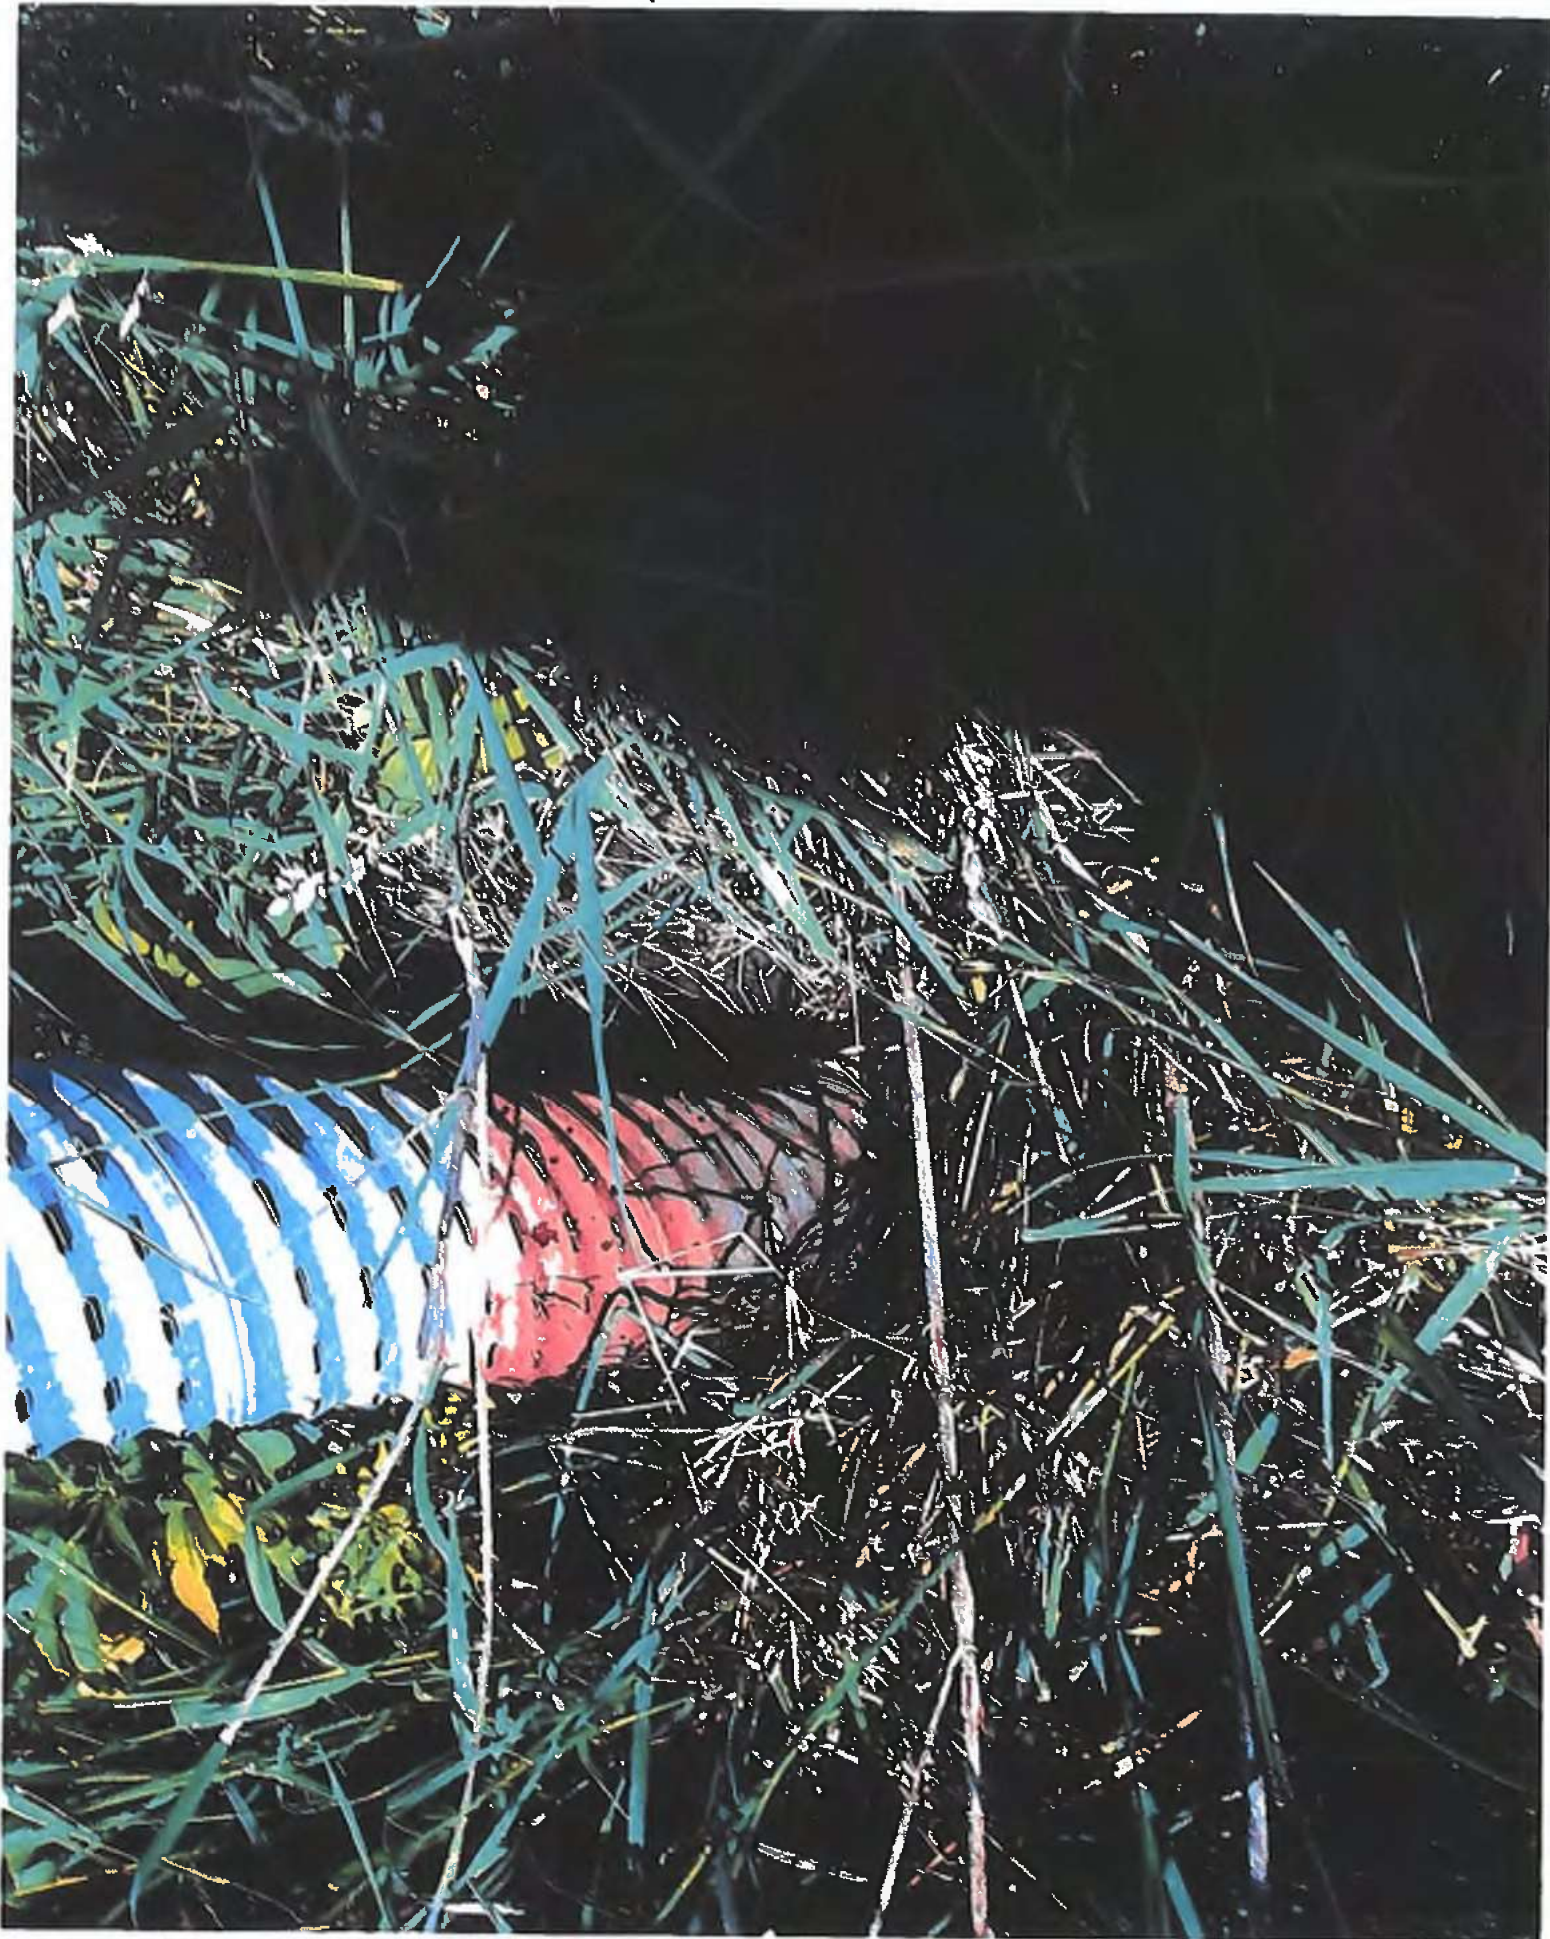
GRAND PIPER ON INTAKE OFFSET NEEDS WORK

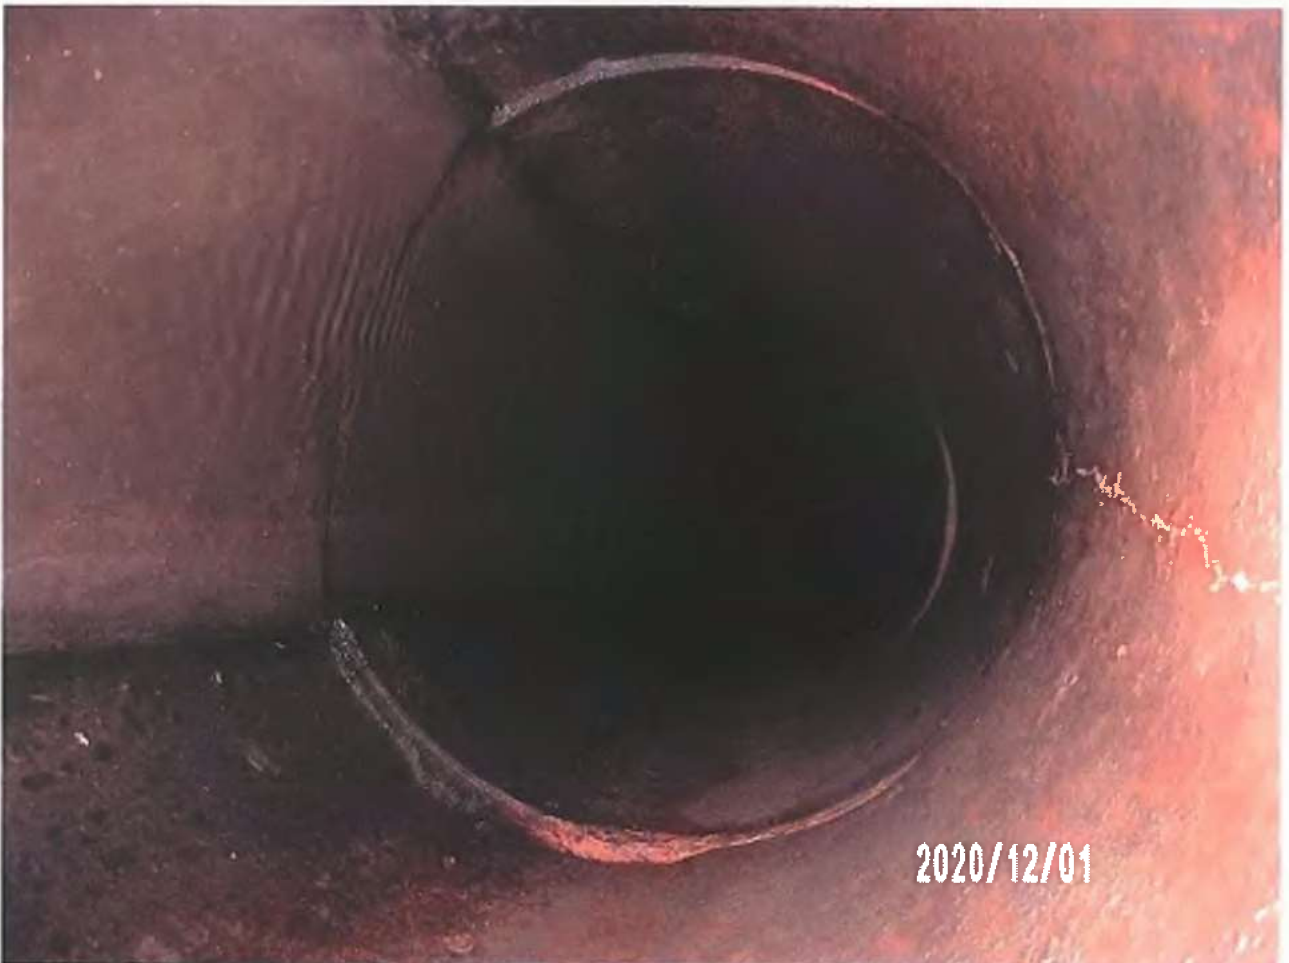
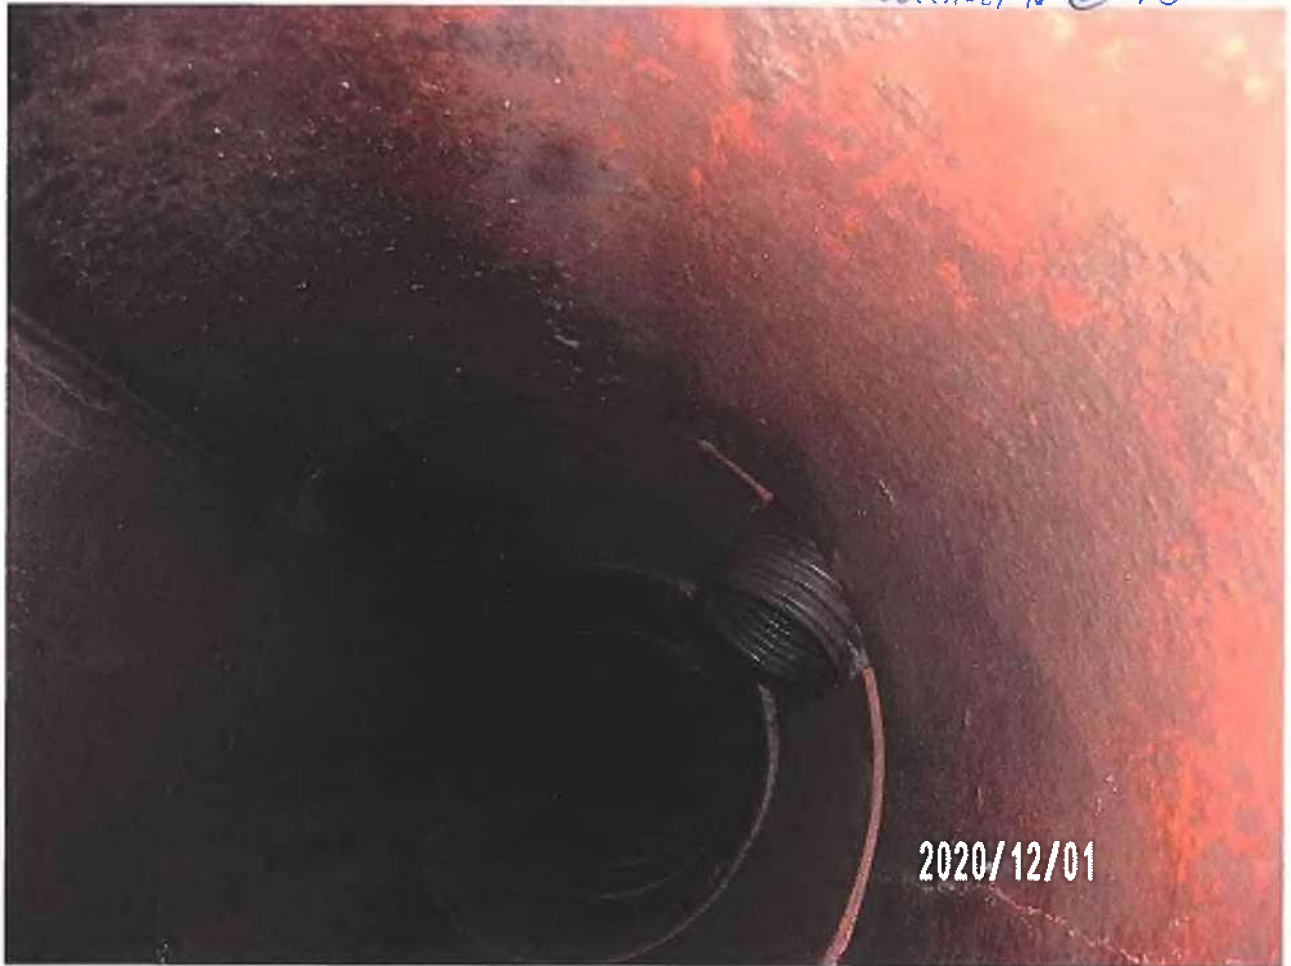
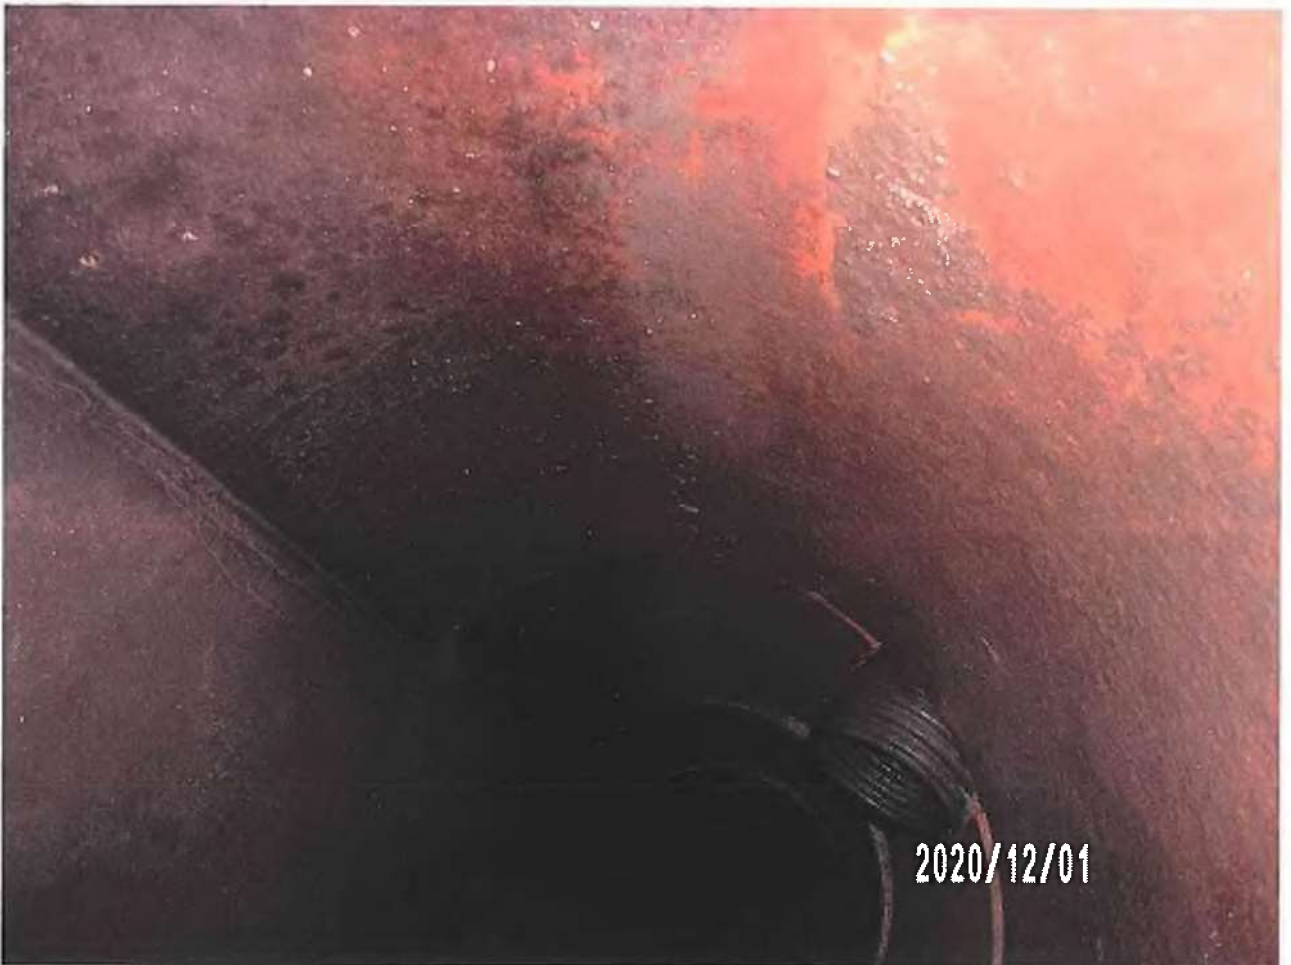
LOOKING S@ 73

- Excavated Lateral 4 again on the north side of Hardin Road (Highway C73) and found the tile to be relatively free of debris, and again, water flowing slowly at approximately 3-inches deep. At said excavation, also found a 4-inch HDPE private tile protruding approximately 2-3-inches into Lateral 4.

- 8:15 ARRIVED ON SITE SET UP BASE @ #12 (GAS METER 8022)  
CUT A HOLE IN THE TOP OF TILE @ 69 TILE HAS  
HAS ROCKS IN FLOW LINE W/ 3" OF SLOW FLOWING WATER  
9:30 STARTED LOOKING FOR TILE @ N ROW OF C-73 FND  
22" VCP @ #73 TILE IS FLOWING SLOWLY @ 3" DEEP  
A 4" FIELD TILE IS STICKING INTO TILE @ 2' ± FURTHER  
N.  
12:00 STARTED LOOKING FOR TILE @ INT #65 FND 5" CLAY  
TILE + STARTED LOCATING FND TILE @ #79, 80, + 83  
RAN LOCATOR N.  
2:00 FND TILE @ #89 CUT HOLE IN TOP TILE HAS 3" OF  
WATER AND IS FLOWING SLOWLY  
3:00 CREW BLEW A HOSE ON THE BACKHOLE AND HAD TO  
REPAIR IT. I SCOUTED THE 6 NW QUAD OF THE  
INTERSECTION OF JUNIPER + C-73 FOUND A 8" HICKY-  
BOTTOM INTAKE W/ A HOPE TILE RUNNING N-S 3' E OF  
INTAKE @ 90  
4:45 PICKED UP BASE AND LEFT SITE CREW WAS GOING TO  
BACK FILL HOLES
