**AGENDA**  
**REGULAR DRAINAGE MEETING**  
**Wednesday, January 20, 2021 9:30 AM**  
**Large Conference Room**

[DD 20 WO 302 - 6502.5 - INVESTIGATION-REPAIR SUMMARY 01\\_05\\_20.PDF](#)

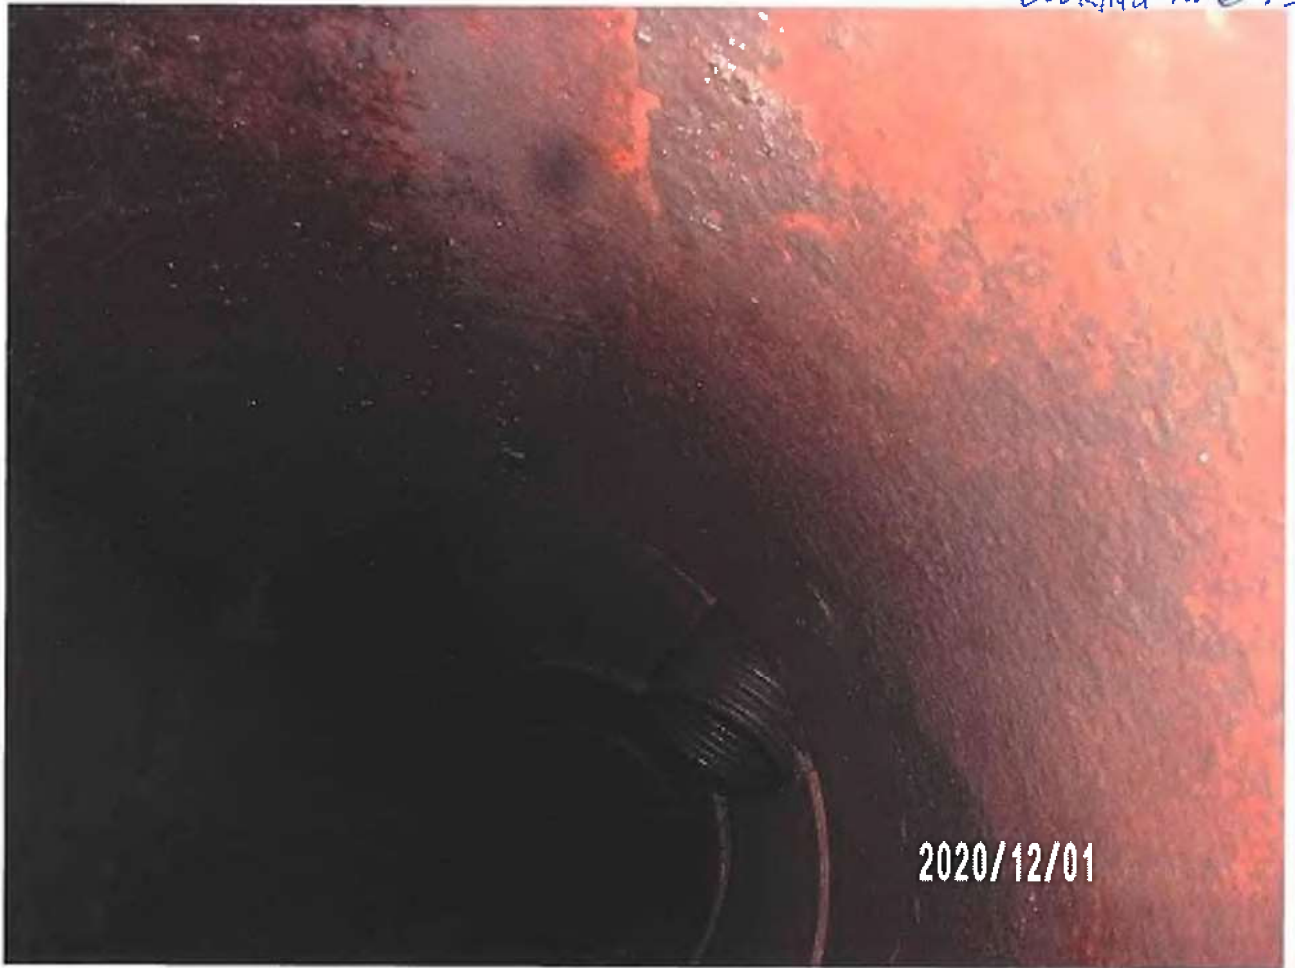
LOOKING N @ 73

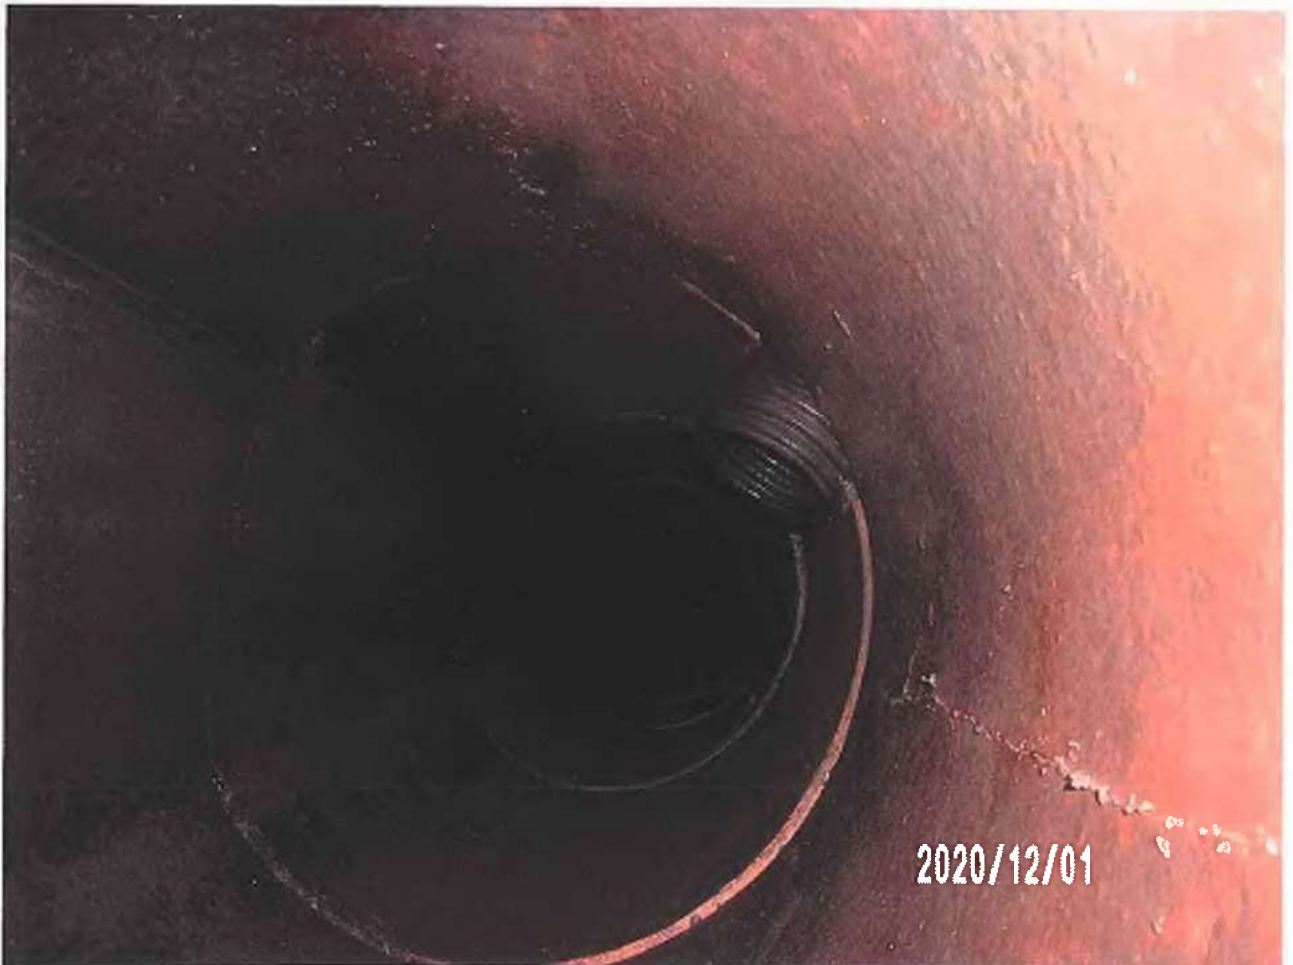
LOOKING N @ 73

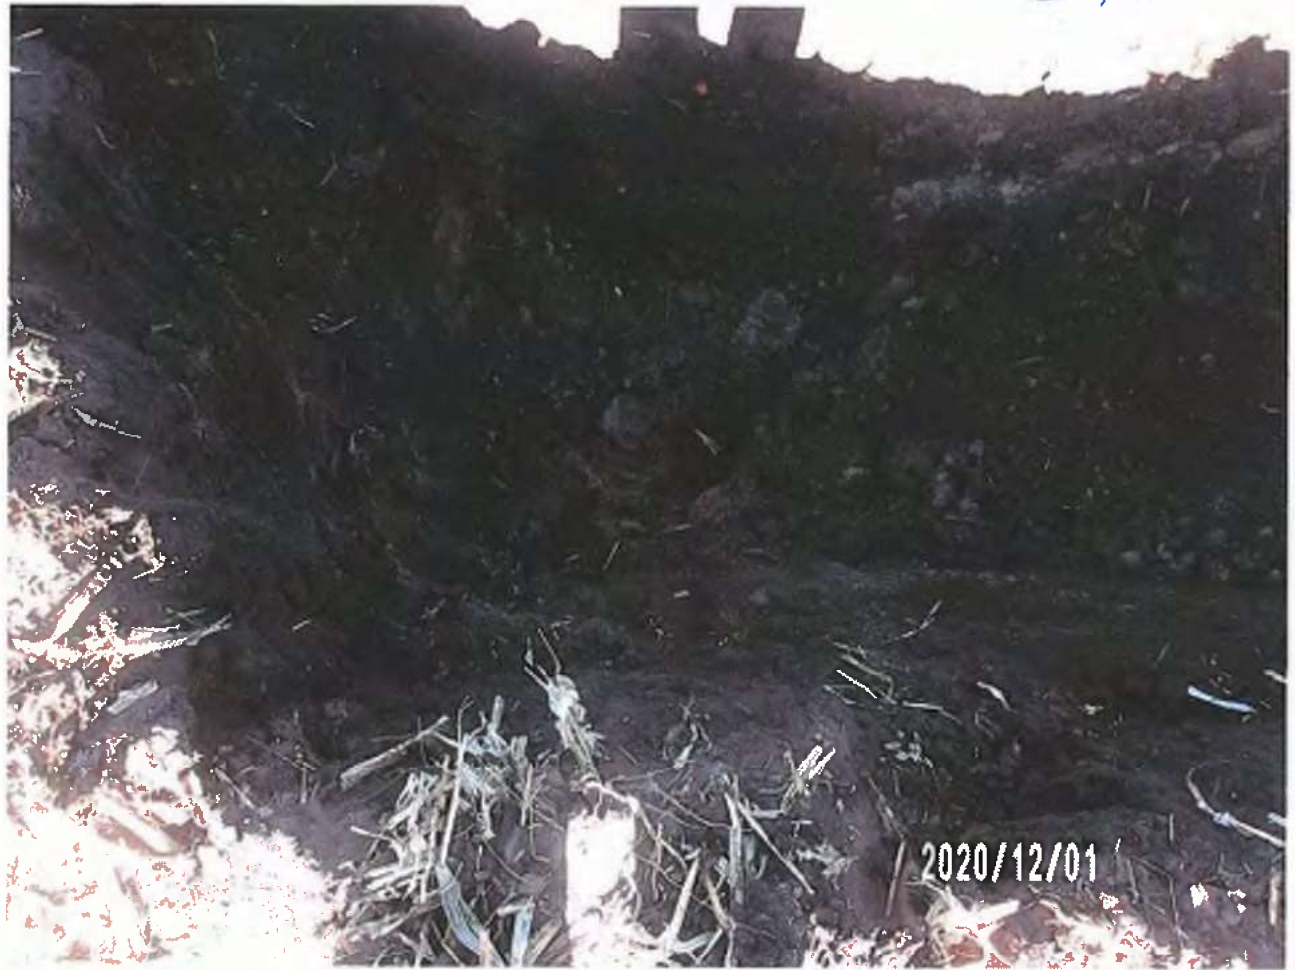
TILE @ 73

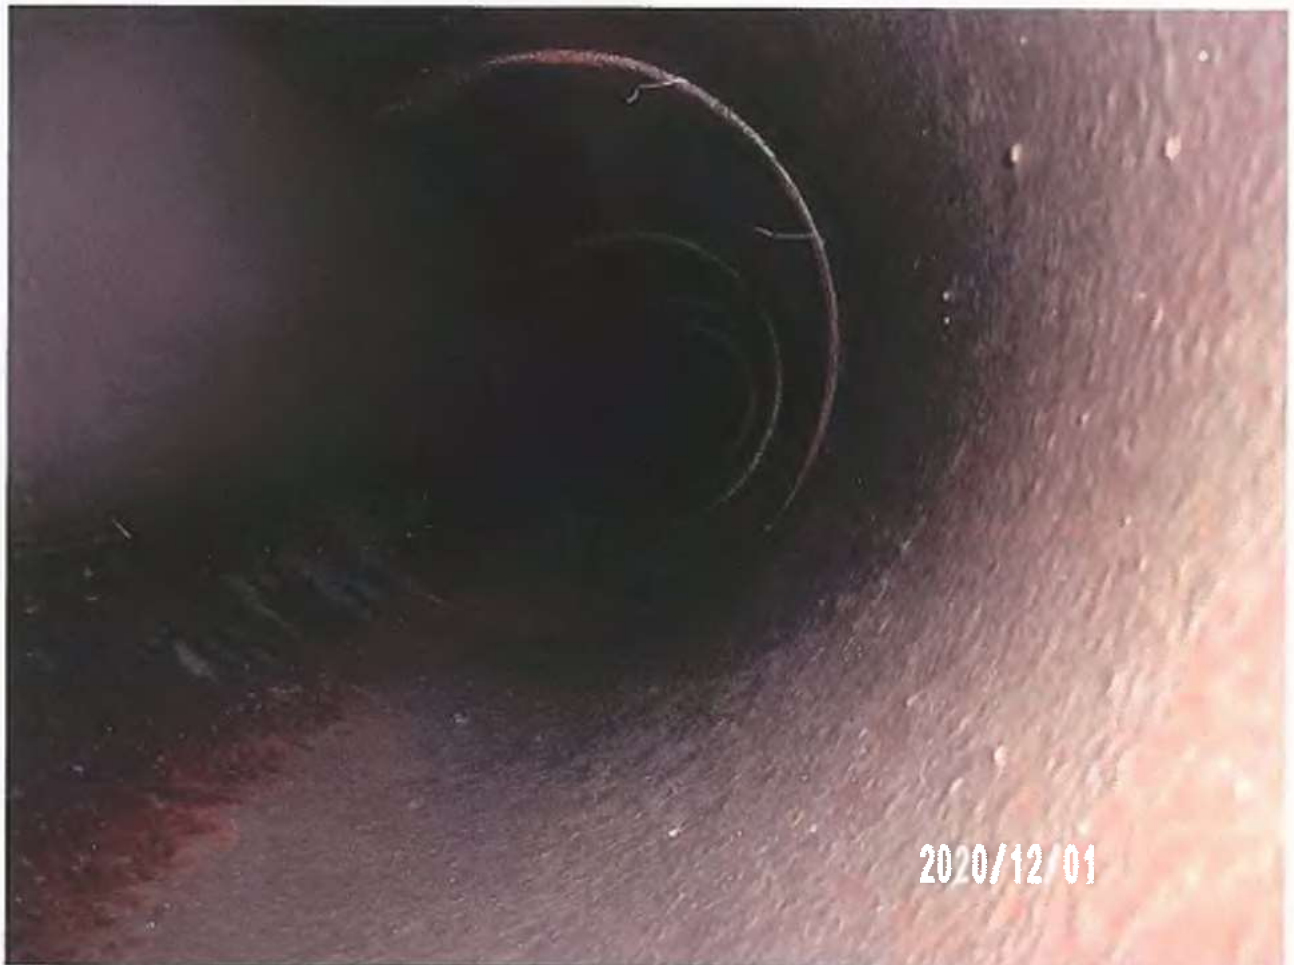
LOOKING W @ 89

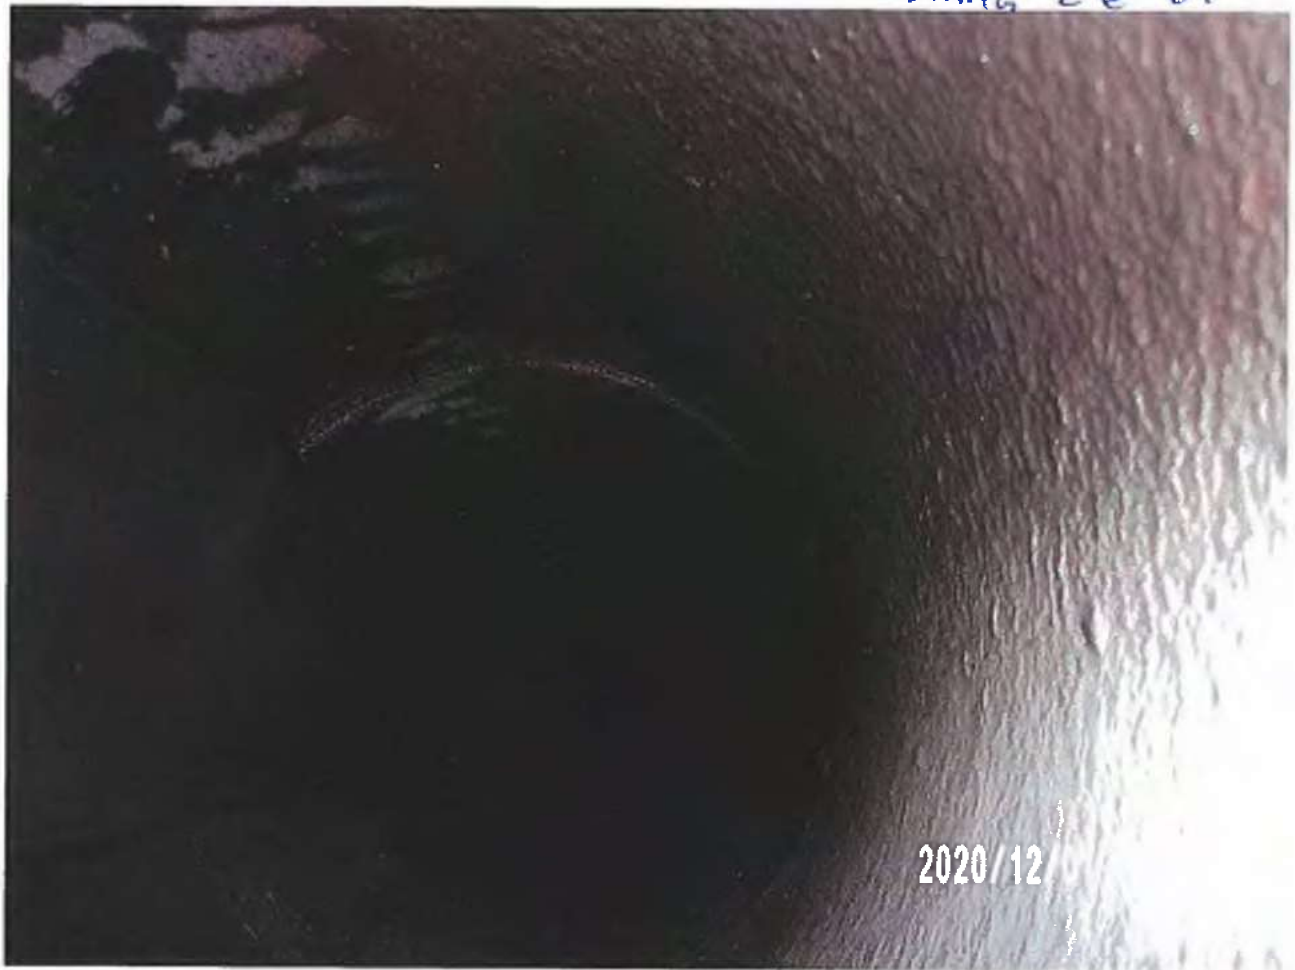
LOOKING E @ 89

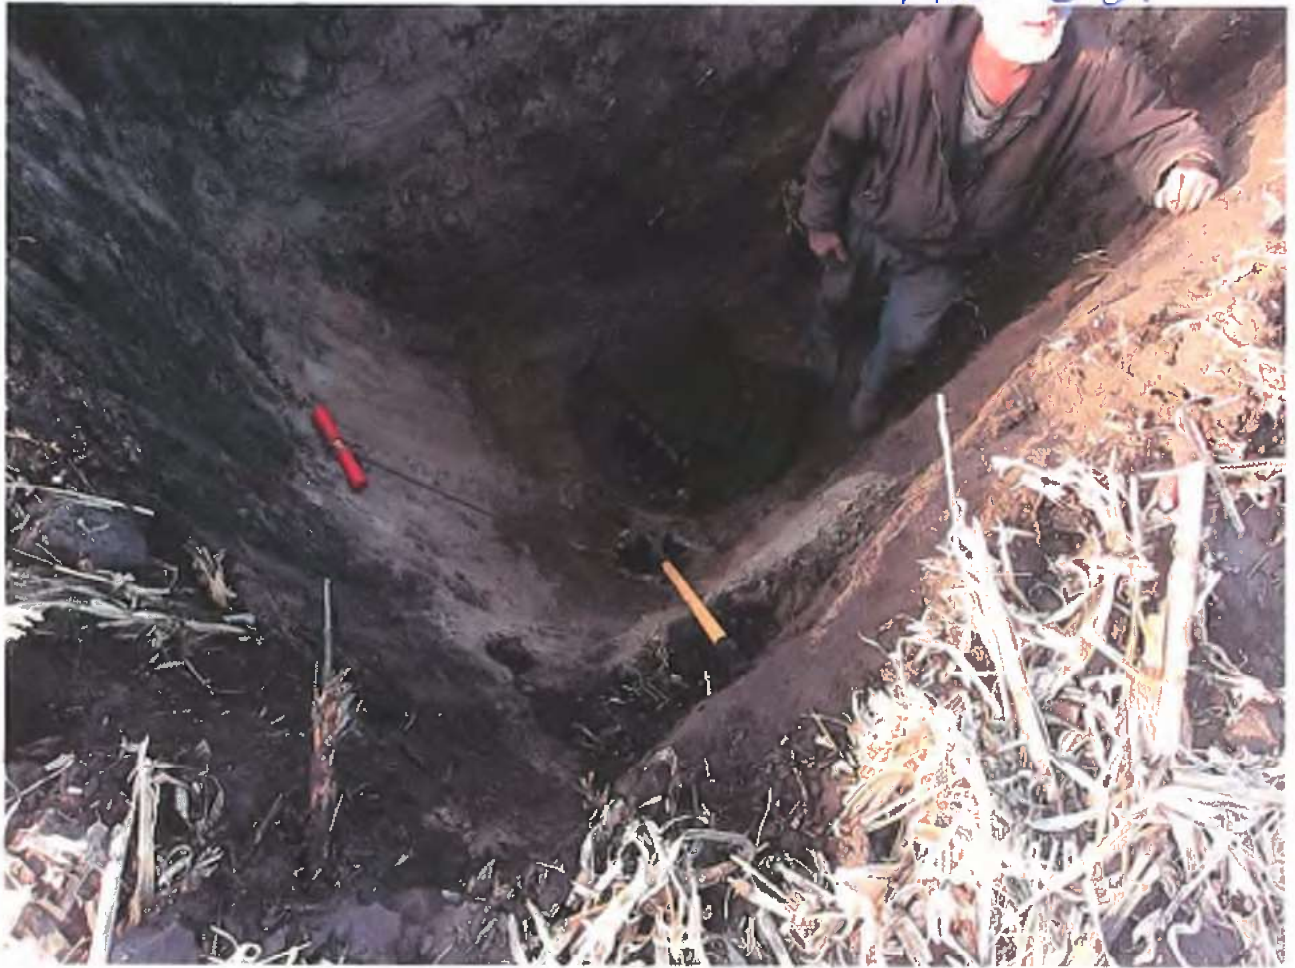
HOLE @ 89

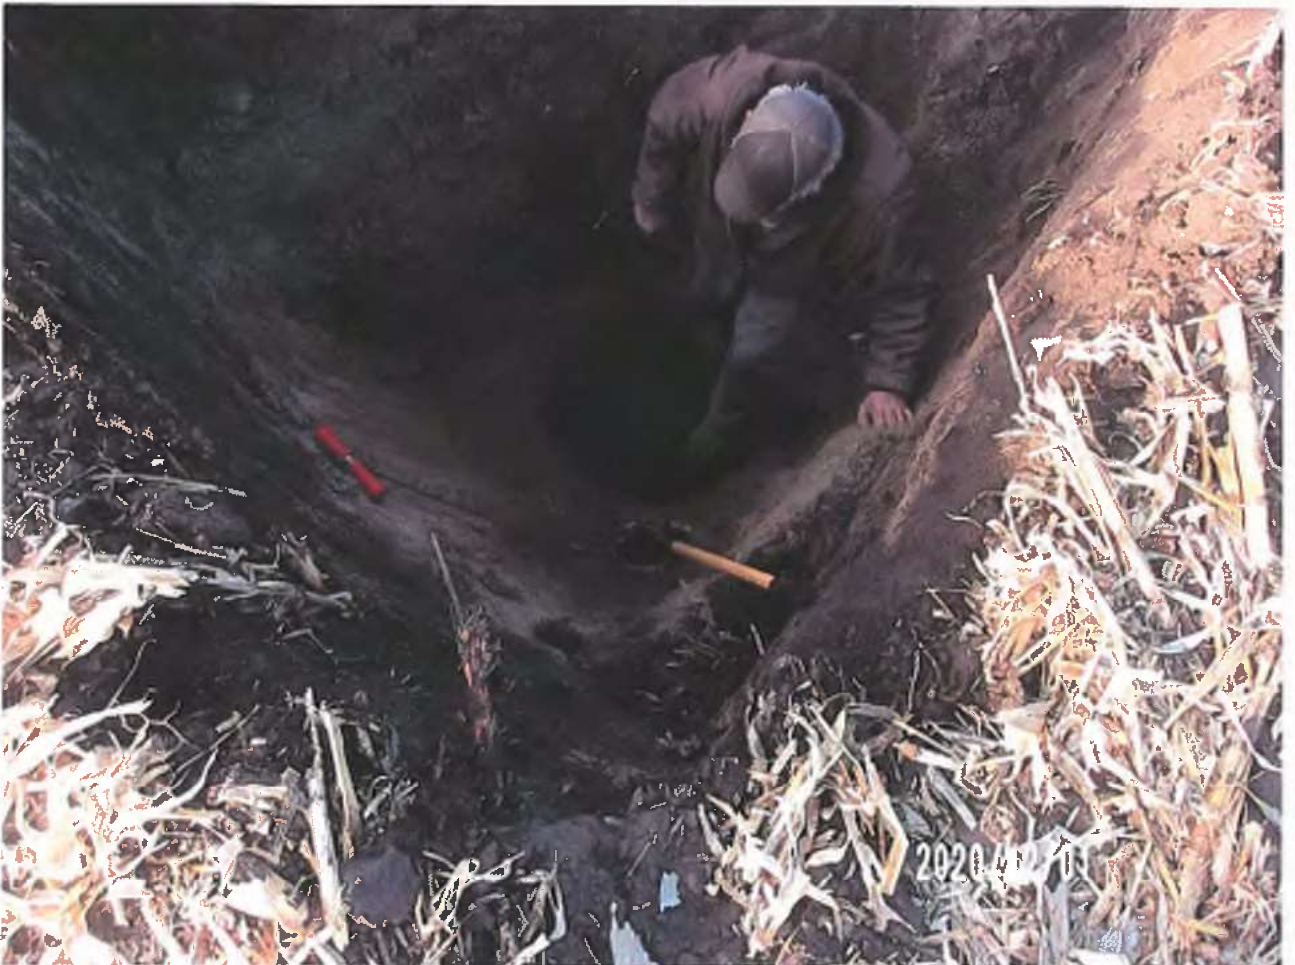
PATCH @ 89

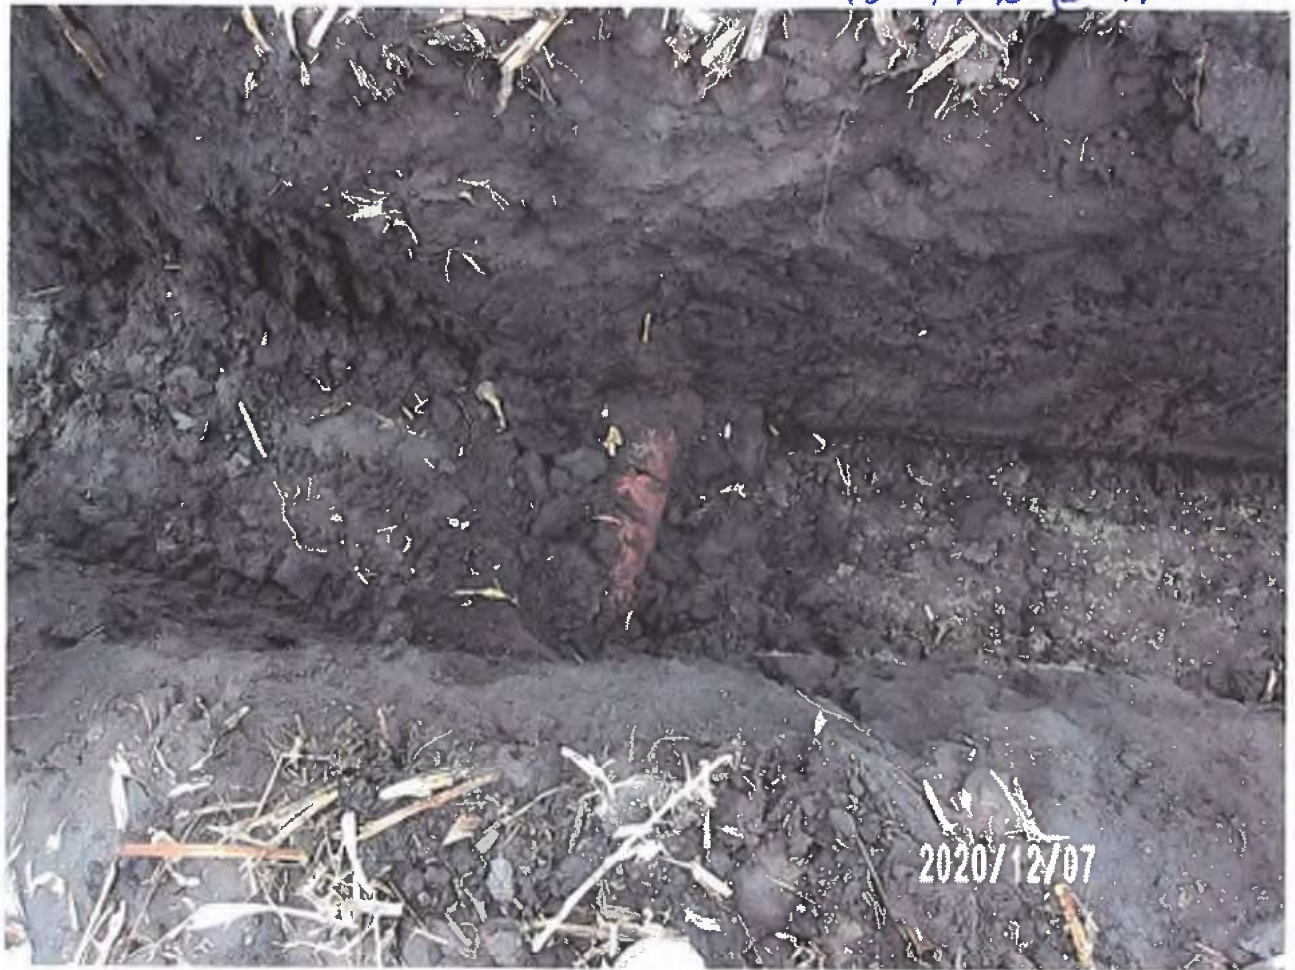
10" TILE @ 91

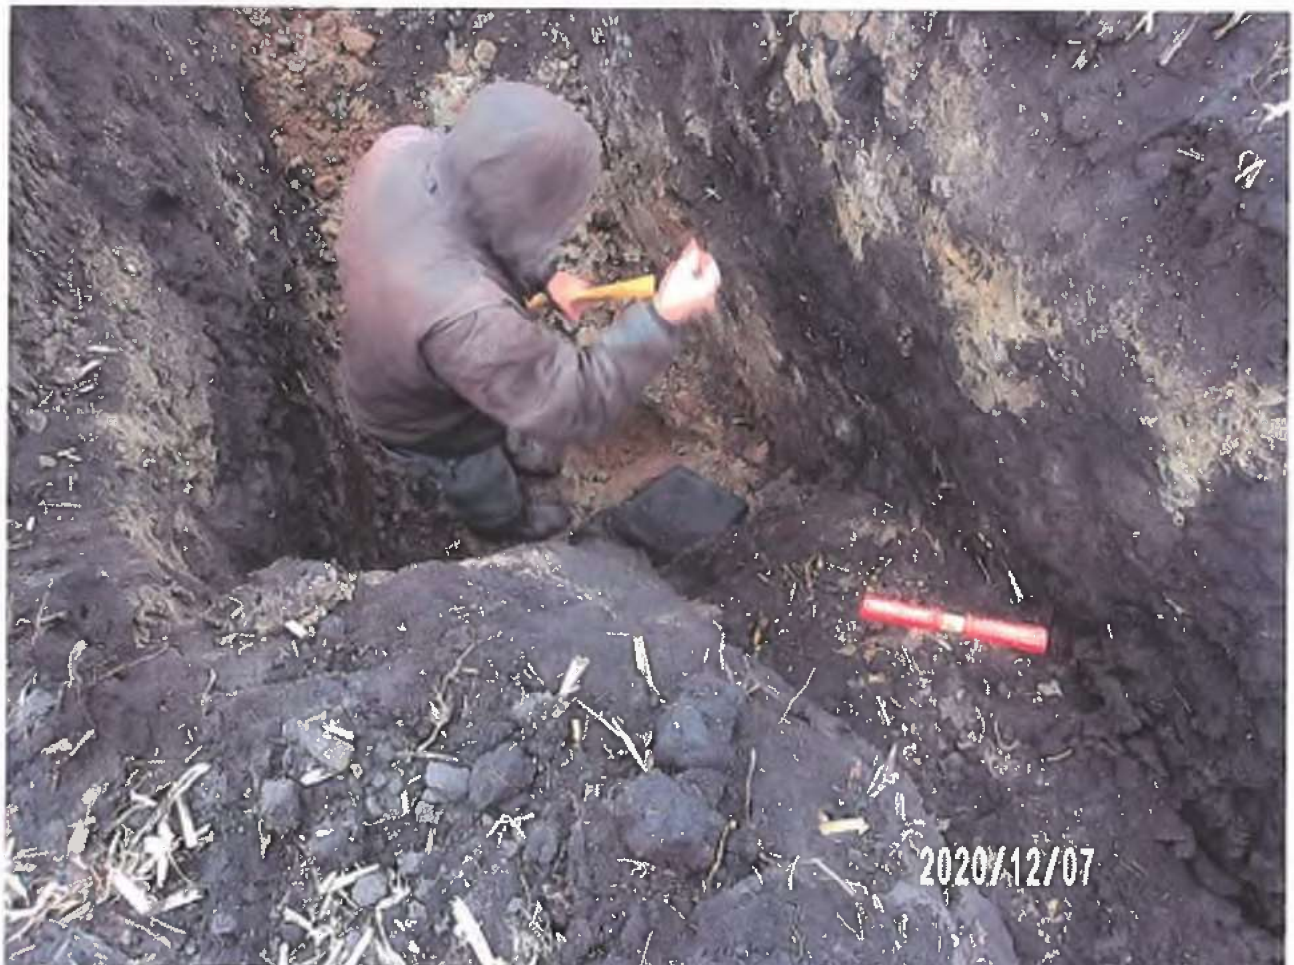
CLEARING DIRT AROUND H92

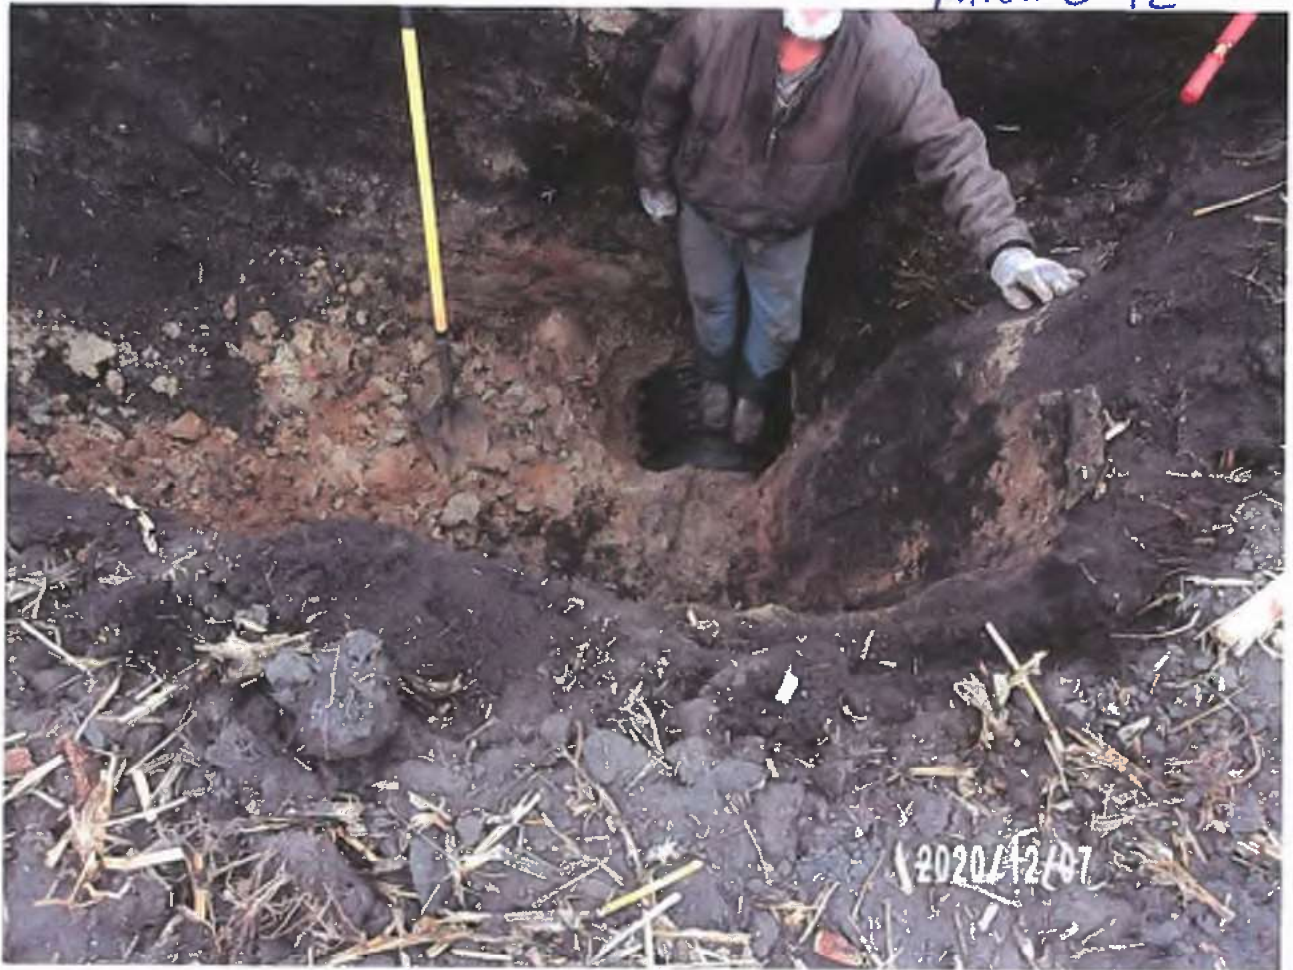
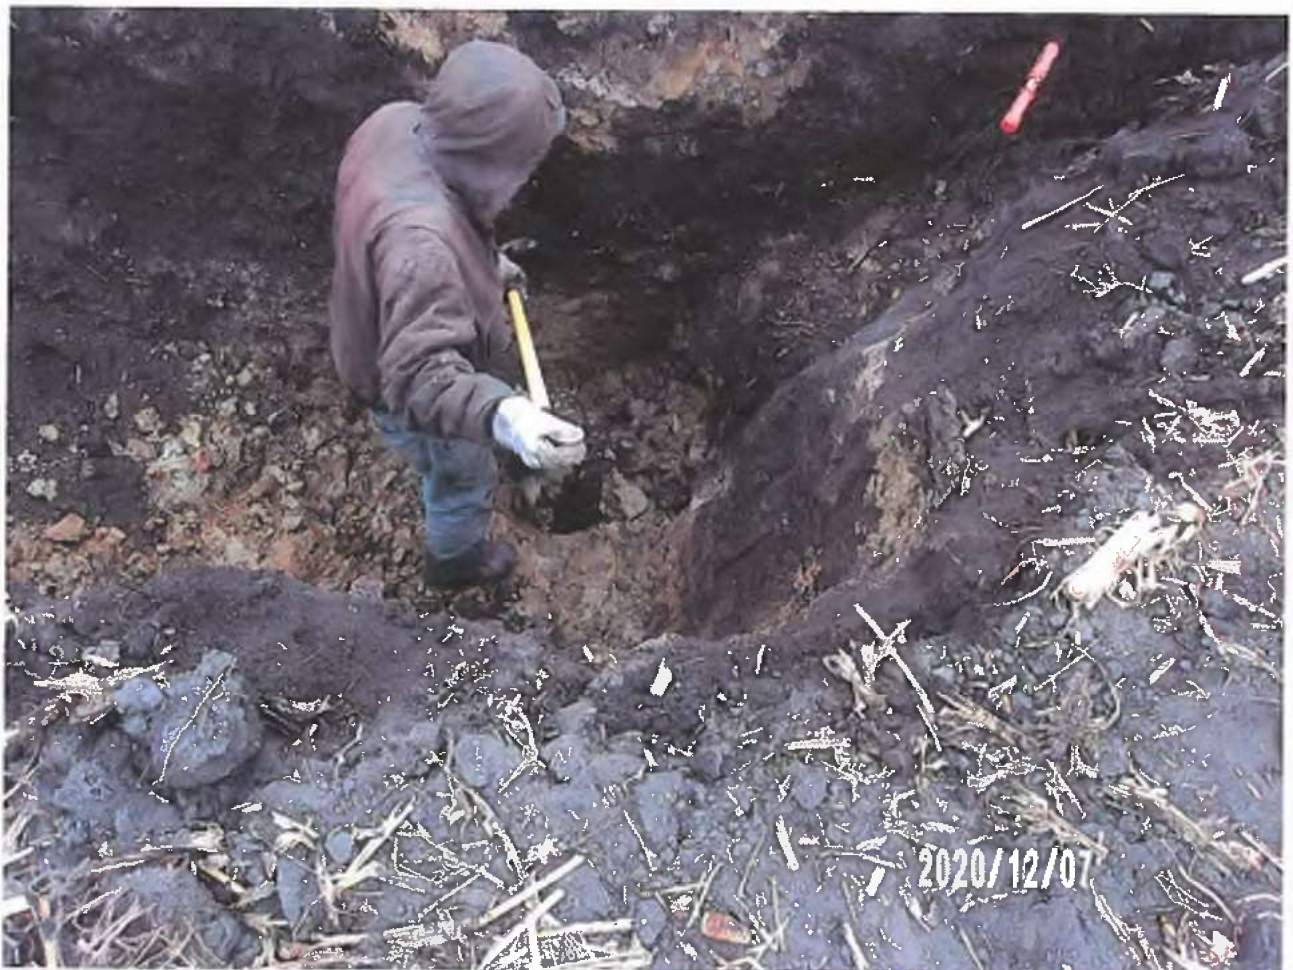
PATCH @ 92

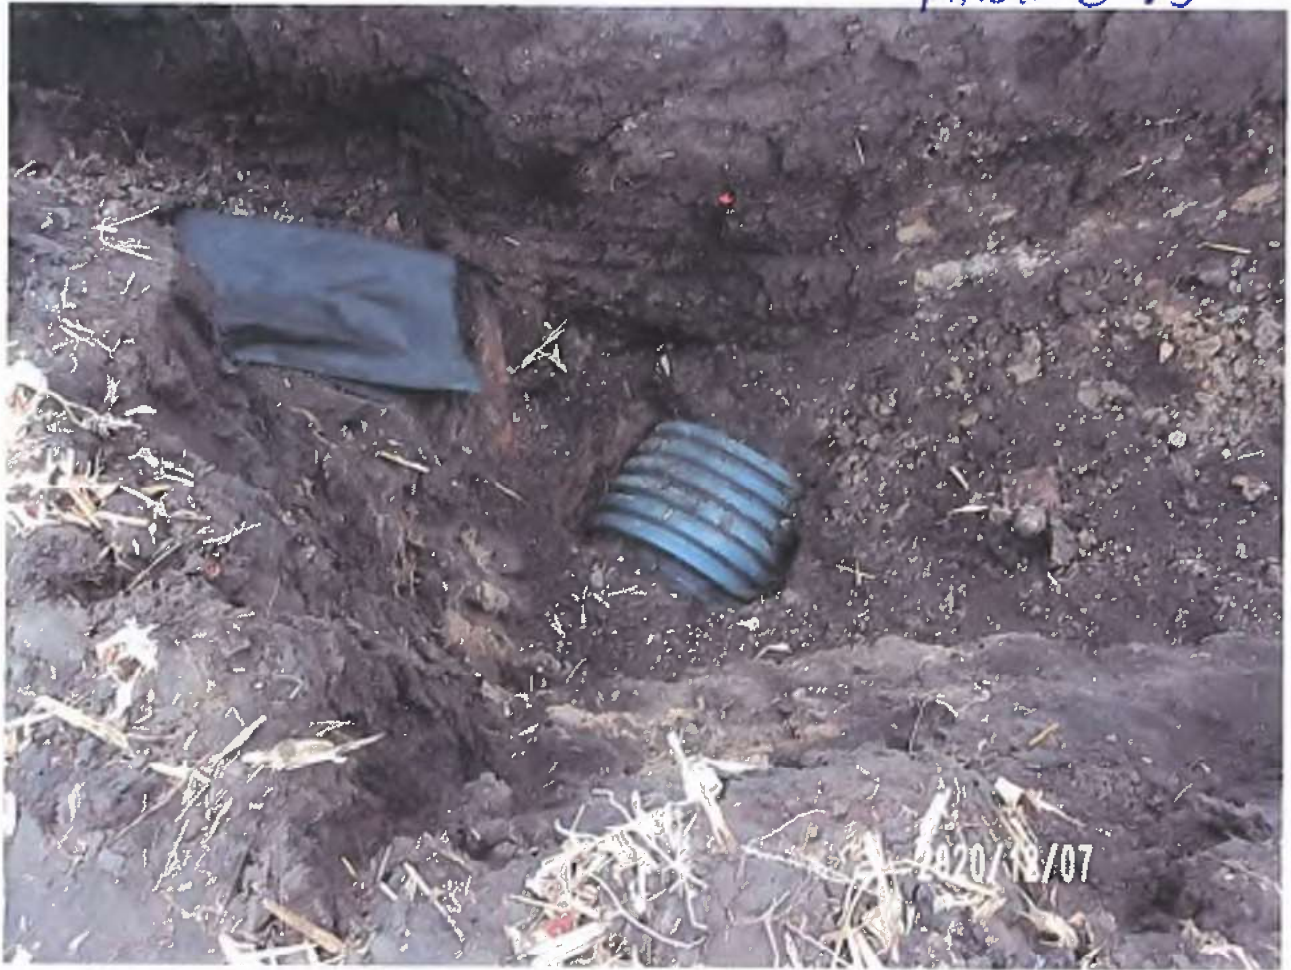
PATCH @ 73

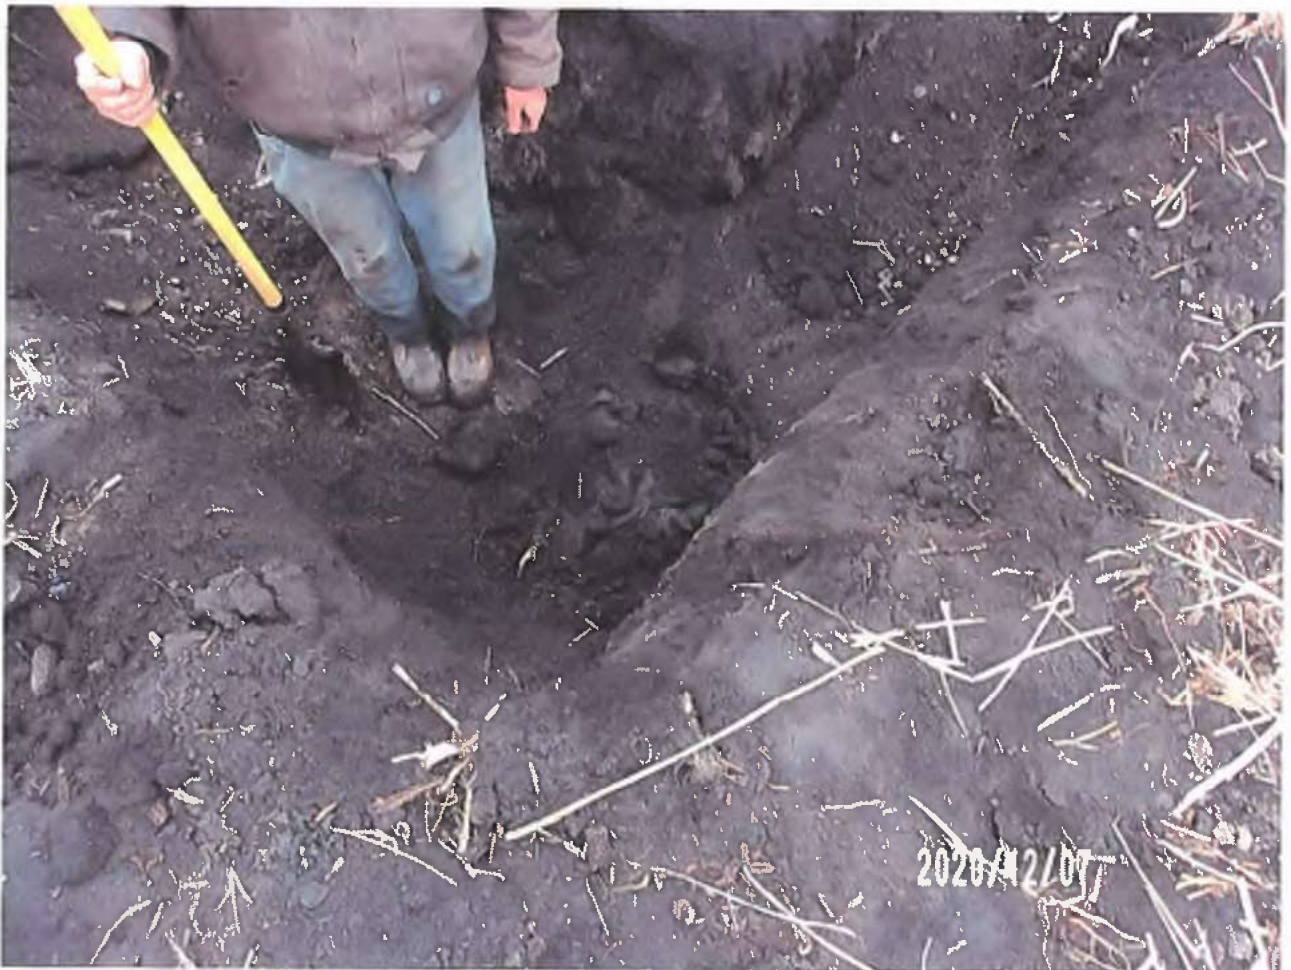
PATCH @ 69

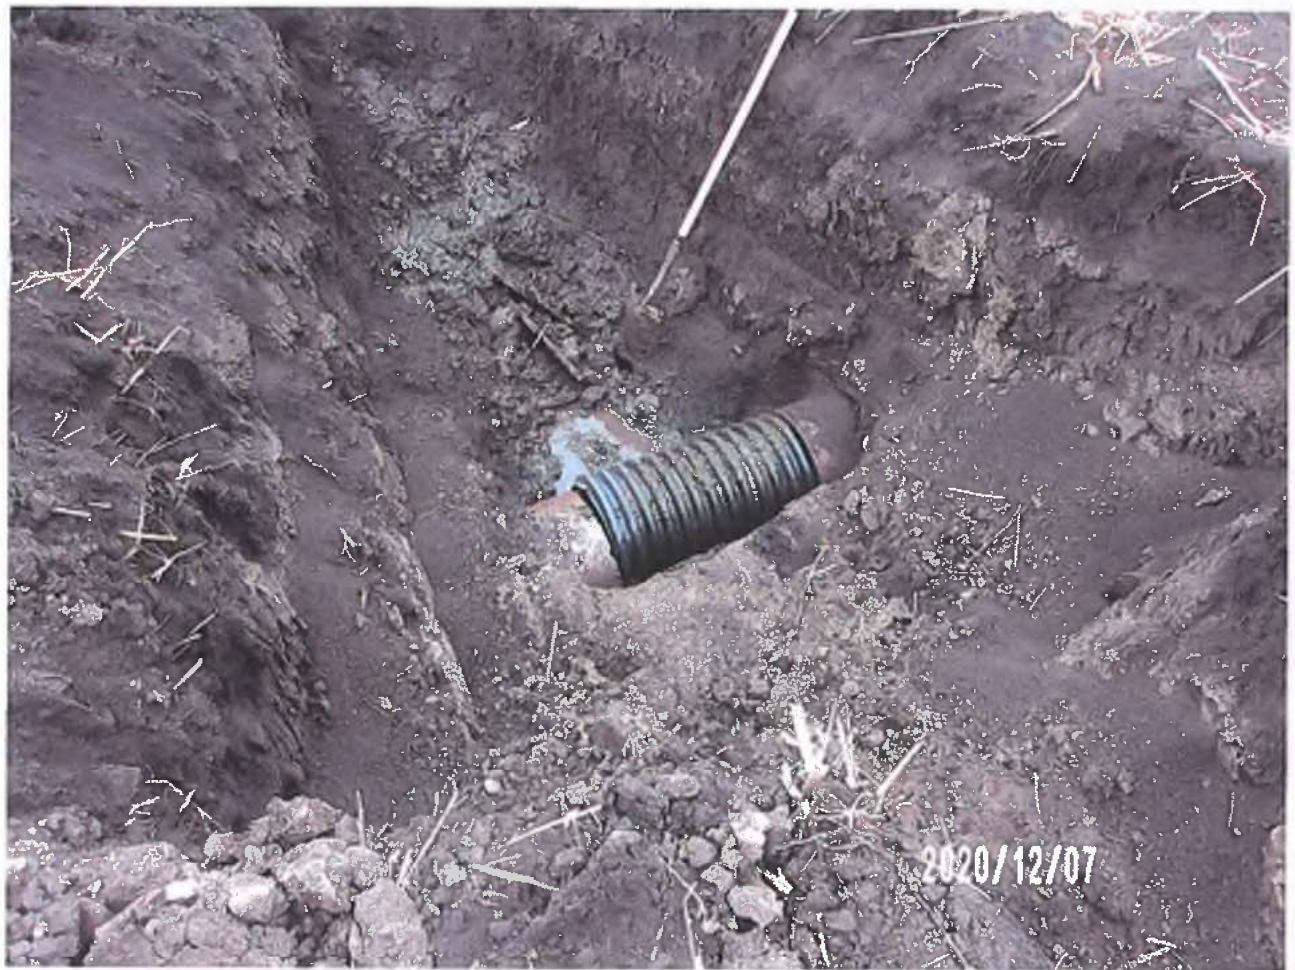
CREW PATCHED BRO REPAIRED BROKEN TILE @ 66 W/  
A 2' PIECE OF HOPE DUAL WALL TILE + WRAPPED IT  
W/ FABRIC.

PATCH @ 66
